CHARITY HALL, LONG LANE, FOWLMERE, CAMBRIDGESHIRE – PHASE 2

HISTORIC BUILDING RECORDING

Report Number: R1064

August 2014

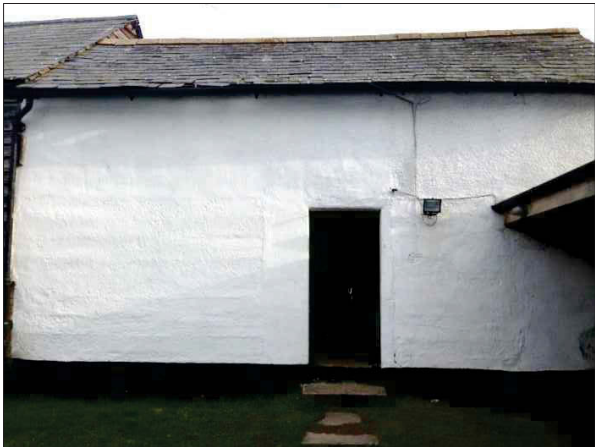
The smaller barn to the south is rendered and heavily painted white, though the underlying coursed clay lump is visible. There is a small door located in the centre (DP. 1). The grey slate roof is at a lower elevation to the adjacent large barn and pitches to the west along its length. Modern security lights and guttering are present.

DP1, Pre-1886 Barn, West Elevation, Looking East

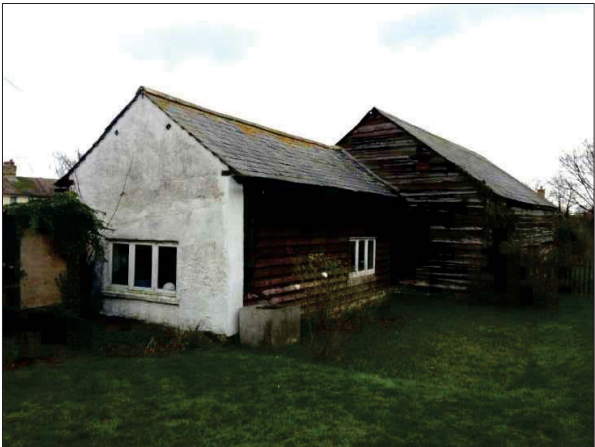
constructed of brown weather boarding and contains a double pane window at its northern end, close to the join with the main barn (DP. 2). The roof is also of well-maintained grey slate and pitches down to the east.

DP2, Barn & Post-1886 Barn to Rear, South & East Elevation, Looking North-West

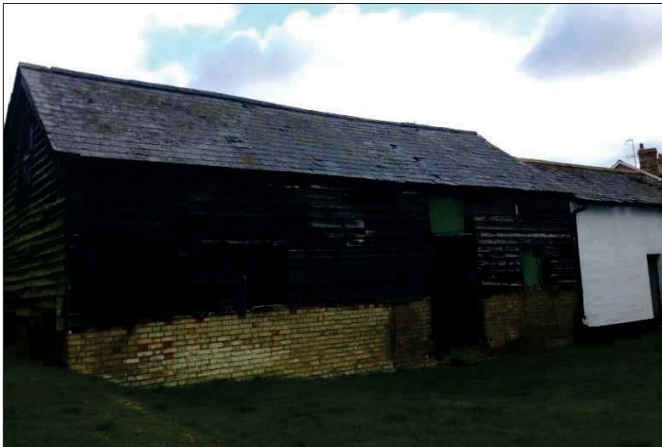
DP3, Barn, West Elevation, Looking South-East

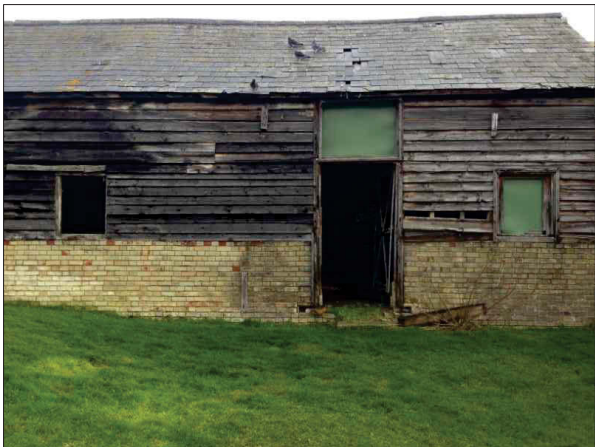
DP4, Pre-1886 Barn, West Elevation, Looking East

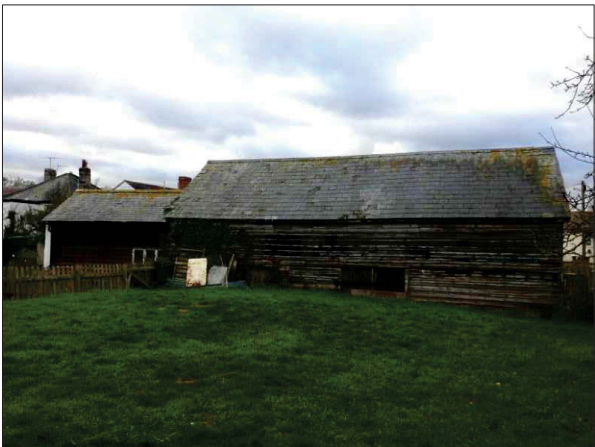
The eastern elevation comprises the long section of both parts of the structure (DP. 5). The larger building to the north is clad in grey/black weatherboarding with a small area of brick plinth visible at the northern end (DP. 6). A two-light casement (lacking glass) is present near the centre and base of the structure and the grey slate roof pitches down to the east. The smaller building to the south is set back from the main building wall by 1.28m and joins the larger structure with a lower roof elevation. It is similarly

DP5, Barn, East Elevation, Looking East

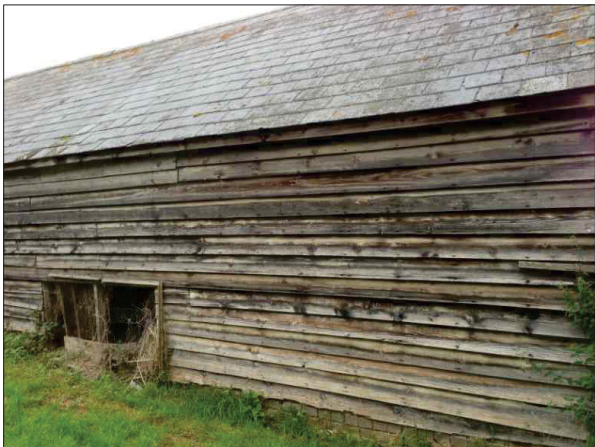
DP6, Barn, East Elevation, Looking South-West

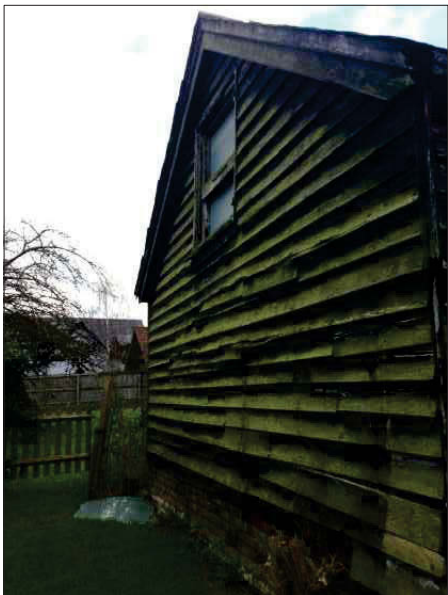
The northern elevation consists entirely of the larger barn gable end. Approximately 0.50m of brick plinth is visible and the remaining structure comprises old weatherboard turned green with algae or moss. A large aperture pierces the elevation at high level. It now contains a window with two vertical panes, but perhaps originally formed a loading aperture (DP. 7).

DP7, Barn, North Elevation, Looking South-East

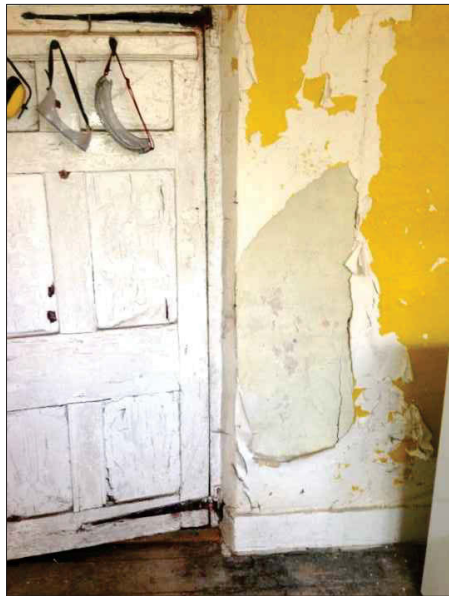
DP8, Main Door, Looking West

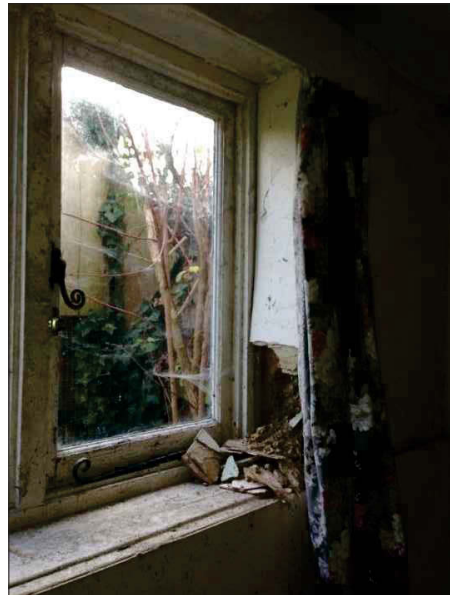
DP9, Internal Window, Looking South

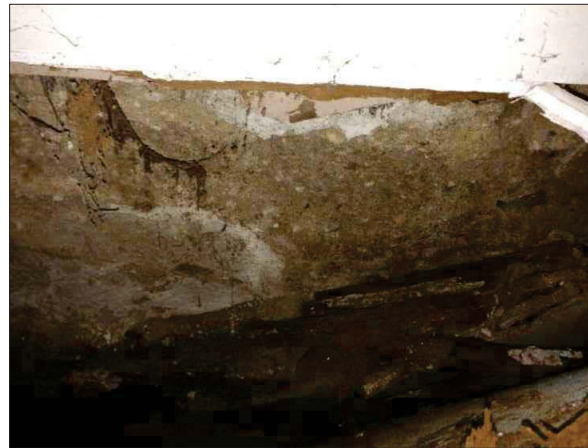
DP10, Internal Wall, Looking West

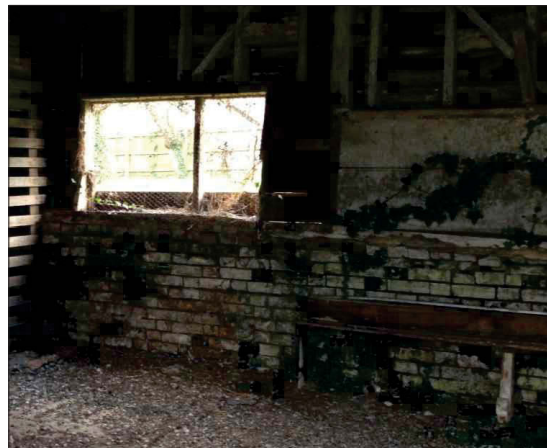
The larger barn is of slender softwood construction following a primary-braced system of studwork over the brick dwarf wall, with the weatherboarding visible to the rear. In some areas horizontal boarding has been applied and the entire south wall is weatherboarded. Evidence suggests this range was originally utilised as a livestock shed or for storage, and the original brick floor appears to survive, overlaying the natural chalk (DP. 11).

DP11 Post-1886 Barn, Internal Eastern Wall, Looking North-East

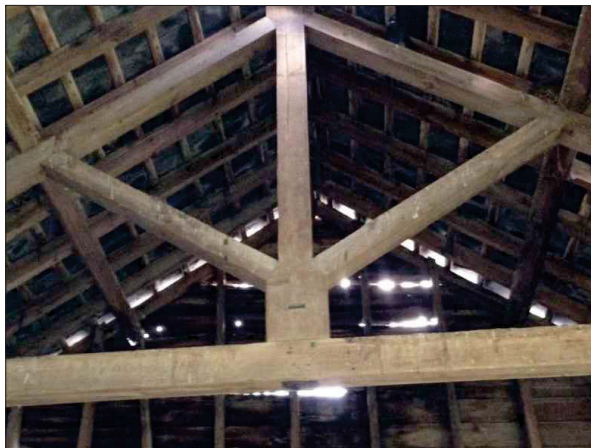
The roof has been somewhat altered though retains a single original truss of typical 19th century double-framed construction (DP. 12). It is of king-post form and comprises a straight tie-beam with the king post shouldered at the head and base, and secured with a coach bolt through the tie-beam. Raking struts rise to the principal rafters and there is a single purlin in each pitch, over which the common rafters ride to a ridgeboard at the apex.

DP12 Post-1886 Barn, King-post Truss, Looking North

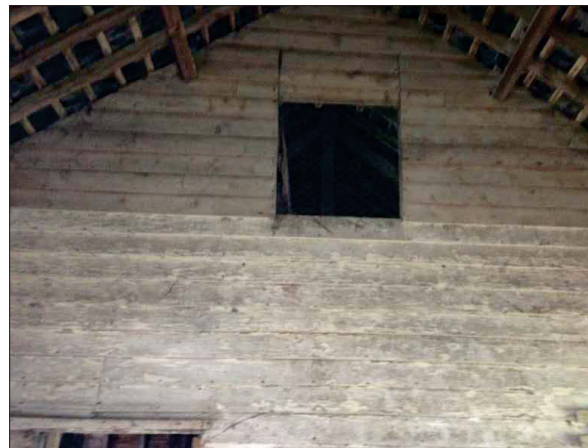
DP13, Post 1886 Barn, Internal Shot, looking South
