NARBOROUGH BONE MILL, NARBOROUGH NORFOLK

DETAILED MAGNETOMETER SURVEY

Site Code	ENF136118	NGR	TF 7325 1261
Planning Ref.	n/a	OASIS	britanni1-203216
Approved By	Matthew Adams	Date	February 2015

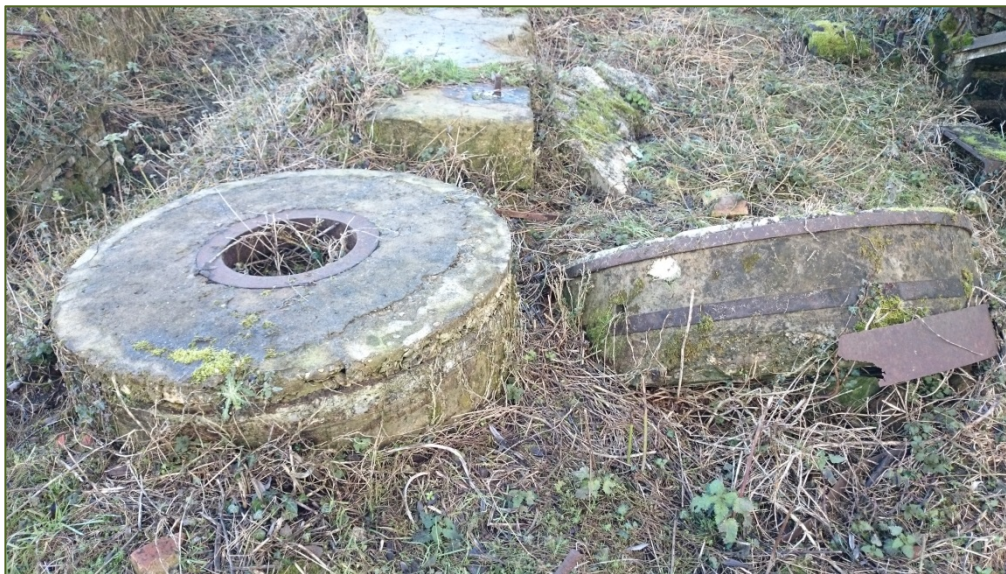
DP1

Extant Mill Stones at Narborough, Facing north-east from the south-west.

Extant remains include the 16-foot (4.9 m) diameter waterwheel, the main mill building foundations, three underground sluices and three millstones. A brick underground tunnel thought to be used as an overflow channel can also be entered. The Nar still flows

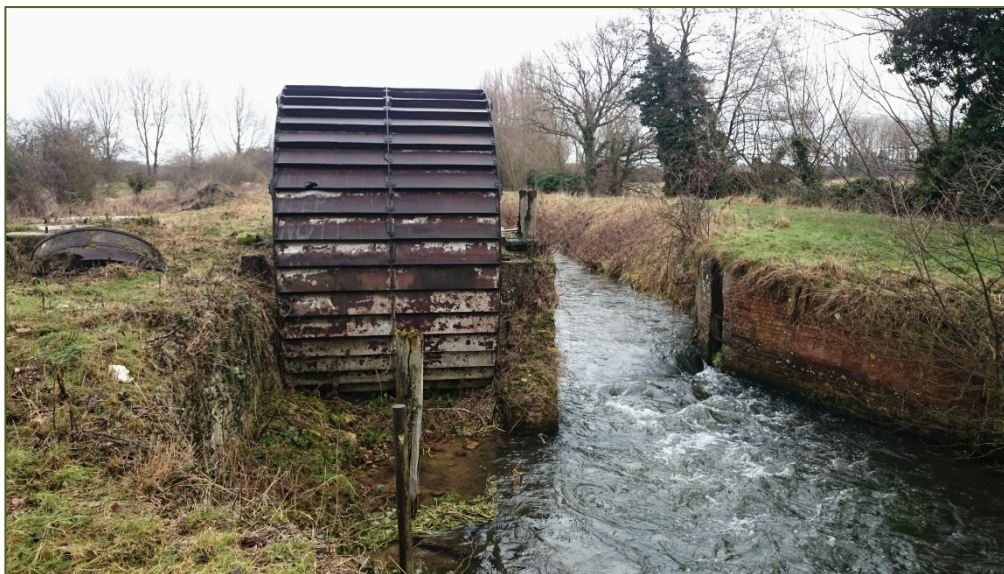
DP2

Low-breast Water Wheel, Facing north-east from the south-west.

This site was specifically chosen to gain maximum efficiency from the low breast wheel. The original stanch gate was replaced with one built for the mill, together with a pair of mitre gates located 52m upstream. These gates prevented the loss of water when a boat moved downriver so that there was no wheel down-time. The mill race was also taken from this partly walled chamber.

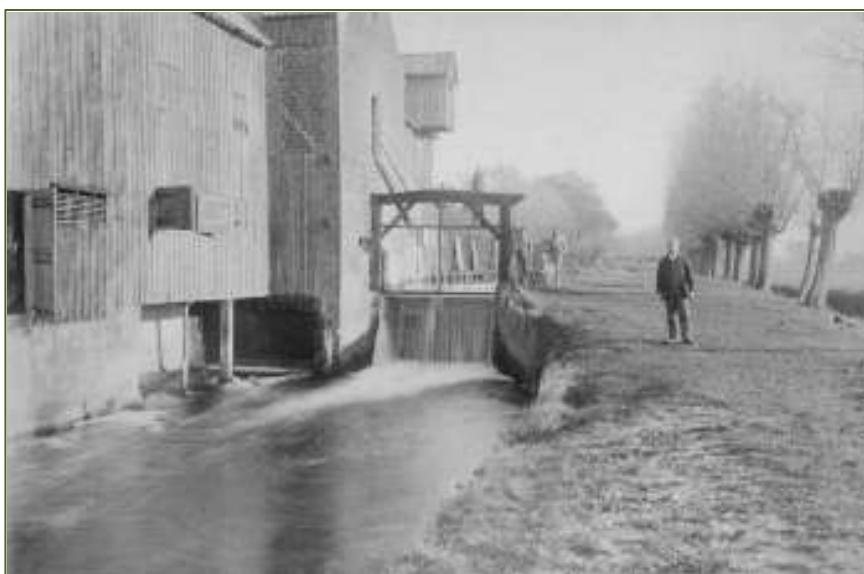
DP3

Photograph dated c.1890, Facing north-east from the south-west, showing stanch gate.

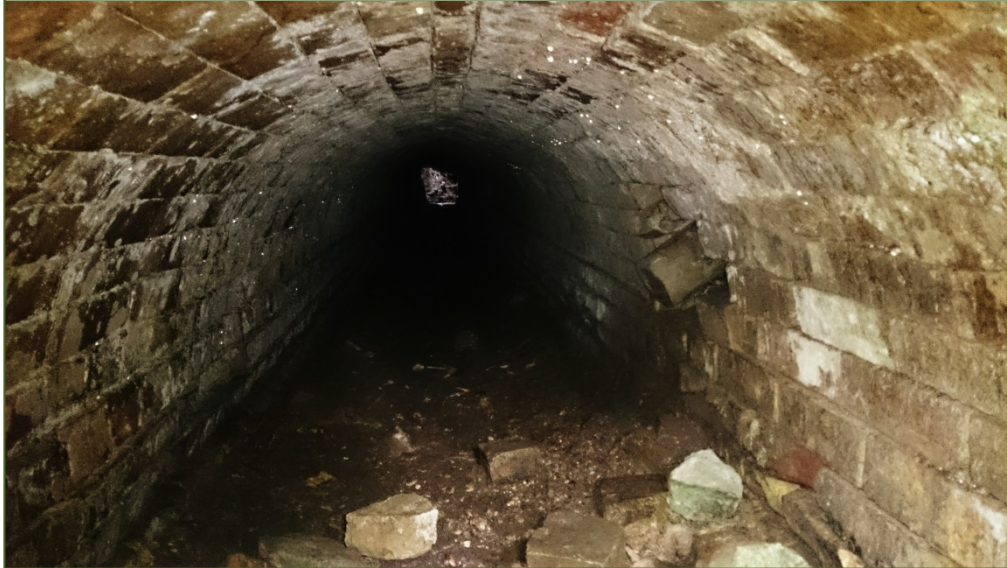
DP4

Brick Overflow Tunnel, Facing north-east from the south-west.
