LAND AT CORNER OF STATION ROAD, FULLBRIDGE, MALDON, ESSEX

ARCHAEOLOGICAL EVALUATION

Report Number: 1126 March 2016

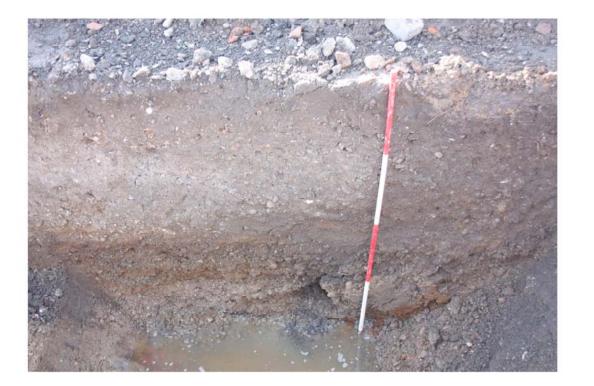
DP3: SAMPLE SECTION 3: VIEW S

Table 1						
Trench No		Orienta		Height AOD		Shot No
3			NW - SE	2.92m		DP3
Sample Sect	ion No		Location		Facing	
_	3		SW	Side		NE Facing
Context No	Depth	Dep	osit Description			
1000	0.00 - 0.19r	n Yard	Surface. Light gree	y concrete hard star	iding mixe	ed with tarmac.
1002	0.19 - 0.54r		Demolition Layer. Dark grey brown, loose sand, silt and clay with large CBM a rubble inclusions.			
1004	0.54 - 1.43r		amation Layer. Mi ble inclusions	d brown orange, I	oose san	dy clay with frequent flint
1005	1.43 - 1.57r		Reclamation Layer. Light orange, loose sandy clay with frequent flint pebble inclusions.			
1007	1.57 – 1.73r		Reclamation Layer. Dark brown grey compact silty clay with infrequent flipebble inclusions.			
1008	1.73 - 1.87r	n Recl	amation Layer. M	id-brown grey, sil	ty clay	with frequent flint pebble

inclusions.
1009	1.87 - 2.02m	Reclamation Layer. Light grey brown, compact sandy clay with frequent gravel inclusions.
1010	2.02 - 2.11m	Reclamation Layer. Mid-grey brown, sandy clay with infrequent gravel inclusions.
1011	2.11 - 2.27m	Reclamation Layer. Light grey yellow, compact sandy clay with infrequent gravel inclusions.
1012	2.27m +	Natural gravels. Light orange brown, loose sandy gravel with occasional moderate sub angular flint inclusions

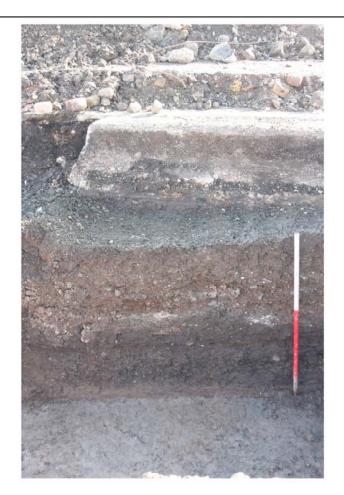
DP7: SAMPLE SECTION 7: VIEW E

Table 9									
Trench No O		Orienta		Height AOD		Shot No			
7			NE - SW	2.95m		DP7			
Sample Section No			Location	Facing					
	7		SW Side		NW Facing				
Context No	Depth	Dep	Deposit Description						
1000	0.00 - 0.12n	n Yard	Yard Surface. Light grey concrete hard standing mixed with tarmac.						
1001	0.12 - 0.46n	n Cond	Concrete Pad.						
1002	0.46 - 0.70n		Demolition Layer. Dark grey brown, loose sand, silt and clay with large CBM and rubble inclusions.						
1003	0.70 - 0.99n		Made Ground. Mid brown orange, compact, silty clay with frequent CBM and flint pebble inductions.						
1004	0.99 – 1.16n		Reclamation Layer. Mid brown orange, loose sandy clay with frequent flint pebble inclusions						
1005	1.16 - 1.59n		Reclamation Layer. Light orange, loose sandy clay with frequent flint pebble inclusions.						
1006	1.59m +	Allu	Alluvial Clay. Mid-grey blue, compact silty clay

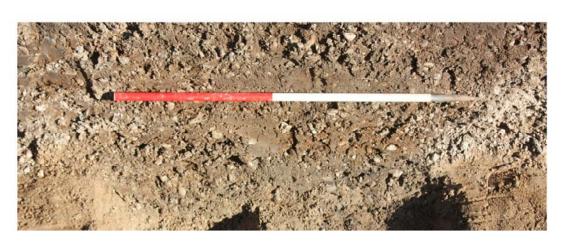
DP8: SAMPLE SECTION 8: VIEW N

Table 10									
Trench No 5		Orientation NW - SE		Height AOD 2.80m		Shot No DP8			
Sample Sect	ion No 8		Location NE Side		Facing SW Facing				
Context No	Depth	Dep	Deposit Description						
1015	0.00 - 0.19n		Demolition Layer. Dark brown grey, loose mixture of sand, silt and clay with frequent CBM rubble inclusions						
1017	0.19 - 0.43n		Former Coal Yard Layer. Dark grey black, loose sandy silt with frequent CBM and coke inclusions.						
1018	0.43 - 0.99n		Reclamation layer. Light yellow orange, loose, sandy gravel with frequent large rounded flint.						
1012	0.99m +		Natural gravels. Light orange brown, loose sandy gravel with occasional moderate sub angular flint inclusions

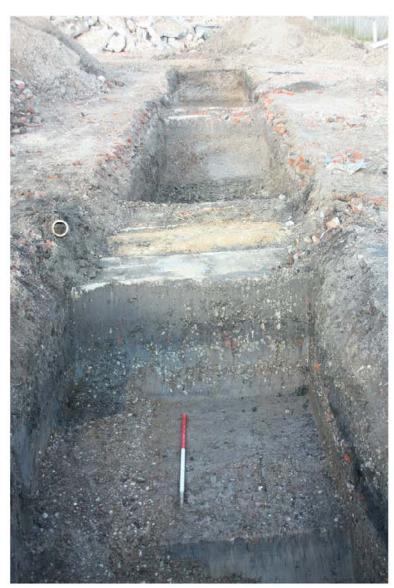
DP9: TRENCH 2: VIEW N

Trench 2 was located in the eastern area of the site closest to the current boundary. It runs parallel to the site boundary and was orientated north-east to south-west. Modern demolition layer 105 was the uppermost layer in the trench which overlay levelling layer 1016. This levelling layer is associated with the workshops that were present in this area until demolished just prior to the archaeological investigations. Layer 1017 associated with the former coal yard was next in the stratigraphic sequence which overlay reclamation layer 1019. Natural gravels 1012 were the final layer in the sequence. Two patches of alluvial clays 1006 were recorded in the trench possibly defining the course of a rivulet through the gravel islands away from the intertidal zone.

The trench contained two sets of modern foundations associated with the former buildings present in this area of the site. These were both orientated east–west and bisected the trench. A modern demolition trench was also present associated with the demolition of buildings relating to the former coal yard.

No archaeological finds or features were present in the trench.

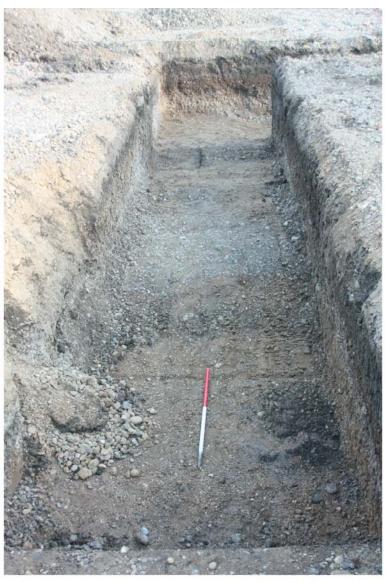
DP10: TRENCH 5: VIEW E

Trench 5 was located perpendicular to Trench 2 at its northern end. The trench was orientated north-west to south-east. The upper layer in this trench was modern demolition 1015 which was above former coal yard layer 1017. The next layer in the stratigraphic sequence was made ground 1018 followed by another series of reclamation layers, (1019, 1020 and 1021). The final deposit in the trench was natural gravels 1012.

The trench contained natural feature 1013, (Fig. 9) which was $1.00m + x 1.00m \times 0.70m$. the natural feature was roughly linear in plan with uneven sides and an uneven base. It contained a single fill of light grey brown, silty clay with frequent large flint pebble inclusions representing an infilling event during the reclamation activity on the site. It is likely that this natural feature is another rivulet running through the former marshland infilled when the site was consolidated for expansion and industry.

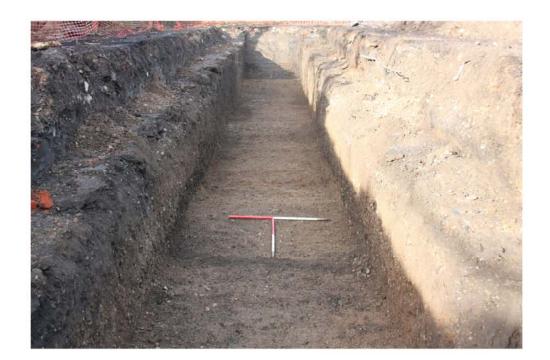
DP11: TRENCH 3: VIEW W

Trench 3 was located in the west of the site perpendicular to the site boundary with Fullbridge and close to Fullbridge House. The trench was orientated north-west to southeast. The first layer in this trench was yard surface 1001, which overlay a layer of demolition (1002), associated with the demolition of the dwelling formerly present in this area of the site. The next layers in the sequence (1004, 1005, 1007, 1008, 1009, 1010 and 1011) are all associated with the raising of the ground level in this area of the site

through a series of reclamation events. The final layer in the sequence was natural gravels 1012.

No archaeological finds or features were present in the trench.

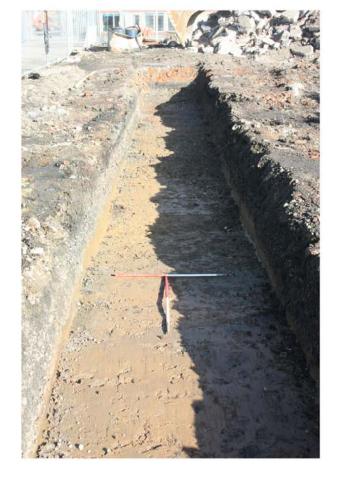
DP12: TRENCH 4: VIEW N

Trench 4 was positioned in the centre east of the site in the area of the former coal yard. It was orientates north – east to south – west. The upper layer of this trench was modern demolition 1015 which overlay levelling layer 1016. Former coal yard layer 1017 was next in the stratigraphic sequence with reclamation material 1019 below. A thin layer of alluvial silt (1022) was present above natural alluvial clay 1006 which was the final layer in the sequence.

No archaeological finds or features were present in the trench.

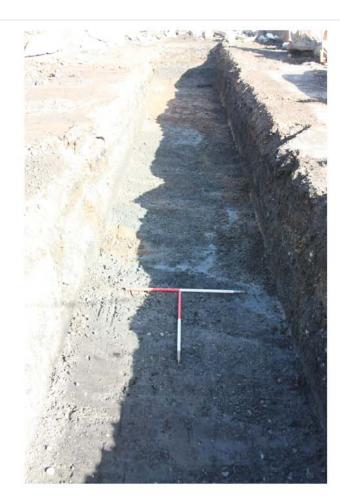
DP13: TRENCH 6: VIEW N

Trench 6 was in the western area of the site and was orientated north-east to south-west. Yard surface 1000 was the uppermost layer in the stratigraphic sequence. This lay above demolition layer 1002. The next layer in the sequence was reclamation layer 1004 followed by a second layer of reclamation (1005). Natural gravels 1012 were the final deposit in the sequence.

No archaeological finds or features were present in the trench.

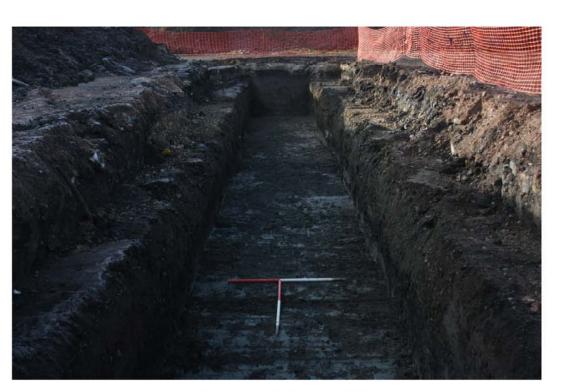
DP14: TRENCH 7: VIEW S

Trench 7 was in the north-western area of the site and was orientated north-east to south-west. Yard surface 1000 was the first layer in the stratigraphic sequence which overlay a concrete pad (1001) that ran the length of the trench. The next layer in the sequence was demolition layer 1002 which in turn overlay made ground layer 1004. Two layers of reclamation material (1004 and 1005) were next in the sequence. The final deposit encountered was alluvial clay 1006.

No archaeological finds or features were present in the trench.

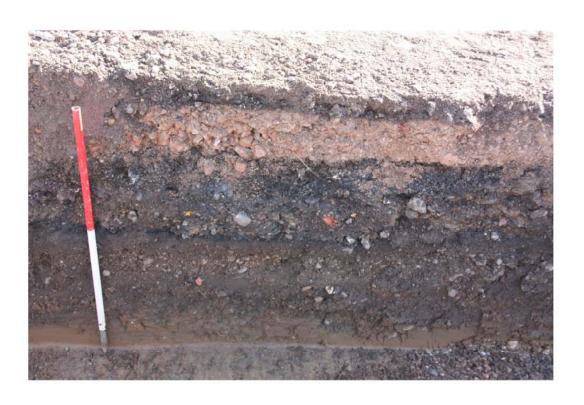
DP6: SAMPLE SECTION 6: VIEW E

Trench No	Trench No 6 Oriei		tion NW - SE	Height AOD 2.85m		Shot No DP6	
Sample Sect	ample Section No 6 Location SW Side Facing NE Faci		NE Facing				
Context No	Depth	Dep	osit Description				
1000	0.00 - 0.04m	n Yard	Surface. Light grey	concrete hard stan	ding mixe	ed with tarmac.	
1002	0.04 - 0.16n		Demolition Layer. Dark grey brown, loose sand, silt and clay with large CBM at rubble inclusions.				
1017	0.16 - 0.48n		Former Coal Yard Layer. Dark grey black, loose sandy silt with frequent CBM and coke inclusions.				
1004	0.48 - 0.72n		Reclamation Layer. Mid brown orange, loose sandy clay with frequent flipebble inclusions				
1005	0.72 – 0.90n		Reclamation Layer. Light orange, loose sandy clay with frequent flint pebble inclusions.				
1012	0.90m +		ral gravels. Light erate sub angular f	,	oose san	dy gravel with occasional
