ALL SAINTS CHURCH, THE STREET, CHELSWORTH, SUFFOLK

ARCHAEOLOGICAL MONITORING

Report Number: 1273

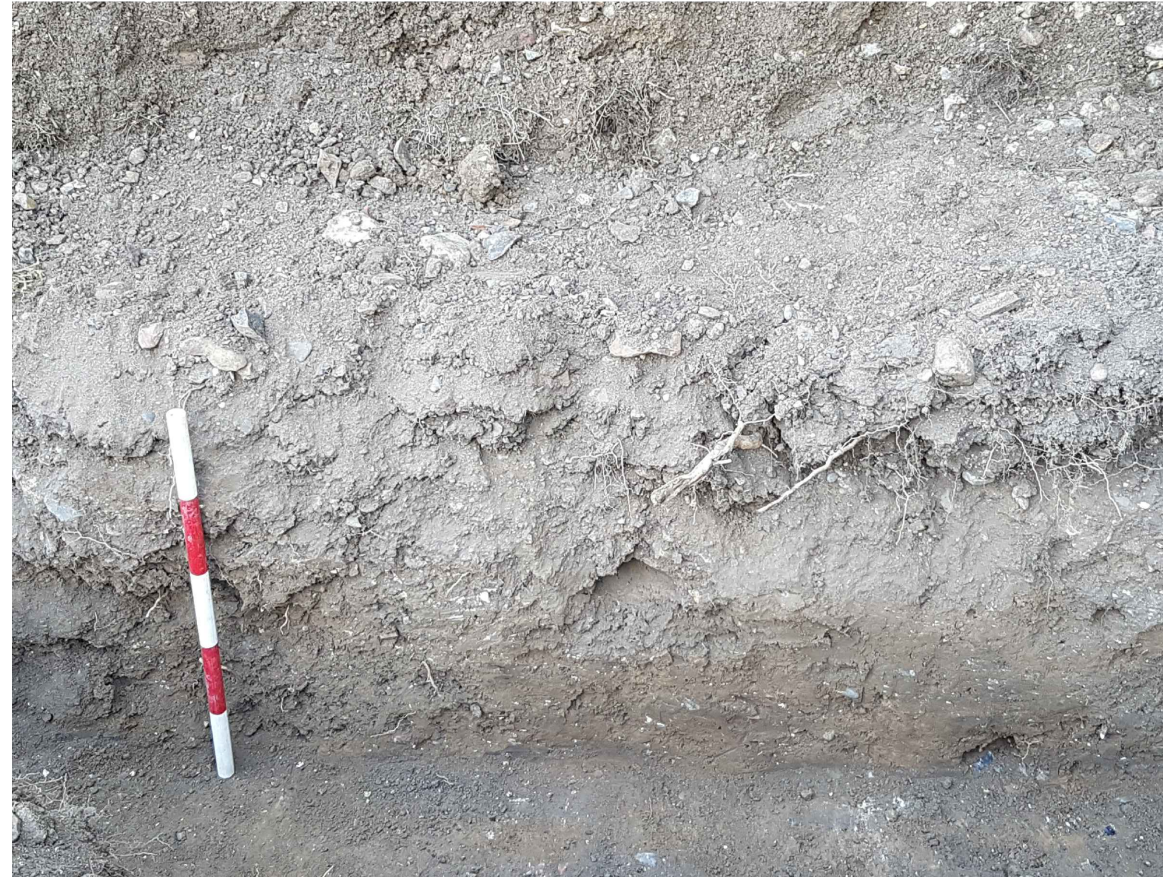
Beneath layer 1002 in sample sections 3 and 4, and at the top of the stratigraphic sequence in sample section 1 and 2 was topsoil **1000** present to a maximum depth of 0.30m in sample section 1. The layer comprised a loose, light greyish brown, sandy silt with frequent inclusions of sub-angular and sub-rounded stones. It represented the current topsoil of the graveyard.

At the base of the stratigraphic sequence in all sample sections was subsoil **1001**. The maximum depth of this layer continued beyond the depth reached during the groundworks. The deepest point at which the layer was encountered was 0.60m in sample section 1. It comprised a loose, mid orangish brown, clayey silt. This layer represented the graveyard subsoil and contained a large quantity of disarticulated human bone.

Trench No n/a	Orientation N-S	Height Aod 34.00	Shot No DP 1
Sample Section No 1	Location E side	Facing W Facing	
Context No	Depth	Deposit Description	
1000	0.00 – 0.30m	Topsoil – Light, greyish brown, loose, sandy silt with frequent inclusions of sub-angular and sub-rounded stones.	
1001	0.30 – 0.60m+	Subsoil – Mid, orangish brown, loose, clayey silt.

DP1 - SAMPLE SECTION 1 - VIEW E

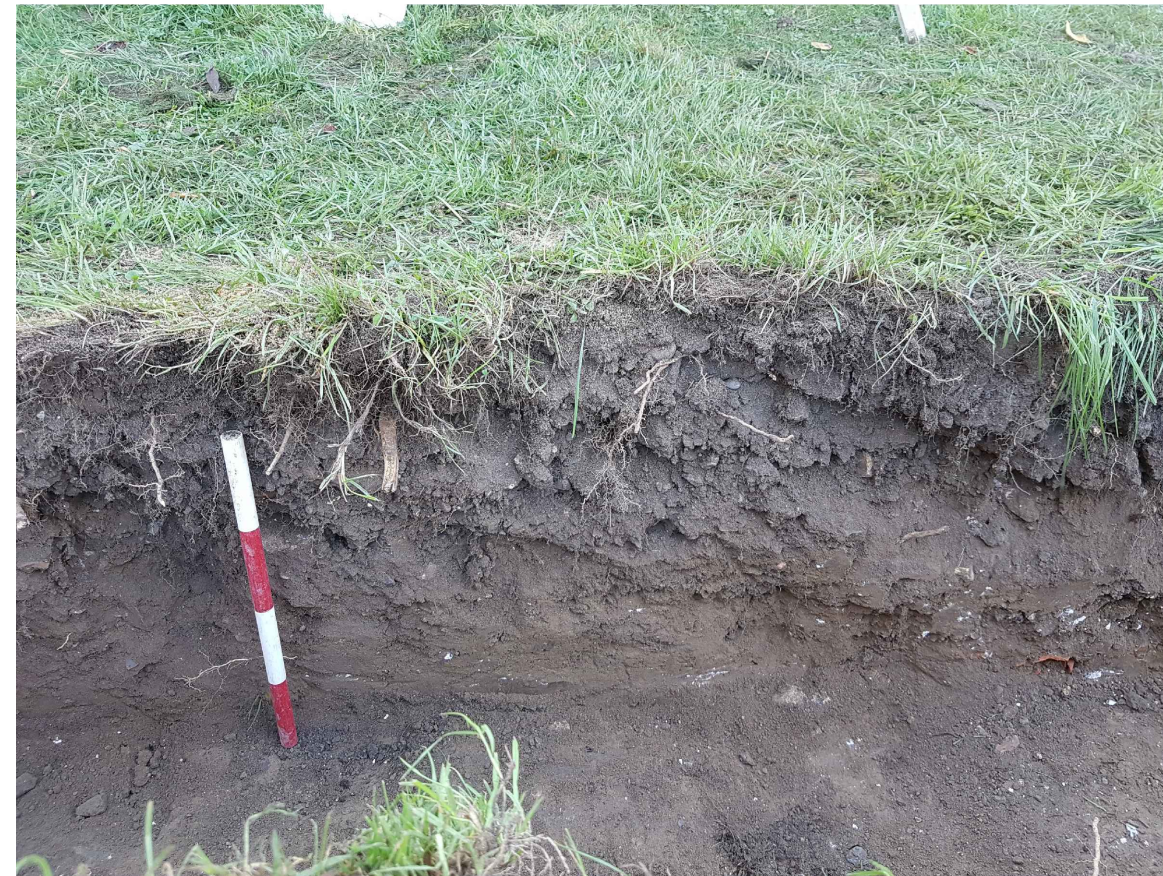
Trench No n/a	Orientation NE-SW	Height Aod 33.97	Shot No DP 3
Sample Section No 2	Location SE side	Facing NW Facing	
Context No	Depth	Deposit Description	
1000	0.00 – 0.30m	Topsoil – Light, greyish brown, loose, sandy silt with frequent inclusions of sub-angular and sub-rounded stones.	
1001	0.30 – 0.53m+	Subsoil – Mid, orangish brown, loose, clayey silt.

DP3 - SAMPLE SECTION 2 - VIEW E

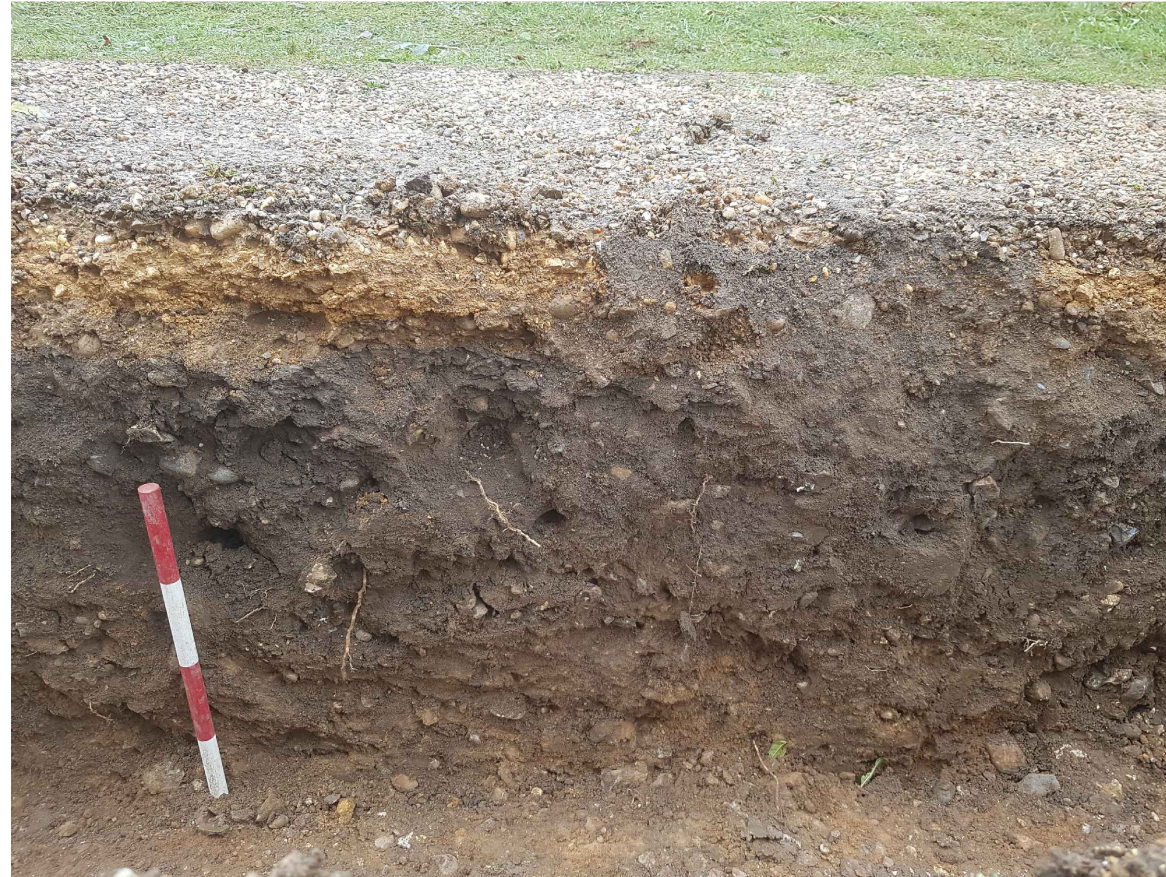
At the top of the stratigraphic sequence in sample sections 3 and 4 was Gravel Path **1002** which was present to a maximum depth of 0.13m in sample section 4. It comprised a loose light brownish orange, sandy gravel with frequent inclusions of moderately sized angular stones. The layer represented the current gravel path running through the graveyard on a NE-SW orientation from the northern side of the church.

Trench No n/a	Orientation NE-SW	Height Aod 33.84	Shot No DP 6
Sample Section No 3	Location SE side	Facing NW Facing	
Context No	Depth	Deposit Description	
1002	0.00 – 0.05m	Gravel Path – Light, brownish orange, loose, sandy gravel with frequent inclusions of moderate angular stones.	
1000	0.05 – 0.27m	Topsoil – Light, greyish brown, loose, sandy silt with frequent inclusions of sub-angular and sub-rounded stones.	
1001	0.27 – 0.50m+	Subsoil – Mid, orangish brown, loose, clayey silt.

DP6 - SAMPLE SECTION 3 - VIEW E

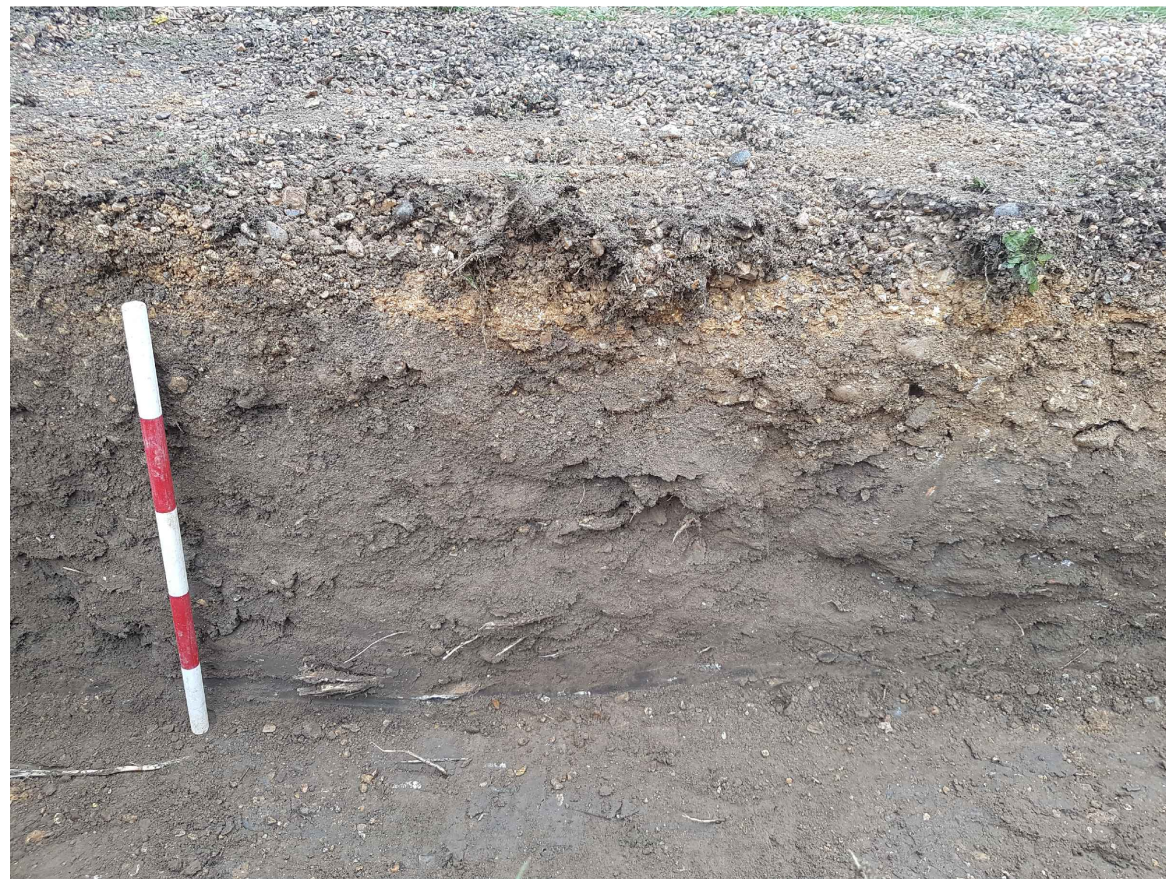
Trench No n/a	Orientation NE-SW	Height Aod 34.75	Shot No DP 8
Sample Section No 4	Location SE side	Facing NW Facing	
Context No	Depth	Deposit Description	
1002	0.00 – 0.13m	Gravel Path – Light, brownish orange, loose, sandy gravel with frequent inclusions of moderate angular stones.	
1000	0.13 – 0.27m	Topsoil – Light, greyish brown, loose, sandy silt with frequent inclusions of sub-angular and sub-rounded stones.	
1001	0.27 – 0.53m+	Subsoil – Mid, orangish brown, loose, clayey silt.

DP8 - SAMPLE SECTION 4 - VIEW E

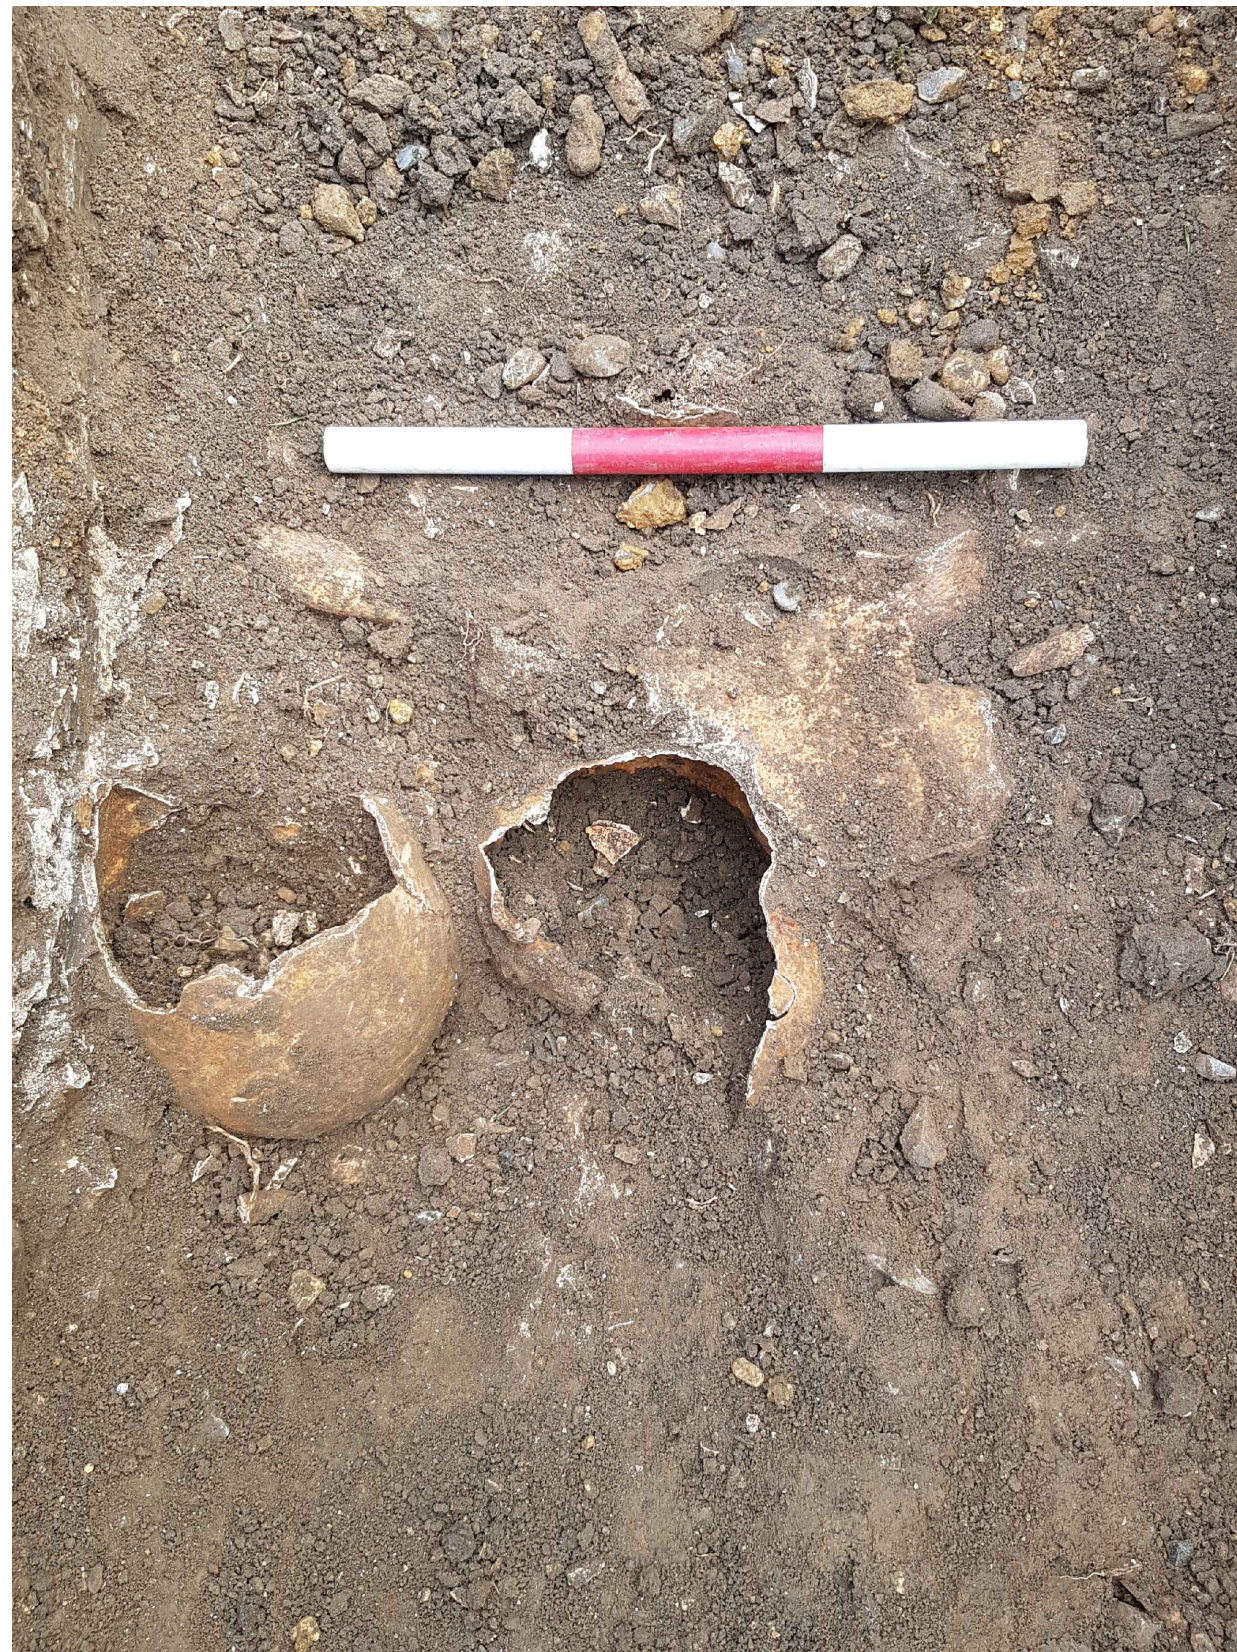
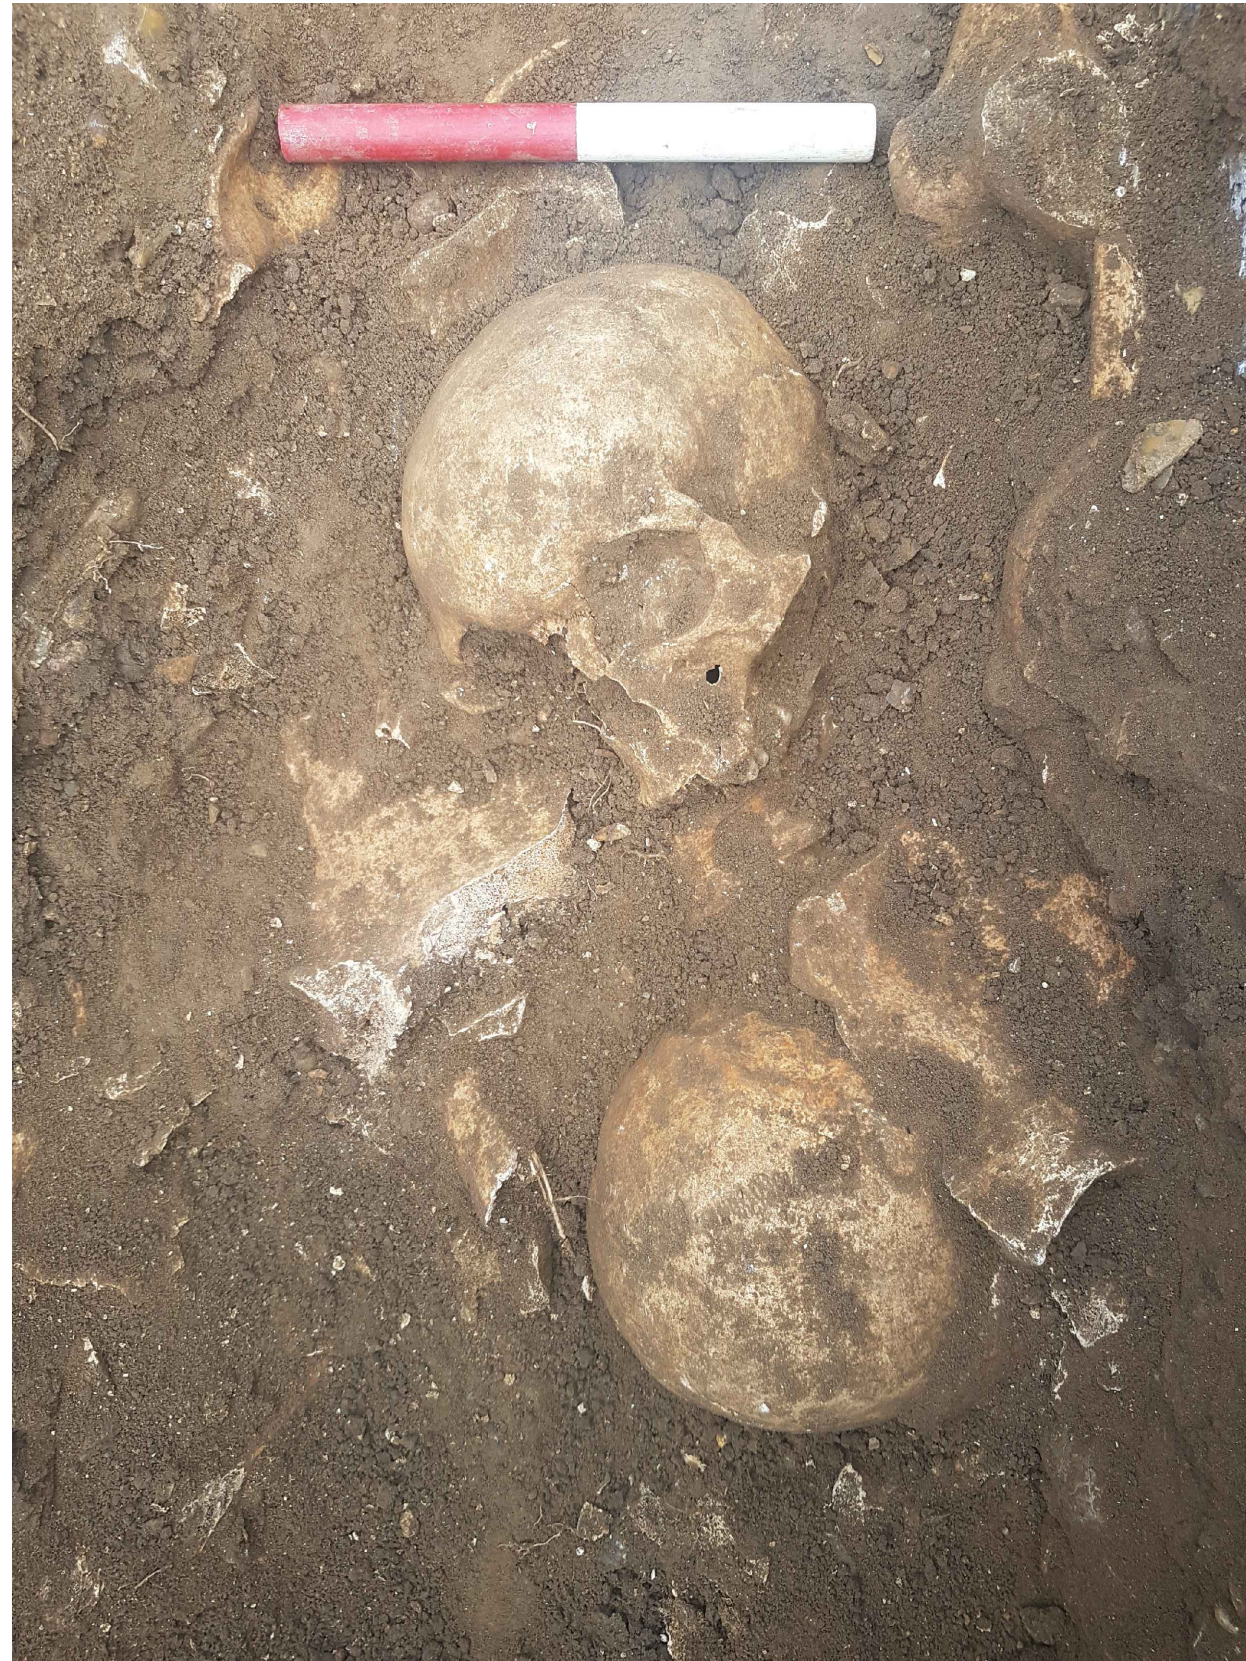
A large quantity of disarticulated human bone was encountered in gravesoil **1001** in the portion of the trench closest to the northern extent of the church, roughly within the first 23.00m of the trench and in the area beneath the current path.

A range of skeletal elements were noted from adults as well as some subadult bone (Martin Brook pers comm). The SCCAS planning archaeologist advised that quantification and assessment of the human bone was not required, and so all effected elements were removed from the trench and immediately handed back to the church for later reburial within the graveyard.

DP4 - HUMAN BONE 5 - VIEW NE

DP5 - HUMAN BONE 5 - VIEW E

Following the investigation, it was confirmed with Dr Abby Antrobus from SCCAS on 25th September 2020 that the service trench could be backfilled. The human remains that were removed from the service trench were re-buried under Church supervision on Monday 28th September 2020.
