Fort Burgoyne, Dover

Watching-brief report

Project Code: FBD-WB-13

Report No: 2013/81

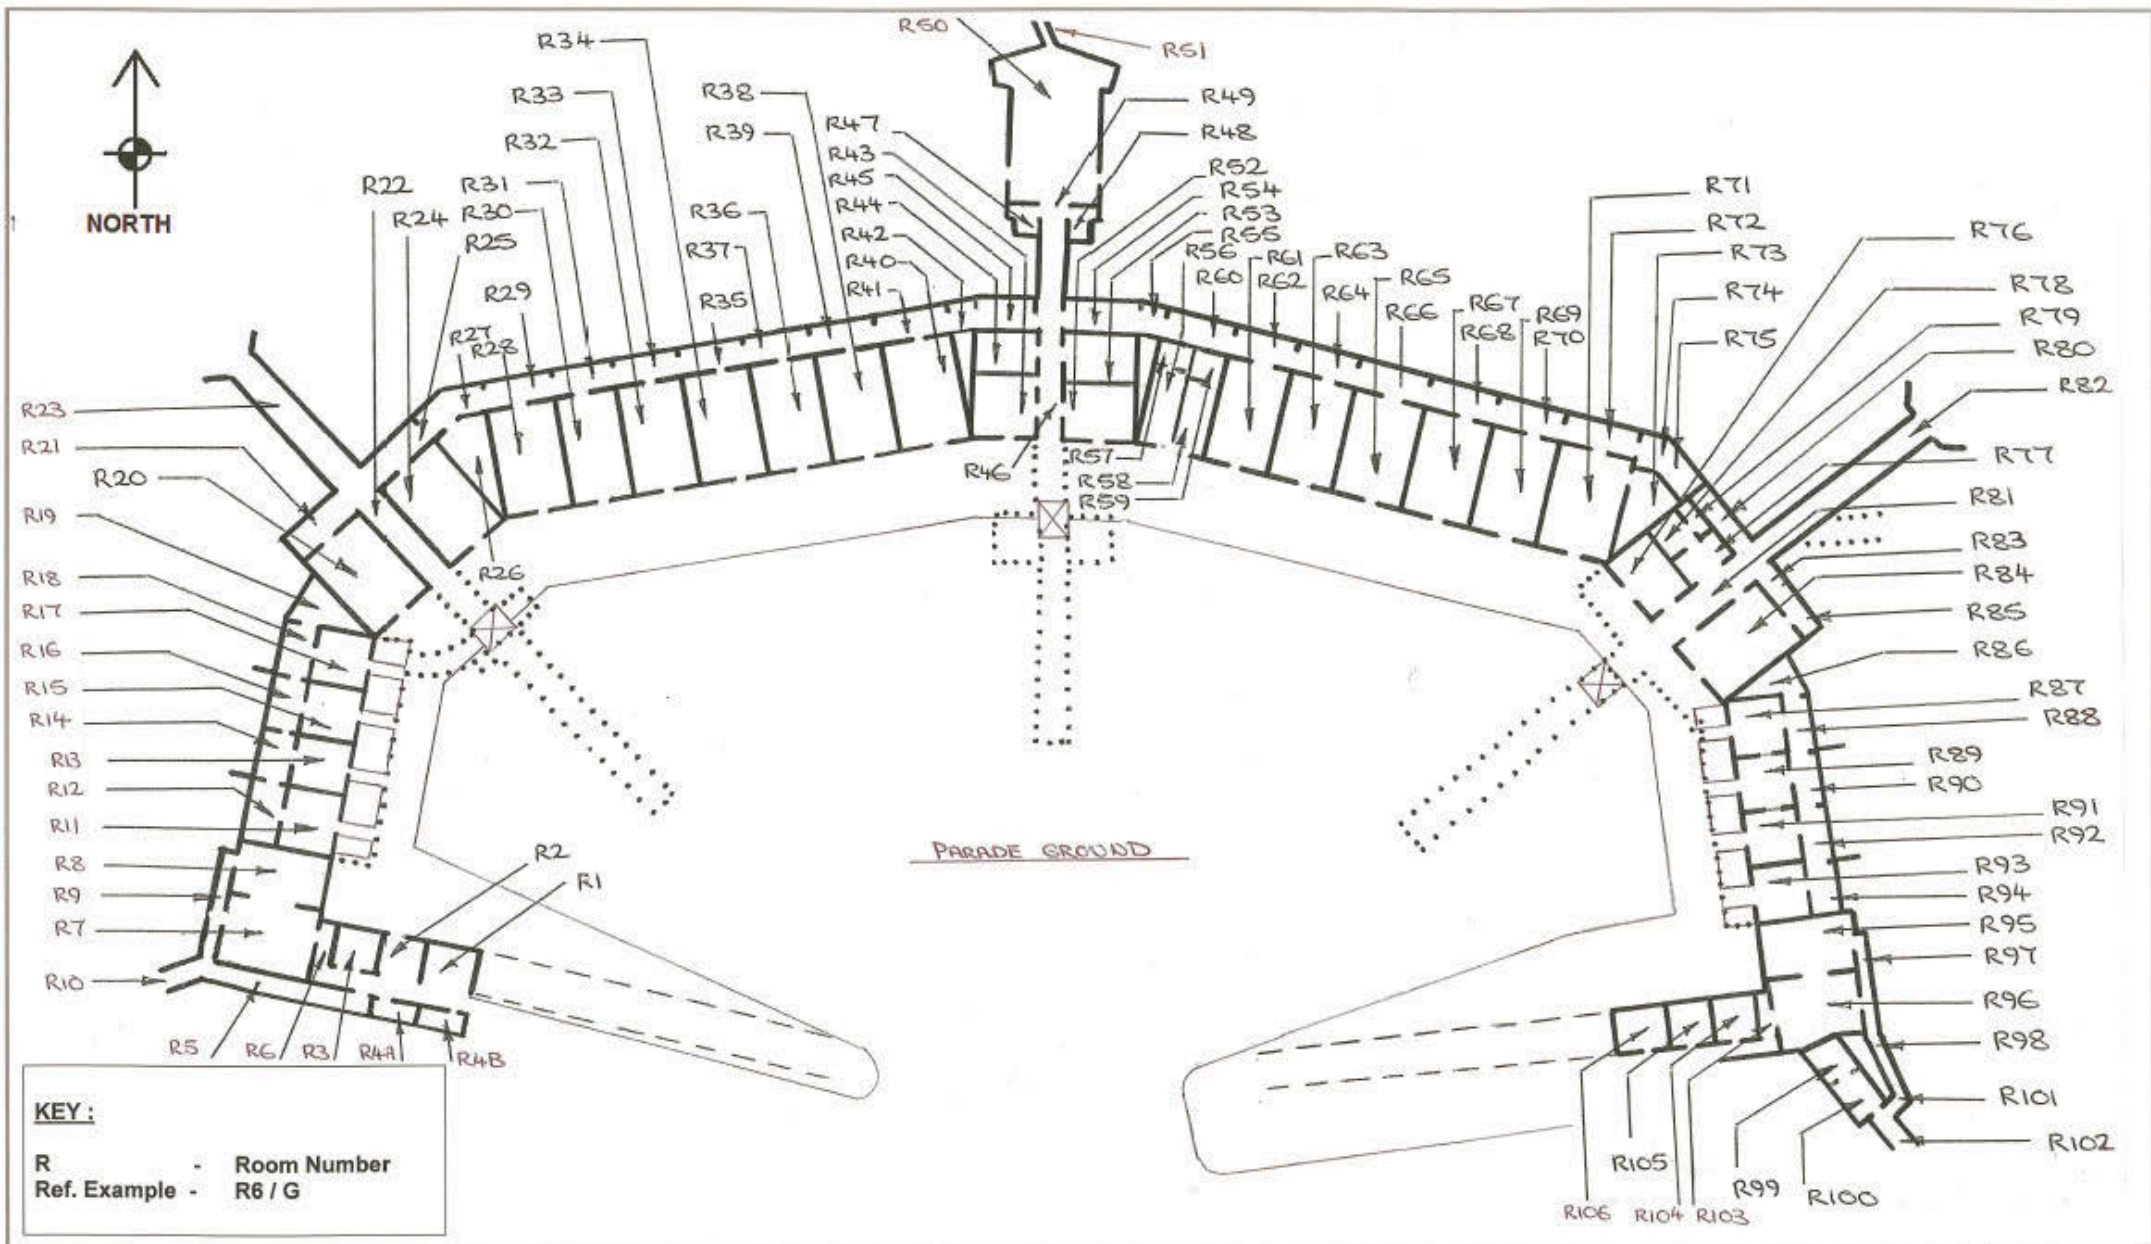
Fig. 5 Ground Floor Plan

4.3.5 Removal of the wooden floors in several room revealed substantial ceramic flue pipes laid from the original hearth to the outside wall of the casemate. In each case the exit had subsequently been blocked and none were visible from the outside. Pipes were noted in Rooms 20, 34, 36 and 65 (Fig. 5; Plates IV & V).

4.6.1 On the north side of the fort, protecting the entrance to a passage that provides access into the interior of the site, is an open, rectangular brick-built flanking gallery or ‘barbican’ (Fig. 5, Room 50). In June 2013 clearance work was undertaken within this structure, when between 0.10 and 0.50m of leaf mould, accumulated soil and vegetation was removed (Plates X & XI). This work was monitored and revealed a number of loose artefacts derived from the occupation of the fort. Finds recovered included two iron brackets (FB/40 & 41), a light fitting (FB/42), an iron coat hook (FB/46), a metal filter unit (FB/48) and part of a mortar bomb (FB/49).

4.6.4 Along the north wall of the gallery vertical scars suggested the former presence of a row of toilet cubicles arranged with six on either side of the passage leading to the outer defences (Fig. 5, Room 51). The clearance work provided confirmation of this and revealed the bases of a dozen lavatory pans and their associated soil pipes. The cubicles were fronted by a concrete path with a drainage gully along its southern side but the lavatories themselves had been previously removed, their associated soil pipes being capped off with concrete and the wall scars neatly repaired.

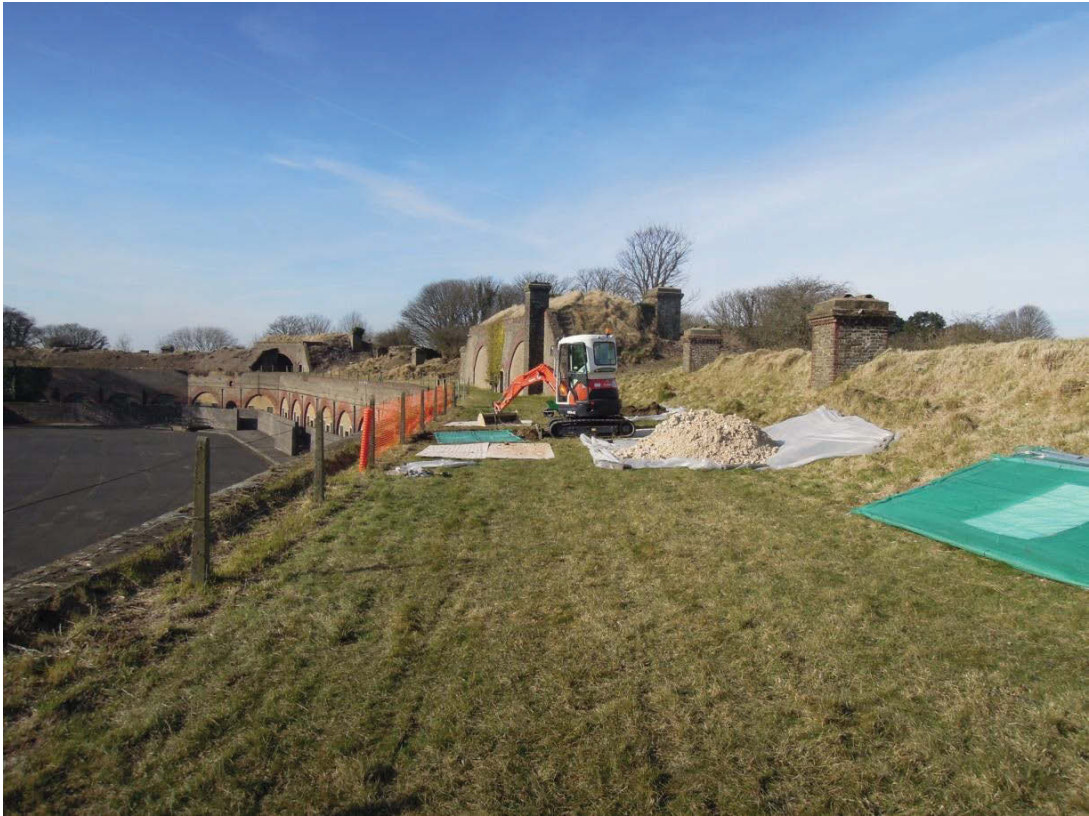
Plate II Trial Pit 1 under excavation, looking north-west (Film 16862/2628)

This was excavated towards the eastern end of the central row of casemates, over the wall dividing Rooms 63 and 65 (Fig. 2; Plates I & II). The machine dug pit was rectangular in shape and measured 3.50m (E–W) by 3.00m (N–S). It was taken to a maximum depth of 2.10m to expose the roof of the casemate structures below. Archaeological observation of the operation allowed the recording of the sequence of (mostly chalk rubble) deposits over the barrack rooms (Fig. 3).

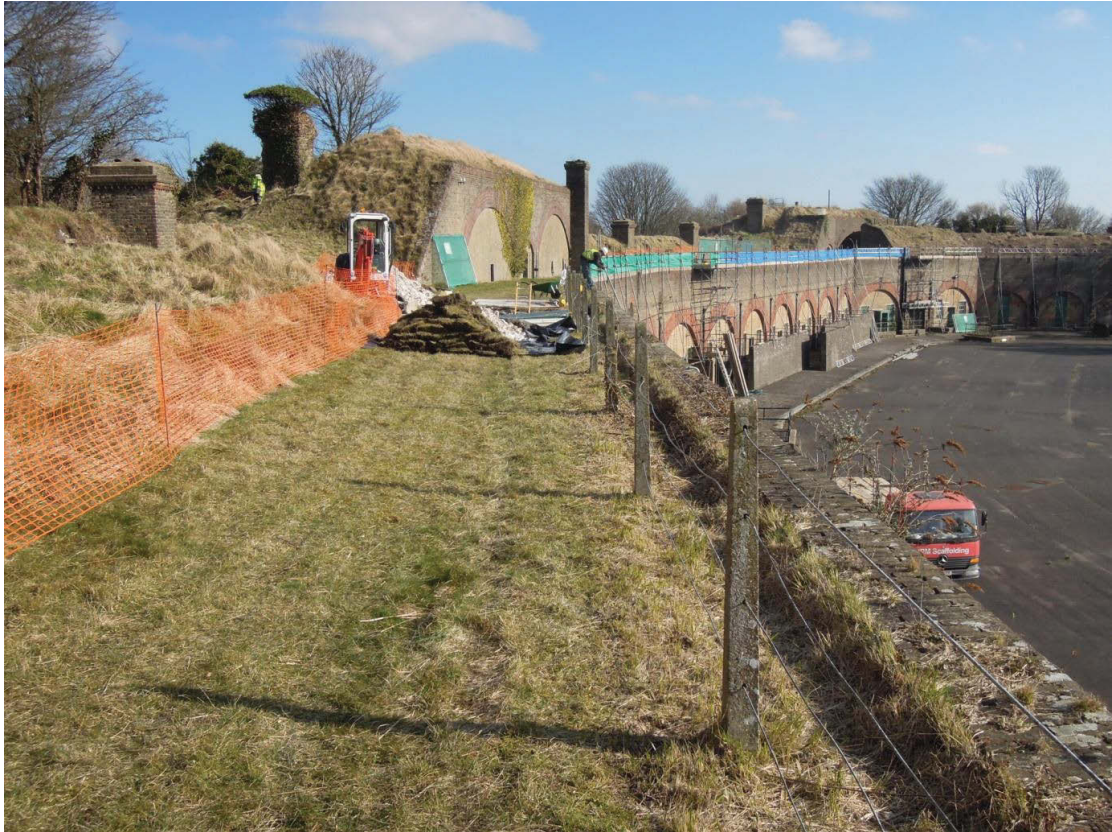
Plate III Trial Pit 2 under excavation, looking east (Film 16863/2667)

This was excavated towards the western end of the central row of casemates, over the wall dividing Rooms 36 and 38 (Fig. 2). The machine dug pit was rectangular in shape and measured 3.75m (E–W) by 3.25m (N–S) at the top. It was taken to a maximum depth of 2.00m to expose the roof of the casemate structures below. The battered sides of the excavation meant that only an area of casemate roof about 1.50m square was exposed. Archaeological observation of the work again allowed details of the deposits sealing the casemates to be recorded (Fig. 4).

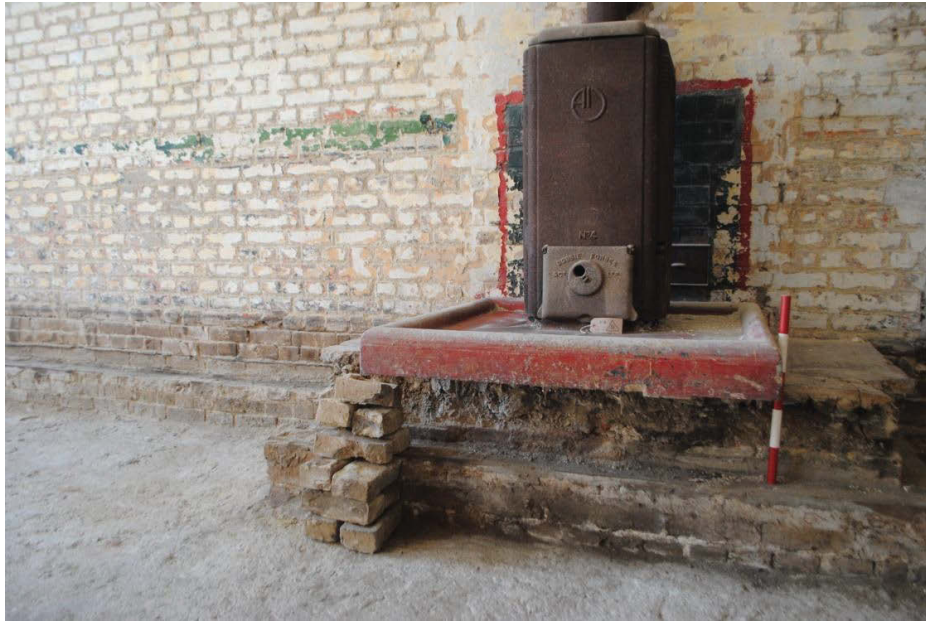
Plate IV Room 20, later fireplace over earlier one, looking SW. Scale, 50cm (Film 16881/22)

4.3.2 Most frequently surviving within the rooms were the remains of stoves and fireplaces (Plates IV & V). Almost every room originally seems to have been provided with a fireplace and it was clear that the bulk of these had been replaced on at least one occasion.

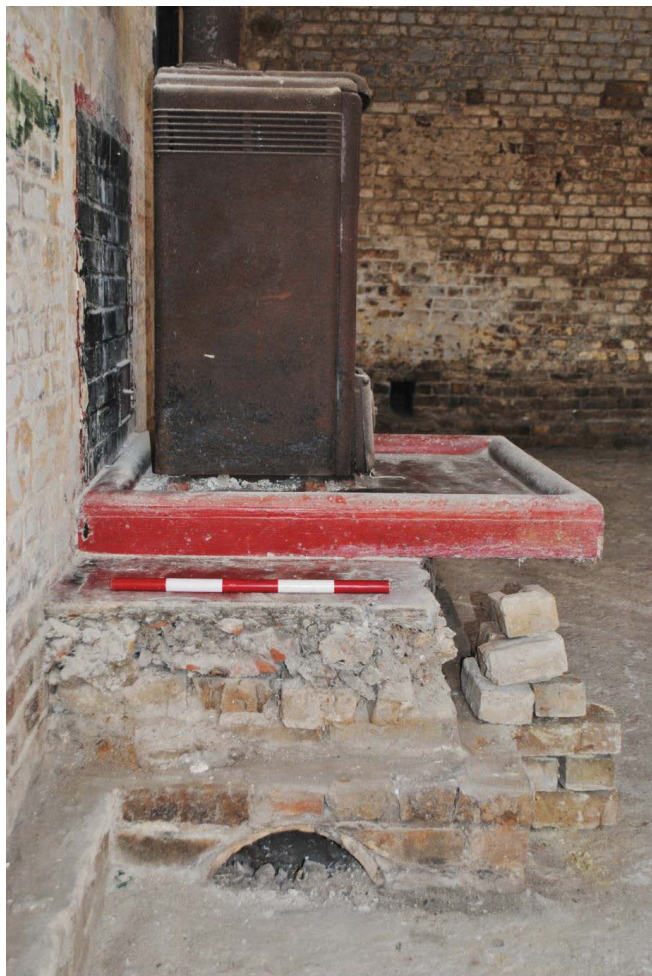
Plate V Room 20, later fireplace over earlier one, looking NW (note vent pipe below earlier hearth).
Scale, 50cm (Film 16881/25)

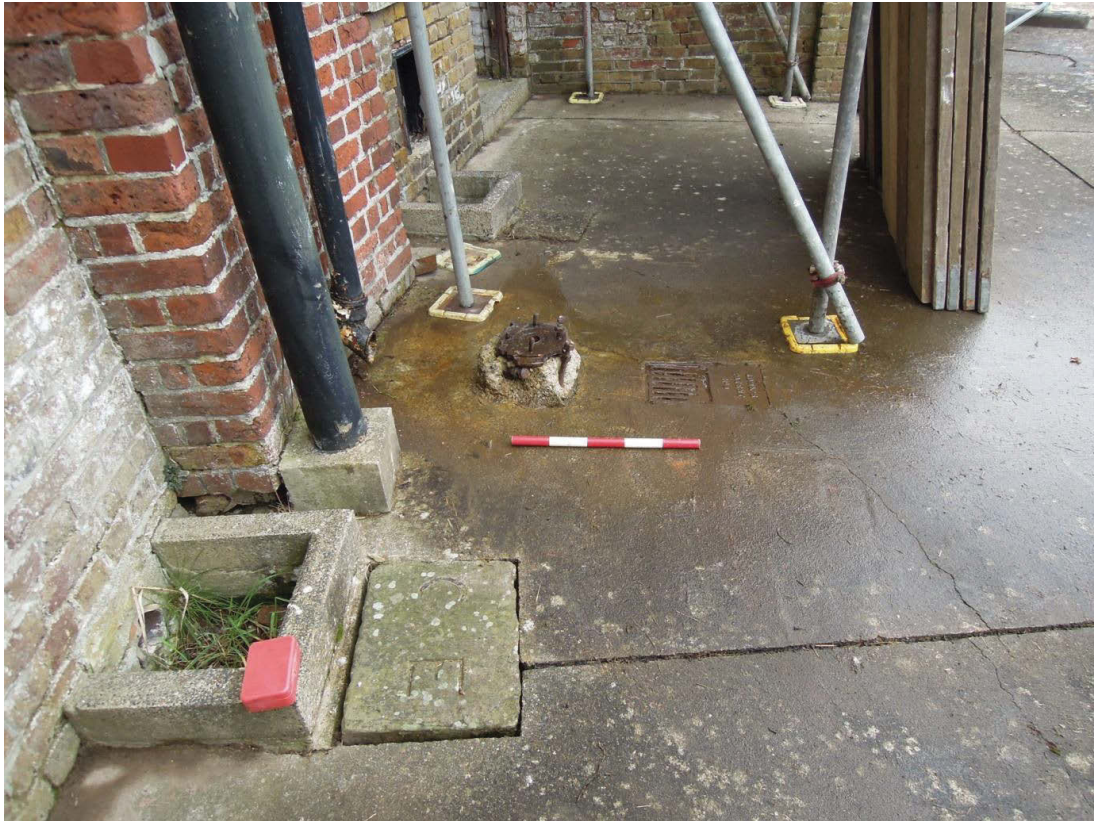
Plate VI Base of probable water pump and drain outside Rooms 52/56, looking E. Scale, 50cm (Film 16864/2759)

Clearance of vegetation on the concrete path in front of casemate Rooms 40/43 and 52/56 revealed the presence of two small, damaged concrete bases into which were set iron bolts. Cleaning and study of these indicated that they are probably the truncated bases for hand-cranked water pumps, which no doubt drew water from the large storage cisterns that lie below Rooms 43 and 52. Each base was associated with an iron drain grate. The eastern one of these appeared to be original and carried the maker’s mark ‘Lowe’s Patent No. 3’ (Plate VI).

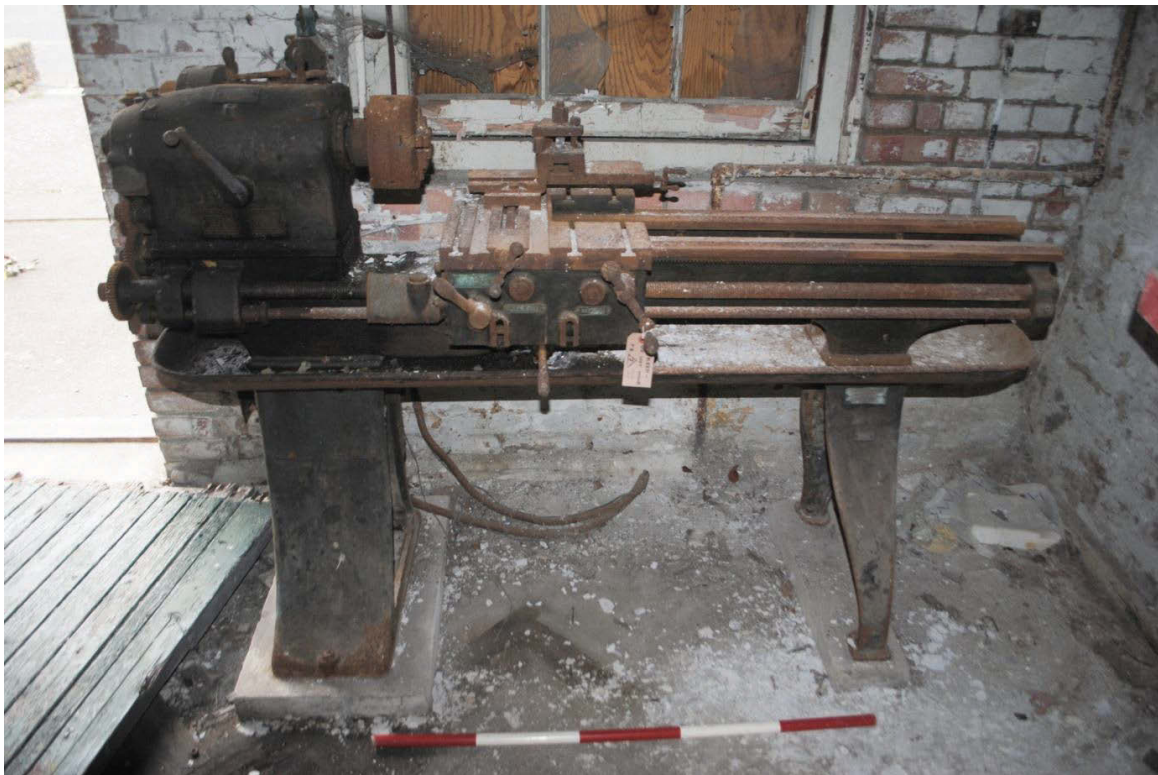
Plate VII Room 43, metal-working lathe *in situ*, looking S. Scale, one metre (Film 16879/17)

4.3.8 A total of fifty-three items from within the casemates and the flanking gallery (Room 50) were catalogued. Although all the loose items were removed to a safe store-room on the site, no attempt to stabilise or conserve them was made. Each item was photographed, *in situ* where possible. The catalogued finds included eleven iron stoves still in place, the large metalworking lathe (Cat. FB/7; Plate VII) set in Room 43 and eleven detached wooden doors.

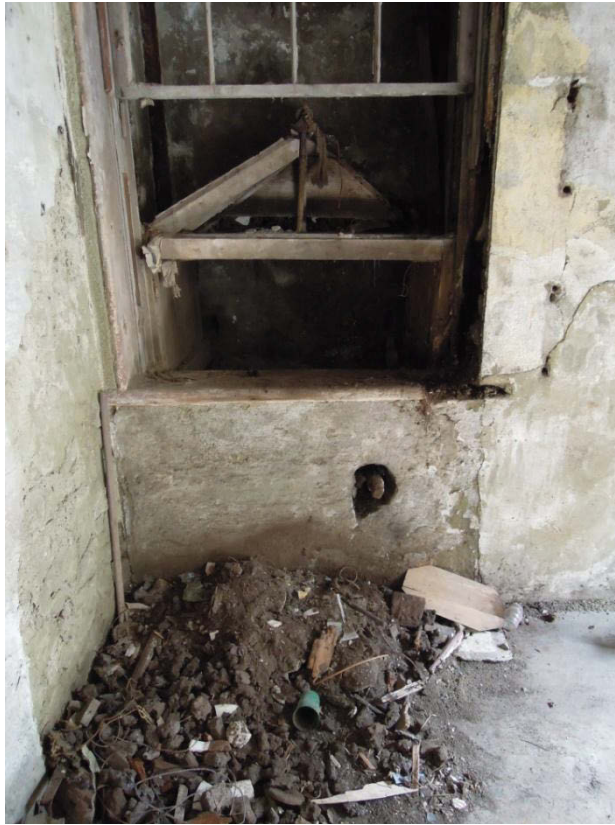
Plate VIII Basement Room 23, shaft for 'dumb waiter' exposed, looking SE (Film 16880/2930)

In the east corner of east basement Room 23, what initially looked like a vertical light-well filled with modern wood, plastic and other late twentieth-century debris, proved to be of rather more interest. Clearance of the hatchway established that this shaft housed a wooden framed elevator/lift, roughly 1 metre cubed in size (Plates VIII & IX). The collapsed remains of the lift structure lay in the bottom of the shaft, along with the associated counter-weights, pulley wheels, and steel hawsers. A small round aperture in the wall below the open hatch housed the spigot to which a crank-handle (not found) had been attached for manually operating the machine (Plate VIII).

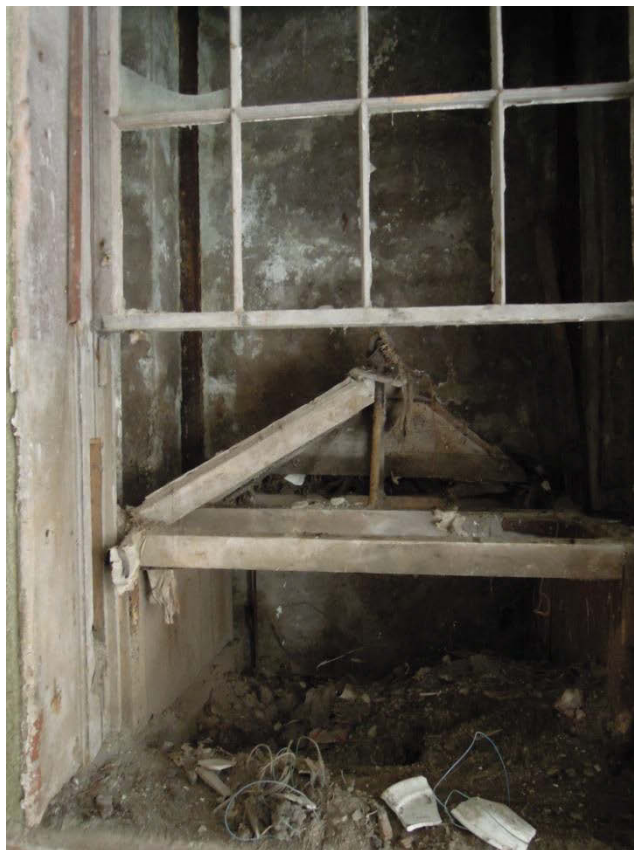
Plate IX Basement Room 23, detail of 'dumb waiter' revealed, looking SE (Film 16880/2924)

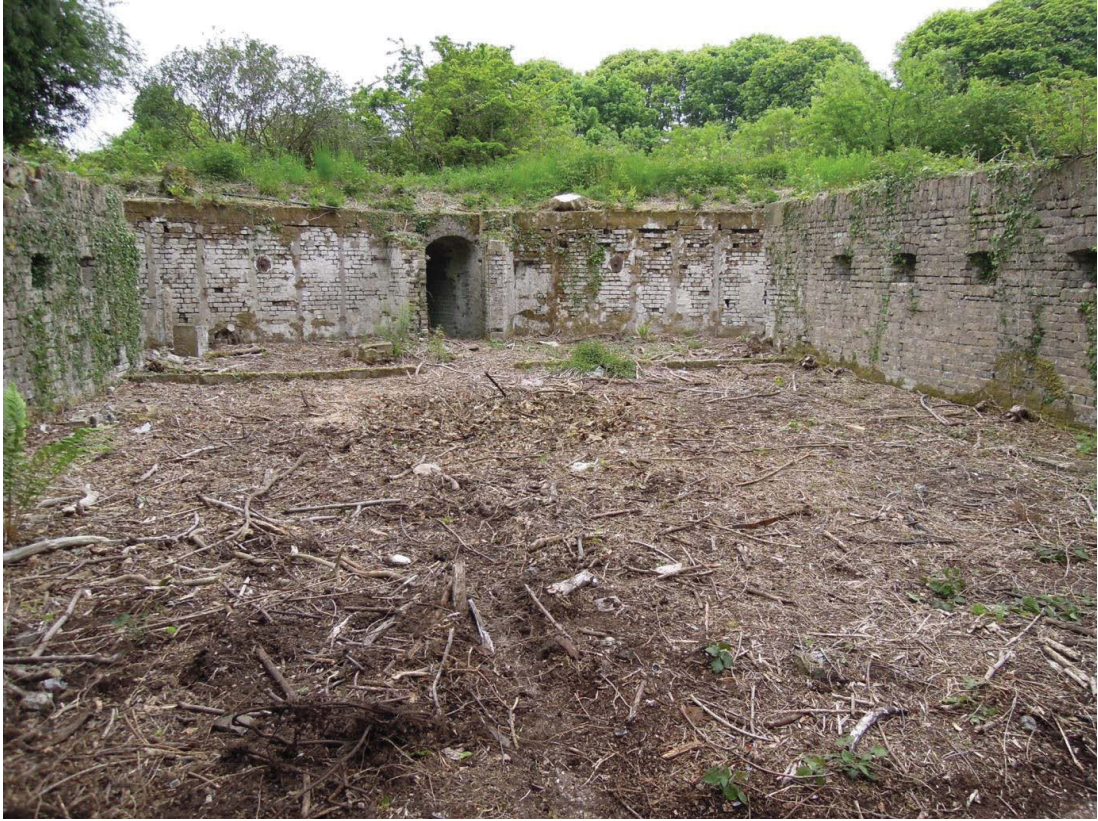
Plate X Barbican structure (Room 50) before clearance, looking north (Film 16893/3157)

4.6.3 Cleared of undergrowth, the brickwork of the gallery walls was found to be in a poor state in many areas and repair works will be required soon if collapse of this structure is to be prevented. Traces of door or gate fittings were noted at the four entrances into the gallery. A large iron strap hinge remained *in situ* at the bottom of the east doorway, encased in a large tree trunk.

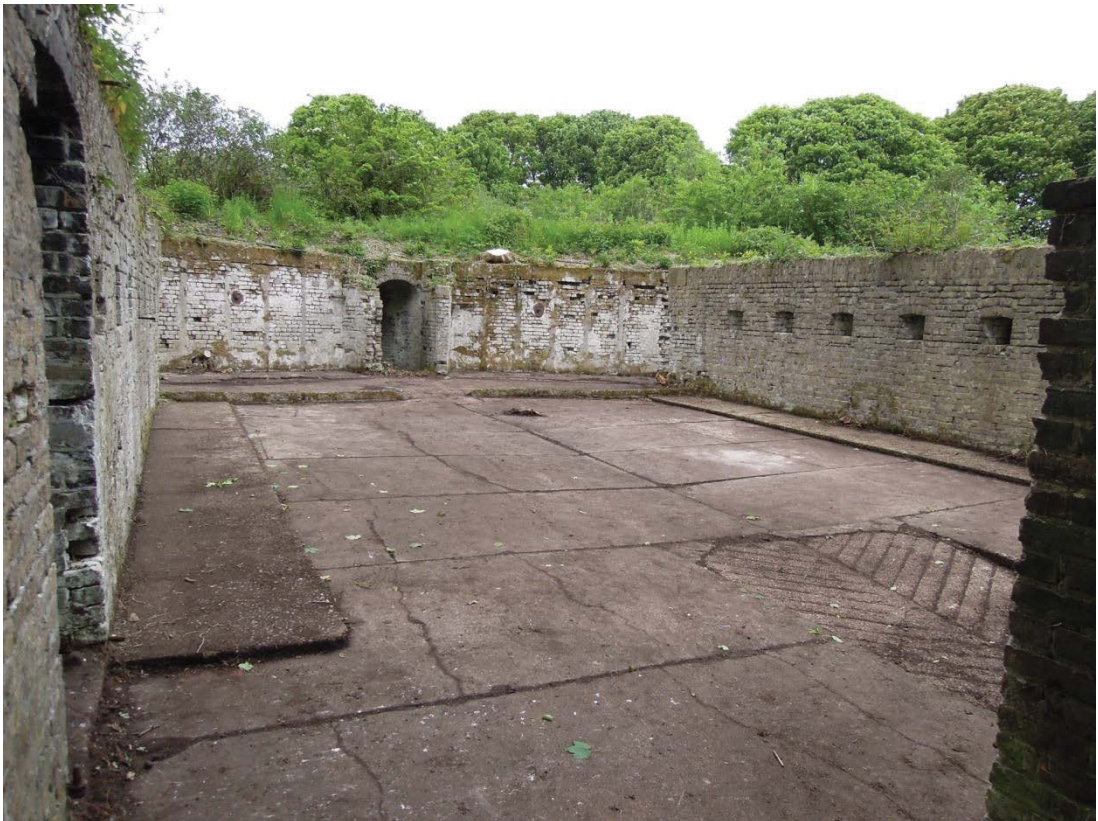
Plate XI Barbican structure (Room 50) after clearance, looking north (Film 16894/3208)

4.6.2 Below the debris it was discovered that there was a concrete floor within the walled area (Plate XI). This was set at several different levels and appeared to be of at least two periods, both later than the gallery walls. An original ramp leading up directly from the passage into the fort had subsequently been blocked by a brick blast wall so that access from then on was via steep side-steps.
