# Fort Burgoyne, Dover

## Watching brief report

Project Code: FBD-WB-16  
NGR: 63243 14272, centred  
Report No: 2016/41  
Archive No: 3583

April, 2016

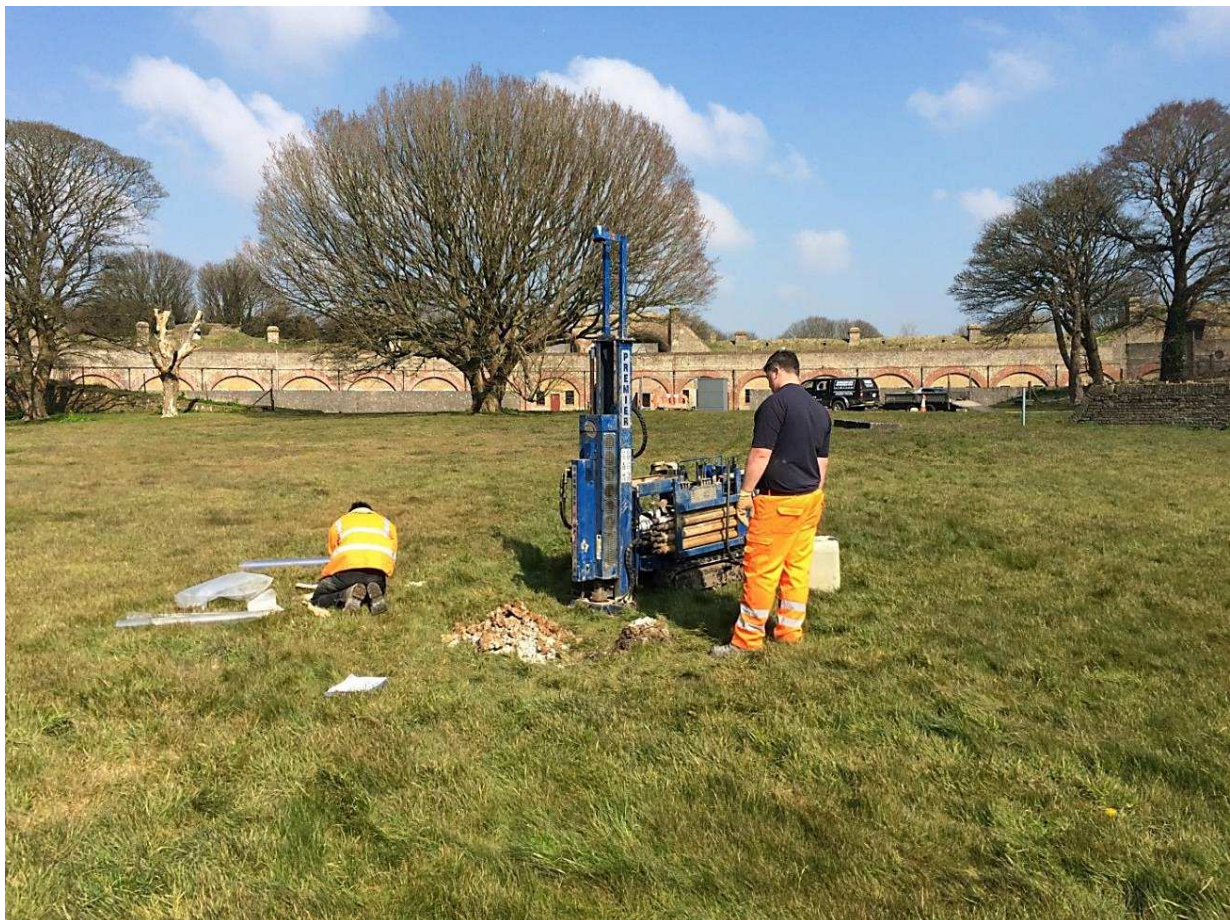
**Fig. 6** Drilling Borehole 3, looking north

This was drilled within the interior of the fort, on the grassed area about 1 metre east of Test pit 3. It established that the natural Clay-with-flints recorded in this area was about 0.30m thick and rested directly on natural chalk bed-rock.

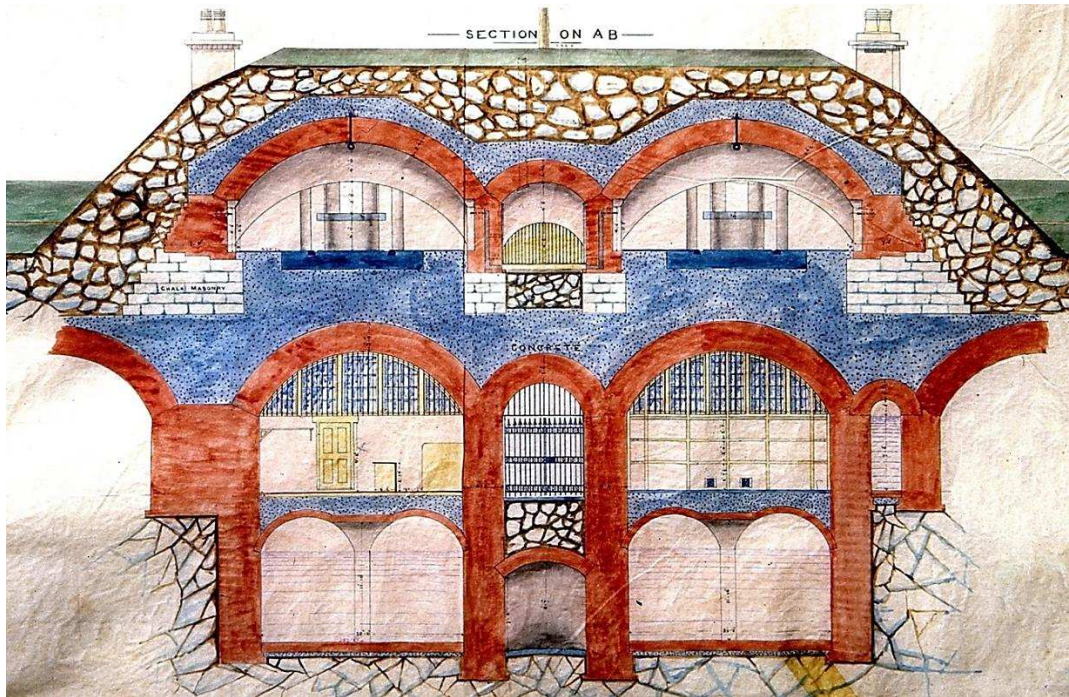
**Fig. 7** Late nineteenth-century elevation drawing showing the underground water cisterns

5.2 According to Victorian records, the water tank under the canteen was supplied direct from Dover Castle, whilst another one under an adjacent room was filled by fort-collected rainwater, filtered through porous artificial stone (Fig. 7).

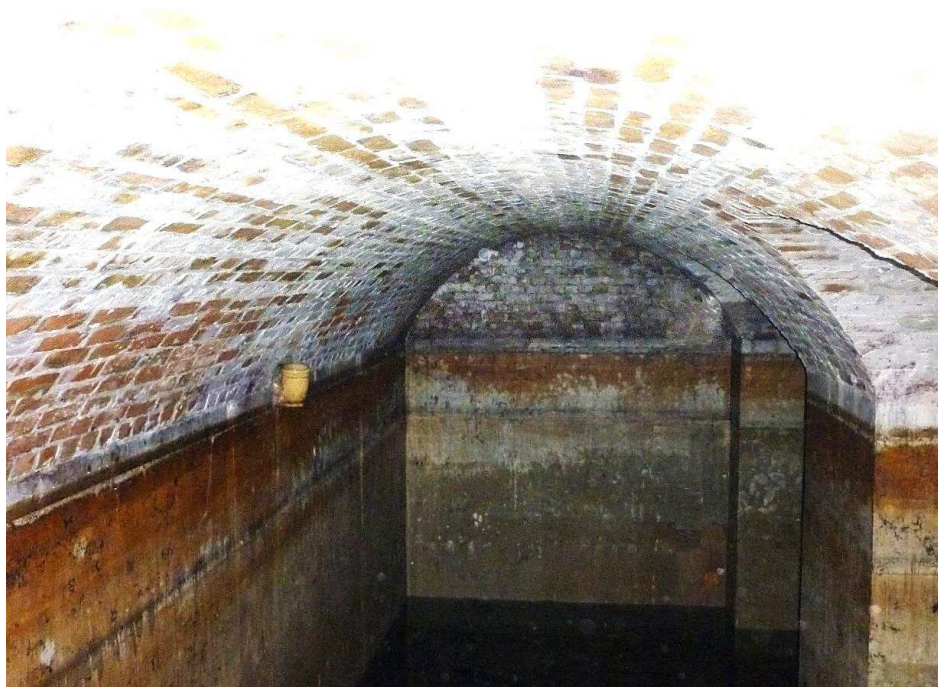
**Fig. 8** General view of the western water cistern, part emptied (*photo, John Daniel*)

**5.1** As an additional piece of investigation work, an underground water cistern below Room 44 (former Canteen; Fig. 7) was partially emptied of water to allow inspection. After a full day of pumping, about 7/8 of the water was removed. The base of the chamber lay at about 4.50m below floor level. The water was reduced down to -3.70m, allowing a brief inspection from the top by torchlight (Fig. 8). This indicated that there was little of archaeological interest contained within the

cistern: a white plastic toilet seat and several pieces of wood, iron rod/pipe were all that was obvious on the bottom. It was noted that the walls of the structure were in very good condition (Fig. 8).
