Land north-west of Admiralty Lookout Dover Castle Kent

Archaeological Watching-Brief Report

Project Code: DCAF-WB-15

March 2015

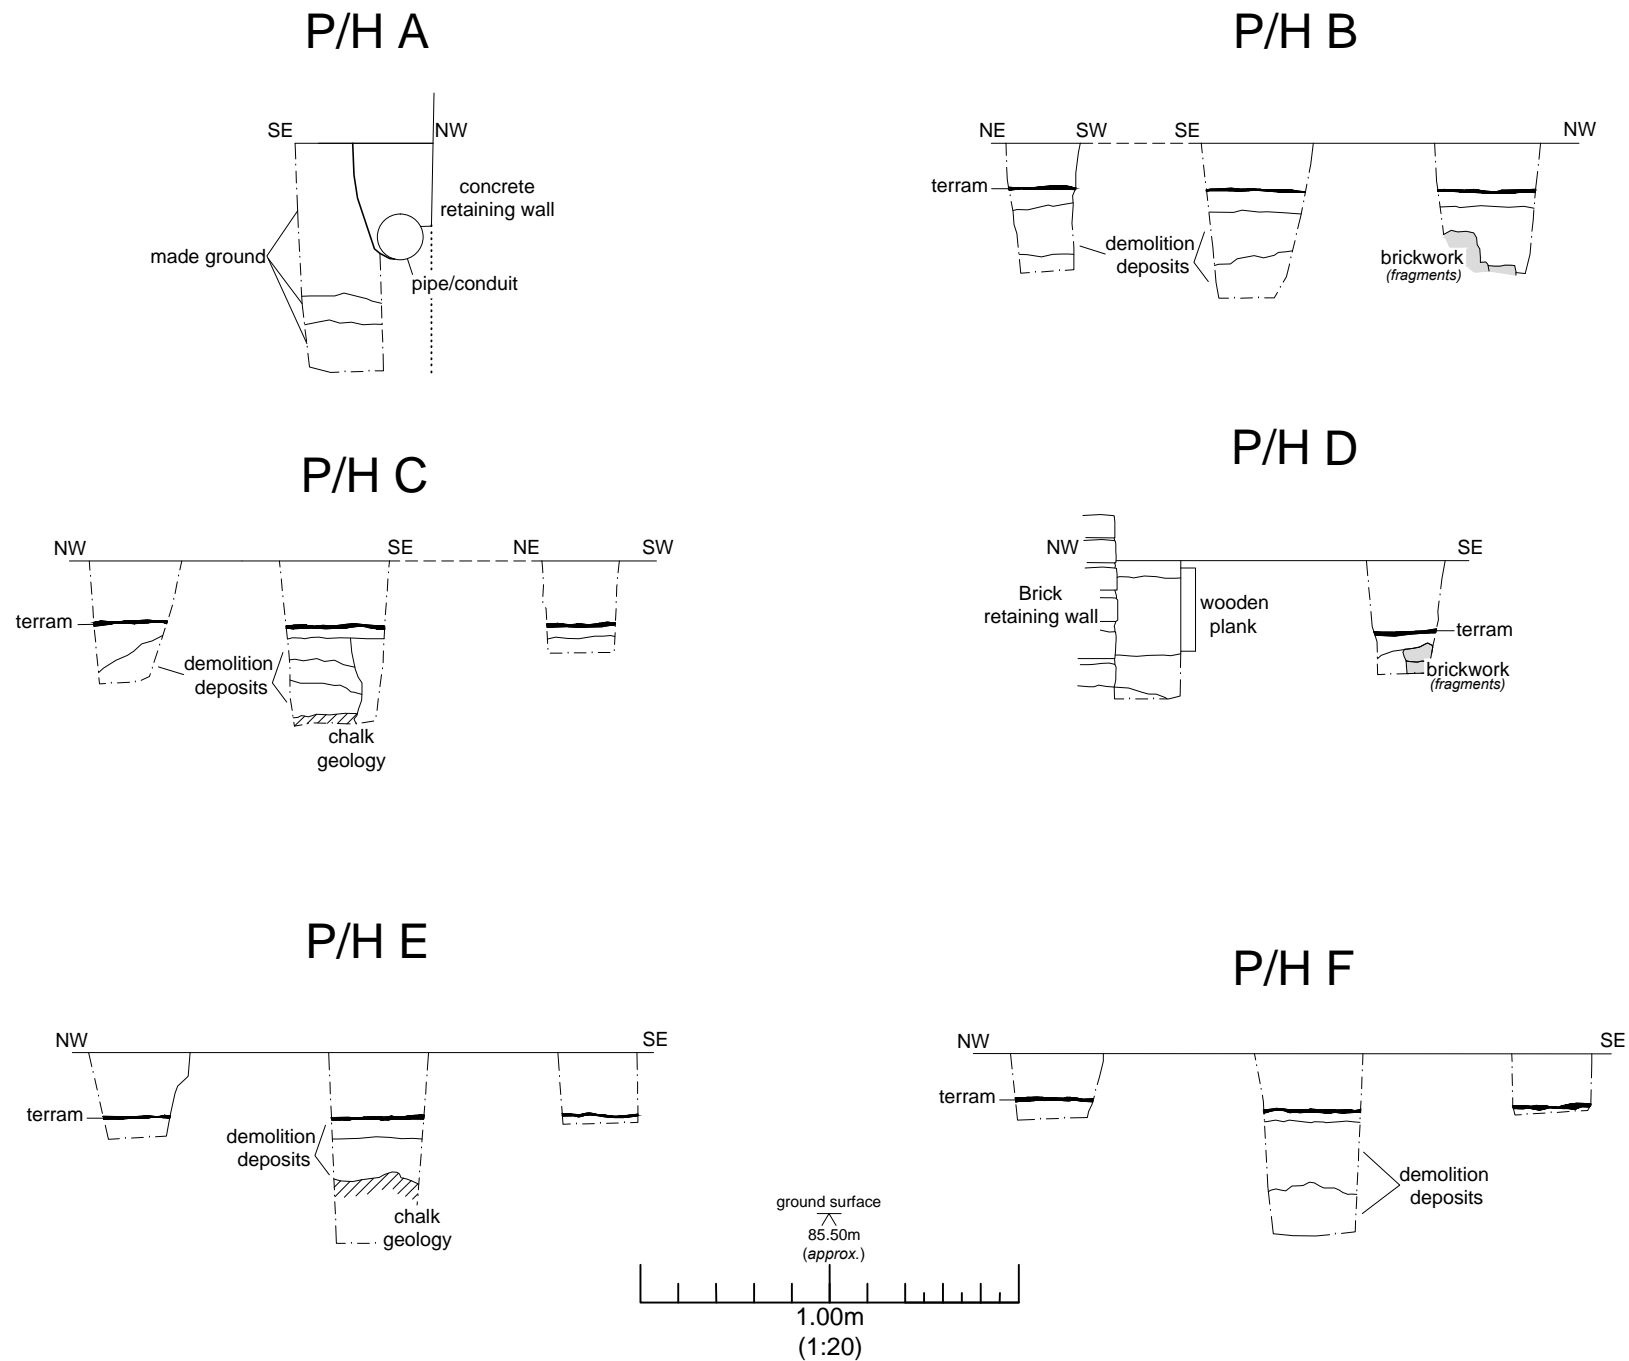
Most post-pits revealed only a succession of modern levelling and demolition deposits (Figs 3-5); the bulk of these appeared to be related to the demolition of the Hospital Barracks (c.1960s).

Fig.3 Sections through recorded deposits in post-pits A-F

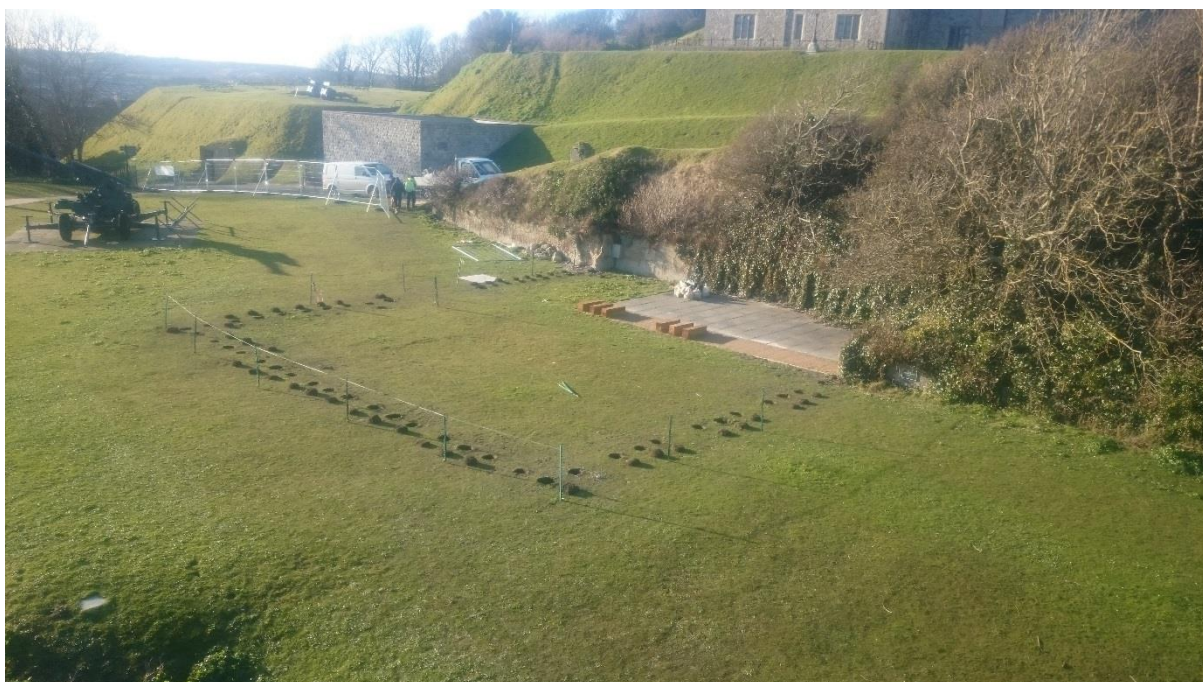
Plate I General view of excavated post-pits, looking north-west

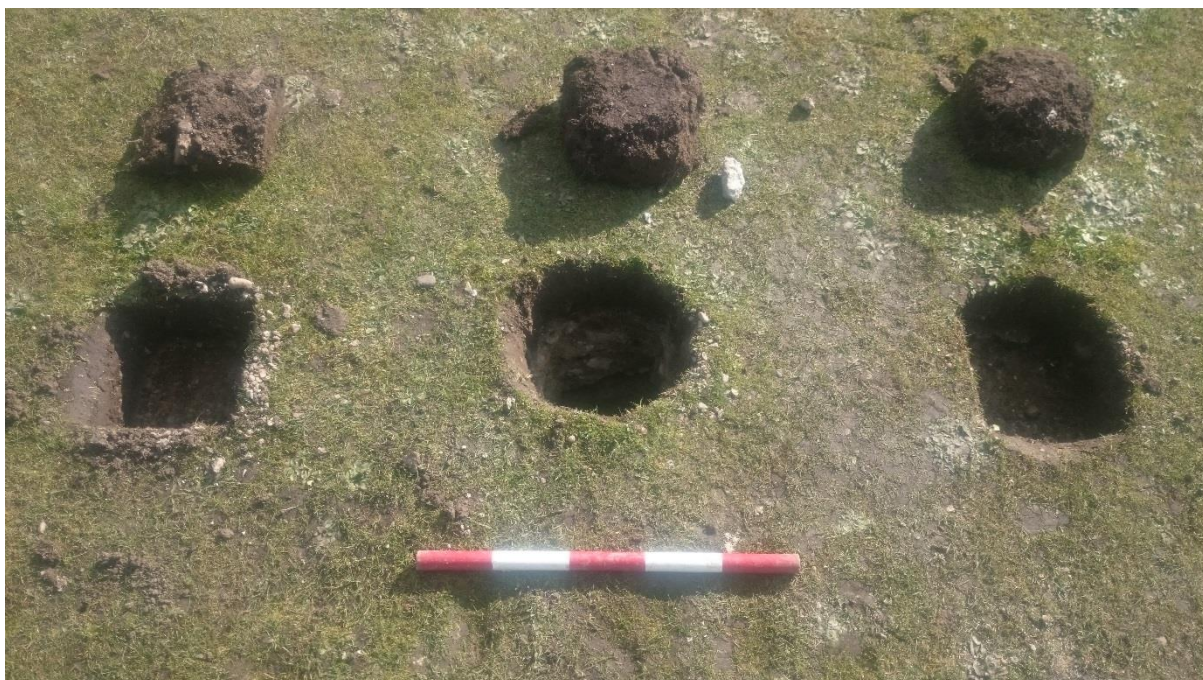
NATURE OF ARCHAEOLOGICAL OBSERVATION: Close observation of the excavation of each post-pit (Plate II)		
EXPOSED DEPOSITS: Natural chalk bed rock was reached in 10 of the main pits, at varying depths of 0.32 to 0.72m below present ground level; the average depth was 0.40m. The chalk was shallowest towards the east and progressively deeper towards the west.

Plate II General view of excavated post-pit group I, looking south-east

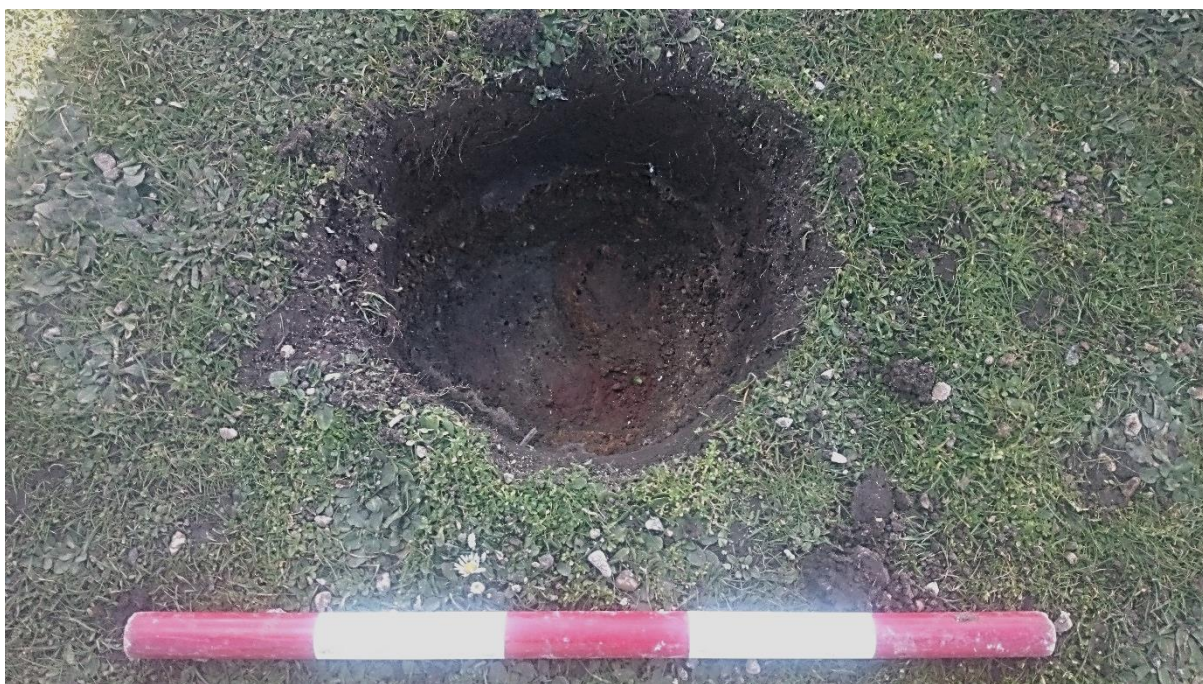
The main post-pit of group L was the only pit to have substantial brick wall remains at a depth of 0.20m below ground (Fig 4). The excavation caused only slight damage to what was clearly a large wall. A total of 0.25m of brickwork measuring approximately 0.23m square was removed. The wall is likely to be aligned north-west by south-east.

No artefacts of archaeological significance were noted during the programme of excavation. The single area of significant brickwork noted is probably related to a wall associated with the former Hospital Barracks building, probably part of south-west entrance area; however, it does not align directly with any walls seen on the known plan from c.1927 (Porter 2014).

Plate III Top of wall in post-pit L before damaged, looking south-east
