Ground adjacent to the Stone Hut, Dover Castle

Watching-brief report

Project Code: SHDC-WB-15

August, 2015

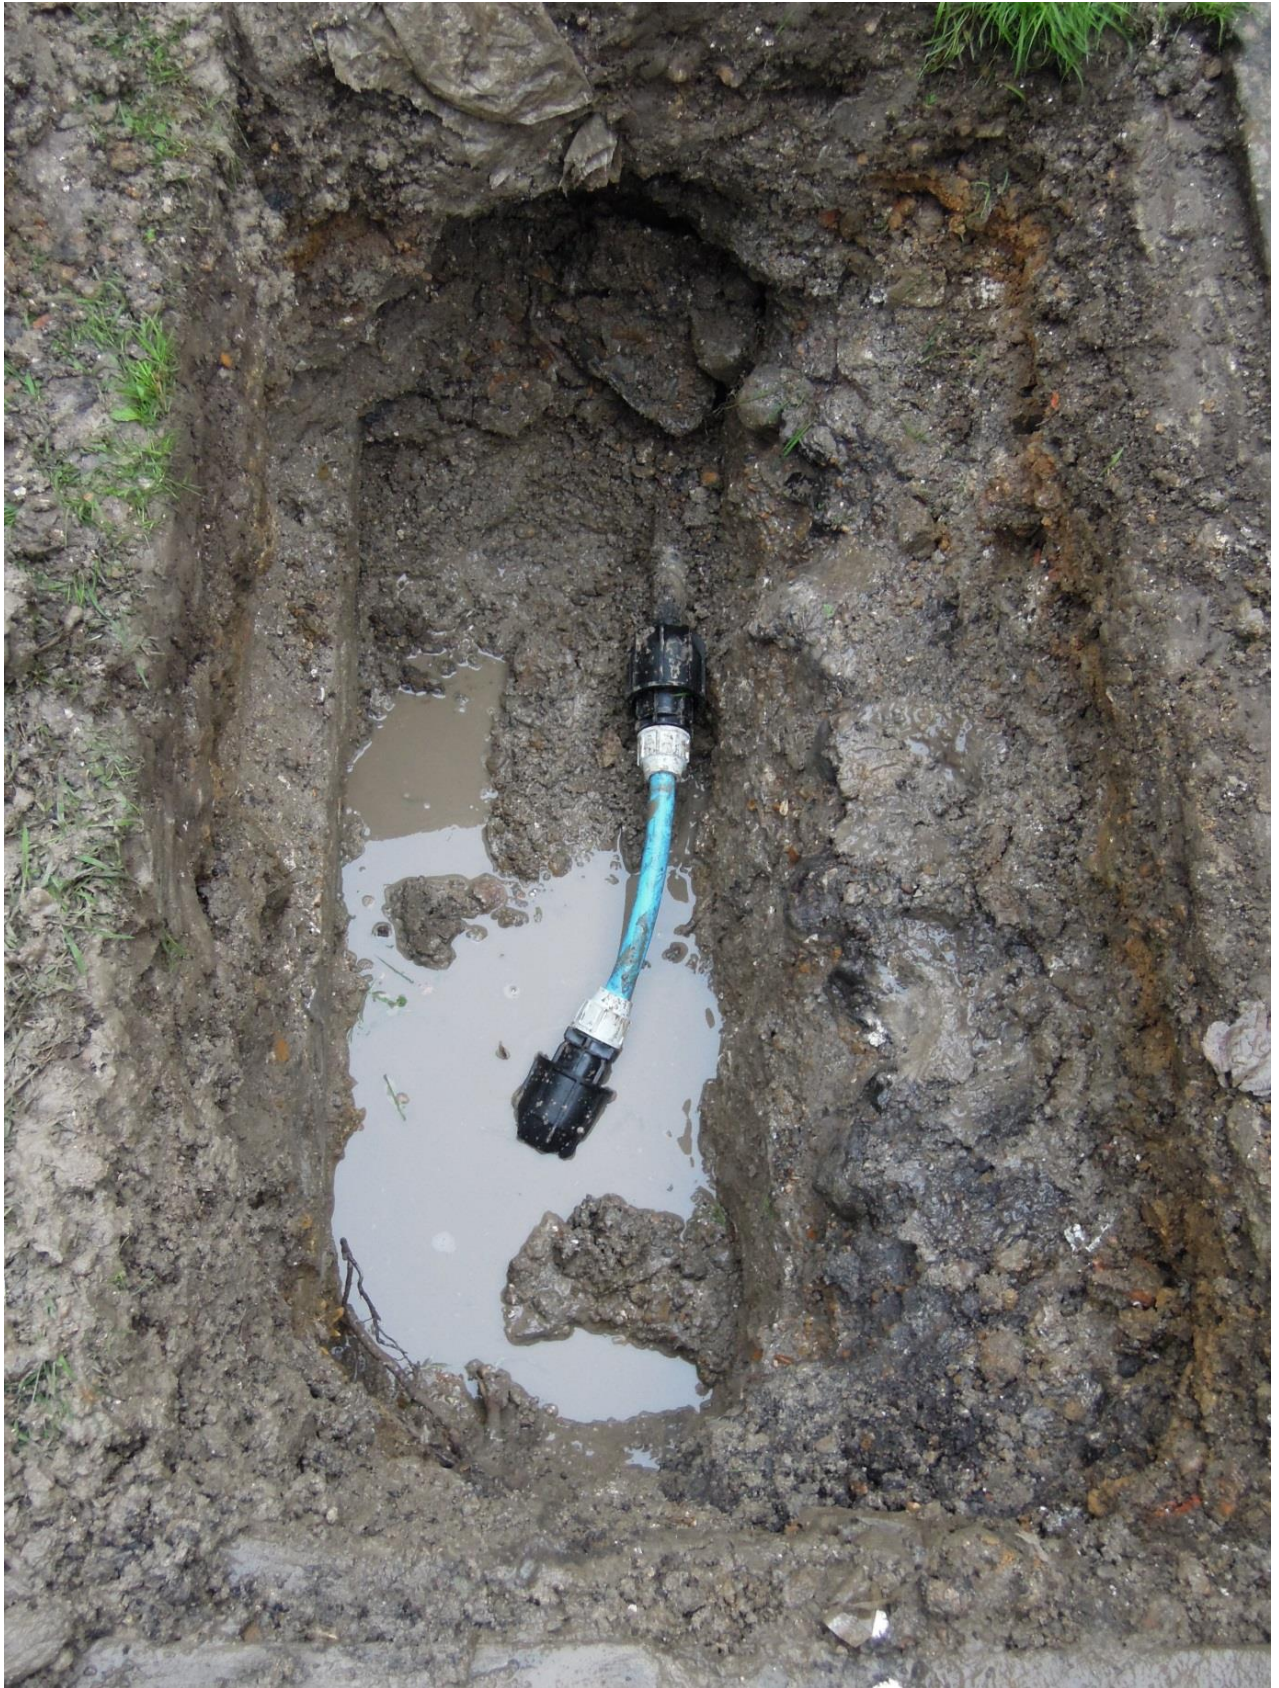
Plate I General view of the excavated pit looking south. The dark ledge on the right-hand (west) side is a laid flint surface (Context 2)

NOTES:		
<p>The bulk of the excavation was through (waterlogged) previous trench fill over a modern plastic water pipe buried at a depth of 0.95m. In the western face of the excavated pit, however, some stratified deposits were exposed (Contexts 2 and 3, see above). These extended into the pit for a distance of about 0.15m and were left untouched (Plate I).</p> <p>Buried at a depth of about 0.35m was a clear surface, probably part of an earlier path or yard (Context 2). In detail, this consisted of a 0.10m thick base layer of large flint cobbles and nodules set in a black loam. The flints were surfaced with a 0.05m</p>

thick layer of compacted black loam containing very frequent small brown flint pebbles (= pea shingle; ave. dia. of stones, 5–10mm). Based on nineteenth-century map evidence (Appendix, figs 3 and 4), this surface seems mostly likely to relate to the former Coal Yard (hence its black colour?).

The flint surface rested upon a dump deposit of clay (Context **3**; full thickness not exposed).

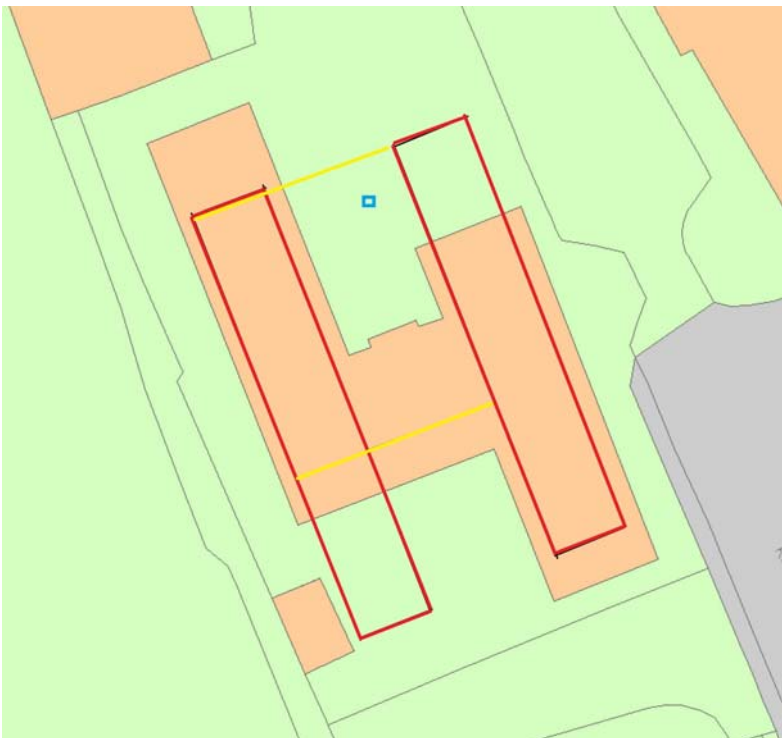
Figure 4. Modern plan of the Stone Hut, with footprint of demolished stables marked in red and north and south boundaries of coal yard in yellow. The blue rectangle marks the approximate position of the water leak.
