# Archcliffe Fort,

## Dover

### Watching brief report

Project Code: DAF-WB-16  
NGR 631566 140279, centred  
Report No: 2016/63  
Archive No: 3590

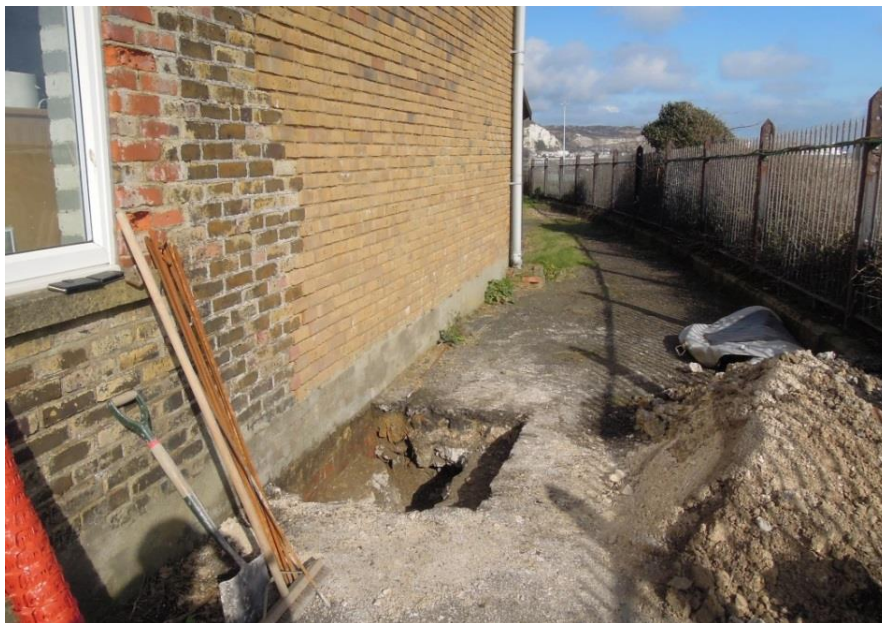
This was cut down the face of the south-east (seaward) wall of the building, some 5 metres from its east corner (Fig. 4; Plate I). The pit measured about 1.40m (NE–SW) by 1.00m (NW–SE) but only one small area could be taken to any depth due to the presence of the solid building foundations and

**Plate I** General view of Test Pit 1, looking north-east

an adjacent concrete encased drain pipe. At the south-west end, it was possible to cut a narrow slot to a maximum depth of 1.70m (Fig. 3). In its base, the top of the natural cream chalk wash (solifluction deposit) was exposed at a depth of about 1.35m below present ground level (Fig. 3, Context 1/7).

The natural deposit (1/7) was overlain by a thin layer of dark brown clay with chalk grits (Context 1/6), which was about 0.12m thick and appeared to be the truncated base of an undisturbed, pre-fort topsoil deposit. It was sealed by a 0.50m thick layer of cream chalky silt (Context 1/5), representing a dump of re-deposited natural, that is most probably connected with earthmoving or landscaping at some stage during the construction or use of the fort. The chalky dump (1/5), was then sealed by another dump of dark grey-brown clay loam containing occasional flint pebbles and chalk lumps (Context 1/4), about 0.60m thick.

Cutting in from the top of Context 1/4 was the foundation trench for the building (F. 3). This was at least 1.60m deep and its lower part was occupied by a substantial pebble concrete foundation, over 0.90m thick. The top of the foundation lay at a depth of about 0.84m below present ground level and supported the main brick wall of the building (Context 1/8), offset to the footing by about 0.25m. The remaining part of the foundation trench had been backfilled with loose grey loam and rubble (Context 1/2). Finally, the whole area had been sealed by a 0.09m thick layer of tarmac (Context 1/1) forming a path around the outside of the building.

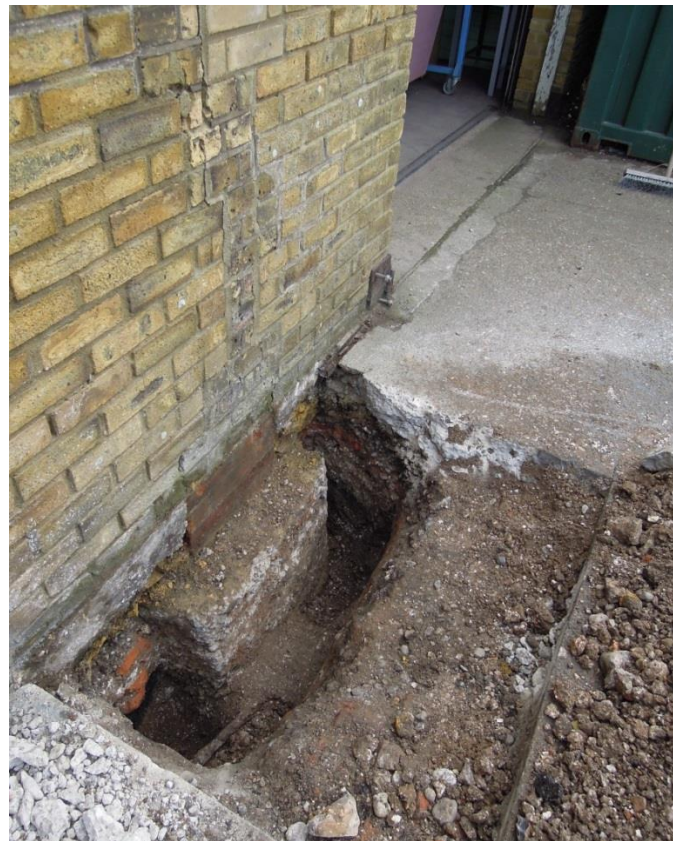
This was cut outside north-west wall, opposite Test Pit 1, adjacent to the main door of the building (Fig. 4; Plate II). Again, the pit measured about 1.40m (NE–SW) by 1.00m (NW–SE) but only one small area was taken to any depth. A narrow slot at the south-western end was excavated to –0.95m below present ground level (Fig. 3). In its base, the top of a layer of brown clay containing frequent small chalk lumps, at least 0.30m thick appeared to be a near natural deposit and clearly predated the construction of the fort (Fig. 3, Context 2/5). Above this, a 0.10m thick layer of dark grey-brown clay with chalk specks (Context 2/4) also appeared to be a pre-fort layer, quite possibly the same as Context 1/6 in Test Pit 1 (see above).

**Plate II** General view of Test Pit 2, looking south-west

The dark clay deposit (2/4) was overlain by a dump of cream-brown chalky clay with flint and chalk lumps (Context 2/3), which was about 0.15m thick. It was sealed by a 0.24m thick layer of compacted shingle and red brick rubble (Context 2/2), which served as a bedding for the overlying concrete yard surface (Context 2/1), which was about 0.15m thick.
