Archcliffe Fort, Dover

Watching brief and excavation inside the fort

Project code: AFGT-WB-16
NGR: 631551 140309 to 631567 140297
Report no: 2017/142
Archive no: 3939

August 2017

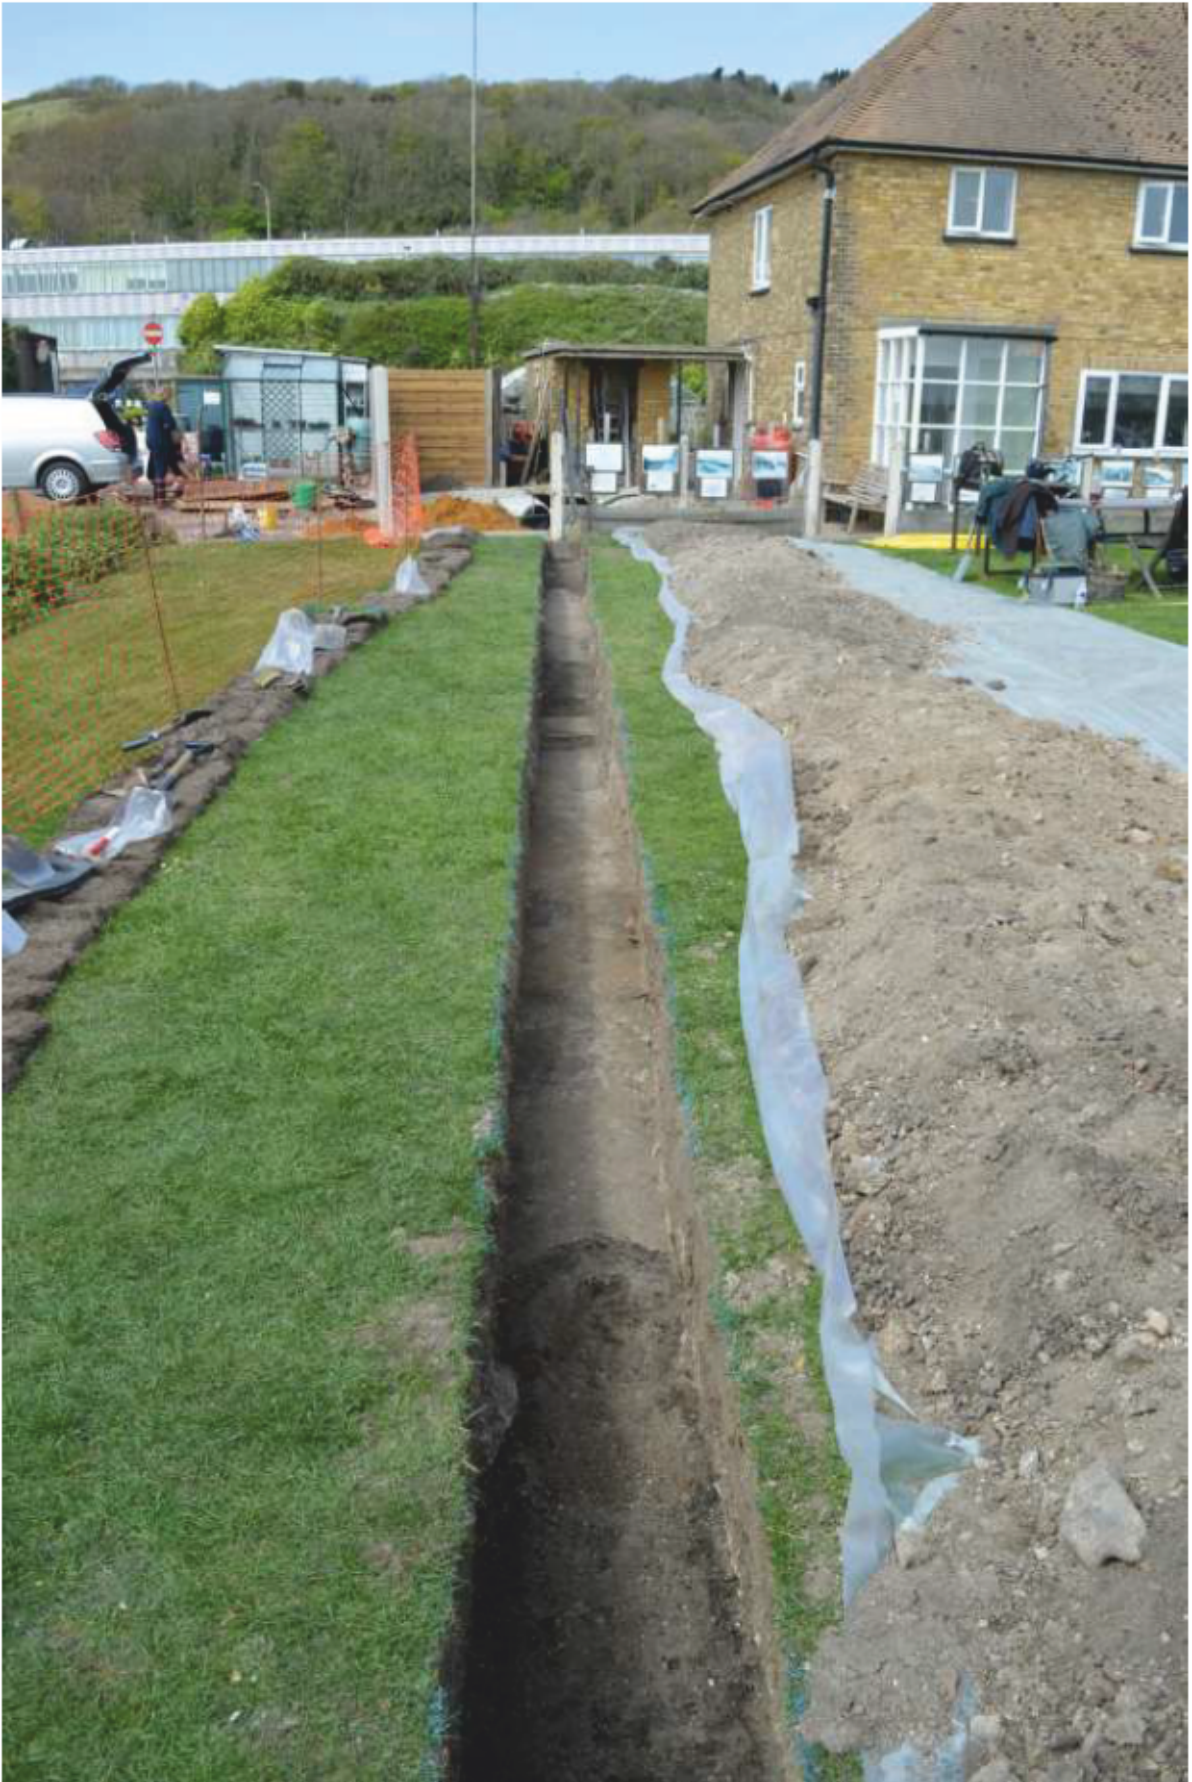
Frontispiece General view of the excavated trench showing buried yard surface, looking north-west

6.2 The new trench was aligned north-west by south-east and was some 18.50m in length. It was 0.40 wide and excavated to a depth of 0.60m (Frontispiece). The ground surface in this area lay at around 16.50m above OD.

9.4 Later, the old yard surface on the north-east side of the fort was buried under a dump of soil and rubble (Context 2) intended to provide the base for a new, slightly raised area of lawn (Frontispiece). A quantity of domestic rubbish had been incorporated into this deposit – most closely datable is a beer bottle stopper dated 1938, but a more unusual find was the military steel helmet of apparently of First World War date.

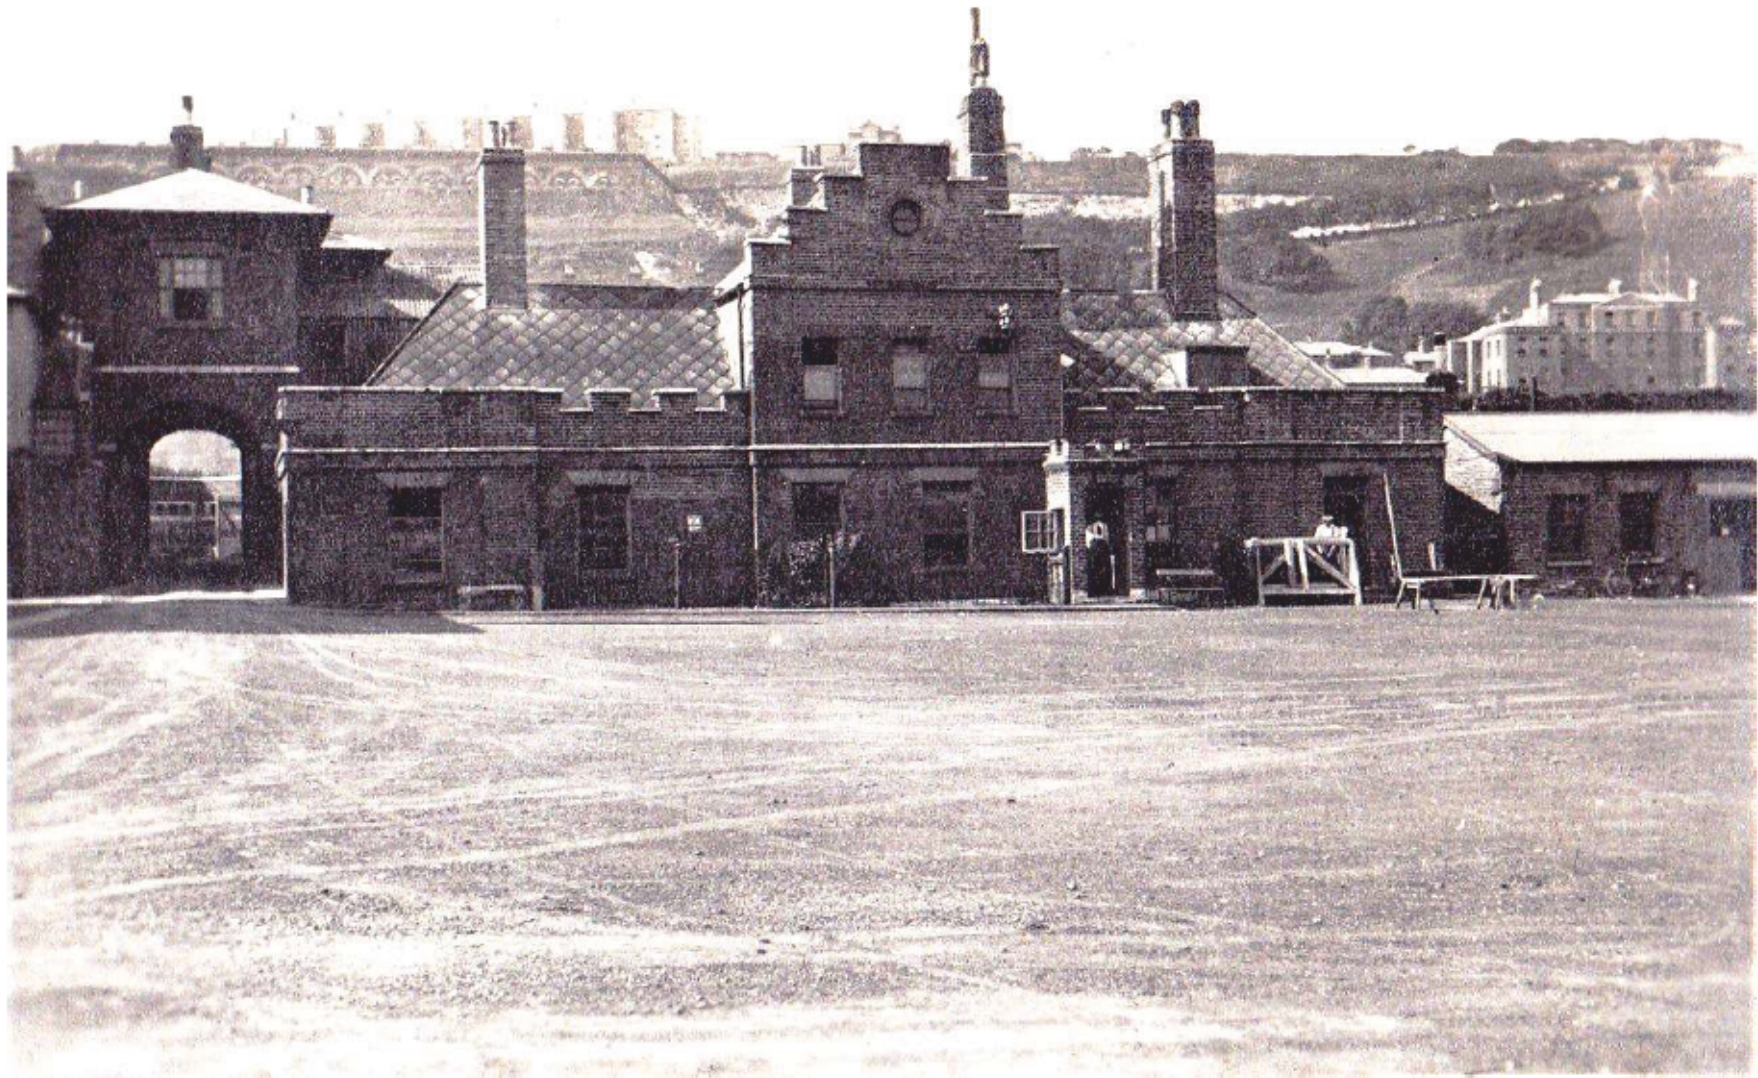
Fig. 4 General view of the fort interior, looking west sometime during the First World War, showing extent of metallized parade ground

9.2 The general dump layer (6) was sealed by a thin layer of brick hardcore (Context 5) which formed the base for an asphalt yard surface (Context 4) that extended along the full length of the trench. This showed some evidence for localised repairs to the original surface. There seems little doubt that this surface equates with the metallated yard/parade ground shown in the First World War photograph of the fort's interior (Fig. 4).

10.2 The work established that the central courtyard/parade ground which presently occupies much of the interior of the fort was once more extensive and originally continued towards the ramparts on the north-east side. This evidence is largely confirmed by a First World War photograph, only discovered by the writer after the excavation had taken place (Fig. 4).
