The Paddock Car Park,

Deal Castle

Watching brief report

Project Code: TPDC-WB-17
 Planning Refs: DOV/16/01370
 NGR: 637762 152116, centred
 Report No: 2018/48
 Archive No: 4077

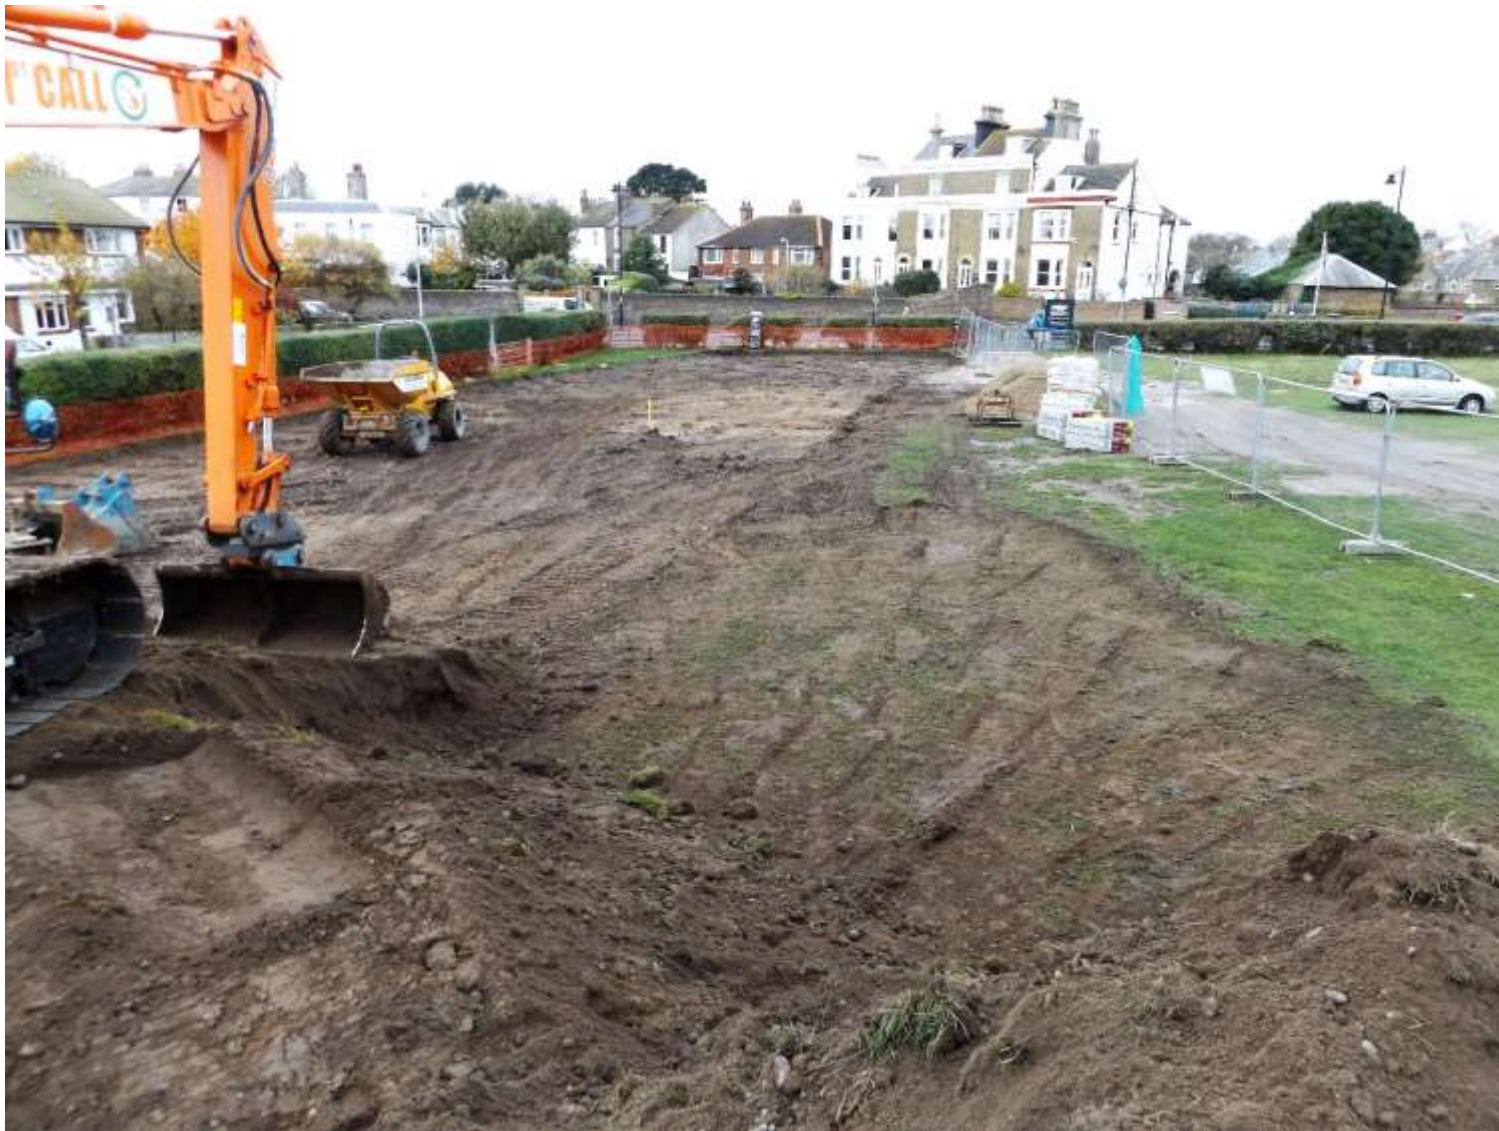
Frontispiece General view of earthmoving on site, looking west (CAT image 3474)

2.5 The groundworks for the new car park required two main areas of the existing grass to be cleared and the cutting of a broad, shallow terrace into the sloping ground (Frontispiece, Figs 2 & 3). The larger excavation was roughly L-shaped in plan, with maximum dimensions of about 15m (N–S) by 48.00m (E–W) and was up to 0.35m deep. A smaller area cleared on the eastern side was between 10 and 14 metres across (Figs 10 & 11). More than 200 tonnes of topsoil was removed from these areas. The remaining ground was left essentially undisturbed, laid to protective matting over the existing grass.

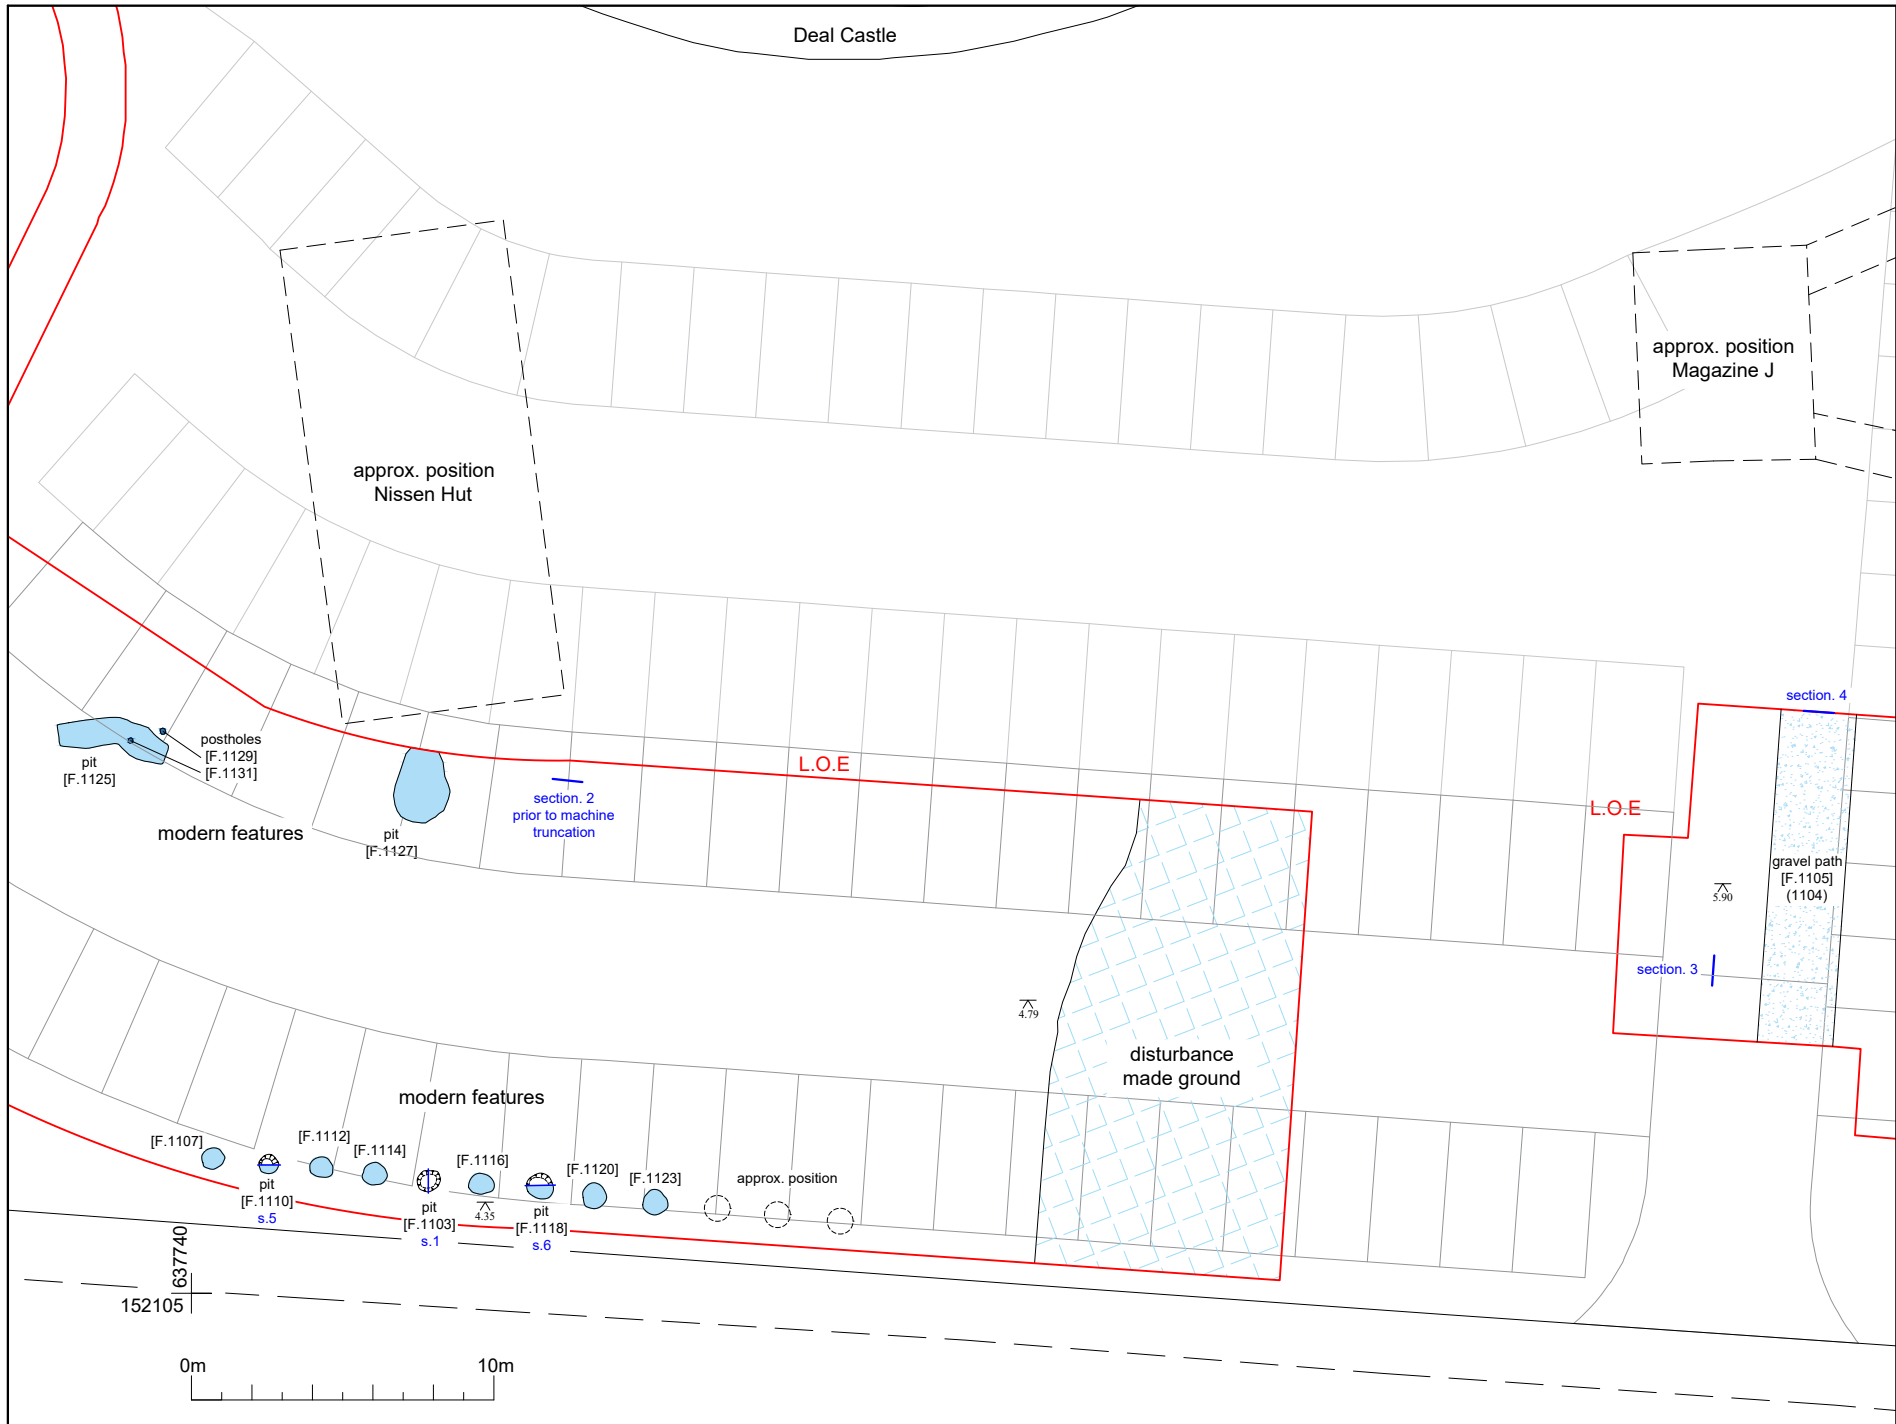
Fig.3

A line of at least a dozen roughly circular pits was noted cutting into the surface of the natural beach (1003) along the south side of the site (Fig. 3). The position of nine was recorded (Fs 1107, 1110, 1112, 1114, 1103, 1116, 1118, 1120 & 1123) and it was possible to sample excavate three of these (Figs 3, 5 & 13; Fs 1110, 1103 & 1118). The pits were evenly placed in a row about 2 metres apart along the southern boundary of the plot, all within 1.50m of the current hedge line. Excavation of Fs 1103, 1110 & 1118 showed that each must have had an original depth of between 0.35 and 0.40m and a diameter of 0.70 to 0.80m (Figs 5 & 13).

Fig. 3 Detail plan showing investigated features

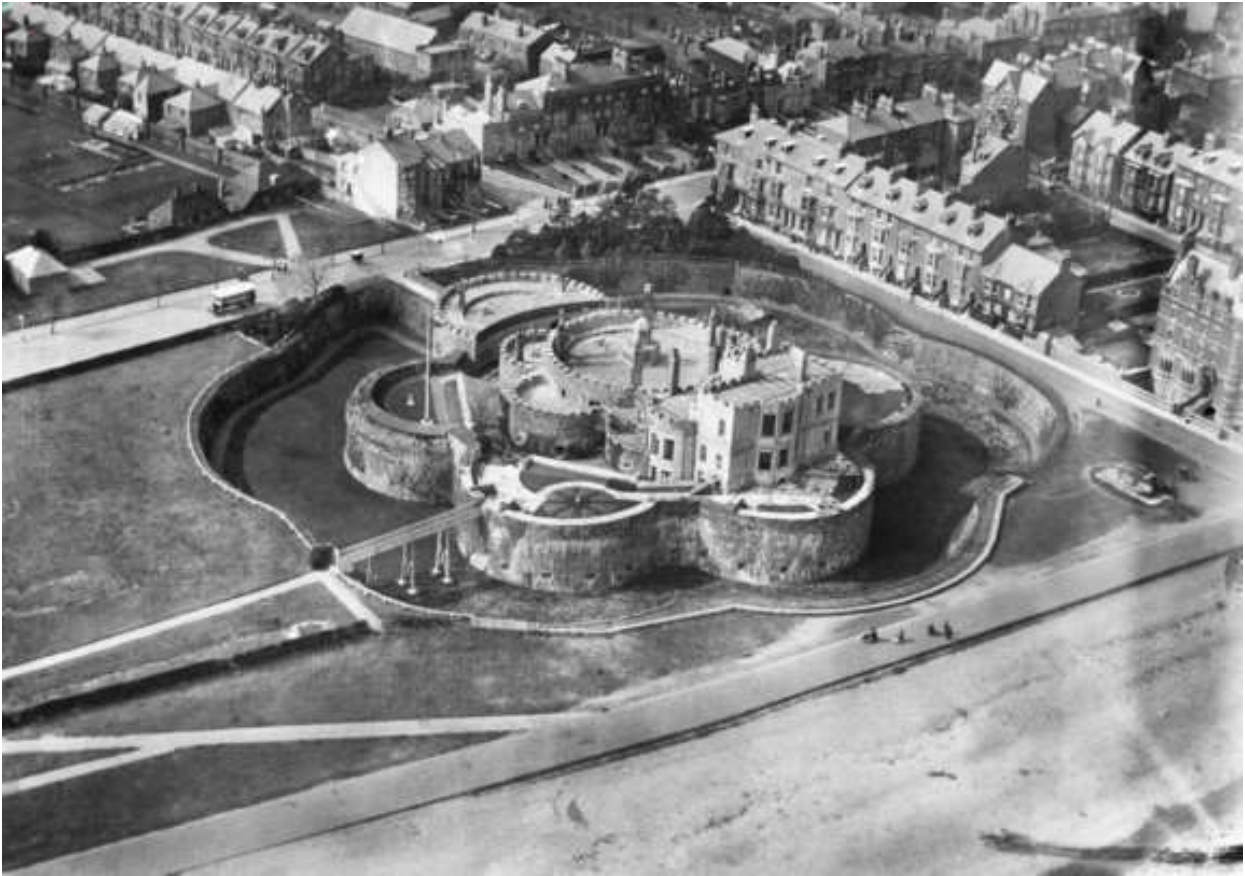
Fig. 6 Aerial photograph of 1920 showing footbridge and pathway across paddock on south side of Deal Castle (Historic England Archive Image EPW000333)

4.6 The boundaries of the present paddock were formally established during the nineteenth century with the current arrangements in place by 1871. The paddock itself remained as an open space but with a path close to its east boundary, running from a footbridge over the castle ditch to its south-east bastion (Porter 2016, 2.11; Fig. 6).

Fairly certainly, this section of pathway can be equated with the access path to a wooden footbridge which formerly spanned the castle ditch on the south side (Fig. 6). Both the path and bridge are recorded on large scale Ordnance Survey maps for 1871 and 1897, and also appear on an aerial photograph of 1920 (Historic England Archive Image EPW000640; Porter 2016; Fig. 6). The bridge and footpath, however, had been removed by the time of an aerial photograph dated August 1927 (Historic England Archive Images EPW000640 & EPW019062; Porter 2016; see Fig. 7).

8.3 A number of sub-surface archaeological features were located. These were mostly pits and post-holes cutting the primary beach or subsoil deposits and all appeared to be of nineteenth- or twentieth-century date. On the eastern side of the site, exposure of a length of north–south aligned gravel pathway (Context 1104) confirms the evidence of early Ordnance Survey maps and aerial photographs, which show a path crossing this area, connecting to a footbridge over the castle ditch (Fig. 6).

8.4 The discovery of a row of possible planter pits close to the southern boundary of the site may relate to an early effort to enclose the area. Contained within the thickness of the present boundary hedge is an intact wrought iron fence which must relate to the subsequent formalisation of the boundary (Figs 6 & 7).

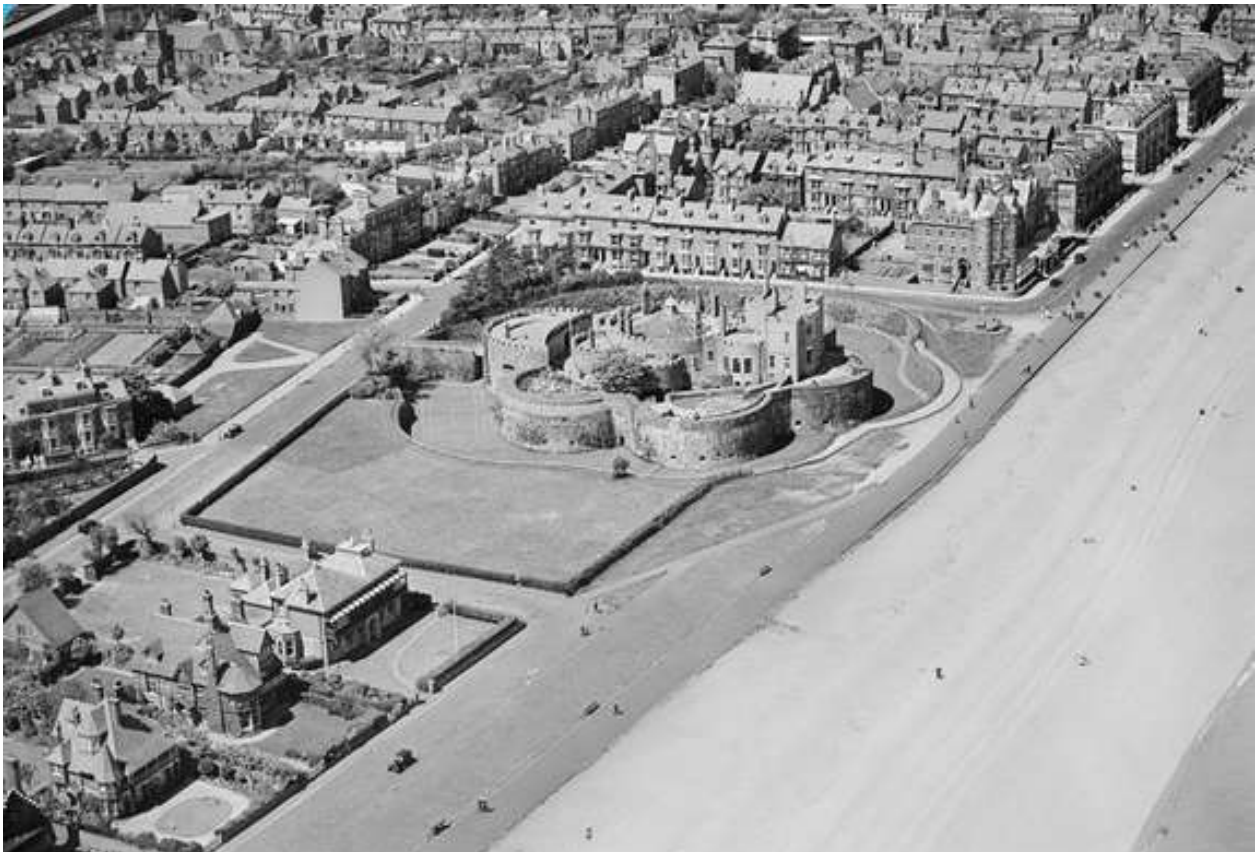
Fig. 7 Aerial photograph of 1931 showing open paddock on south side of Deal Castle – note footbridge has been removed (Historic England Archive Image EPW035432)

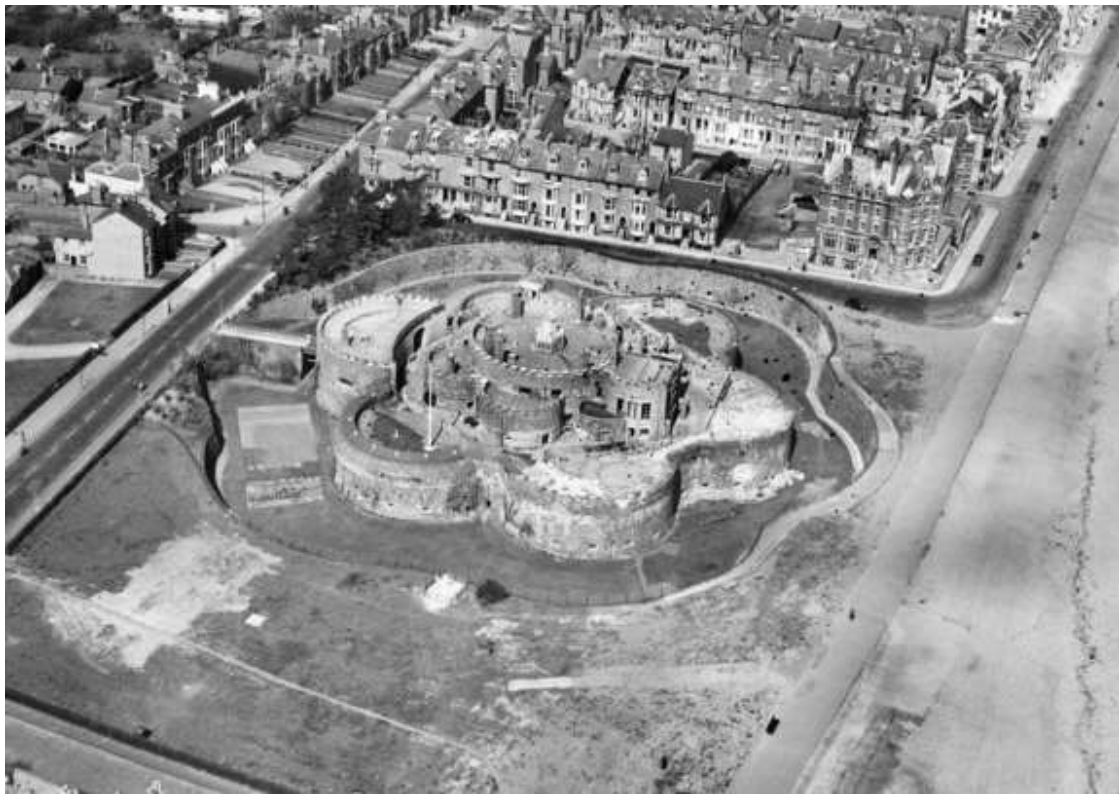
Fig. 8 Aerial photograph of 1948 showing scars left by removal of Second World War defences and bomb damage to Deal Castle (Historic England Archive Image EAW014345)

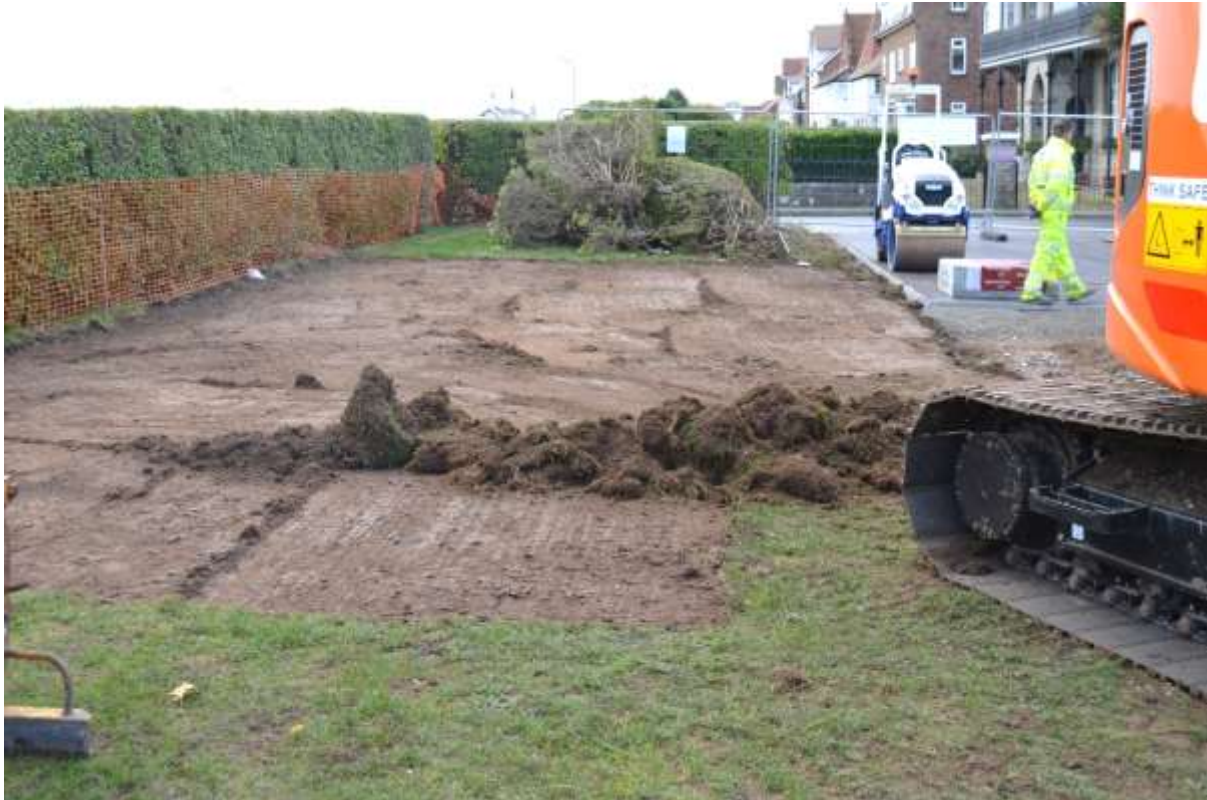
Fig. 10 Initial machine stripping of topsoil on the east side, looking south (CAT image 0459)

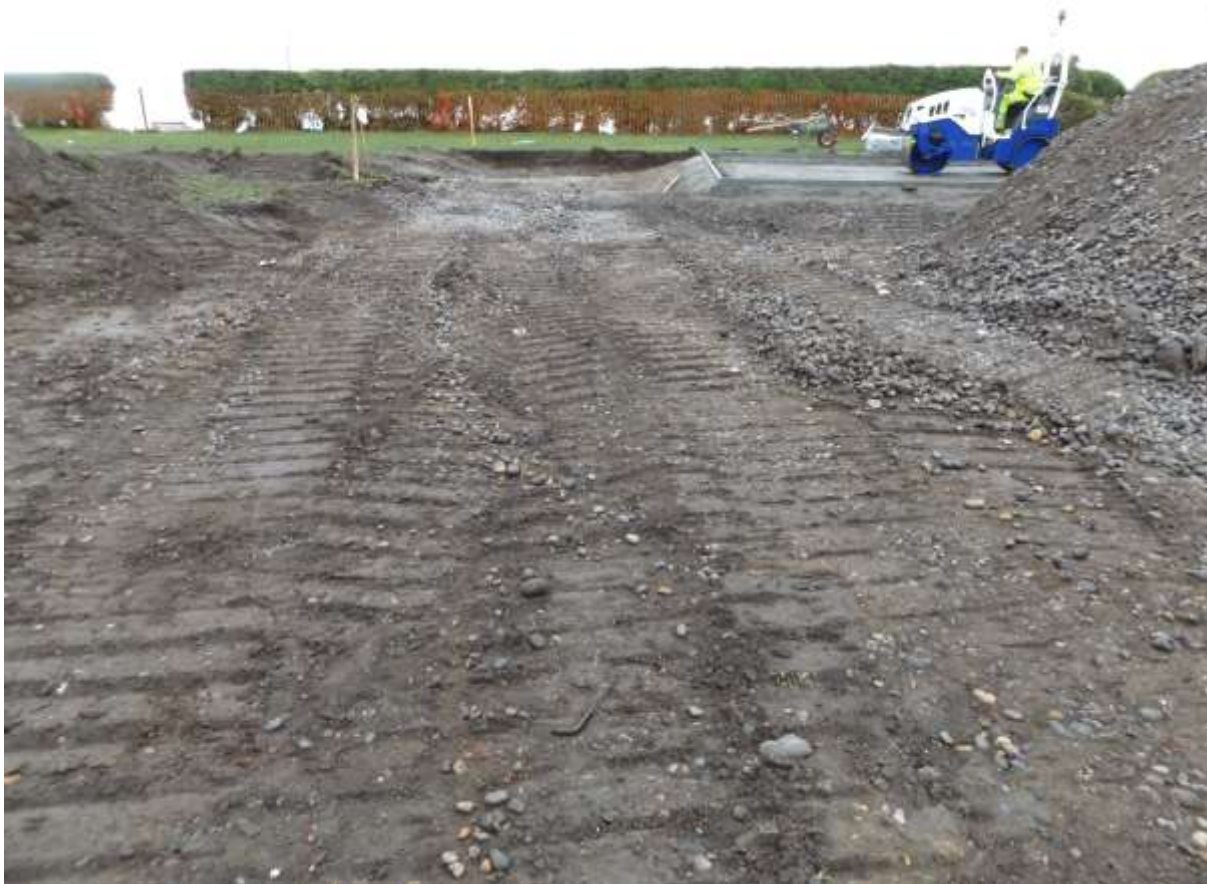
Fig. 11 Excavations for the car park, looking east (CAT image 3440)

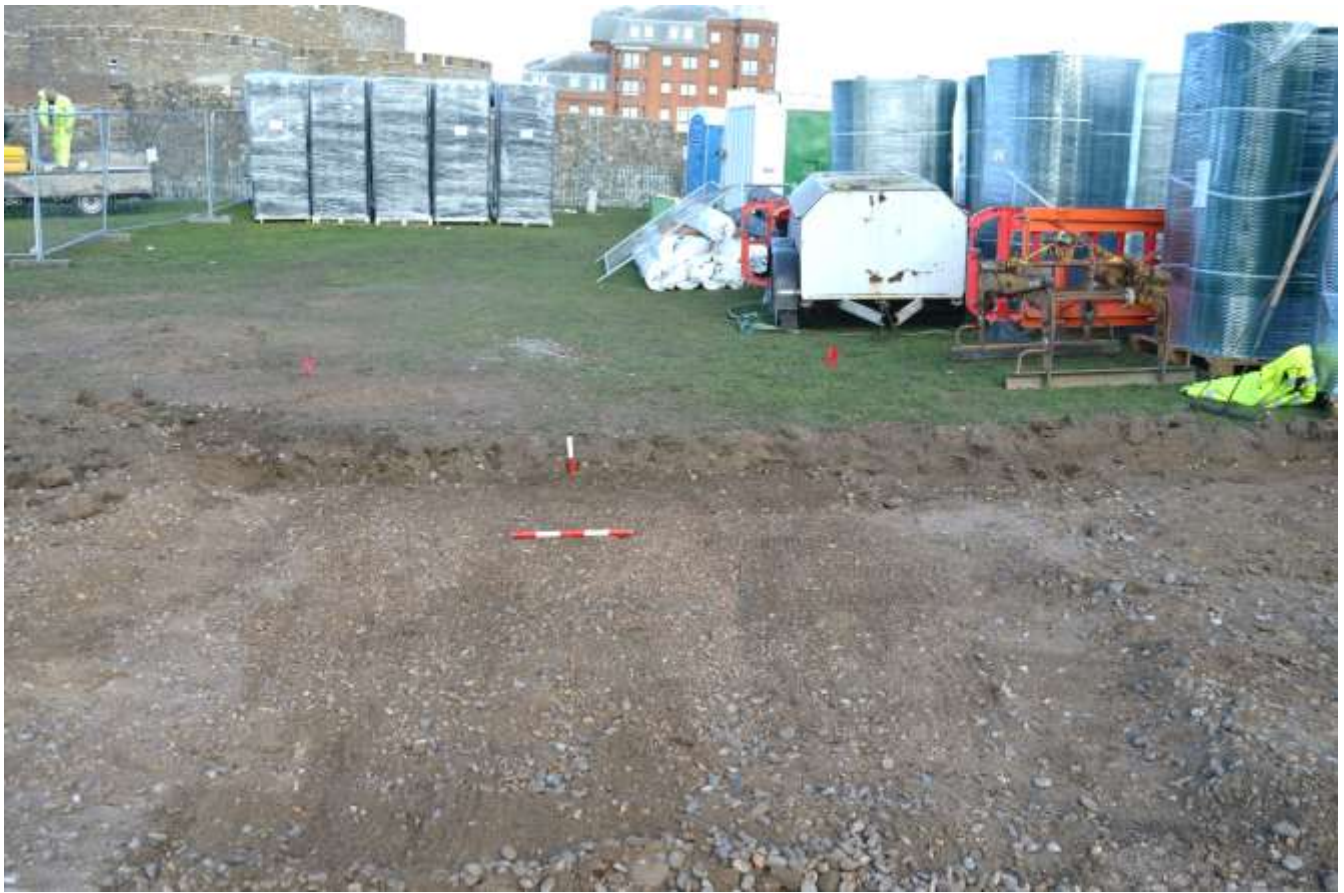
Fig. 12 View of gavel path (1104) heading towards castle, looking north. Scales, 20 and 50cm (CAT image 0463)

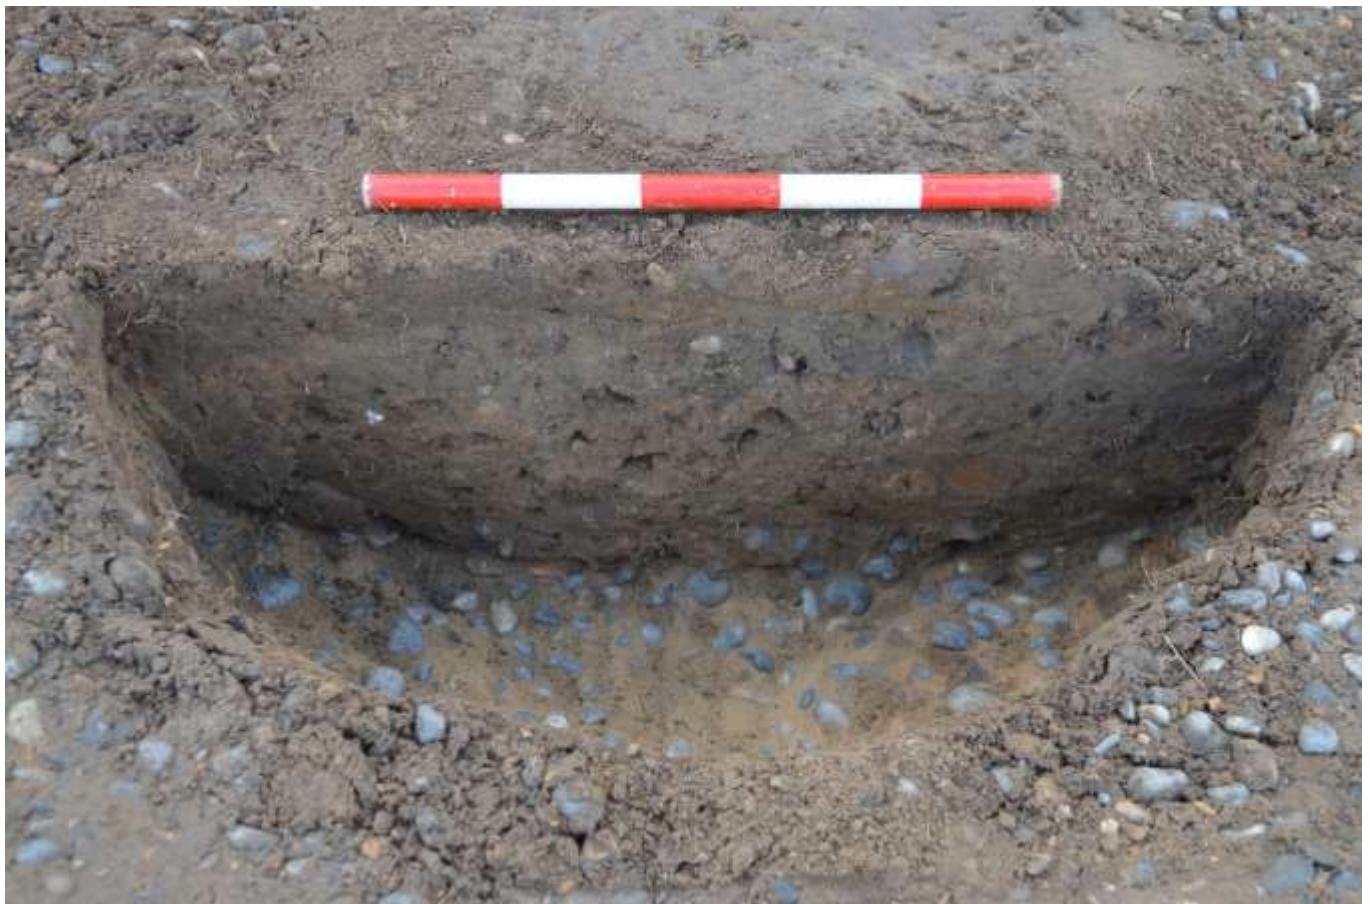
Fig. 13 Pit F. 1118, half sectioned, looking south. Scale, 50cm (CAT image 0487)

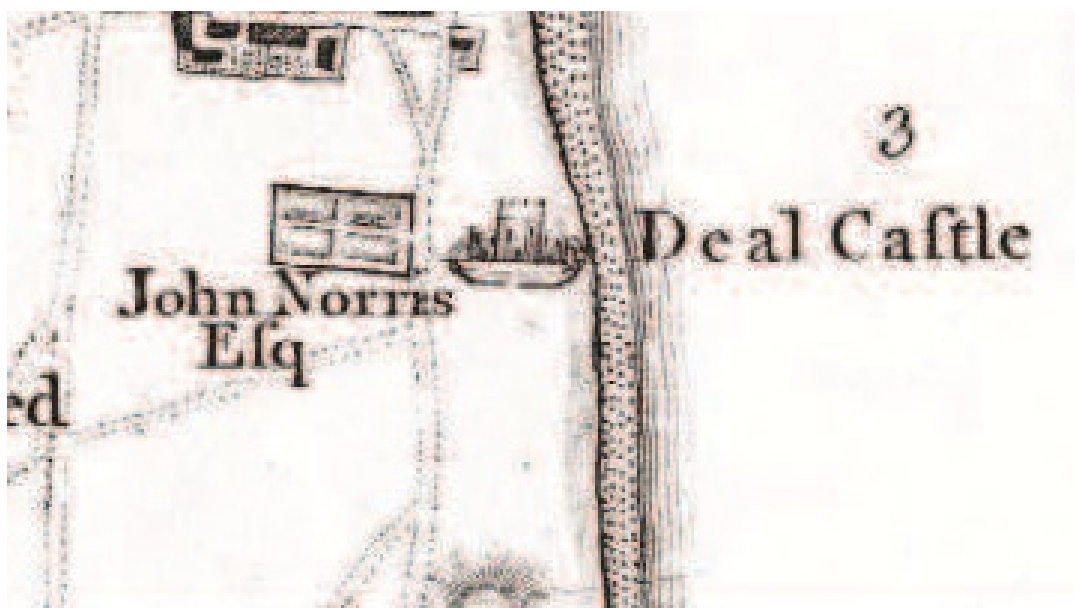
Figure 4. Detail from Andrews, Dury and Herbert's map of 1769.

2.9 Despite attempts to prevent development within the line of fire of the castle, Deal town grew up to the north of the castle, achieving corporation status in 1699.⁸ By this time a naval victualing yard had been established directly north of the castle between it and the urban development. By contrast, the land to the south appears to have remained undeveloped. Cartographic evidence of the 18th century shows the castle in isolation from the town, sitting to the east of the Deal-Walmer road, and with the captain's garden on the west side of the road the only closely located feature. Andrews, Dury and Herbert's map of 1769 shows one of the bulwarks of the Tudor linear defences to the south of the castle but there is no indication of the defensive ditch. In contrast to the captain's garden to the west of the castle, no formal boundary is shown around the site of the later paddock / car park. Hasted's map of 1790 shows the recently constructed naval hospital and barracks southwest of the castle but again nothing either within the study area or on its perimeter. The Ordnance Surveyor's field drawing of Deal, prepared in c.1800, also presents the study area as a formally undefined open area, though a rectilinear feature is shown approximately 40m to the south of the current southern boundary.

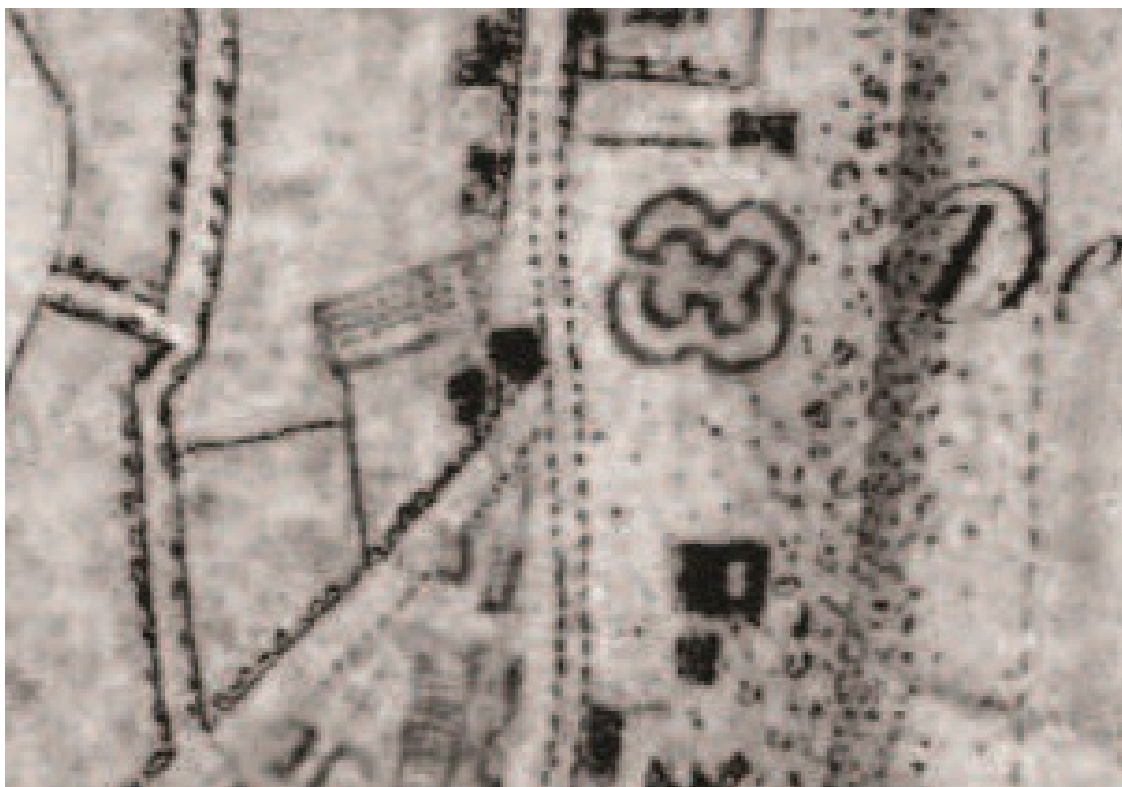
Figure 5. Ordnance Surveyor's field drawing of Deal, prepared in c.1800.

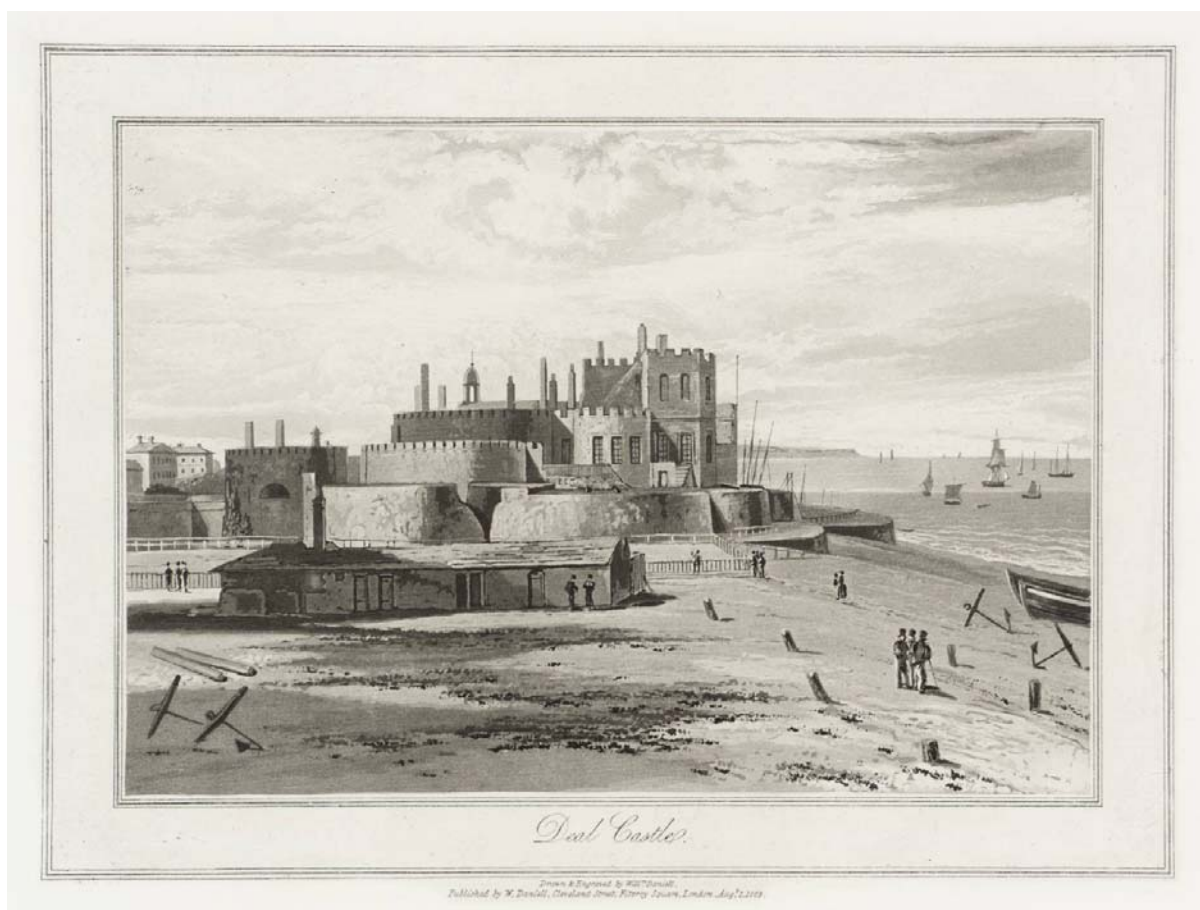
Figure 6. Deal castle from the south by William Daniel, c.1823. The paddock is shown with a fenced boundary.

- 2.10 The paddock's boundaries were formally established during the 19th century. A drawing by William Daniel of c.1823 provides a view from the south, across the paddock, and towards the castle. This shows a post and rail fence on the paddock's north, south and east boundaries (the west boundary is out of view). On the north the boundary skirts the castle ditch's counterscarp, while on the east the boundary runs north-south aligned, roughly, with the eastern edge of the castle's southeast bastion, with the foreshore beyond to the east. The paddock is shown empty and it has been suggested that it provided garden or parade ground space. In the foreground of Daniel's drawing, to the south of the paddock is a long single-storey building with pitched roof, axially aligned east-west, with an out-house visible on its northern side.

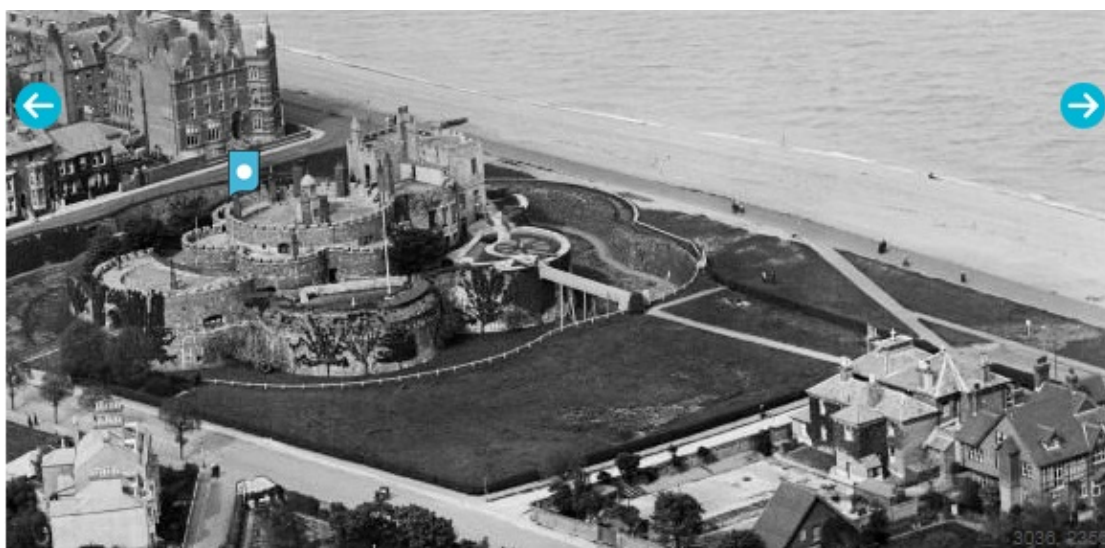
Figure 9. Aerial photograph, April 1920. Historic England Archive Image EPW000640.

- 2.11 Ordnance Survey maps show how the paddock was further defined during the 19th century. The current boundaries had been established by 1871, with residential development occurring to the south of the newly created Marine Road before 1897. The paddock remained an open space but with a footpaths close to its east boundary, running from a footbridge over the castle ditch to its southeast bastion. One of these footpaths ran north-south across the paddock, the other east-west towards the shore. This arrangement can be seen in an aerial photograph taken in April 1920 but the bridge and footpaths had been removed by the time of a subsequent aerial photograph in August 1927.⁹

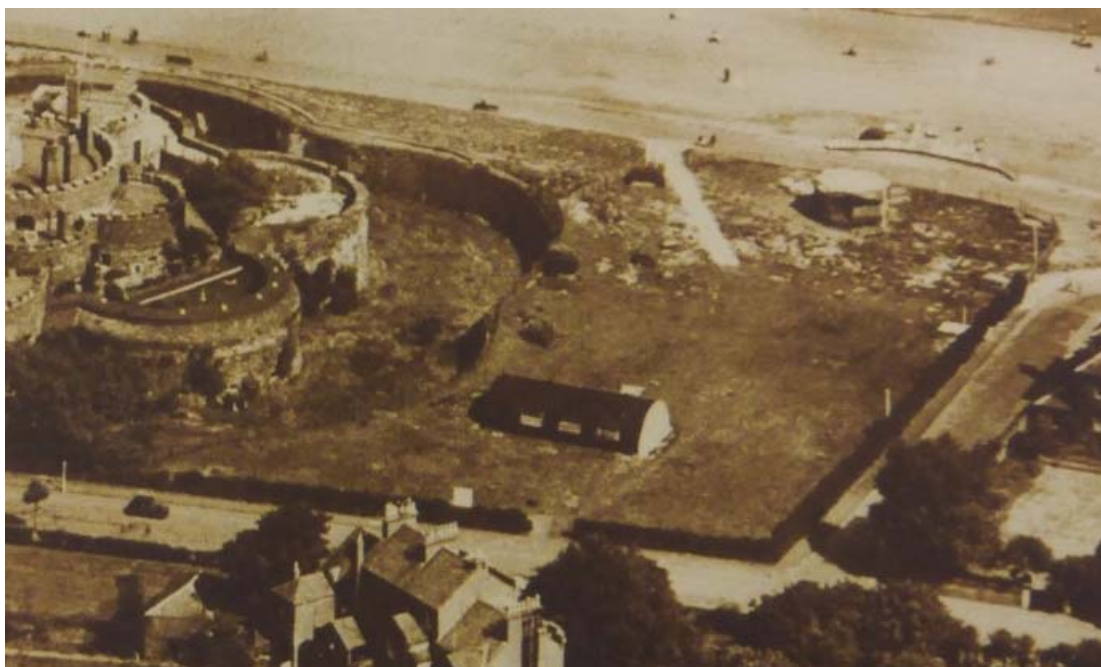
- 2.13 The battery was removed soon after World War II. An aerial photograph of c.1945-46 shows the northern gun post demolished, while an aerial taken in April 1948 shows the structures of the battery completely removed from the paddock and adjacent to it, leaving the ground heavily scarred.¹⁴ The treatment of the magazine is unknown but it is likely that it was in-filled and its western steps buried. Since 1948 the eastern boundary has been restored and a hedge planted on it, and the paddock has remained an open grassed space.

Figure 12. Detail of aerial photograph of c.1945-46, looking northeast across paddock. Note Nissen hut and gun post to the east. The northern gun post has been demolished. The light scar is on the line of the subterranean passage which ran between the north gun post and the buried magazine.

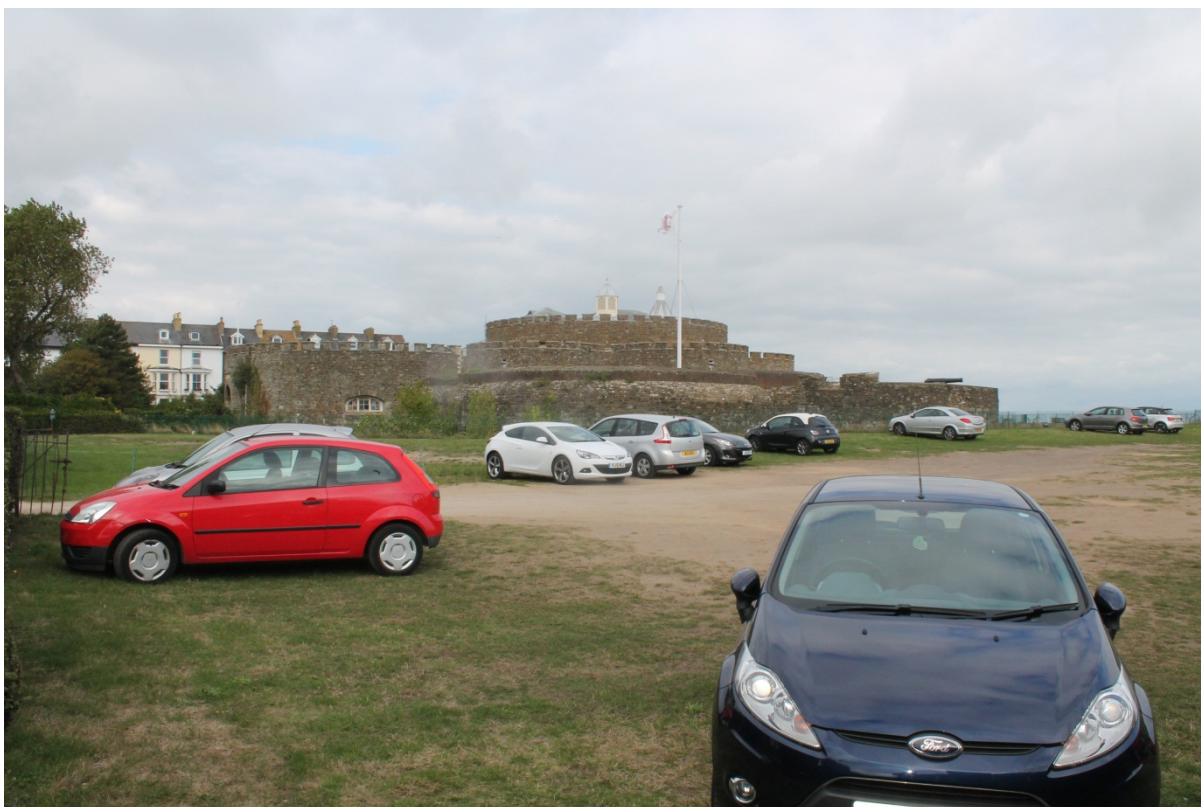
- 3.6 The paddock is used as a car park, currently without any formal surfacing or indication of parking bays. As a consequence there has been extensive damage to ground surface in the paddock's northeast corner and while drivers are at liberty to park anywhere within the site, it is usual for places close to the counterscarp of the castle's ditch to be taken first. The combination of ground damage and regular parking directly adjacent to the counterscarp erodes the amenity of the castle and harms the ability of visitors to enjoy its setting.

Figure 15. View across paddock looking northeast, showing the effect on the castle's setting by cars parking close to the counterscarp.
