Leysdown Connections, Isle of Sheppey, Kent

Watching Brief Report

Client: Southern Water
 Project Code: WB LCS 18
 NGR: 599546 169856 to 600025 170267
 Archive No: 4161
 Report No: 2019/10
 Prepared by: Adrian Gollop

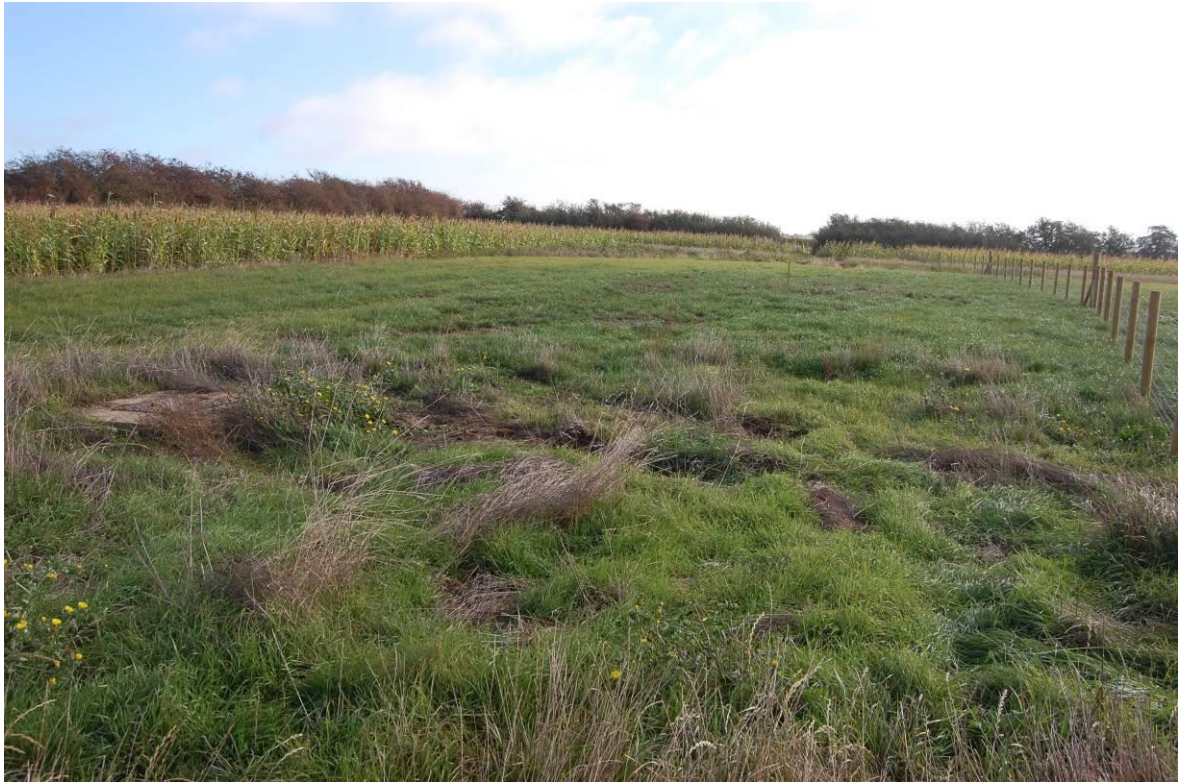
Plate 1. Pre-work shot taken at the extreme western end of the Eastchurch Scheme (chainage 0–135m area), as viewed from the west with the existing manhole to the left. No scale.

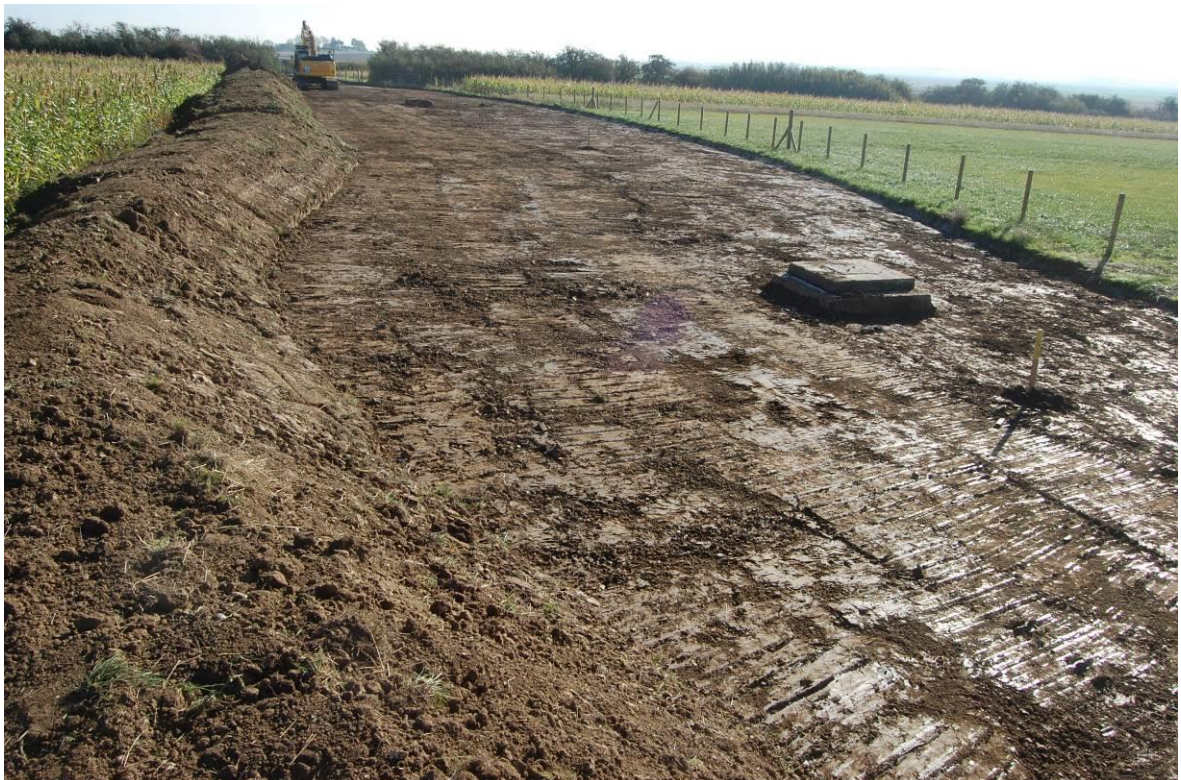
Plate 2. View taken from the extreme western end of the Eastchurch scheme (chainage 0–135m area) during the initial topsoil strip, as viewed from the west. No scale.

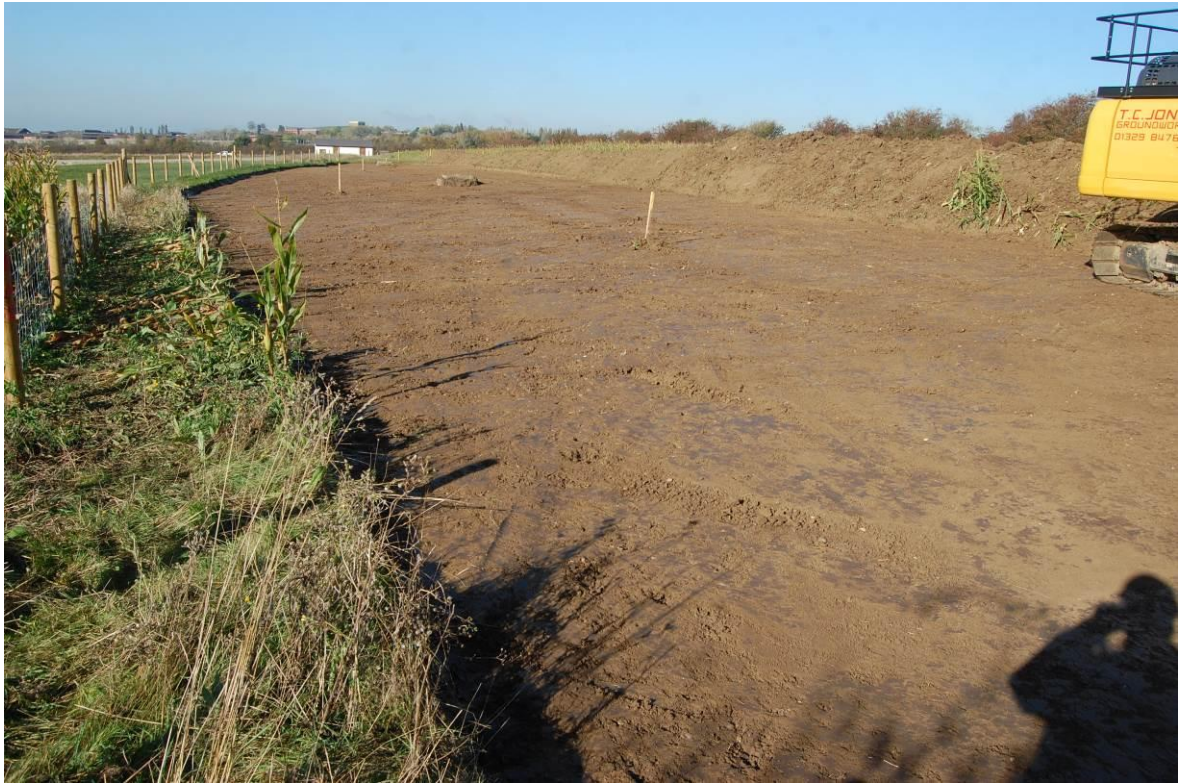
Plate 3. View taken from the eastern end of the Eastchurch scheme (chainage 0–135m area) during the initial topsoil strip, as viewed from the east. No scale.

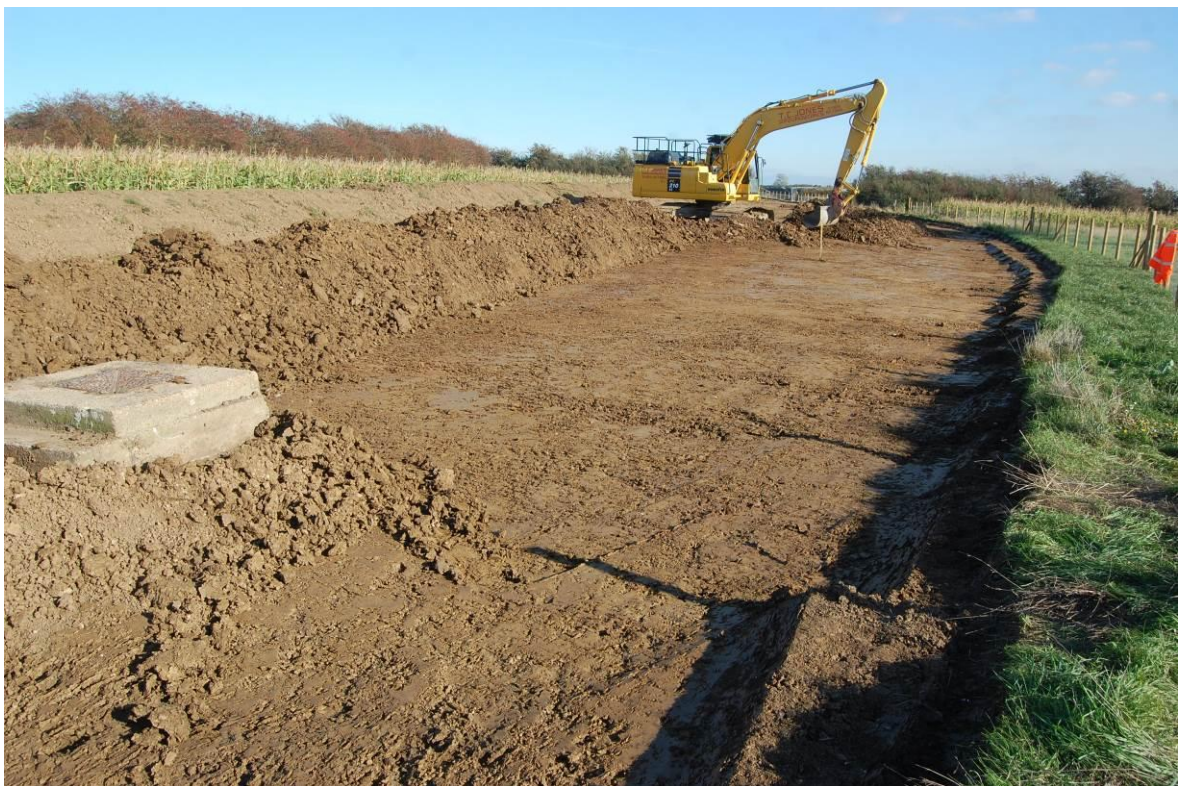
- 2.1.5 The exposed natural subsoil (201) comprised moderate to firmly compacted mid brown slightly silty sandy clay with occasional small- to mid-sized (0.02–0.08m) rounded and sub-rounded flint pebbles. No archaeological features were present. A series of modern ceramic field drains traversed the stripped area at an approximate north-west to south-east alignment; these were partially infilled with clinker to aid drainage.

Plate 4. View taken from the eastern end of the Eastchurch scheme (chainage 0–135m area) during the lower subsoil strip down to natural London Clay as viewed from the west. No scale.

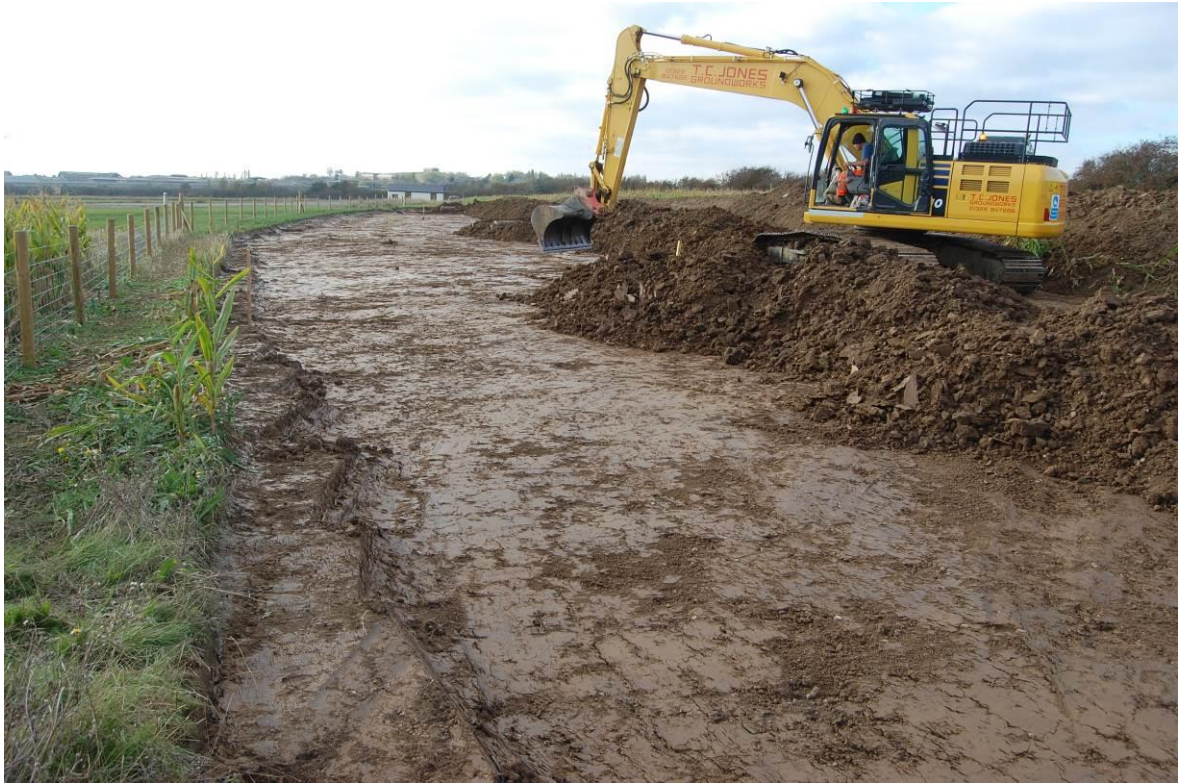
Plate 5. View taken from the extreme eastern end of the Eastchurch scheme (chainage 0–135m area) during the lower subsoil strip down to natural London Clay as viewed from the east. No scale

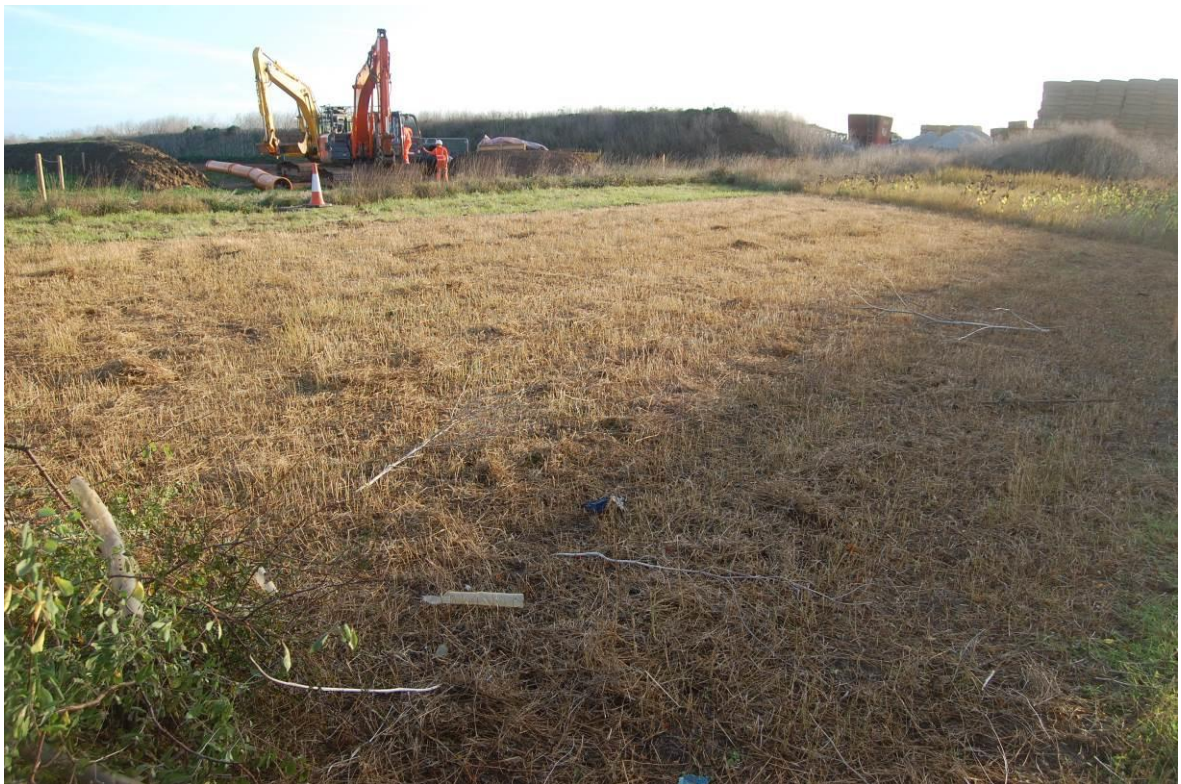
Plate 6. Pre-work shot taken at the Eastchurch Scheme (chainage 540–575m area), as viewed from the south-south-west. No scale.

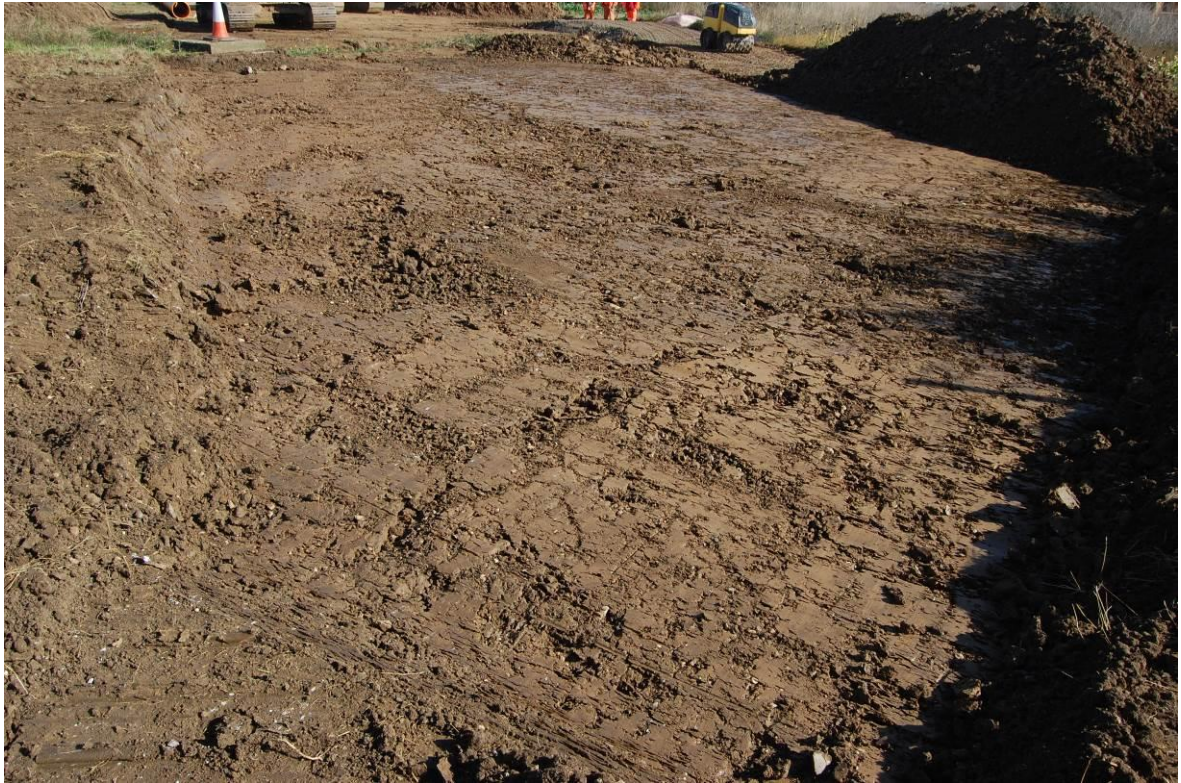
Plate 7. Eastchurch Scheme (chainage 540–575m area), after machine reduction down to the upper surface of the exposed London Clay, as viewed from the south-south-west. No scale.

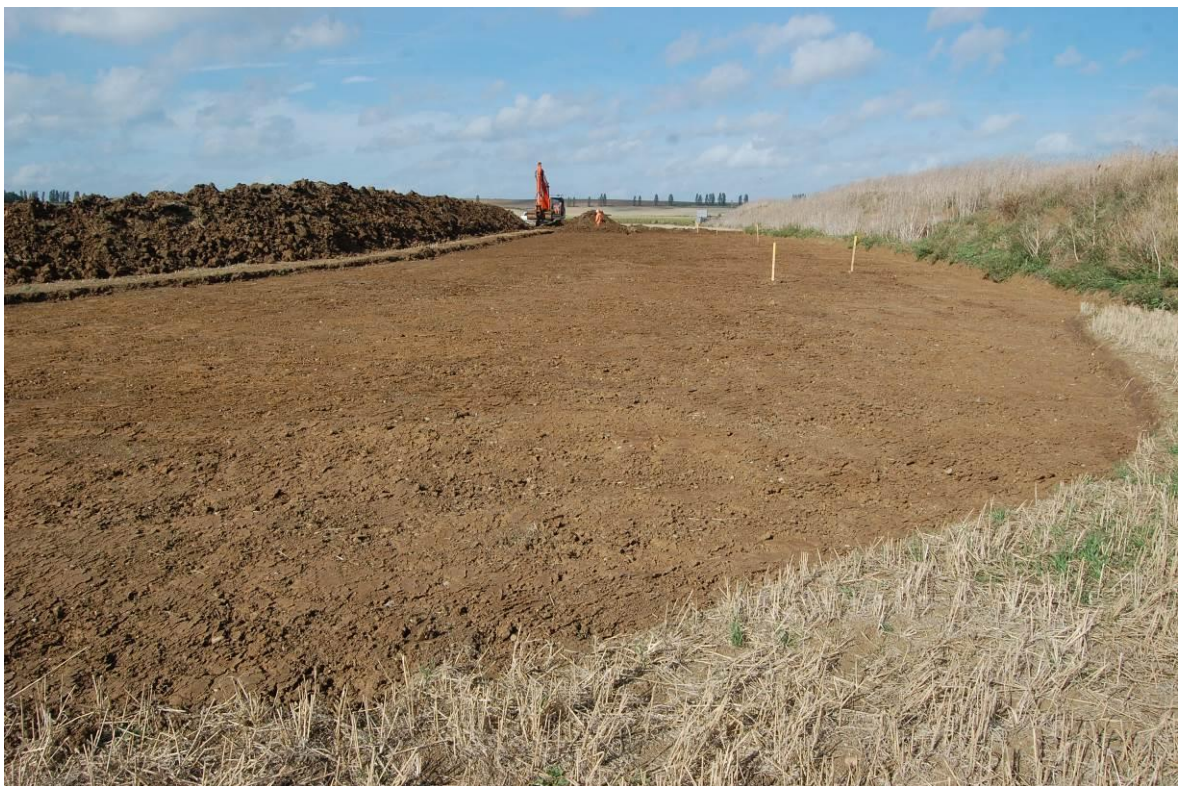
Plate 8. Southern end of Eastchurch Scheme (chainage 575–800m area), after machine reduction down to the upper surface of the exposed London Clay, as viewed from the south. No scale.

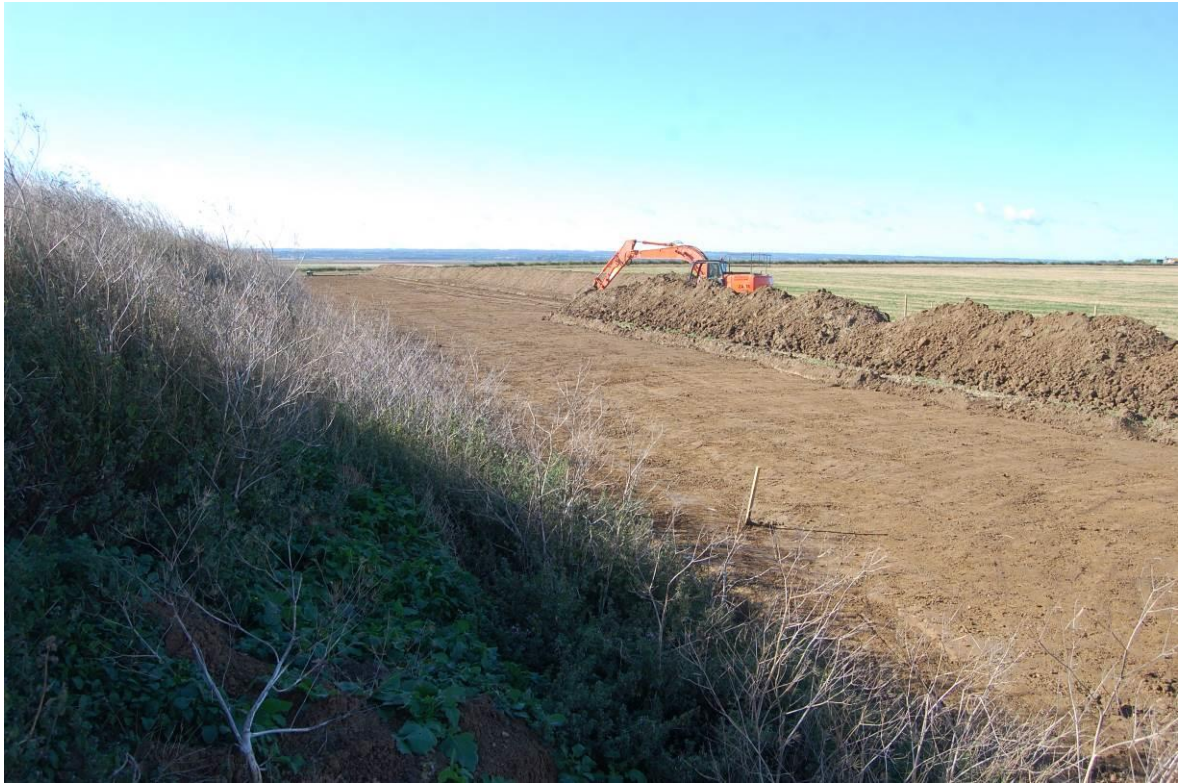
Plate 9. Northern end of Eastchurch Scheme (chainage 575–800m area), after machine reduction down to the upper surface of the exposed London Clay, as viewed from the north-east. No scale.

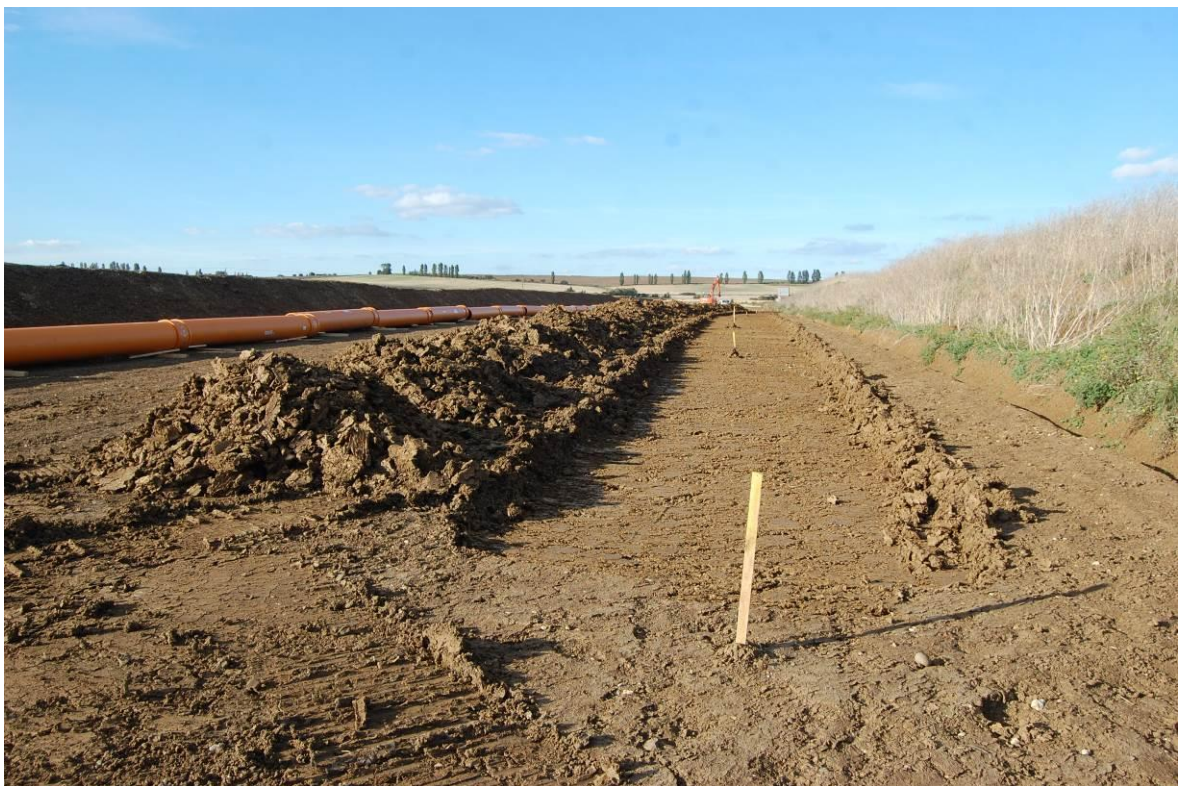
Plate 10. Southern end of Eastchurch Scheme (chainage 575–800m area), after further machine reduction of the disturbed London Clay upper horizon, as viewed from the south. No scale.

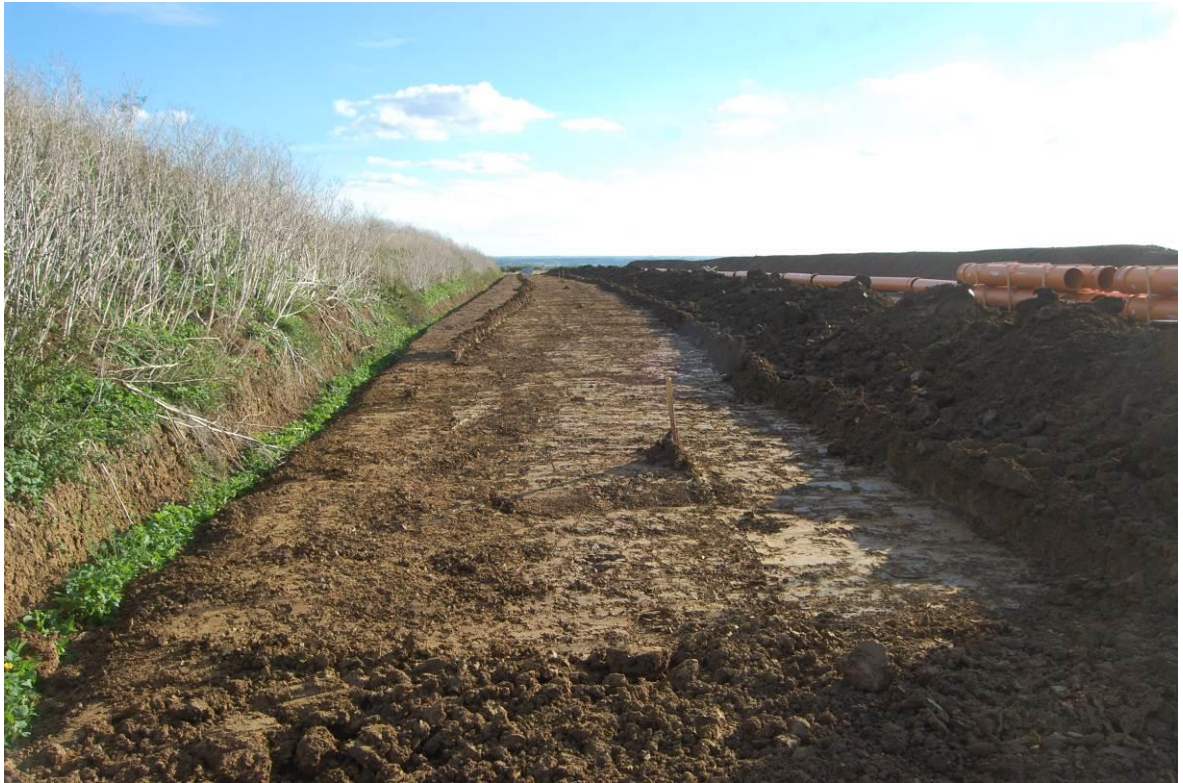
Plate 11. Northern end of Eastchurch Scheme (chainage 575–800m area), after further machine reduction of the disturbed London Clay upper horizon, as viewed from the north. No scale.

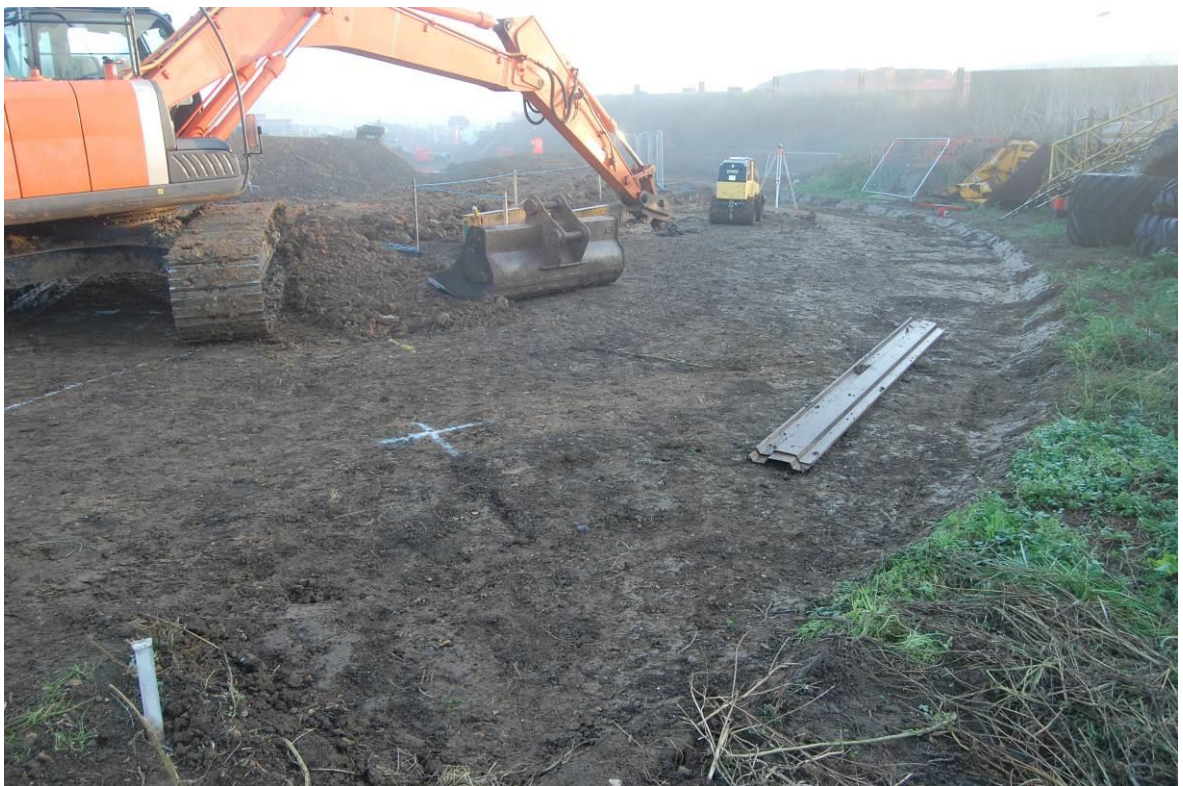
Plate 12. Southern end of Eastchurch Scheme (chainage 800–875m area), after topsoil strip, as viewed from the south-south-west. No scale.

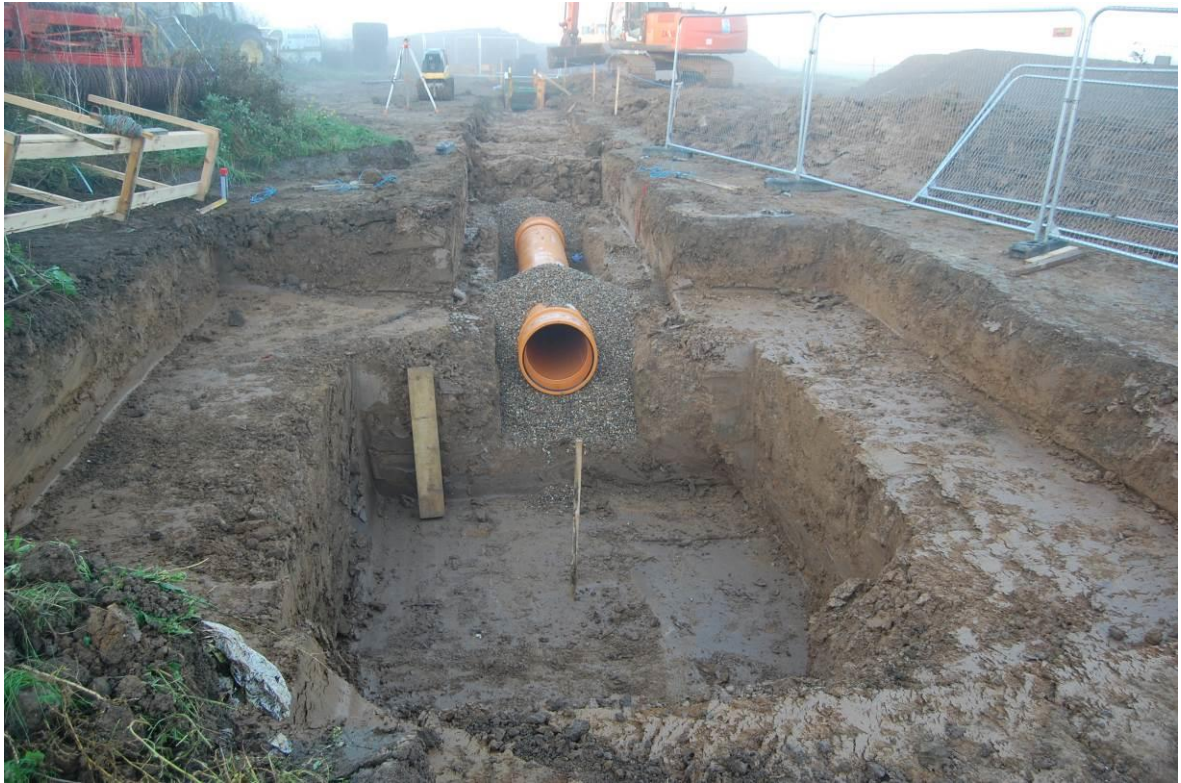
Plate 13. Reduced area for man-hole location at the northern end of the Eastchurch Scheme (chainage 575–800m area), as viewed from the east. No scale.

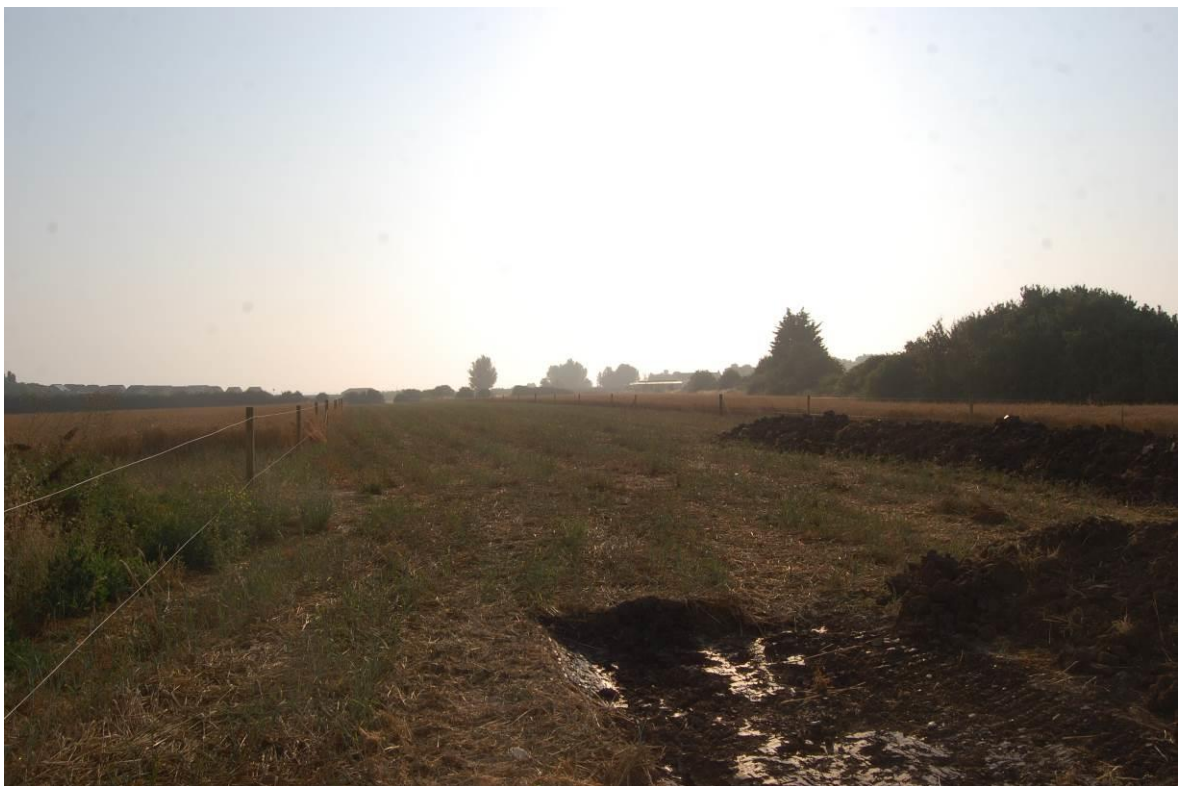
Plate 14. Pre-work view of the North-east to south-west section of the Warden Bay scheme, as viewed from its south-western end. No scale.

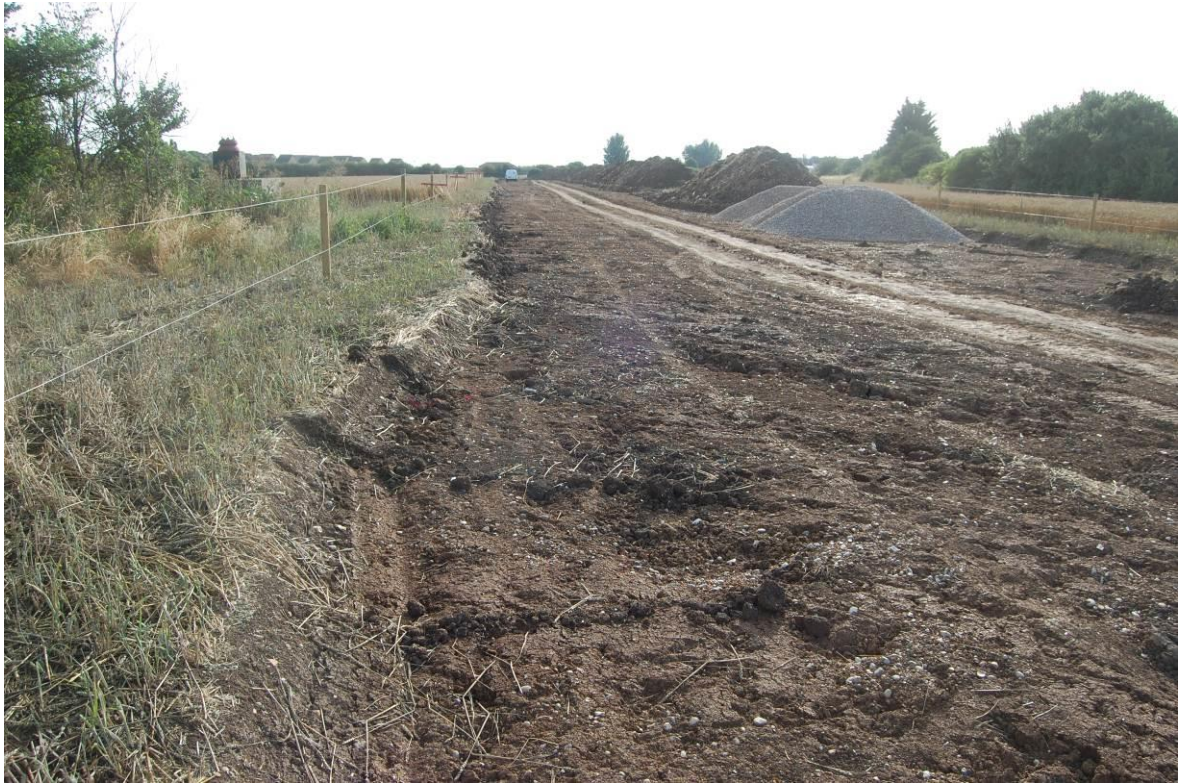
Plate 15. View of the north-east to south-west section of the Warden Bay scheme, from its south-western end, after machine reduction to the exposed upper surface of the London Clay. No scale.

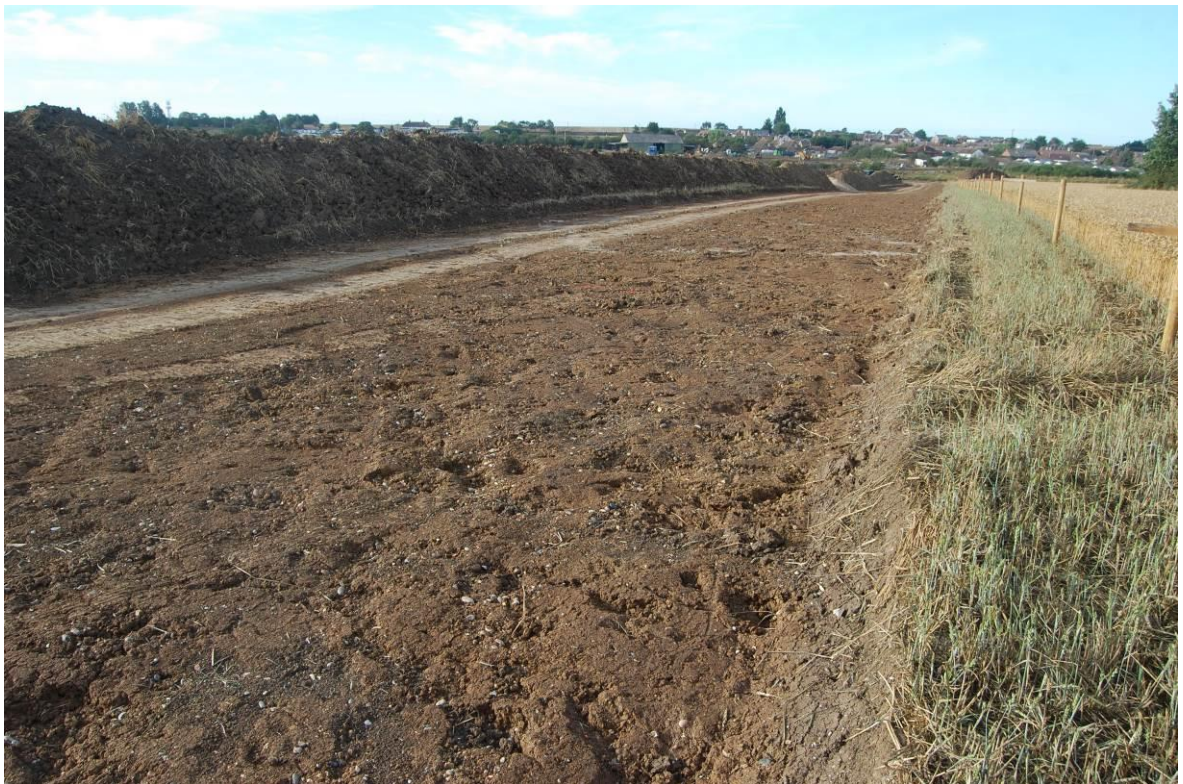
2.2.4 The exposed natural recorded in the lower north-north-east to south-south-west section of the Warden Bay scheme route (Plate 16) comprised moderately to firmly compacted mid to dark brown slightly silty clay (107) with occasional small- to mid-sized (0.02–0.08m) rounded and sub-rounded flint pebbles; very occasional larger (0.08–0.12m) sub rounded and sub-angular flint nodules/pebbles were also present. This deposit was seen as representing the natural London Clay solid geology. It was noted that this deposit appeared to have been previously horizontally truncated; the route of the existing Rising Main falls within the stripped area and it is likely that an easement was stripped for its construction during the late 1960s. Two archaeological features (Building F1 and Pit F2) were identified.

Plate 16. View of the north-north-east to south-south-west section of the Warden Bay scheme, from its north-eastern end, after machine reduction to the exposed upper surface of the London Clay. No scale

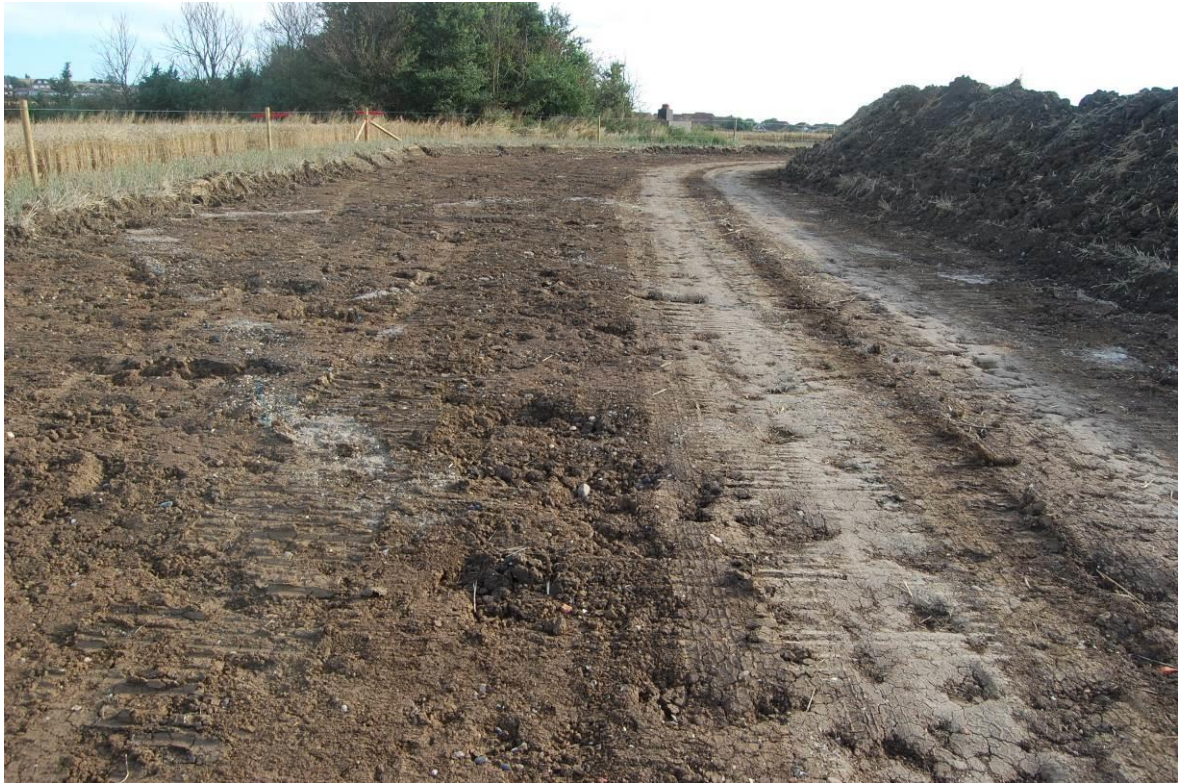
2.2.6 The remains of the foundations for a small building were identified towards the top of the rise at the northern end of the north-north-east to south-south-west section of the Warden Bay scheme route. The foundations were constructed by rough concrete footings laid on a layer of gravel, measuring between 0.50m and 0.60m wide, and surviving to a depth of between 0.10–0.22m. These formed the outline of a rectangular building, aligned roughly north-north-west to south-south-east, measuring approximately 11.50m long by 8m wide. Internal sub-divisions suggested a smaller room in the building’s south-east corner. There was no obvious evidence for the building’s purpose. It does not appear on any maps, but it is visible on an aerial photograph dated December 1960 (Google Earth). Notably the building is absent from a photograph dated 1946 (KCC HER), suggesting it post-dates the Second World War. The building was aligned parallel with the current surviving field boundaries and it appears likely it was a former farm building.

Plate 17. View of the concrete footings marking the outline of the building (archaeological feature F1) at the northern end of the north-north-east to south-south-west section of the Warden Bay scheme, as viewed from the south-west. No scale.

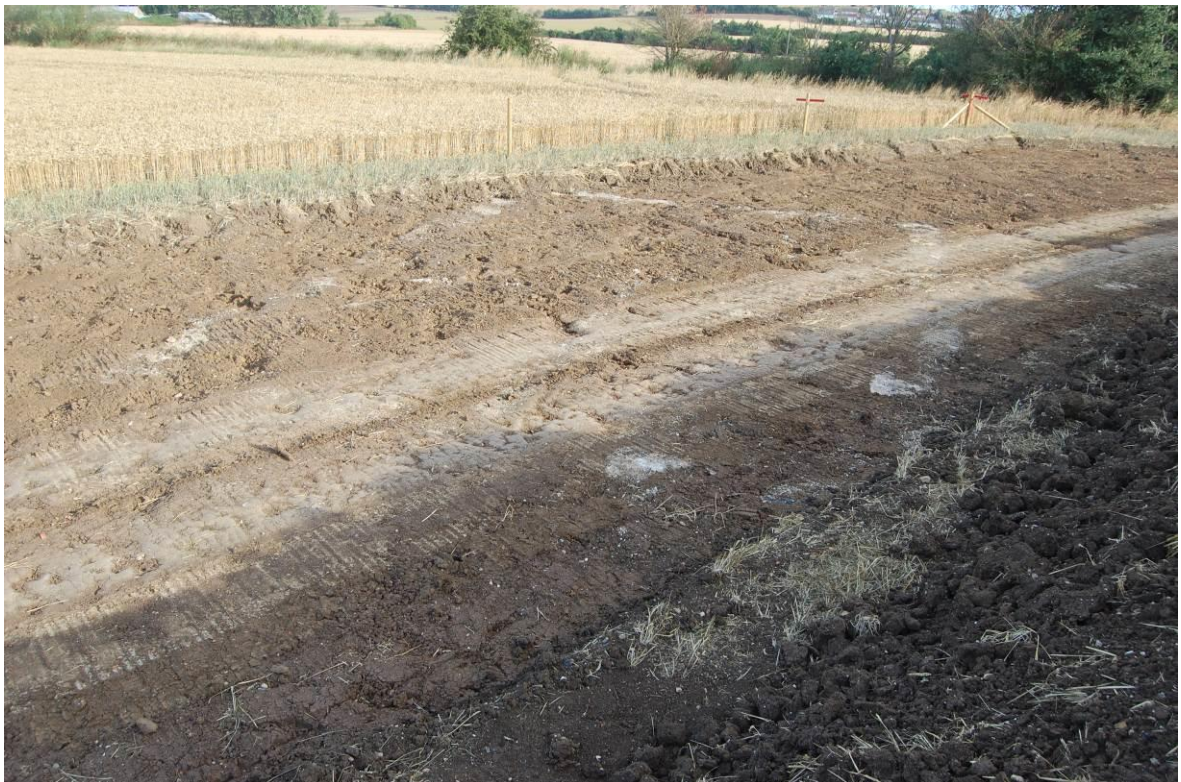
Plate 18. View of the concrete footings marking the outline of the building (archaeological feature F1) at the northern end of the north-north-east to south-south-west section of the Warden Bay scheme, as viewed from the south-east. No scale.

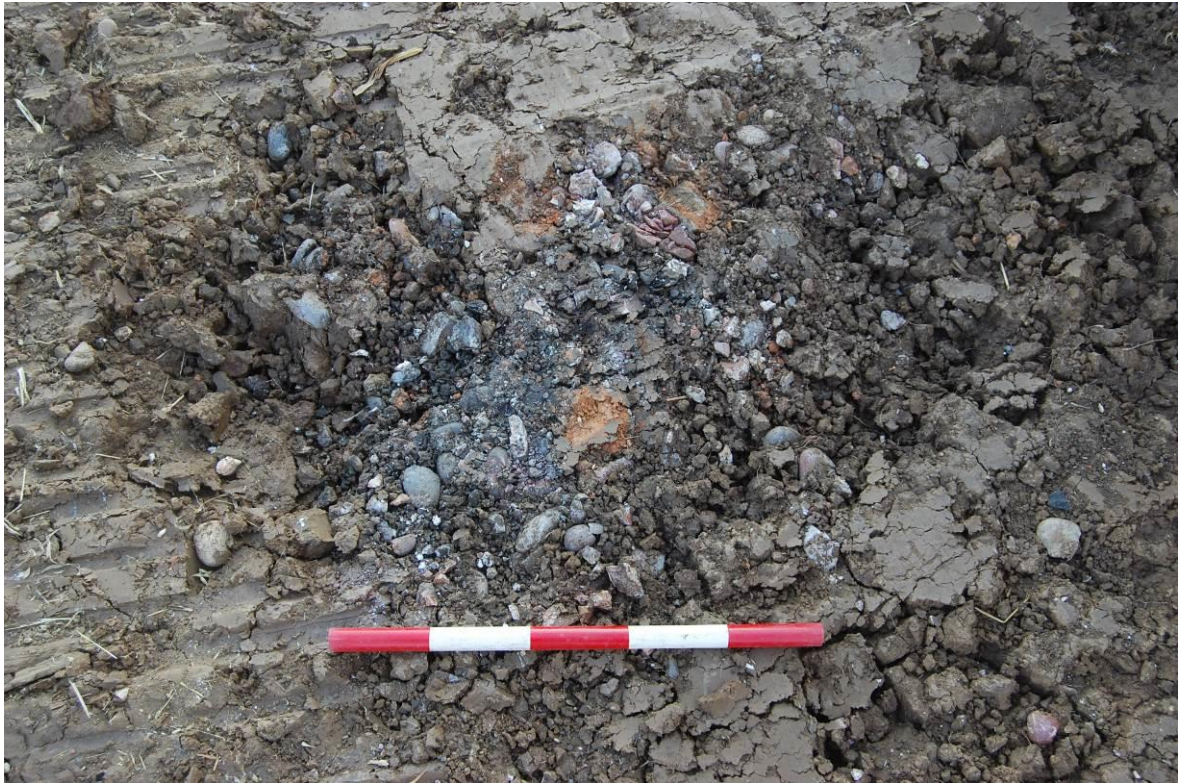
2.2.7 A small pit [102] was located south of building F1. The pit was oval in shape, aligned east to west, and measured 0.68m in length by 0.36m wide. Sample excavation revealed a surviving depth of 0.26m with a slightly concave base and extended ‘U’ shaped profile. The pit was infilled with a concentration of burnt flint mixed with clay (101). Several fragments of burnt daub was also present, however this was undiagnostic and could not be dated. The pit potentially represented a small field oven or fire pit.

Plate 19. Pre-excavation view of archaeological feature (F2) identified along northern end of the north-north-east to south-south-west section of the Warden Bay scheme, looking west. Scale 0.5m.

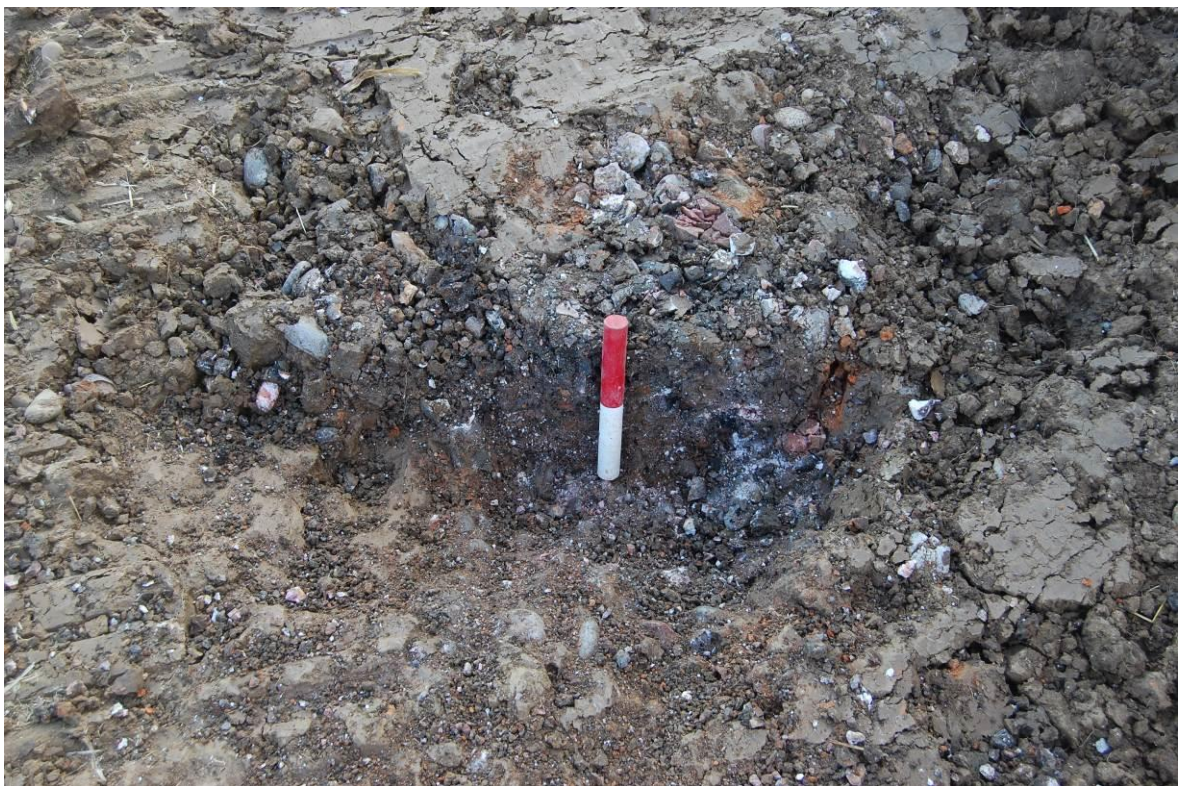
Plate 20. Section detail of archaeological feature (F2) identified along northern end of the north-north-east to south-south-west section of the Warden Bay scheme, looking west. Scale 0.2m.
