Maison Dieu Ladywell, Dover

Archaeological Watching brief

Project Code: DMAD-WB-20

Archaeological observations at Dover Maison Dieu, January 2020

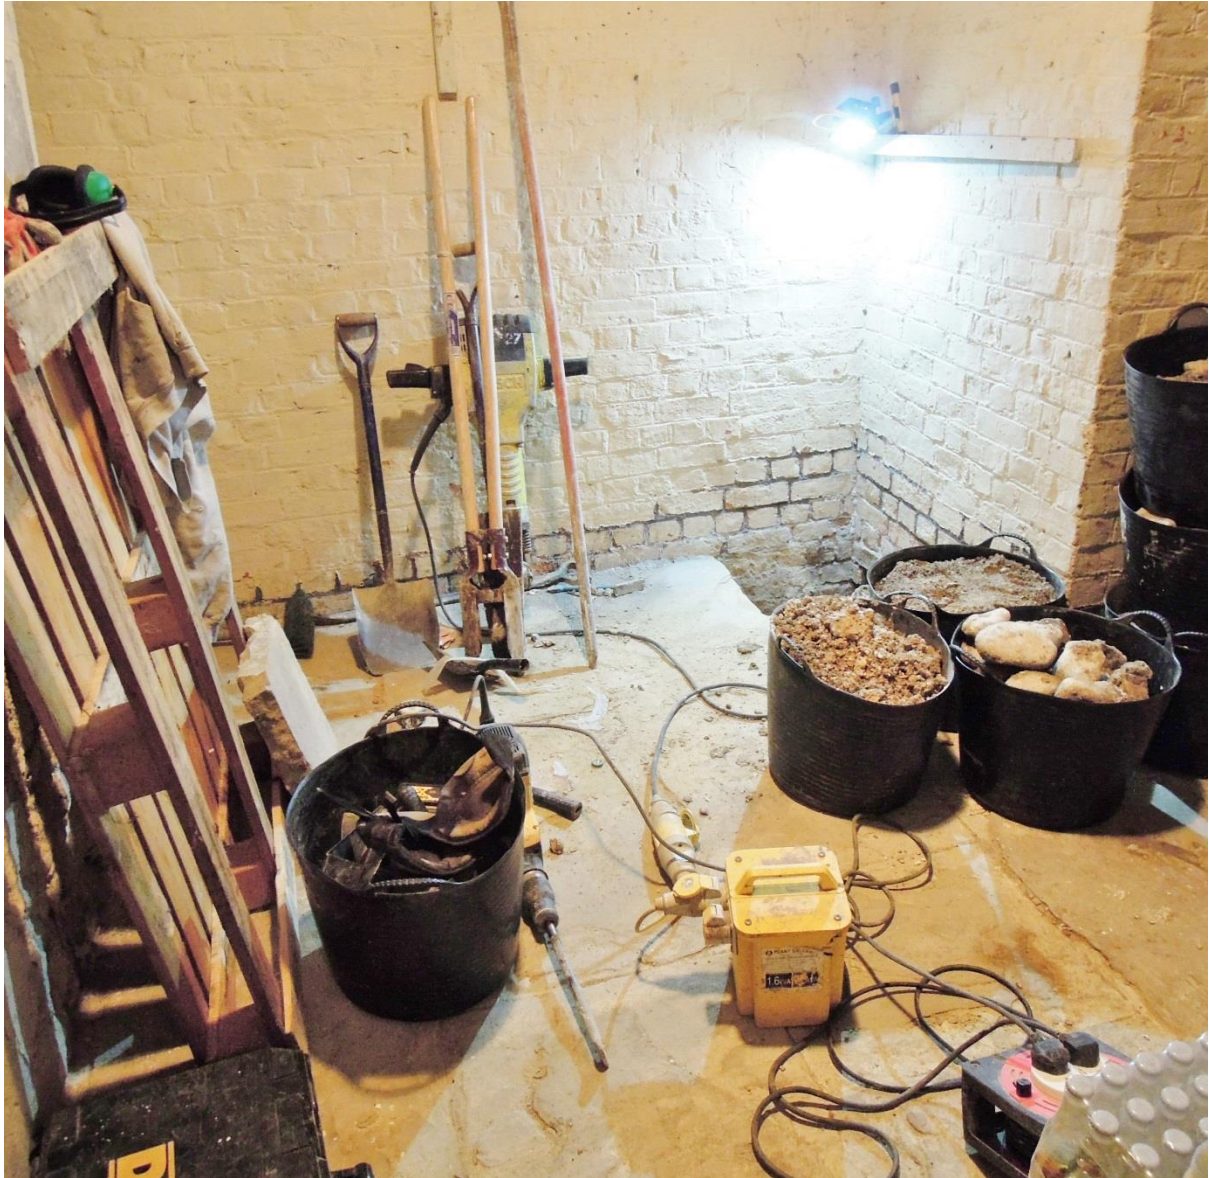
Frontispiece Excavation of Test Pit 2 in the Kitchen Store, looking south-west

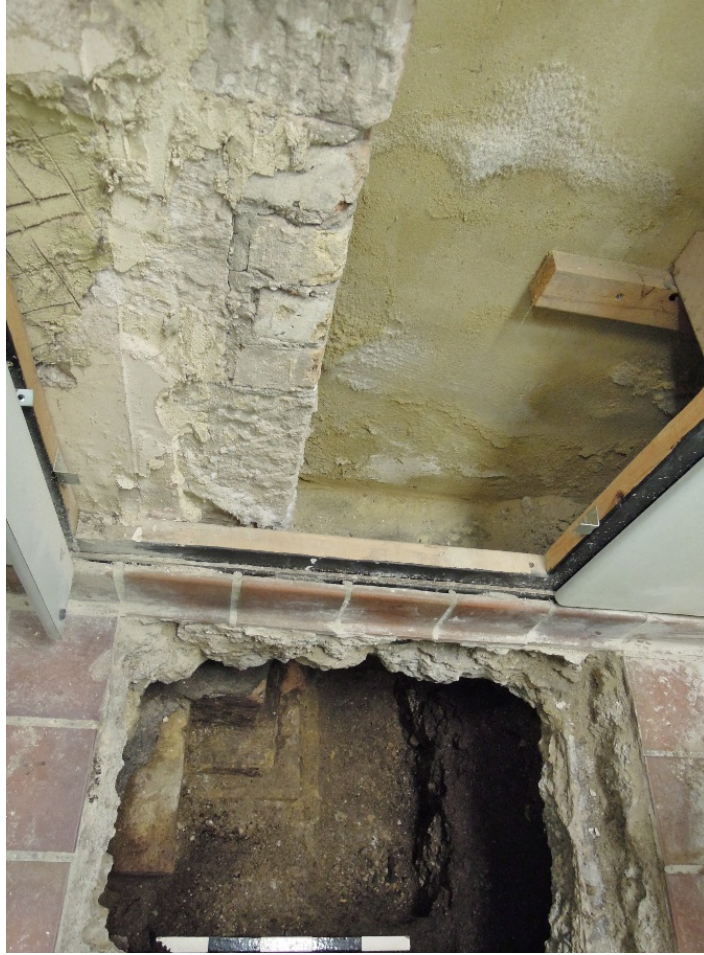
Fig. 9 Test Pit 1 in Gents toilet. Stepped brick footing exposed, looking south-east. Scale, 50cm

6.2.4 The full depth of the concrete could not be confirmed but it was at least 0.75m thick and cut into the water-table. The foundation itself supported a triple-stepped brick footing for the main wall of the building (Context 106), which at this point included a shallow projecting pier (Fig. 9).

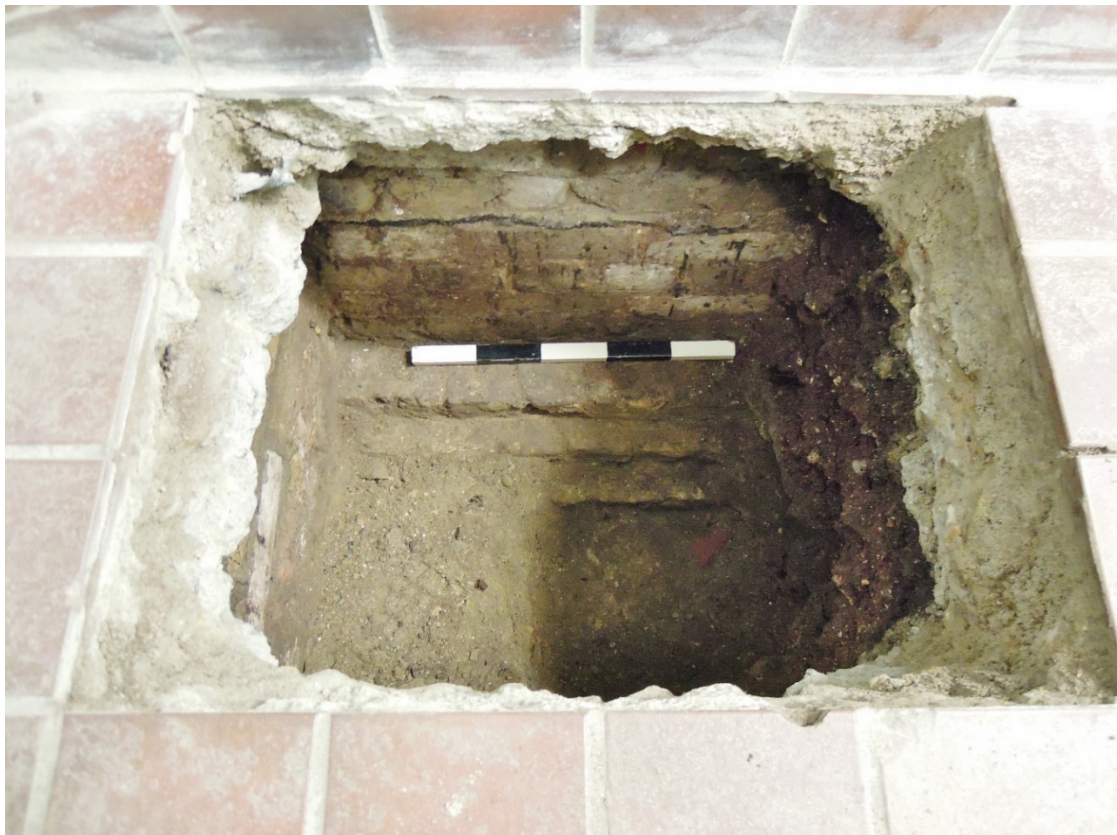
Fig. 10 Test Pit 3 in Gents toilet. Stepped brick wall footing 305 with bitumen damp course, looking north-east. Scale, 50cm

6.3.1 This was also cut in the gents' toilets and lay some 1.90m north of Test Pit 1 (Fig. 3). It was rectangular in shape and measured about 0.58m (NE-SW) by 0.70m (NW-SE). It was taken to a depth of 0.85m and in the base revealed the concrete foundation (Context 307) of walls relating to the Connaught Hall above (Walls 305 & 307; Figs 6 & 10).

6.3.2 At a height of 0.50m above to the top of the foundation, the walls incorporated a thin horizontal layer of bitumen, similar to that seen in Test Pit 1. Again, this would appear to represent a damp course.

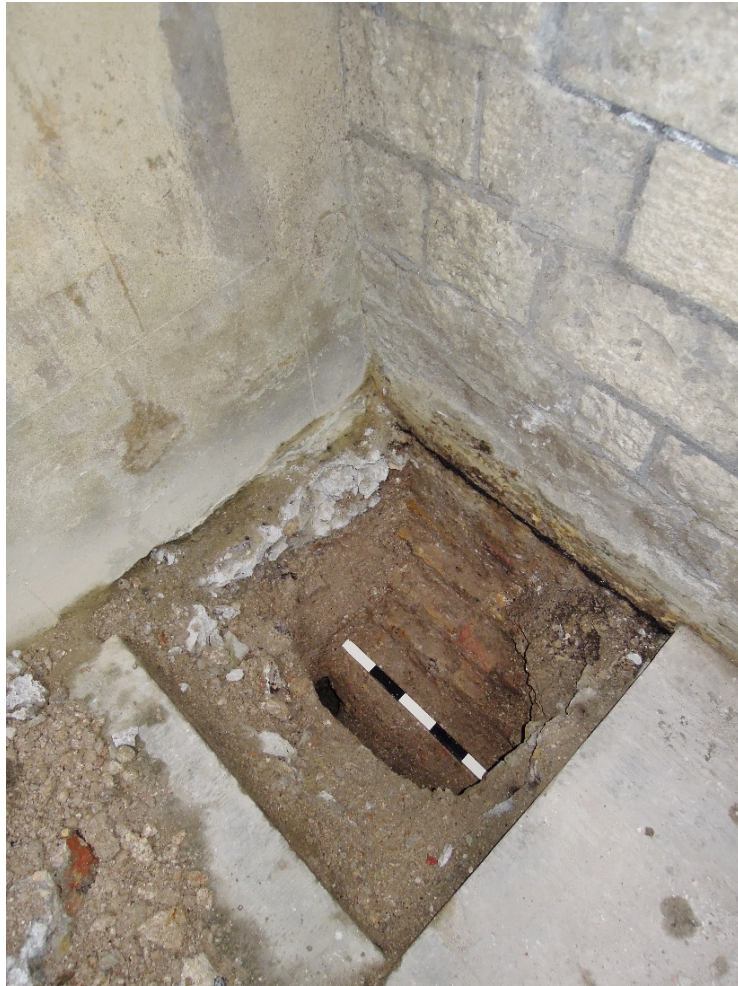
Fig. 11 Test Pit 5 in courtyard. Stepped brick footing to north-west wall 504, looking west. Scale, 50cm

6.6.3 It was soon confirmed that the wall of the Kitchen (503) had no formal foundation, having been built directly off the surface of the paved yard (Context 501, Figs 7 & 11). It abutted Wall 504 and was clearly a later addition, which had significantly reduced the original length of the courtyard. Wall 504 itself was of much more substantial construction and was undoubtedly part of the Burges plan.

6.6.5 The foundation for Wall 504 was of concrete at least 0.60m thick, supporting the familiar triple-stepped brick footing for the main wall. As seen in other test pits, the brickwork of the main wall at a point about 0.30m above the top of the stepped footing incorporated a thin layer of bitumen apparently serving as a damp course. Just above the level of the present courtyard surface, the brickwork was replaced by neatly squared ragstone ashlar in imitation of medieval walling (although in reality much finer than any such medieval stonework surviving in Dover).

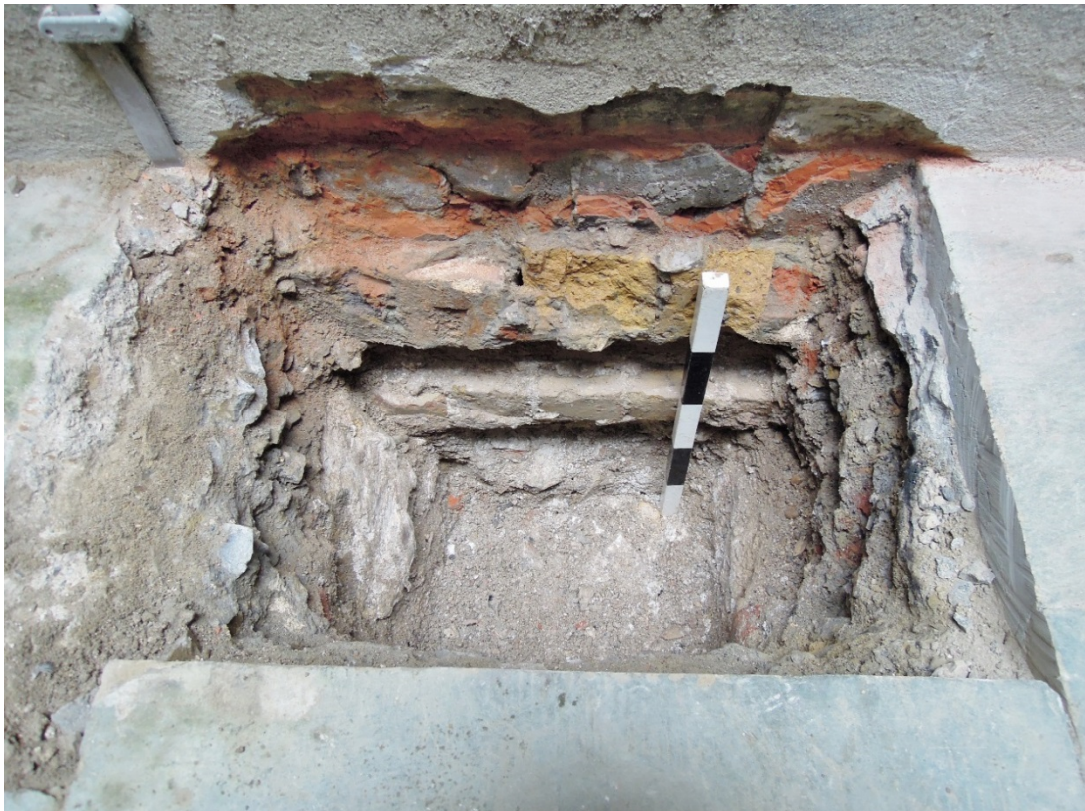
Fig. 12 Test Pit 6 in courtyard. Brick wall footing 605, resting on chalk dump layer 604, looking south-east. Scale, 50cm

6.7.4 The footing rested directly on the surface of soil layer 604 with no obvious construction trench visible. Abutting the north-west face of the footing was a dump layer consisting of a grey gritty loam with crushed grey mortar, brick rubble and small ragstone fragments (Context 603). It is not impossible that this deposit was filling a broader foundation trench whose edge lay outside the excavation.

8.7 The absence of medieval walling in Test Pit 6 has already been noted above. What was apparent was that the nineteenth-century wall foundation exposed here rested on a levelling dump of soil and chalk rubble. This contained fragments red brick rubble probably of eighteenth- or nineteenth-century date, implying that this dump was of later post-medieval date. It was at least 0.22m thick and earlier stratified deposits could remain below.
