Ground north-west of NAAFI Building, Dover Castle, Dover, Kent

Archaeological watching brief report

Project Code: DCNAF WB 20

Report No: 2020/114

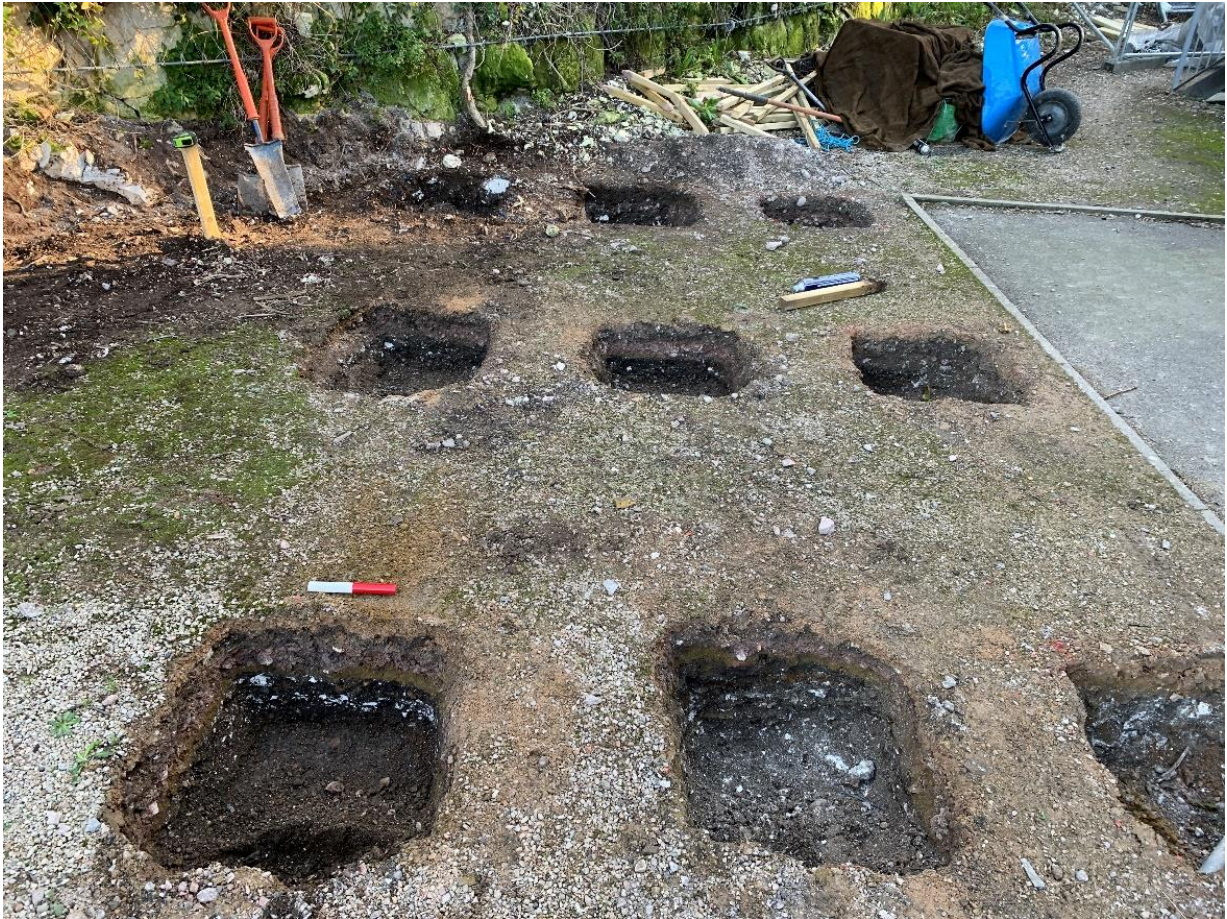
Fig. 4 General view of hand excavated pits looking north-east to the corner of the site. Scale, 20cm

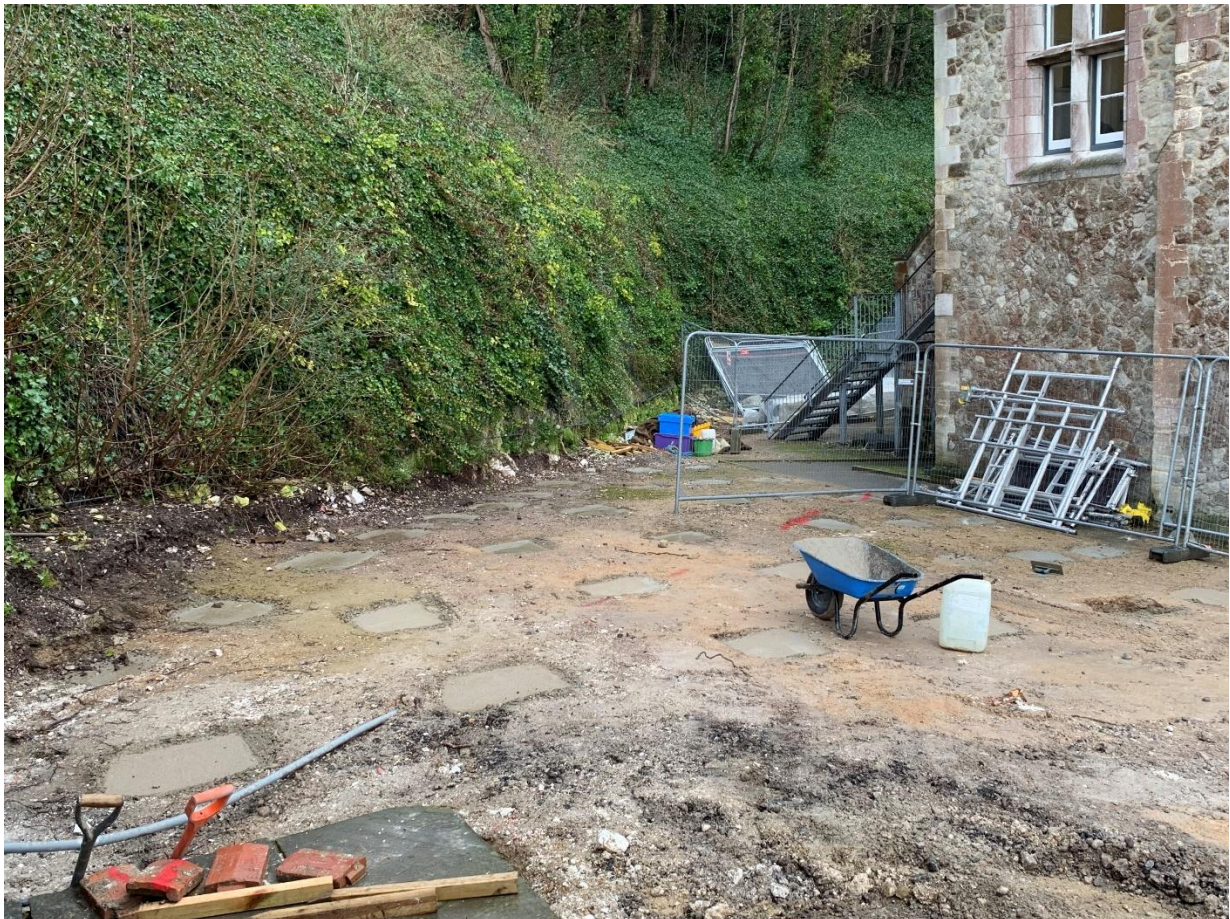
Fig. 5 Excavated pits on north-eastern side of the site filled with concrete
