Archcliffe Fort, Dover, 2020

Archaeological Evaluation

Report No: 2020/81

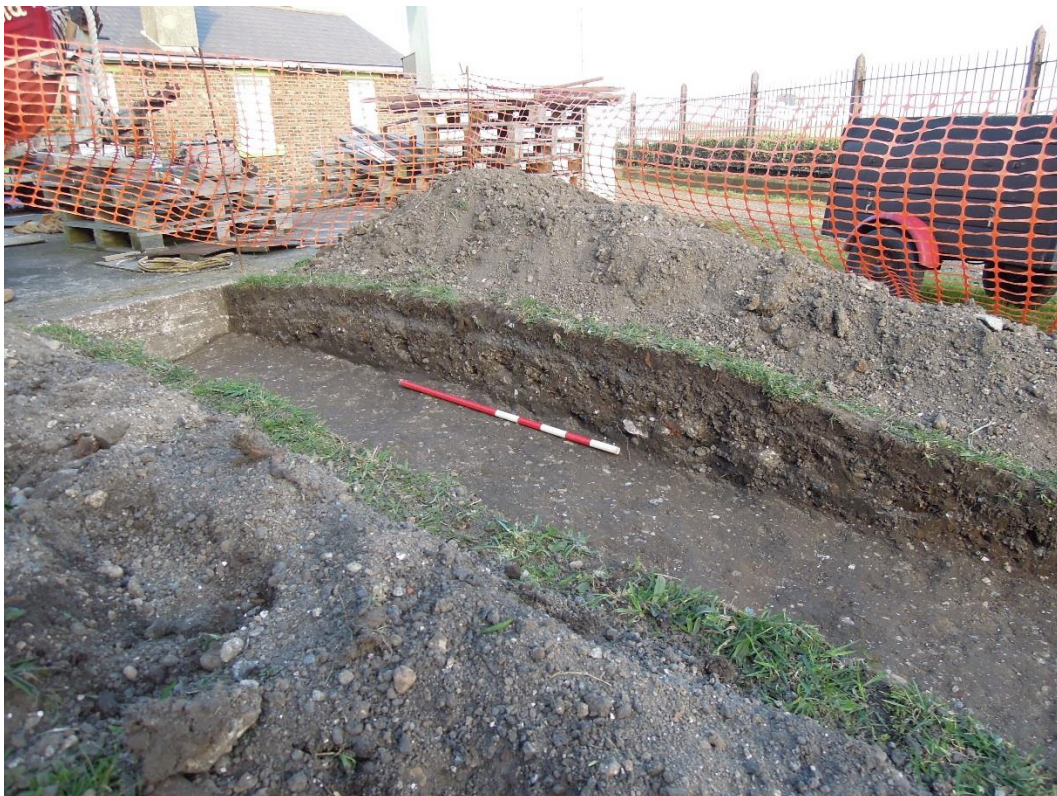
Fig. 8 View of south-east face of Trench 1 showing dump layers against concrete platform, looking east. Scale, 1m

4.5.11 Towards the north-eastern end of the trench, a thin layer of coal fire ash and cinder rested on the surface of layer 103 (Section 2, Context 102; Fig. 8). This was no more than 0.04m thick but it produced three clay tobacco pipe fragments including one with a marked spur, a residual prehistoric struck flint (Table 1) and a small piece of white glazed wall tile, that could be twentieth- rather than nineteenth-century in date.

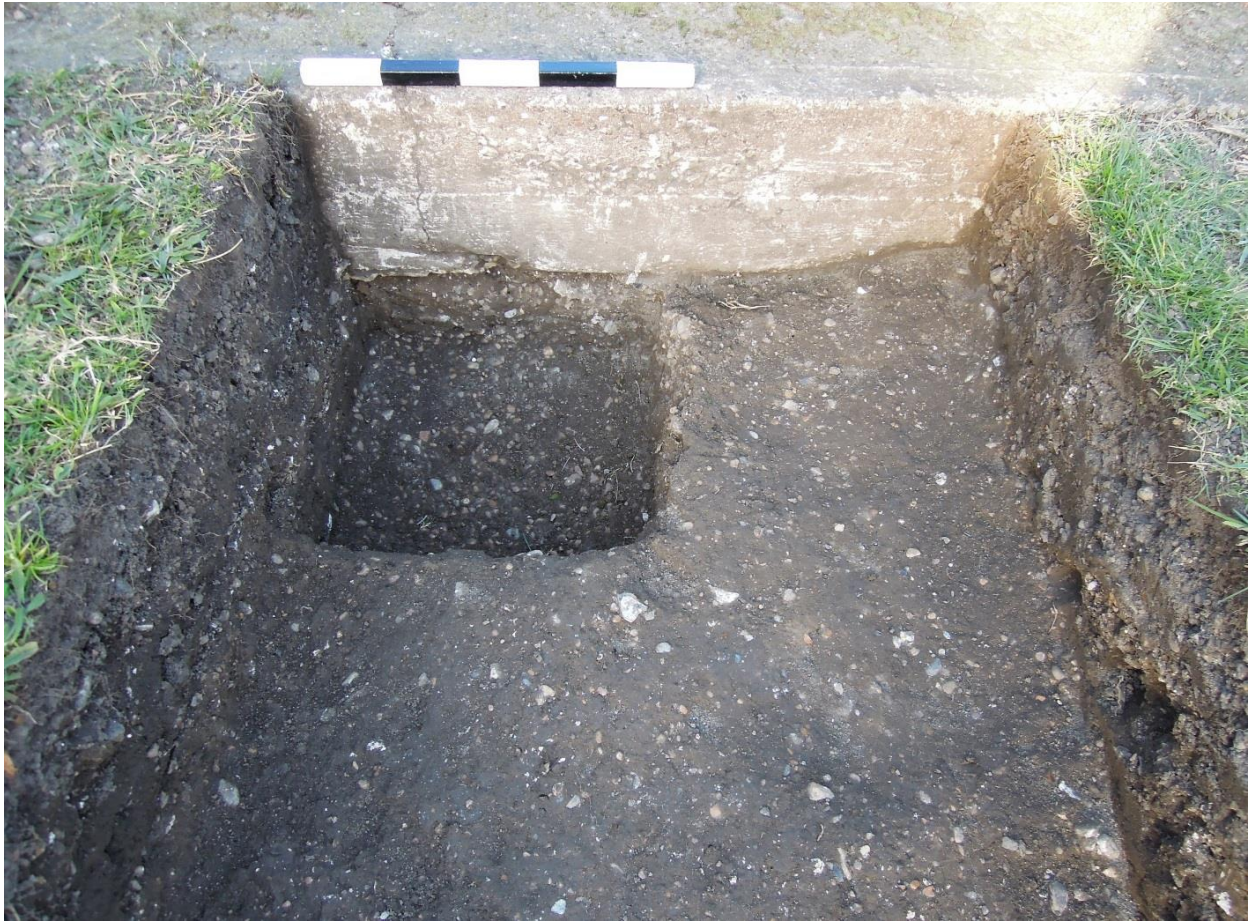
Fig. 9 North-eastern end of Trench 1 showing soil dump layers abutting concrete platform. Scale, 50cm

4.5.4 Excavation work ceased once the bottom of the mound deposits were identified, with a small *sondage* cut at the north-eastern end to examine the base of the concrete platform and something of the earlier soil deposits below (Fig. 9).

4.5.5 In the base of the *sondage* a layer of dark grey clay loam containing very frequent small sub-rounded flint pebbles (Fig. 3, Section 2, Context 108; Fig. 9) represented the earliest deposit exposed. This extended under the concrete platform and its well-defined surface could represent some sort of walking surface. The deposit was not excavated since it is unlikely to be affected by the new works.

4.6.2 A few specific structural features concerning Building 9 may be usefully highlighted here. Ground observation shows that the rectangular base had originally been constructed as a free-standing platform, about 0.34m high. This had been built directly off the existing ground surface (represented by layer 107 in Trench 1). Horizontal wooden shuttering (2 boards high) had been used to hold the concrete in place during the pour (Figs 9 & 10).

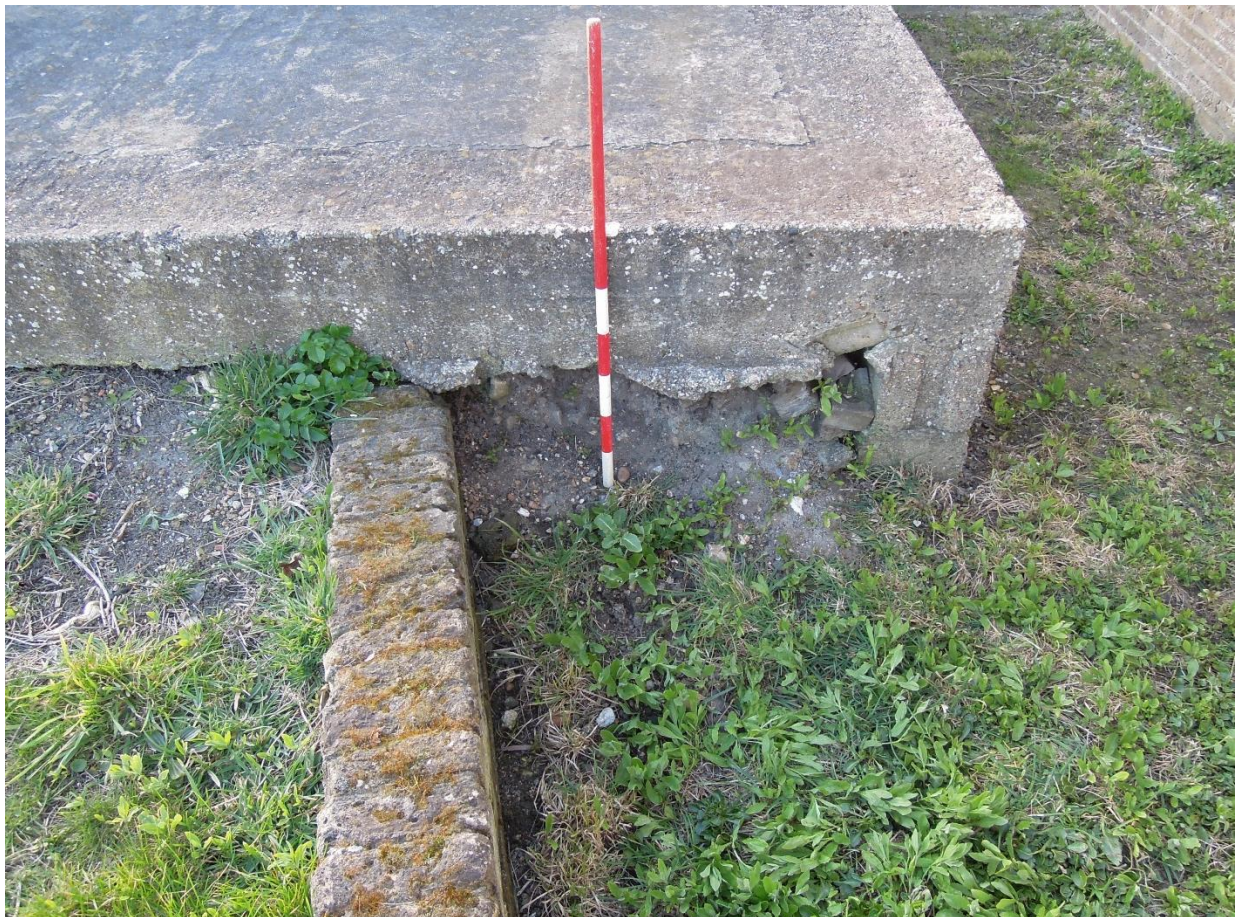
Fig. 10 Detail of concrete building platform at east corner, looking north-west. Scale, 1m

4.6.3 Towards the north-eastern end the platform was constructed over the line of a pre-existing brick retaining wall (Figs 2 & 10), which itself would appear to post-date the 1884 site plan (Fig. 5). Probably at some later date the ground level directly behind Karen's Block was reduced, undermining the concrete base and necessitating the insertion of two courses of concrete blocks as underpinning along its north-eastern side (Fig. 10).

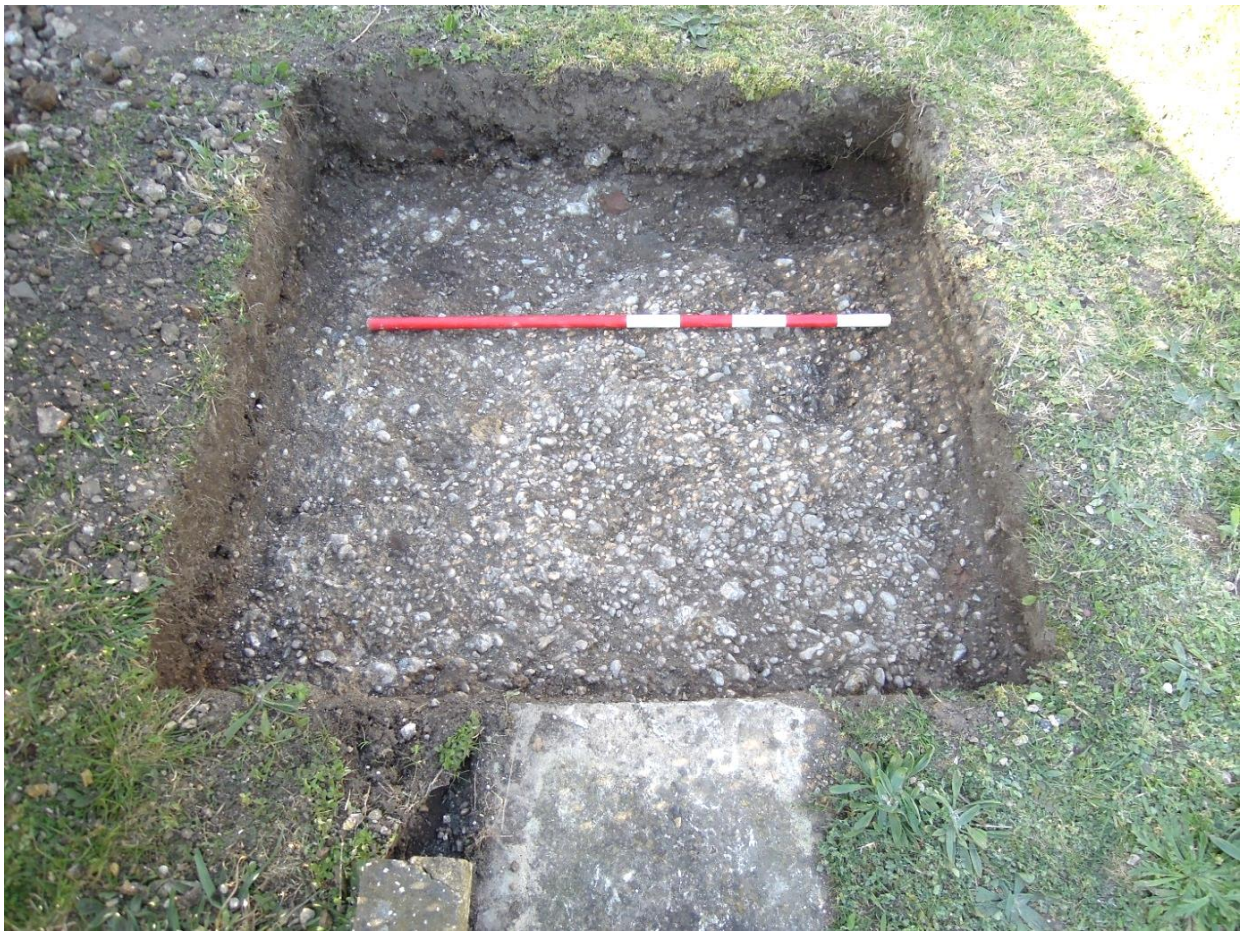
Fig. 11 Concrete layer (202) under topsoil in Trench 2, looking north-west. Scale, 1m

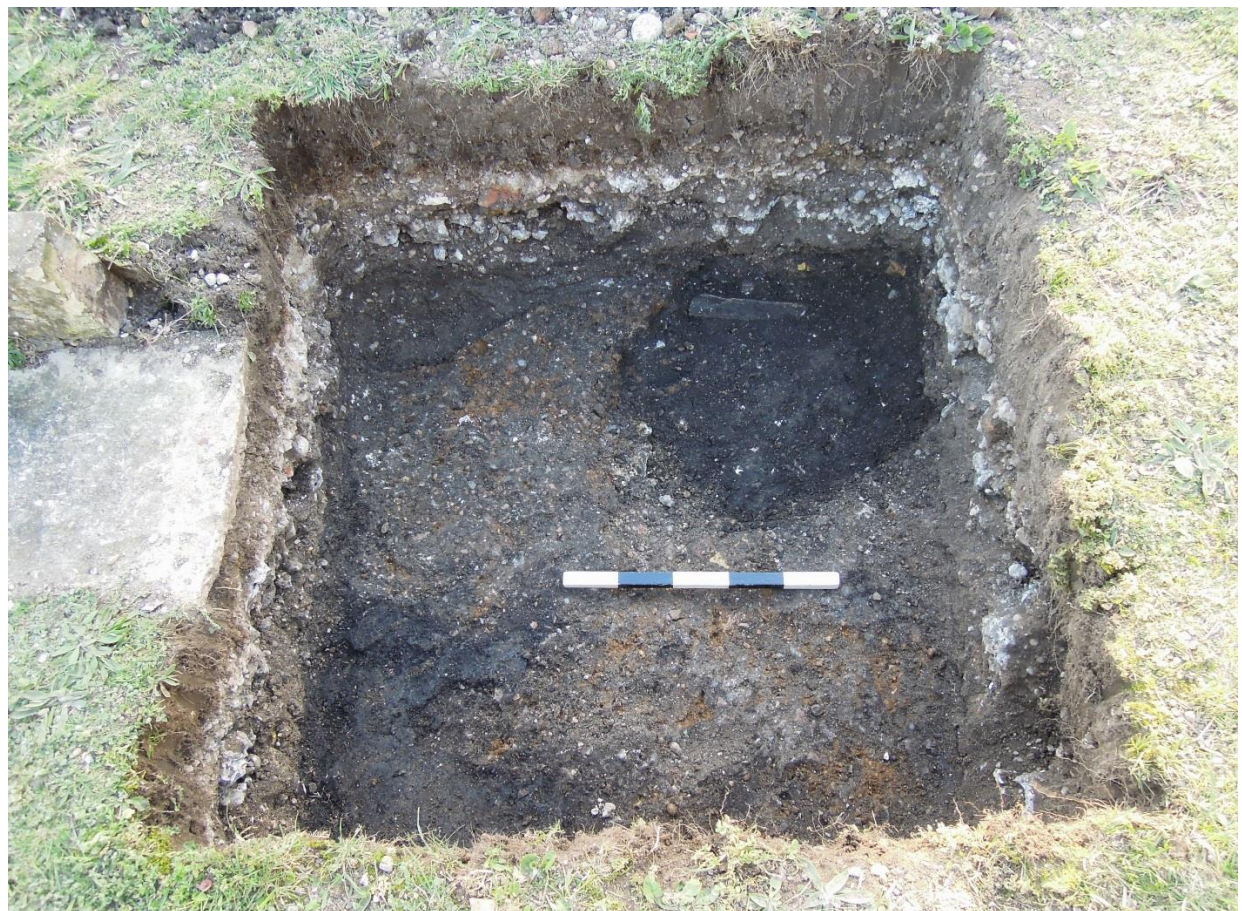
Fig. 12 Detail of pit, F. 205 in Trench 2, before excavation, looking south-west. Scale 50cm

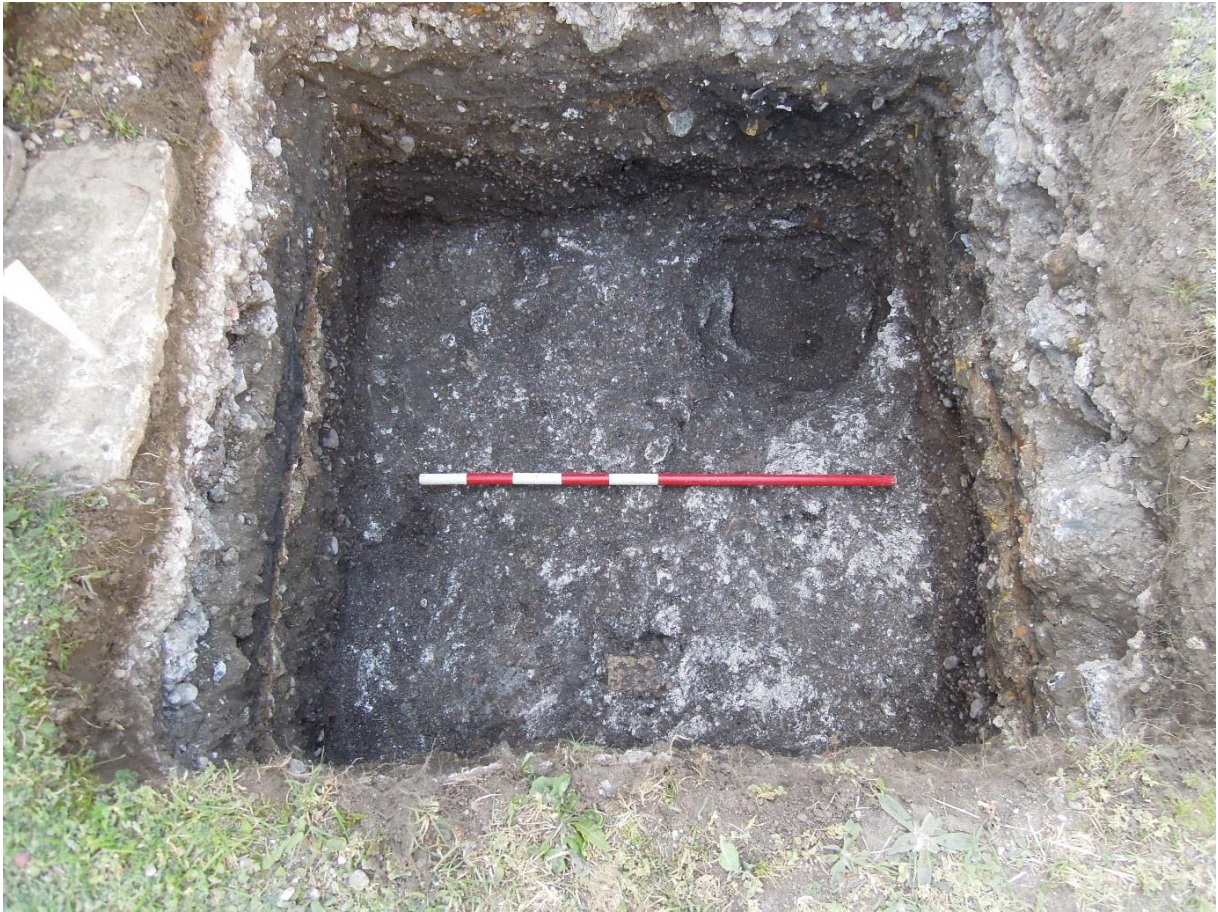
Fig. 13 Chalk surface 213 in Trench 2, cut by pit, F. 205, looking south-west. Scale, 1m

4.7.10 Sealing soil layer 214 was a thin but continuous layer of rammed chalk rubble, no more than 0.08m thick and perhaps representing a walking surface (Section 1, Context 213; Fig. 13). Apart from a few fragments of red and yellow brick this layer failed to produce any datable finds.

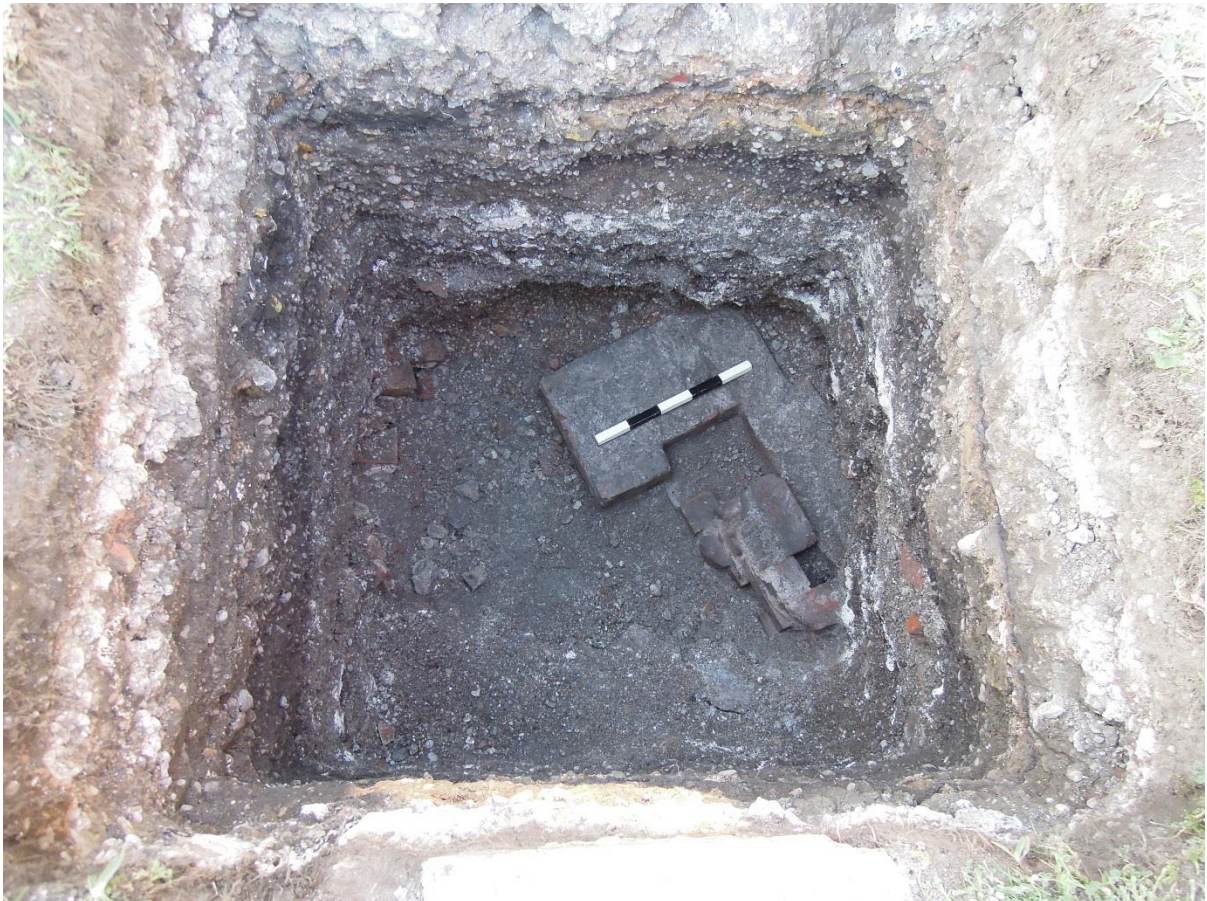
Fig. 14 Brick structures 217 and 218 located in the base of Trench 2, looking north-west. Scale, 50cm

4.7.4 At the base of the excavated sequence, brick and rubble demolition deposits (Fig. 4, Section 1, Contexts 215 and 216) abutted and partially sealed two fragments of earlier brick walling (Walls 217 and 218), the precise interpretation of which remains unclear due to the small area seen (Figs 4 & 14). It was readily apparent from the character of the rubble deposits that these represented the collapsed upper levels of the brick structure revealed.

4.7.5 Located in the northern corner of the excavated trench, Wall 217 was L-shaped in plan, with maximum dimensions of 0.70m (NW–SE) by 0.90m (NE–SW). It was at least two courses high (0.16m), constructed of red bricks set in a coarse grey mortar containing quantities of chalk/lime specks and coal specks (Figs 4, 5 & 14). Traces of surface mortar rendering occurred on the south-east and south-west faces of the brickwork.

4.7.6 Abutting the south-western side of the 217 brickwork was a small, added section of later brickwork (Wall 218). This was about 0.26m wide, constructed from red bricks (some with shallow frogs) set in a grey mortar containing chalk/lime specks and coal specks – very similar to that used in Wall 17 (Figs 4, 5 & 14). The south corner of this brickwork appeared to have been deliberately chamfered.

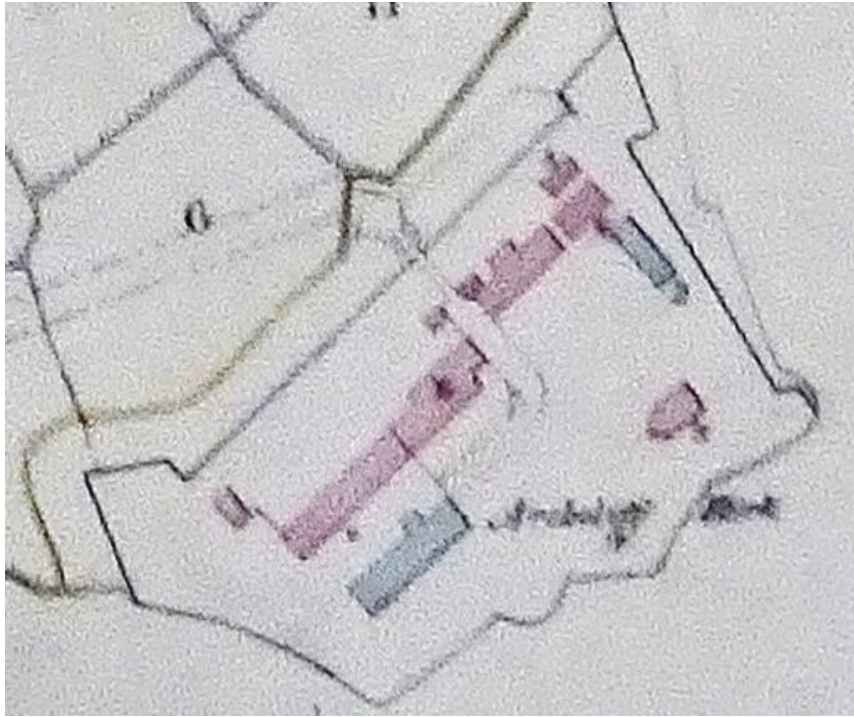
Fig. 15 Extract from plan of 1804 showing a building (grey tone) to the south-east of the main accommodation block (TNA: ??; from a photo by Janette Platt, WSP)

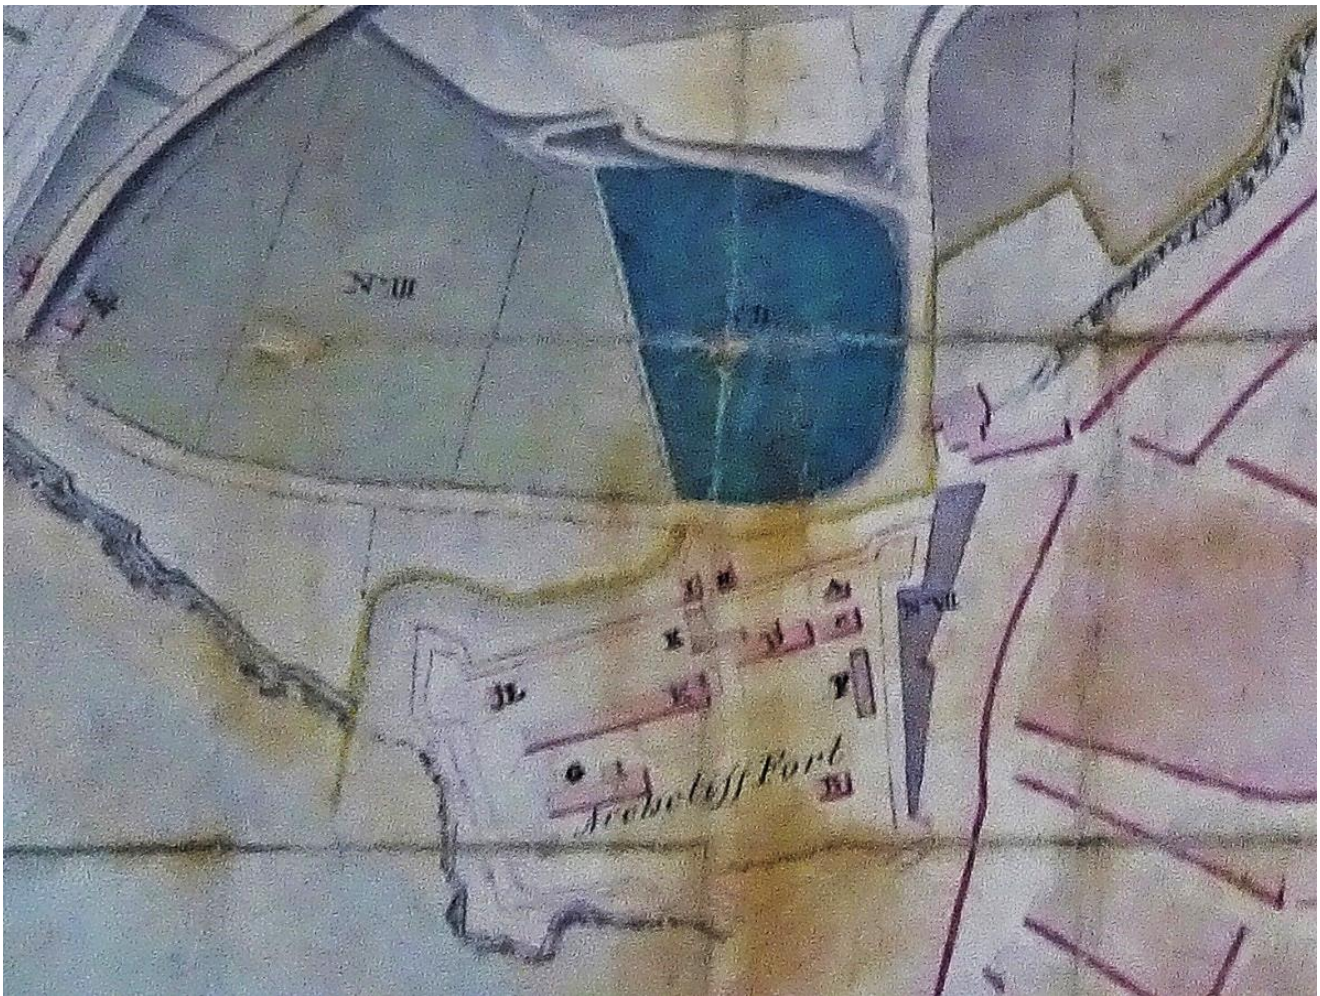
Fig. 16 Extract from plan of 1811 showing a building to the south-east of the main accommodation block (TNA: MPH/1/506; from a photo by Janette Platt, WSP)
