Archcliffe Fort, Dover, 2021, New workshop construction, Archaeological watching brief

Project Code: AFDL-WB-21

Report No: 2021/36

March 2021

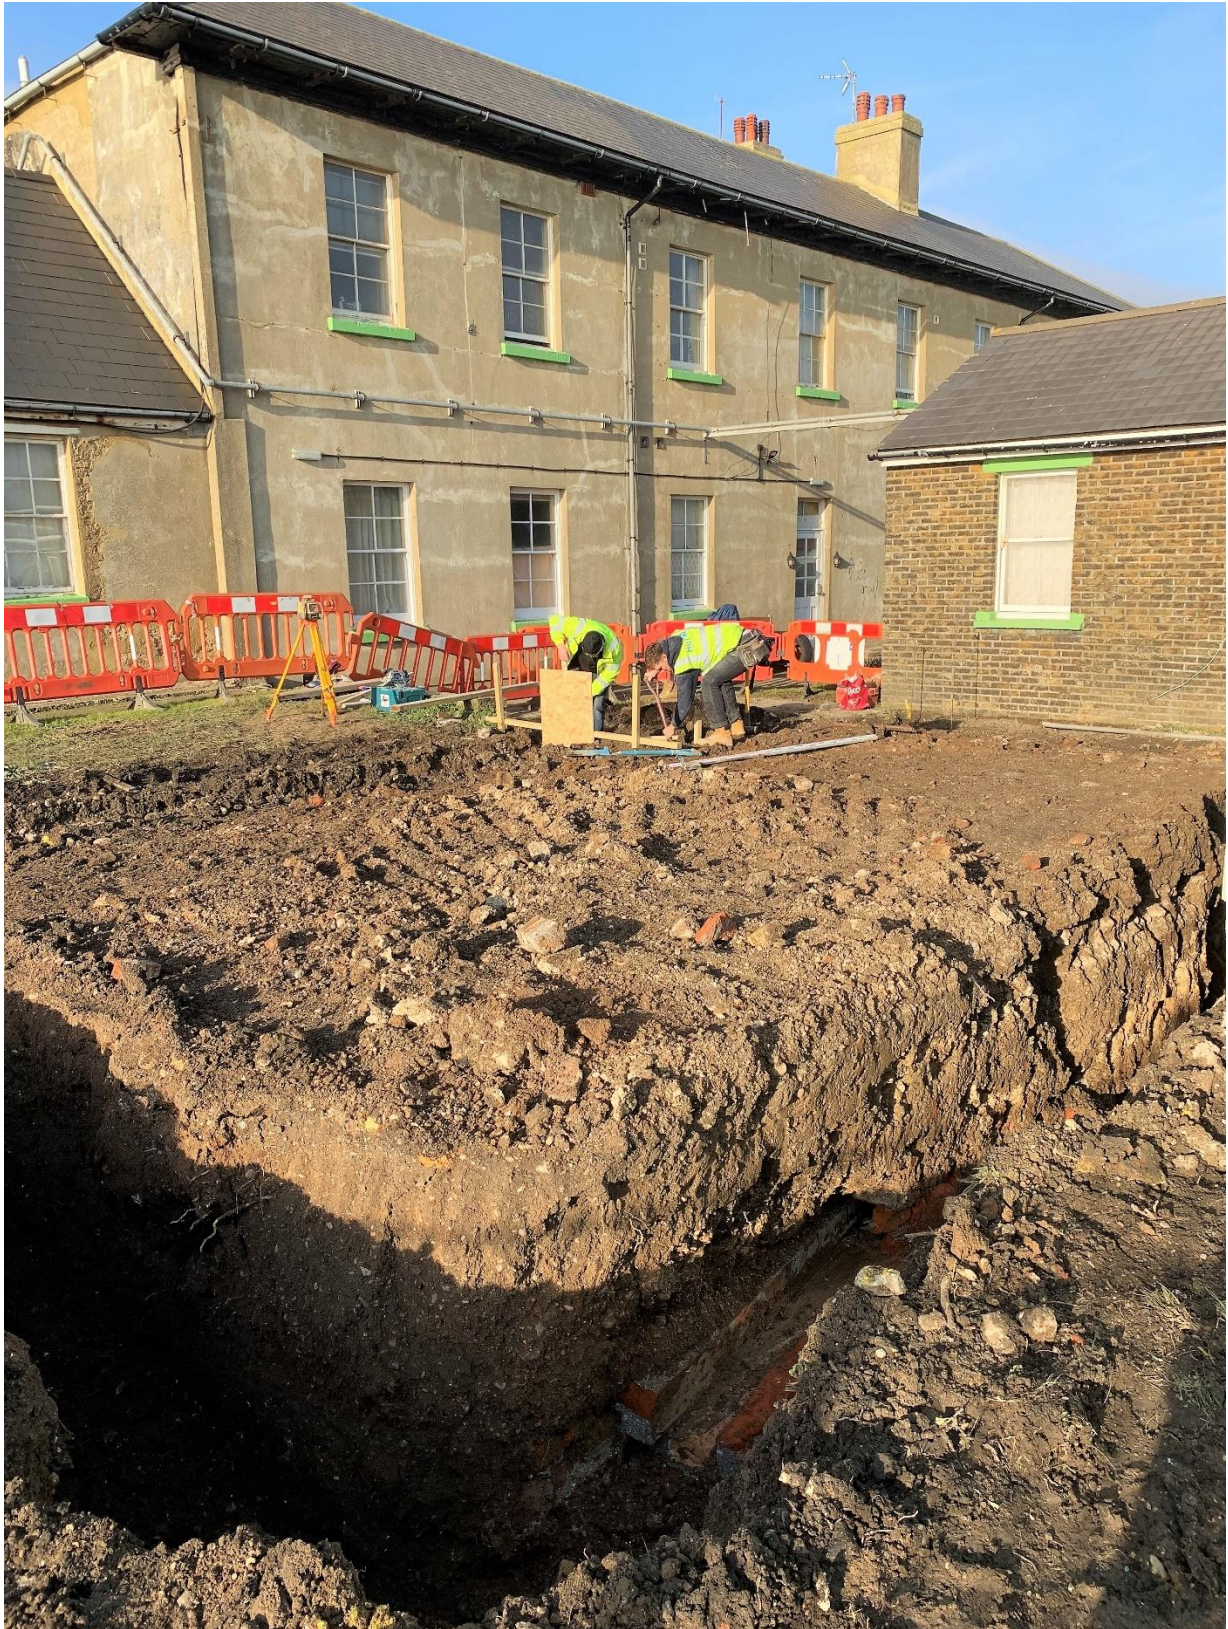
Frontispiece General view looking north across the site with concrete platform of Building 9 removed and new foundation trenches cut (Buildings 2 and 4 in background)

7.7.1 A small, tracked excavator was used to cut five foundation trenches for the new workshop building (Frontispiece; Figs 2 & 10). The four outer trenches covered a rectangular area measuring externally 6.20m (NW–SE) by 9.50m (NE–SW). These trenches were between 0.65 and 0.70m wide and 1.00–1.40m deep. An additional internal trench, 0.40m wide and 1.00–1.40m deep, aligned north-east by south-west, was subsequently dug along the central axis of the new structure (Fig. 2).

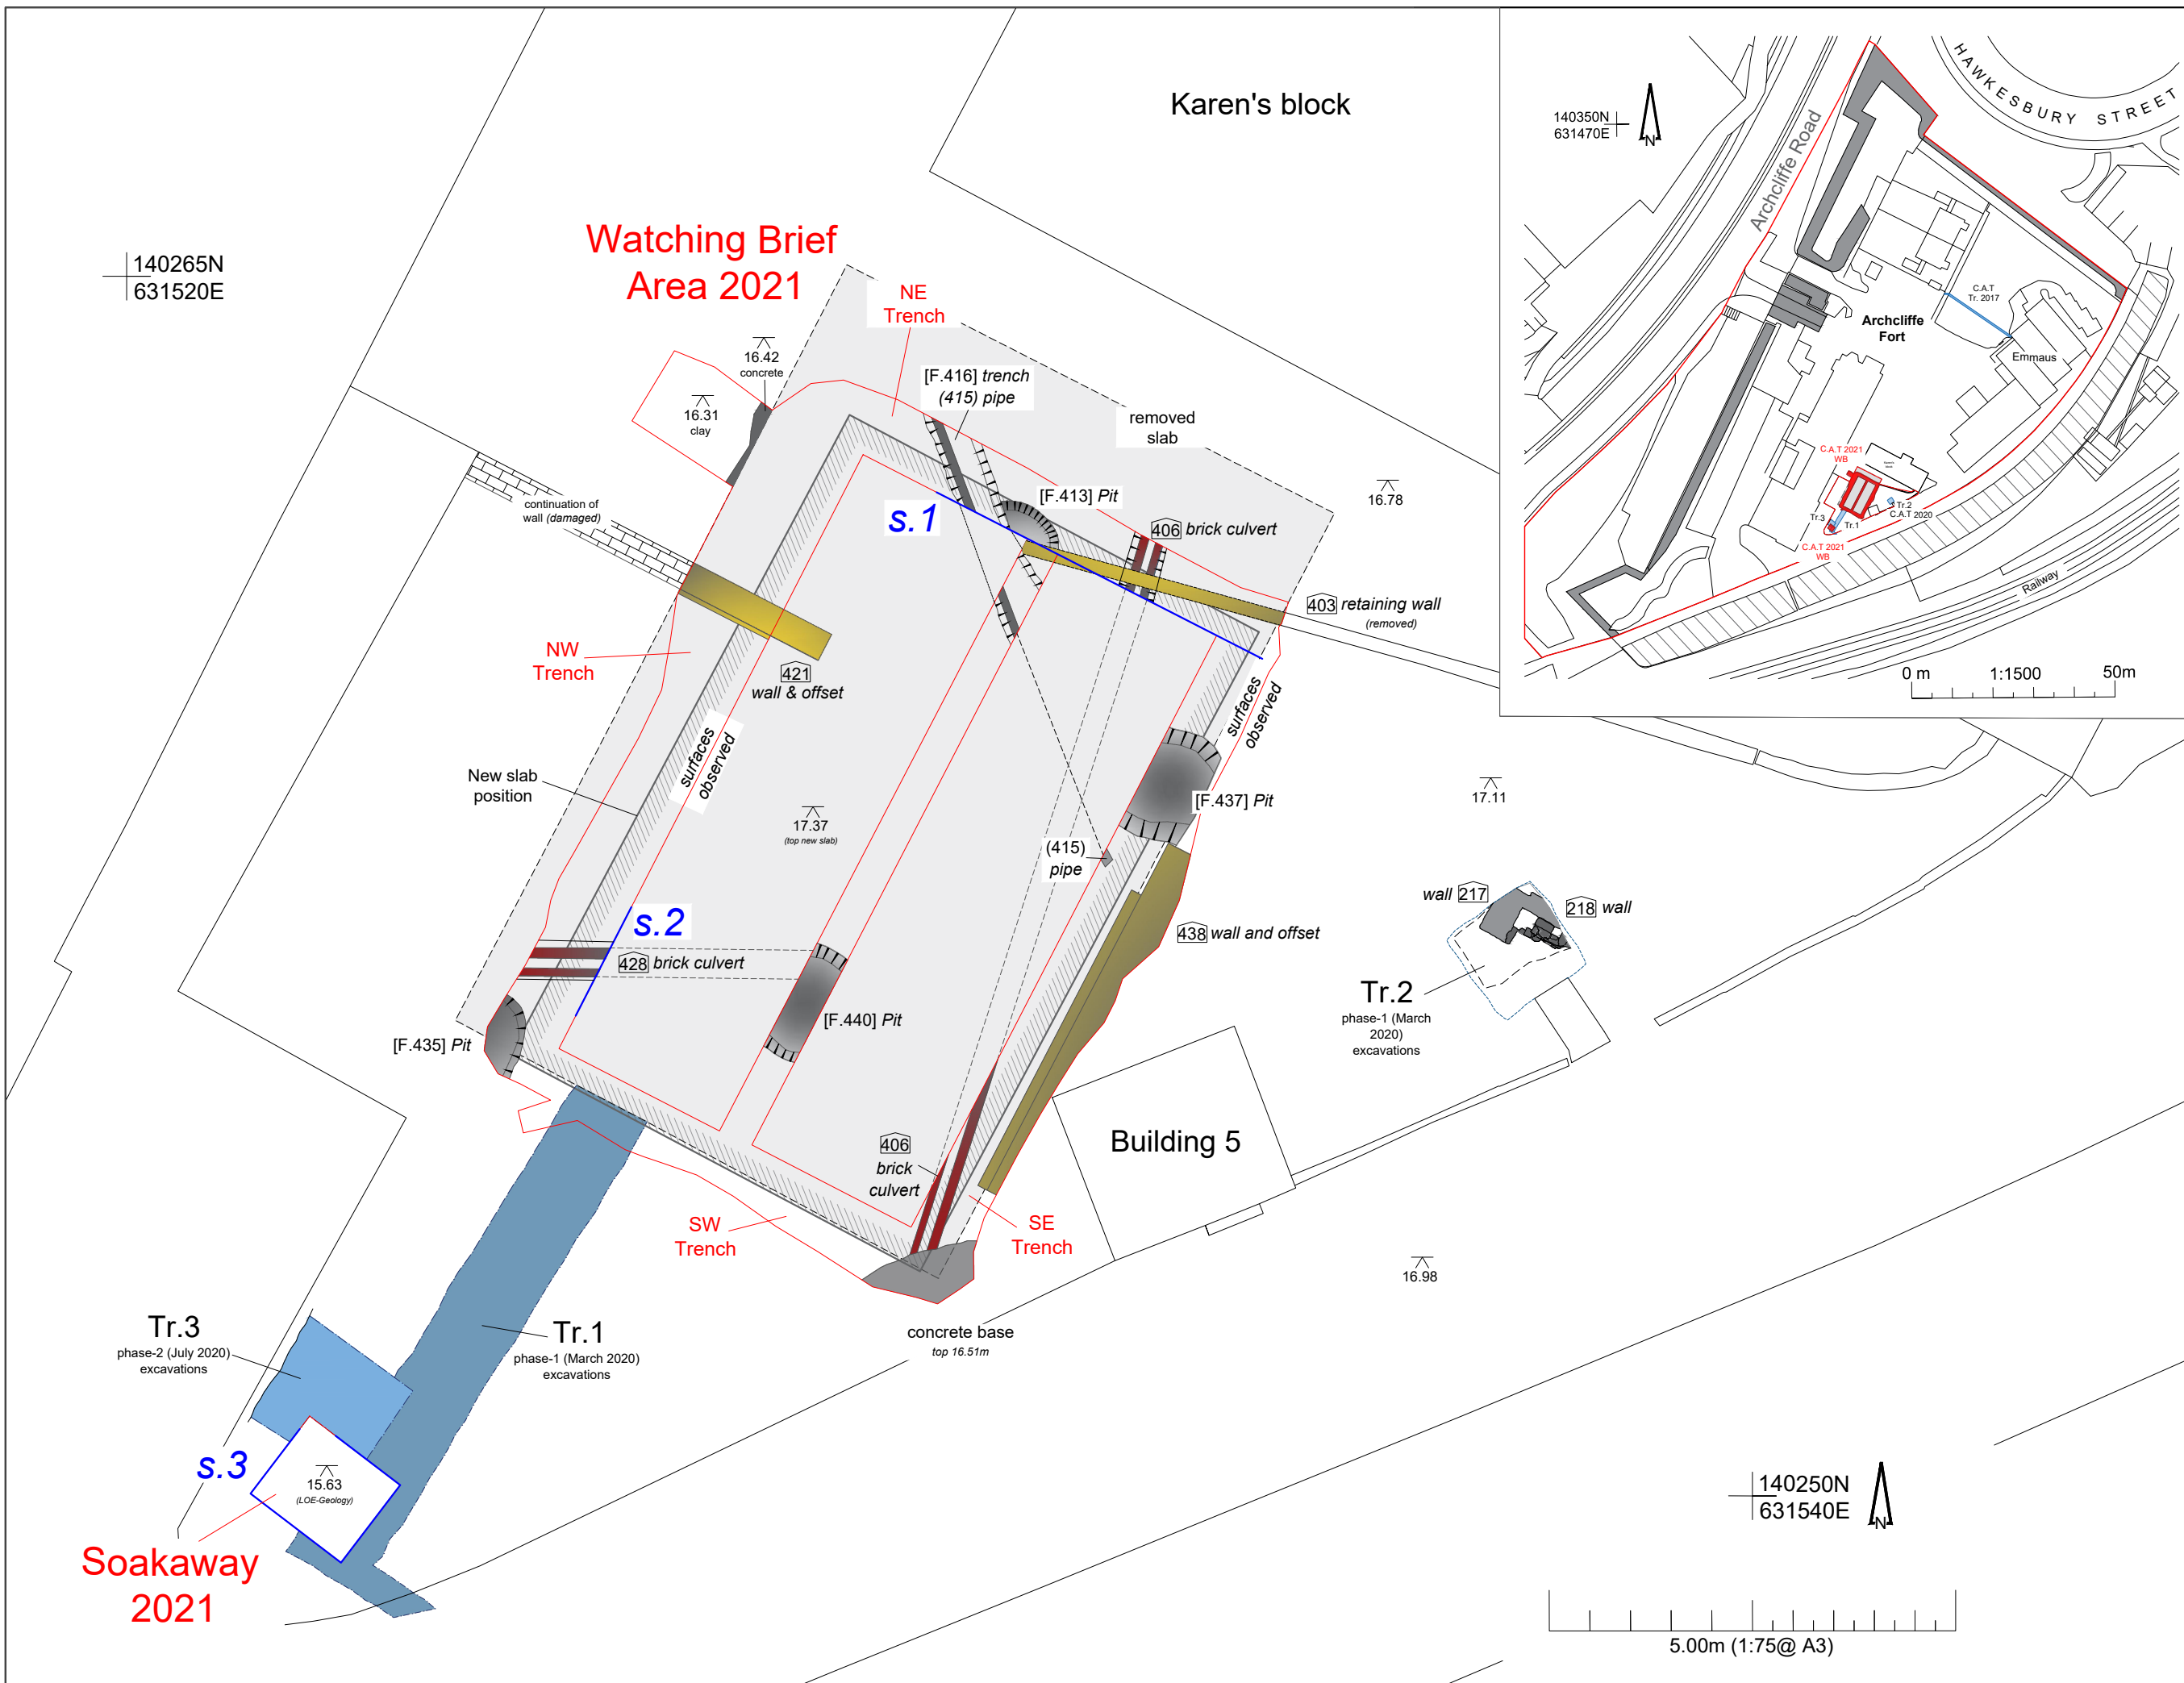
Figure. 2

Fig. 2 General site plan showing recorded features

7.5 Retaining wall 403 (Fig. 2)

7.5.1 Removal of concrete slab 401 and the underlying levelling deposit (Context 402) established that an extant, low retaining wall (Fig. 2, Context 403) running eastwards from the platform also continued on the same alignment under the concrete base for a distance of 3.15m, before terminating in a roughly finished end. This structure had clearly been buried when the base for Building 9 was laid down.

7.6 Retaining wall 421 (Fig. 2)

7.6.1 Removal of concrete slab 401 and the underlying levelling deposit (Context 402) on the north-western side showed that another extant low retaining wall (Context 421), running north-westwards from the platform also continued on the same alignment under the concrete base for at least another 1.35m. As with Wall 403, this wall had clearly been buried when the base for Building 9 was laid down (Fig. 2).

7.7.4 Careful inspection of the excavated foundation trenches allowed the recording of a number of deposits and structures of archaeological interest, adding to information previously recorded in this area during the evaluation trenching (Fig. 2).

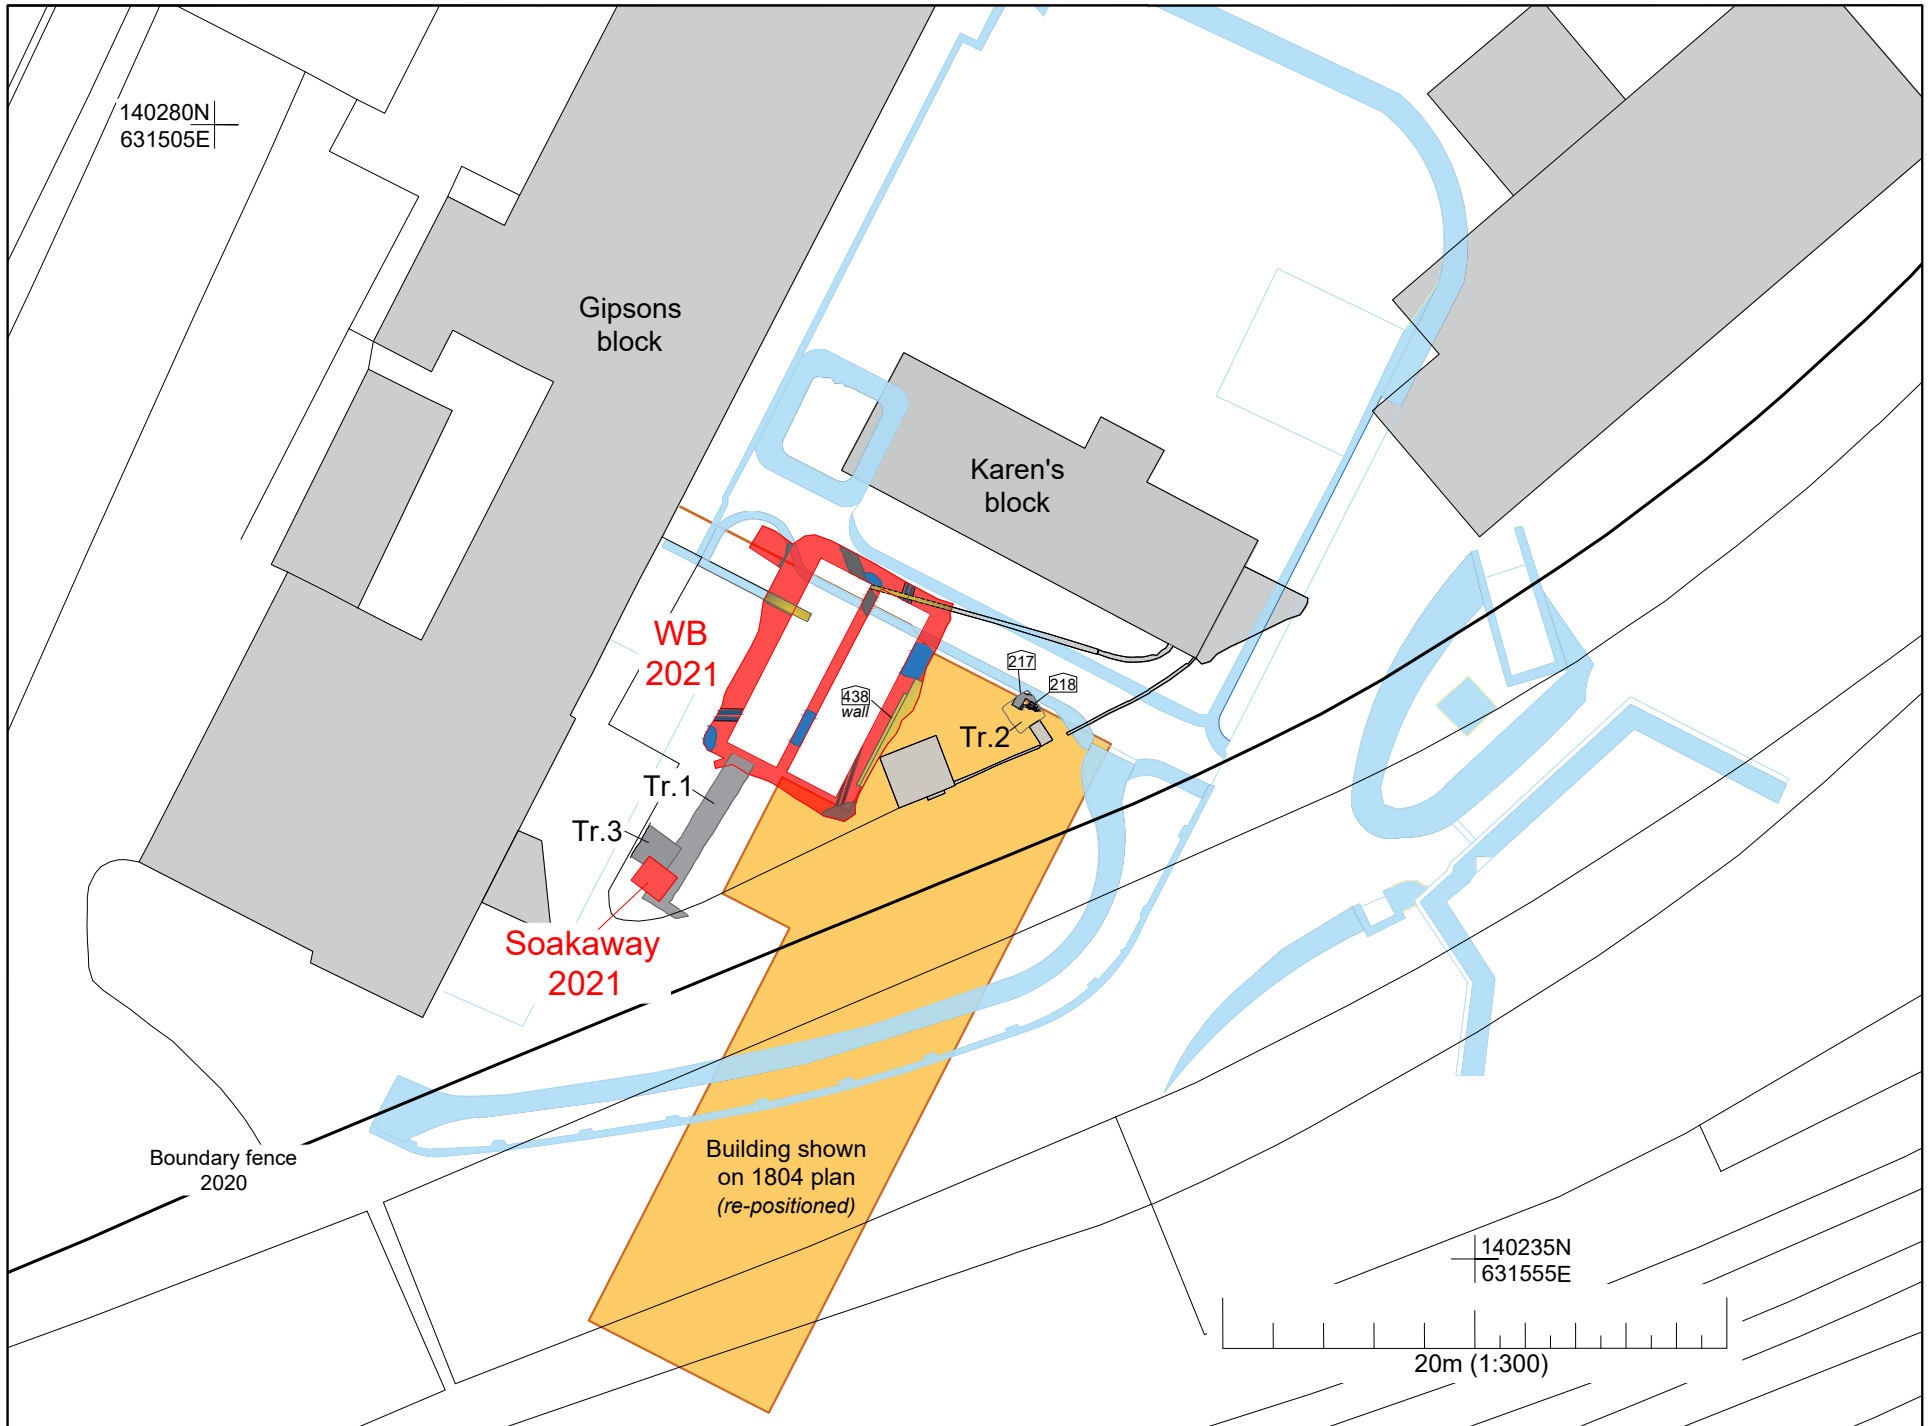
Fig. 3 Plan of excavated trenches in relation to the 1804 and 1884 plans with location of excavated walls

7.10 Wall 438 (Figs 2, 3, 11 & 12)

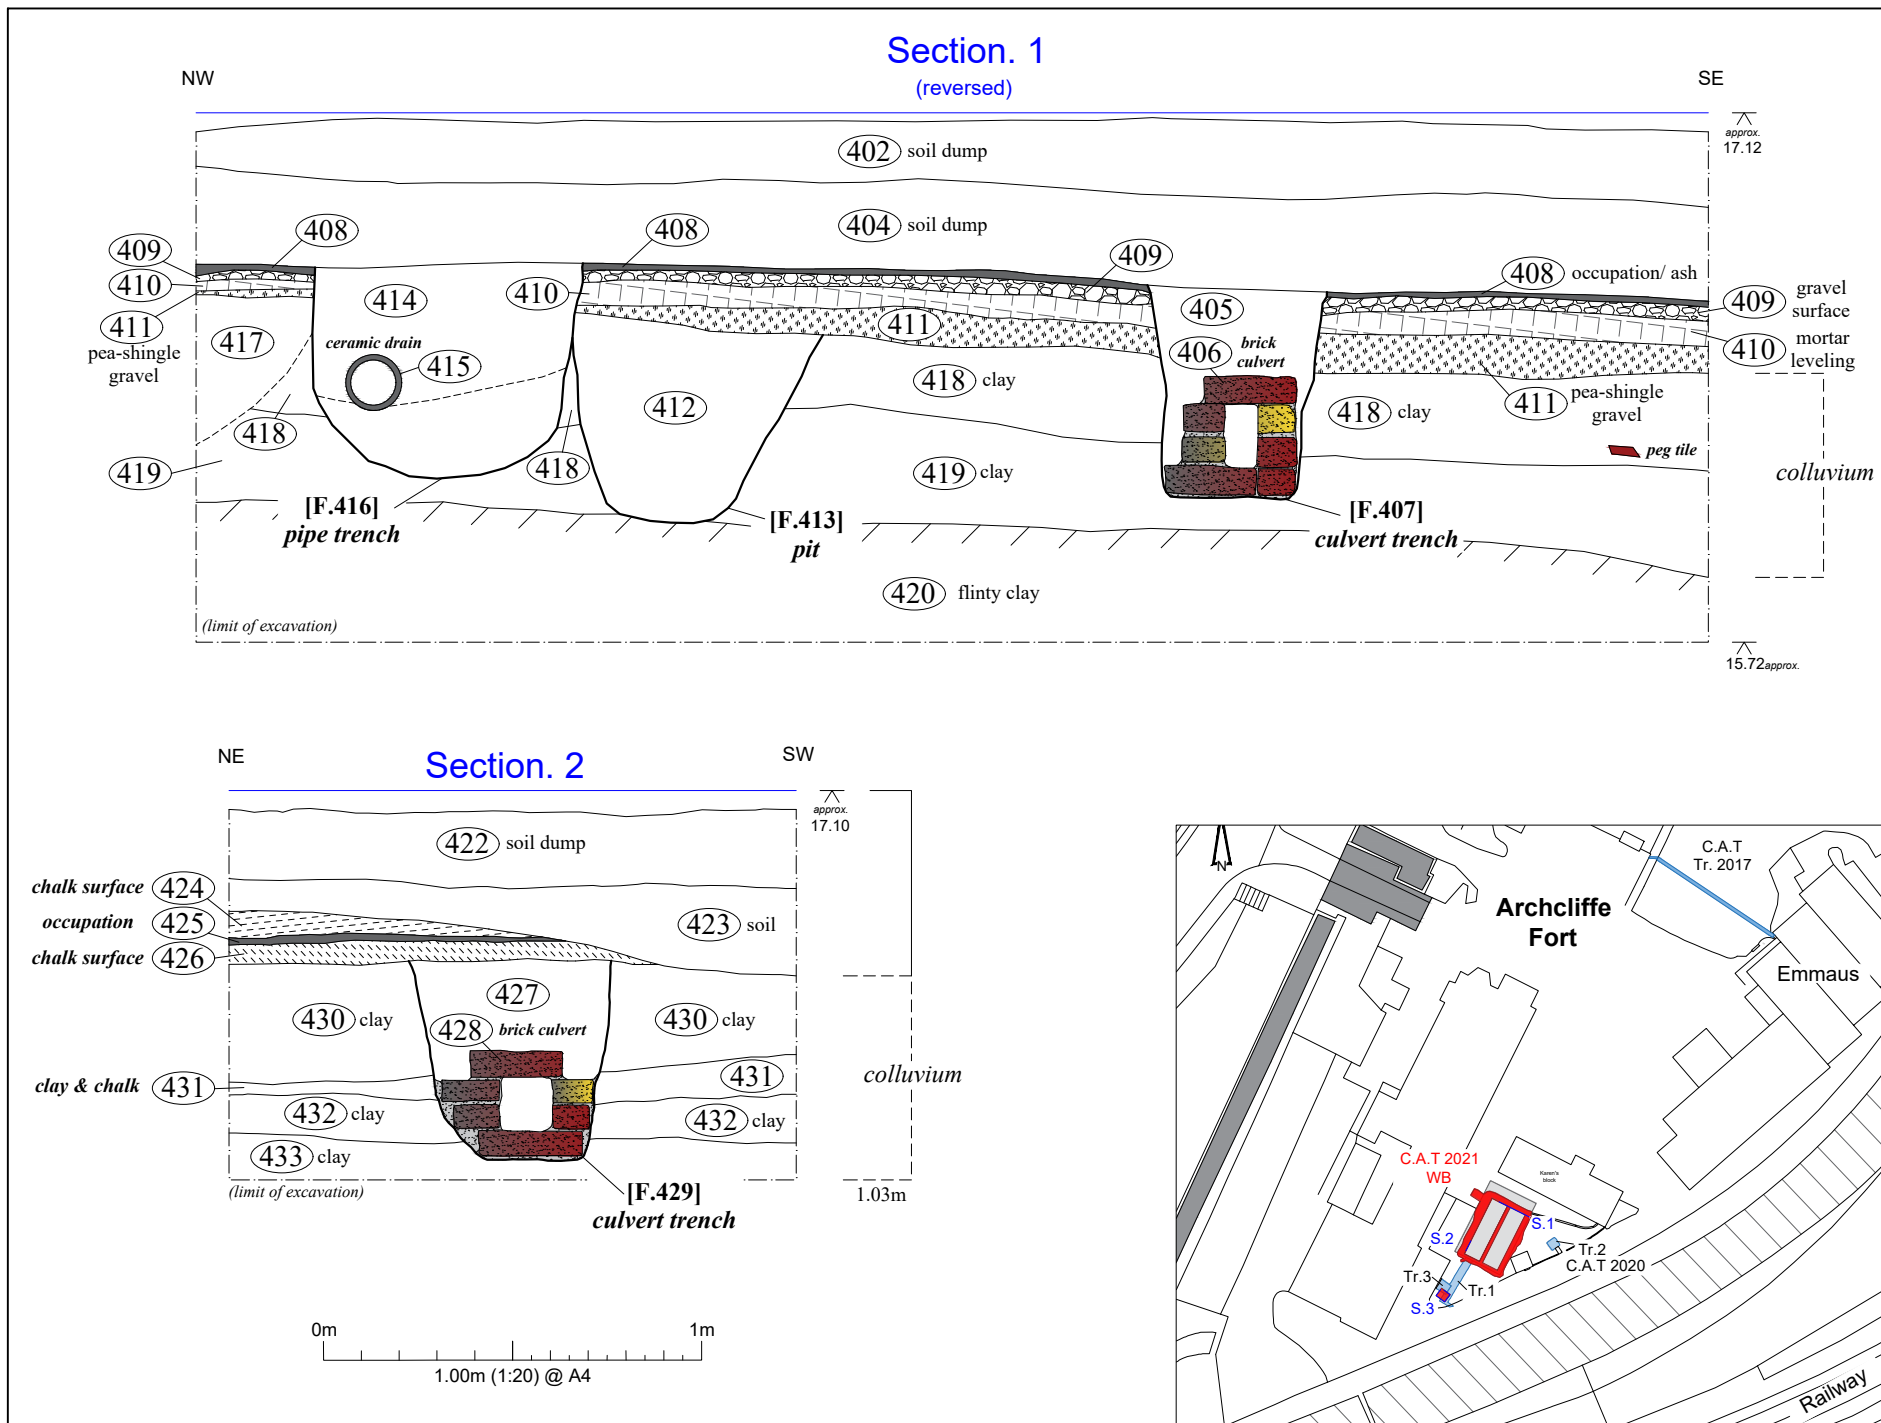
Fig. 4

Fig.4 Sections through recorded deposits with inset location plan

7.8 Early clay deposits (Figs 4, 5, 13, 16 & 17)

7.8.1 Across the site of the new workshop, the deeper trenches in the north-eastern half of the plot provided the most complete sections through the deposits present, to a depth of about 1.40m under the concrete platform of Building 9 (Figs 4 (Section 1) & 13). Further to the south-west, another good section was provided by the new soakaway pit cut next to evaluation Trench 3 (Figs 5 & 17).

7.14.3 Above the colluvium, a series of yard surfaces was recorded from a depth of about 0.25m. These were similar to those more extensively seen in the adjacent foundation trenches for the new workshop (Fig. 4). Context 443 clearly equates with surface 309 previous recorded in evaluation Trench 3 (Fig. 5).

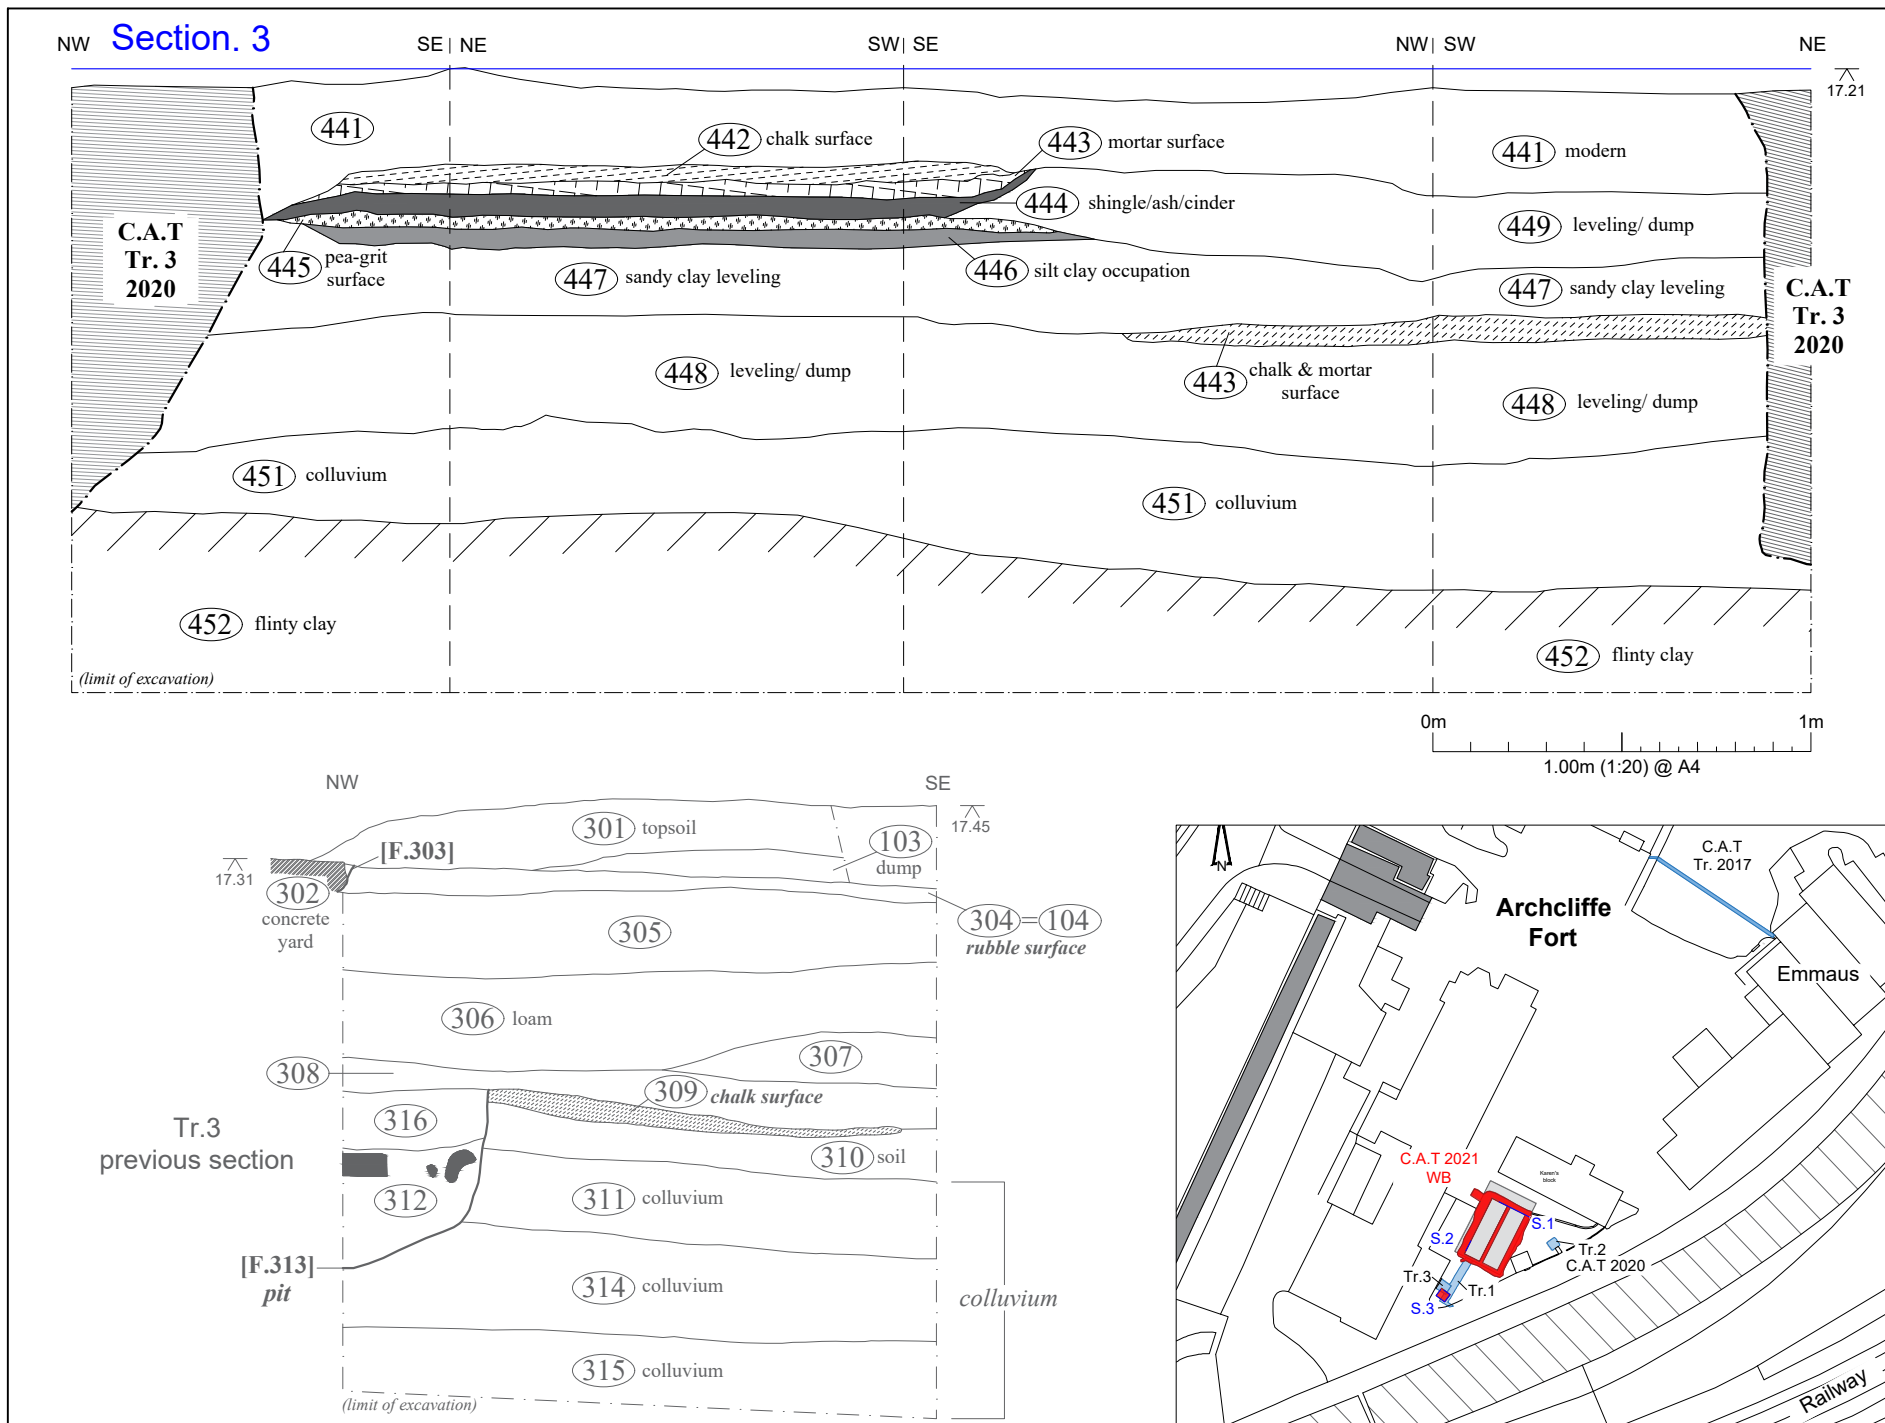
Fig. 5

Fig.5 Sections through recorded deposits in soak-away pit 2021 with inset location plan and previous section from trench-3

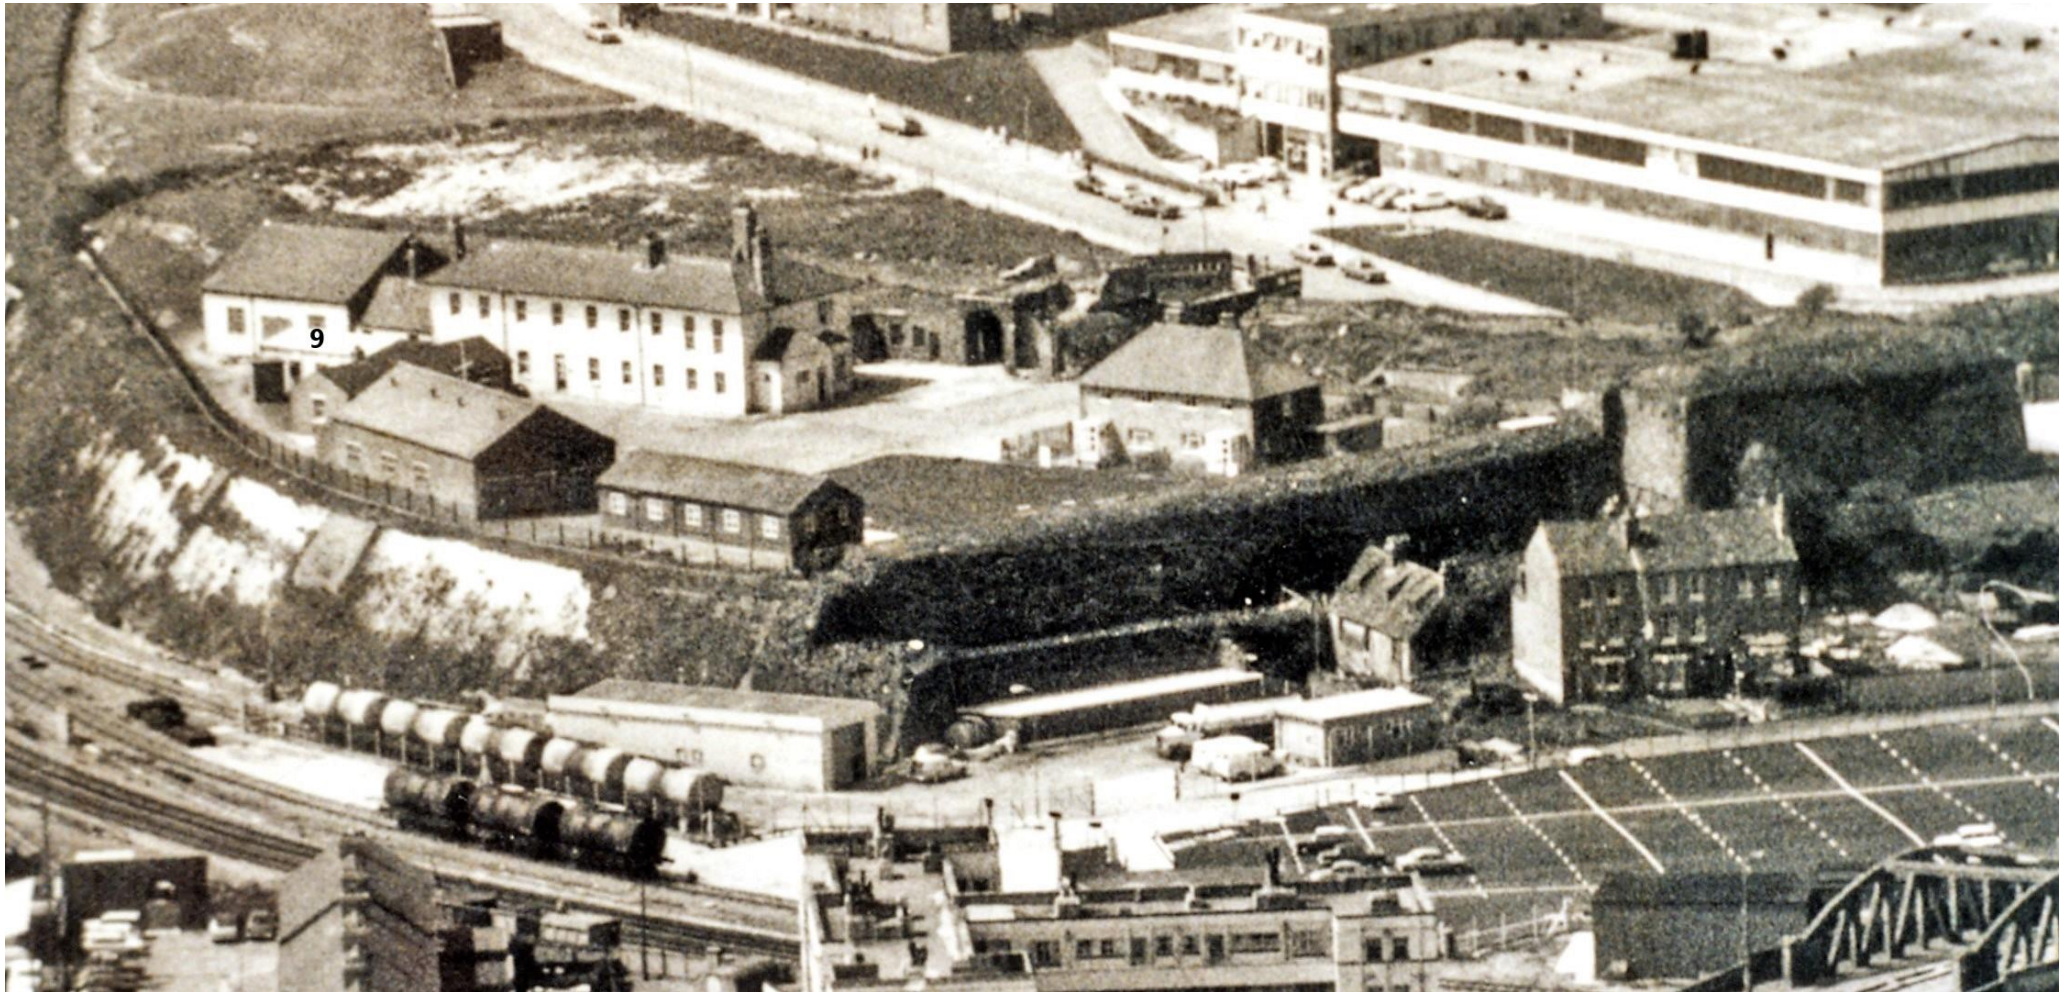
Fig. 6 Twentieth century aerial photograph (pre 1973) of Archcliffe Fort showing Building 9 standing with a flat roof (*courtesy of Dover Museum, ref. d 43190*)

7.4.4 A previously unknown aerial photograph of Archcliffe Fort has recently been located at Dover Museum (*ref.* d 43190; Fig. 6). Taken sometime during the second half of the twentieth century, but before 1973, this shows Building 9 as then standing, covered with a flat roof.

7.4.5 The available evidence now combines to suggest that Building 9 post-dated the Second World War. Accordingly, it would seem to be of minimal historical interest. The former position of the structure will be broadly marked by the new workshop building.

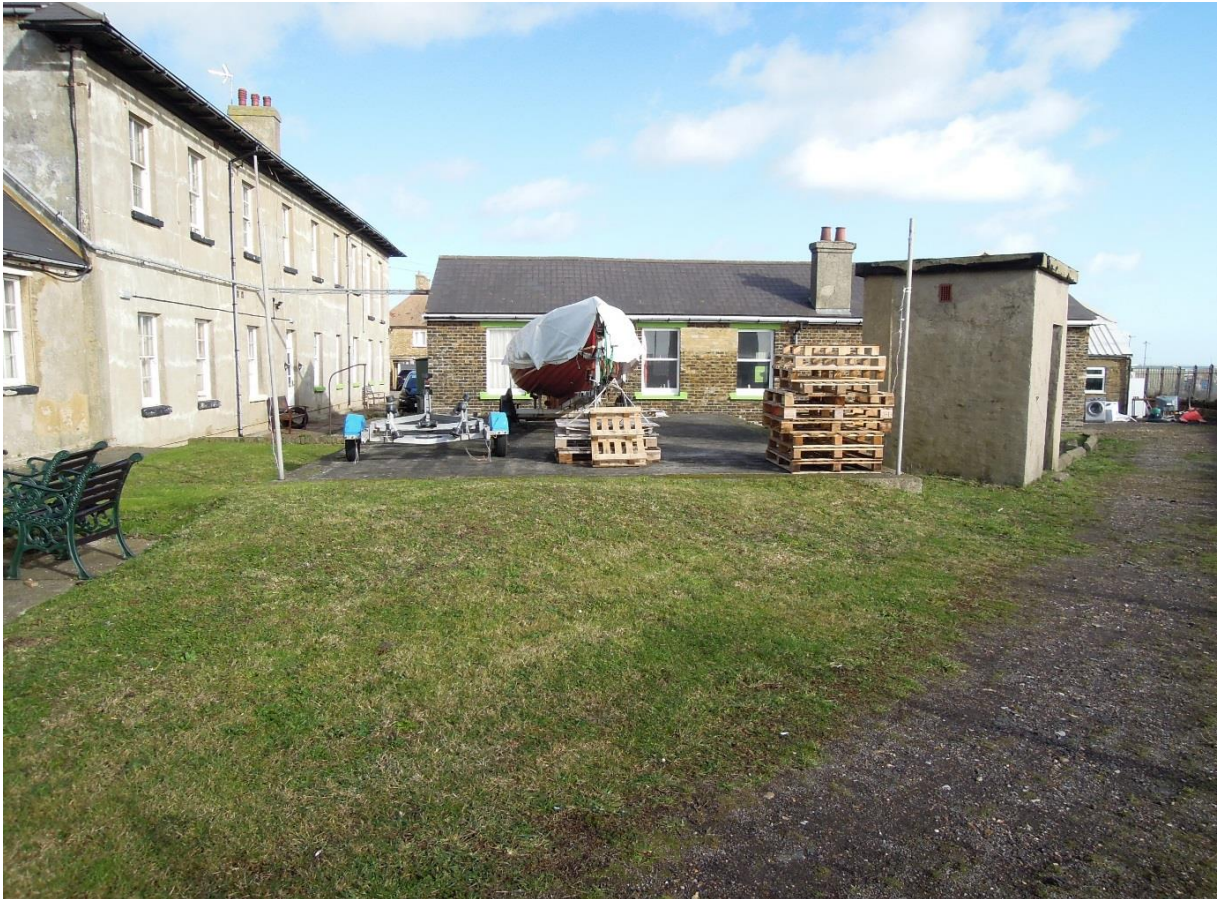
Fig. 7 General view of Building 9 (platform) looking north-east in 2019

A raised rectangular concrete base lies immediately south-west of Building 4 [Karen's Block], very close to Building 5, parallel with Buildings 2 and 3 [Gipson's Block]. This clearly once supported another, presumably lightweight, building now removed (Figs 6–8).

Built of concrete blocks and poured concrete, the platform is rectangular in shape, measuring 6.75m (NW–SE) by 10.48m (NE–SW). At the north-eastern end, the platform stands about 0.80m above present ground level but the structure is not built on horizontal ground so that the south-western end is level with the ground surface there (Fig. 7).

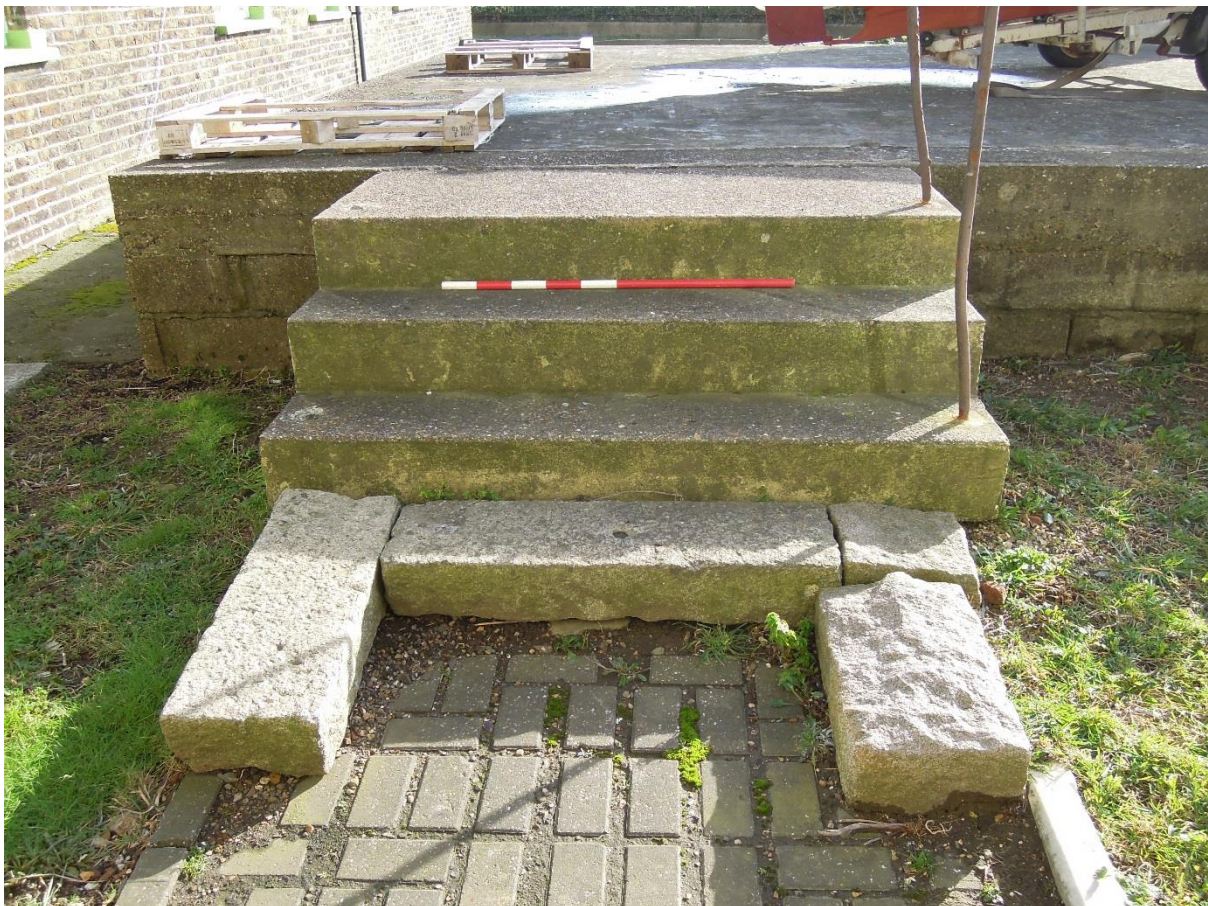
Fig. 8 Detail of steps leading up to Building 9 (platform) looking south-east in 2019. Scale, 1m

On the north-western side, towards the north corner, two concrete steps give access to the building platform (Fig. 8). The remains of a brick and concrete ramp occurs on the south-eastern side (damaged by roots). These suggest that doors into Building 9 lay on the north-west and south-east sides.

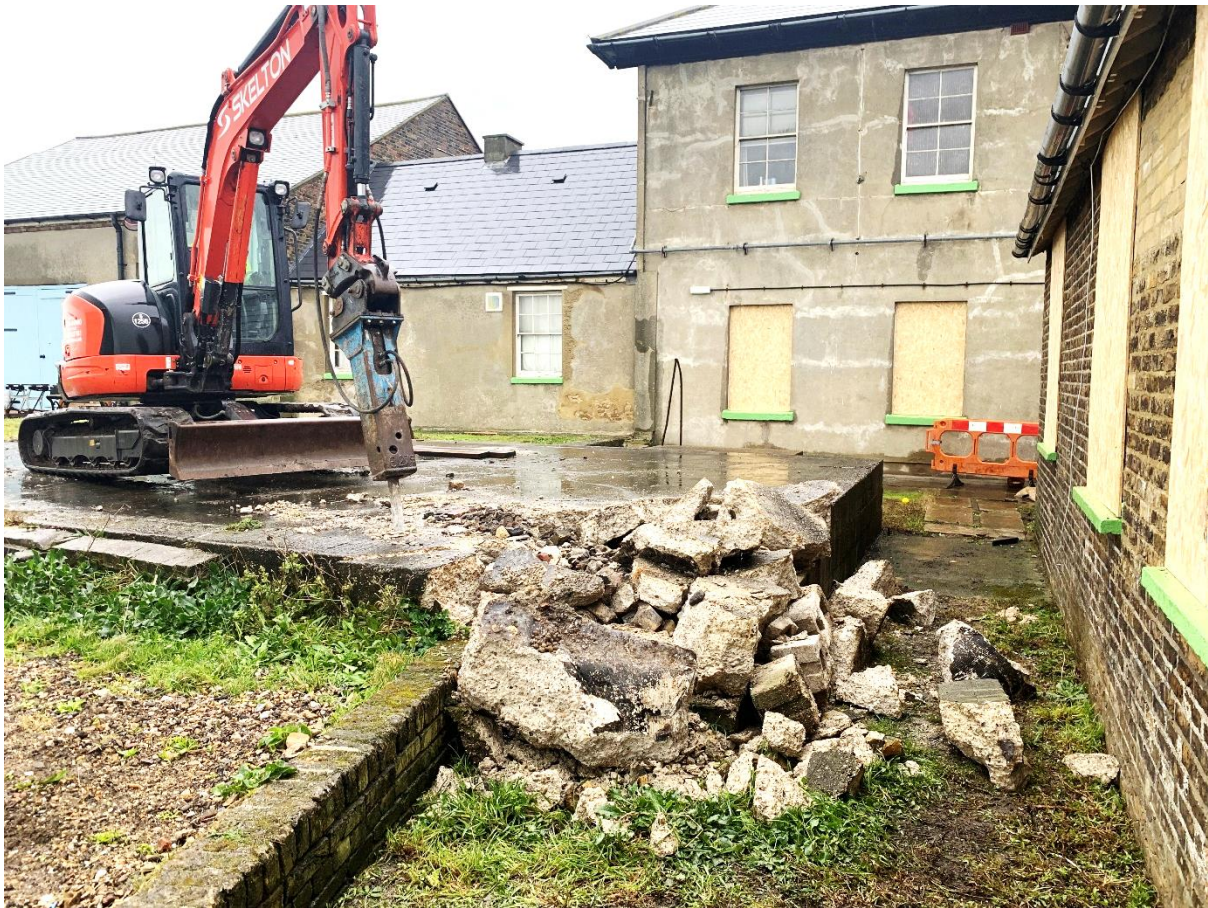
Fig. 9 Breaking out the concrete platform of Building 9, looking west (note brick retaining wall 403)

7.4.1 Observation during the removal of the extant building platform (Building 9) provided further details of its construction. It was readily apparent that the concrete base of the platform (Fig. 9; Context 401) had been poured as one, over layers of loose soil and rubble with a slightly undulating surface. Traces of some sort of thin membrane with a bitumen coating was noted adhering to the base of this concrete, showing that it had not been poured directly onto the underlying deposits.

7.5.2 Wall 403 stood to a height of 0.45m (5 courses; top course of bricks laid on edge) without any obvious foundation (Fig. 9). It was 0.24m wide and was constructed from frogged yellow stock bricks

7.7.2 A height differential of between 0.50 and 0.70m occurred at the north-eastern end of the new building plot (Fig. 9; see above). This change in level was marked by two low brick retaining walls (Contexts 403 and 421).

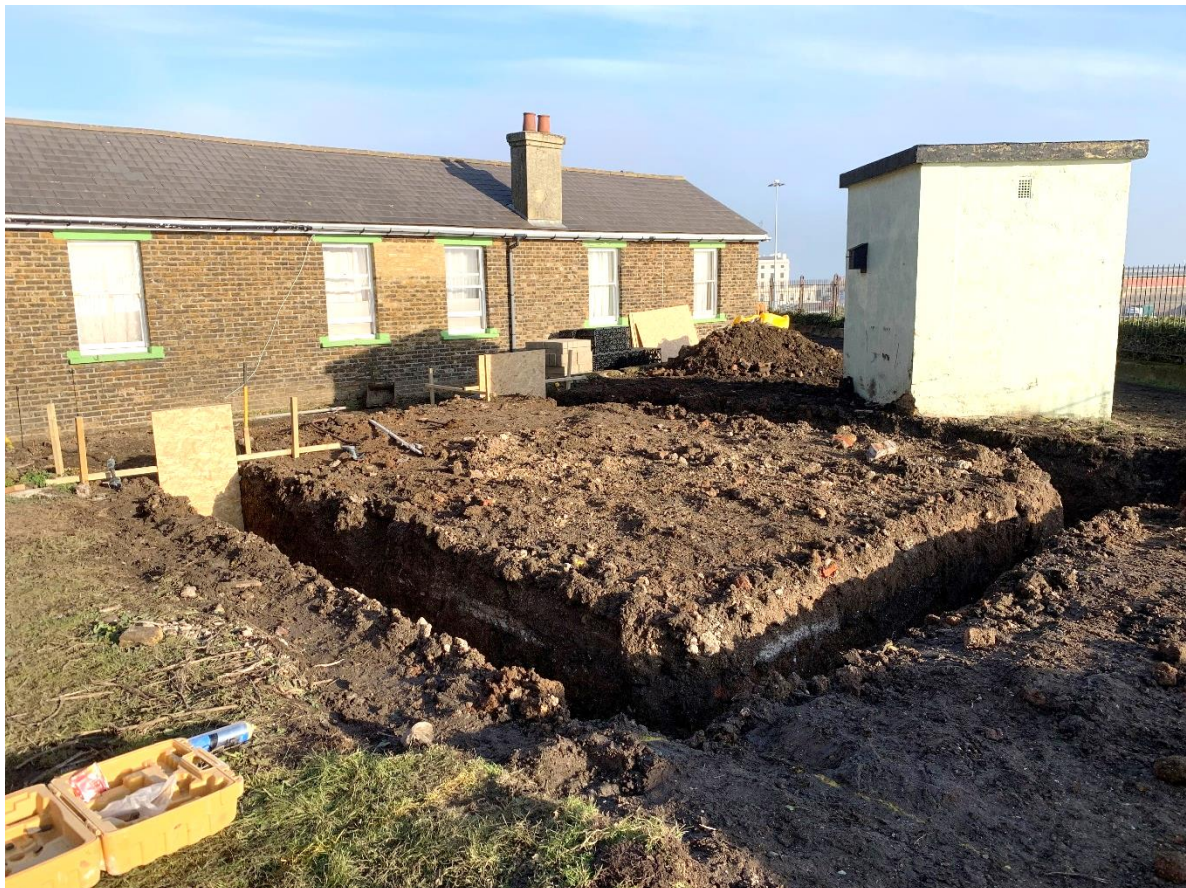
Fig. 10 General view of excavated foundation trenches, looking east with Buildings 4 and 5 in background

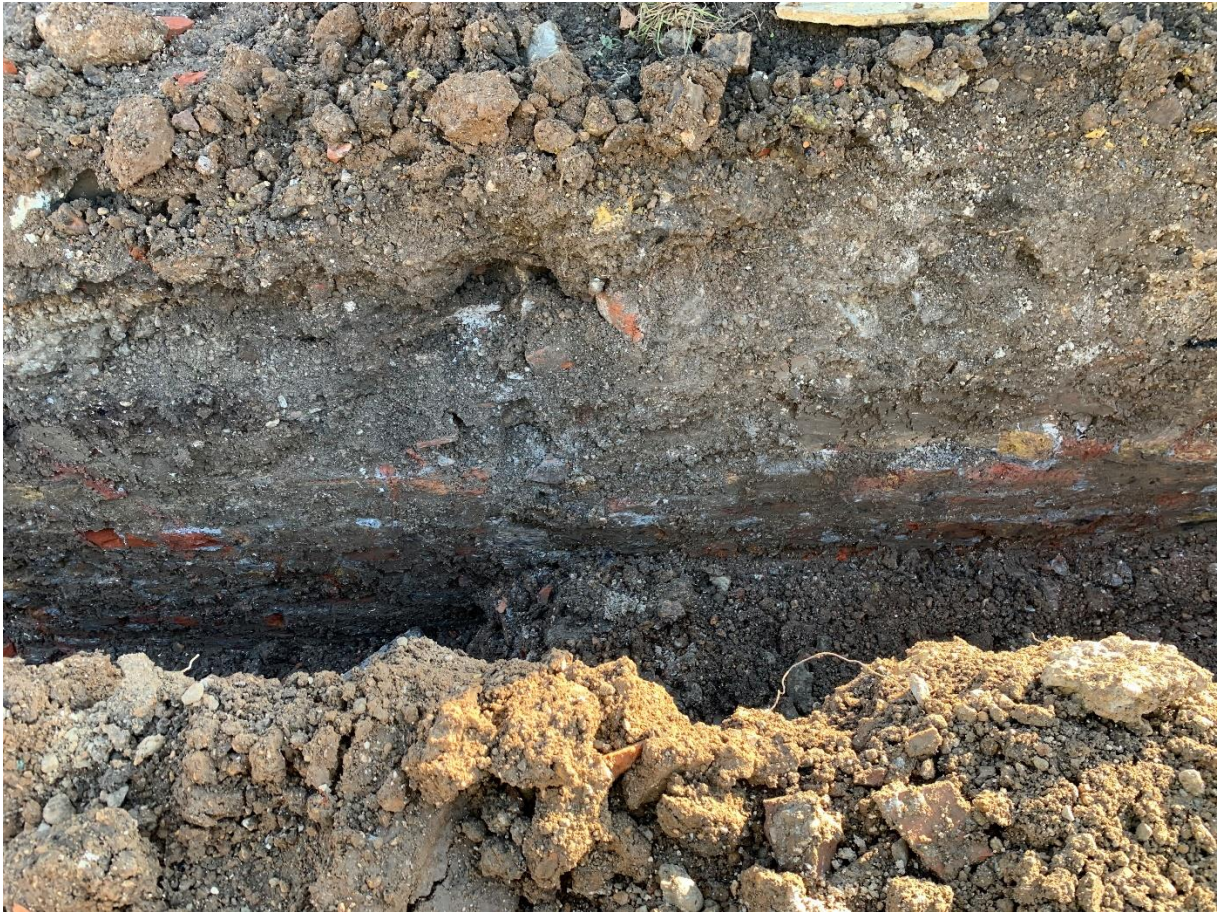
Fig. 11 Detail view of brick wall 438 exposed in face of SE Trench, looking south-east

7.10.3 Wall 438 was constructed of red (95%) and occasional yellow (5%) bricks set in a mid-grey gritty mortar with moderate quantities of chalk/lime specks and coal specks/grits. Most of the wall was more than 0.80m high (11 courses, foundation not exposed) and fairly certainly constituted a basement wall but, at the north-east the end, it was set back to the south-east by about 0.10m and was less deep, being only about 0.50m high in total (6 courses). Pit F.437 had been cut down the face of the wall at this point (Figs 2 & 12).
