Archcliffe Fort, Dover, 2021, New workshop construction, Archaeological watching brief

Project Code: AFDL-WB-21

Report No: 2021/36

March 2021

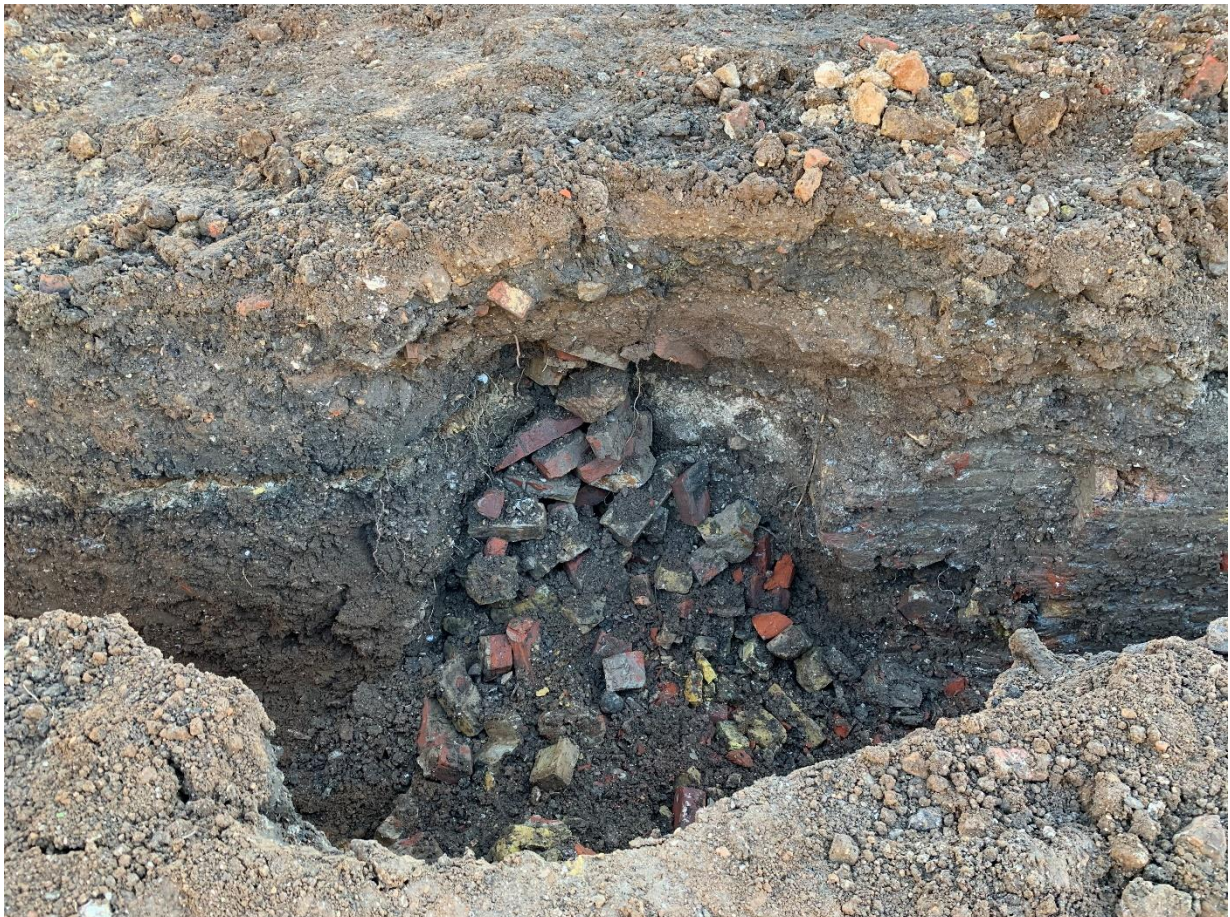
Fig. 12 Collapsing fill (436) of pit F. 437 adjacent to wall 438 in SE Trench, looking south-east

7.10.3 Wall 438 was constructed of red (95%) and occasional yellow (5%) bricks set in a mid-grey gritty mortar with moderate quantities of chalk/lime specks and coal specks/grits. Most of the wall was more than 0.80m high (11 courses, foundation not exposed) and fairly certainly constituted a basement wall but, at the north-east the end, it was set back to the south-east by about 0.10m and was less deep, being only about 0.50m high in total (6 courses). Pit F.437 had been cut down the face of the wall at this point (Figs 2 & 12).

7.13.1 Portions of three substantial pits (Fs 435, 437 & 440; Fig. 2) cutting through Context 430 and the overlying yard surfaces appeared to be relatively modern in date. Their generally loose brick rubble fillings (Contexts 434, 436 and 439; Fig. 12) might suggest that they had been intended as soakaway pits, although they could equally well have been dug to dispose of unwanted building debris.

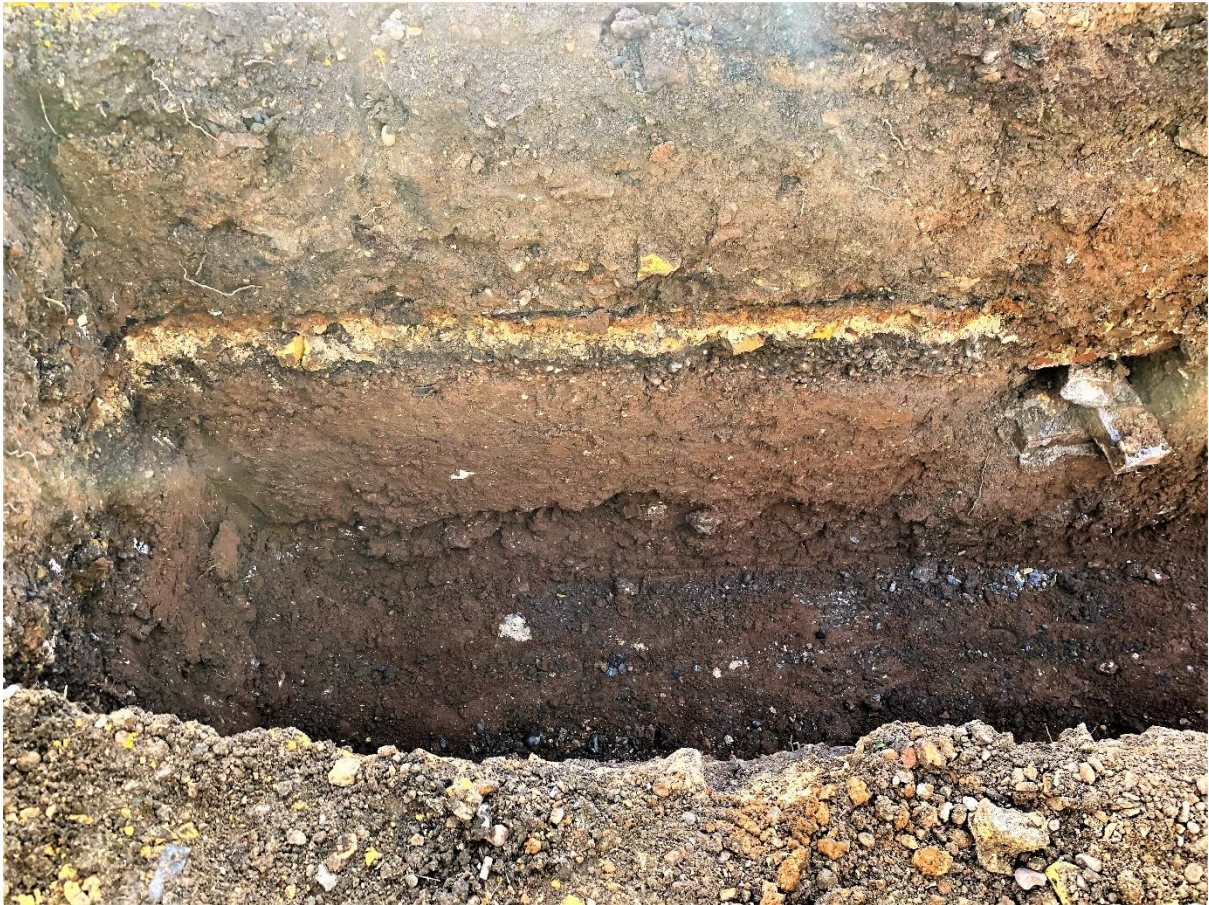
Fig. 13 Brick culvert 406 and adjacent deposits exposed in NE Trench, looking south-west (see drawn Section 1)

7.8 Early clay deposits (Figs 4, 5, 13, 16 & 17)

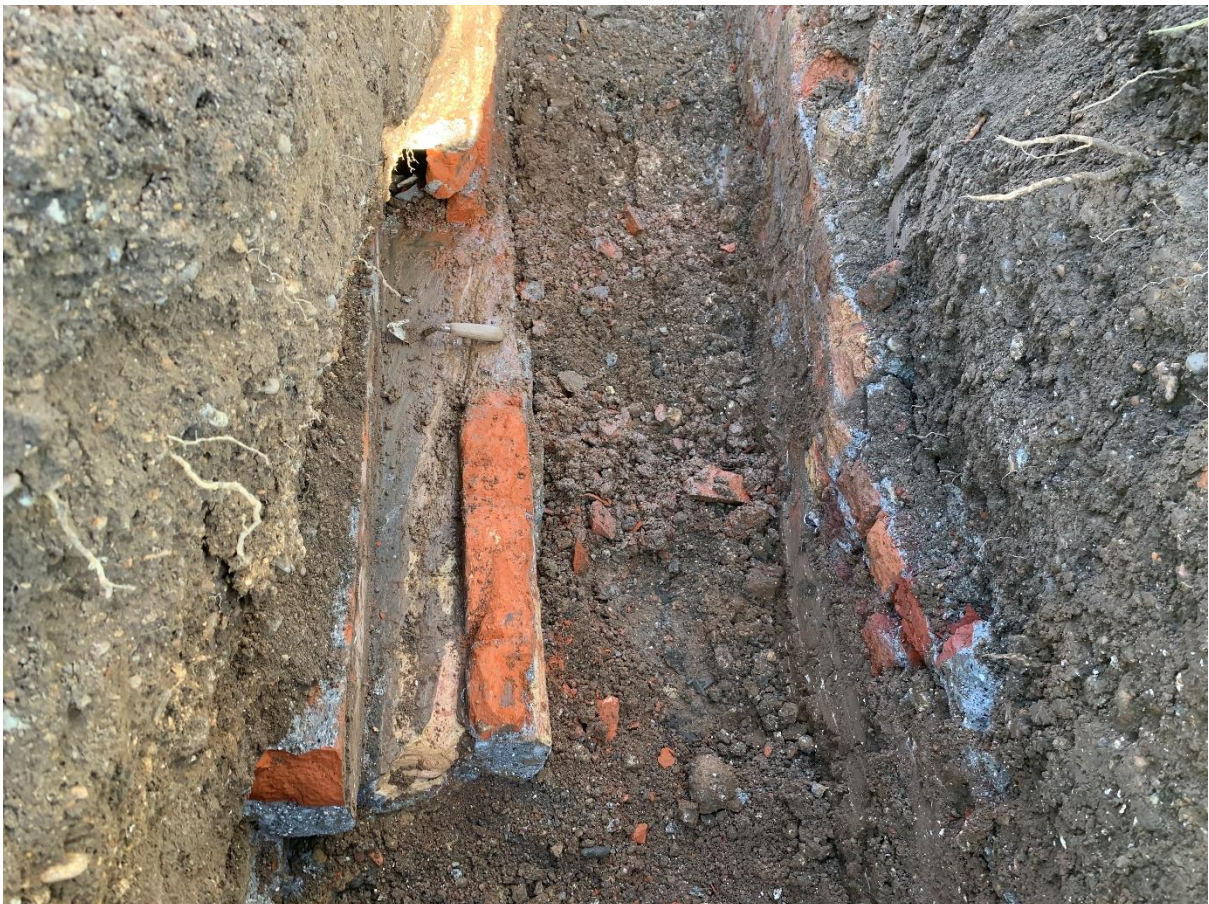
Fig. 14 Brick culvert 406 and Wall 438 exposed in SE Trench, looking north-east

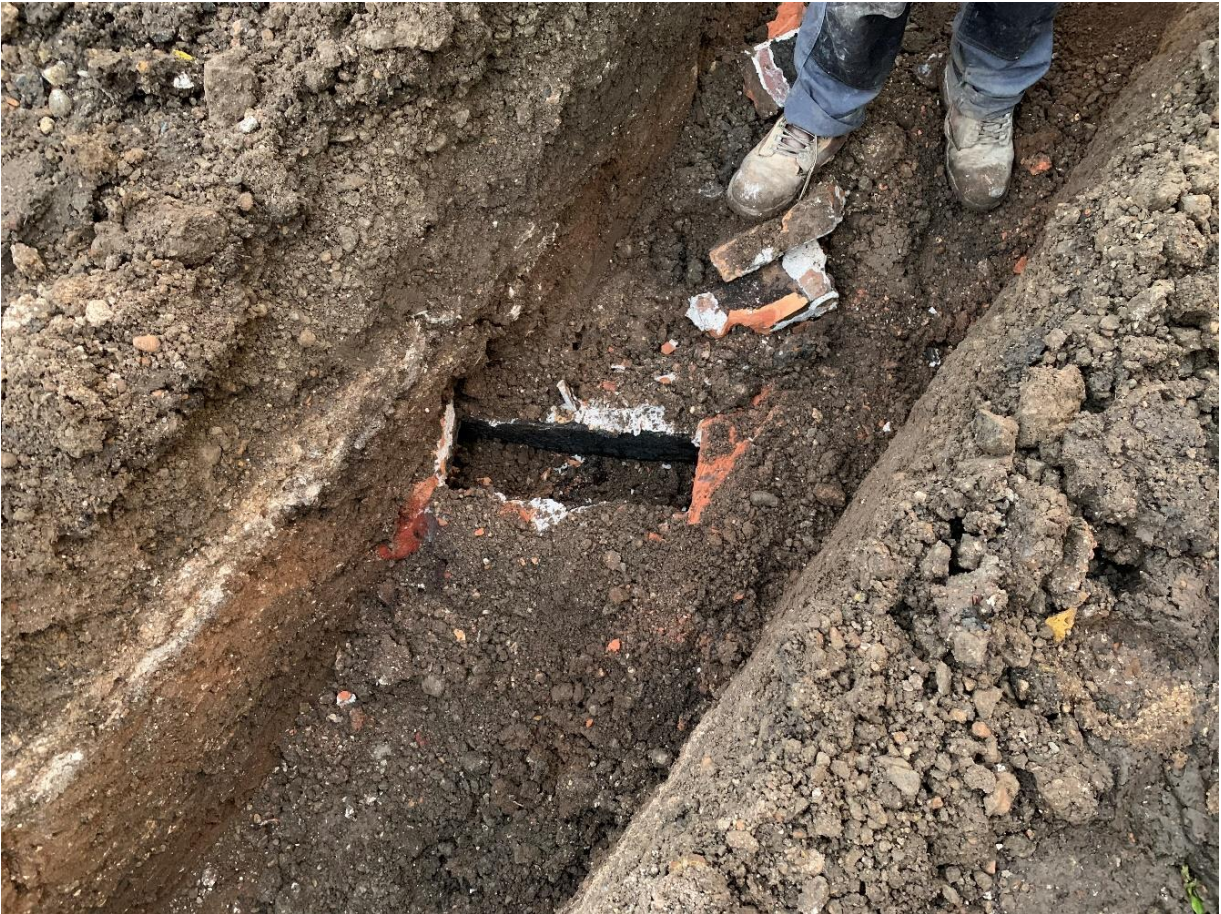
Fig. 15 Brick culvert 428 as first exposed in NW Trench, looking south

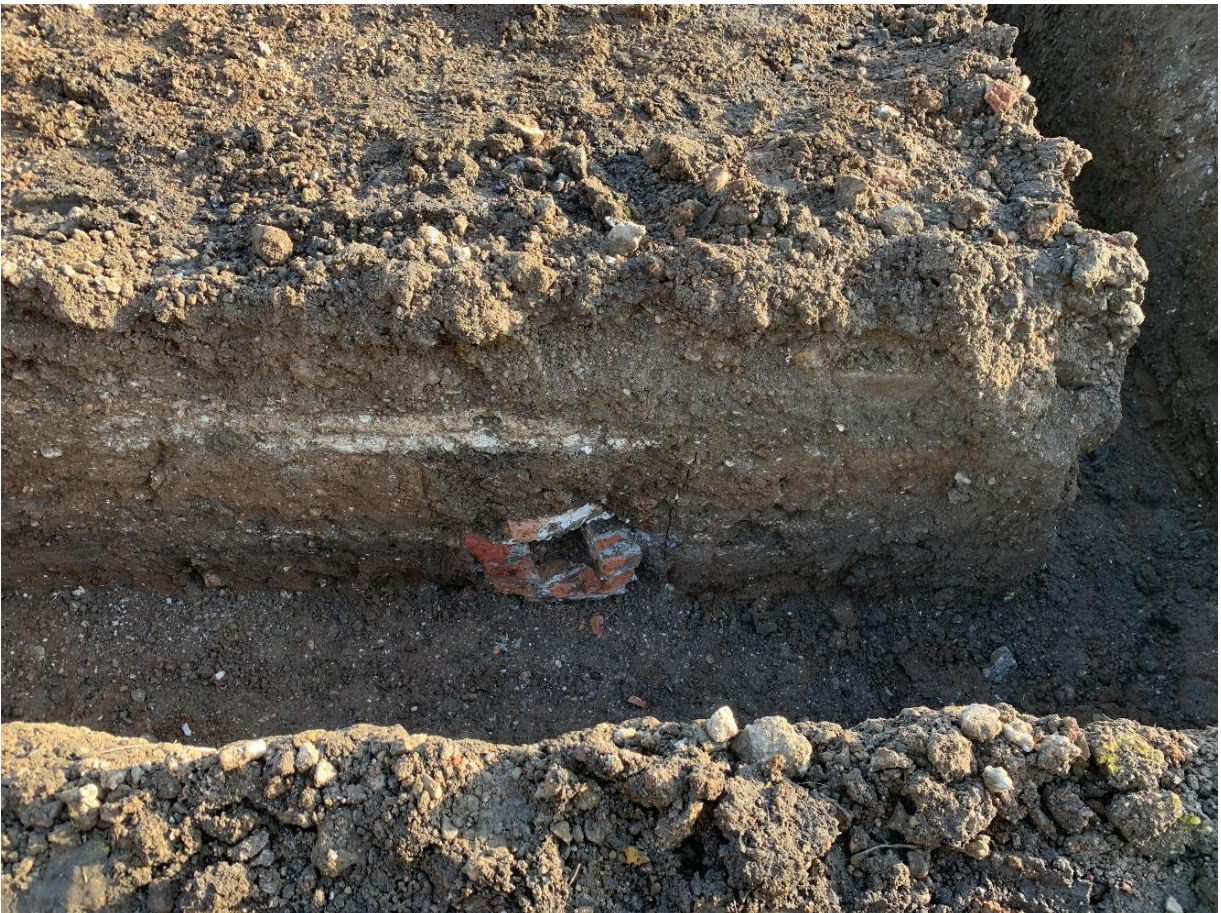
Fig. 16 Brick culvert 428 sectioned by NW Trench, looking south-east (see drawn Section 2)

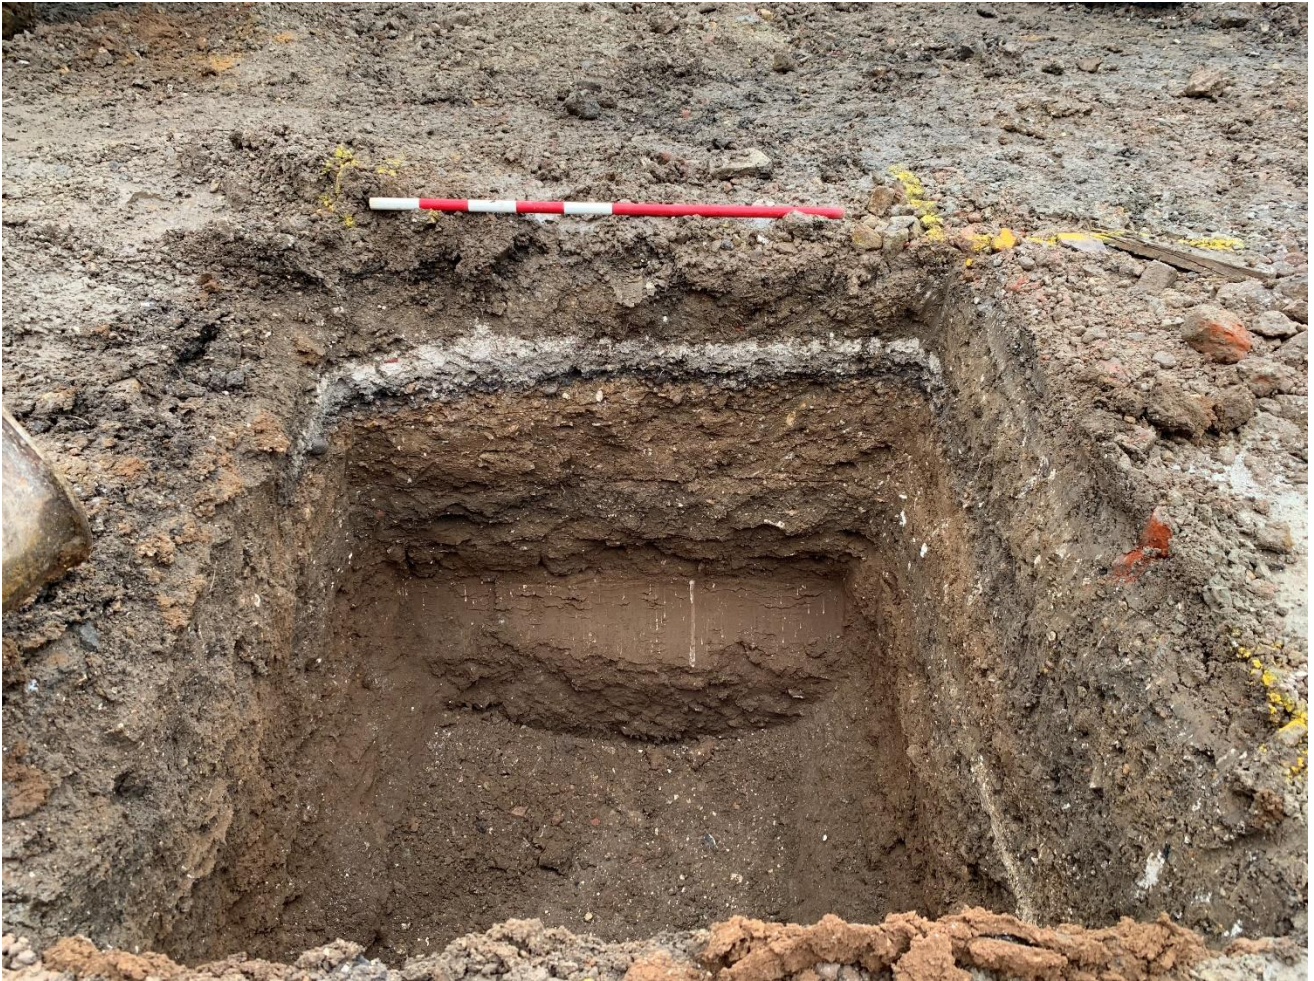
Fig. 17 The excavated soakaway pit looking SE, showing early clays overlain by subsequent yard surfaces. Scale, 1m (see drawn Section 3)

7.8.1 Across the site of the new workshop, the deeper trenches in the north-eastern half of the plot provided the most complete sections through the deposits present, to a depth of about 1.40m under the concrete platform of Building 9 (Figs 4 (Section 1) & 13). Further to the south-west, another good section was provided by the new soakaway pit cut next to evaluation Trench 3 (Figs 5 & 17).

7.11.2 Traces of comparable yard surfacing had been previously noted in evaluation Trenches 2 and 3 (Parfitt 2020b; 2020c) and more was seen in the new soakaway pit (Figs 5 & 17), implying that most of the area had once been covered by a succession of surfaces. This conclusion, however, is not borne out by the evidence of the 1884 site plan, where the area is shown as being either kitchen garden or lawn, divided only by a narrow path. From this, it would seem that the recorded surfacings were earlier, possibly forming a metalled yard between Building 2 and the recently identified demolished building that lay to the south-east (Wall 438, etc.; see above).

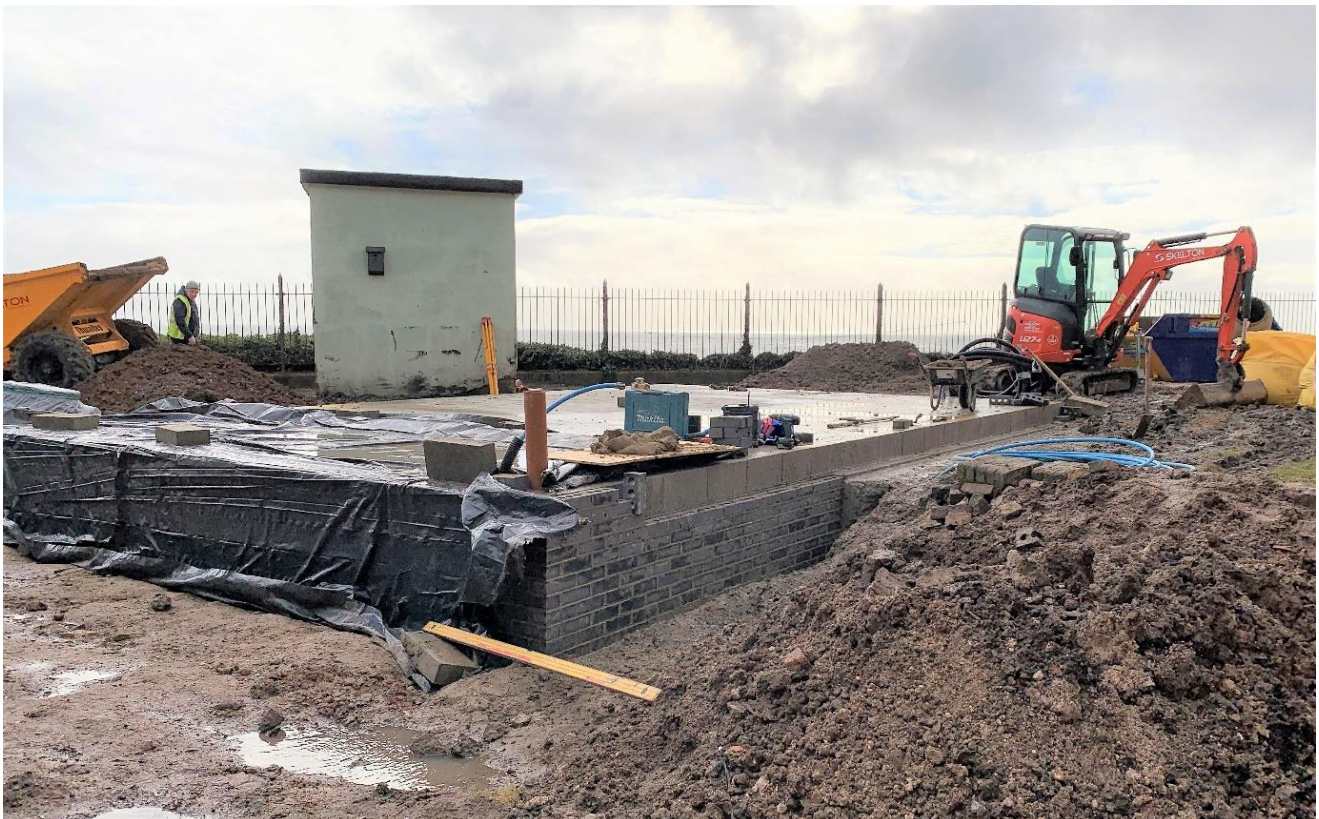
Fig. 18 The completed foundation for the new workshop, looking south
