**West Norman Road,  
Dover Castle,  
Dover,  
Kent**

**Archaeological watching brief report**

Project Code: DCWNR WB 21

Report No: 2021/42

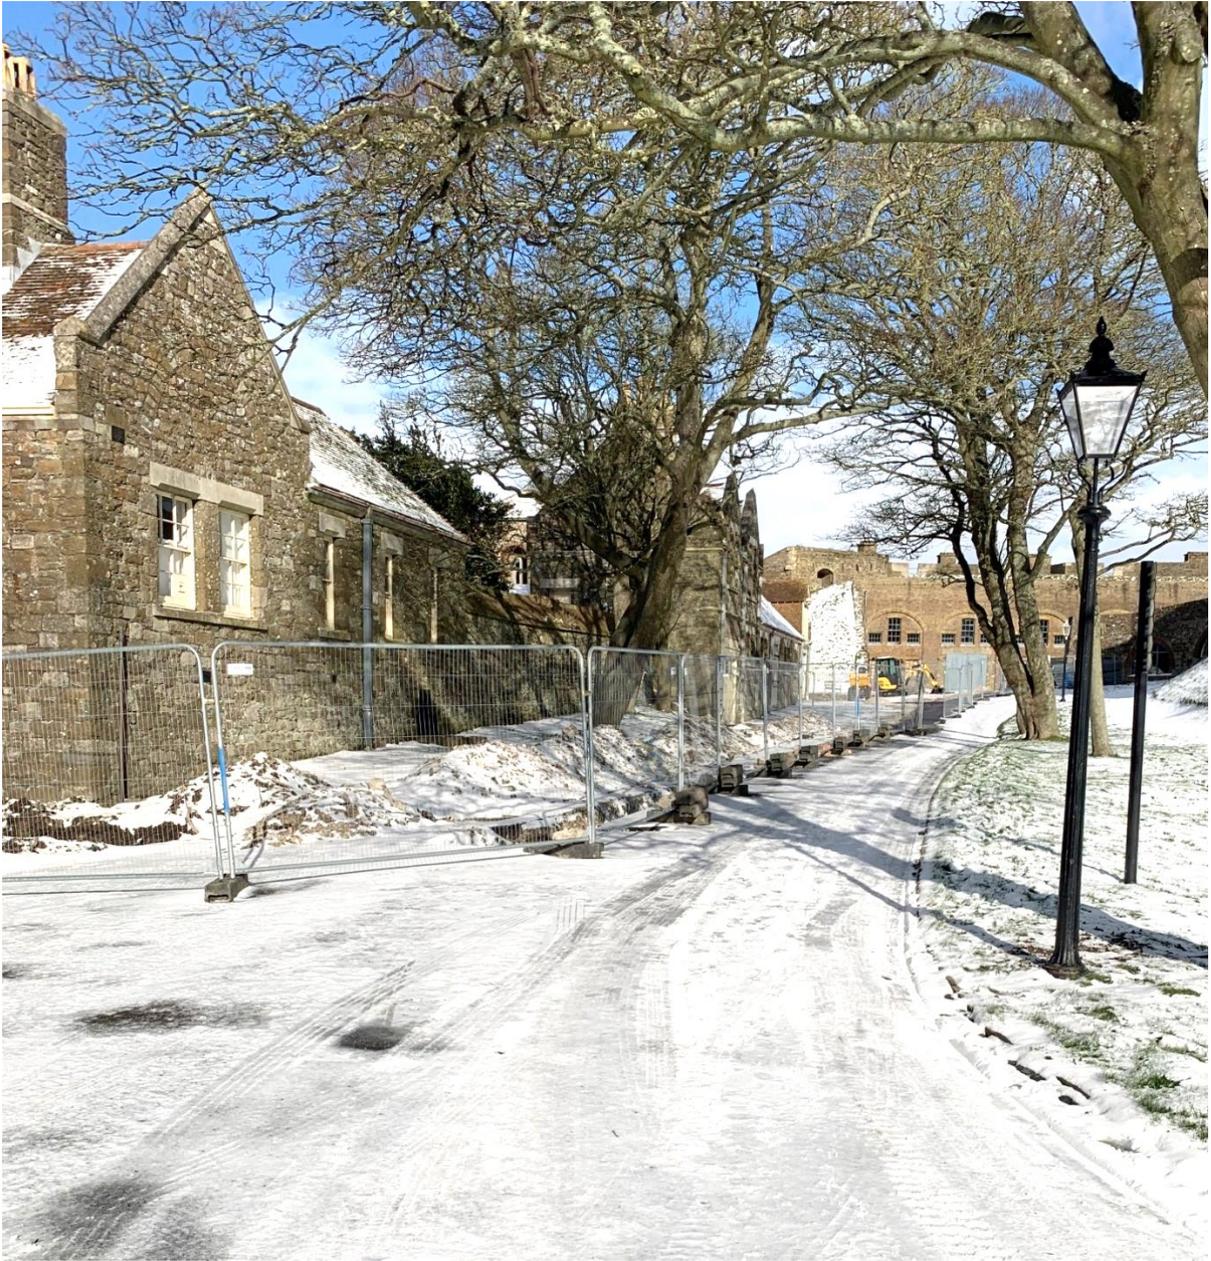
**Frontispiece** General view of trenching along West Norman Road, February 2021, looking north

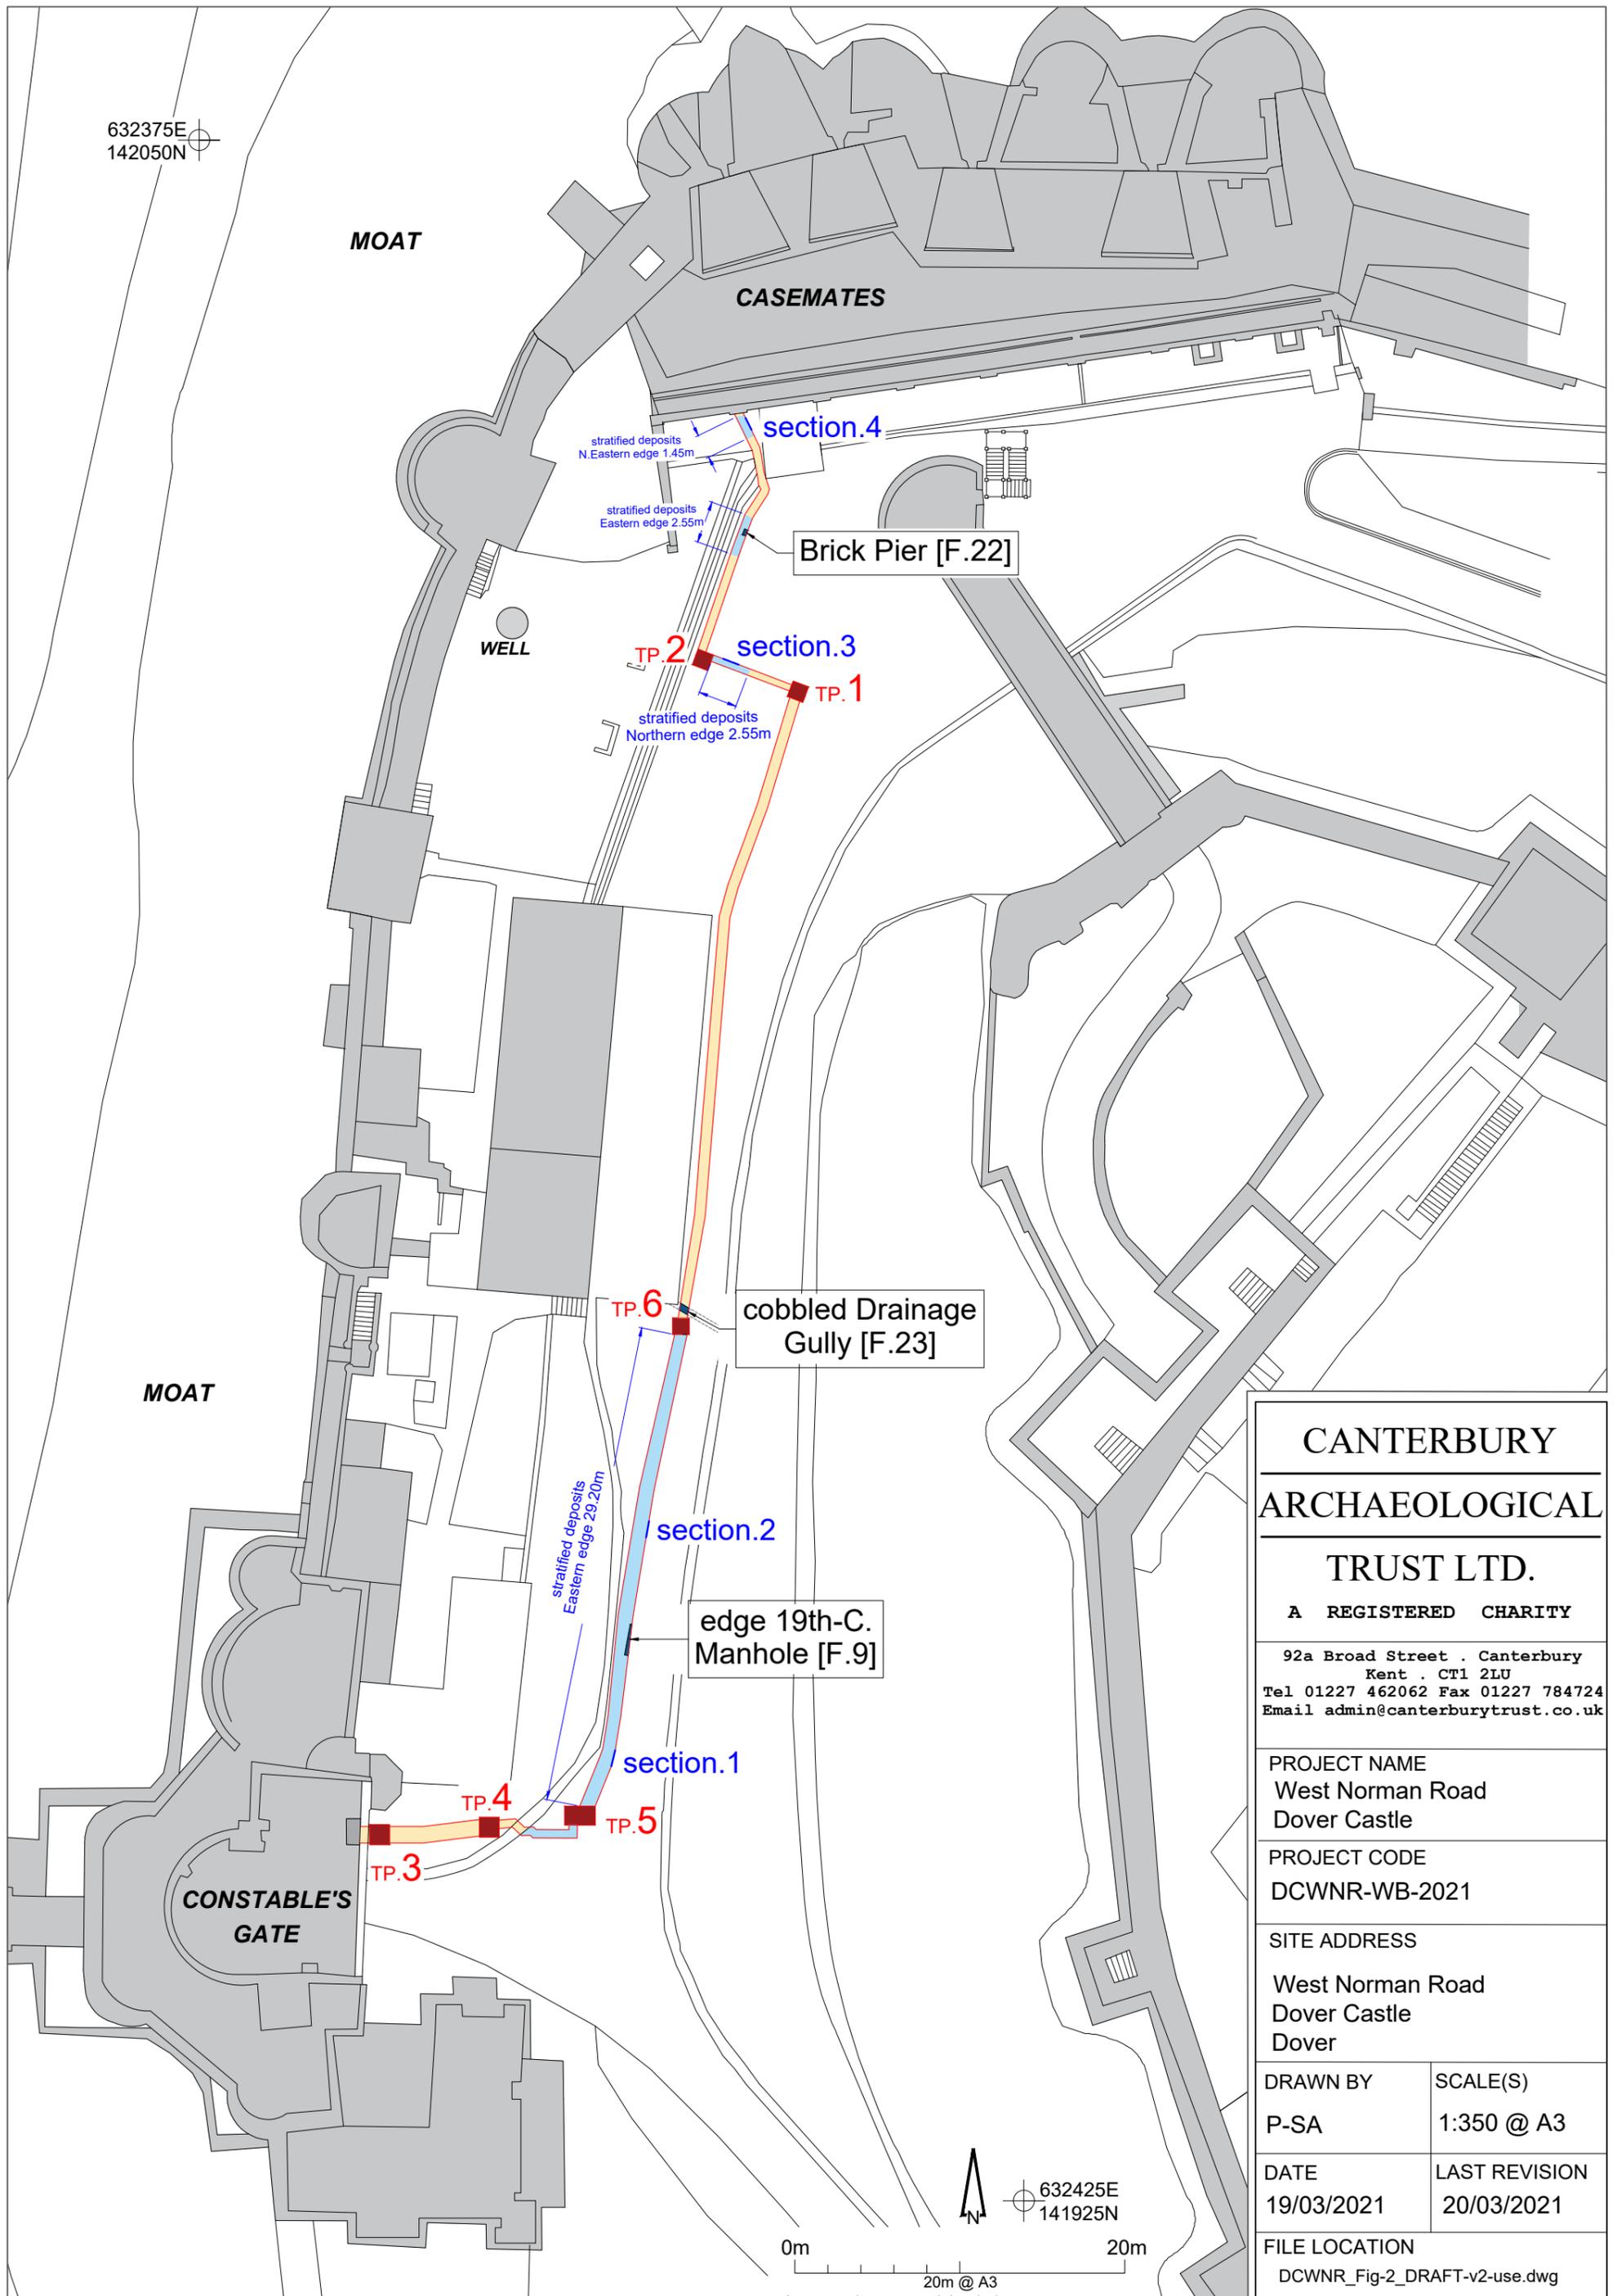
Fig. 2 Location plan showing position of excavated trench and position of observed features and deposits

**2.3** The new cable trench was designed to follow the line of its immediate predecessor so that disturbance of any earlier features or deposits of archaeological significance would be largely avoided. On the ground, this was mostly the case, but several minor features and areas of stratified deposit were exposed where the new trench was over-cut or strayed slightly from the earlier route (Fig. 2). Details of the recorded information are set out below.

**5.1** A series of six small test pits (TPs 1–6) were initially cut along the line of the existing power cable (Fig. 2). These were monitored by the writer and served as control points, allowing something of the below-ground deposits to be examined and recorded (see below). The pits showed that the original

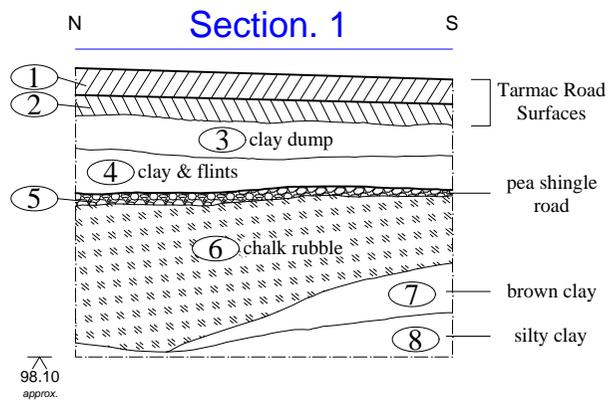
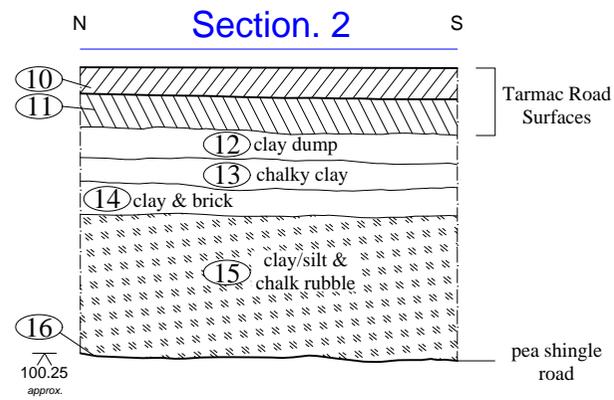
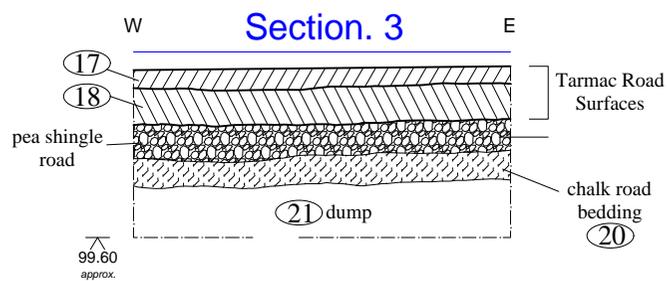
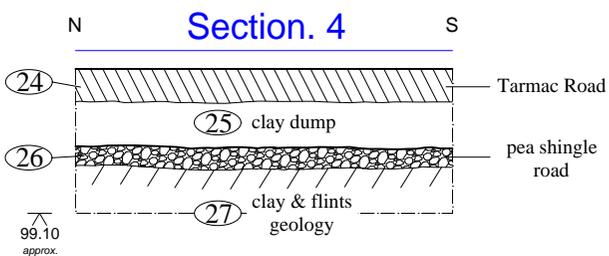
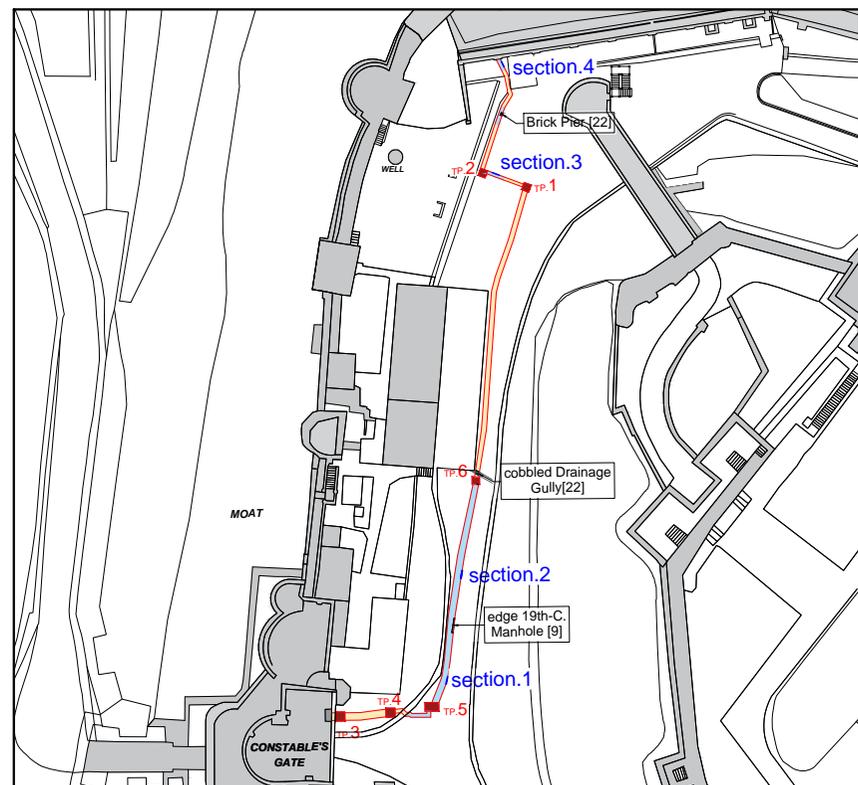
Fig. 3

Fig.3 Sections through recorded deposits with inset location plan

chalk rubble overlain by road surfaces and their associated make up layers. Details were recorded in two representative block sections (Fig. 3, Sections 1 & 2, Figs 9 & 10) set about 16 metres apart along the trench (Fig. 2). No good dating evidence was recovered but brick and very occasional Welsh slate fragments present in a number of these deposits indicate a broadly eighteenth- or nineteenth-century date for them. There was no suggestion of any stratified medieval deposits here.

6.4.4 In the area of Section 1 was a succession of dump deposits (Fig. 3, S. 1, Contexts 6, 7 & 8), the highest one of which (Context 6), a 0.40m thick layer of chalk rubble, supported an early road surface (Context 5). The early road was subsequently sealed by make-up layers (Contexts 3 & 4) that supported two subsequent asphalt road surfaces (Contexts 1 & 2), the highest one of which (1) forms the present metalling of West Norman Road.

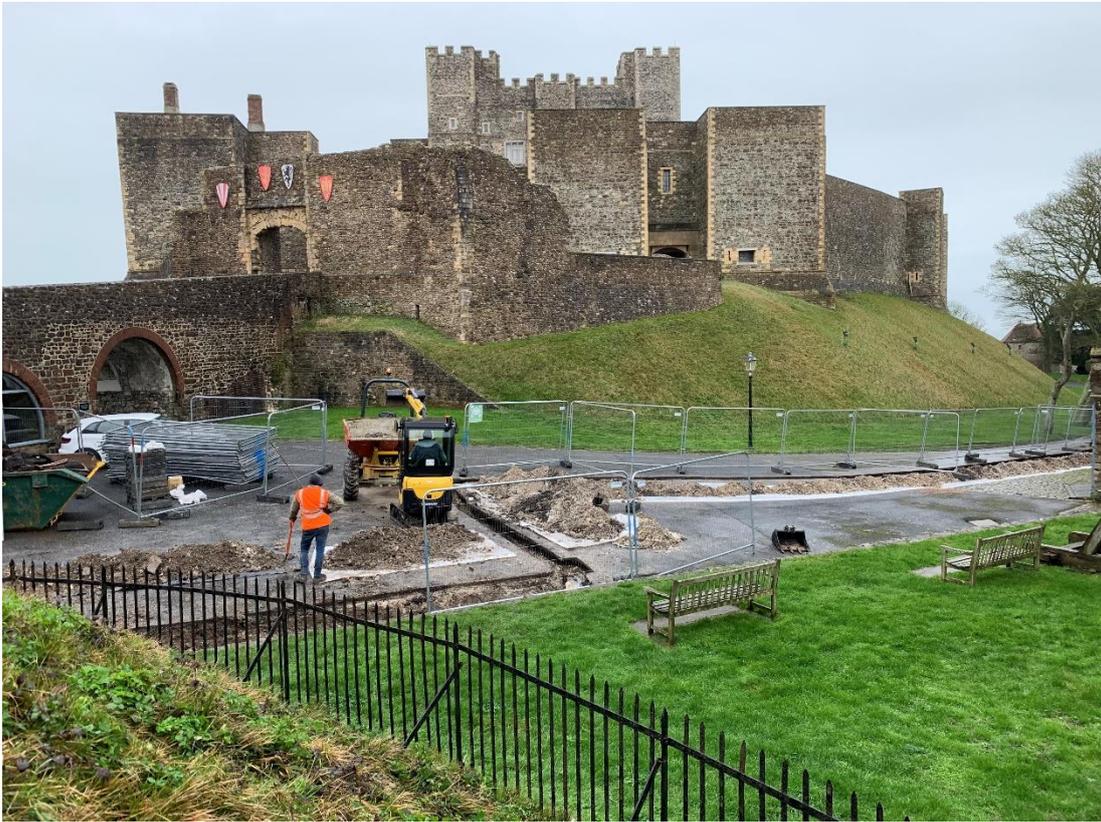
**Fig. 4** Trenching work in the area of Test Pits 1 and 2, looking south-east

6.1 The main trenching for the new cable was undertaken in two phases, with the excavation of the section between TPs 3 and 6 being cut in January 2021 and the remaining section in February 2021. The excavation work progressed from south (Constable's Gate) to north (Spur Casemates), with the trenching in January being undertaken using a three-tonne machine with a 360 degree slew (Fig. 8). The work in February was undertaken employing a smaller, one-tonne machine with a 360 degree slew (Fig. 4).

6.6.1 This section of trench was about 8m in length and was cut across the northern end of West Norman Road, aligned roughly east–west (Figs 2 & 4). It was between 0.35 and 0.40m in width and about 0.45m deep. Most of the trench was cut through the backfilling of the earlier cable trench but an area of stratified deposits was exposed in the north side of the new trench extending for a distance of about 3.00m east from TP 2 (Fig. 3, Section 3, Contexts 19–21). This included a probable early road surface (Context 19).

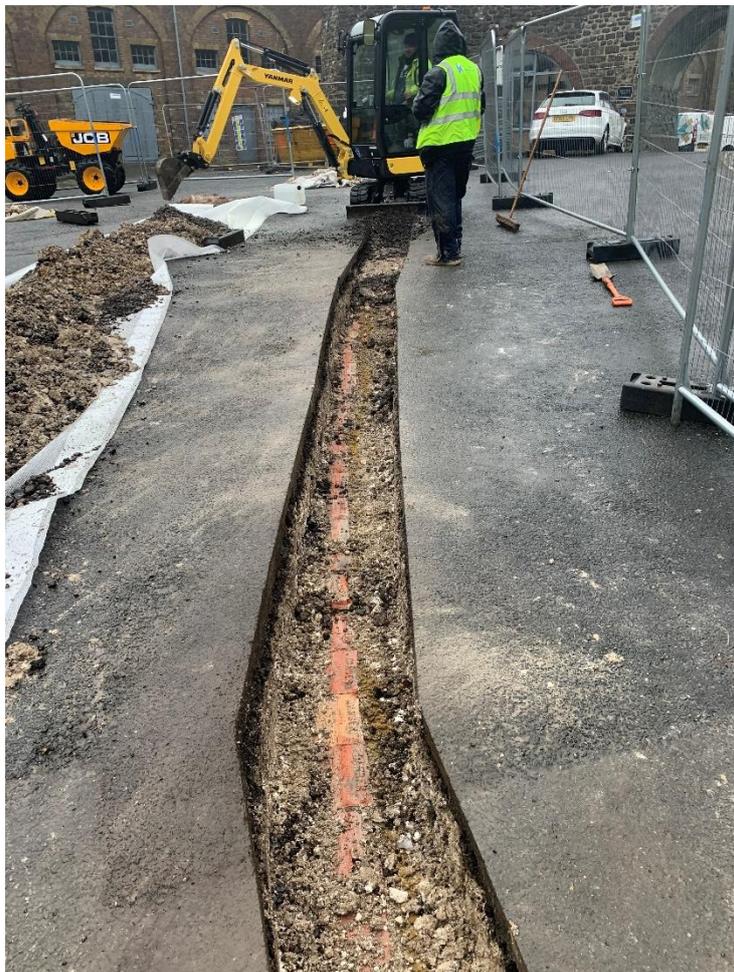
**Fig. 5** Trenching between Test Pits 6 and 1, showing earlier cable line marked by cover tiles, looking north

cable lay buried at a depth of between 0.35 and 0.75m, generally surrounded by clean sand and covered by a continuous line of ceramic marker tiles (Fig. 5).

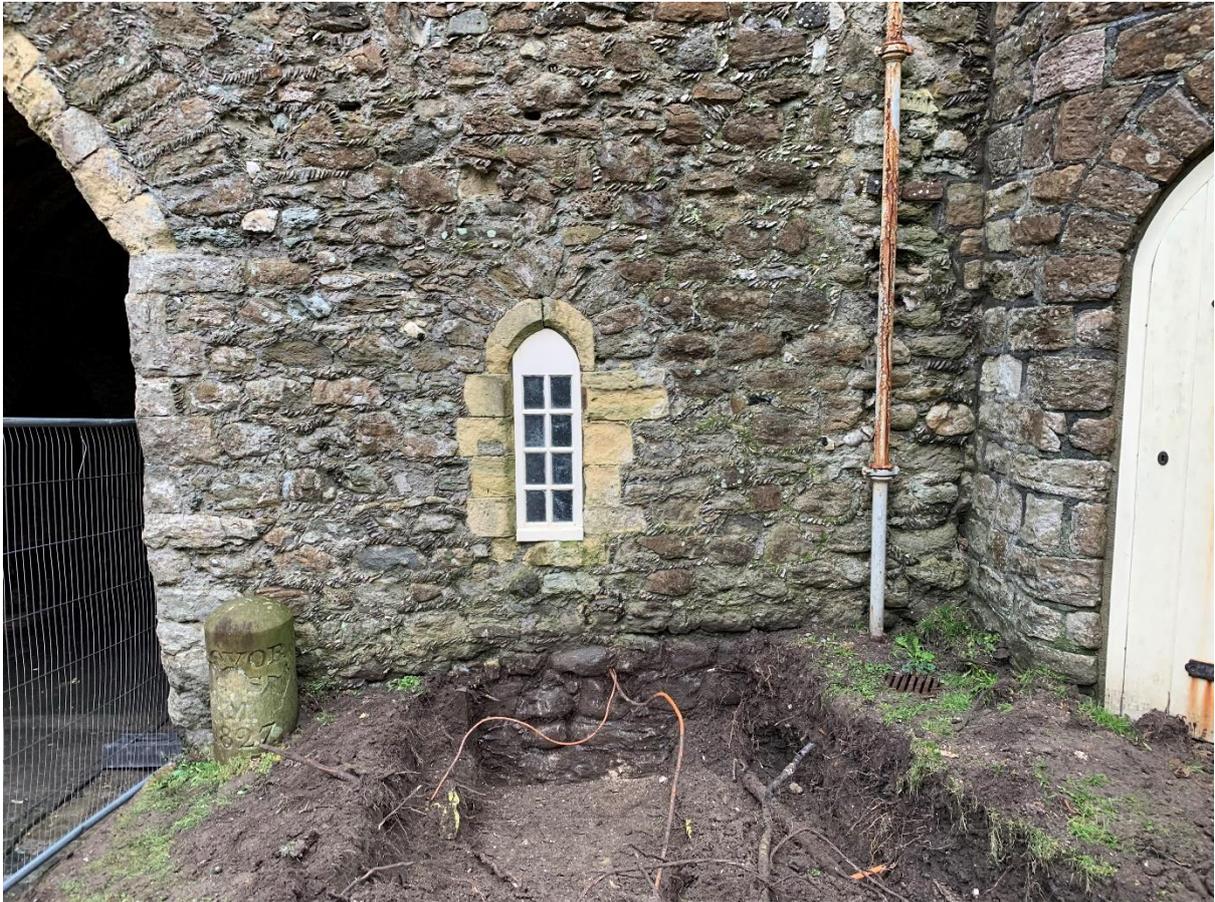
**Fig. 6** General view of trenching on eastern side of Constable's Gate-tower, looking west

The original hand dug TP 3 was subsequently enlarged by machine to form a pit about 1.50m square. This revealed further lengths of old service pipes and cables within the same mixed loam soils as seen previously. More of the east face of the Constable's gate-tower was revealed: about 0.60m of the buried gate-house walling was exposed (Figs 6 & 7).

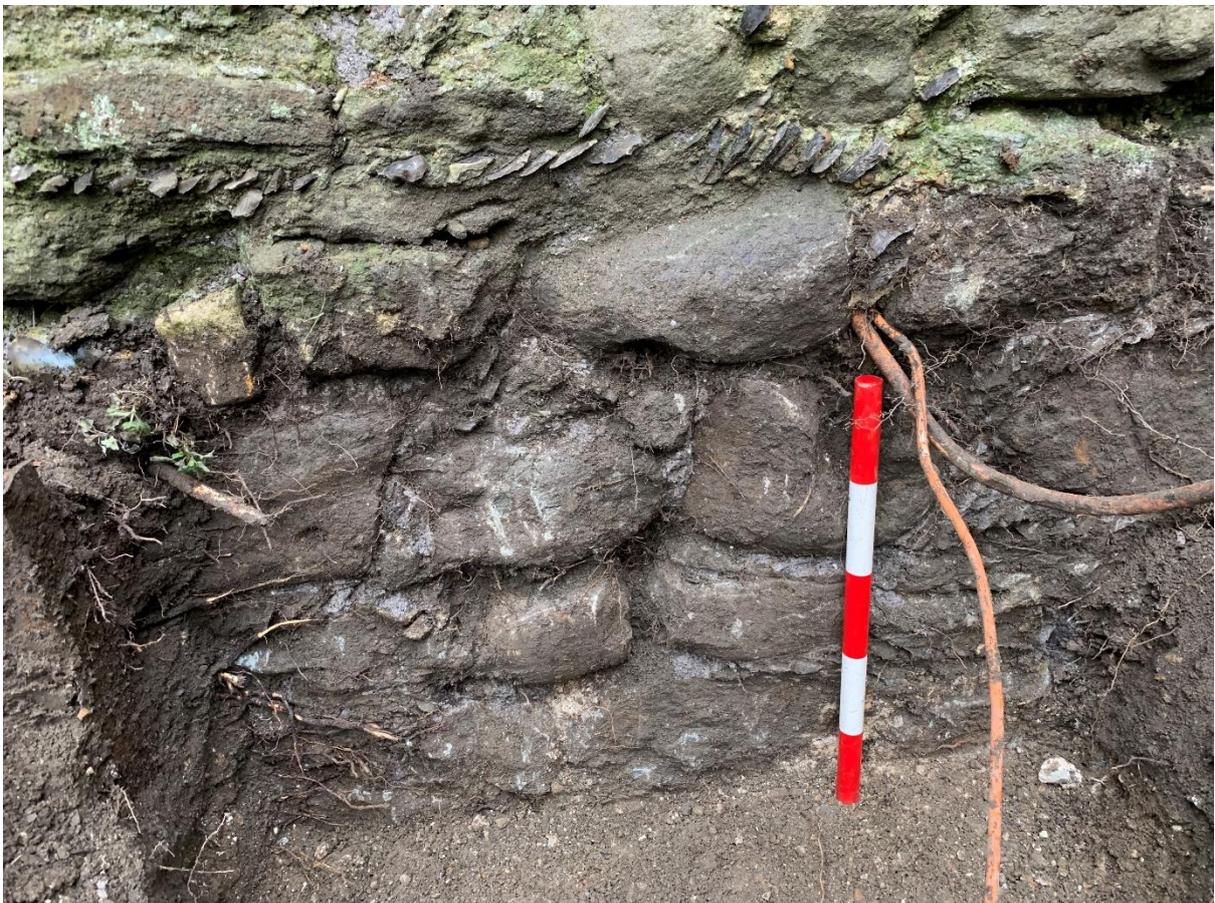
**Fig. 7** Detail of construction of east wall of Constable's Gate-tower below ground. Scale, 50cm

6.2.7 Cleaning of the masonry exposed showed 4 to 5 courses of water-rounded greensand boulders from Folkestone. There was clear evidence for quite extensive repointing of these in a mid-grey mortar containing frequent coal specks and occasional chalk/lime grits, with some flint galletting, as seen higher up in the wall (Fig. 7). From this, it would appear that the presently below-ground walling had undergone a programme of repointing during the nineteenth century, when it may have stood above contemporary ground level. Quite possibly, this repointing work was undertaken when the medieval gate-house was extended to form the Deputy Constable's residence during the 1880s (Coad 2001, 37).

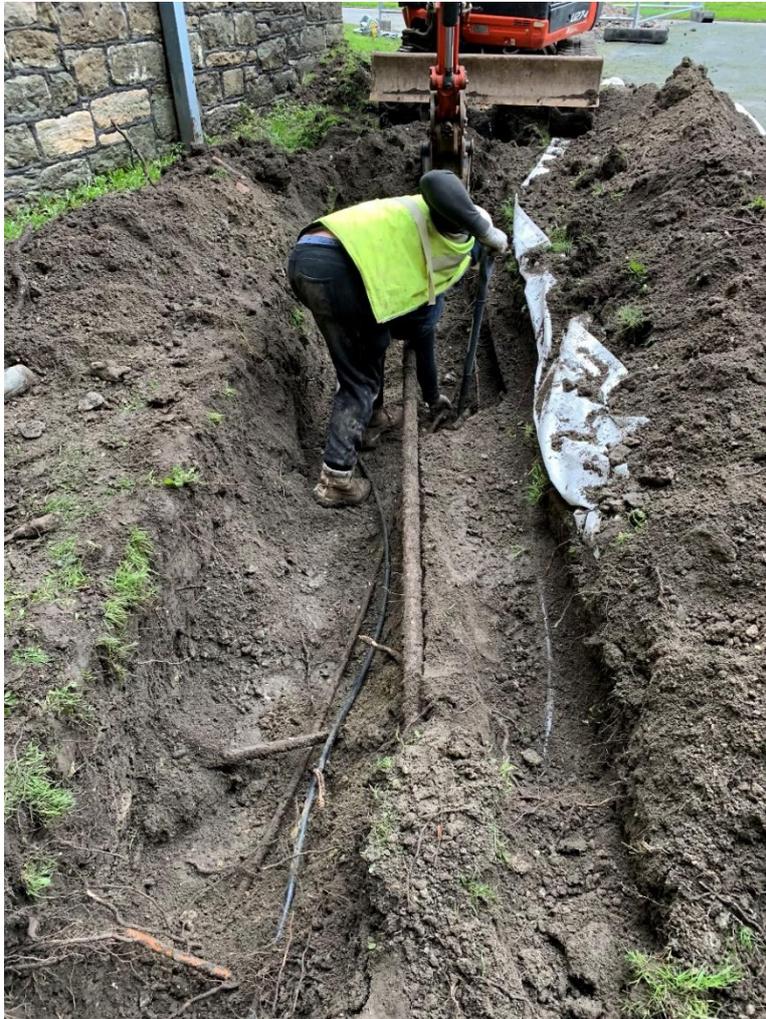
**Fig. 8** Trenching across the grassed area east of Constable's Gate-tower showing numerous services present

6.2.4 The dark soils exposed in the excavated trench largely represented the mixed backfilling of a succession of earlier service trenches (Fig. 8). No artefacts of any significance were discovered: material noted included very occasional small pieces of Victorian pottery and glass together with a quantity of broken glazed ceramic drainpipe (none retained).

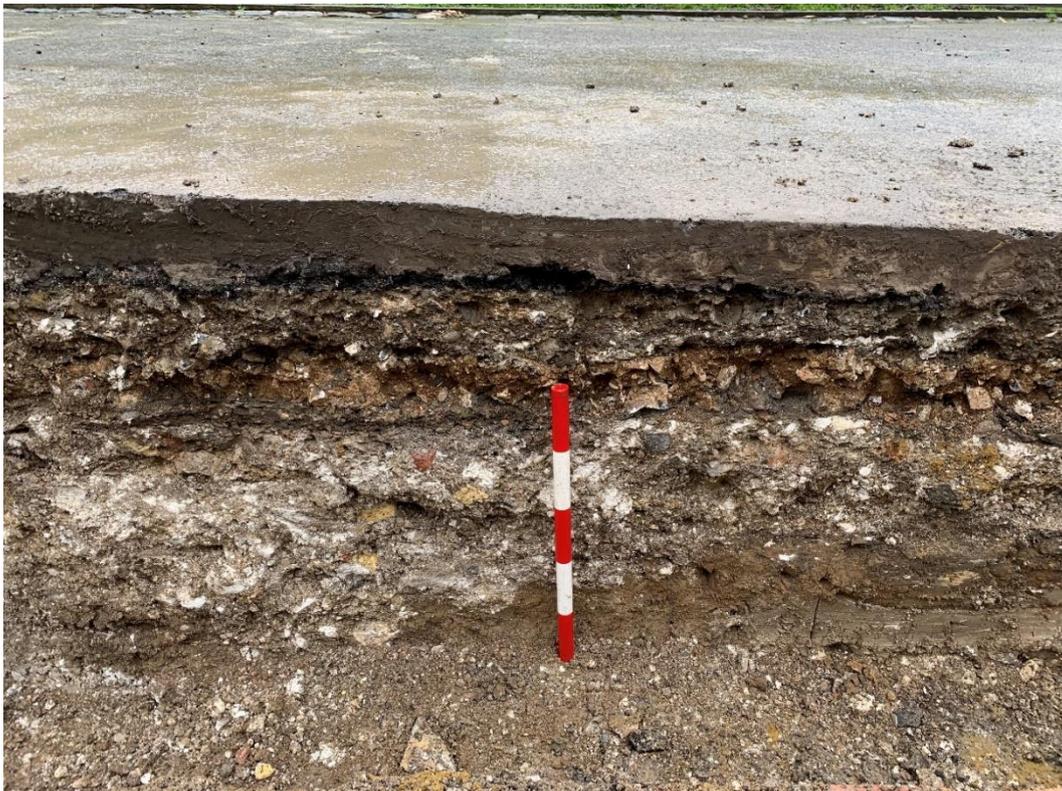
**Fig. 9** Section 1 showing early road surfaces and other stratified deposits in east face of trench. Scale, 50cm

For a distance of around 20 metres, the eastern face of the new trench revealed a thin, near continuous layer of compacted soil and pea shingle, clearly representing an early road surface (Contexts 5 & 16). This surface appeared to be laid to a more shallow gradient than the modern road above, so that in the area of TP5, at the south end of the trench, it was at -0.29m below present ground level, whilst at the site of Section 2, some 11 metres to the south of TP6, it was at -0.77m. At a point about 8 metres south of TP 6 it dipped below the base of the excavated trench.

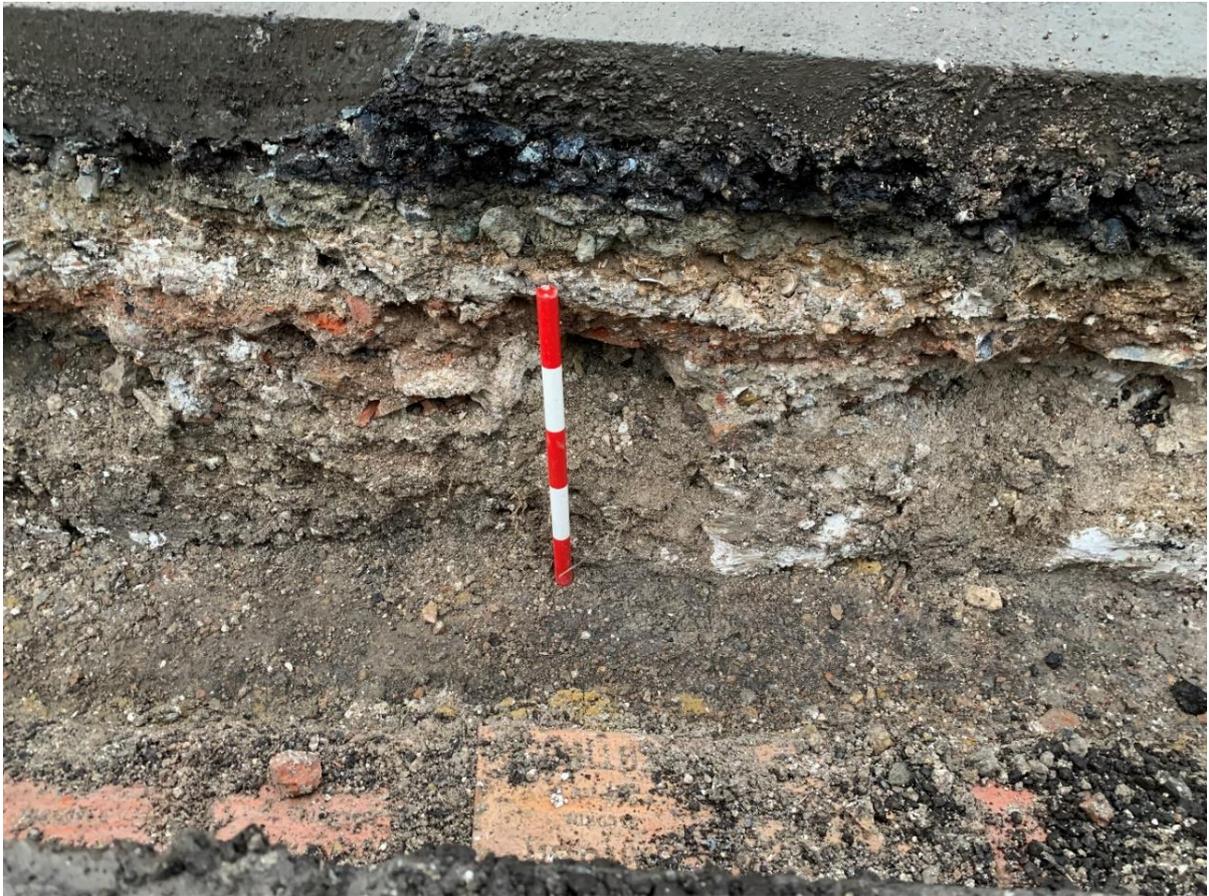
**Fig. 10** Section 2 showing early road surfaces and other stratified deposits in east face of trench. Scale, 50 cm

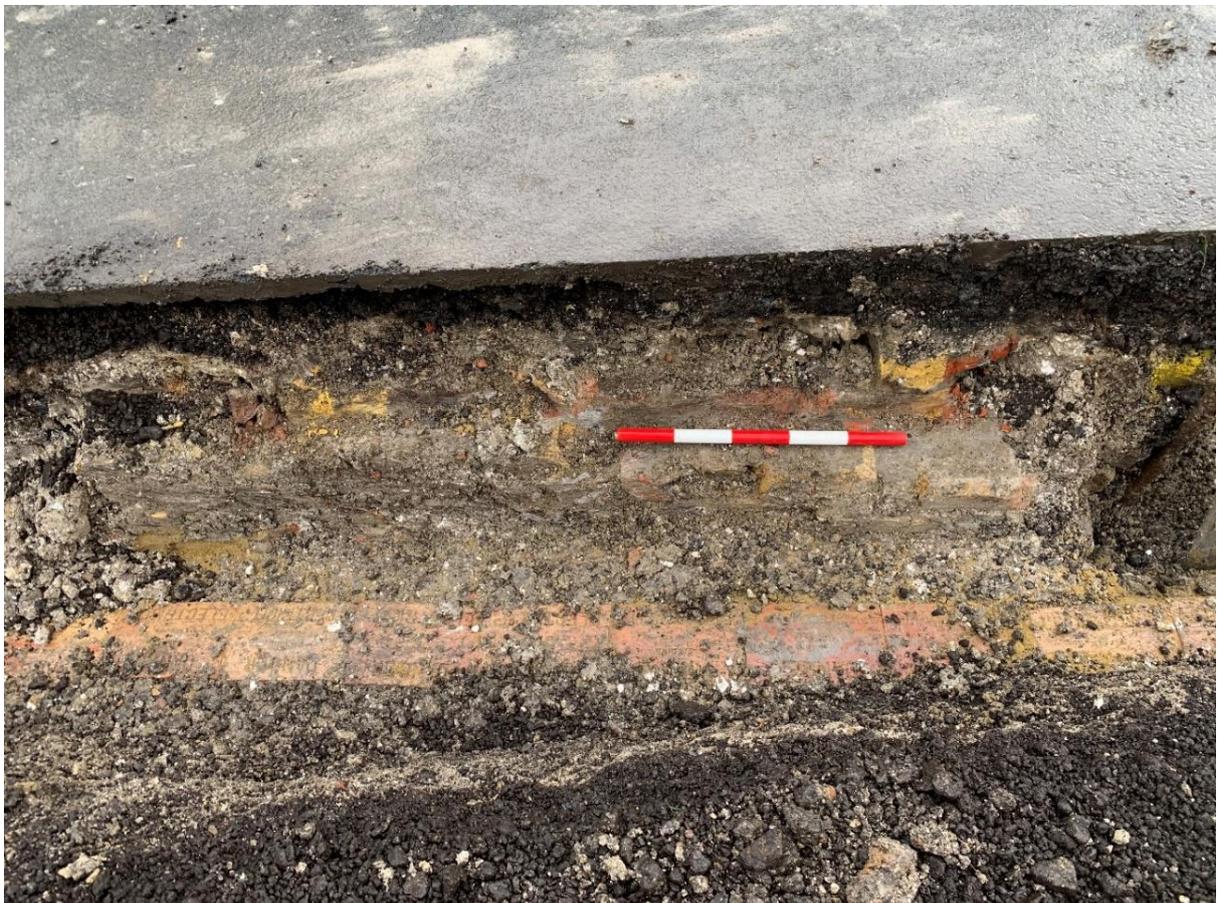
**Fig. 11** Detail of nineteenth century brick manhole, Context F. 9, exposed in east face of trench. Scale, 50cm

At one point about 10 metres north of TP5, the eastern edge of the trench grazed the side of a brick manhole (Context 9). This projected into the trench for a distance of between 0.10 and 0.22m. It was 1.90m across and at least 0.40m high (5 courses). The structure was cut in from above the level of the early metalling (Context 5) and its top lay at about 0.23m below present ground level.

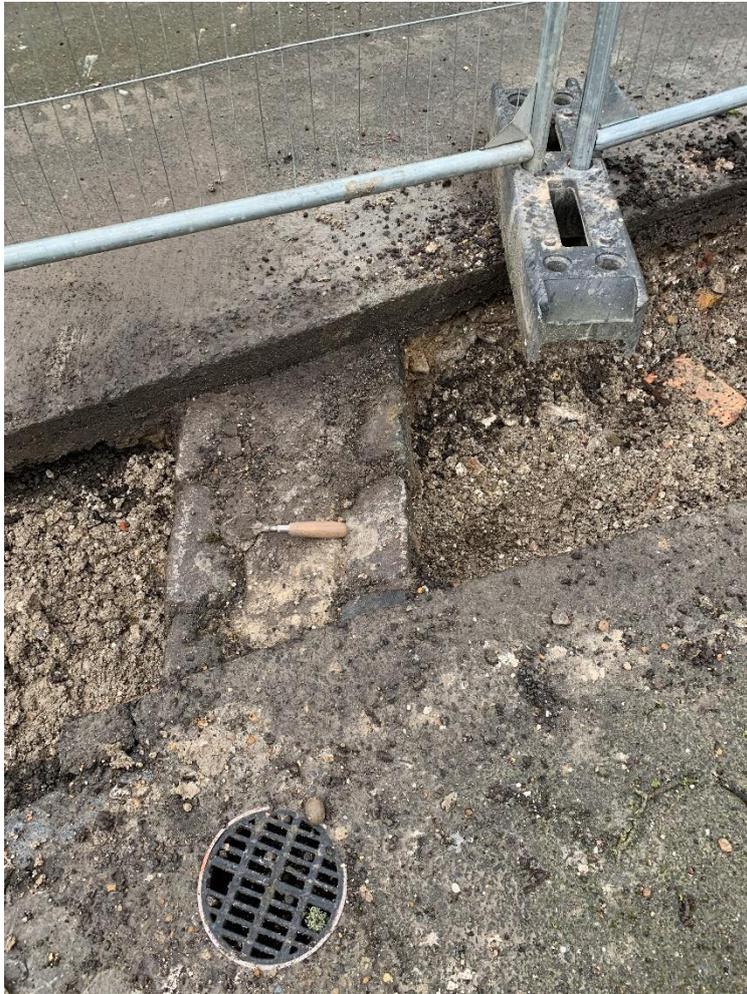
**Fig. 12** Cobbled drainage gully, Context F. 23, exposed to the east of stable block, looking east

Immediately north of TP 6, in front of the stable block (south end) the trench revealed a shallow drainage gully lined with granite setts (Context 23) running diagonally across the road. This gully was sealed by the upper modern asphalt surface of West Norman Road but appeared to be contemporary with the lower asphalt surface. The gully was preserved undamaged and the new cable was tunnelled under it.

As seen in the new trench, the gully was 0.40m wide and 0.02m deep, with the individual setts employed about 0.20m in thickness (Fig. 12). Traces of the same structure were noted beyond the new trench, on the eastern side of West Norman Road. Fairly certainly, this gully was concerned with surface drainage away from the yard area in front of the stables. The stables, themselves, represent the last remaining military stables surviving in the castle (Coad 2001, 38).

The gully may be identified on a large-scale services plan of the castle maintained between 1922 and 1955, where it is shown discharging into a catch pit (C.P.) located on the eastern verge of the road. The capping of this pit is still visible.

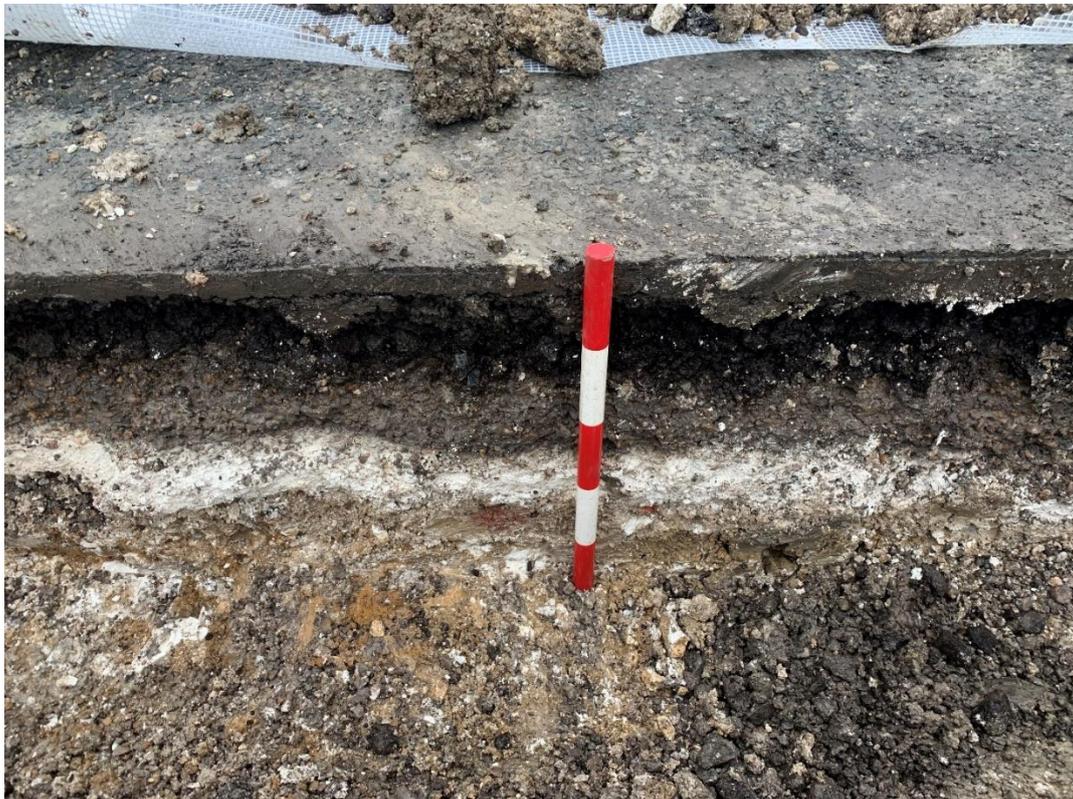
**Fig. 13** Section 3 showing early road surfaces and other stratified deposits in north face of trench. Scale, 50cm

A 0.08m thick layer of fairly compact light grey-brown gritty loam containing very frequent small brown flint pebbles (= pea shingle) was revealed in the northern face of the trench, east of TP 2 (Fig. 3, S. 3, Context 19). Buried at a depth of about 0.15m, directly below the modern asphalt surfaces (Contexts 17 & 18), this layer fairly certainly represents an earlier road surfacing which might be the same as that represented by Contexts 5 and 16 further to the south (see above).

Context 19 rested on a thin bed of rammed chalk rubble (S. 3, Context 20, Fig. 13). No dateable finds came from either of these two deposits but it was noted that a chalk and clay dump layer below the rammed chalk rubble (20) contained odd fragments of maroon brick of eighteenth- or nineteenth-century date (S. 3, Context 21).

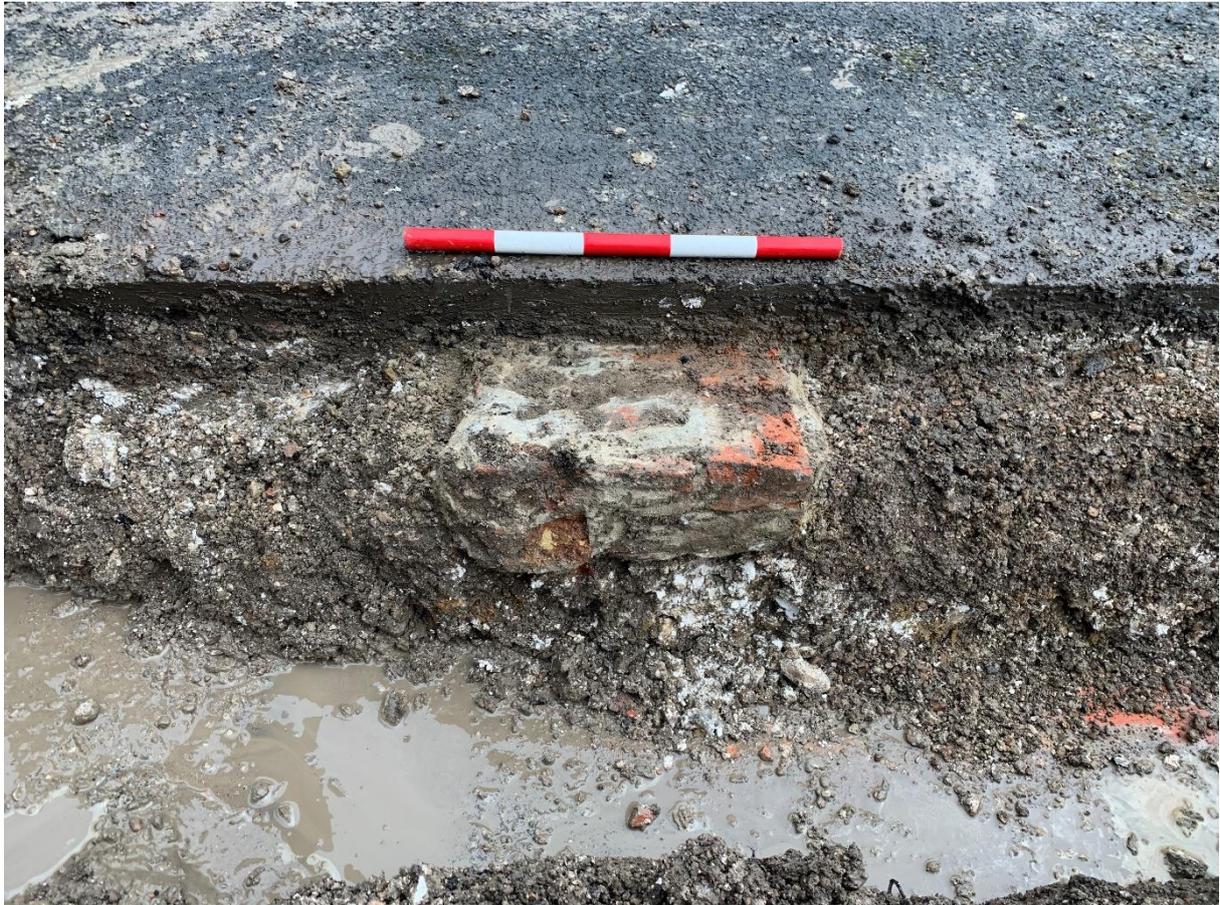
**Fig. 14** Small brick pier, Context F. 22, located south of Spur Casemates, looking east. Scale, 50cm

In the central sector of this portion of the trench, 6.45m out from the south wall of the casemate, a small brick base or pier was partially revealed in the eastern side of the excavation (Figs 2 & 14). This was buried below the modern tarmac at a depth of 0.10m and measured 0.38m (N–S) by at least 0.22m (E–W). It stood to a height of 0.18m and was constructed of red bricks set in a yellow-grey sandy mortar containing moderate amounts of chalk/lime grit (Fig. 14). The previous cable trench seemed have been cut down its western face and not removed any of it. The structure appeared to be solid and rested on an underlying dump deposit of grey clay loam and chalk rubble that occurred along this part of the trench. The purpose of this base remains unclear. It was set at a slight angle to the casemate wall. The general construction suggests a late nineteenth- or early twentieth-century date. The present cable trench was again cut down its western face without damage.

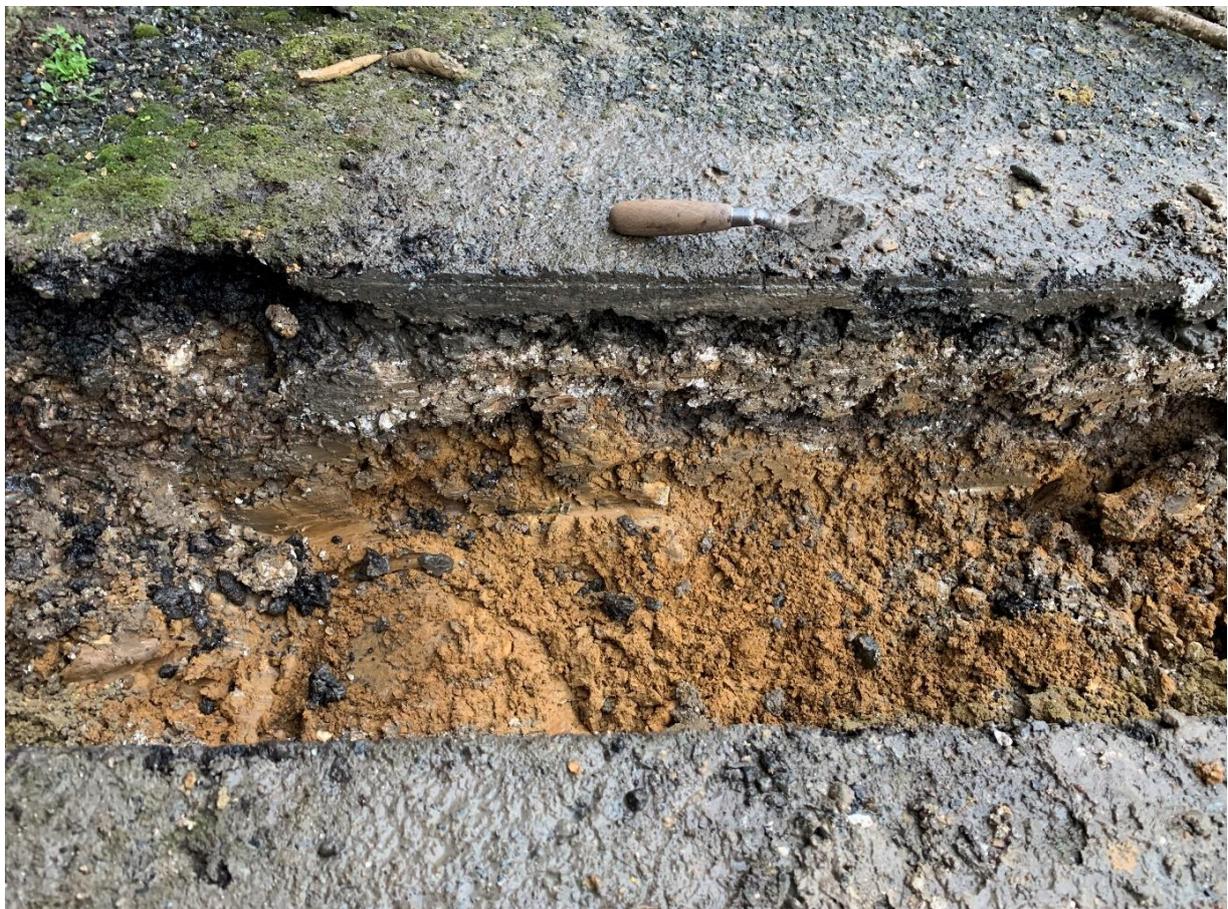
**Fig. 15** Probably natural Clay with flints deposit (Section 4, Context 27) exposed south of Spur Casemates

Immediately south of the casemate wall, a small area of stiff orange clay was revealed at a depth of about 0.26m (S. 4, Context 27). Containing a quantity of natural flint nodules this had every appearance of being a natural undisturbed Clay-with-flints deposit (Fig. 15). Such drift material does occur on Castle Hill and there can be no doubt that Context 27 is derived from this deposit. What is less certain, however, is whether this was a genuine, untouched geological deposit or material that had been redeposited during the extensive post-medieval earthmoving that has clearly taken place in

this area. On balance, the writer's view is that this probably was undisturbed natural clay, but too little was seen for this to be certain.
