**Gilton Mill,  
Poulton Lane,  
Ash-next-Sandwich,  
Kent**

**Archaeological watching brief**

Project Code: GMA-WB-21  
 Planning Ref: DOV/13/00961  
 Client: Carla and Michael Lorne  
 NGR: 628157 158182 centred

Report No: 2021/69  
 Archive No: 4625

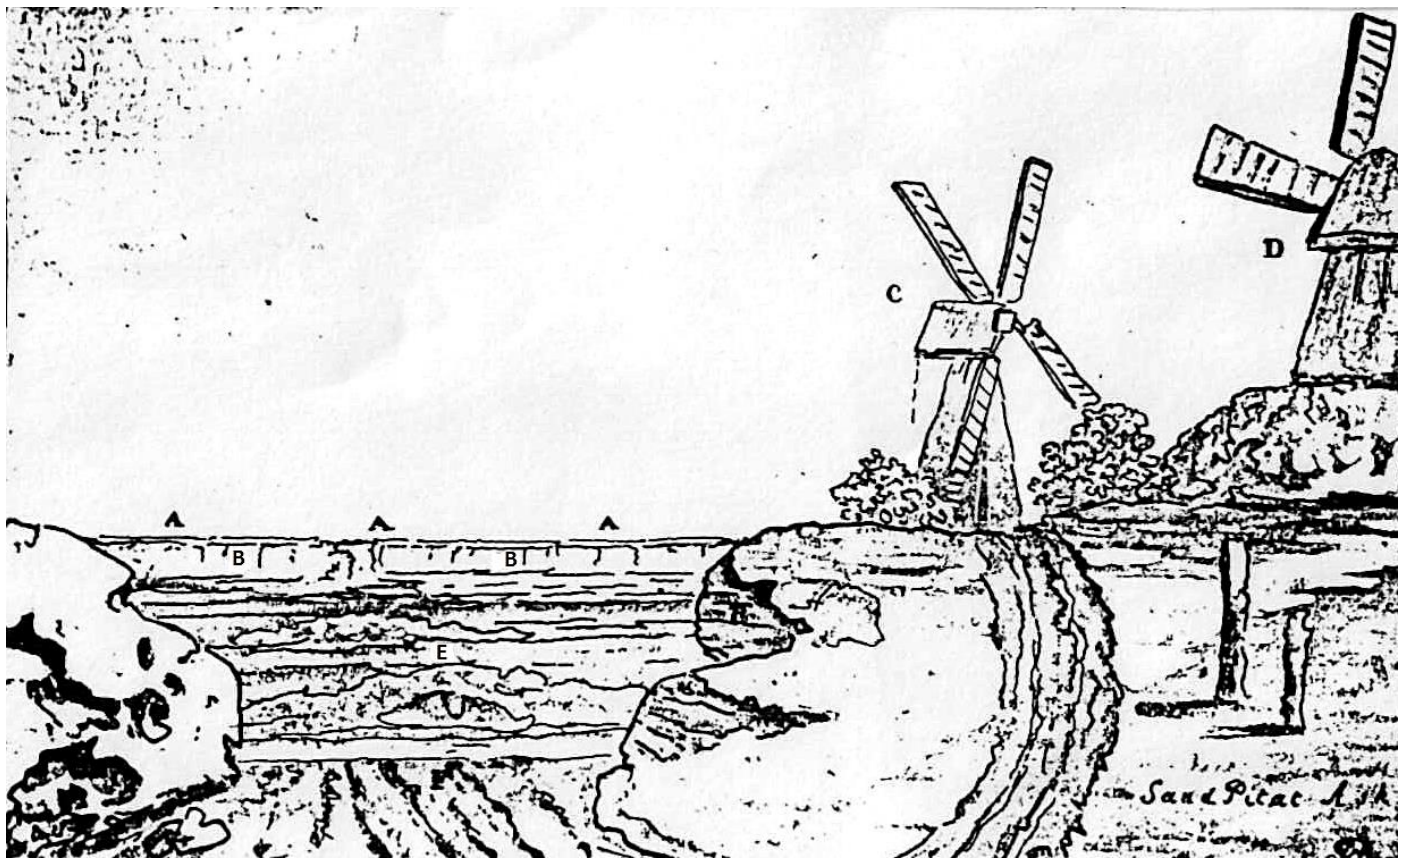
Fig. 3 View of the sandpit in 1797 by James Douglas (1793, 25). A, Level ground now a ploughed field; B, Depth at which interments are usually discovered; C, Lower mill; D, Upper Mill; E, Sand pit excavated

**2.2** The site, NGR 628157 158182 centred, is located within the parish of Ash, at the top of a south-east facing slope, overlooking the valley of the Durlock Stream. It stands at an elevation of about 23 metres above OD (Figs 1 & 2). The natural geology here consists of sands belonging to the Palaeocene Lambeth Group (British Geological Survey 2019). The sands in this area have been dug for building material since at least the eighteenth century (Figs 3 & 4).

**4.2** To the west of the mill, the new development site is situated in a region of considerable archaeological interest and potential, falling within the general area of a known Anglo-Saxon cemetery. The ground is accordingly Scheduled as an Ancient Monument (Gilton Anglo-Saxon cemetery, Monument No. 1005141). Much of the area of this cemetery would seem to have been previously quarried away for building-sand (Figs 3 & 4).

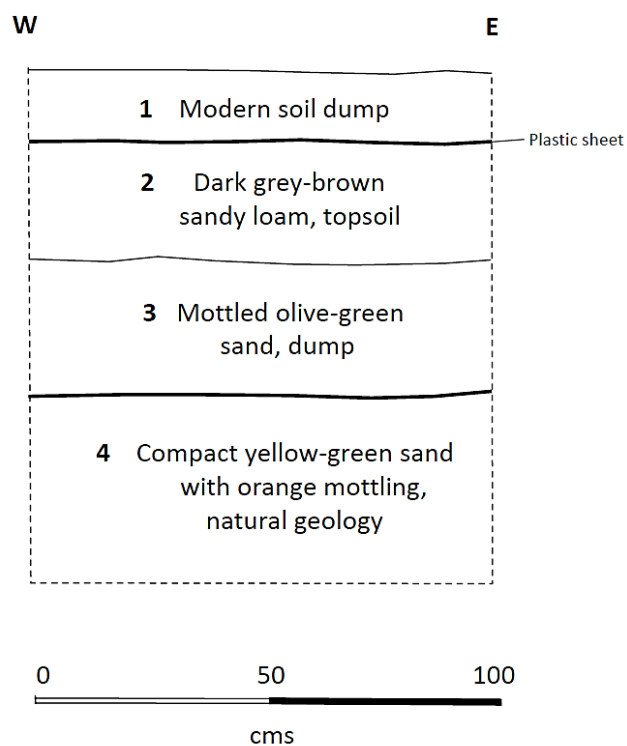
**Fig. 8** Block section of deposits exposed in Trench 1 (Section 1)

**6.3.2** The natural sand was overlain by a deposit of similar sandy material about 0.30m thick (Fig. 8, Context 3). At first sight, this appeared to represent an upper zone to the natural sand layer, but further inspection suggested that it was actually a recent dump of redeposited natural material. It was slightly less compact than the underlying Context 4 and it was also slightly darker in colour. Traces of this same layer were noted in parts of Trench 2 to the west (see below) but no datable finds were recovered at any point.

**6.3.3** The redeposited sand (3) was sealed by a recent topsoil deposit about 0.25m thick (Fig. 8, Context 2). This consisted of a uniform dark grey-brown sandy loam. No finds were recovered from this layer.

**6.3.4** Sealing the topsoil (3) was a layer of blue plastic sheeting sealed by a 0.15m thick layer of modern dumped soil (Fig. 8, Context 1).

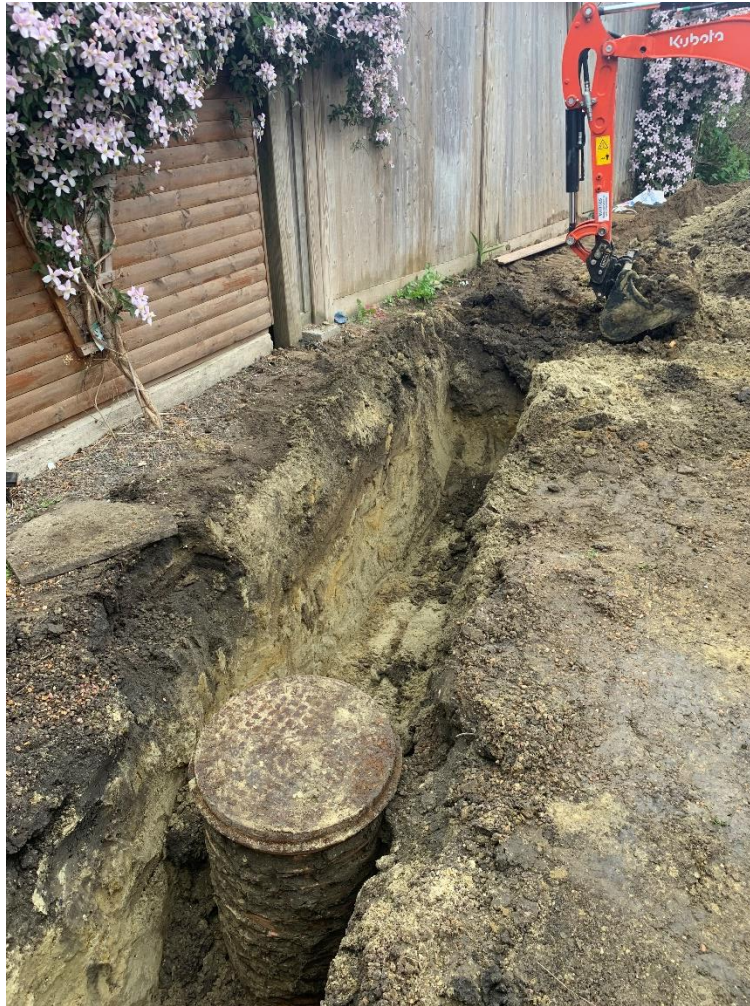
**Fig. 11** General view of Trenches 2 and 3 under excavation, looking north

**6.4.3** North of the inspection chamber an undisturbed sequence of deposits, very similar to that revealed in Trench 1, was observed (Fig. 11). The top of the natural sand here lay at about 0.60m below present ground level. No finds or features of archaeological interest were discovered.

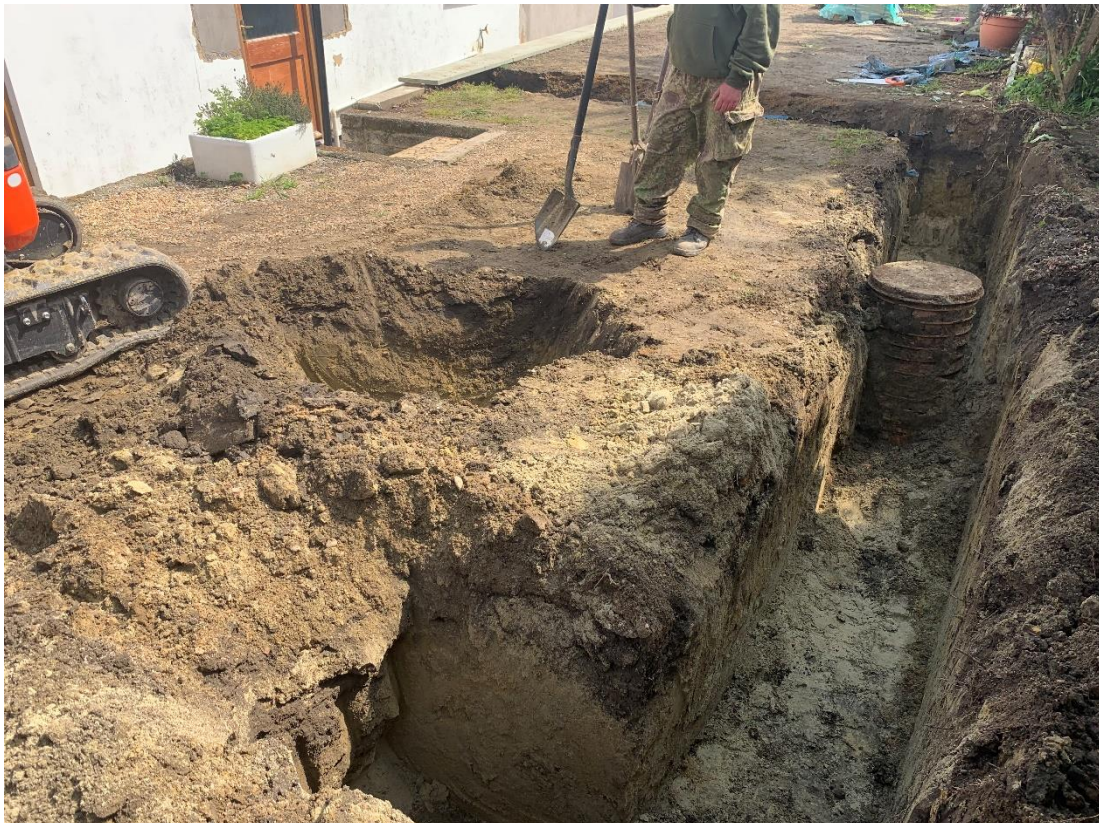
**Fig. 12** General view of completed trenches, looking south

6.5.2 The undisturbed sequence of deposits exposed in Trench 3 was the same as that revealed in the adjacent Trench 2. No finds or features of particular archaeological interest were noted but a quantity of broken post-medieval (?) pan-tile noted in the topsoil layer (Context 2), may have actually been contained within a poorly defined shallow pit.

6.6.2 The excavation of Trench 4 confirmed that there was an angle-change in the line of the drainpipe at the inspection chamber. It also established that in the area of Trench 4 the drainpipe was of glazed ceramic type, indicating that there are two phases of development to this drainage system. No undisturbed soil deposits were revealed in the trench and there were no archaeological finds.
