Crowded Places Bollard Installation Scheme, Canterbury, Kent

Archaeological Watching Brief

Project Code: WB CPSC 18; EV CPSC 19
NGR: 614881 157840 (centred)

Report No: 2022/88
Archive No: 4315
OASIS ID: canterbu3-596807

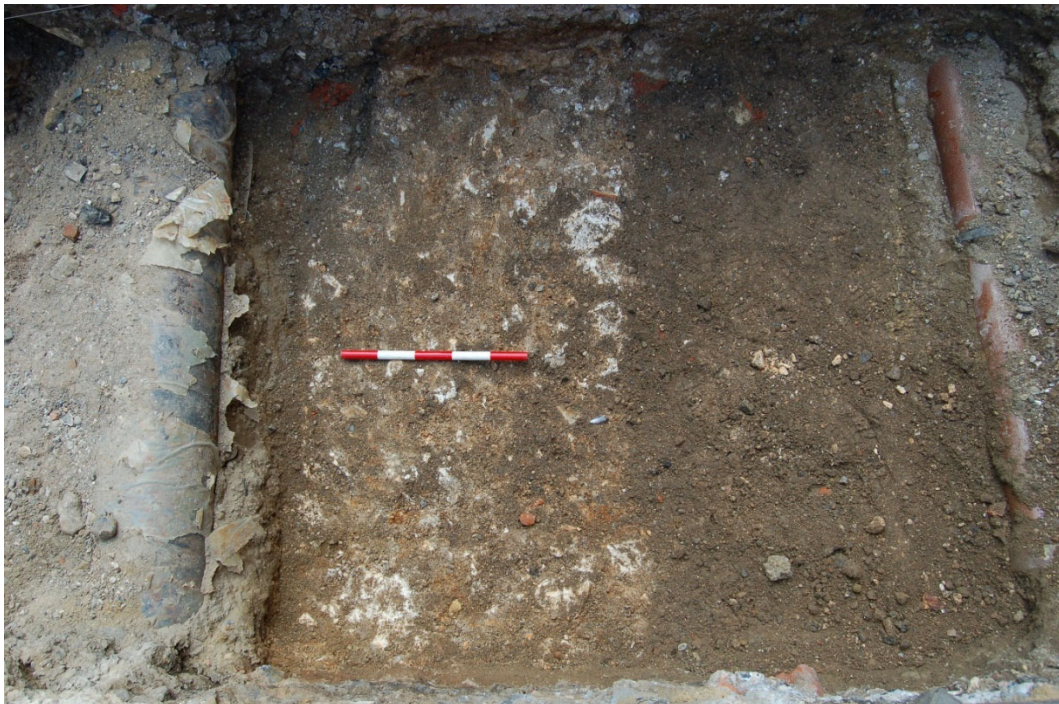
Photo 2. Site 1 St Peter's Street, detail of wall (119), looking north-west (scale 0.5m)

- 2.3.6 Both wall (119) and gravel surface (121) were partly overlain by a patchy deposit of grey silt (120). This was sealed by a loose chalk and mortar rubble layer (122), which might represent demolition of wall (119). The potential demolition material (122) was overlain by a sequence of compacted gravel layers (118, 117, 116 and 115) representing later metalled road surfaces.

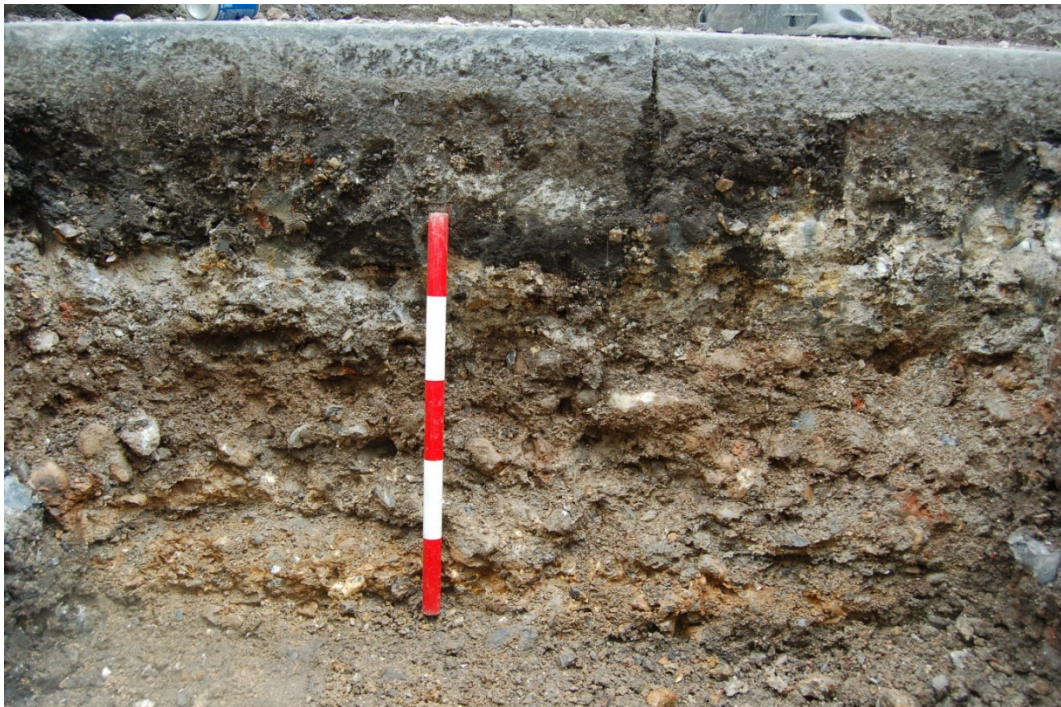
Photo 6. Site 3 St Peter's Lane, section detail showing successive road surfacing, looking south-east (scale 0.5m)

- 4.3.5 At the south-east trench end, this comprised a deposit of compact orange brown gravel (325) observed at a depth of 0.58m bgl. The gravel (325) deposit was sealed by a compact yellow mortar (324) which was overlain by a thin layer of grey silt (323) and a compact deposit of green grey sandy clay with gravel (322). The uppermost surface in this sequence was encountered at 0.4m bgl.

- 4.3.6 At the north-west trench end, a comparable sequence was observed. This comprised a deposit of loose green grey sandy silt with gravel (319) at a depth of 0.6m bgl, which was sealed by loose orange brown gravel (318=328). This was overlain by a thin deposit of grey silt (331), sealed by an orange brown gravel (317=327) layer. The uppermost surface in this sequence was encountered at 0.29m bgl. Pottery (BF68), dated from the thirteenth to fourteenth century, was recovered from the earliest deposit (319).

4.6.1 Deposits probably related to successive road surfaces were observed within the trench investigated on St Peter’s Lane, the earliest of which produced pottery dated to the thirteenth to fourteenth century.

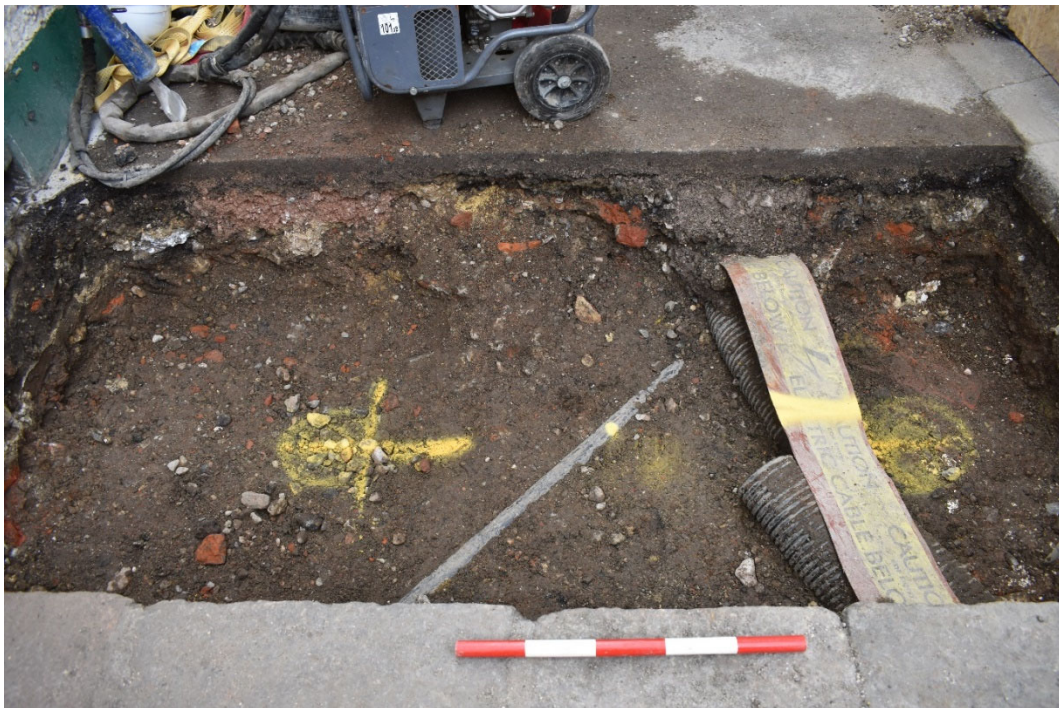
Photo 8. Site 4 St Peter's Grove, excavated trench, looking north-east (scale 0.5m)

- 5.3.4 The earliest deposit observed at Site 4 was a modern deposit comprising mixed soil and Type 1 aggregate bedding (402). This layer was encountered at a depth of 0.12 bgl. The deposit was cut by several utility trenches (401), which were sealed by the present tarmacadam surface (400).

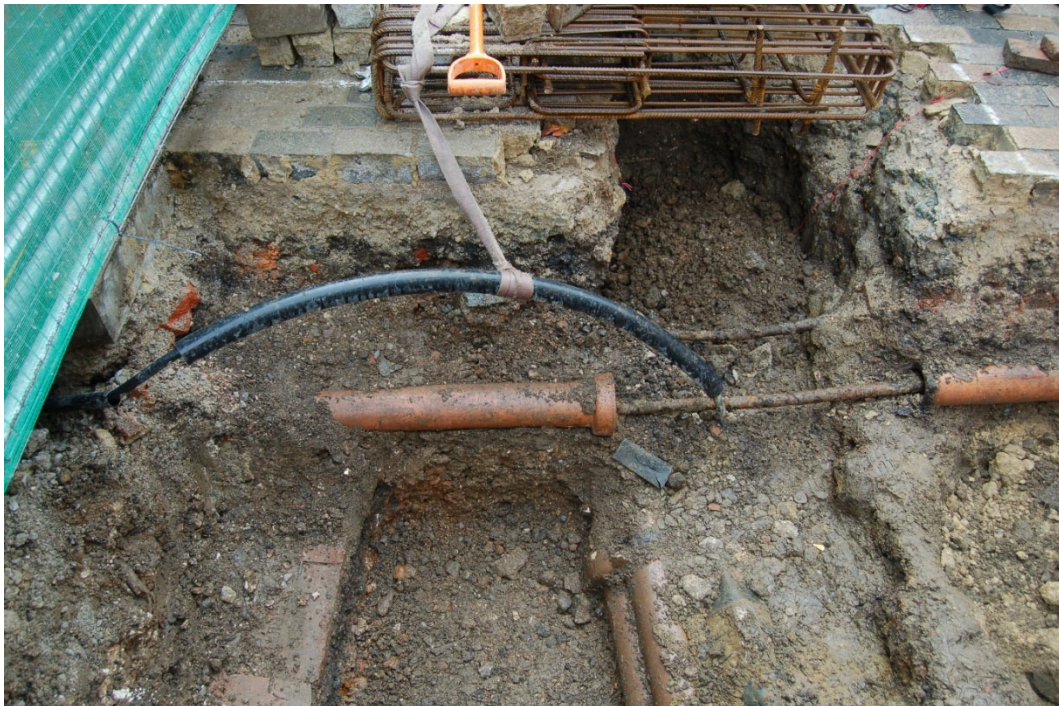
Photo 12. Site 6 Best Lane, excavated trench, looking north-west (no scale)

7.3.4 The earliest deposit observed at Site 6 was a compacted red brown gravel (610), which likely represented a former road surface, encountered at a depth of 0.88m bgl. This was sealed by a layer of dark brown clay with gravel (609) which, in turn, was sealed by dark grey brown clay silt with rubble (608).

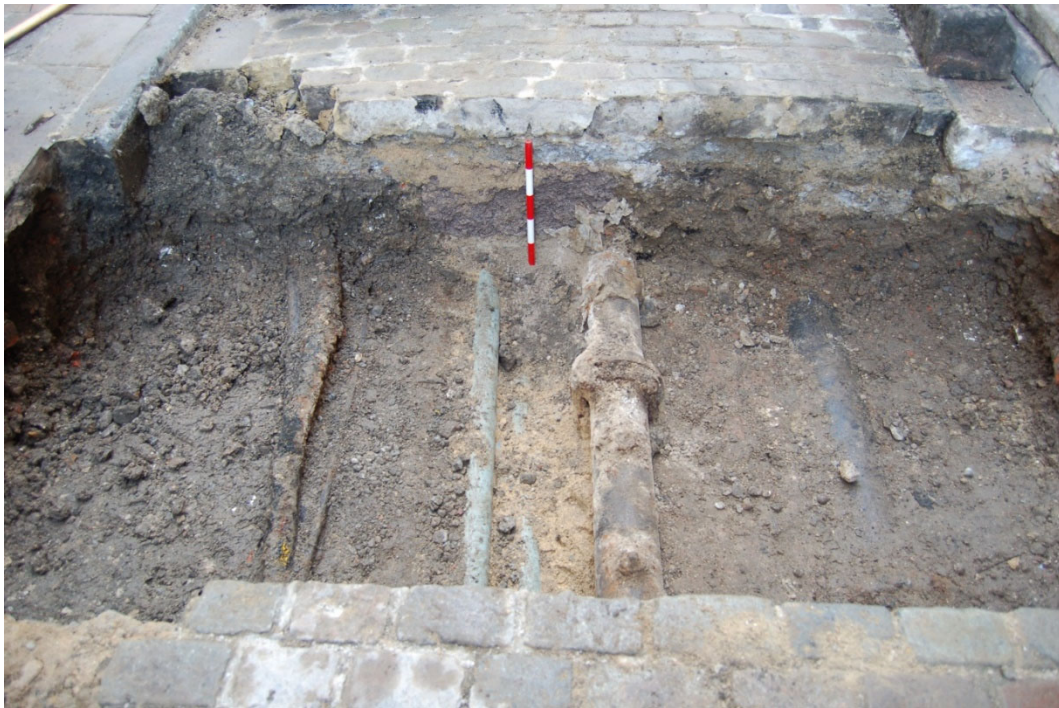
Photo 14. Site 7 Stour Street, excavated trench, looking north-east (scale 0.5m)

- 8.3.4 The earliest deposit observed at Site 7 was dark brown clay with gravel (7004), which was encountered at a depth of 0.32m bgl. This deposit was cut by a series of utility trenches (7003). Sealing the utility trenches was a layer of concrete (7001) which acted as bedding for the present stone block paving (7000).

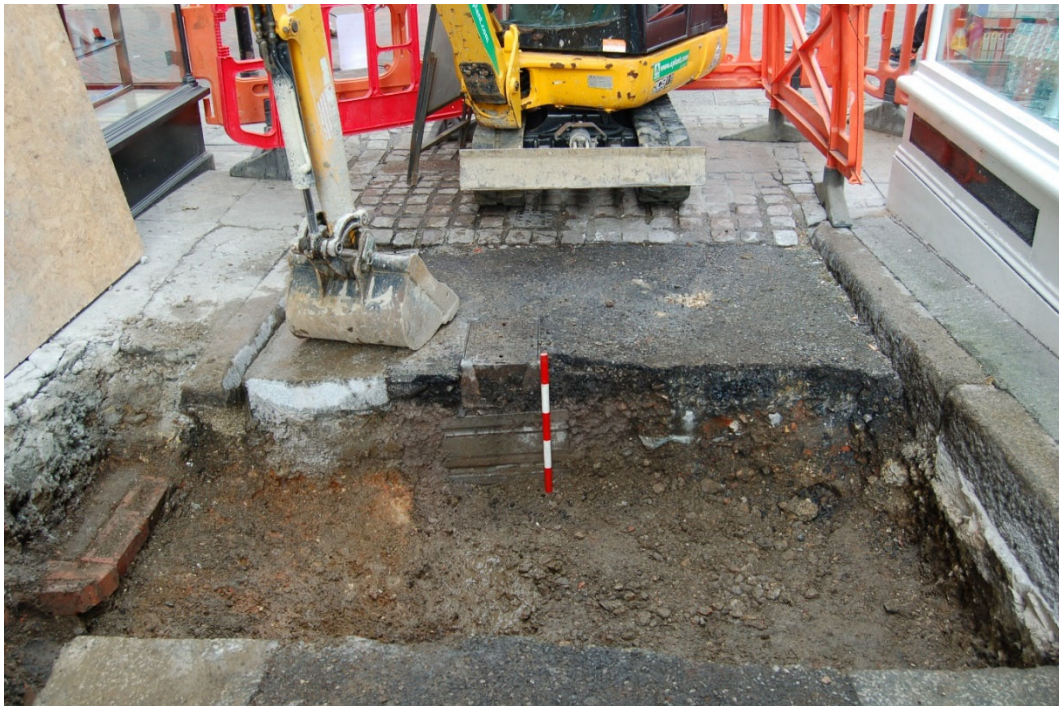
Photo 16. Site 8 White Horse Lane, excavated trench, looking north-east (scale 0.5m)

- 9.3.4 The earliest deposit observed at Site 8 comprised a mixed dark grey brown silty clay containing gravel and rubble (801), encountered at a depth of 0.18m bgl. The deposit was cut by several utility trenches (8003, 8005, 8008), which were sealed by concrete bedding (806) for a stone kerb and gutter and the present tarmacadam surface (800).

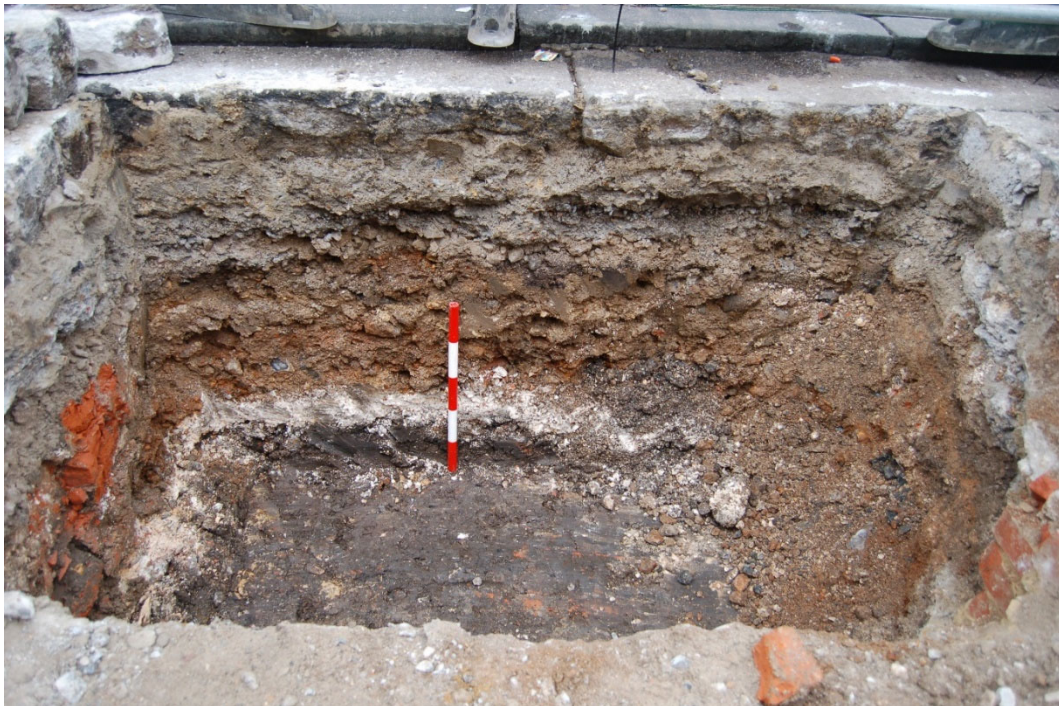
Photo 20. Site 10 Sun Street, north-east facing section (scale 0.5m)

11.3.4 The earliest deposit observed at Site 10 comprised a dark grey silty clay (1019), encountered at a depth of 0.86m bgl. Deposit (1019) was sealed by a compacted layer of crushed chalk (1018), which may have been set down as a bedding material for a compacted gravel (1017). This gravel likely represented a metalled road surface and was overlain by a layer of red brown silty clay (1016). This was sealed by a further metalled surface, comprising a compacted yellow silty gravel (1015), which was overlain by a red brown silt deposit (1014) encountered at a depth of 0.46m bgl.

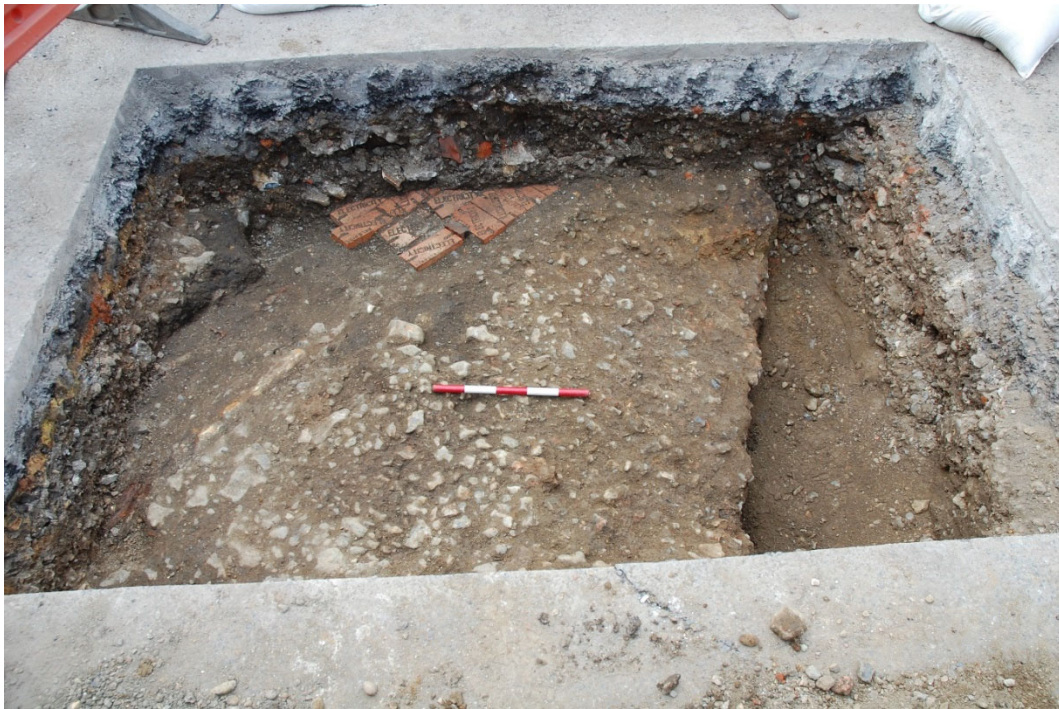
Photo 22. Site 11 St Margaret's Street, compacted gravel surface (1110), looking south-west (scale 0.5m)

- 12.6.4 The latest phase of road resurfacing (1110), dated to the fifteenth to sixteenth century, was overlain by what appeared to be a disturbed horizon of mixed gravels and soils, which might represent disturbance associated with the formation of the modern street frontage. These were cut by a nineteenth-century brick drain, the wall foundation trench to the current property at 1 St Margaret's Street, and subsequent modern utility trenches laid immediately below the present road surface.

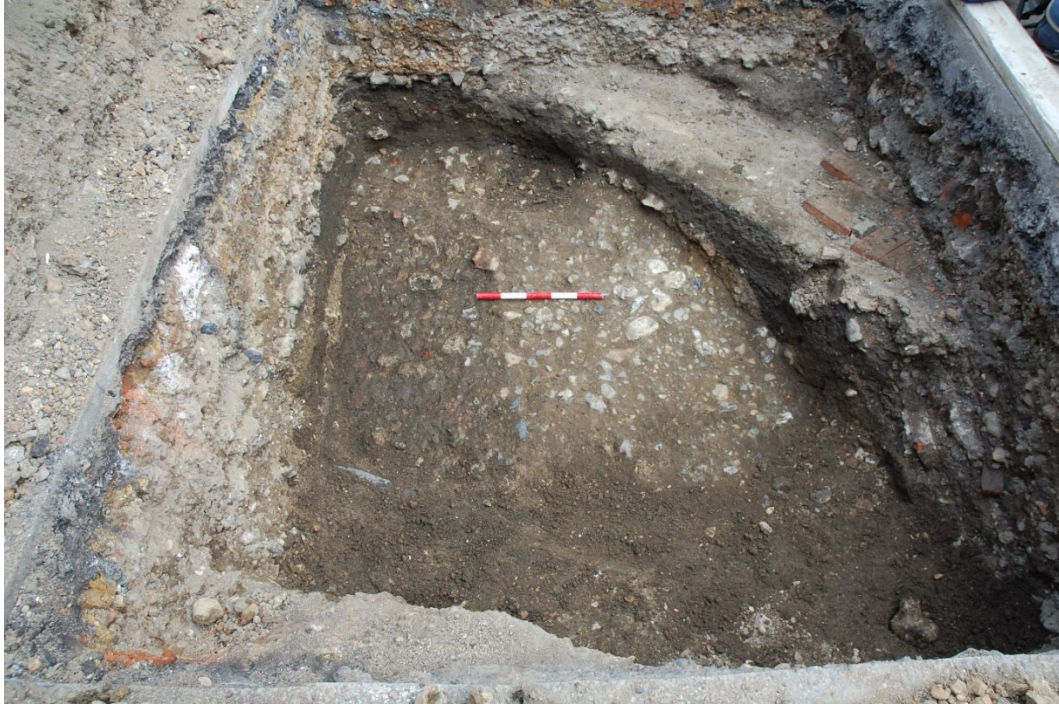
Photo 23. Site 11 St Margaret's Street, compacted gravel surface (1122), looking south-east (scale 0.5m)

12.3.4 The earliest deposit observed at Site 11 comprised a surface of compacted gravel (1122), encountered at a depth of 0.74m bgl, from which four fragments of Roman tile were recovered. The gravel (1122) was sealed by a deposit of grey silt (1119), potentially representing a tread layer formed above the gravel, containing a single sherd of medieval pottery, dated to the eleventh to twelfth century, and ten fragments of Roman tile.

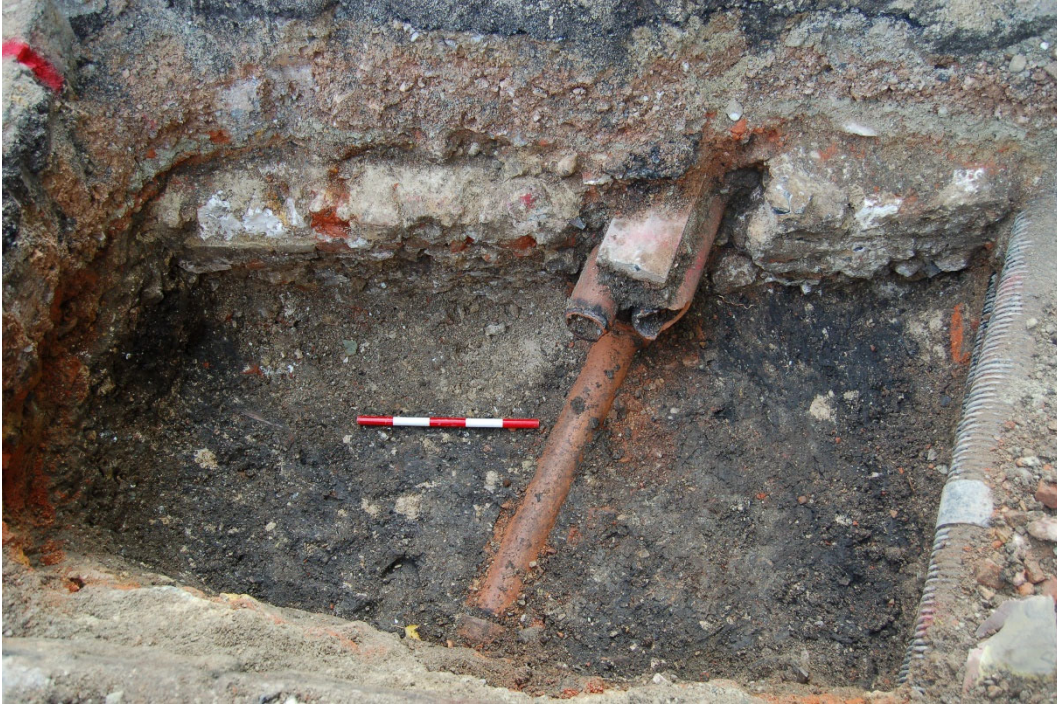
Photo 25. Site 12 St George's Street, masonry wall (1209), trench A, looking south-west (scale 0.5m)

13.3.5 Deposit (1212) was cut by a construction cut [1211] for wall (1209). Wall (1209) was located on the south-west side of trench A and only the north-east face was exposed. The wall was constructed of mainly flint and chalk lump bonded with a yellow mortar. The south-east end of the observed wall segment had upper courses of red brick, potentially representing a later alteration or repair. The surviving upper course was encountered at a depth of 0.58m bgl and the wall had a visible height of at least 0.42m and a visible width of 0.3m. A dark grey brown silt with gravel (1210) and mixed brick and mortar (1214) abutted the north-east face of wall (1209) within construction cut [1211].

13.6.2 In Trench A, the latest soil horizon was cut by a foundation trench for a masonry wall. The wall, formed of mainly flint and chalk, is likely to represent the foundation of a building that fronted the south side of St George's Street, illustrated on nineteenth- and twentieth-century maps of the locality before extensive bomb-damage during the Second World War led to redevelopment of the area. The date of construction of this building is unknown but might be late medieval or early post-medieval, with later alteration or repairs to the fabric being made in red brick.

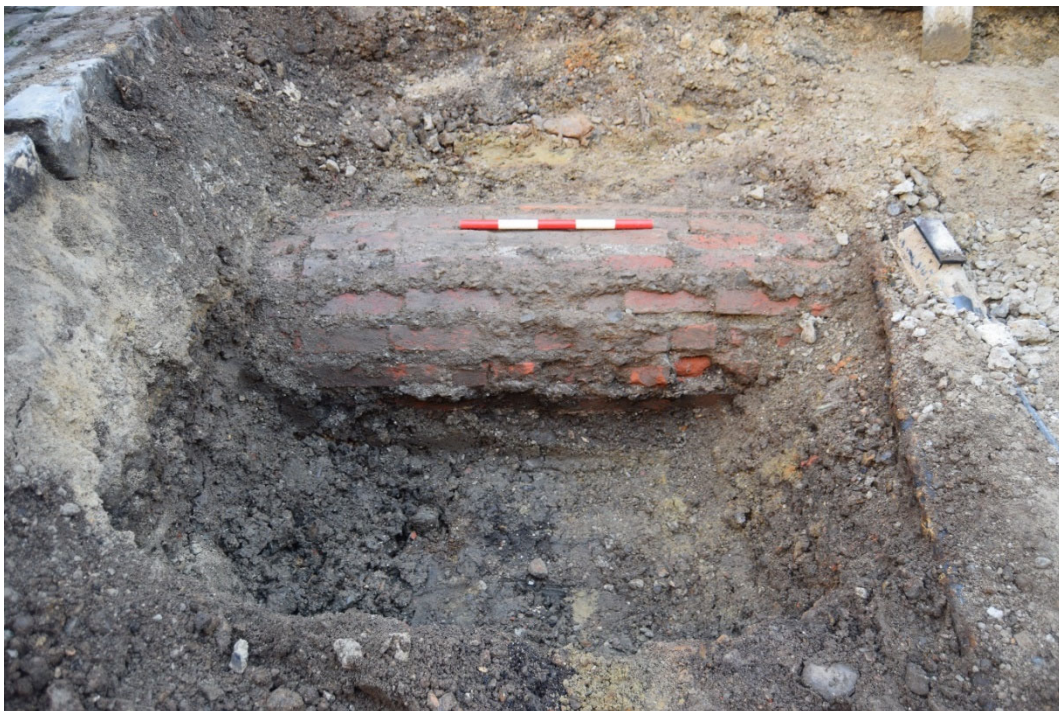
Photo 28. Site 13 Burgate, brick drain (1306), looking south-west (scale 0.5m)

14.3.7 In the bollard trench, the compacted gravel was sealed by a dark grey brown sandy silty clay deposit (1308). This deposit was cut by a utility trench [1307] for a brick-lined cylindrical drain (1306), which extended to the north-west along the full length of the monitored service trench, recorded as cut [1327] and drain (1325), respectively. The drain (1306 and 1325), constructed of unfrosted red stock bricks, had
