# Hostile Mitigation Scheme

## Marlowe Theatre, The Friars, Canterbury, Kent CT1 2AS

### Archaeological Watching Brief

Report No: 2022/124  
Archive No: 4314  
OASIS ID: canterbu3-508172

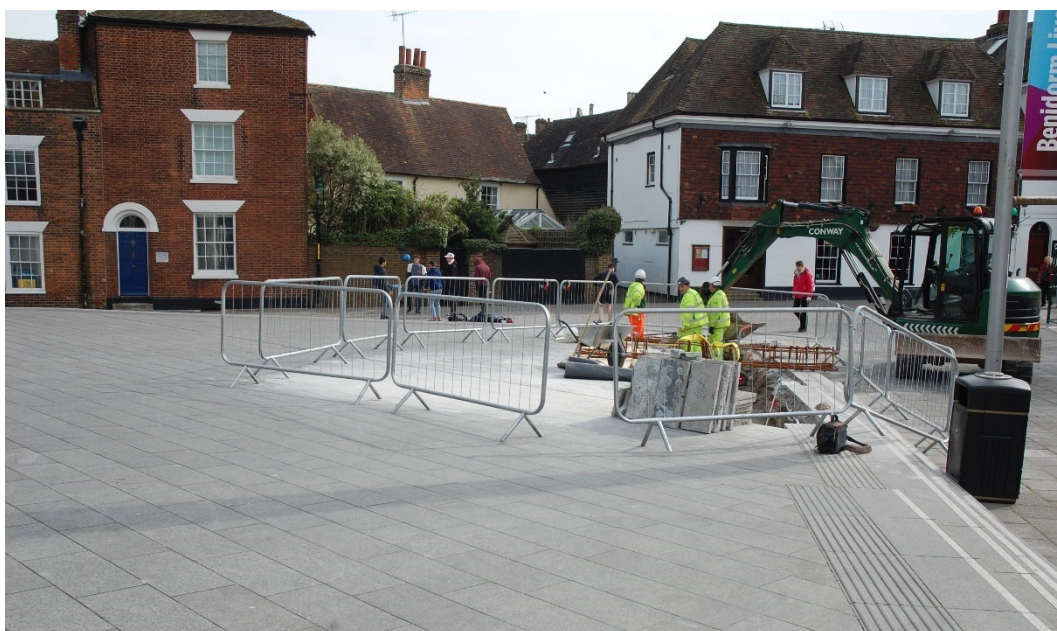
Photo 1. Marlowe Theatre Area 1, bollard installation trench location, looking south (no scale)

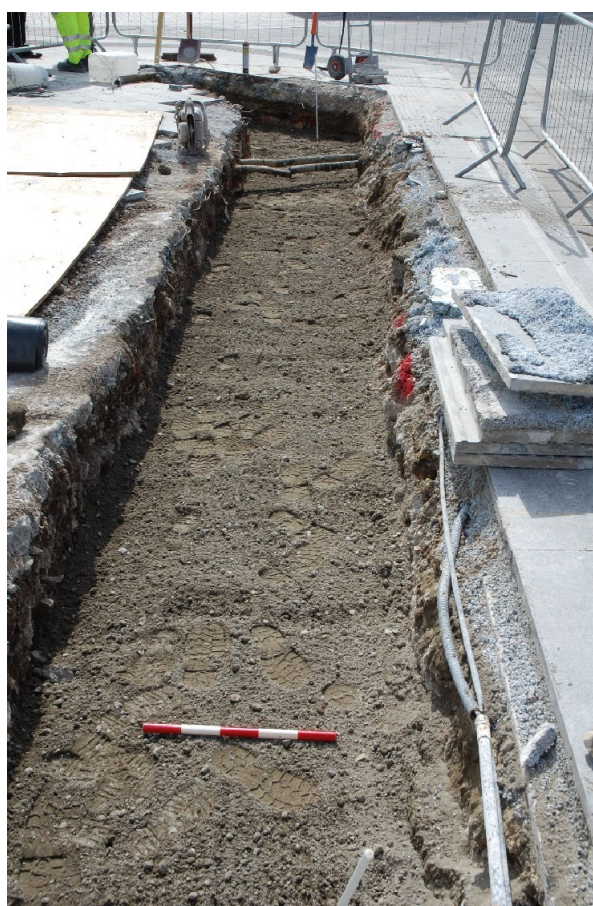
2.1.3 The earliest deposit exposed comprised a mid yellow brown silty clay deposit with common brick and concrete fragments (1005), exposed at a depth of 0.32m bgl and continuing below the level of excavation. This was part sealed by a layer of light yellow-white crushed concrete (1004), exposed at a depth of 0.14m bgl. The crushed concrete was overlain by a layer of mid yellow-brown silty clay with common light yellow coarse sand and brick fragments, which was sealed by a Type 1 concrete aggregate mixed bedding (1002) for the concrete paving slabs (1001) which form the existing ground surface.

Photo 2. Marlowe Theatre Area 1 bollard installation trench, looking south (scale 0.5m)

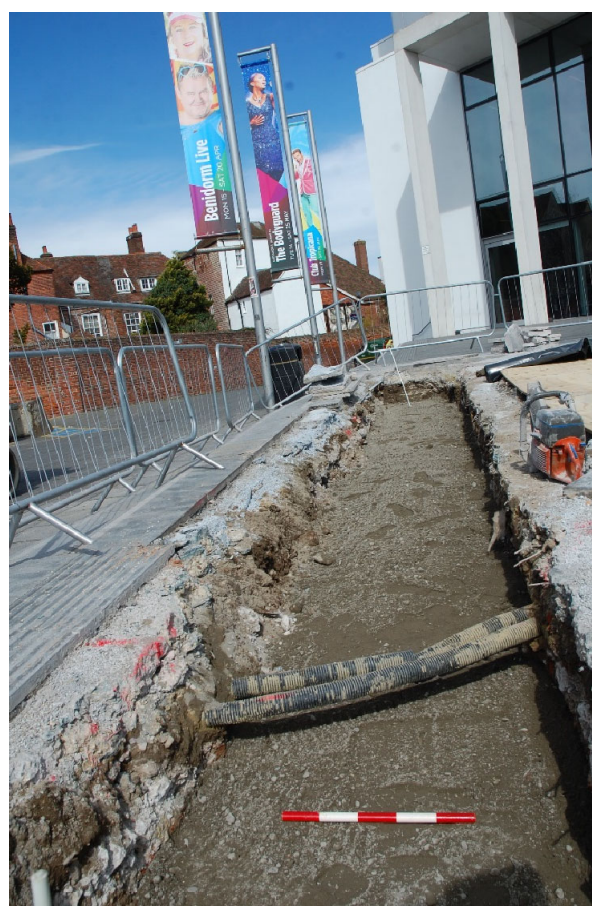
Photo 3. Marlowe Theatre Area 1 bollard installation trench, looking north (scale 0.5m)

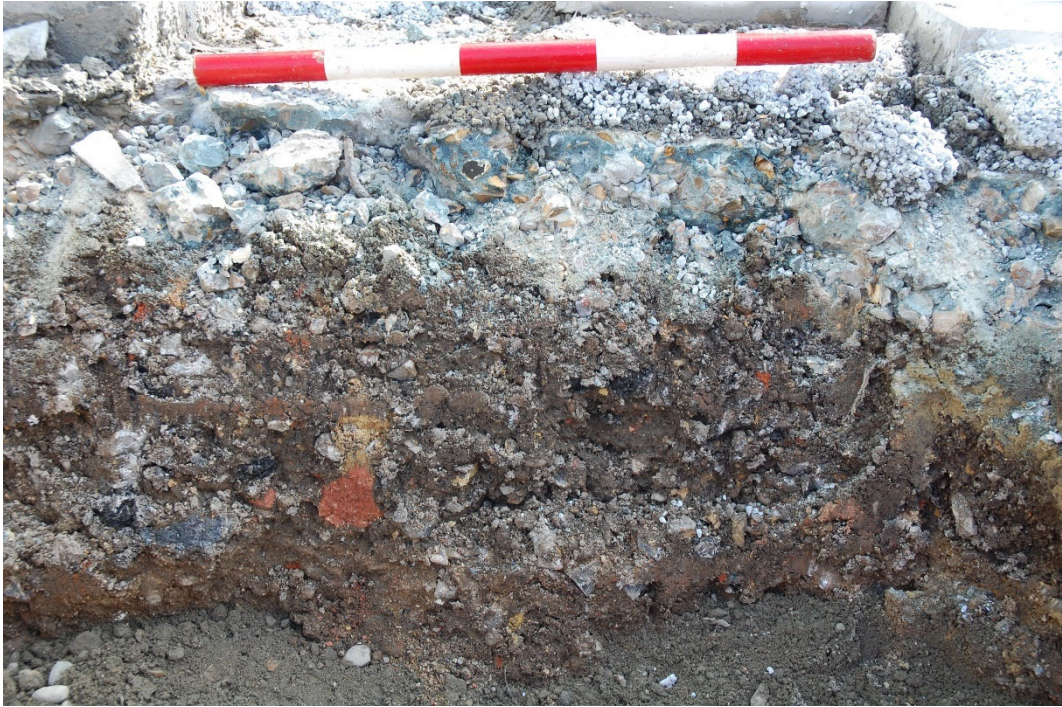
Photo 4. Marlowe Theatre Area 1 bollard installation trench, sample section detail showing modern ground formation deposit, looking west (scale 0.5m)

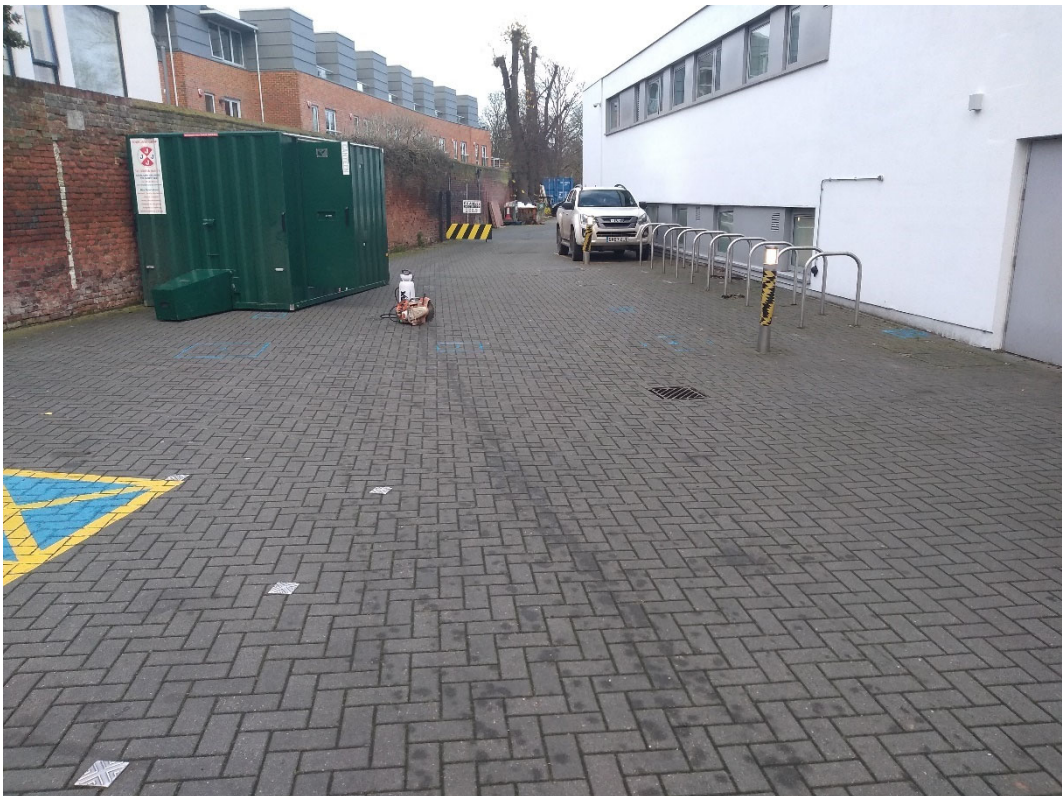
Photo 5. Marlowe Theatre Area 2 security gate installation location, looking north-east (no scale)

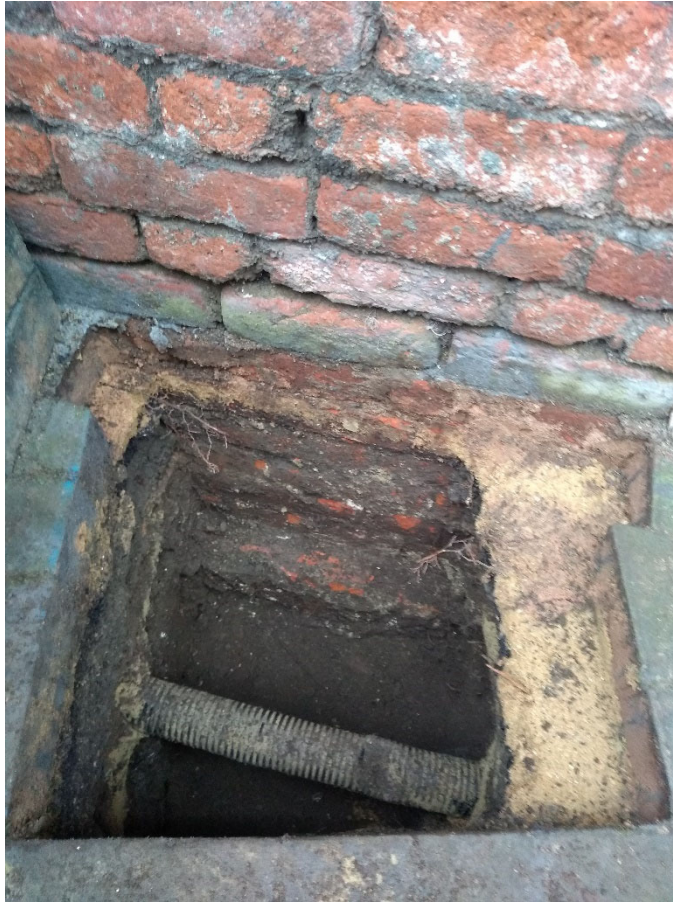
Photo 6. Marlowe Theatre Area 2 security gate installation trench P1, looking north-west (no scale)

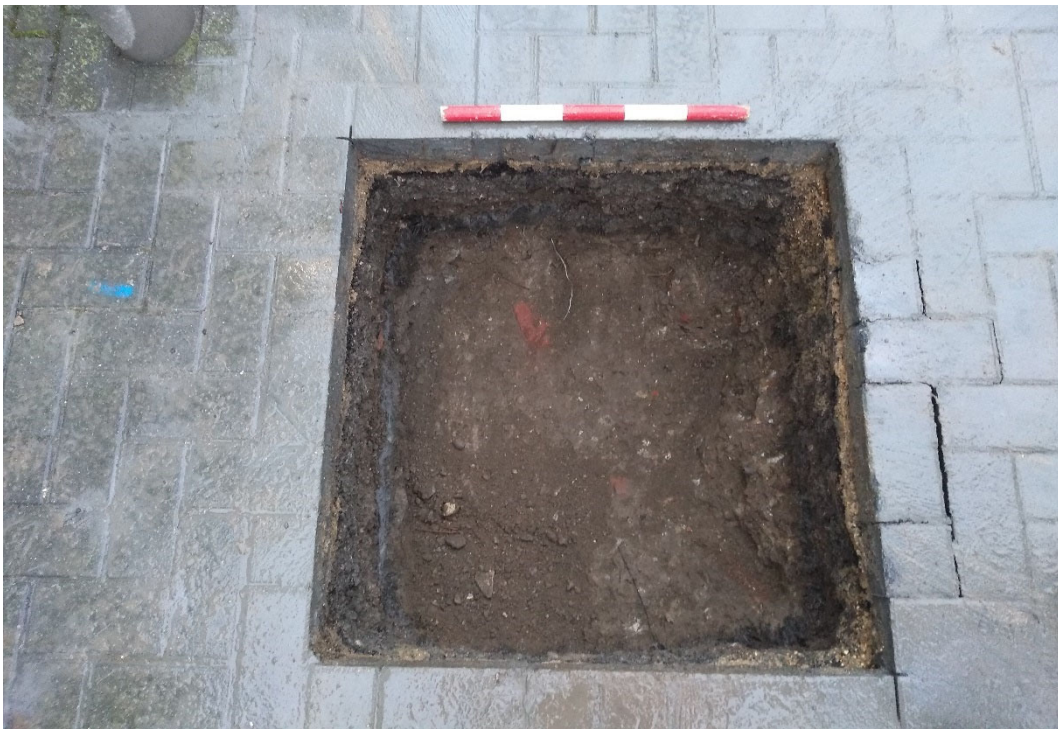
The trench measured 0.6m long by 0.4m wide and 0.65m deep. The earliest feature observed was the brick offset foundation (2113) of the standing western boundary wall. The top of the foundation was encountered at a depth of 0.41m bgl. The foundation was overlain by a fine soft grey soil (2106) which was in turn overlain by a Type 1 aggregate bedding (2103) and the present surface of brick block paving (2100).

Photo 7. Marlowe Theatre Area 2 security gate installation trench P2, looking south-east (scale 0.5m)

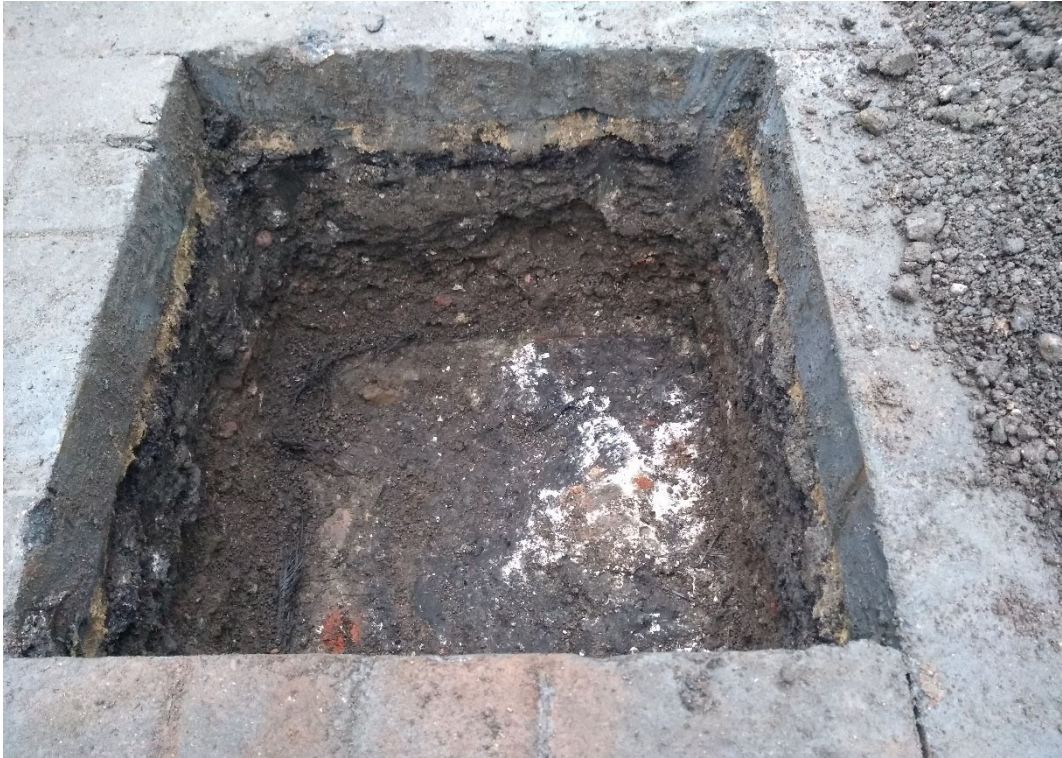
- 2.2.5 Trench P3 measured 0.3m long by 0.3m wide and 0.54m deep. A wall (2108) formed of chalk blocks, and possibly originally flint-faced, constructed within a foundation trench (2109), was exposed at the base of the trench. The wall was sealed by a compact mid reddish brown silty clay and gravel deposit (2112). This was in turn overlain by compact dark orange brown silty clay (2107), which was also observed in trench P2. The sequence was completed with Type 1 bedding (2103), sand bedding (2101) and the present block paving (2100).

Photo 8. Marlowe Theatre Area 2 security gate installation trench P3, looking north-west (no scale)

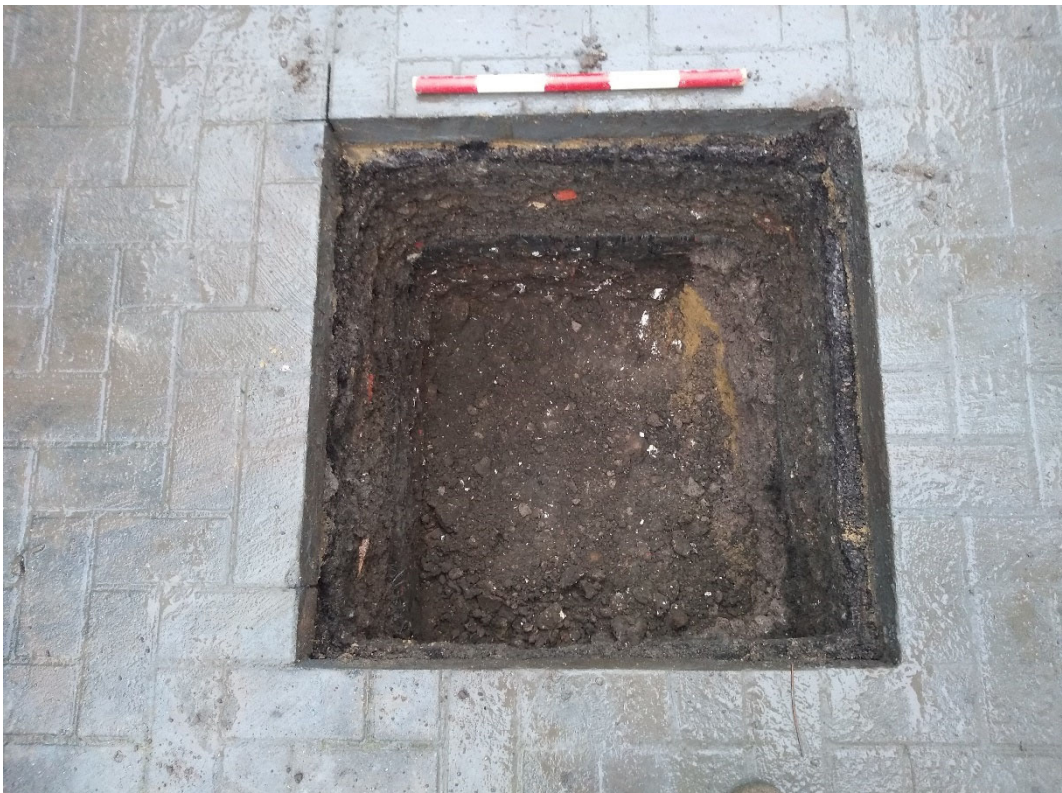
- 2.2.6 Trench P4 measured 0.8m long by 0.8m wide and 0.62m deep. A concrete wall foundation (2105) was encountered at a depth of 0.44m bgl. This was sealed by a Type 1 aggregate bedding (2103 and 2104), tarmacadam (2102), sand bedding (2101) and the present block paving (2100).

- 2.4.4 A poured concrete foundation recorded in Area 2 trench P4 may be associated with a foundation for the 1930s Odeon Cinema.
- 2.4.5 In Area 3, the sequence of soil horizons (30013, 3012, 3011) corresponded with gardens illustrated on the 1874 OS map, while a brick structure, represented by wall 3005, brick floor 3004 and internal partition wall 3003, are probably associated with a glasshouse, also shown at this location on the same map.

Photo 9. Marlowe Theatre Area 2 security gate installation trench P4, looking south-west (scale 0.5m)

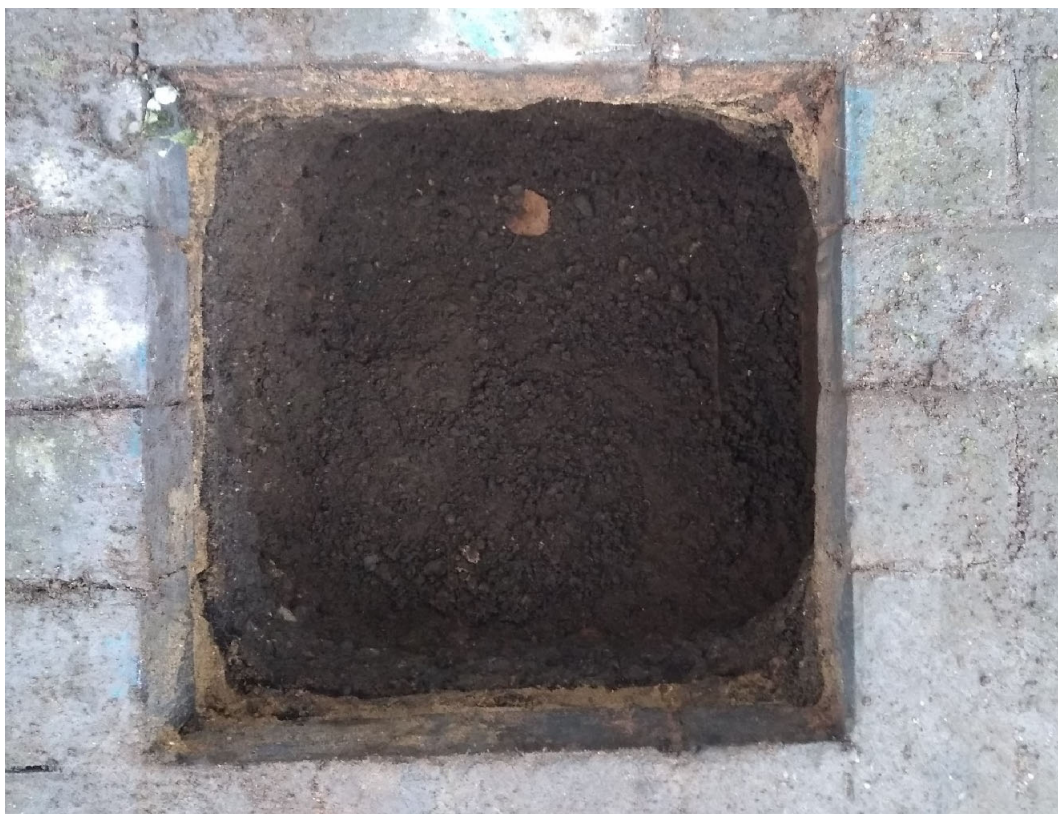
Photo 10. Marlowe Theatre Area 2 security gate installation trench P5, south-west (no scale)

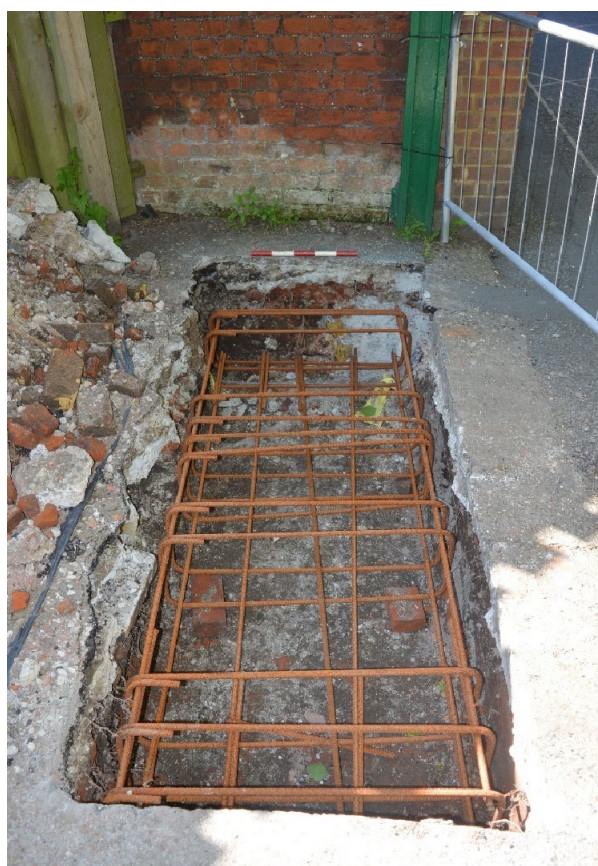
Photo 11. Marlowe Theatre Area 3 bollard installation trench, looking north-west (scale 0.5m)

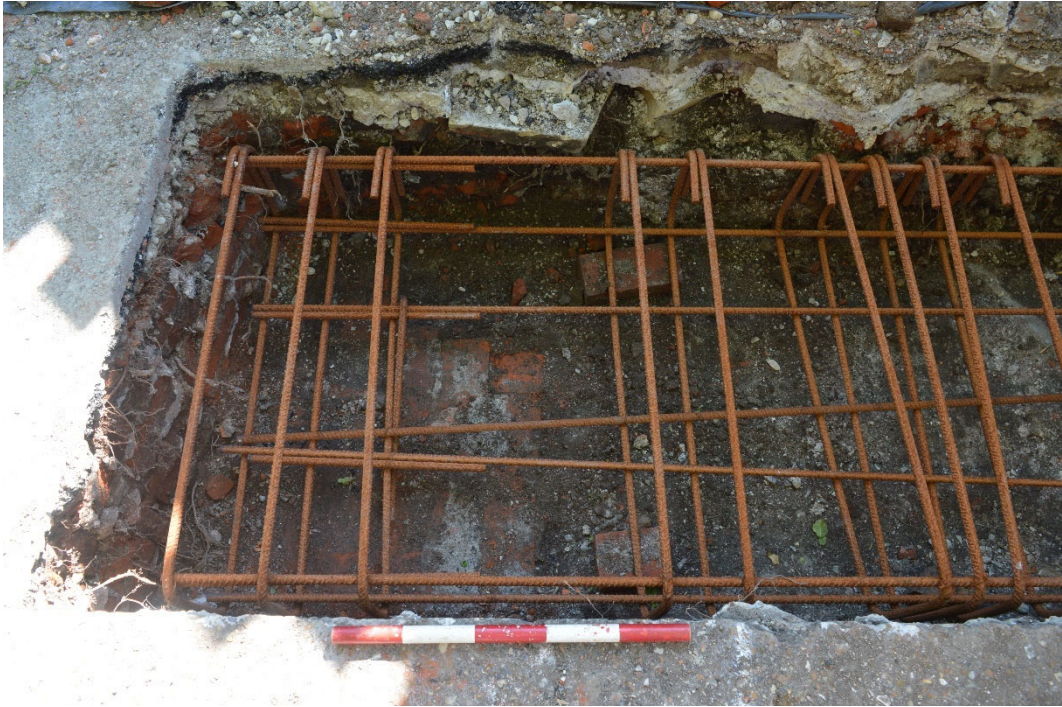
Photo 12. Marlowe Theatre Area 3 bollard installation trench, brick floor 3004, looking south-west (scale 0.5m)

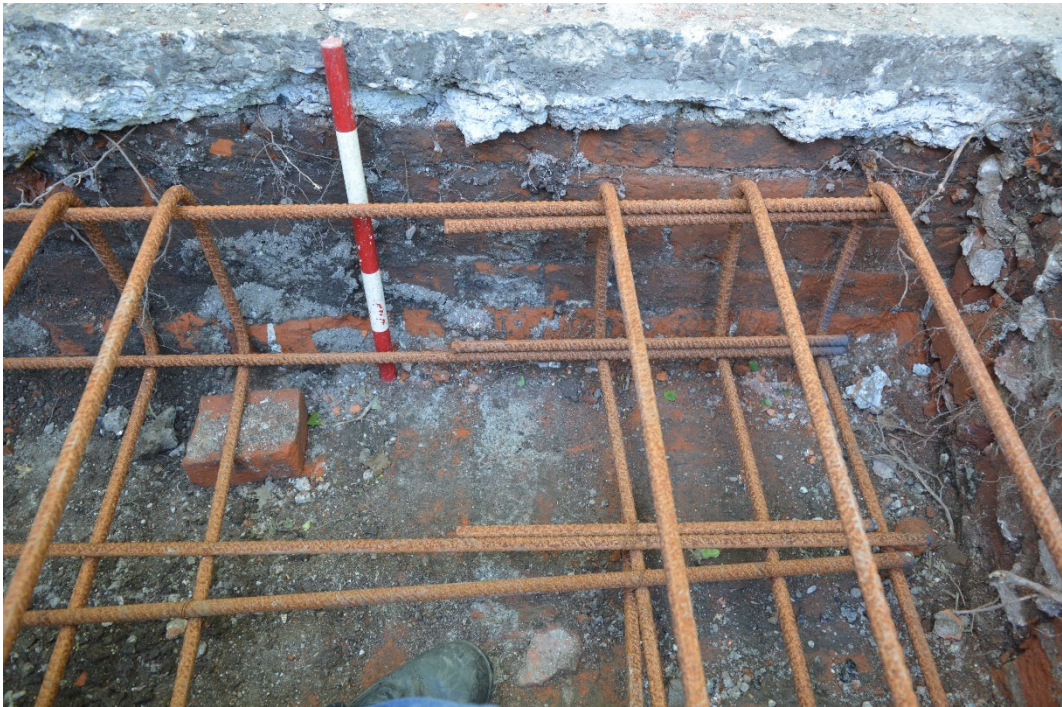
Photo 13. Marlowe Theatre Area 3 bollard installation trench, brick wall 3003 and brick floor 3004, looking north-east (scale 0.5m)

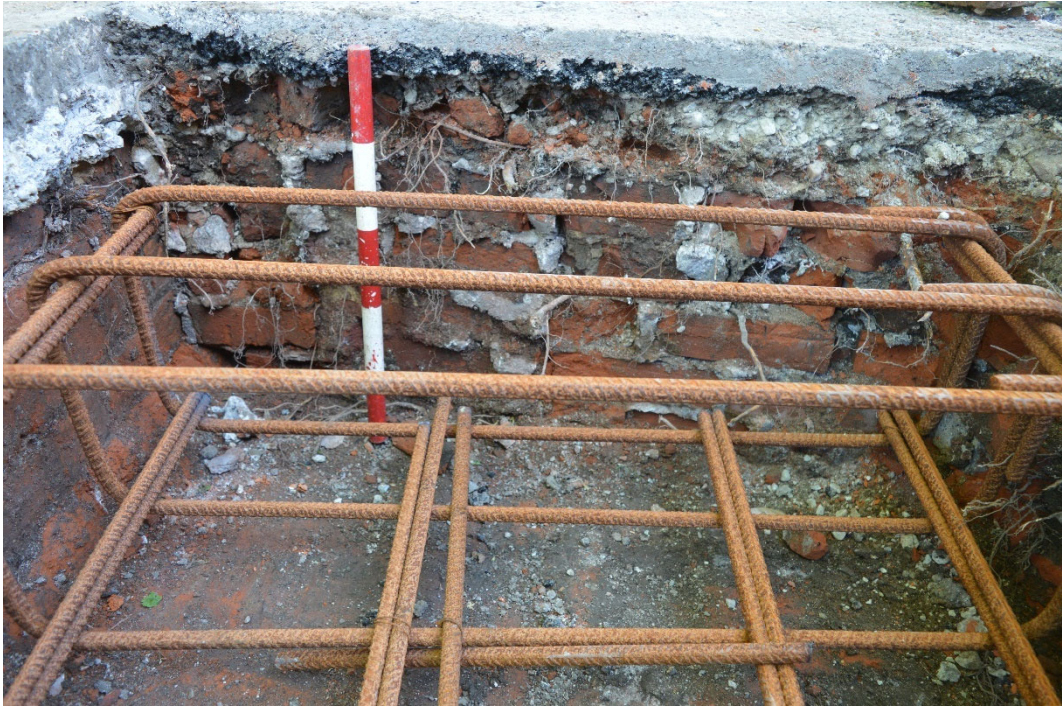
- 2.3.5 A modern utility trench (3010), aligned north-west to south-east, truncated wall 3005. This was overlain by a layer of concrete, broken sandstone paving and brick rubble fragments (3008), capped by a coarse sand bedding deposit (3007) for the existing tarmacadam surface (3007) to the south-west, and a Type 1 aggregate bedding material (3002) for a concrete surface (3001) to the north-east.

Photo 14. Marlowe Theatre Area 3 bollard installation trench, brick floor 3004 and brick wall 3005, looking south-east (scale 0.5m)
