Land at Elm Grove, Liverpool (18F/1967)

Final Report on an Archaeological Evaluation (Pre-Demolition and Post Demolition Phases)

Document Number: 3429.R03a

October 2019

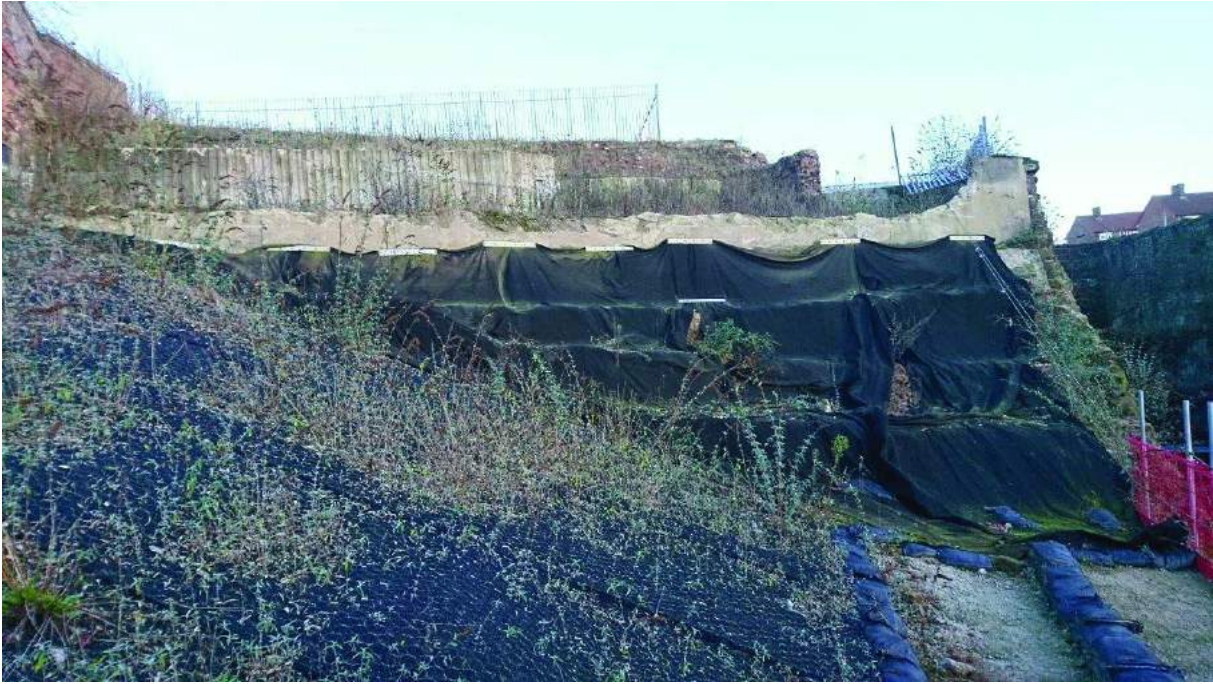
Plate1: Concrete structure obscuring the eastern extent of the 'Triple Decker Tunnel'

The tunnel commonly known as the 'Triple Decker Tunnel' is known to be present at the south-eastern portion of the site, orientated approximately NNE-SSW. Historic mapping, historic accounts and informed conjecture by the Friends of Williamson's Tunnels suggests the tunnel extends towards the south-eastern boundary of the site where it was severed by the railway cutting. The presumed eastern extent of the tunnel is obscured by a concrete structure, at the surface (Plate 1).

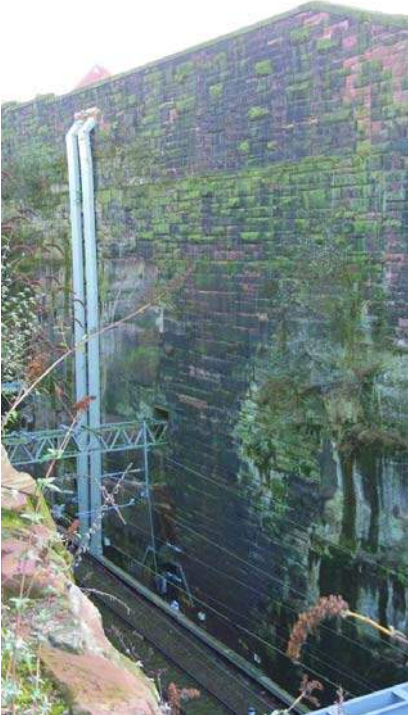
Plate 2: The stopped-up continuation of the 'Triple Decker Tunnel'

A not unreasonable assumption is that the base of the tunnel would be expected at a similar depth to the base of the sandstone cutting in which the Liverpool – Manchester railway line is present. The stopped-up continuation of the 'Triple Decker Tunnel' is visible in the southern side of the sandstone cutting (Plate 2), defined by ashlar blocks.

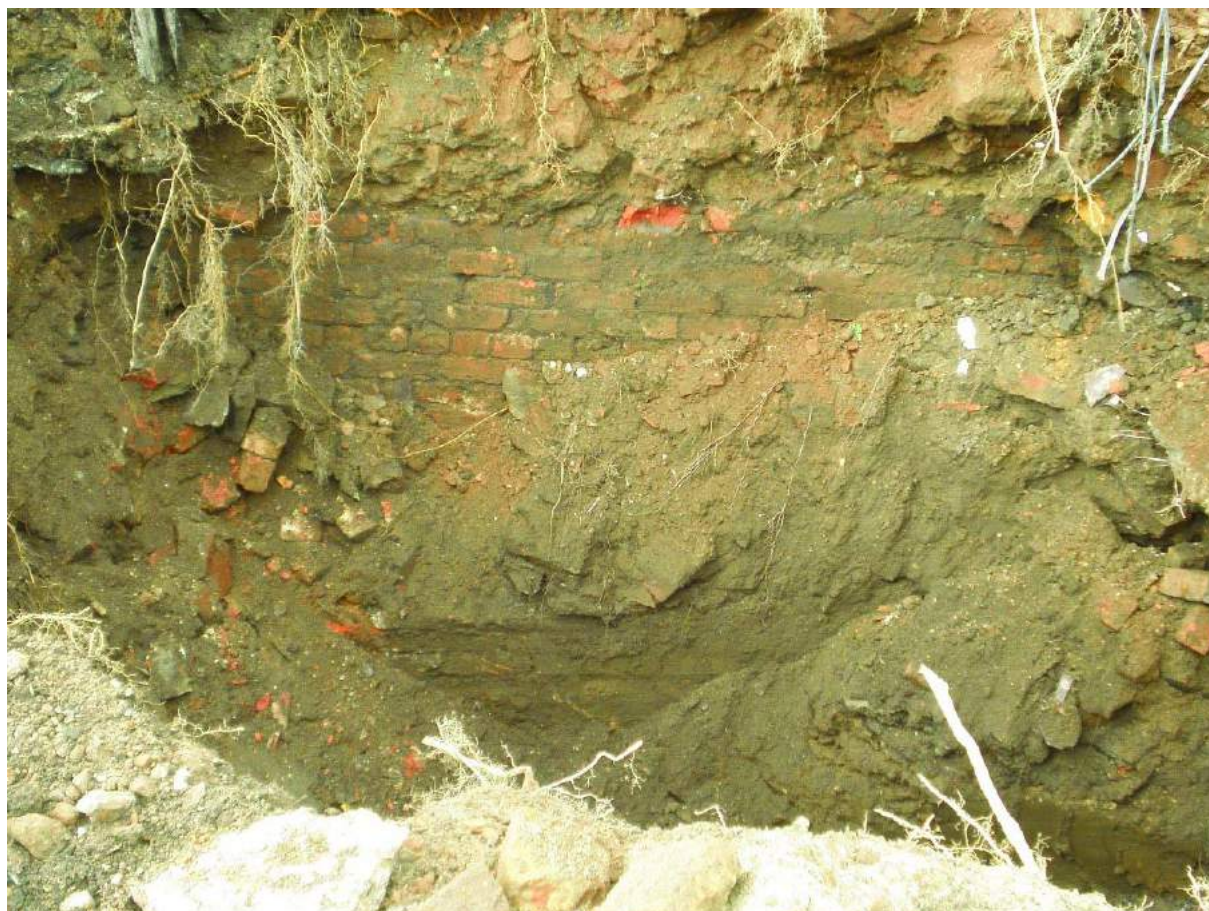
Made ground in the form of black/brown sandy gravel containing angular to sub-rounded and fine to coarse fragments of concrete, brick, timber and glass extending 2.20m bgl giving way to a deposit of loose brown/orange fill of angular cobbles of brick 0.30m thick. Beneath this deposit was an articulated brick floor 0.15m thick laid on top of a dark brown sandy gravel containing angular to sub-angular and fine to coarse demolition material including cobbles of angular brick. Excavation ceased within this material at 3.00m bgl. Two parallel, brick-built walls were also identified in this trial pit, surviving to a height of 16 courses. The observing archaeologist considers that neither the floor nor the walls were characteristic of Williamson tunnel capping or tanking and were likely to represent built elements of St. Stephen's School or 19th century residential dwellings at Hamilton Terrace. The anthropogenic debris within the made ground is likely to be demolition debris arising from the razing of St. Stephen's School and/or 19th century residential dwellings at Hamilton Terrace. However, the possibility that brickwork at the upper levels of Williamson Tunnels can take the appearance of cellar walls, especially within small scale excavations must be taken into account when offering interpretations of subterranean structures in this part of Liverpool.

Plate 3: TP604, North-East Facing Section of TP604 showing brick-wall

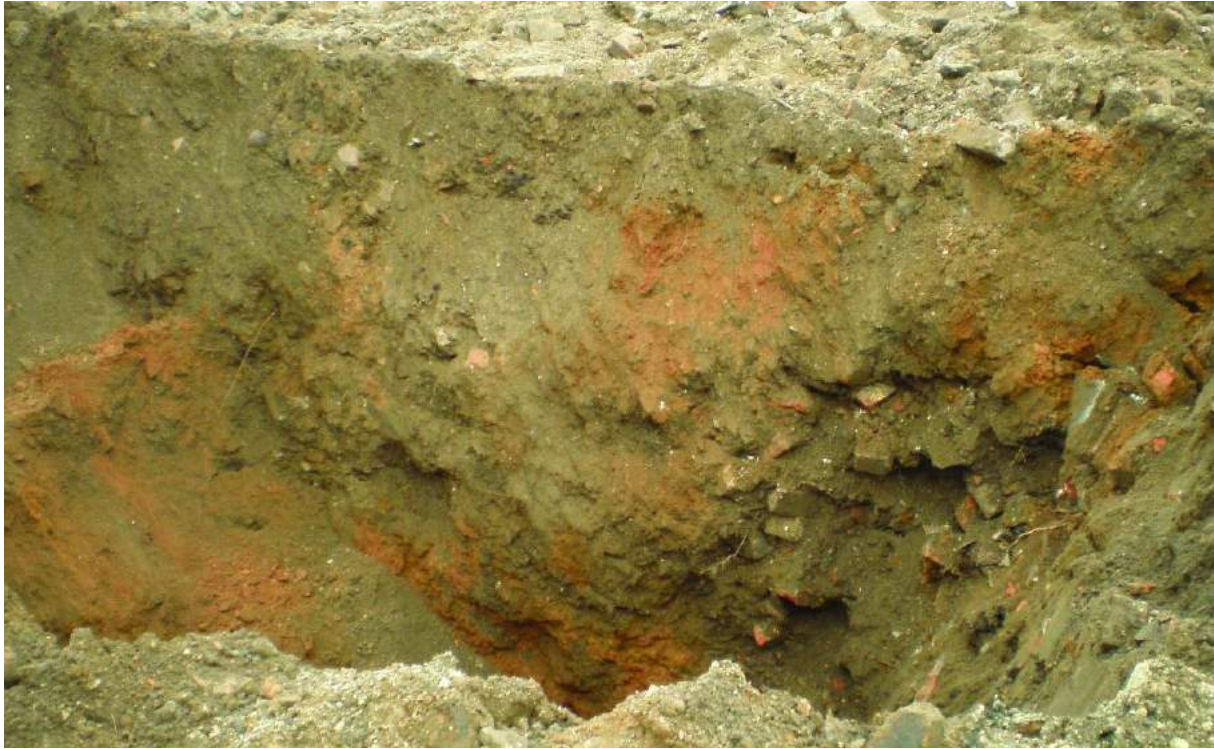
Made ground of dark-grey clayey-sand with frequent inclusions of sandstone fragments, brick fragments (whole and partial bricks) Orange brown sandstone at 2.40m bgl. Excavation ceased at 2.80m bgl. No evidence of any voids or any other features which could be said to be evidence of Williamson tunnels. The made ground is likely to represent demolition debris arising from the razing of St. Stephen's School and/or 19th century residential dwellings at Hamilton Terrace.

Plate 4: TP609, North-East Facing Section

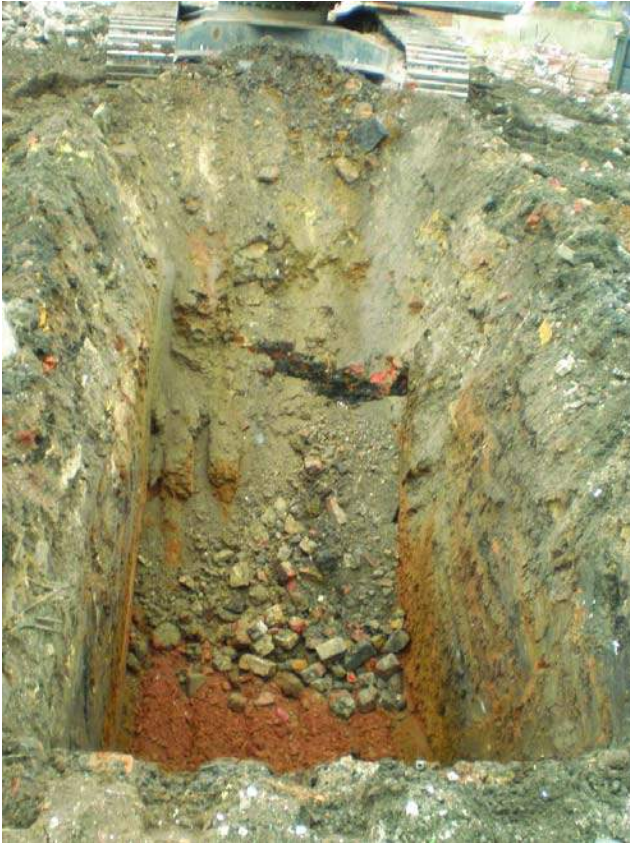
The deposit to a depth of 2.70m bgl is characterised as made ground – a dark grey-brown clay silt with frequent inclusions of brick. Excavation extended c. 0.50m into an orange-brown clay silt above sandstone bedrock. Excavation ceased at 3.20m bgl. A single-skin brick wall was observed in the south-east facing section, at least 0.5m high. Unfortunately the depth at which the wall outcrops was not recorded. The wall is not characteristic of Williamson tunnel structure and is likely to represent built elements of St. Stephen' School or 19th century residential dwellings at Hamilton Terrace. The anthropogenic debris within the made ground is likely to be demolition debris arising from the razing of St. Stephen' School and/or 19th century residential dwellings at Hamilton Terrace. However, the possibility that brickwork at the upper levels of Williamson Tunnels can take the appearance of cellar walls, especially within small scale excavations must be taken into account when offering interpretations of subterranean structures in this part of Liverpool.

Plate 5: TP610, south-east facing section with brick wall partially visible.

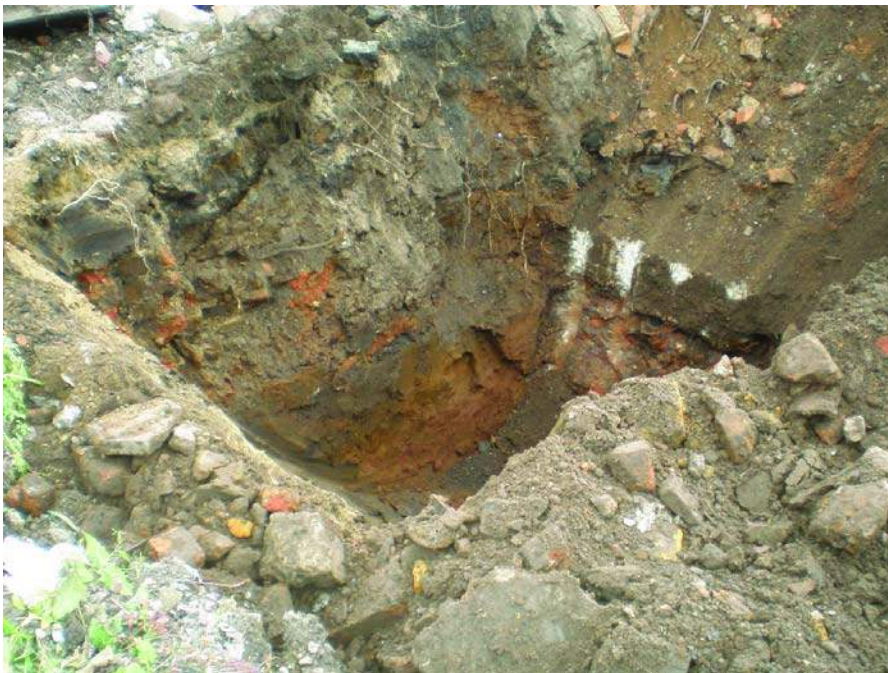
The deposit to a depth of 2.50m bgl is characterised as made ground – a dark grey-brown clay silt with frequent inclusions of brick, mortar and crushed sandstone. Excavation extended c. 0.30m into an orange-brown clay silt above sandstone bedrock. Excavation ceased at 2.80m bgl. No evidence of any voids or any other features which could be said to be evidence of Williamson tunnels. The made ground is likely to represent demolition debris arising from the razing of St. Stephen's School and/or 19th century residential dwellings at Hamilton Terrace.

Plate 6: TP611, South-west facing section

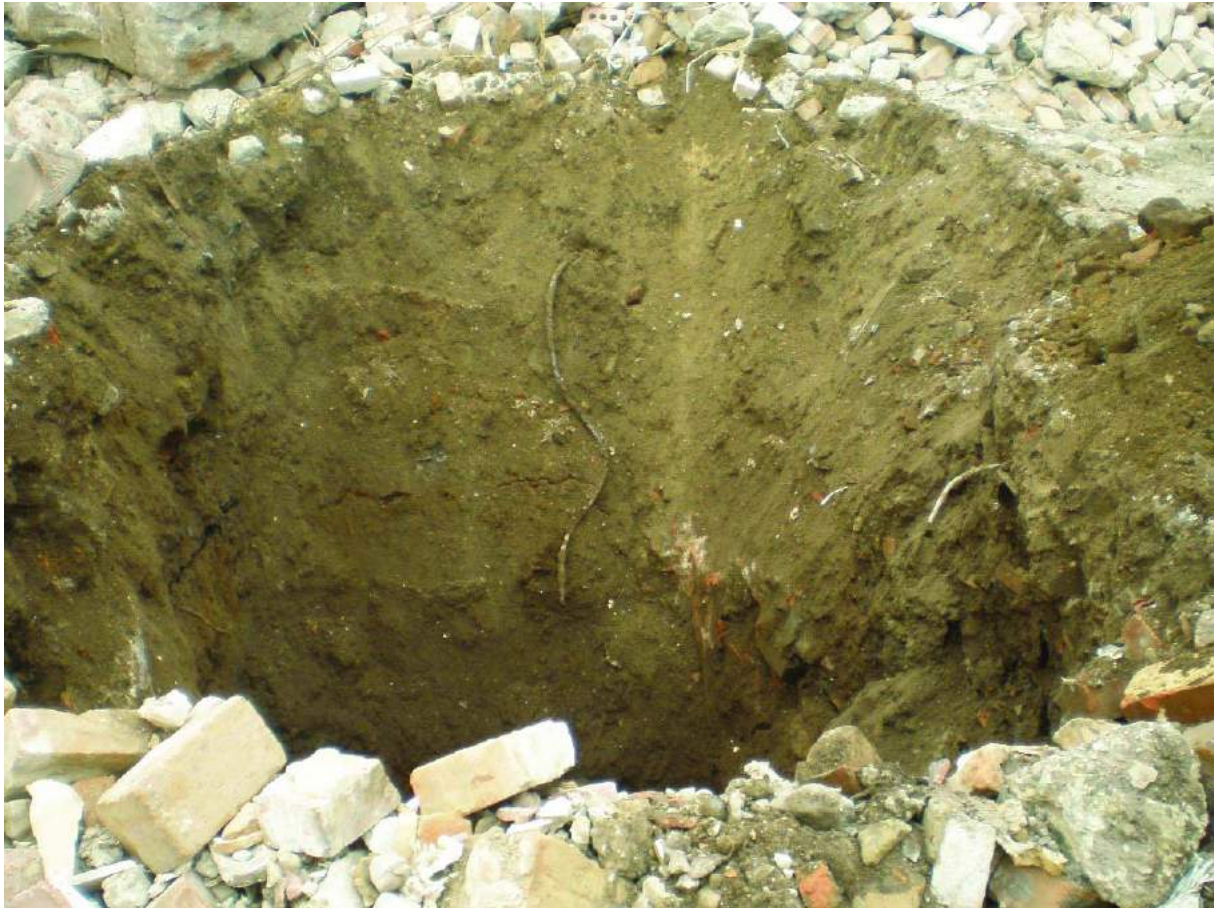
The location of this trial pit was moved to the south-east as a spoil heap occupied the proposed location. A deposit extending 2,80m bgl was identified as made ground comprising a dark-grey brown clay silt with inclusions of brick rubble and mortar. Below this was a crushed red sandstone representing the degraded outcropping of the sandstone bedrock within which excavation ceased at 3.00m bgl. No evidence of any voids or any other features which could be said to be evidence of Williamson tunnels. The made ground is likely to represent demolition debris arising from the razing of St. Stephens's School and/or 19th century residential dwellings at Hamilton Terrace.

Plate 7: TP612, North-West Facing Section

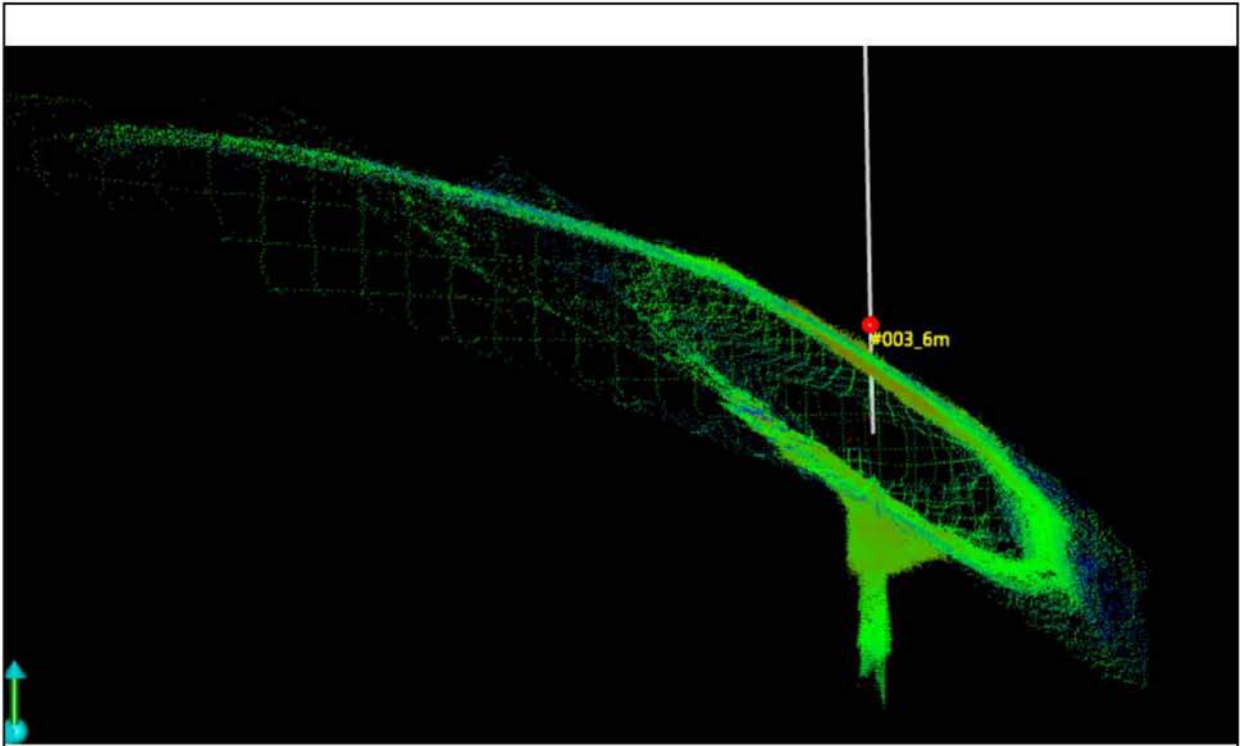
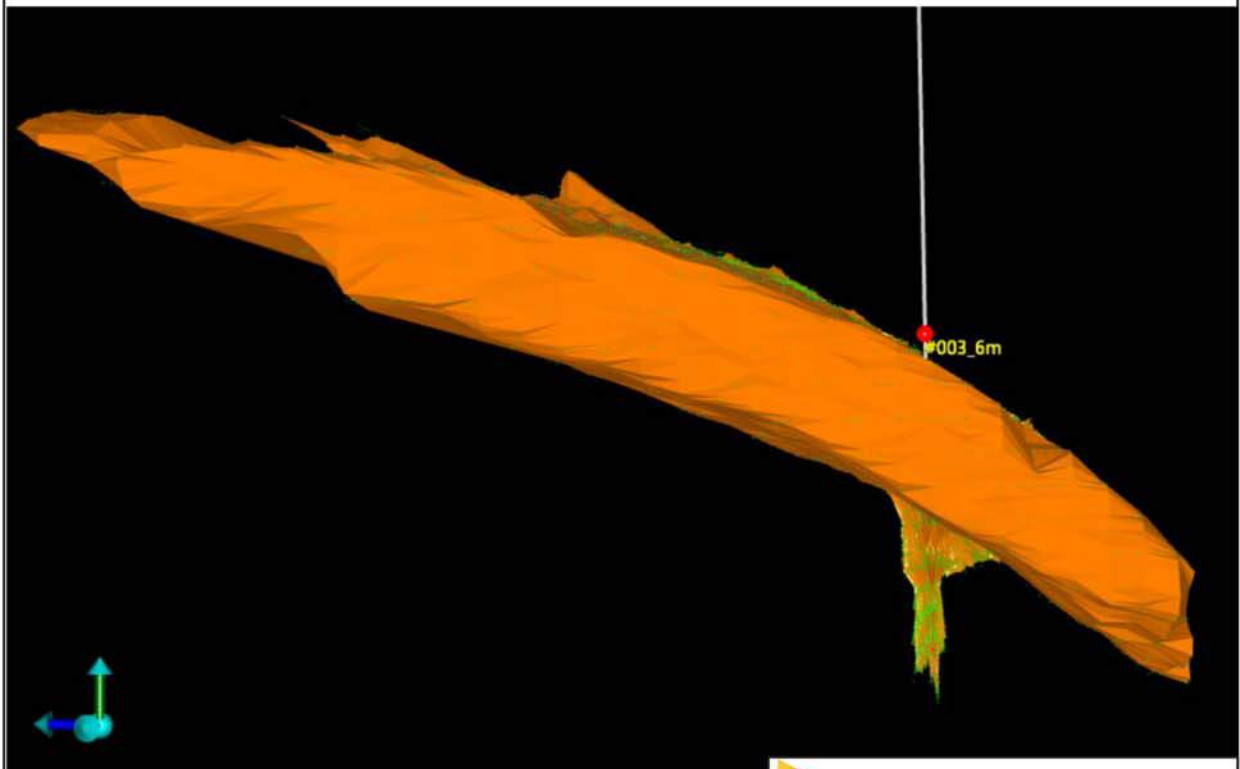
FIGURE:
9

DRAWING TITLE:
*Geoterra 3-D Point-Cloud Screen-Grabs of the Void
 Scanned in the Tunnel (Possible Continuation of the
 'Triple Decker') at ROH512*

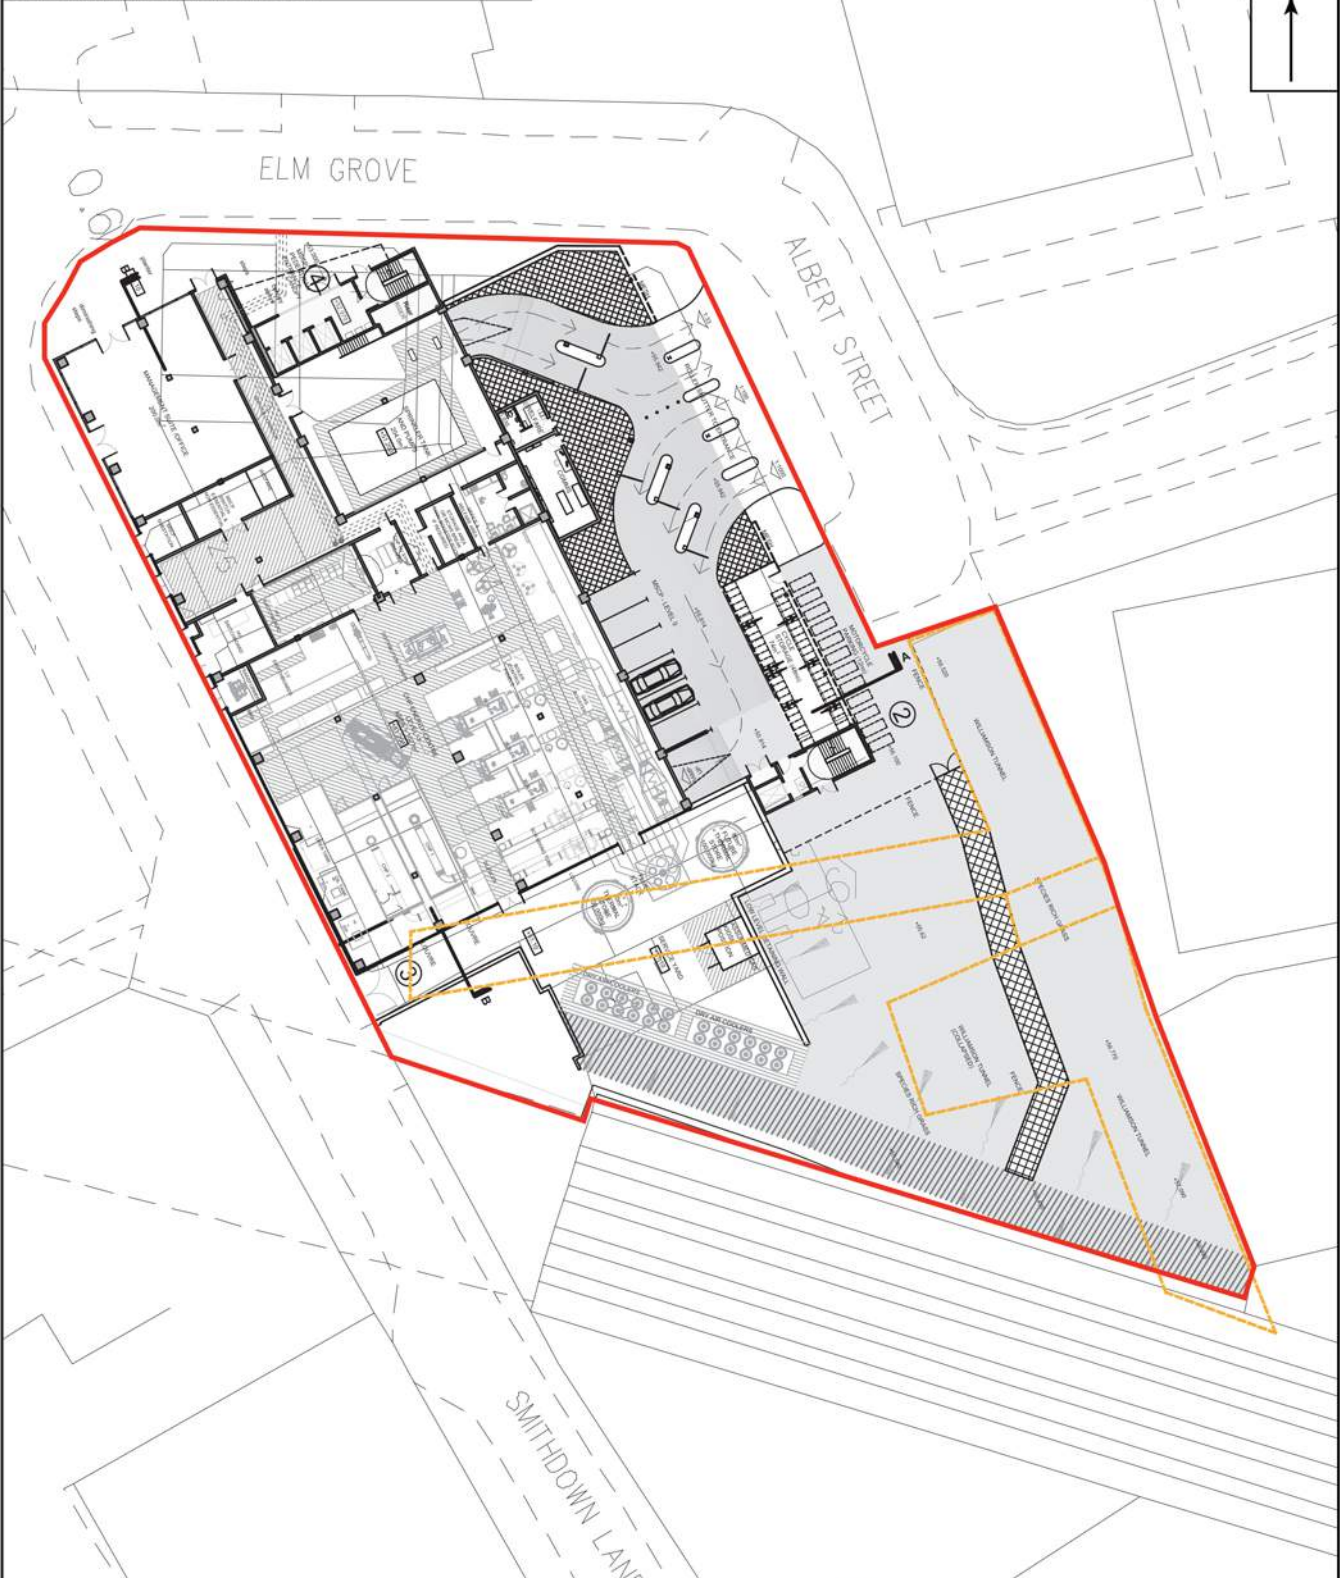
Williamson Tunnel as observed
