**Historic Building Assessment
and
Documentary History**

**FARM BUILDINGS AT
HEAD BARTON FARM,
CHITTLEHAMHOLT,
DEVON**

*By R.W. Parker
and
L.M.S.F. Browne*

REPORT No. 2019.02

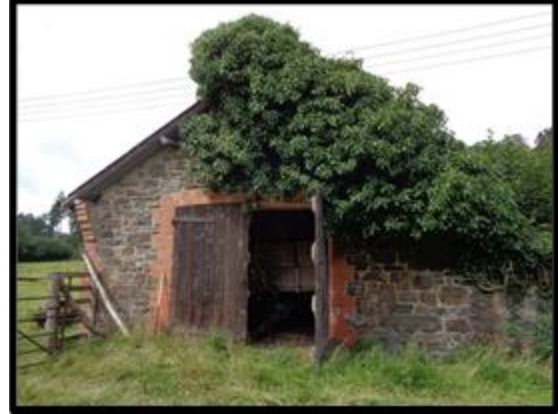
Fig. 15 The trap house at the eastern end of the southern range of buildings, showing the corbelled eaves detail.

This small single-storeyed building (Figs 15, 16) is of stone construction, of snecked brown Culm-measures rubble with orange, wire-cut brick dressings, under a slate roof. The roof is low-pitched and contemporary with the building, its eaves plates continuing beyond the gable wall and supported on bull-nosed corbelling- a detail also found in the presumed granary building dated 1882. It is probable that both buildings are contemporary.

The west wall (Fig. 15) has a wide, low, segmental archway containing double doors, hung on long, square-ended strap hinges, stamped at their terminals by way of ornament. The archway is in poor condition and may be at risk of collapse. Above it is a louvred ventilator opening with a slate sill and brick dressings, now almost entirely masked by ivy. The north and south walls feature small ventilator openings with brick dressings and segmental arched heads, both retaining their metal ventilator grilles. The northern wall is much overgrown with ivy.

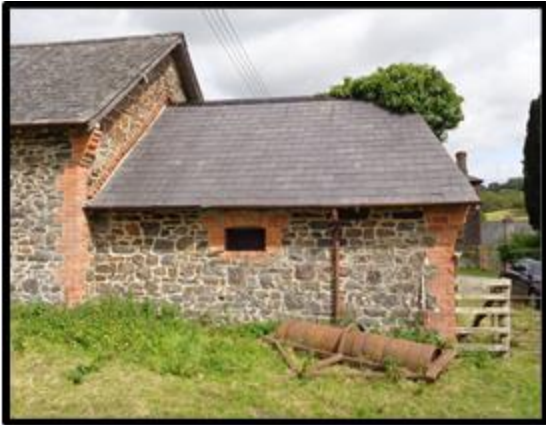
Fig. 16 The south elevation of the trap house, showing the brick weatherings built into the gable of the adjacent linhay.

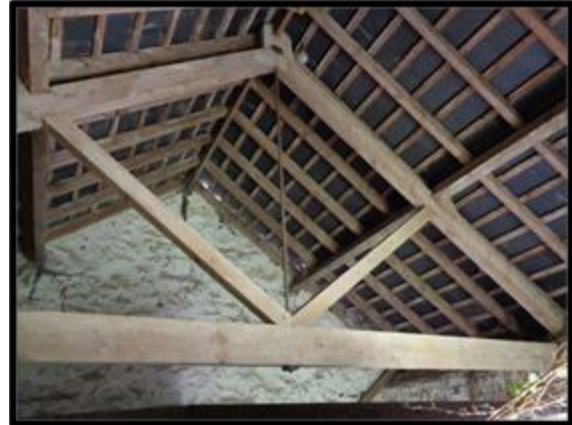
Fig. 17 The trap house roof showing the roof truss with raking struts and suspension rod.

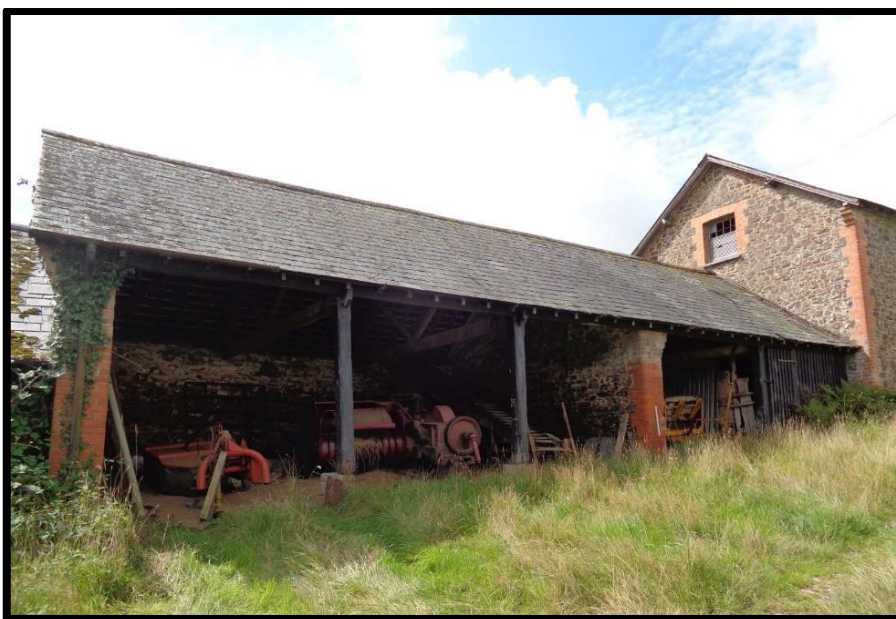
Fig. 18 The north elevation of linhay I.

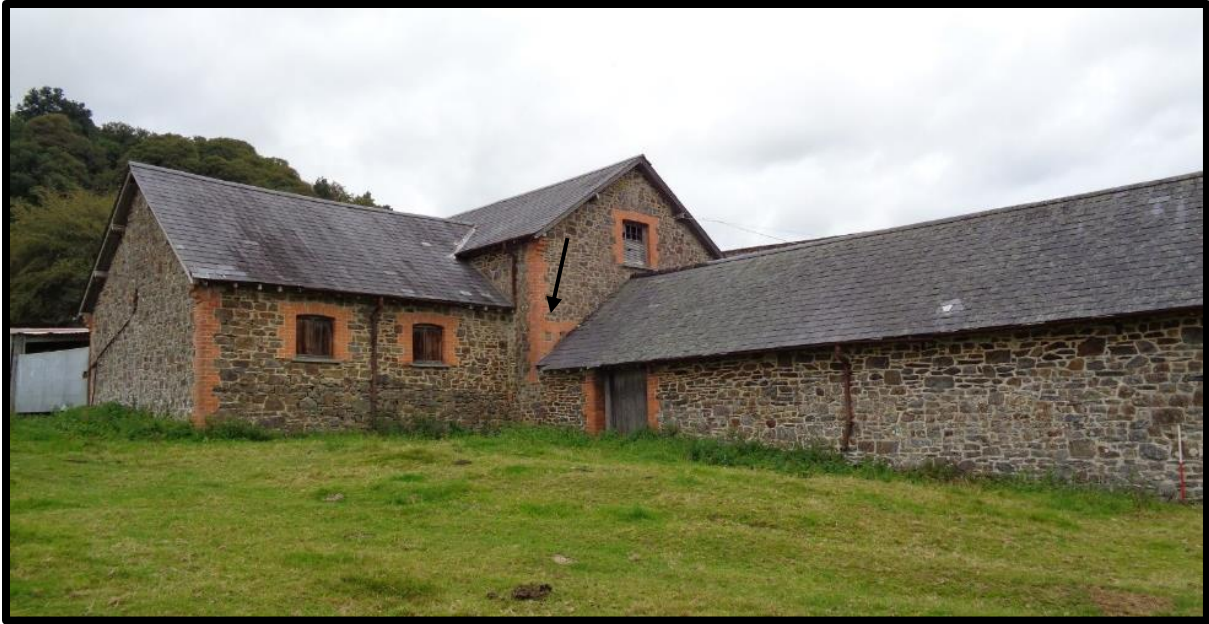
Fig. 19 The south elevation of linhay I (right) showing the differing masonry of the upper section of walling beneath the eaves, the partially blocked opening in the east wall of the threshing barn (arrowed) and the east elevation of the horse-engine house (left).

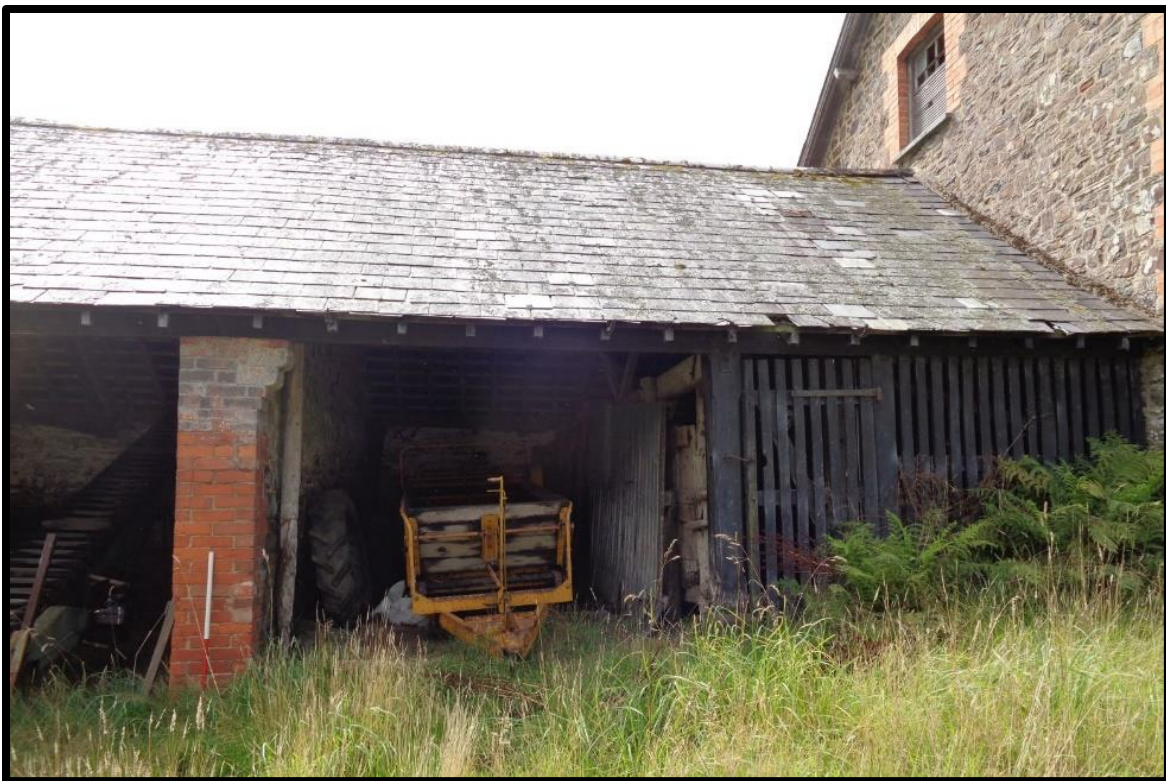
Fig. 20 The north elevation of linhay I showing the brick pier with corbelling marking the original western limit of the building (left) and the ventilation screens to the western bay of the extension (left).

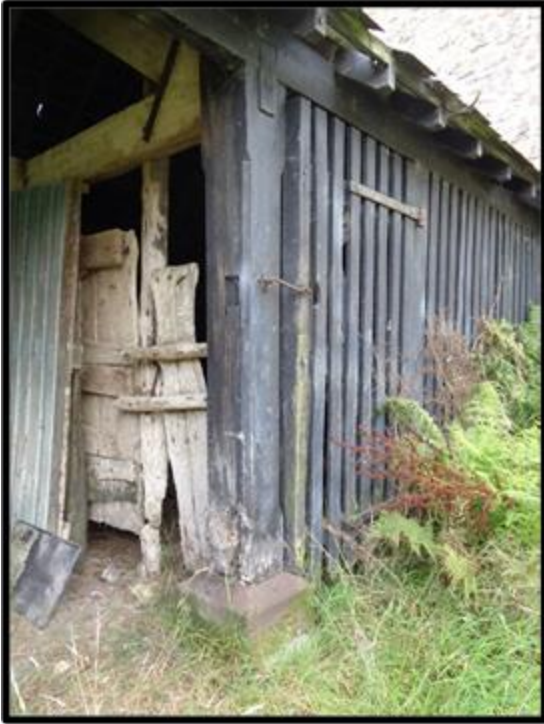
Fig. 21 Detail of the post and base supporting the western bays.

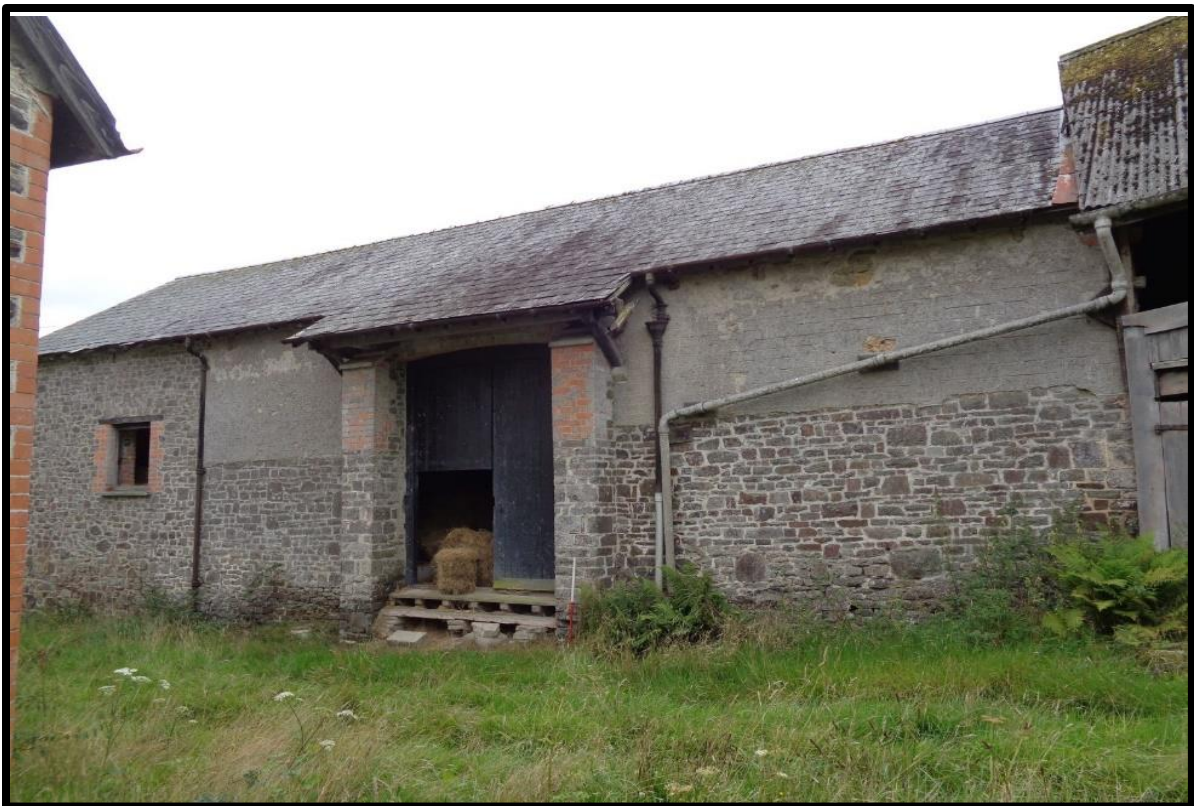
Fig. 23 The north elevation of the threshing barn, showing the secondary extension to its east end (left) and the 19th-century pent roof over the main doors.

The lower part of the south elevation of the early part of the barn has stone walls about two to three metres in height, with cement-rendered cob walling above (Fig. 23). The main doors have solid, square-sectioned buttresses of stone without brick dressings though their upper parts have been entirely rebuilt in brick, presumably replacing earlier cob. The doorway has a wide, low, segmental arch and weathering, over which a pent roof has been constructed in the late 19th century, supported on small struts springing from corbels flanking the buttresses. The doors all bear hinges and furniture stamped with a bold, capital letter 'R', probably referencing the Rolle estate. There are no ventilation slits or other openings and the barn was presumably lit by simply opening both pairs of doors. The eastern part of the barn is a later addition dating from the late 19th century, with stone walls rising to eaves height and dressings of red wire-cut brick. This part of the elevation has a small window with red brick dressings presumably to provide light for those operating the threshing machine. A doorway in the east wall formerly has been partially blocked by the roof of the adjoining linhay (Fig. 22)

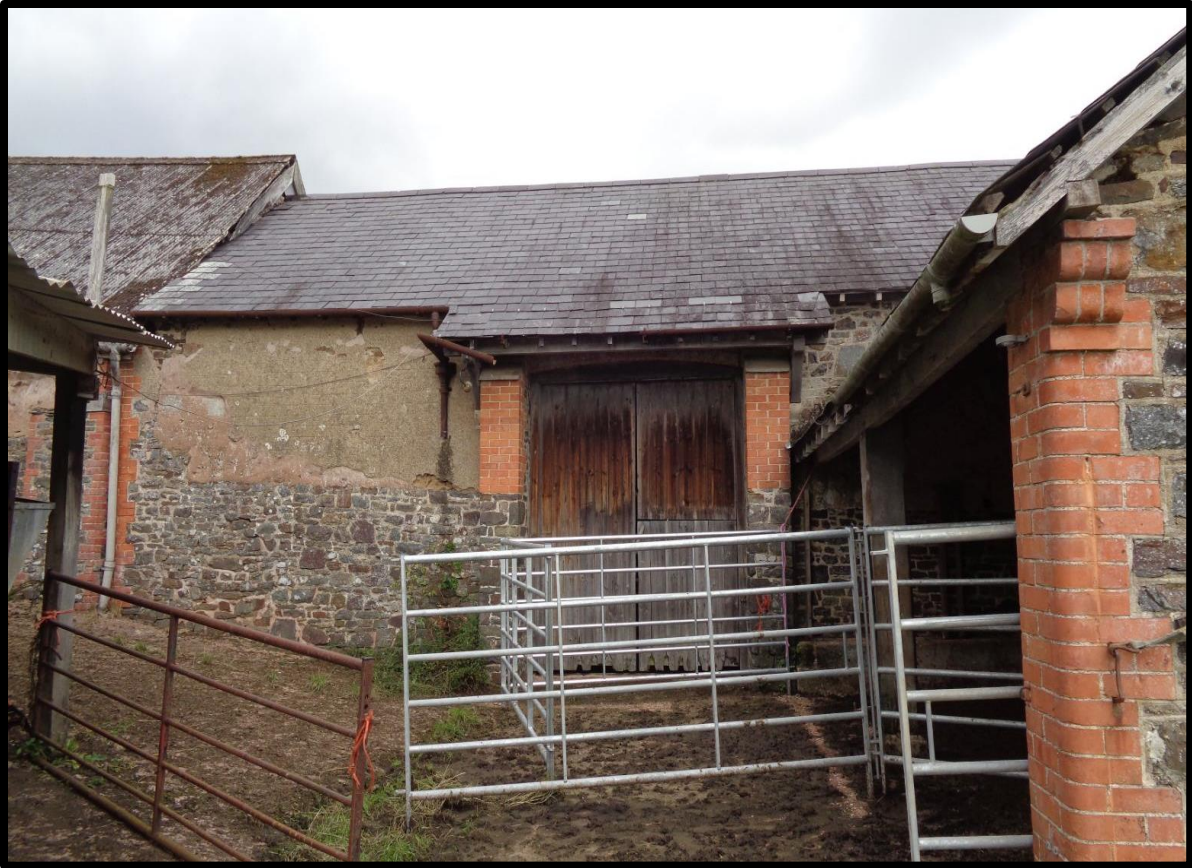
Fig. 24 The south elevation of the threshing barn, showing its relationship with the horse-engine house (right).

The south elevation of the barn has lower stone walls, to about two metres in height, with the same rendered cob masonry above. The buttresses on either side of the main threshing doors are of solid stone, without brick dressings, but have been wholly rebuilt above. Above the doorway is a similar late 19th-century pent roof supported on struts springing from semi-circular corbels. The eastern part of the elevation is partially masked by the horse-engine house. Here the

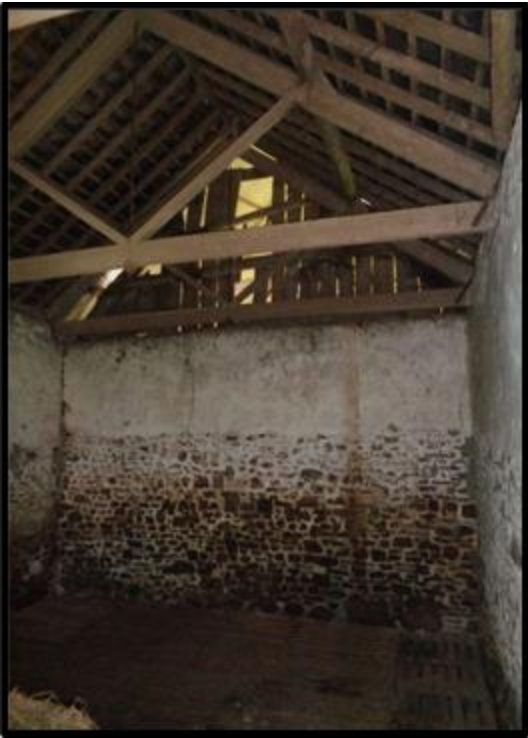
Fig. 25 The interior of the threshing barn, looking west, showing the roof structure.

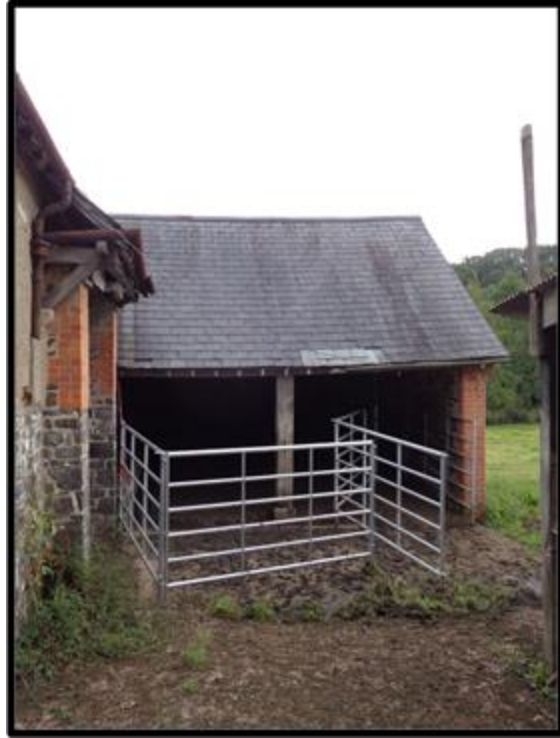
Fig. 26 The west-facing elevation of the horse engine house and the pent roofs over the barn doors.

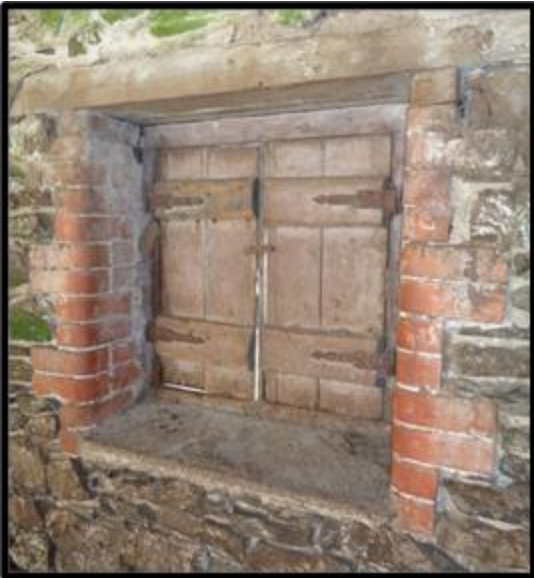
Fig. 27 One of the Shuttered windows of the horse-engine house.

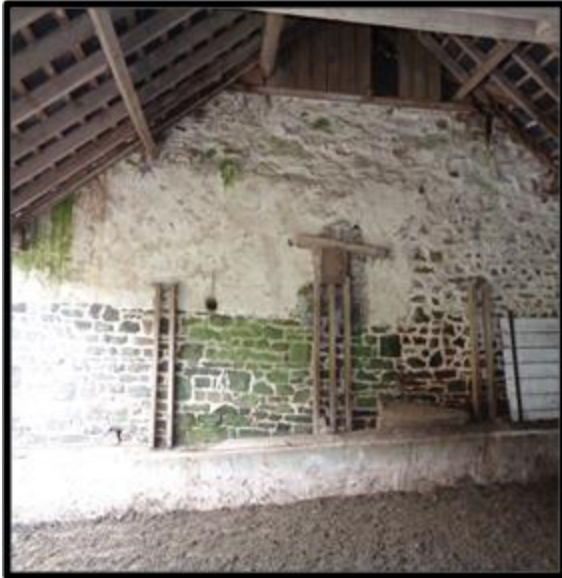
Fig. 28 The interior of the horse engine house showing the traces of beams and openings in the south wall.

end of a massive beam is visible, sawn-off flush with the surface of the wall. This may have projected into the horse-engine house to support the pinions of the capstan. Alternatively, the beam may have crossed the barn to support the threshing machine on a first-floor structure, since removed. The aperture for the drive shaft from the horse engine to the threshing machine may have passed through an aperture in the wall above the beam, now blocked.

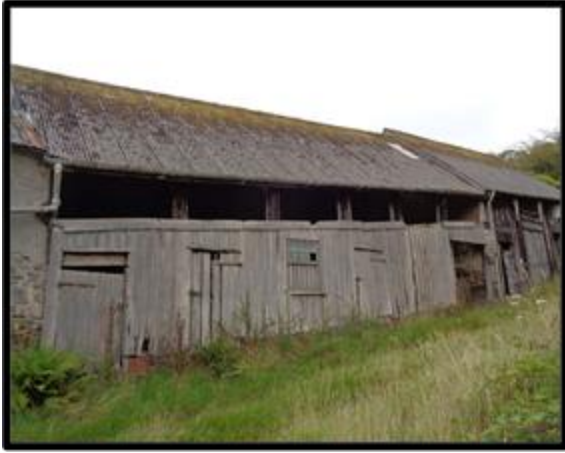
This is one of the oldest structures now visible at the site and is in correspondingly rickety condition (Fig. 29). The building rises steeply with the hill slope to the west and the first-floor platform is therefore not level but slopes steeply eastwards. It is clear that this can never have served as more than a tallet or hay loft.

Fig. 29 The north front of Linhay II showing the late 19th-century enclosure of the lower part of the façade.

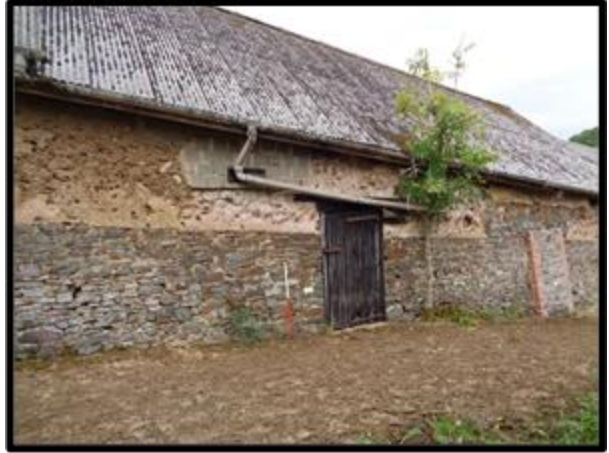
Fig. 30 The south elevation of Linhay II showing the much patched and buttressed rear wall of cob and stone with later buttresses.

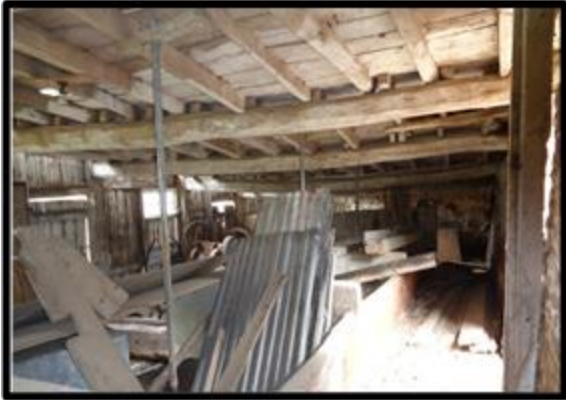
The loft beams and joists are of a blond, wide-grained timber, probably of elm, the floor joists being staggered from bay to bay, simply resting on, rather than housed or tenoned into the principal beams (Fig. 31). The timbers are crudely but effectively shaped and laid flat so that their irregular form in an horizontal plane does not affect the floor. They are agreeably wiggly. The floor boards are in relatively poor condition but are also probably of elm and may be contemporary.

Fig. 31 The interior of Linhay II showing the staggered joists of the first-floor structure.

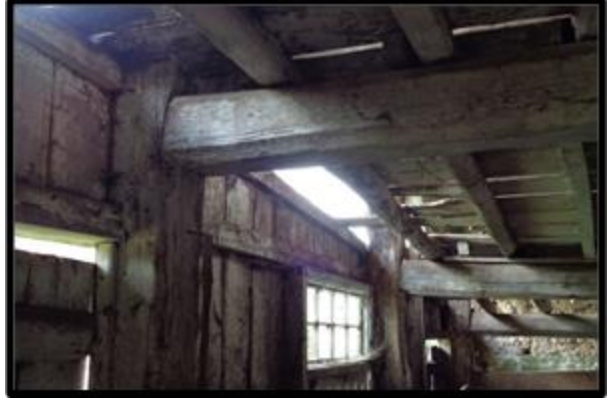
Fig. 32 Detail of the construction of the north front of Linhay II showing the junction of the wall posts and the principal first-floor beams.

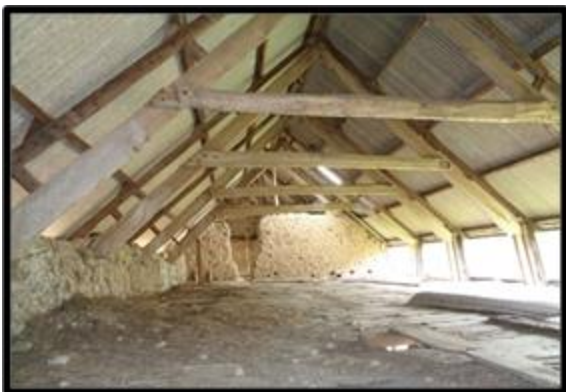
Fig. 33 The first-floor interior of Linhay II, looking west, showing the lapped collars of the roof trusses and the cob walling.

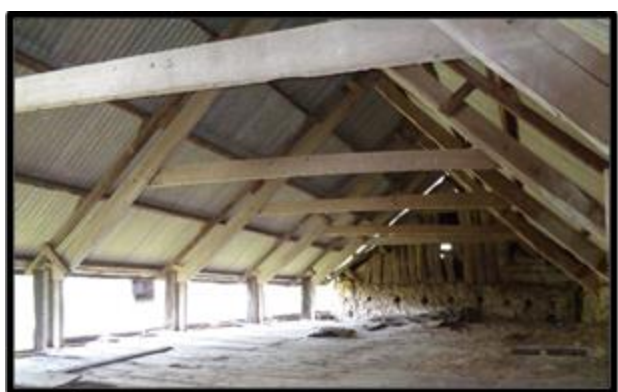
Fig. 34 The interior of the loft of Linhay II looking east, showing the redundant sockets for an earlier first-floor structure in the gable wall.

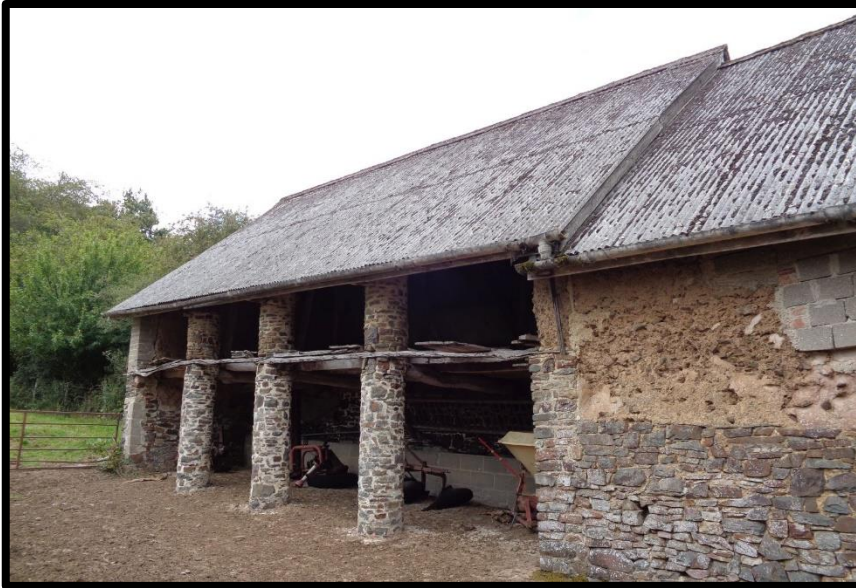
Fig. 35 The south elevation Linhay III, showing the cylindrical piers supporting the first-floor structure and roofs.

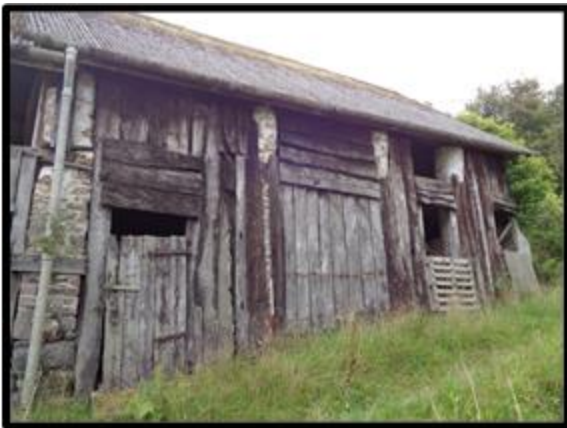
Fig 36 The north front of Linhay III showing later enclosure of the façade.

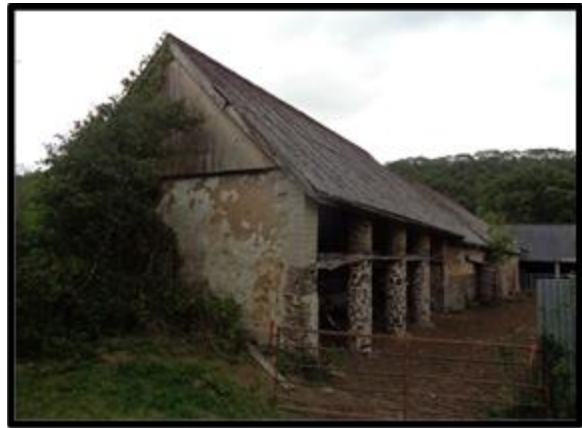
Fig. 37 The western gable of the double linhay III showing possible evidence for a half hip.

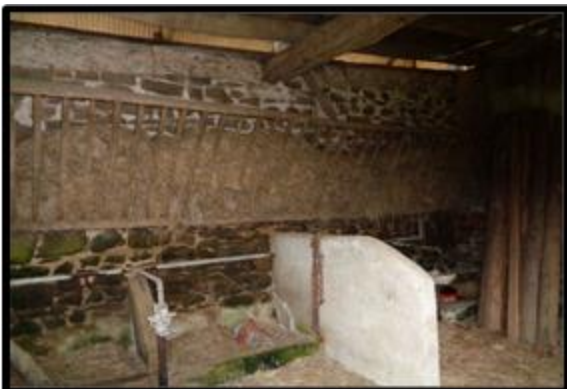
Fig 38 The interior of the north side of the double linhay showing the timber manger below the pitching void and the remains of modern cattle stalls.

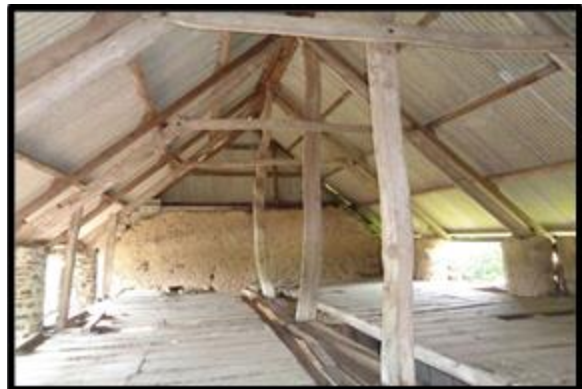
Fig 39 The interior of the first floor of the double linhay showing the single loft with a central pitching void serving both sets of mangers.

The roof and loft of this building are not accessible due to concerns about the condition of the floor, however the three 'A'-framed trusses appear to be contemporary with the building. They have applied collars secured with pegs and secured to the central posts below the ridge (Fig. 39).

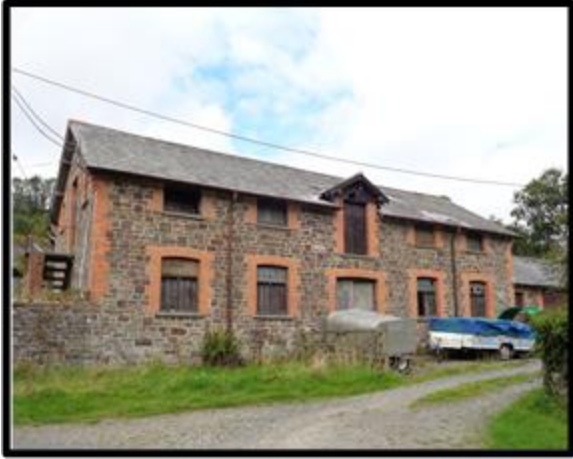
Fig. 40 The east front of the granary and possible stable block close to the house.

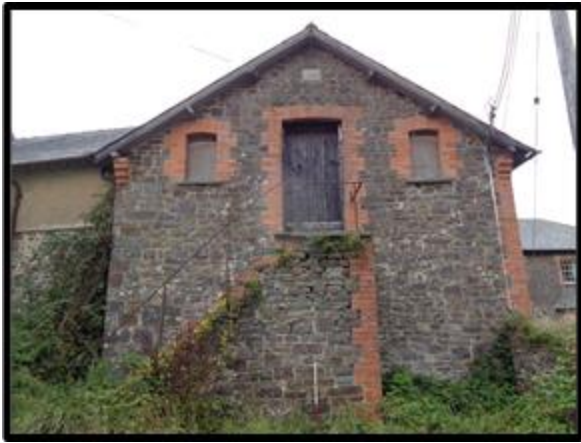
Fig. 42 The gable end of the granary showing the loft access.

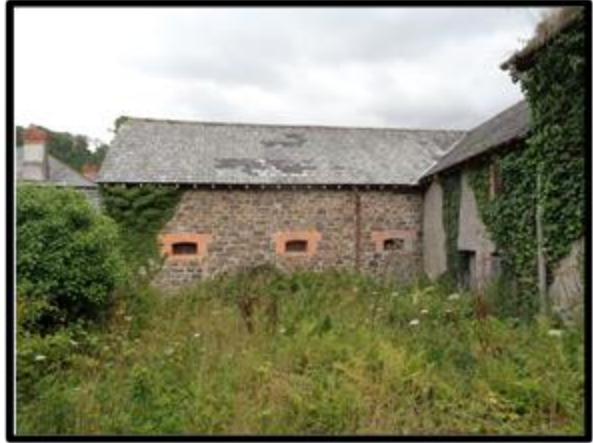
Fig. 43 The rear elevation of the granary showing possible stable ventilator windows.

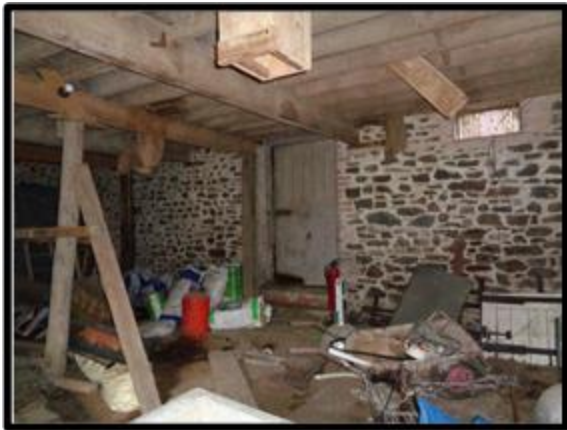
Fig. 44 The interior of the possible stable showing chutes from the granary floor above and the door to the poundhouse .

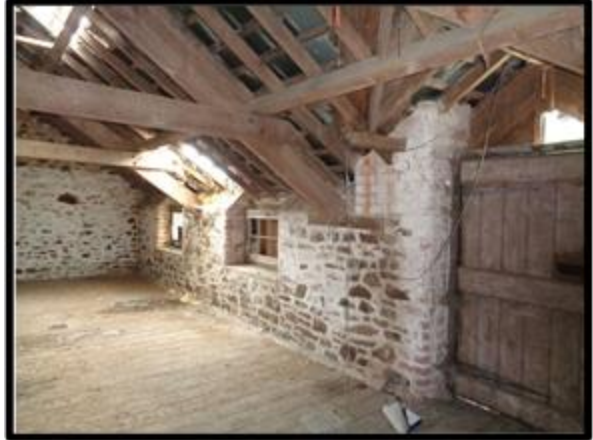
Fig. 45 The interior of the granary, looking north-east.

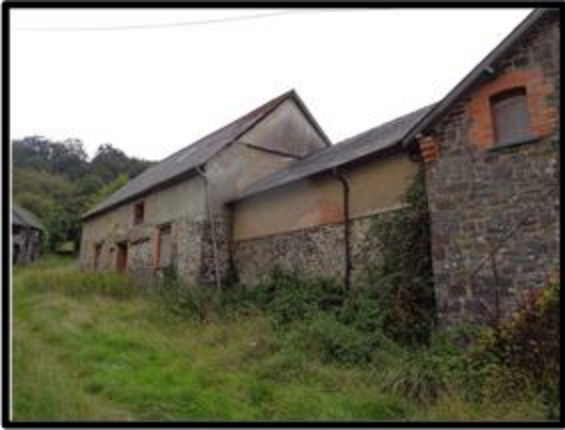
Fig. 46 The south elevation of the stable (left) and poundhouse (Right) from the farmyard.

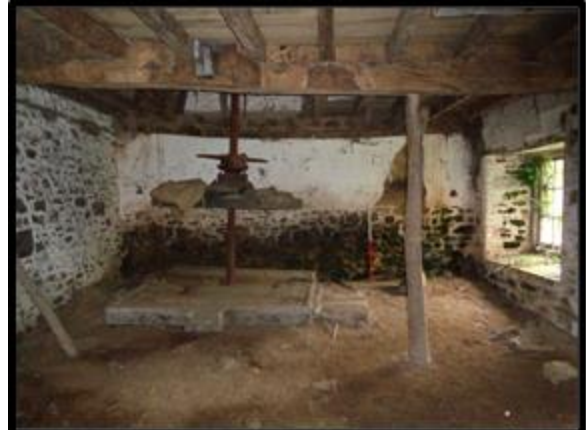
The room contains a handsome cider press (Fig. 47), though this too has probably been re-sited here since it cuts into the ceiling joists. A stair-ladder in the north-eastern corner of the room leads to the loft and also cuts through the ceiling (Fig. 48).

Fig. 47 The interior of the poundhouse, showing the cider press and the construction of the loft floor.

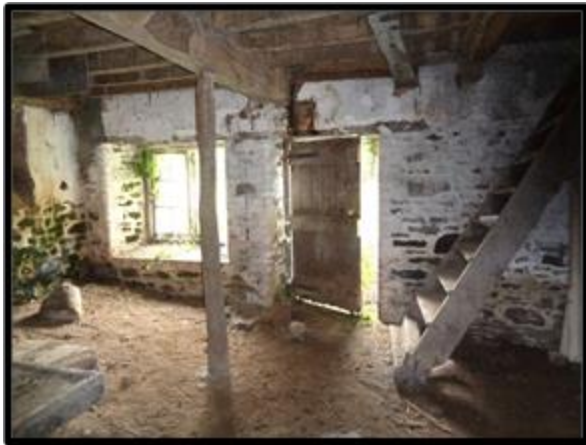
Fig. 48 The interior of the poundhouse looking towards the northern stair.

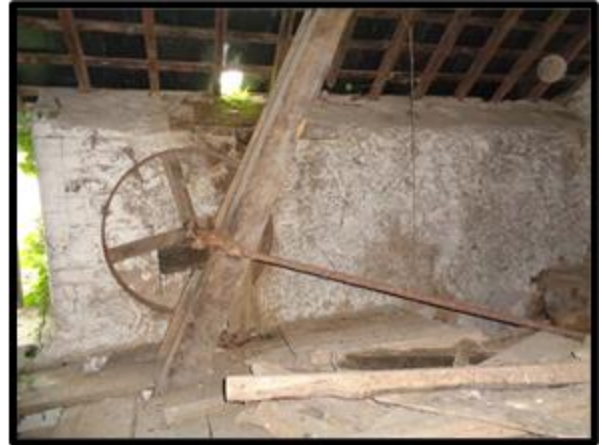
The first-floor loft has a small loft hatch to the yard, with red brick dressings. Close to this is the remains of a piece of farm machinery, consisting of part of a belt drive and transmission shaft (Fig. 49). Unfortunately, there is no evidence for where the power to drive this machinery came from; it seems unlikely that this kind of machinery could have driven the cider press, and it is possible that the shaft provided power to a missing piece of machinery, such as an apple cutter. The roof is the same as that in the granary and must have been entirely replaced when the farm buildings were reconstructed in the late 19th century. The building may, however, be considerably older and may perhaps be recognised on the tithe map of 1845 (Fig. 9).

Fig. 49 The remains of a belt drive and transmission shaft above the doorway in the north wall of the poundhouse loft.

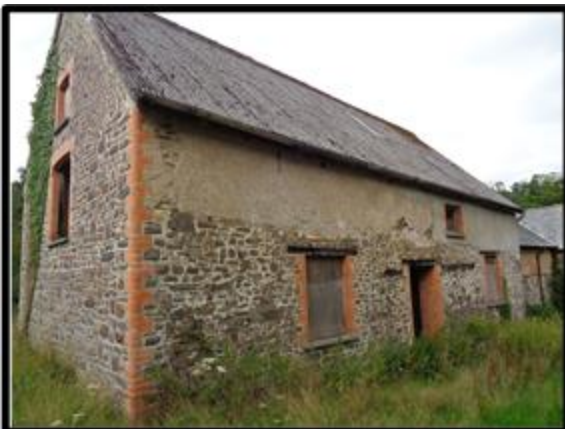
Fig. 50 The south elevation of the stable showing 19th-century red brick repairs to the openings and jambs.

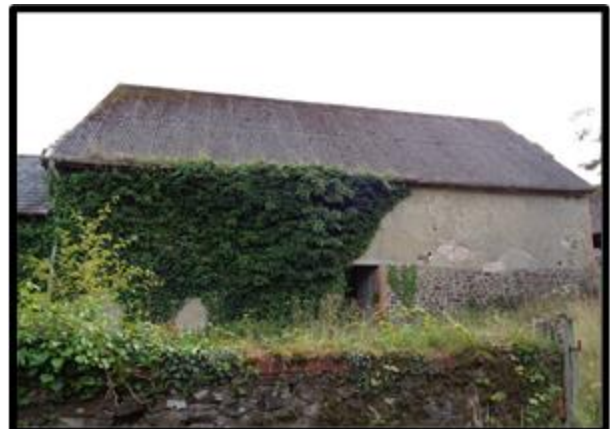
Fig. 51 The north elevation of the stables.

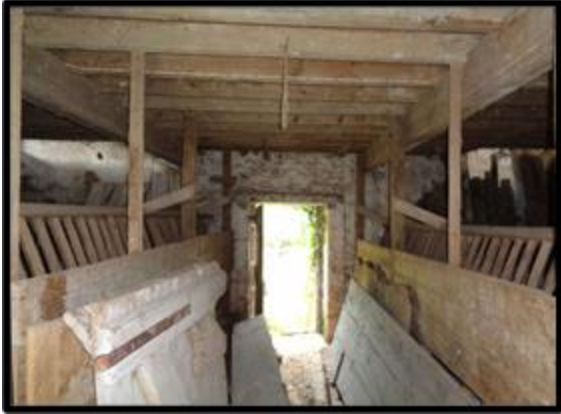
Fig. 52 The interior of the stable showing the head walk forming a cross passage through the building.

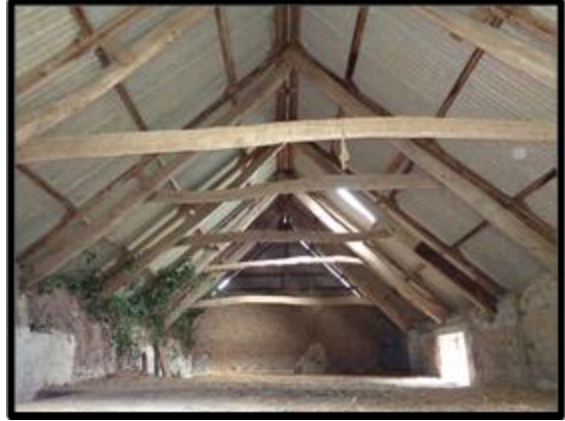
Fig. 53 The roof and loft over the stables.

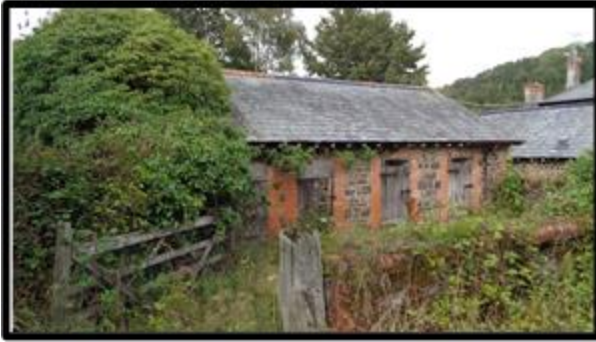
The piggeries also date from the 1870s or 1880s and probably occupy the site of the earlier farmhouse. They consist of a low range of buildings, almost square in plan, under a pitched slate roof (Fig. 54). The piggeries are very sturdily constructed of snecked rubble with red brick dressings. The main façade looks out onto a walled enclosure onto which four doorways open. These have all retained excellent quality door furniture manufactured specially for the Rolle estate and bearing the Capital letter 'R', as found across the entire site (Fig. 55). Unusually, the doorways have projecting blocks of ham stone built into their eastern jambs which formed very sturdy stops for the doors (Fig. 56).

Fig. 54 The piggeries at the north edge of the site.

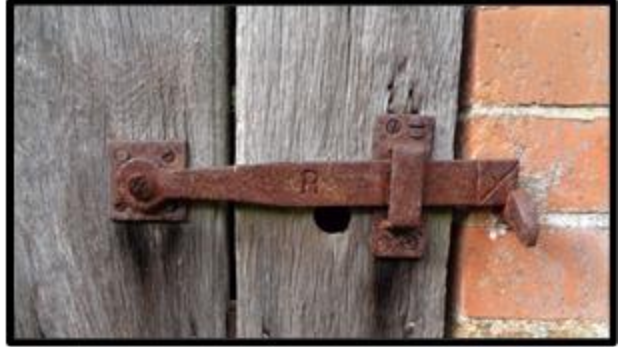
Fig. 55 Detail of the attractive door furniture on the piggeries and many other buildings.

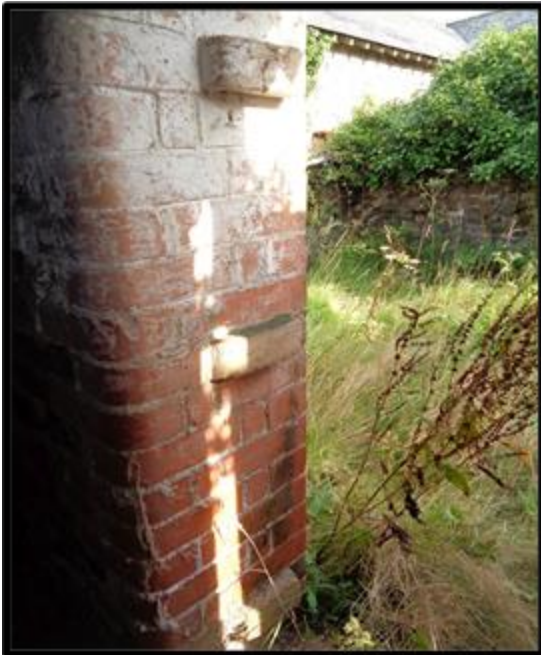
Fig. 56 The unusual projections at the piggery door jambs.

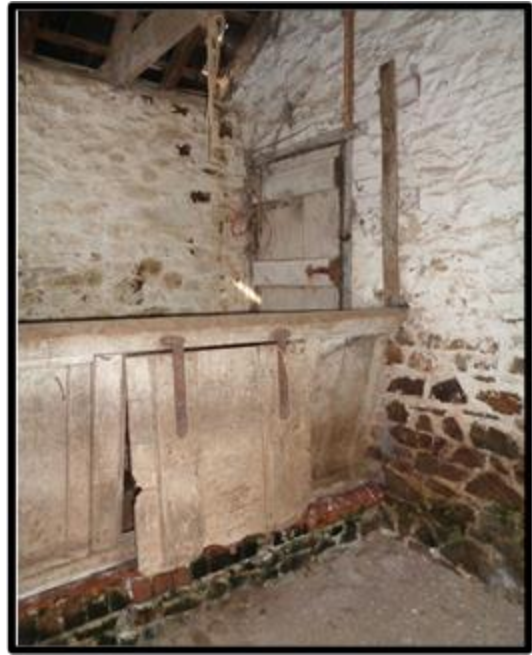
Fig. 57 The interior of the piggeries showing a feeding hatch from the headwalk.

The interior of the piggery is exceptionally well preserved, divided into four pens, each with a low but substantially constructed partition with a cat-flap-style hatch opening upon the head walk, which extends across three fourths of the north side of the building (Fig 57). This is accessed by a doorway in the east wall of the building, presumably from a passage or alley near the western side of the farmhouse.
