Historic Building Survey

**THE CRAWFORD HOTEL,
FORMERLY 'LION HOUSE',
ALPHINGTON ROAD, EXETER**

By R. W. Parker

REPORT No. 2013.02

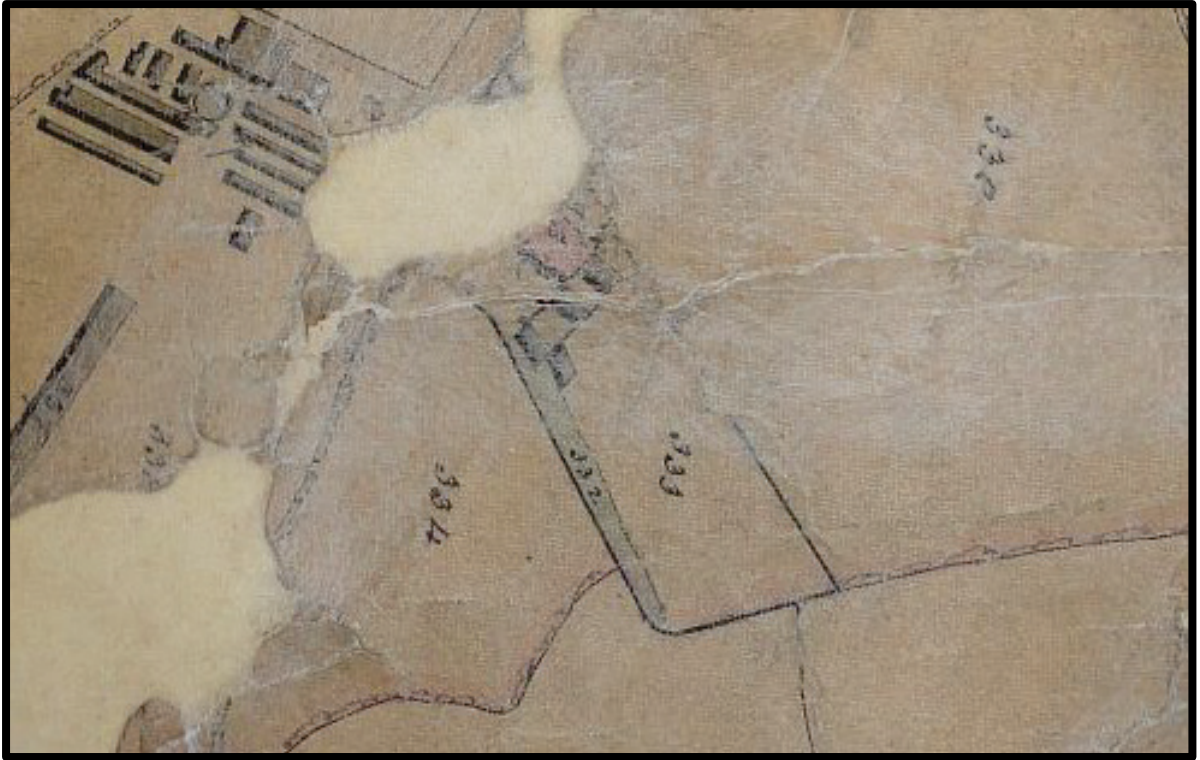
Fig. 7 Extract from the St Thomas tithe map, probably made to accompany the tithe apportionment of 1838, but stamped '1841', showing the layout of the site and buildings at that time, when the property may have been newly completed.

The St Thomas tithe map, presumably made at the same time as the apportionment, but later stamped with the date '1841', must show the property much as first constructed. The map (Fig. 7) is unfortunately damaged, but shows the main house as a large rectangular block, coloured pink, with three smaller blocks to the rear, linked by walls and separated by two small courtyards. These are coloured grey, and appear to have been service ranges. A fourth grey block beyond the eastern wall is offset slightly from the east end of the southernmost service block and extends along the boundary of a narrow strip of ground, coloured blue, which appears to have been a long narrow garden. All but two of these structures survive today.

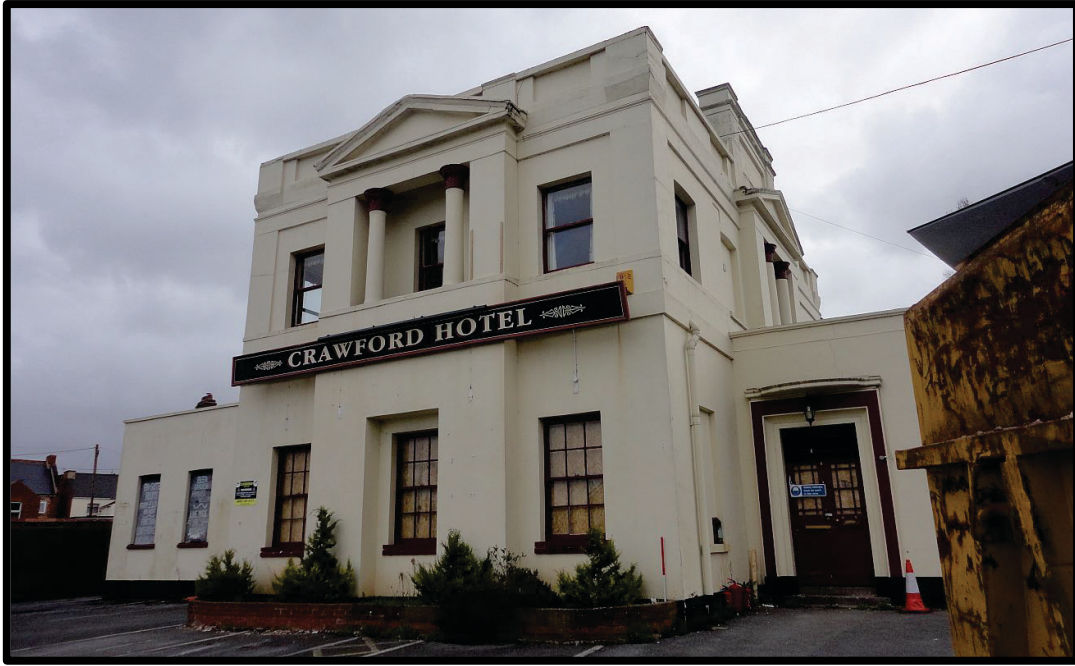
Fig. 11 The main elevation of the house from the south west, showing the unusual proportions of the ground floor, which were formerly resolved by the sloping roof of a verandah.

The unusual proportions of the west front; tall and narrow, with a particularly high and prominent lower storey (Fig. 11), was both necessitated and resolved by a single-storey verandah, which does not survive. The sloping roof of this verandah would have masked the high-waisted appearance of the ground floor. All three ground-floor windows were originally full-height French windows opening onto the verandah. They were partially blocked in 1938-9 at the conversion of the building. The central bay is brought forward into a projecting two-storey aedicule crowned by a pediment, with square piers supporting the entablature and a pair of tall cylindrical columns with highly unusual 'basket-work' capitals decorated with anthemion (honeysuckle) motifs framing the central window. These capitals (Fig. 12) may reflect ancient theories about the origins of the Corinthian order (a funerary basket overgrown with foliage and covered by a tile) as first described by Vitruvius in *De Architectura Libri Decem IV*, chapter I (Fletcher, 1950, 113) and popularised in the 18th and 19th centuries by William Chambers' *Treatise on Civil Architecture*, published in 1759 and re-published in 1791 and 1825. (Summerson 1980, 135, 138;). These capitals are extremely rare: these are the only examples of this type known to the author.

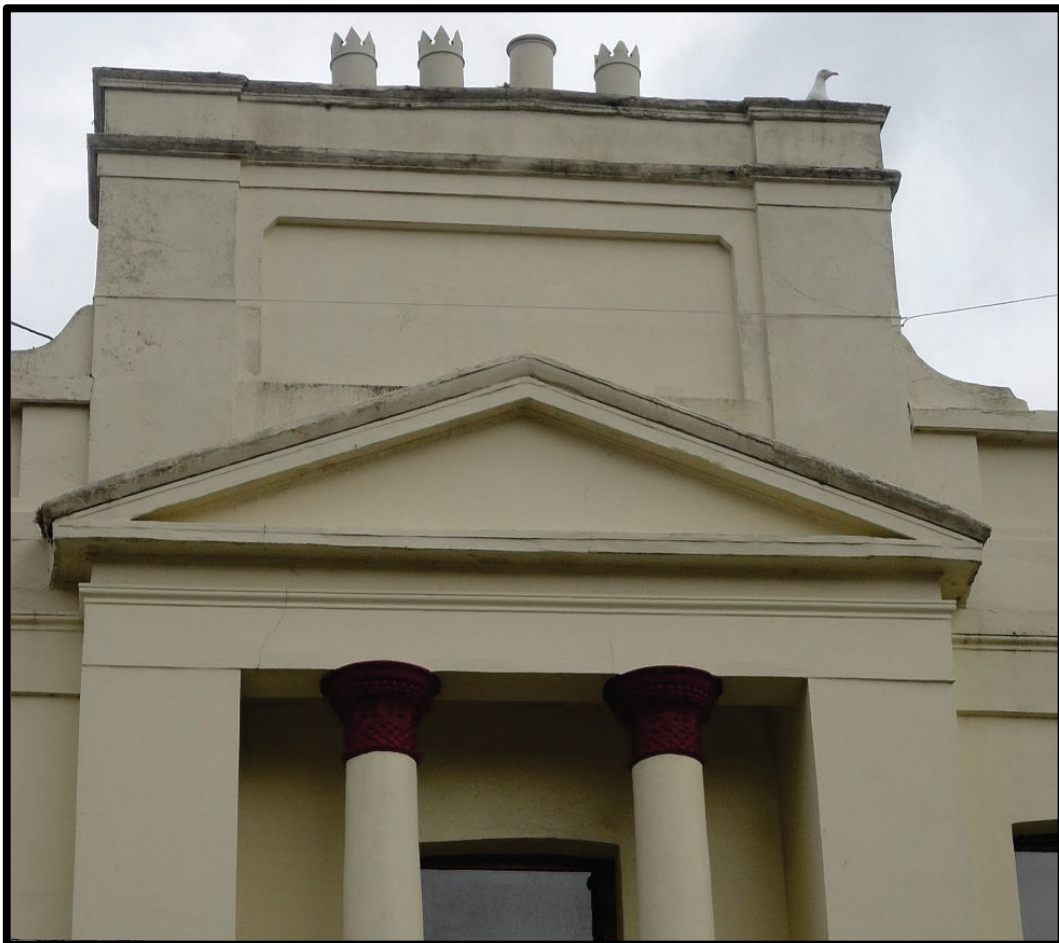
Fig 12 Detail of the pedimented aedicule and attic masking the chimneys on the south front of the house and showing the unusual 'basket-work' character of the capitals of the columns.

The wall on either side of the central aedicule is slightly recessed, giving the effect of piers at each corner and forming recessed panels framing the windows. All the windows are replacement sashes of c.1938-9. The cornice of the entablature of the central aedicule originally ran around the entire building but has been damaged and very crudely repaired, surviving only in the pedimented sections of the three façades. Above the cornice the high parapet is treated with recessed panels defining the angle piers and further recessed panels within these. It is highly likely that there was a further cornice above this and that the angle piers were crowned with urns or finials, but these do not survive: the wall is now capped by a plain coping dating from 1938, or perhaps a subsequent repair.

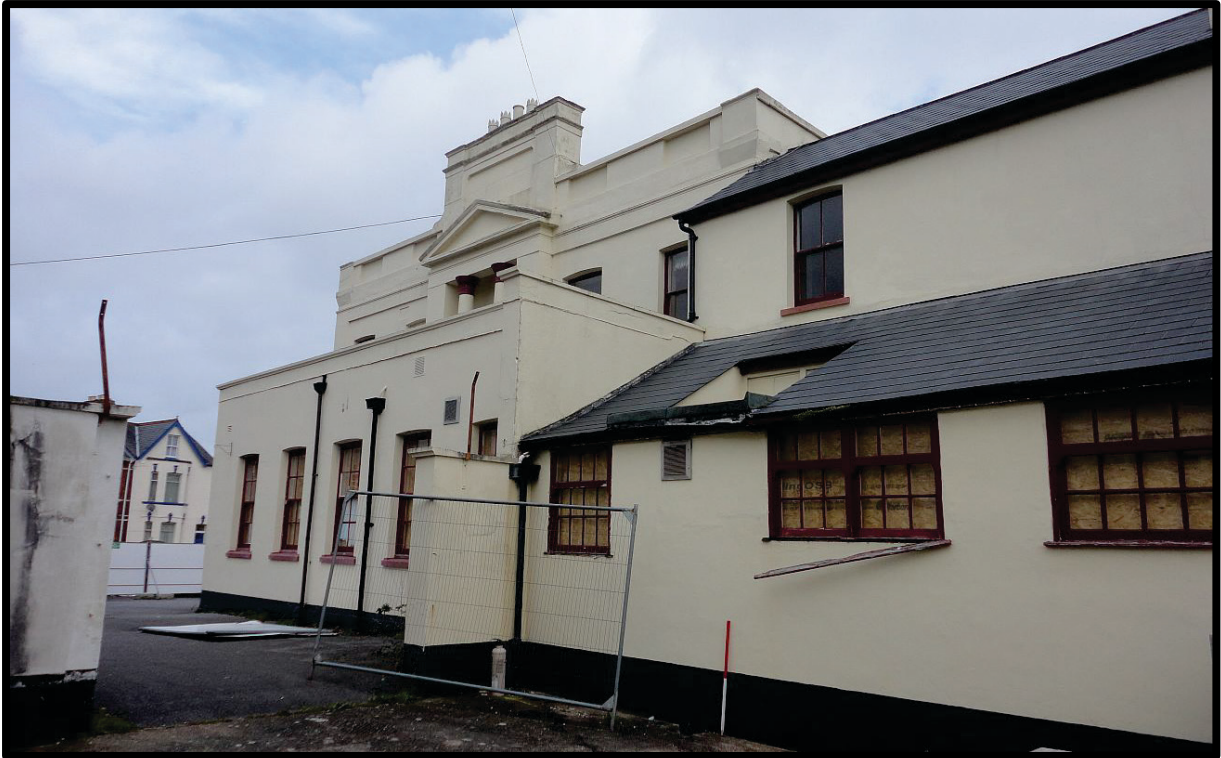
Fig. 13 The south elevation seen from the stable yard, showing the nucleus of the original house rising above the later 1930s porch extension added against its entrance façade (centre) and the lean to structure which might represent parts of the original central service range (right).

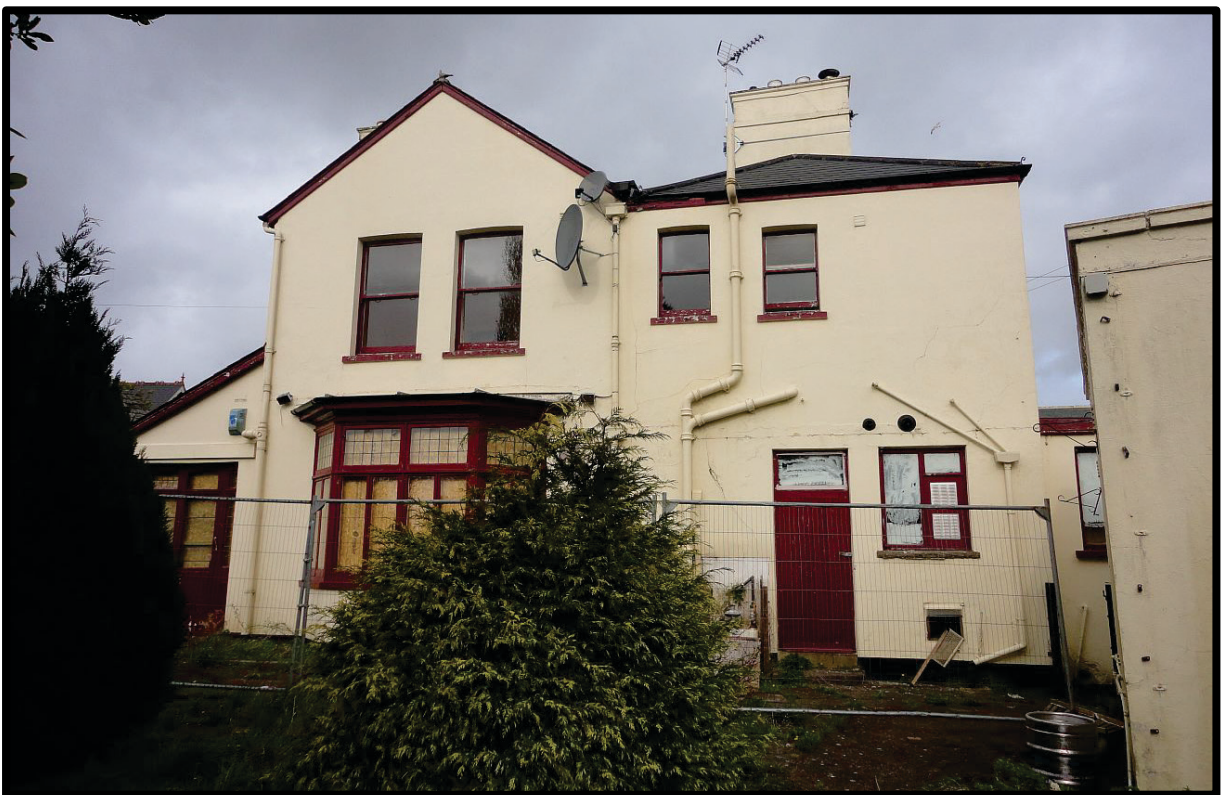
Fig. 14 The eastern elevation, showing the lean-to structure representing the remains of a further service range (left), the gabled elevation of the late 19th- or early 20th-century extension (centre) and the end of the original service wing (right).

The eastern elevation of the house shows very clearly the development of the building (Fig. 14). This was the least significant elevation of the building and was not treated architecturally. The original main service wing, of two storeys, with a low-pitched hipped roof can be clearly discerned today as the northern part of the elevation, though its fenestration has been much altered. Adjoining it to the south is the large gabled two-storey extension infilling the original kitchen yard. This was perhaps added in the late 19th or early 20th century to increase the domestic accommodation by the addition of extra reception rooms and bedrooms. The lean-to structure adjoining this perhaps represents the remains of the original central service range, though it is likely that this has been extensively rebuilt, since the large two storey extension must have encroached upon it. Both the gabled extension and the lean-to structure have large ground floor windows designed to connect the house with the garden. The large bay window in the gabled range has leaded upper lights and a moulded cornice and might well be as early as *c.*1900, but it is also possible that it was added later in the century, at the conversion of the house to an hotel. The French windows in the adjoining lean-to have similar leaded glazing, but seem more likely to belong to the later period, after the internal partitions shown on the 1932 OS map were removed and the area converted to a long reception room with direct communication with the gardens

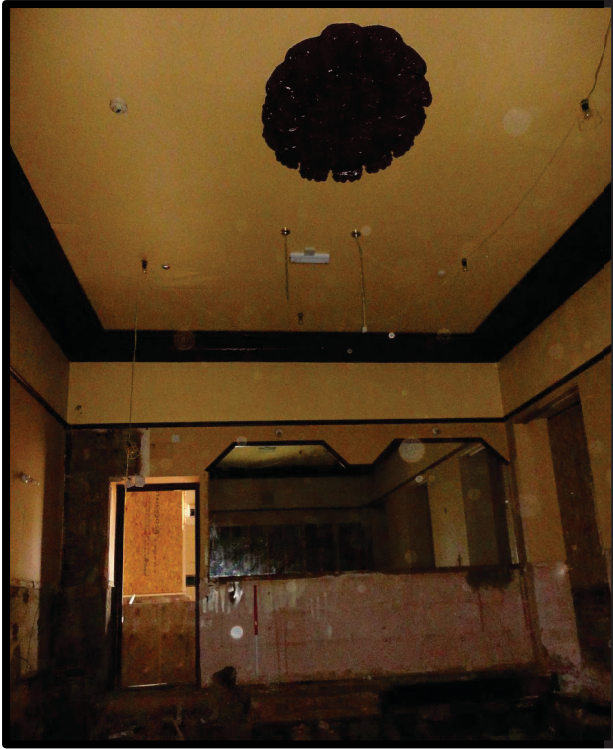
Fig. 15 Interior of the parlour of the original house, showing the plasterwork.

The main surviving room on the ground floor relating to the original house is a large room in the western part of the building. This has been severely altered and a large part of its walling has been removed, but it retains elaborate and very rich plasterwork cornices and a ceiling rose featuring anthemion (honeysuckle) motifs (Figs 15, 16). The room originally opened onto the verandah by three tall French windows, but these have been partially blocked and replica Georgian sashes have been inserted in their place. There was originally a fireplace in the east wall, probably central to the room, but this has not survived and its opening is blocked. This room was probably the drawing room or parlour; the principal reception room of the original house.

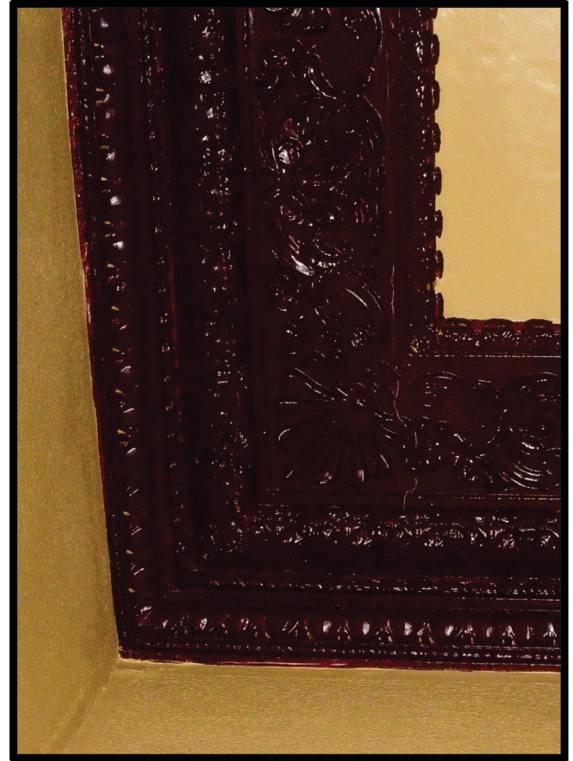
Fig. 16 Detail of the plasterwork.

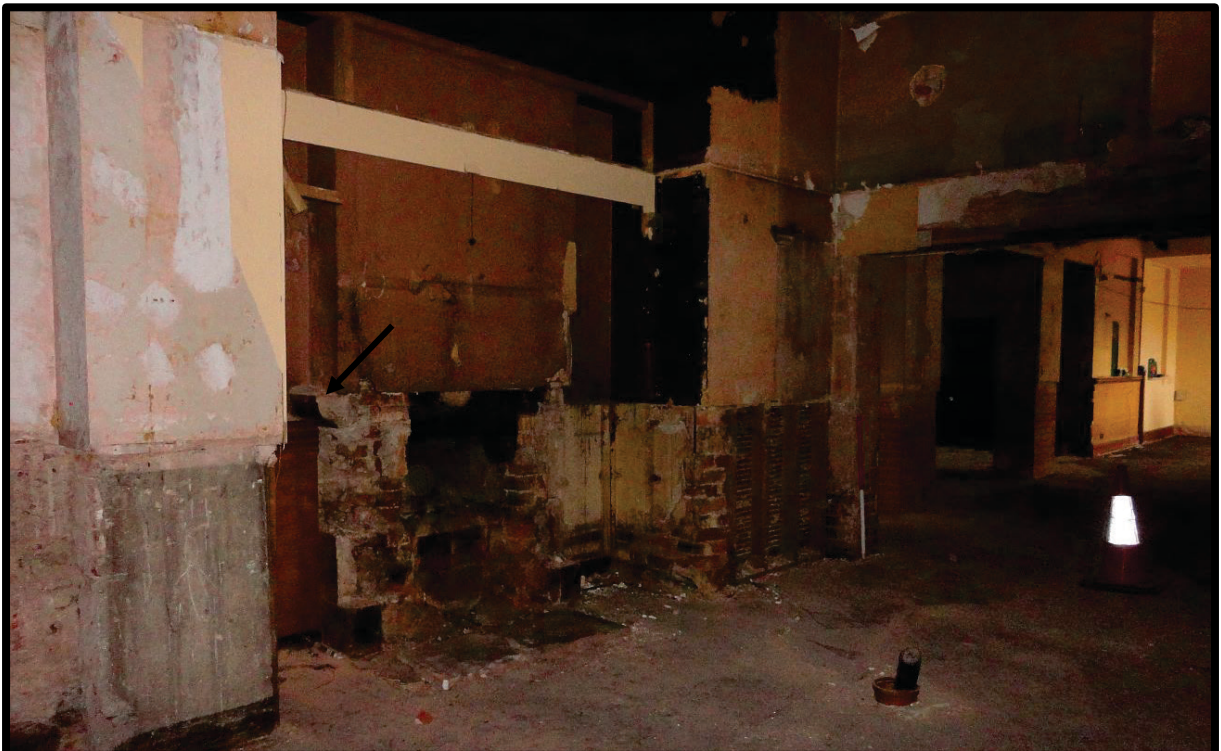
Fig. 17 View of the ground-floor rooms looking from the presumed site of the dining room to the site of the conservatory and the 1930s wing to the north, showing the remains of a chimney breast featuring a very large 'architectural' fireplace with a ovolo-moulded stone mantel shelf (arrowed), probably added as a feature in 1938-9.

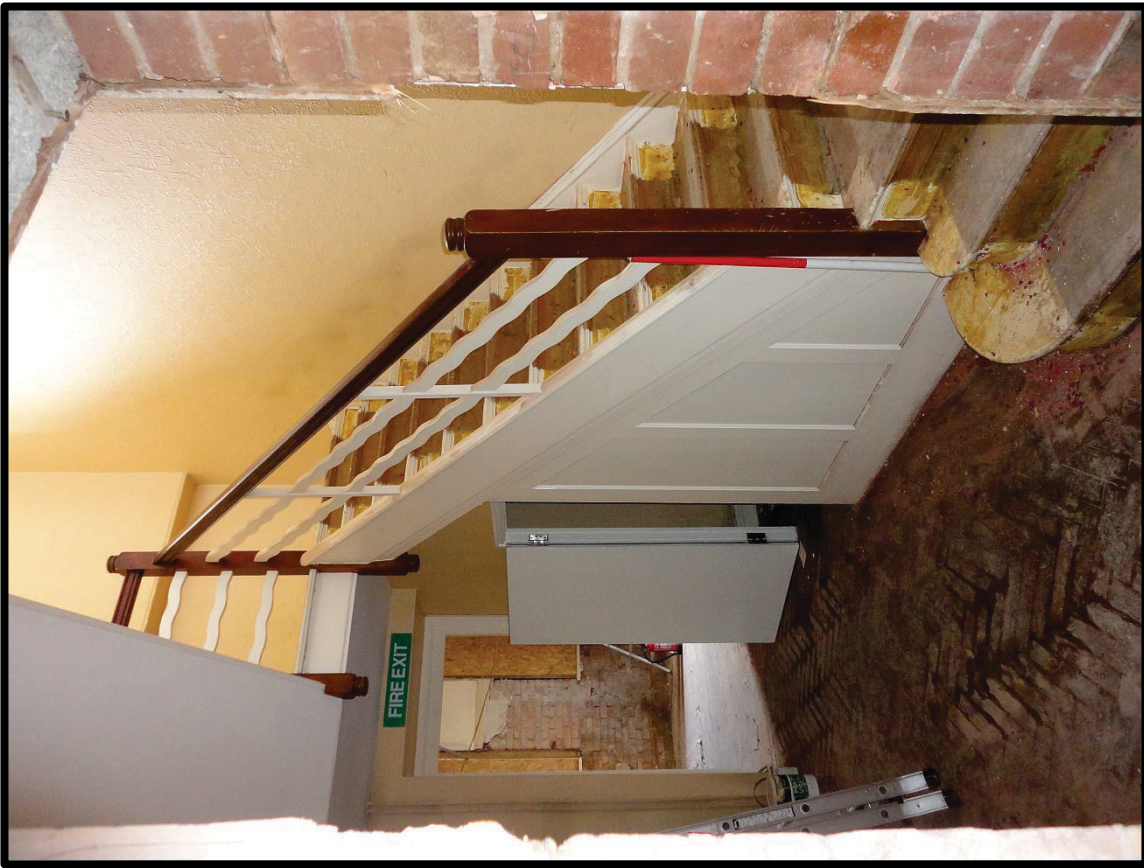
Fig. 18 Detail of the 20th-century main stair added within the original entrance lobby in 1938-9.

The existing modern staircase rises to the first floor within the area of the presumed entrance lobby, returning against the west wall. This staircase (Fig. 18) has a decorative balustrade of wavy horizontal bars and newels crowned by ball finials. It was probably added in 1938 to provide access from the reception area to the hotel bedrooms.

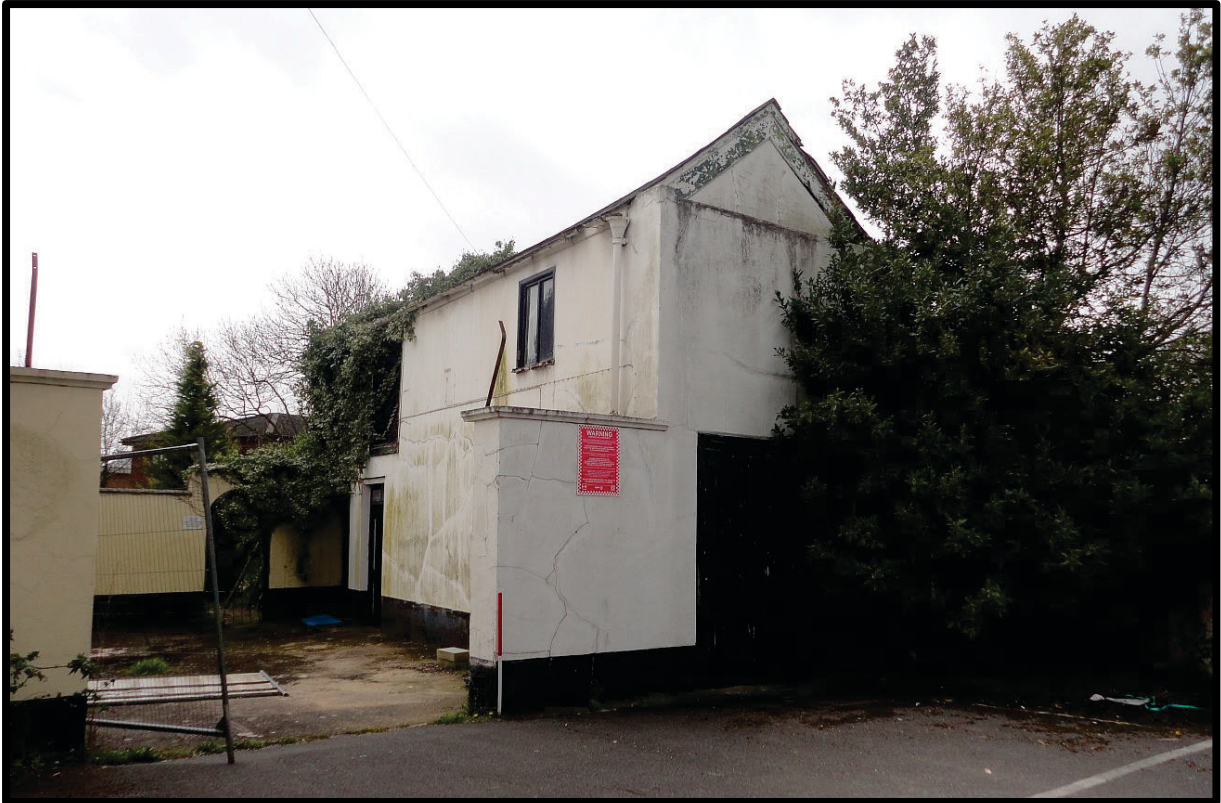
Fig. 20 View of the stables from the north west with the entrance to the stable yard on the left.

This small, rendered building, although much rebuilt, is one of the primary structures on the site. It formed one of the service ranges, and appears on the tithe map of 1838. The building is constructed on a trapezoidal plan, partially of stone and partially of cob. The cob walling rises only to first-floor level, above which is timber-framed studwork covered in lath and plaster. The stone wall to the south rises to the full height of the building and may represent 19th-century reconstruction of a failing cob wall, though no dating evidence remains to confirm this. The western façade of the building features a pair of modern double doors suitable for a vehicular entrance (Fig. 20). The jambs of these doors are of concrete and have certainly been rebuilt. There is no evidence of a vehicular entrance here on the 1st-edition OS map, which shows a shrubbery against this wall. All access to this building must therefore have been from the stable yard. Above this the gable is blind and there are no signs of blocked openings either internally or externally.

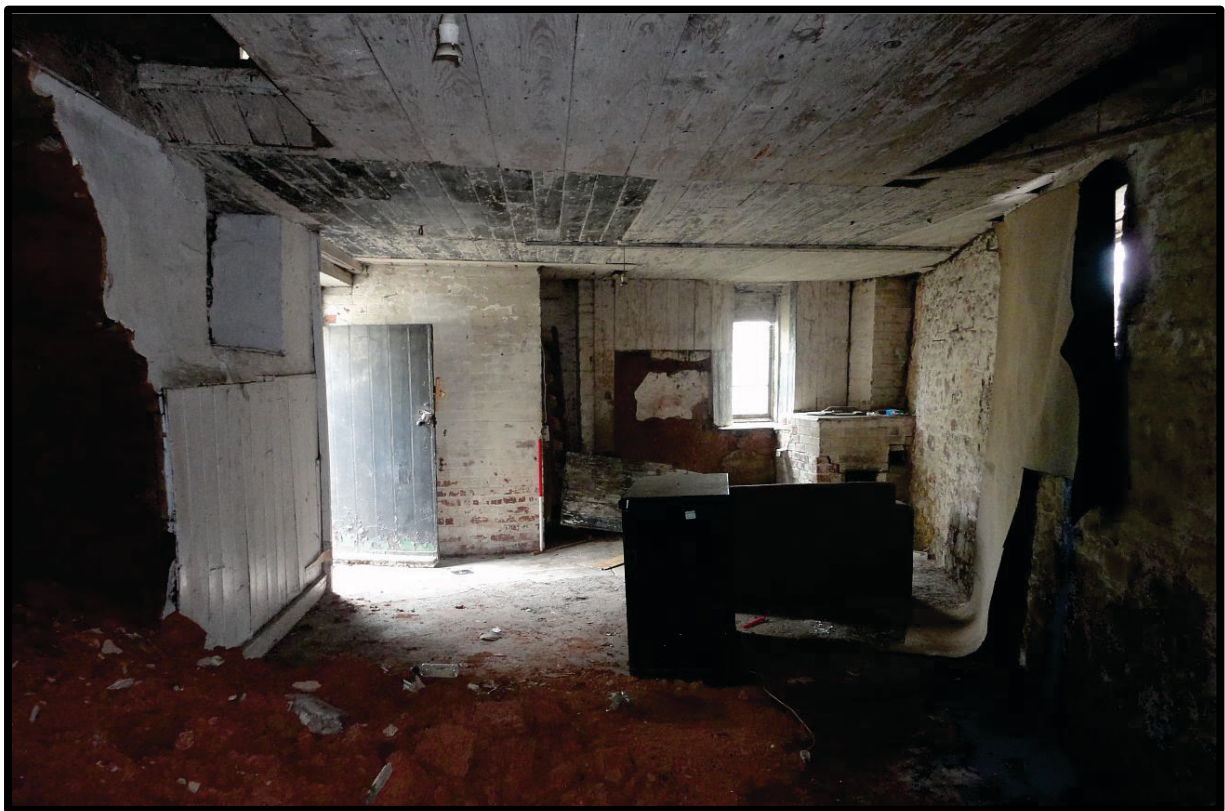
Fig. 21 Interior of the stables, looking east, showing the collapsed cob walling and the position of the washing copper in the south-eastern corner.

The interior of the building is now a single volume (Fig 21), but it is clear from the historic maps and from the paving of the floors that the building was originally divided into two parts. The two doorways and the number of windows, plus the loading door at first floor level all strongly suggest that this building was originally a stable, though no stable fittings remain and it has most recently been employed as a garage and store. The only surviving fixture on the ground floor is an early 20th

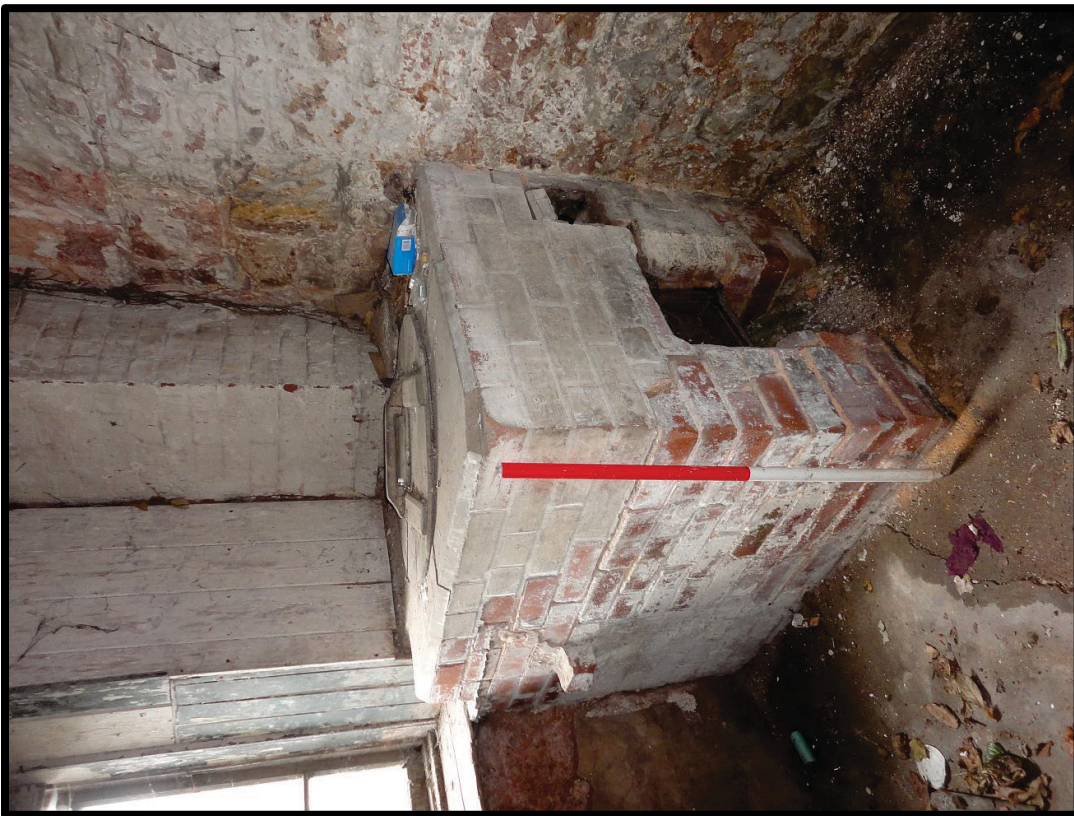
Fig. 23 Detail of the washing copper in the south-eastern corner of the stables showing the stokehole, flue and the timber lid.

century washing copper at the south-eastern corner. This is a rare survival as it is complete, including its wooden lid and bowl, and with a brick flue rising in the corner of the building. The copper suggests that the building was employed as a laundry before the conversion of the house to an hotel.

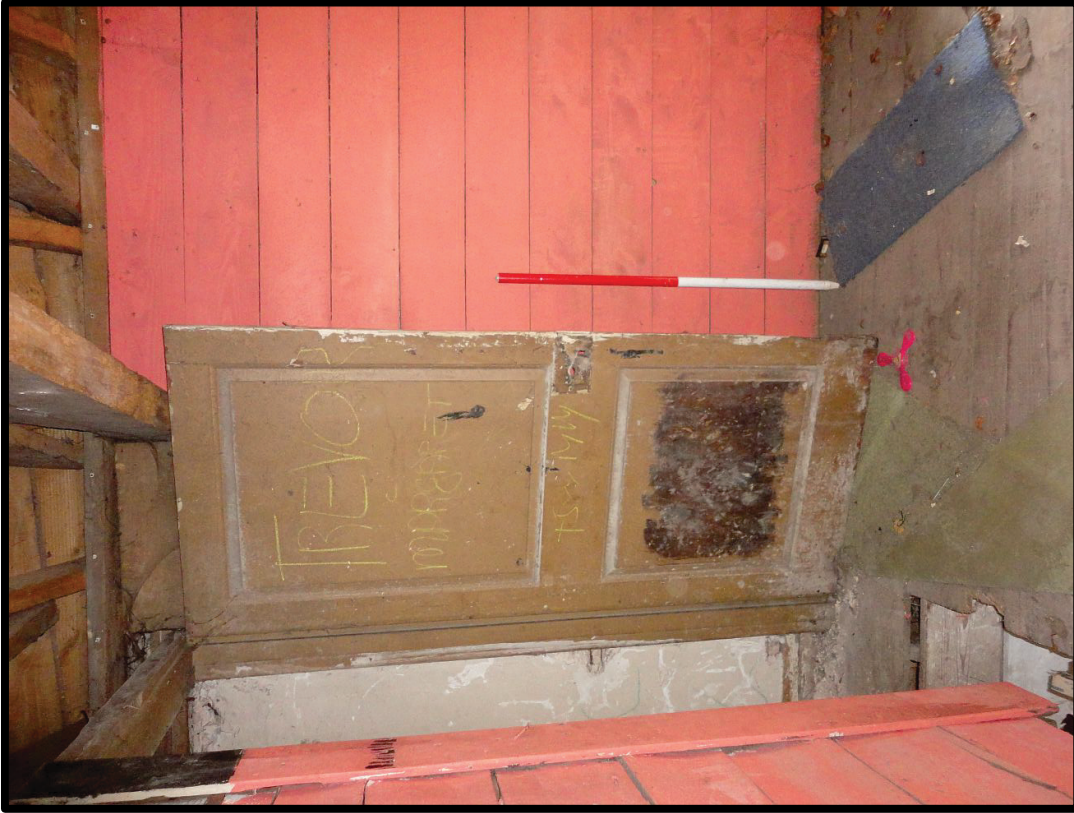
Fig. 23 Interior of the stables at first-floor level, showing a reused 18th-century door with two raised-fielded panels hung in the dividing partition.

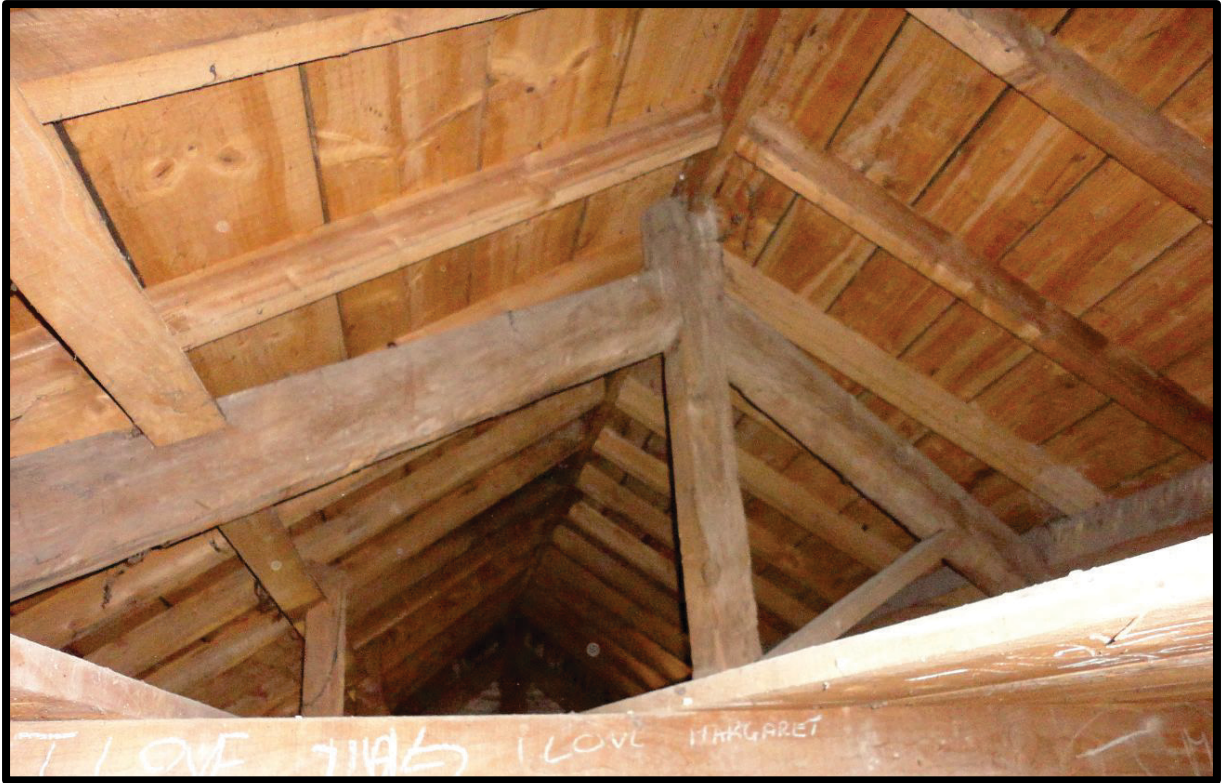
Fig. 24 The roof of the stable block, showing primary king-post trusses but later 19th- or 20th-century purlins, rafters and sarking boards.

The roof timbers have been renewed in the late 19th or early 20th century. Only the simple diagonally-braced king-post trusses (Fig. 24) seem to have been retained from the original roof.
