# Historic Building Survey

**THE BISHOP'S PALACE GATEHOUSE,  
EXETER, DEVON.**

*By R. W. Parker*

**REPORT No. 2013.01**

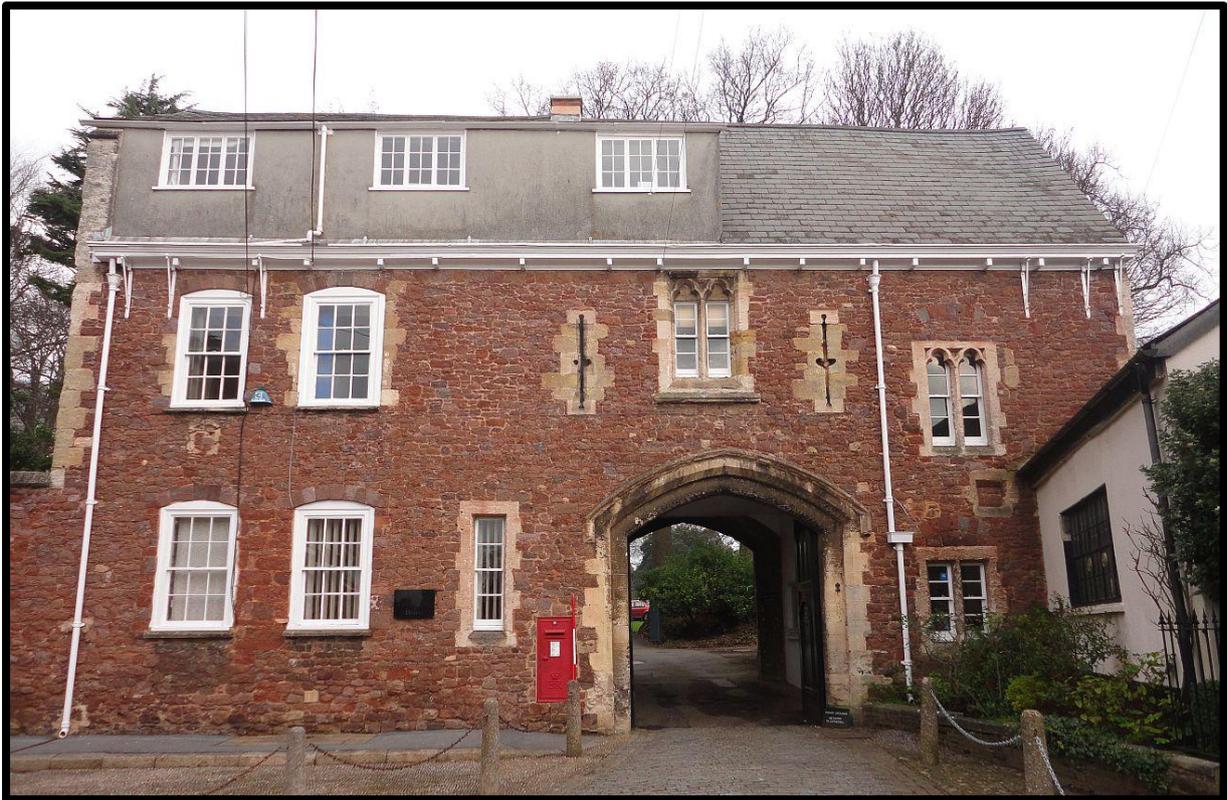
Fig. 1 The south-western elevation of the gatehouse as seen from Palace Gate.

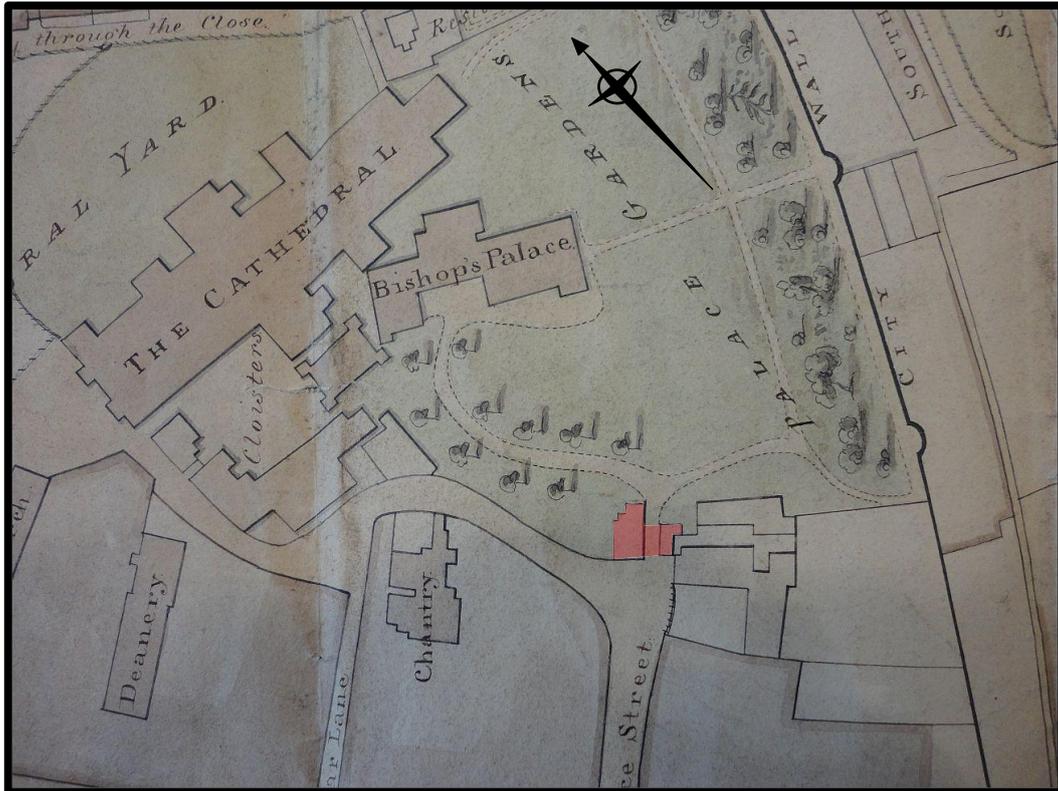
Fig. 9 Extract from an undated 19th-century map of the Cathedral Close *c.*1840 showing the realignment of the driveway to the west, the removal of the grotto and the footprint of the gatehouse highlighted in pink (DRO Bishop's Archives Chanter Ref. 1205).

The new curving driveway to the Palace does not appear on Brown's Map of the city, dated 1835, which also shows the Grotto or garden house still in existence, but this map is not very detailed and may simply repeat elements shown on earlier maps. A more accurate plan showing the layout of the Bishop's gardens and also of the Gatehouse is found among documents at the Devon Record Office relating to the purchase of the City Walls from the City Council in 1843 by Ralph Barnes and the sale of the walls to Bishop Philpotts in 1853 (DRO Bishop's Archives Chanter ref. 1202; 1204). The plan (*ibid.*, 1205) is undated and perhaps schematic, but it shows the western wing of the Palace, which was demolished in 1846, and therefore it is considered likely to have been drawn in *c.*1843. The gatehouse is shown as on Coldridge's map, without the adjoining garden wall and without the grotto, which may have been removed for the landscaping of the new drive (Fig. 9). It is suggested that the curving driveway may have been an innovation of the early years of Bishop Philpotts' tenure at Exeter and that it perhaps dated from the 1830s. The rear of the gatehouse, which appears to be conceived of as a picturesque incident in the drive from the Palace to the town, might have been modified at this time. From this point onwards the gatehouse may have looked very much as at present, and any subsequent alterations to it were probably minor.

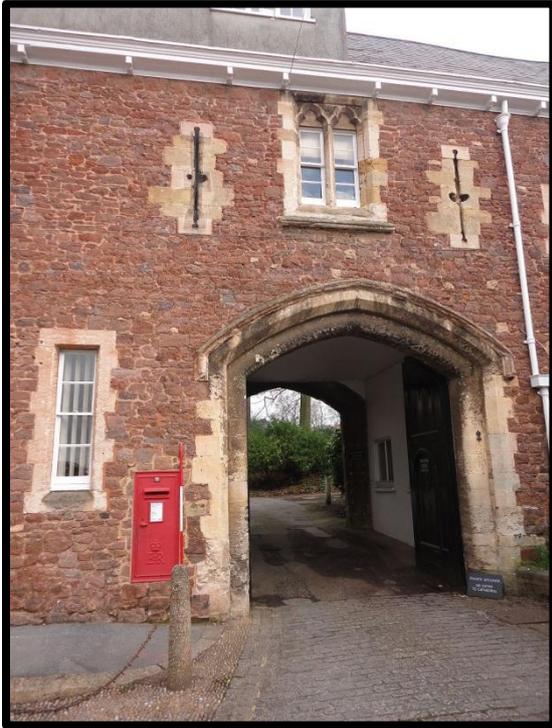
Fig. 11 Detail of the gateway, showing the arrow slits and varied geology of the window openings.

Above the archway, on either side of the central window but not quite centred upon the arch below, are a pair of cross-shaped arrow loops. There is no evidence that these are cut into the masonry or that they have been over-restored. The greater part of their dressings are of yellow/brown Salcombe stone and are probably of medieval date; only the topmost and lowest blocks and one block of the western jamb of the western slit are in a paler stone which probably represents restoration at the hand of William Butterfield in c.1875. The central window, as noted before, is not centred over the arch, though it is equidistant between the arrow loops. It is a two-light window with a square head and two chamfered orders, the upper parts of the lights trefoil-headed with blind tracery. Most of the dressings and tracery of this window appears to be 19th-century restorations and the existing sashes are certainly Victorian, but there is evidence of Salcombe stone dressings in the lower part of the eastern jamb and it is likely that this is a reasonably faithful restoration of the original form of the window.

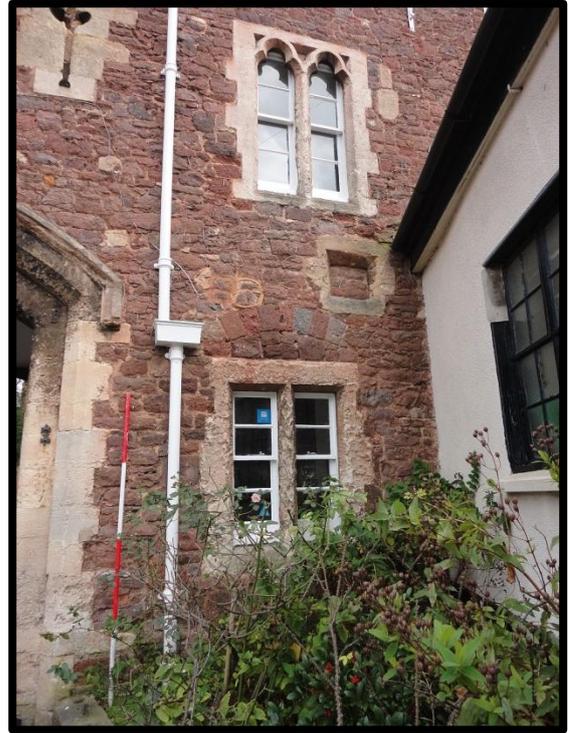
Fig. 12 Detail of the wall east of the gate, showing 19th-century windows and the remains of earlier features

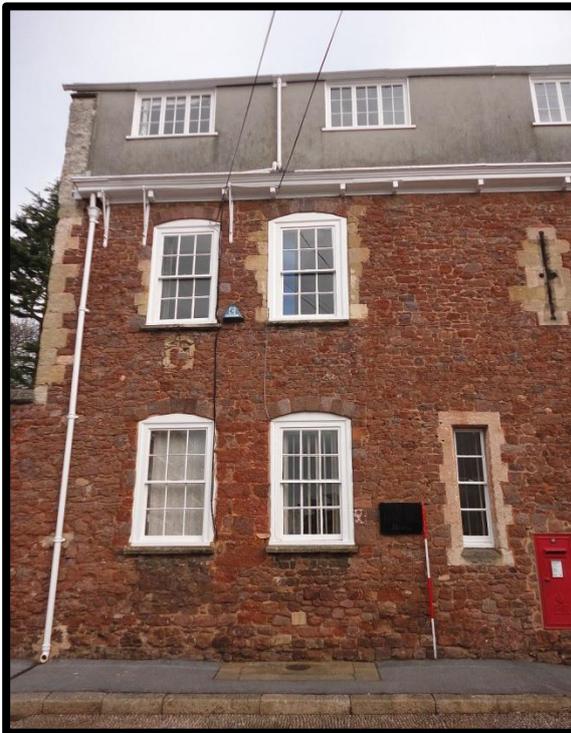
Fig. 13 Detail of the wall west of the gate showing the dressings around the first-floor window openings and the ground-floor windows cut into the walling.

To the west of the archway (Fig. 13) are pairs of tall 18th- or early 19th-century sash windows on the ground and first floors, lighting the principal rooms on each storey. These have segmental heads, which may imply that they were inserted in the early 18th century. The lower windows are clearly cut into the earlier masonry and incorporate much red Heavitree breccia. These may replace a blank wall, since large windows at this level would have compromised the security of the complex. The first-floor windows have dressings of Salcombe stone to both sides of the eastern opening and one side only of the western. This strongly suggests that there were two original windows, one of two lights (the same width as the existing sash) and another of one light only, which was widened to the east when the present sashes were inserted. Below the western window is a much damaged rectangular feature of uncertain function, which appears to be a primary feature. It is possible that this was a window, ventilation grille or chute similar to that on the eastern side of the gate, or that it contained a decorative feature such as a Coat of Arms or an inscription.

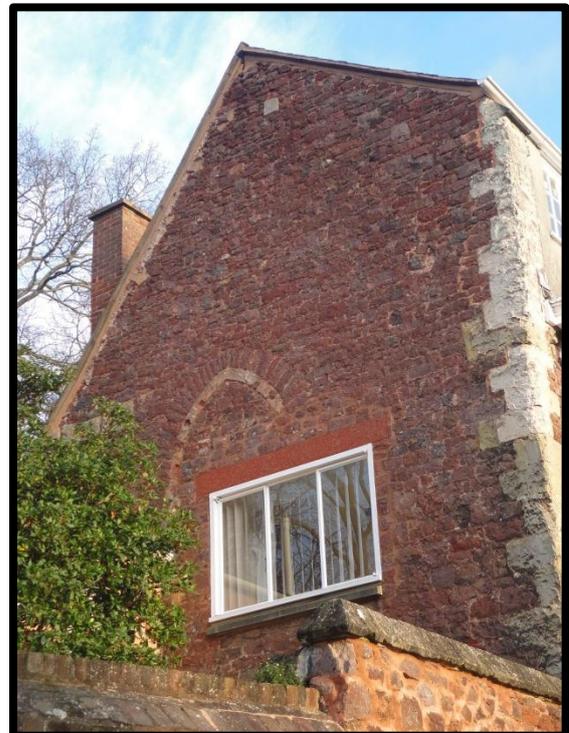
Fig. 14 Detail of the north-west wall of the gatehouse showing the remains of a very large arched window cut by a modern Crittall window.

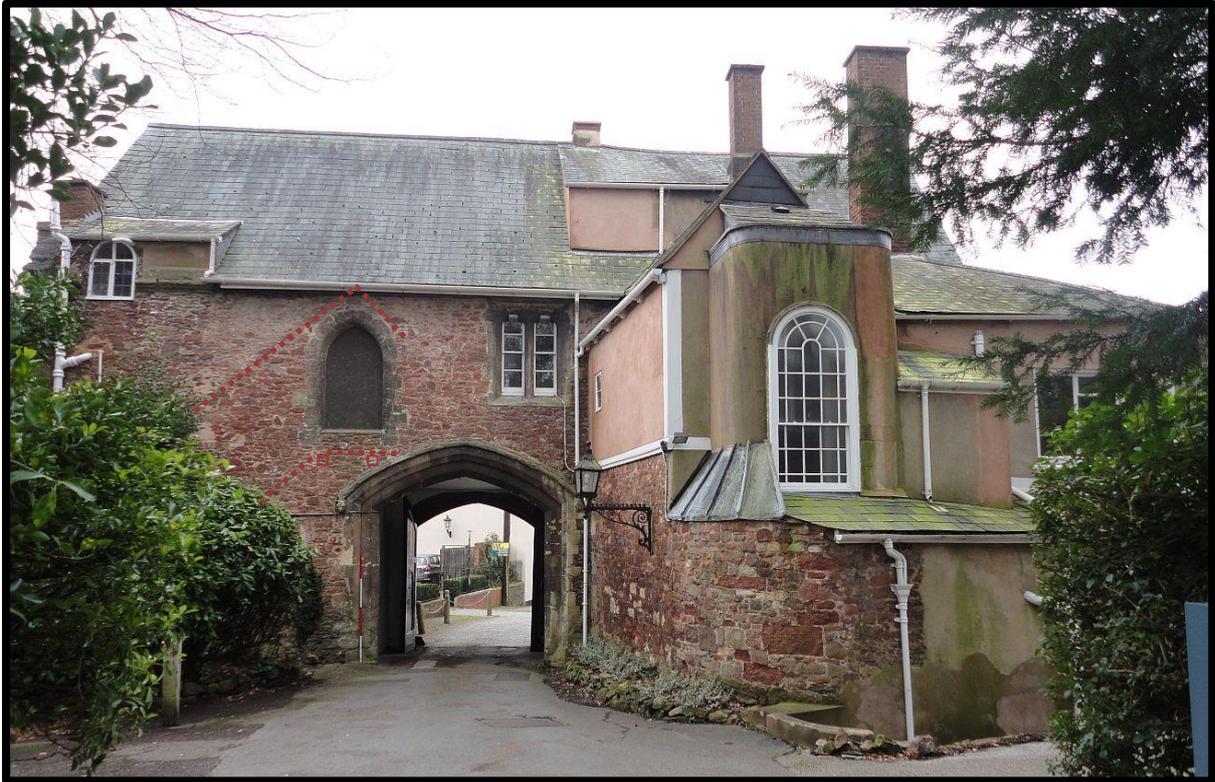
Fig. 15 View of the rear of the gatehouse, showing the first-floor doorway over the arch and the scar of the roof, sockets and string of an external covered staircase serving the principal chambers (dotted). The remains of the wall dividing the great court can be seen projecting from the rear of the gatehouse beyond the 19th-century bracket lamp. This wall was demolished beyond this point and rebuilt as a curved corner in c.1812.

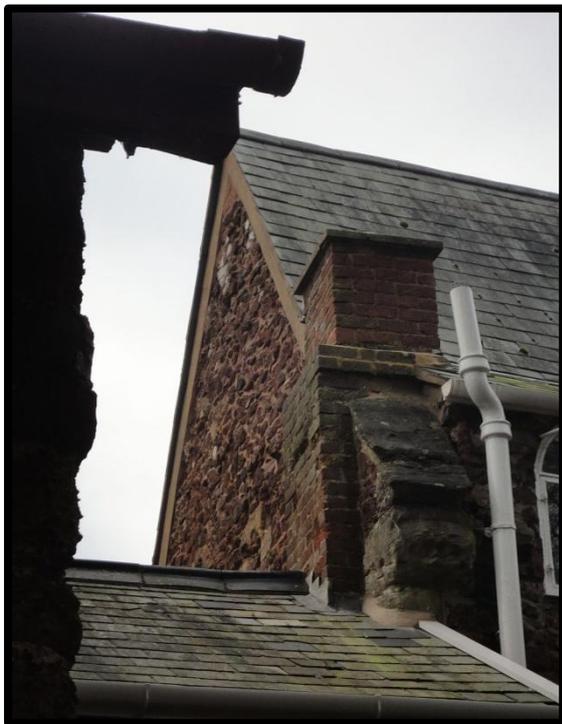
Fig.16 Detail of the eastern corner of the gatehouse showing the remains of a primary coping and decorative kneeler.

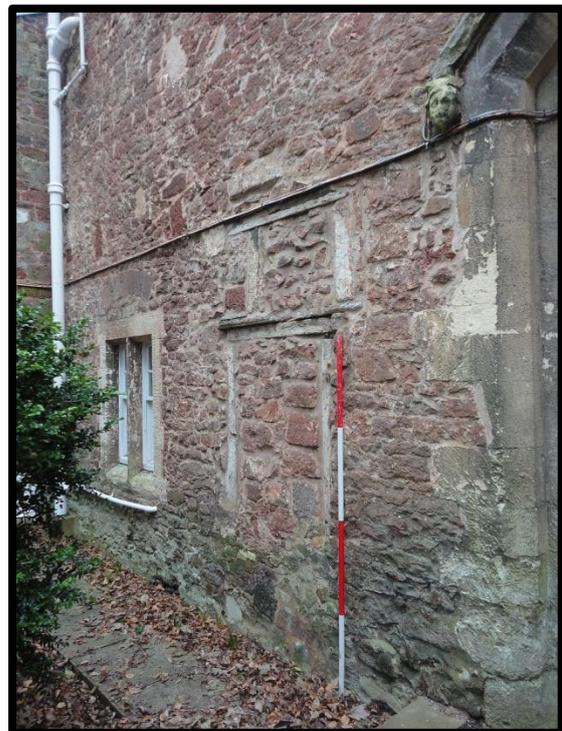
Fig. 17 Detail of the rear wall of the gatehouse to the east of the gateway, showing the remains of doorways and window openings cut into the walling.

century two-light window matching that in the south-western elevation. Closer to the archway are the remains of a post-medieval doorway with a timber frame, cutting two smaller blocked openings, one at a lower level than the other and offset slightly to the west of the doorway and the earlier window above. These windows appear to have lit a spiral stair in the corner of the room to the east of the gate passage. The door may have been broken through into the base of the stair subsequently to improve access to this room and the stair, possibly after the demolition of the medieval external stair.

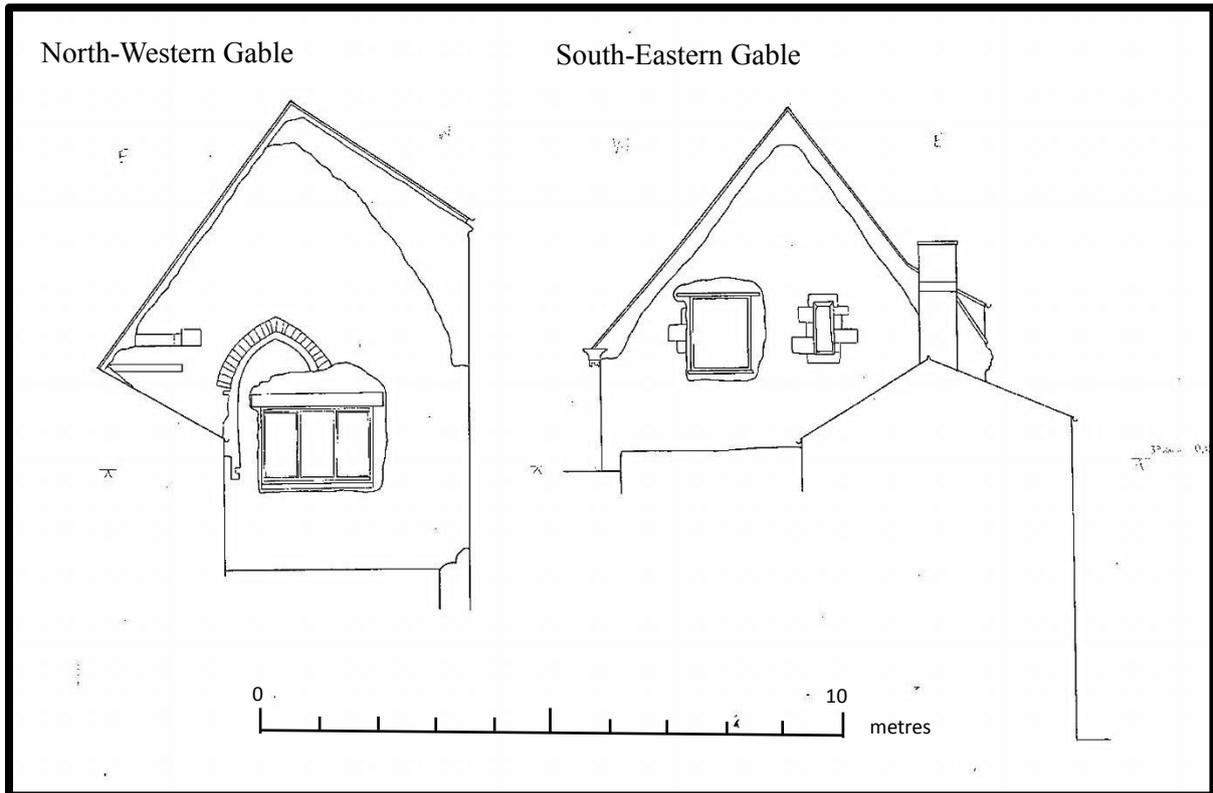
Fig. 18 Unfinished elevation drawings of the gable ends of the building made by Neil J. Goodwin of Exeter Archaeology in December 1998, showing features which were not accessible during the present survey

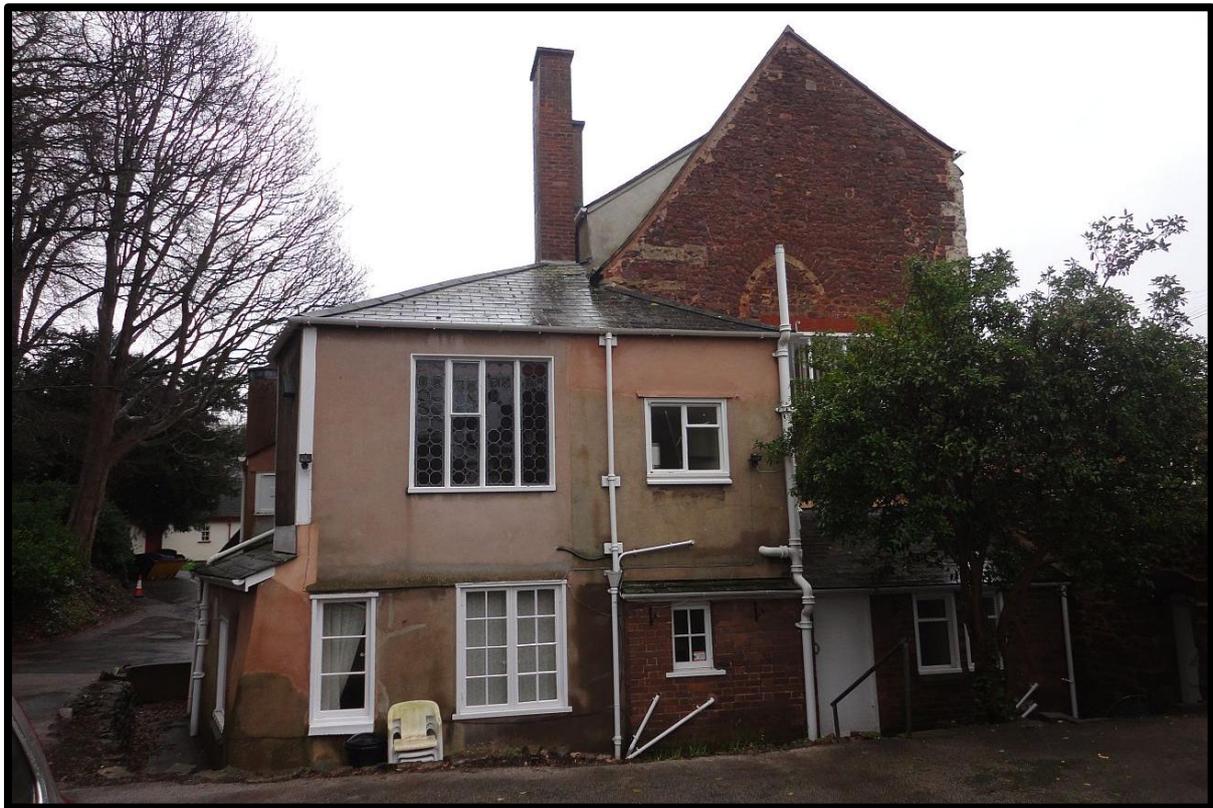
Fig.19 The north-western elevation of the projecting rear extensions, showing (extreme left) the angled wall possibly representing an early garden wall absorbed into a lean-to structure, the timber-framed structures at first-floor level above it and the later brick extension (right) underlying it against the original gable wall of the gatehouse.

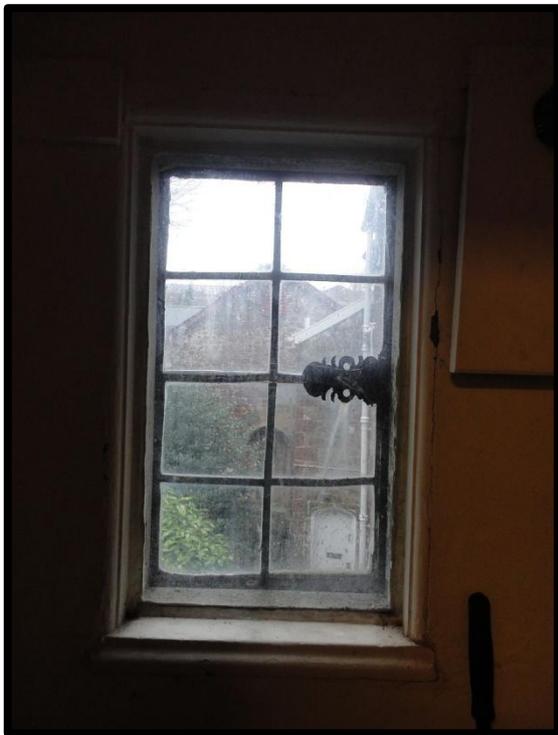
Fig.20 Detail of the 17th-century window casement in the stair wing added to the rear of the gatehouse, possibly associated with a 17th-century staircase.

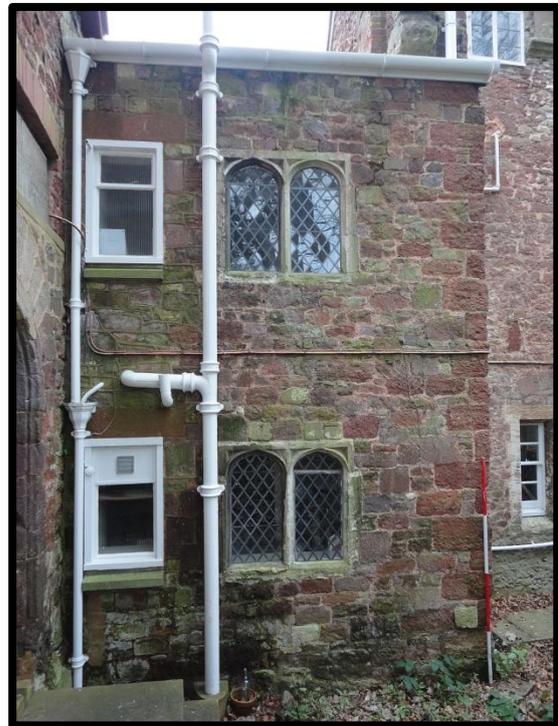
Fig. 21 Elevation of the small square building added at the eastern corner of the building, possibly to provide a replacement for the medieval newel stair.

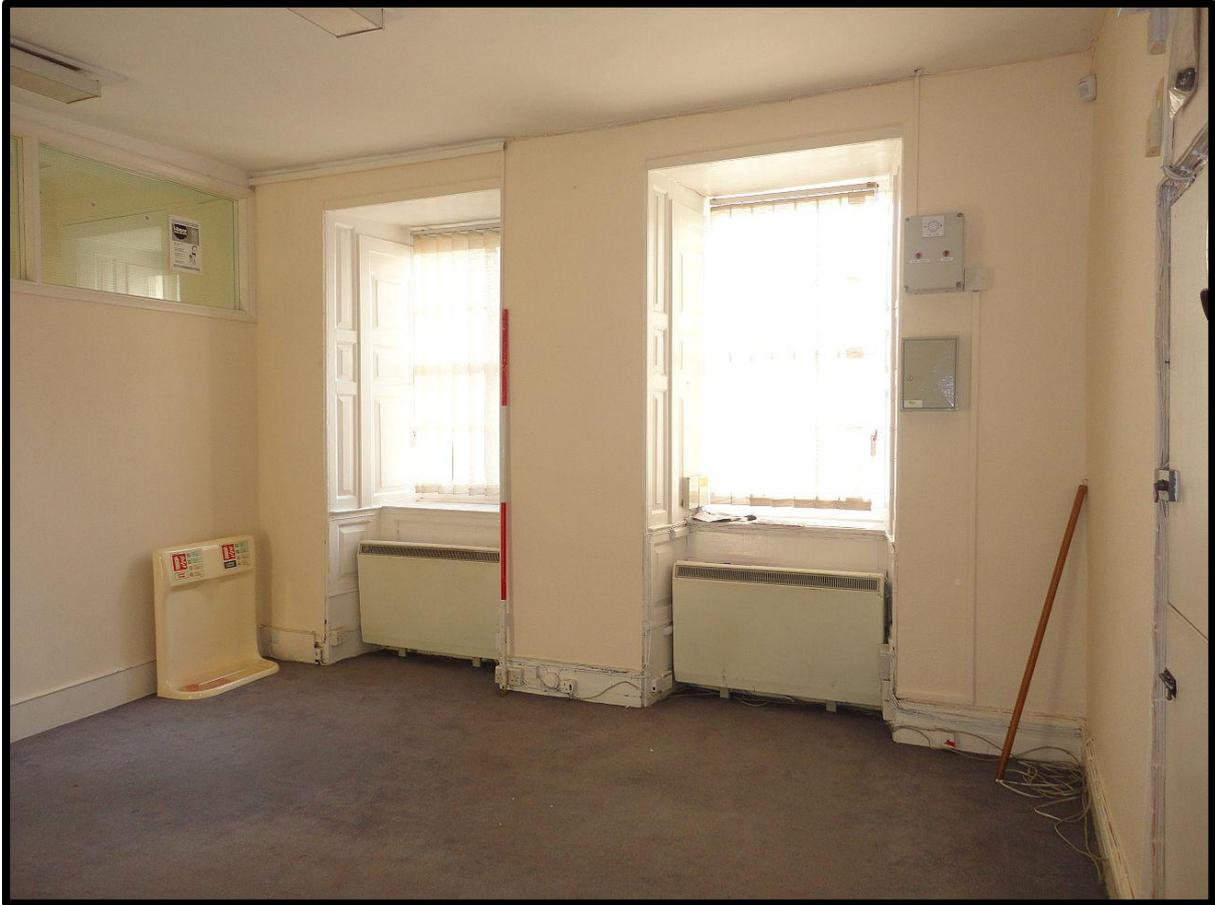
Fig. 22 View of the large ground-floor room to the west of the gate passage showing the extent of the post-medieval and modern alterations, concealing the medieval fabric.

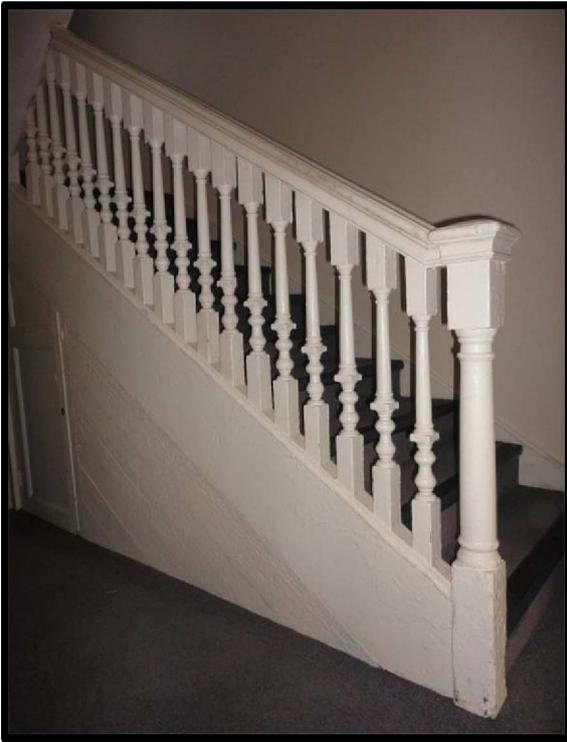
Fig. 23 Detail of the early 18th century balustrade of the staircase, modified in the 19th century so that the stairs climb on the other side of the string.

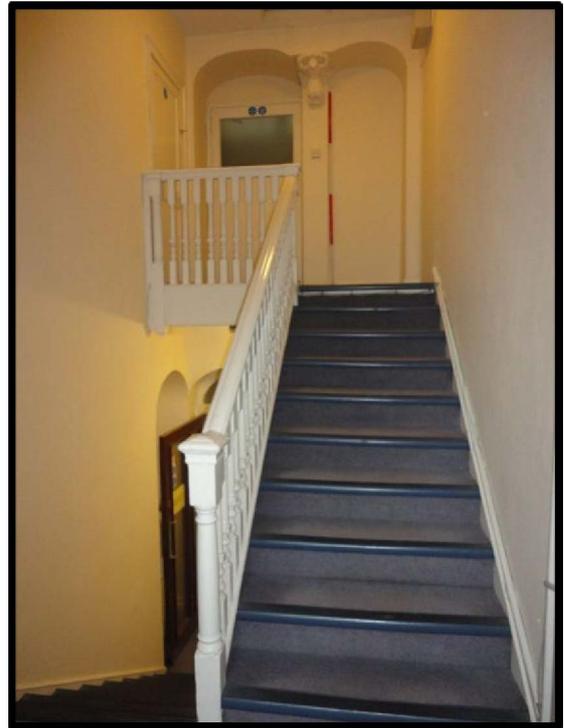
Fig. 24 View of the staircase showing the paired openings at the summit perhaps relating to an earlier stair turret.

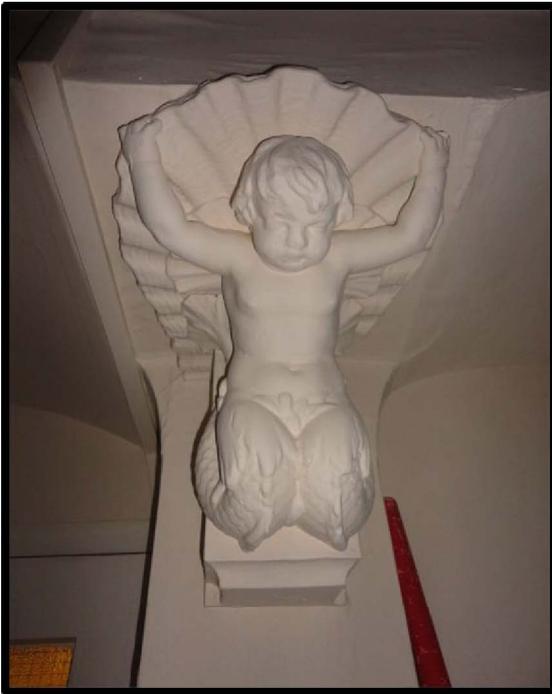
Fig. 25 Detail of the plaster caryatid representing a mer-boy supporting the arches between the rear stair wing and the main building

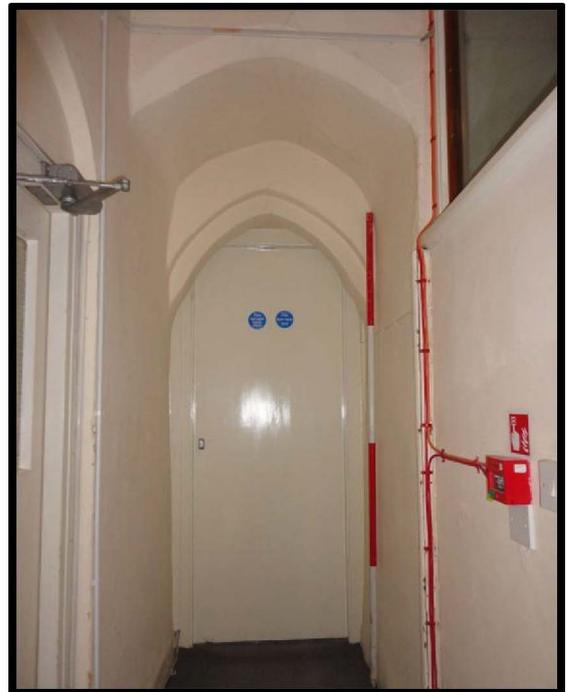
Fig. 26 Detail of the archway between the western chamber and the room over the gate passage showing a two-centred medieval archway rebated for a door opening into the chamber.

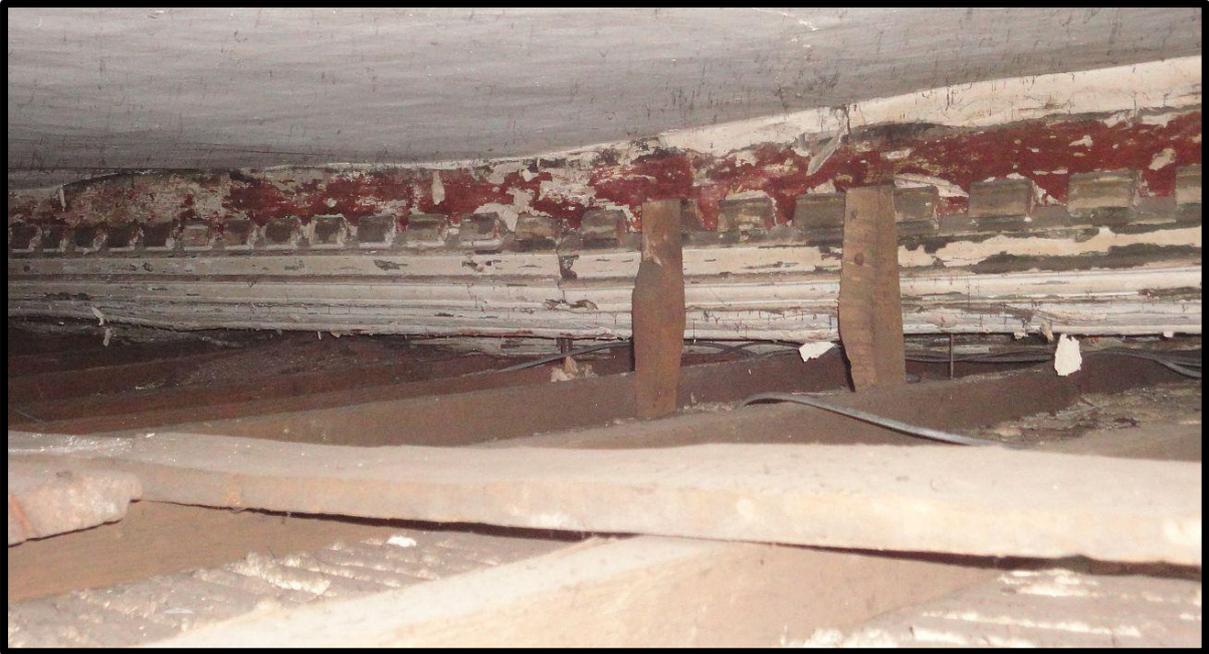
Fig. 27 View of the brattished beam crossing the large first-floor chamber at eaves level, now sandwiched between two later ceilings. The brattishing appears to be applied ornament decorating the structure, which probably crossed open space at eaves level and supported a crown post at its centre providing lateral bracing for the roof. The beam retains evidence of historic blue/green and red paint.

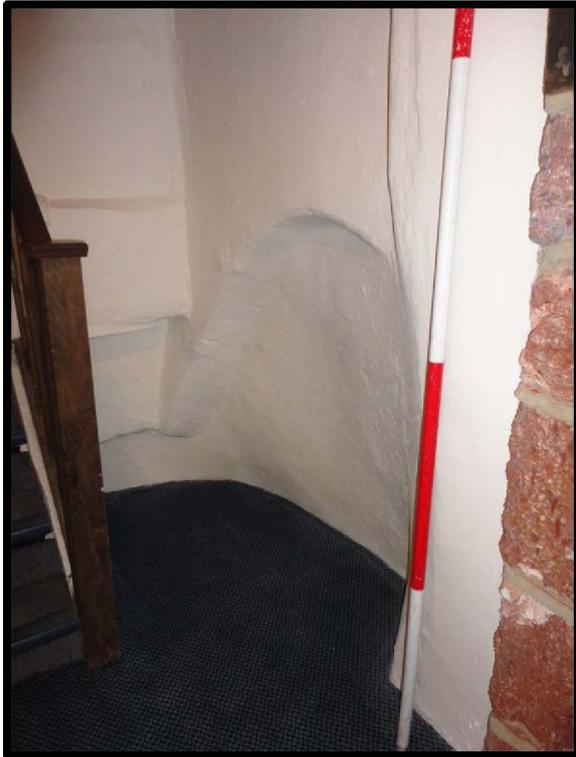
Fig. 28. The upper part of a newel staircase rising within the eastern chamber.

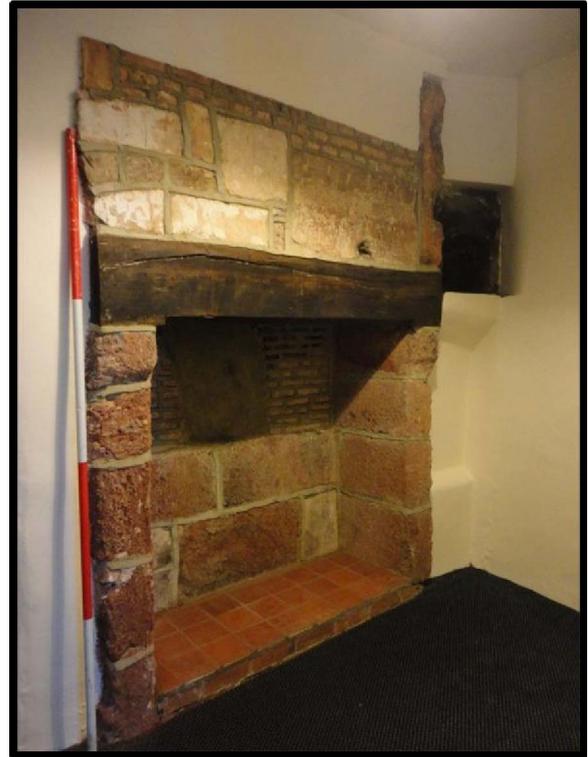
Fig. 29. Detail of the fireplace and oven in the eastern chamber, as rebuilt in the 17th-century by truncating a projecting hood.

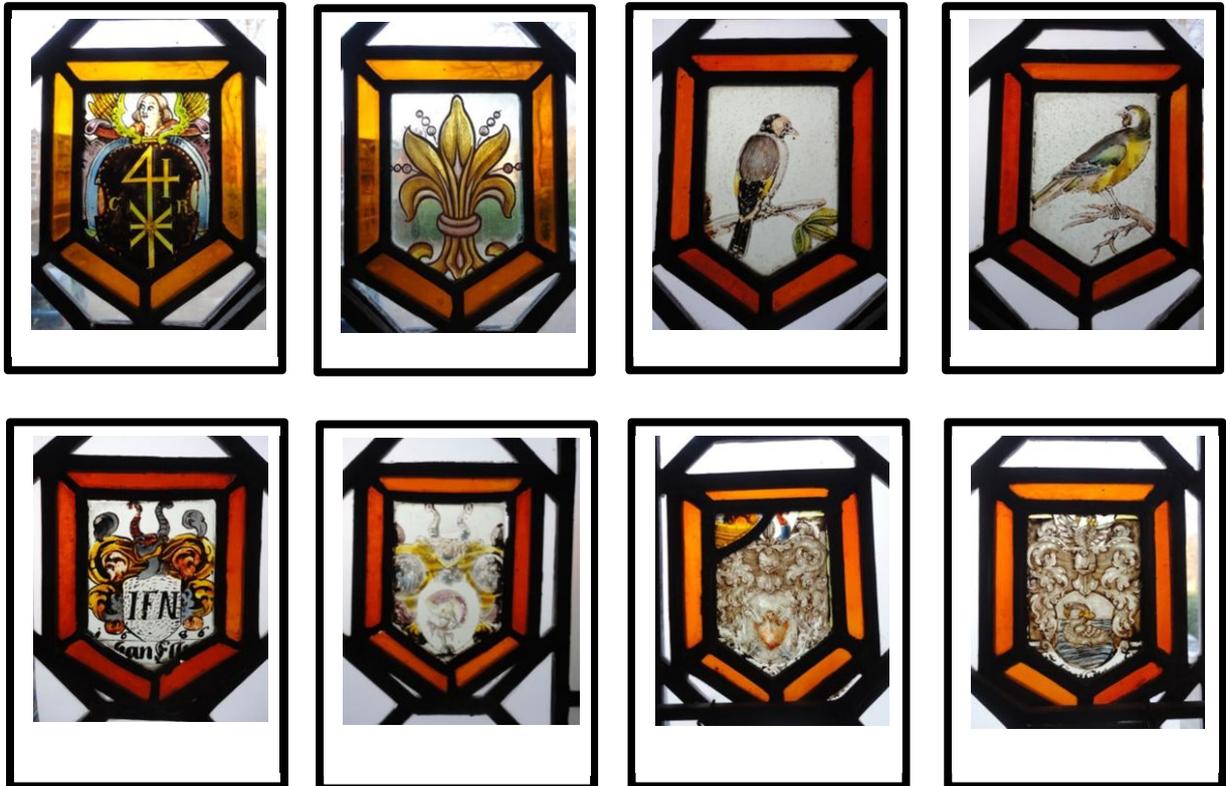
Fig. 30. Eight panels of 17th-century German painted glass reset in the western window of the first-floor room in the rear extension.

of Arms, a merchant's mark, two studies of birds and a possible dedication inscription. The painted birds are from the Low Countries and are probably based on early 17th-century pattern books such as the bird books by Collaert. The other panels are probably German (Kees Berserik and David Cook, pers. comm.). The origin of the collection and the reason for its setting here is unknown.

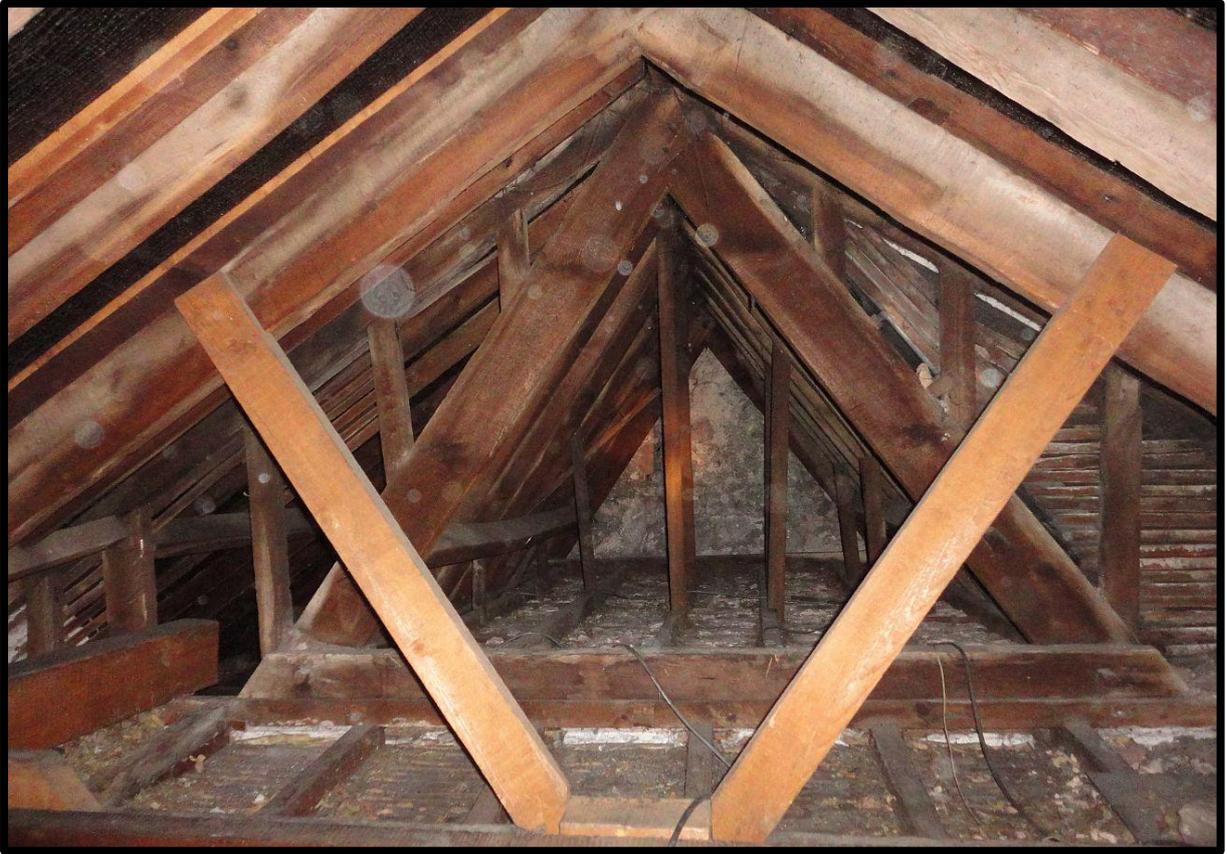
Fig. 31 View of the roof structure over the western attic rooms showing two phases of 18th- or 19th-century roofs replacing the original trusses over the western chamber.

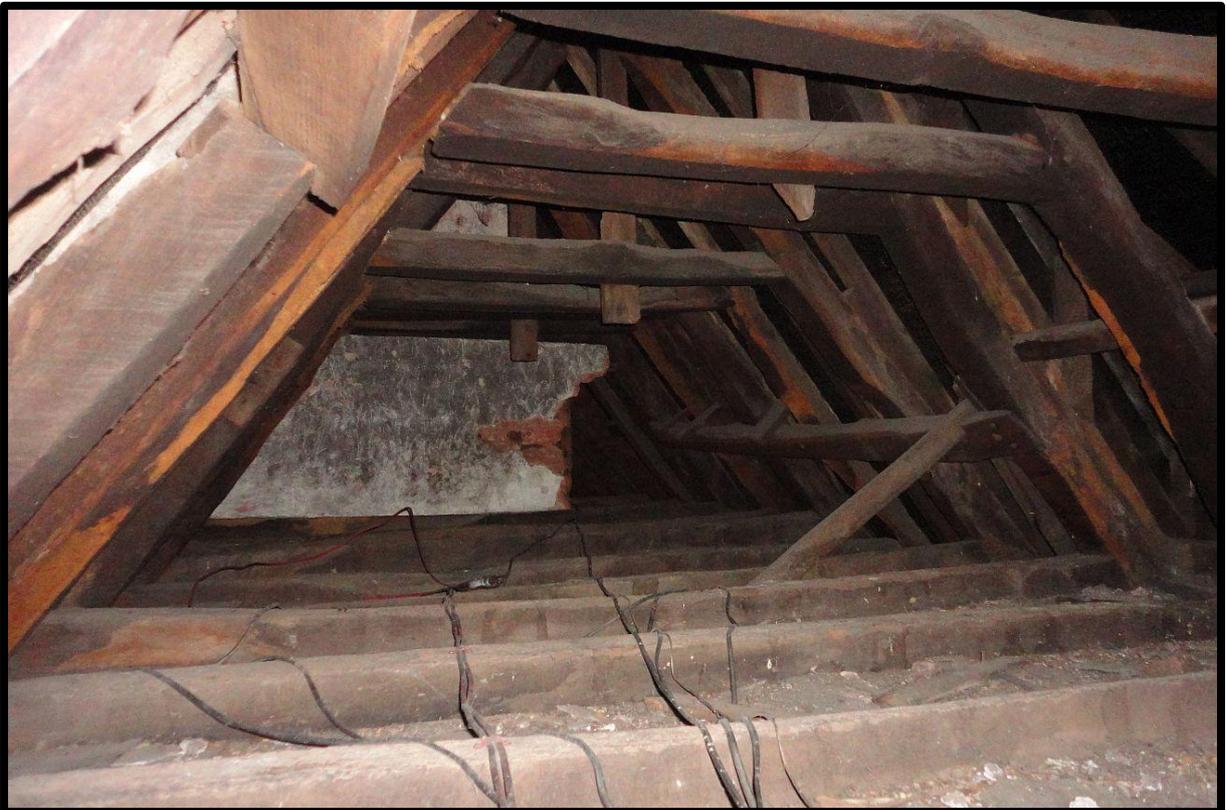
Fig. 32 View of the central section of the roof, looking east, showing common rafter trusses with upper and lower collars and the remains of a cob and timber partition to the eastern chambers.

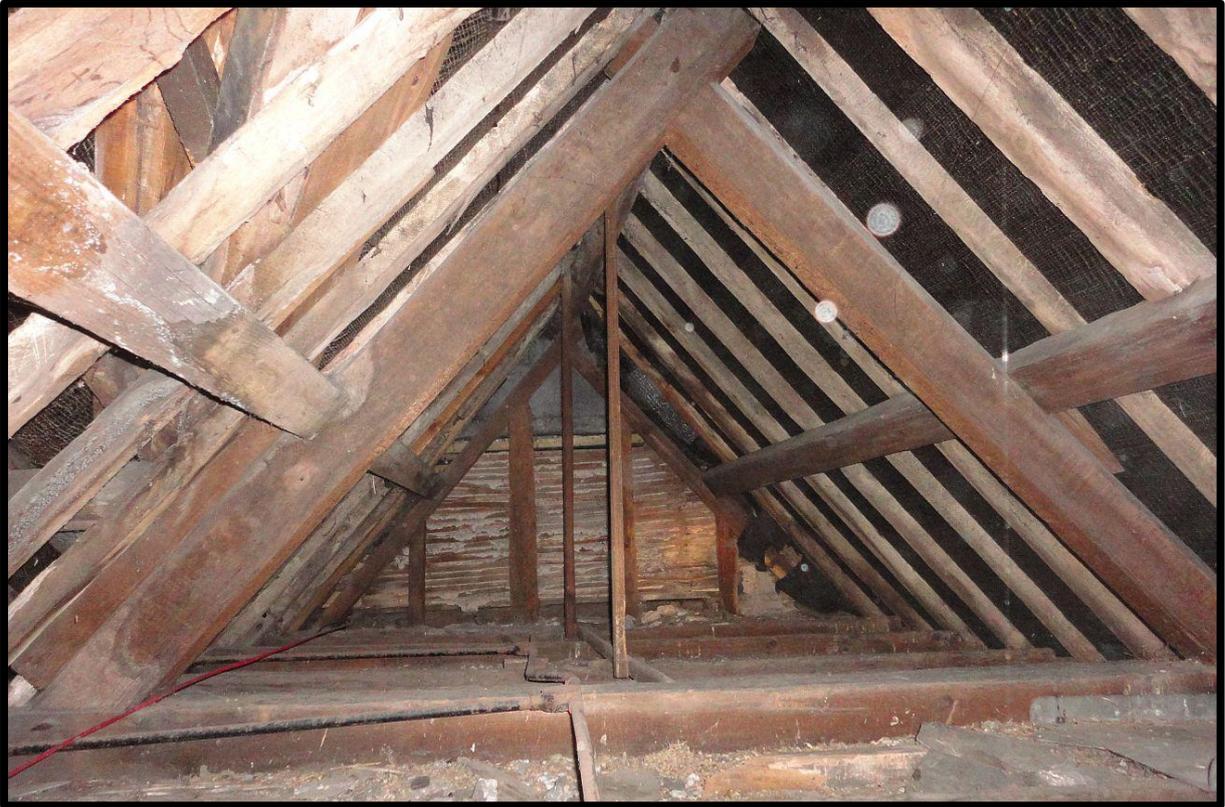
The roof structure over the stair tower at the rear of the gatehouse is perhaps of 17th- or early 18th-century date (Fig. 33). It is of two bays supported by a central truss consisting of principal rafters crossed and pegged together at the apex to support a diagonally-set square ridge tree, the pegs being left protruding. The collars at ceiling level are applied to the sides of the principals and secured by pegs, again left protruding. There is a single level of purlins on each side of the roof, that on the north western side being slightly trenched into the back of the principal rafter. Most of the common rafters appear to be original. The closed truss at the north-eastern end of the wing is probably contemporary.

Fig. 33 View within the roof of the stair wing at the rear of the building showing typical trusses and the interruption of the end truss, perhaps to allow for a demolished chimney.

consisting of vertical studs lath-and-plastered externally. This truss appears to be interrupted at its north-eastern corner, perhaps to allow a former chimney stack to rise above the roofline, serving a possible fireplace now concealed in the wall above the half landing of the main staircase. This would relate to a room now incorporated within the stair well. The rear of the medieval building is rendered, possibly with a surface pre-dating the construction of the extensions against the wall, though only a limited area could be examined due to the large chimney built against the rear wall of the medieval building, which blocked the view to the west. The moulded cornice which survives at the eastern end of the rear wall does not survive at the junction of the two buildings and it is possible that the original medieval wall has been rebuilt at the point where the stair block and the gatehouse meet. Certainly, a low, brick relieving arch is visible within the wall, which may represent an attempt to relieve the strain above the archways in this wall.

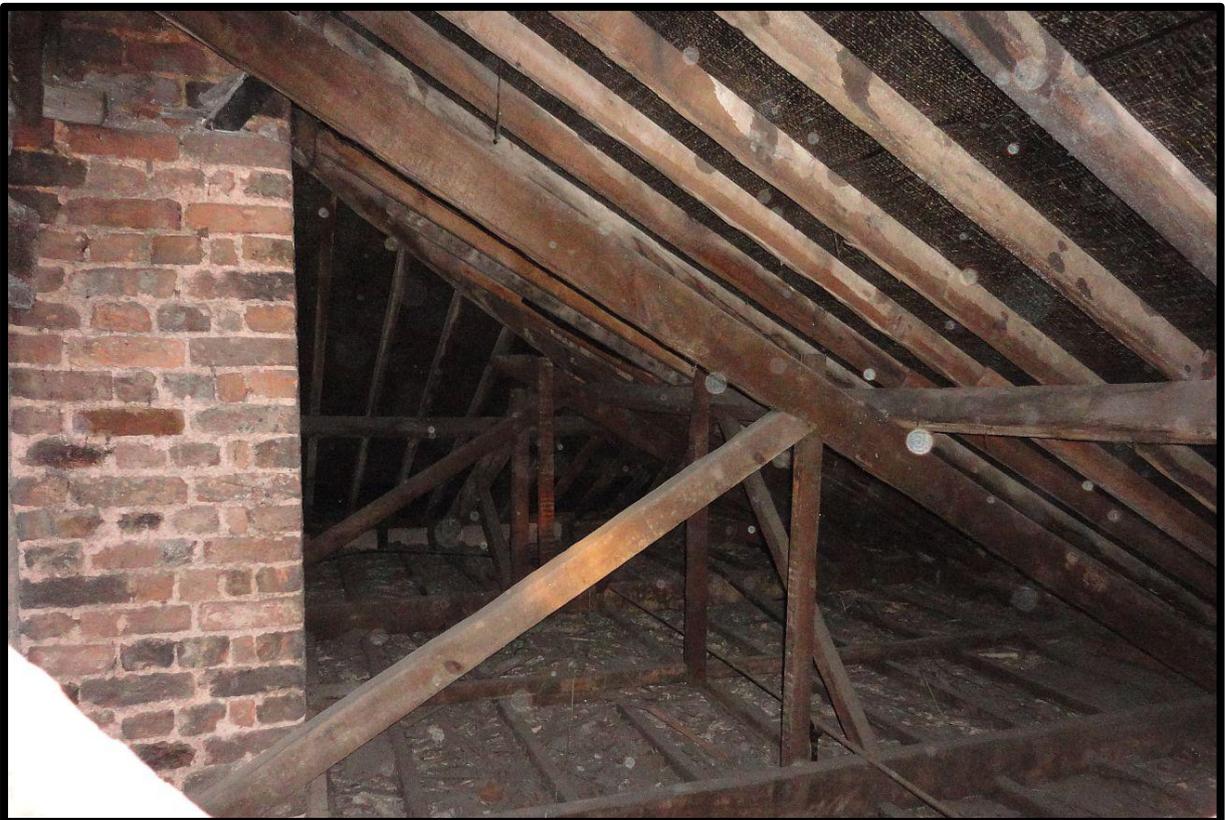
Fig. 34 View within the roof of the extension at the rear of the building showing crude 19th-century trusses and braces and the chimney rising against the rear wall.

The roof over the rear extension (Fig. 34) probably dates from c.1812 and is a relatively crude construction supported upon widely-spaced triangular trusses, consisting of tie beams at the level of the ceilings, suspended from the principal rafters by vertical ties. The principals are braced by raking struts notched and housed in their undersides. There is a single level of purlins passing over the backs of the principal rafters. Most of the common rafters appear to be contemporary, though the whole of the roof coverings have been renewed and there may be many replacement timbers. The chimney rising against the rear wall of the medieval gatehouse is probably of early 19th-century date, constructed of dark red bricks laid in a soft, lime mortar.
