**Archaeological Watching Brief  
and Documentary Research**

**St NICHOLAS' CHURCH, RINGMORE,  
SHALDON, DEVON**

*By R.W. Parker*

**REPORT No. 2018.02**

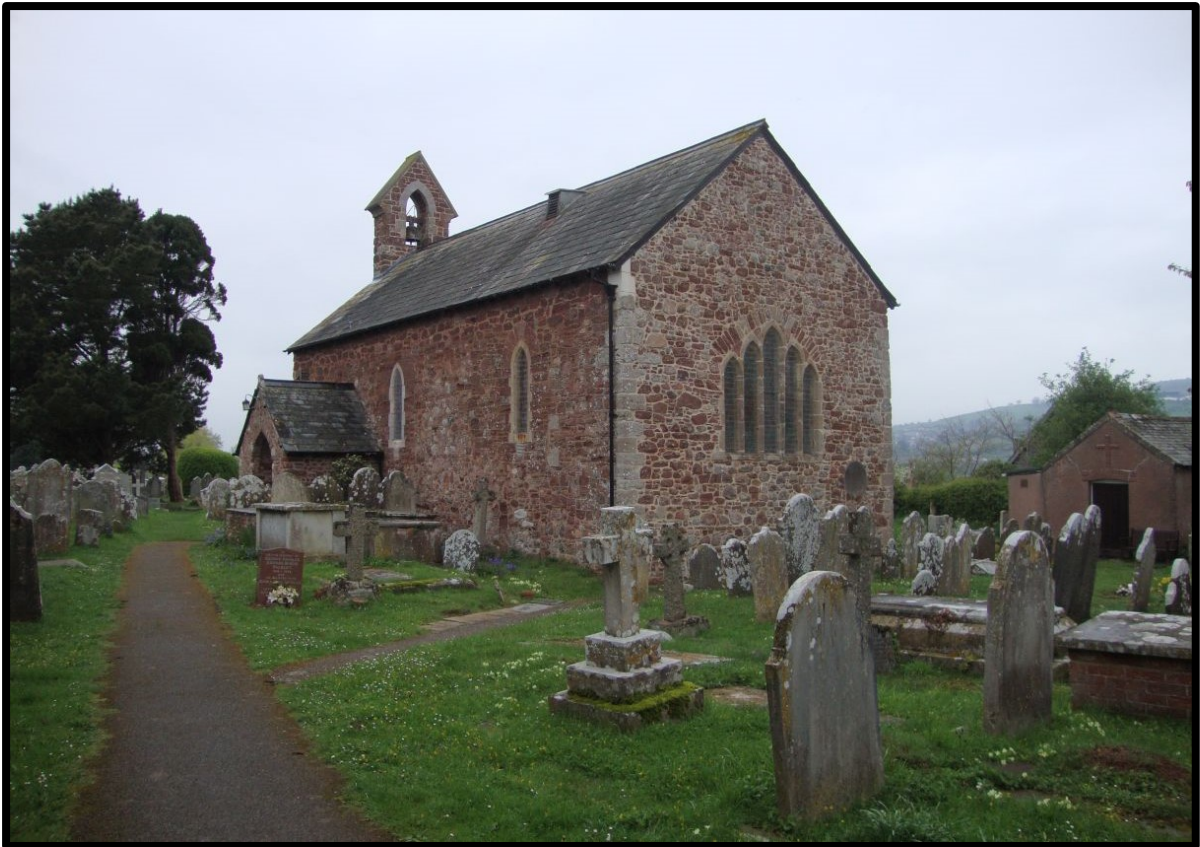
Fig. 2 General view of the church from the south east, looking north west, showing the simple rectangular form of the building, the densely-occupied churchyard, the fine group of 13th-century lancet windows at the east end and the 18th-century vestries at extreme right.

The building is a small medieval church lying on the south bank of the Teign estuary at Ringmore, in the Teignbridge district of Devon (Fig. 1). The church is a Grade II Listed Building and currently consists of a single cell, incorporating a nave and chancel under one uninterrupted roof, with a porch extending to the south and a small vestry on the north side. The walls are constructed of local rubble masonry and preserve evidence of 13th-century fabric, especially at the east end, where the group of five graduated lancets forming the east window is considered to be one of the best surviving examples of this type of architectural composition in Devon (Fig. 2).

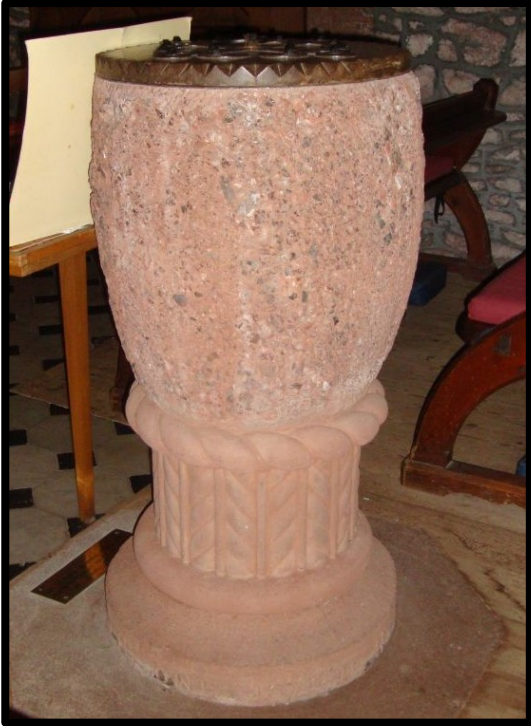
Fig. 4 The unusually tall, goblet-shaped font, probably of 12th-century date, recovered from the churchyard and re-erected in the 19th century.

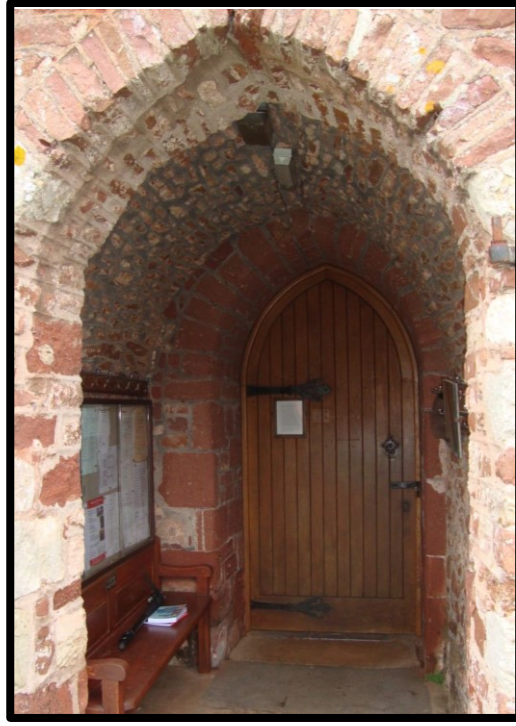
Fig. 5 The stone barrel vault of the porch, which with the graduated lancets of the east end may be the best surviving 13th-century fabric in the building.

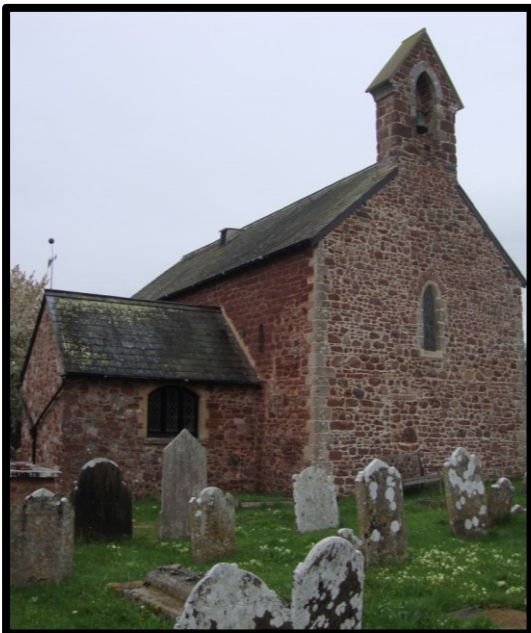
Fig. 6 The church from the north west, showing its simple un-aisled plan, as restored in the late 19th century, and the modern vestry attached to the north-western corner of the nave.

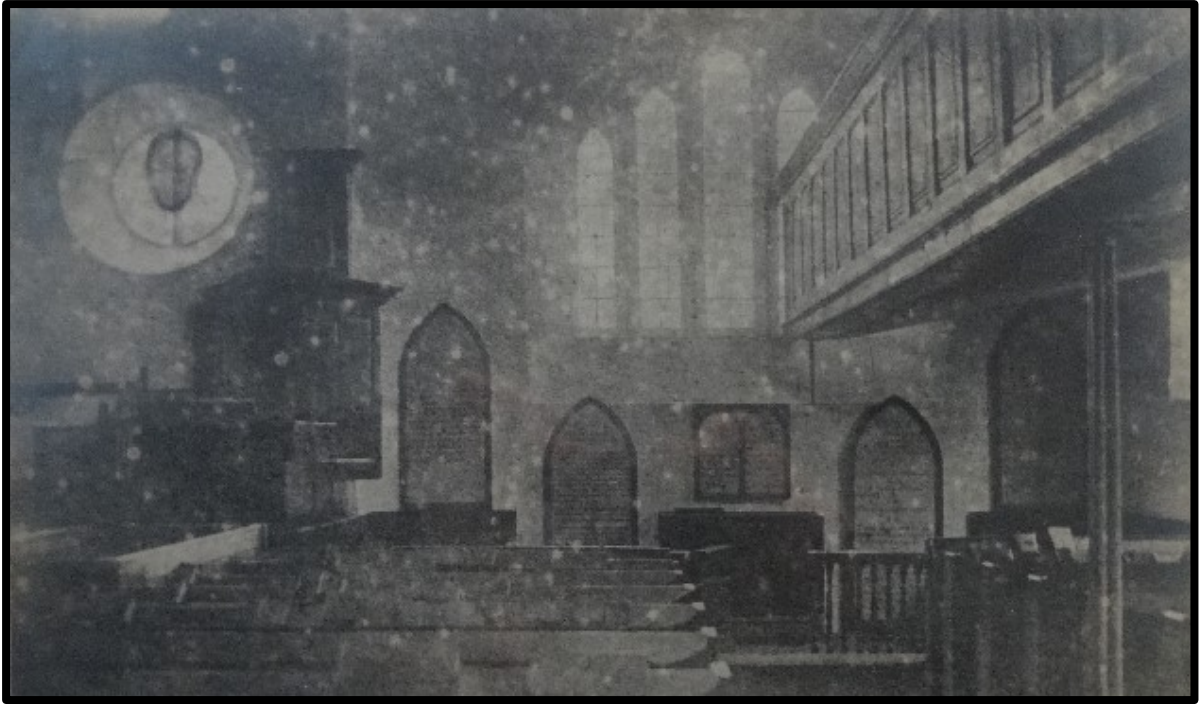
Fig. 11 Photograph of the interior in *c.*1875 prior to restoration, showing the church as enlarged in 1790-1812 with the south gallery of 1822 still in place and both open benches and box pews (Photograph held by the PCC of St Peter with St Nicholas Shaldon).

A photograph of the interior, taken prior to the restoration of the church to its medieval form in c.1900 (Fig. 11) shows the building as enlarged, looking east, with the altar still in its medieval position beneath the original east window, and a high, three-decker pulpit against the east wall, lit by an enormous bull's eye window or oculus. This photograph probably dates to c.1875; it shows open benches with book desks in the body of the old church, probably for the accommodation of the poor of the parish and casual visitors, and box pews for richer families paying pew rents just visible in the 18th-century aisles to the north. The three-decker pulpit against the east wall was later replaced by an organ, as shown on the later 19th-century plans (Fig. 9). The location of the pulpit after this alteration is not known.

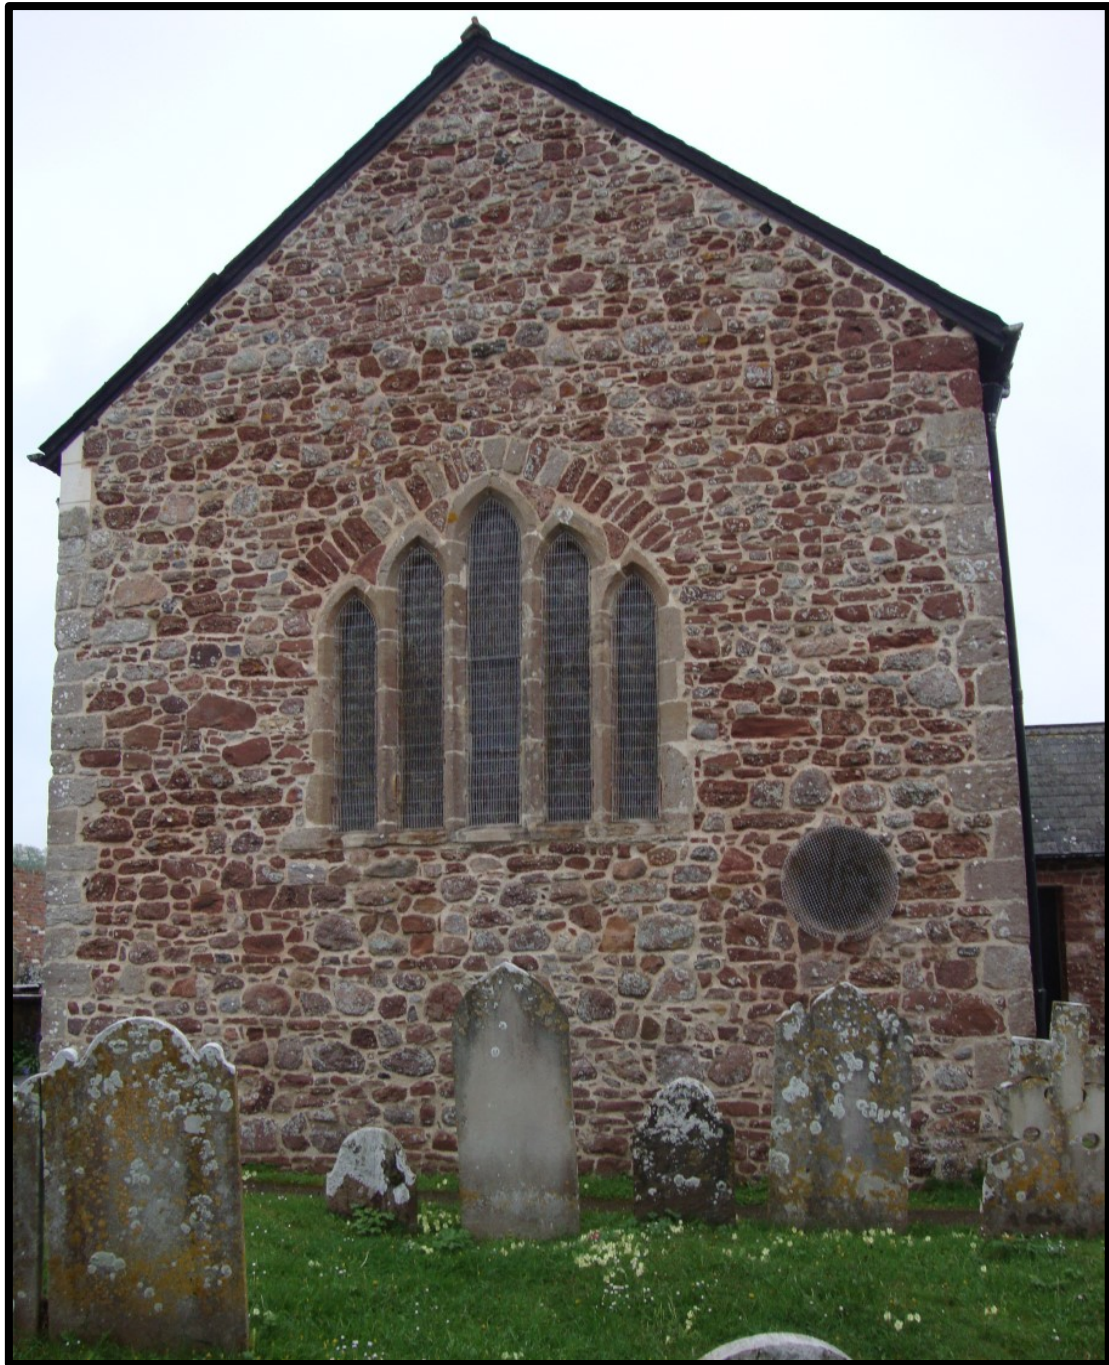
The east wall of the church is the best-preserved part of the building and is almost entirely of 13th-century date (Fig. 18). It is constructed of small blocks of local sandstone rubble with very wide mortar joints, and the dressings to the quoins are of a silvery-grey stone, possibly volcanic in origin. There are no signs of significant restoration or alteration except immediately below the roofline, where a very shallow course of later masonry must represent rebuilding associated with the replacement of the roof. The earlier gable was perhaps reduced in height a little at some period, but the present pitch of the roof may closely follow the original, which seems to have been only marginally steeper. The outstanding feature of this elevation is the fine series of five graduated lancets with un-cusped lights contained beneath a single relieving arch, without hood moulds. This window, which seems largely unrestored, is one of the only five-light lancet windows of this kind surviving in Devon, where most surviving 13th-century work, as at Bere Ferrers, Broadnymet or Denbury, usually incorporates bar tracery or basic plate tracery and rarely extends to more than three lights. There may have been many more windows of this type, but most seem to have been replaced with larger traceried windows in the 15th and 16th centuries. The best comparisons for this window are perhaps the 13th-century three-light windows at Sampford Peverell, the magnificent group of lancets at St Lawrence, Crediton, those in the aisle at Milton Damarel, in the nave at Broadwoodwidge, and the early 14th-century lancet groups in the transepts at Ottery St Mary.

Fig. 18 The east wall of the church showing the best-preserved area of 13th-century masonry and the fine group of graduated lancets.

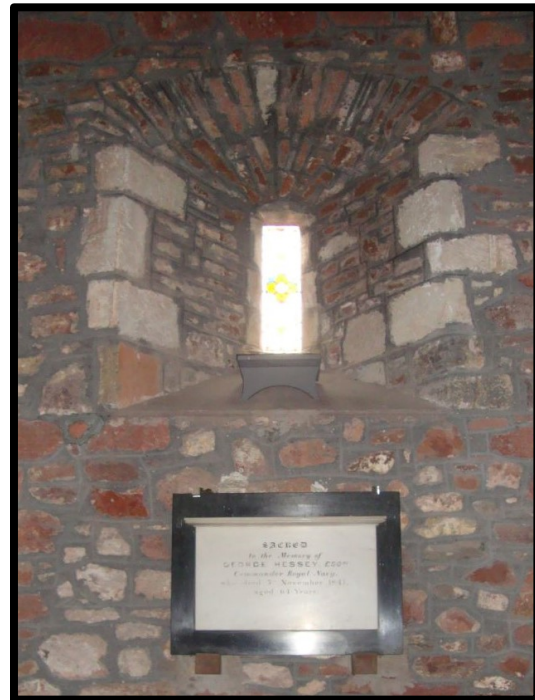
Fig. 20 The slit window seen from the interior showing the medieval jambs and vault to the embrasure.

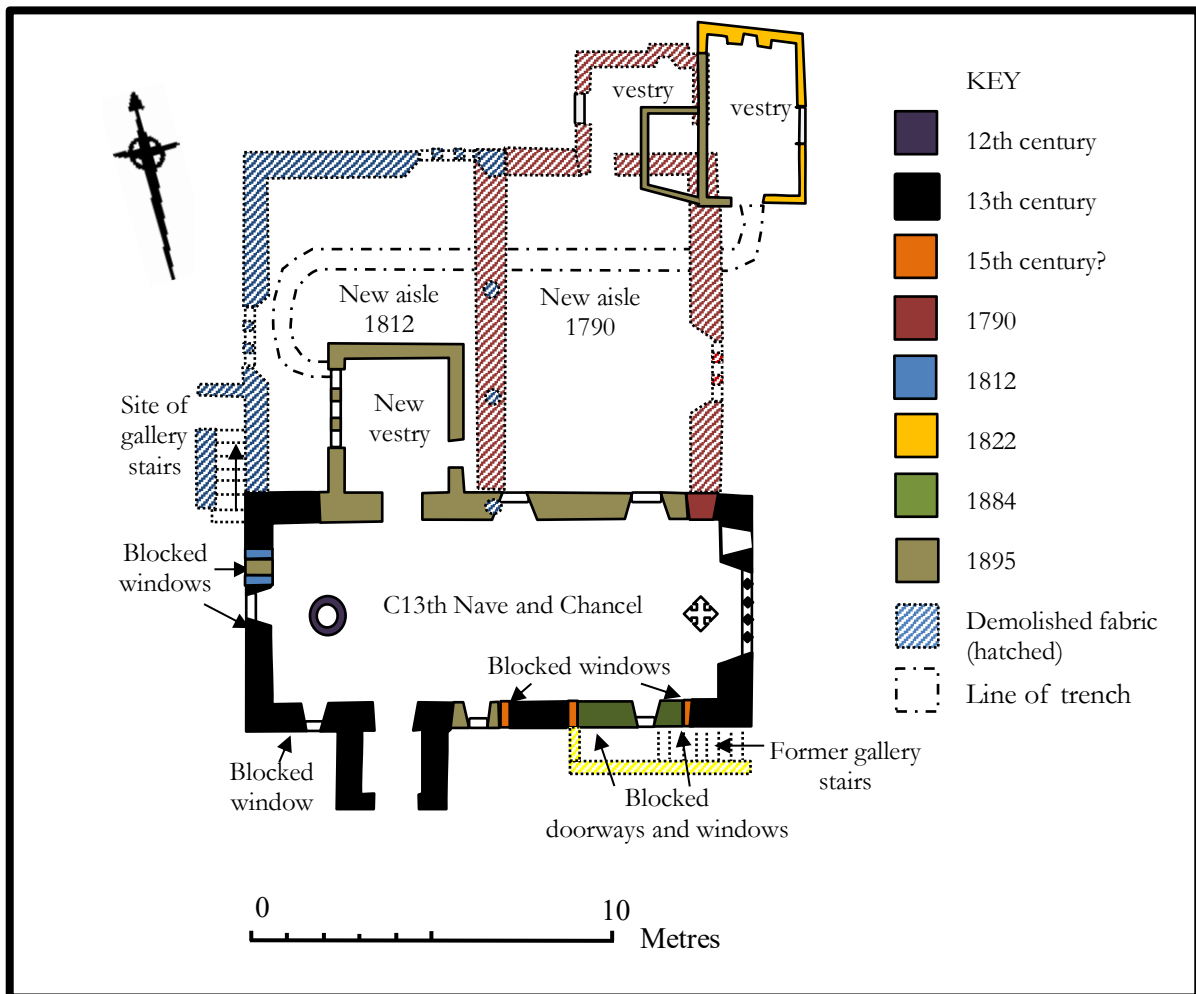
Fig. 23 Plan of the site and buildings, based upon the historic plans, showing the suggested phasing of the existing and demolished fabric and the route of the trenching through the site (scale approximate).

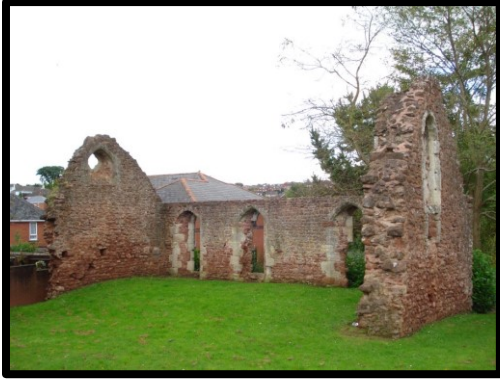
Fig. 25 The ruined chapel of St Loye at West Wonford, showing an almost unaltered 13th-century church of single-cell plan, comparable to St Nicholas.

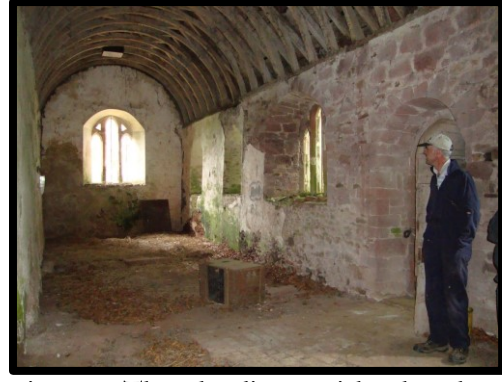
Fig. 26 The derelict parish church of Broadnymet in mid Devon, also a single-cell church of 13th-century date, but retaining its medieval wagon roof intact.

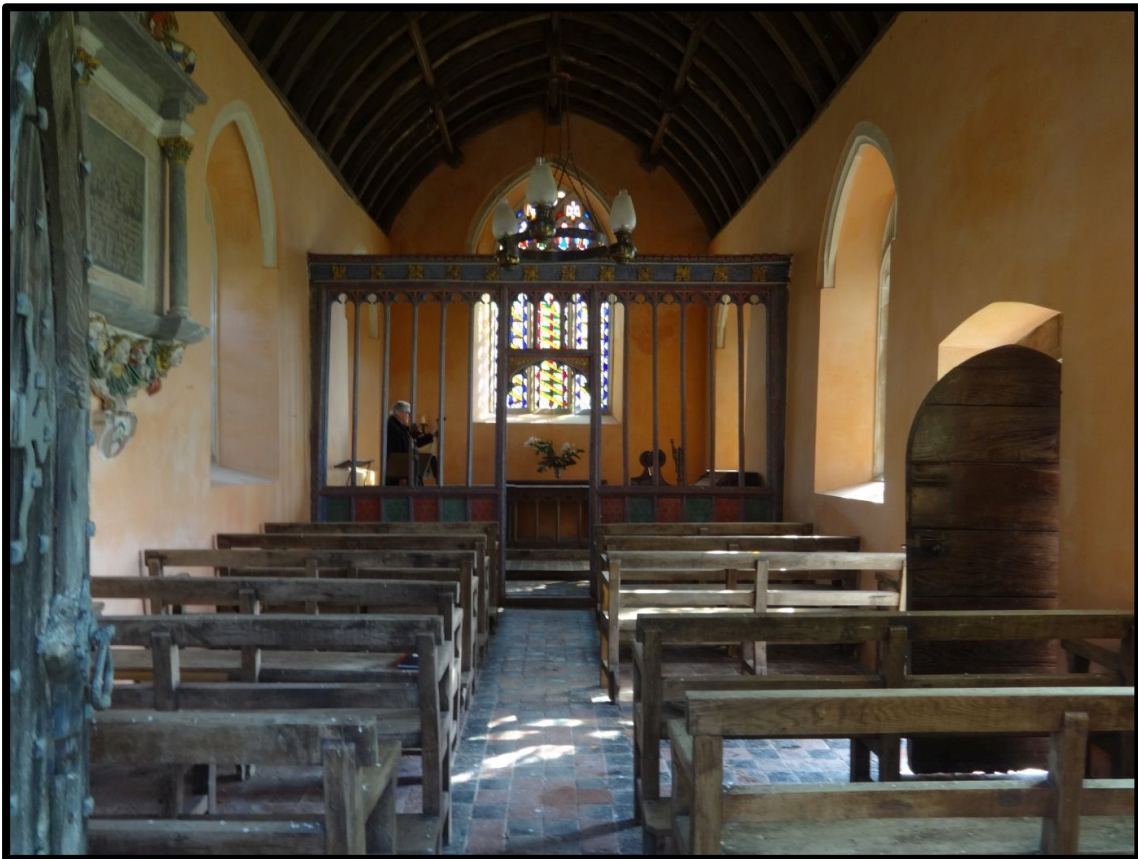
Fig. 27. The small, single-celled chapel at Ayshford, Burlescombe, Devon, showing features which are likely to have existed at St Nicholas, including a plain medieval rood screen, without a loft, and a wagon roof. The open benches shown are of 19th century date, but benches were in use in Devon from the 13th century.
