Archaeological Observations

**WINDOUT FARM,
TEDBURN ST MARY, DEVON**

By R. W. Parker

REPORT No. 2015.02

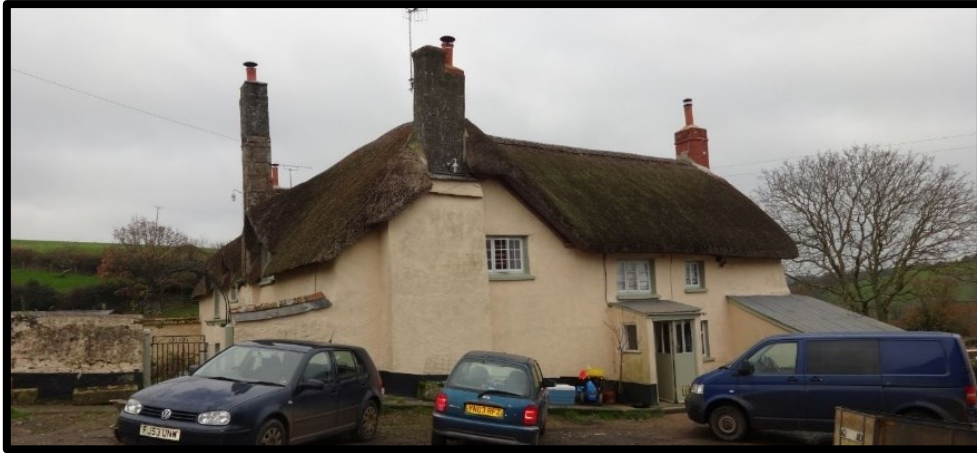
Fig. 2 General view of the farmhouse from the south, showing the 17th-century rear wing (right) attached to the rear of the main house.

probably when the ancillary buildings were listed in 1986. The listing text is extremely detailed and identifies the house as of ‘probably medieval origins, remodelled in the circa late C16’ with a three-room-and-cross-passage plan extended to the east by the addition, at the southern end (Fig. 2), of a kitchen wing ‘added in the C17’ (EH Listing Description; Building ID: 401607). The main body of the house retains important features such as decorated plaster ceilings and plank-and-muntin screens dividing the rooms and the cross passage. There is a large lateral and two gable stacks (Fig. 3) and a further, very large chimney stack in the south-east wing, with ovens, which forms the main subject of this report (Fig 4).

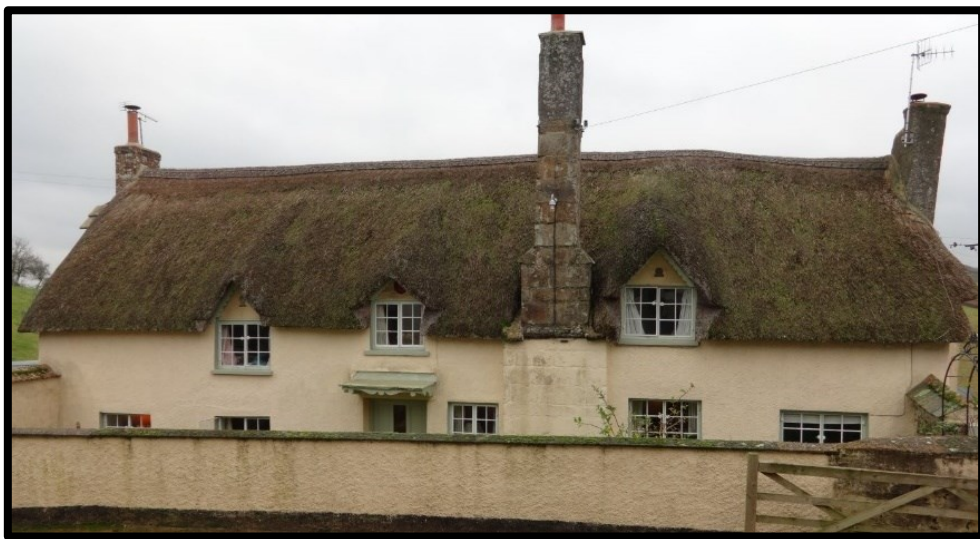
Fig. 3 General view of the farmhouse from the west, showing the façade with a lateral stack and floor levels descending to the north.

position of the room, at a lower level than the hall (Fig. 3), might perhaps have been chosen to allow effluent to drain away to the north, and the broad passage would have allowed easy access to the shippon for cattle. If this room was originally a shippon it appears to have been converted to a lavishly-decorated, high-status room at an early date by the insertion of the plaster ceilings and the large sgraffito fireplace at the north end of the house. Unfortunately the insertion of the fireplace may have removed any evidence in the end gable for a primary drain. Evidence of a shippon in the form of stake-holes for tethering posts and earlier floor surfaces with drains might survive below the modern floor surface but no evidence of such features is now visible.

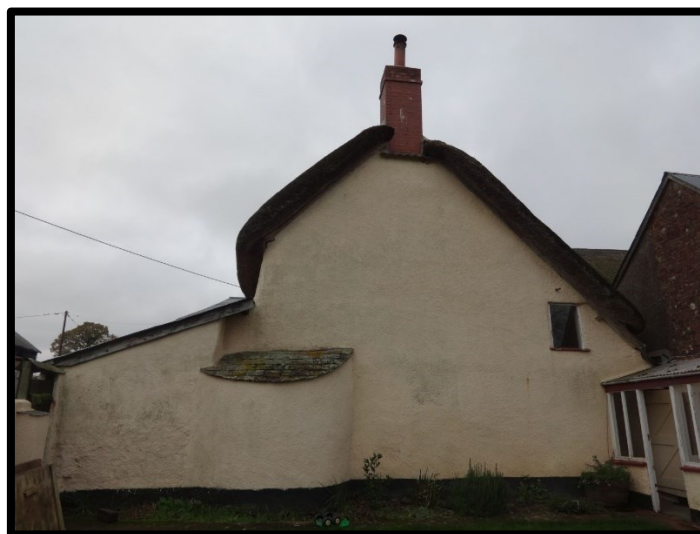
Fig. 4 General view of the farmhouse from the east, showing the projection for the oven. The whole elevation is effectively the chimney breast of the kitchen fireplace.

In the southern part of the fireplace are a pair of ovens of great interest. One of these has a pointed brick arch over a cast-iron door cast by the Bodley foundry in Exeter. This oven is contained within a large semi-circular projection beyond the east wall (Fig. 4) and probably dates from the 19th century. The other oven, within a smaller recess in the south side of the fireplace is a more unusual and potentially important survival. This has a square opening with a stone lintel and a stone shelf below it and contains a ceramic cloam oven, built into the thickness of the wall beyond the opening. This oven is a hollow structure with a dome featuring raised seams radiating towards the rear where the sheets of clay were 'draped' to form the dome and then pinched together, to considerable decorative effect.

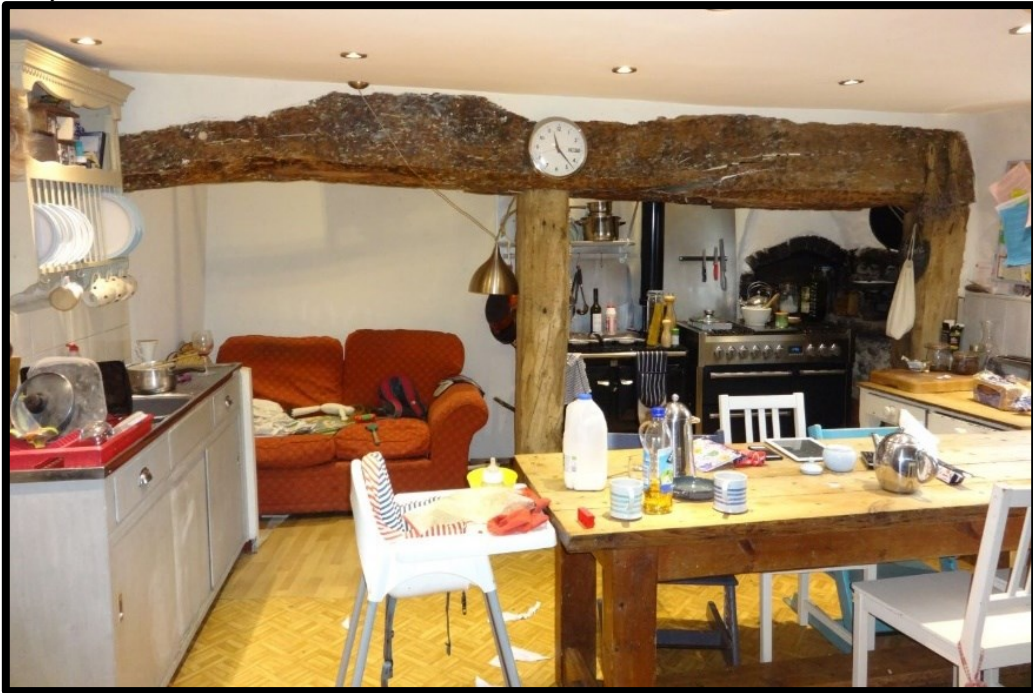
The ground-floor room was clearly the kitchen and is dominated by the enormous fireplace, which fills the entire east wall of the room. This has a long timber lintel spanning the whole width of the room and decorated with a chamfer (Fig. 5). The lintel is now propped with wooden posts, but it is probable that it originally spanned the room without interruption. The sides of the chimney did

Fig. 5 View within the south-east wing, looking east, showing the enormous fireplace filling the entire east wall.

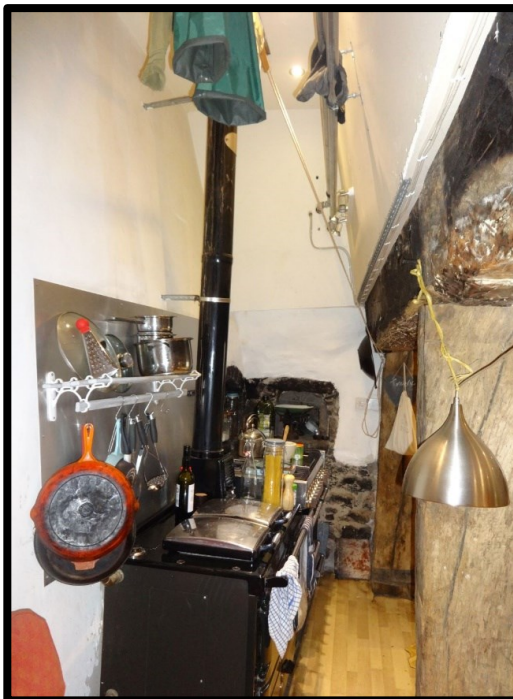
Fig. 6 View within the fireplace looking south, showing the very large space within the kitchen chimney which may have been employed as a smoking chamber.

not rapidly contract inward above the level of the lintel to form a narrow flue, as is usual, but rather formed a high, enclosed area (Figs 6, 7) screened off from the kitchen by the lintel and the front of the chimney breast and rising higher than the first-floor level. The main chimney flue must have risen off-centre in this semi-enclosed bay, its position perhaps being betrayed by the stove pipe of the modern range. The interior of the chimney is now plastered and the upper parts of the flue are blocked off to reduce heat loss to the room.

Despite Brears' reservations, the very spacious chimney compartment at Windout Farm could well have been designed for smoking meats; the high, rectangular recess within the fireplace would have allowed the meats to be hung up well away from the heat of the fire, probably in the northern part of the chimney recess. A high-level window in the eastern gable of the house (Fig. 4), lying more or less between ground and first-floor level, might perhaps have served as a vent for a flue from the chimney, drawing the smoke past any hung meats, but the existing modern finishes and blocking of the chimney obscure any evidence within the upper part of the chimney for flues, recesses or hatches and it is difficult to be certain how the fireplace functioned. Evidence for bars chains and other fixtures for hanging the meat, and also devices such as pot hooks may yet survive within the chimney, above the modern blocking of the flue.

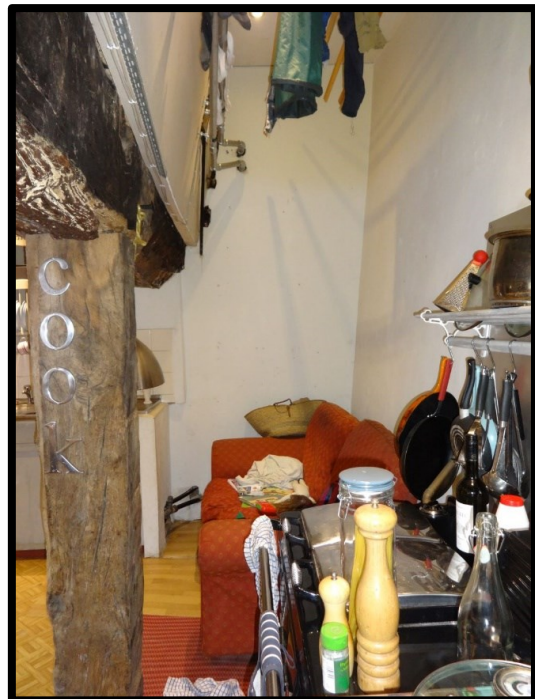
Fig. 7 View within the fireplace looking north showing the very large size of the flue area.

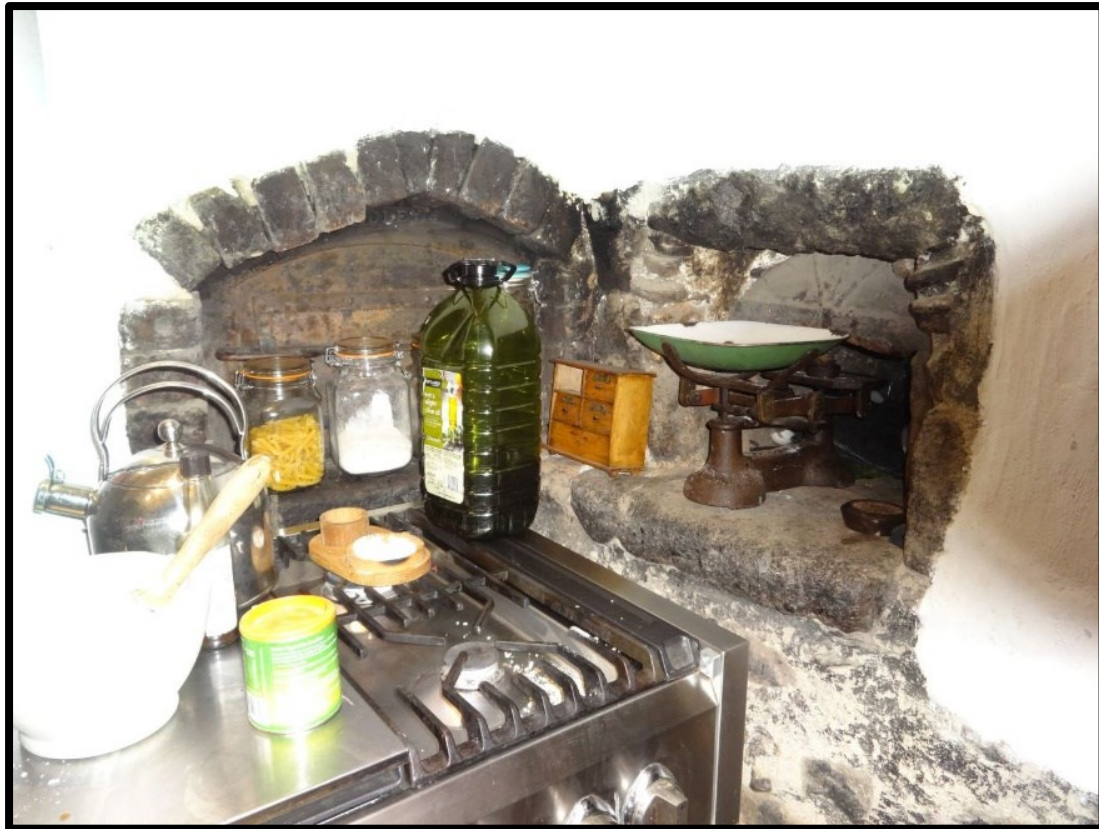
Fig. 8 View of the ovens in the south-eastern corner of the fireplace, showing a clay cloam oven built into a recess alongside a larger bread oven.

This type of ceramic oven was sometimes intended as a portable, or free standing oven, but they could be built, as here, into an opening in the side of the fireplace. They were fired with bundles of brushwood, which, when the clay oven was white hot, were raked out and the unbaked food inserted. The opening was then sealed with a detachable door bedded in wet clay and, after a suitable cooking period, the door would be opened and the cooked loaves removed.

Despite their popularity over a long period, and the fact that some such ovens remained in use into the 1960s, complete examples of ceramic cloam ovens are now extremely rare. Tedburn St Mary lies at about the southern limit of the known distribution of such ovens in the county, most surviving examples being found north of Dartmoor. Without specialist study of the fabric of this oven it is difficult to be certain whether it is an early example; however, it seems highly likely that in this case the early oven was superseded in the 19th century by the more modern oven adjoining, with a cast iron door, and it is thus possible that the clay oven may perhaps be of 18th-century or even earlier date.
