Historic Building Survey

**POWLESLAND FARMHOUSE,
POWLESLAND LANE,
SOUTH TAWTON, DEVON**

By R. W. Parker

REPORT No. 2016.01

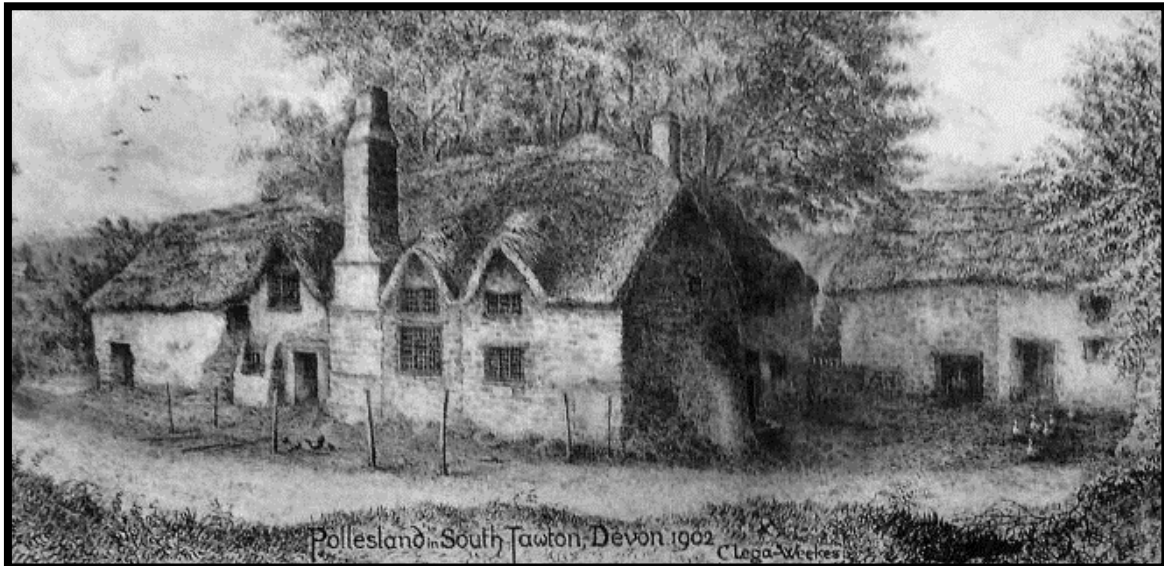
Fig. 2 South elevation of the farmhouse, drawn by Cletia Lega Weekes in 1902, showing the building prior to 20th-century alterations and the cottages behind.

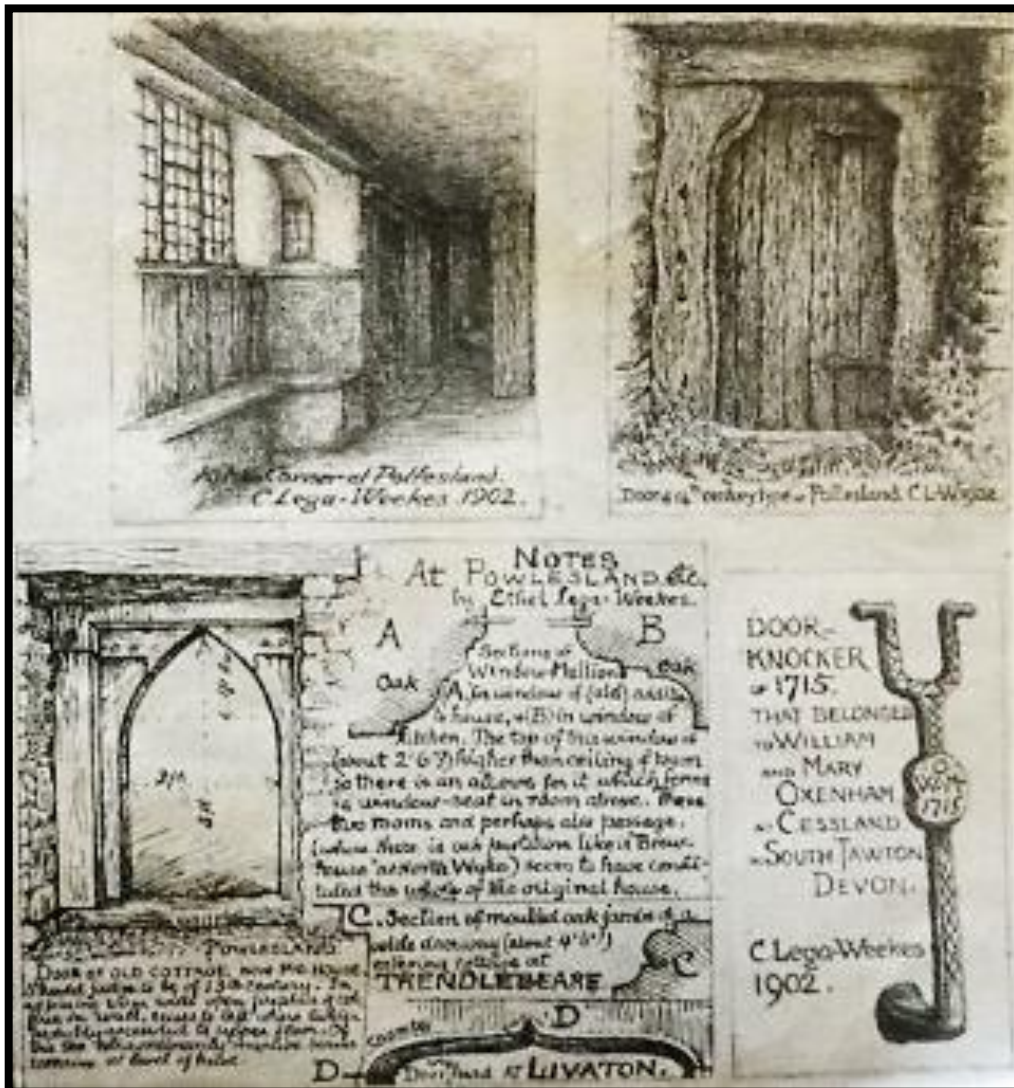
Fig. 3 Details of the doorways, windows and moulded timbers of the building drawn by Cletia Lega-Weekes in 1902, with sketches of the interior, showing some features which no longer survive.

wing (Fig. 3, A & B) were removed shortly afterwards during a phase of early 20th-century refurbishment.

The Lega-Weekes' drawings (Fig. 28) show the hall window as taller than at present, with its lintel very close to the sill of the window in the hall chamber above, and describes the window embrasure as 'higher than the ceiling' (Fig. 3, B), suggesting that the embrasure, if not the window itself, predated the insertion of the present ceiling. Unfortunately the window was replaced in c.1935 and its date can no longer be determined. It may have been inserted in place of an earlier window in the mid 17th century. The drawings (Fig 28) also show a vertical break in the walling adjacent to the north-eastern jamb of the window, as though the hall window and the window above have been pushed out flush with the outer face of the stack, and with the front wall of the building to the north east. This may mean that the hall window was originally recessed slightly, in the presumed plane of the original wall of the medieval house, and that the front wall of the north-eastern rooms had previously been brought forward to its present alignment.

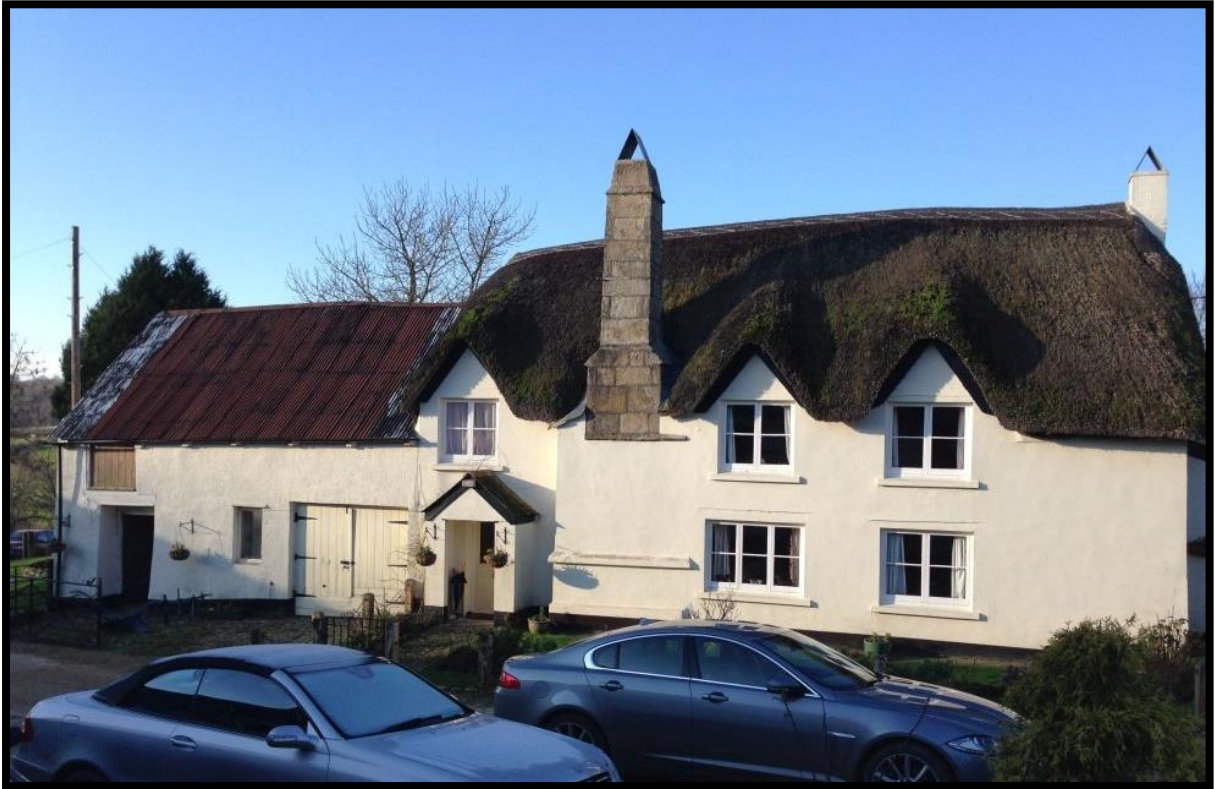
Fig. 12 South elevation of the farmhouse, seen from the farmyard showing the shippon on the left and the domestic accommodation on the right.

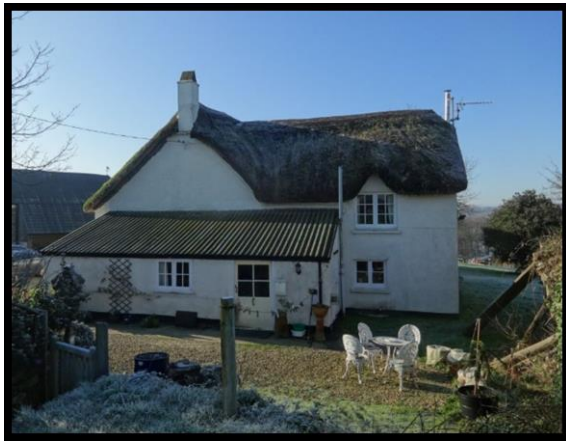
Fig. 13 The north eastern gable of the farmhouse showing the rear extension, lean to and the collapsing walls of the ruined building to the north (extreme right).

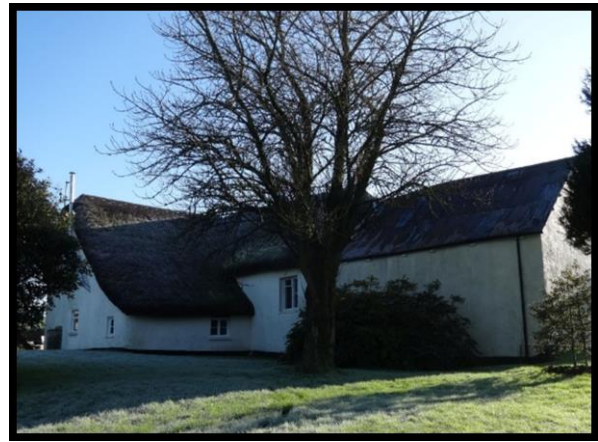
Fig. 14 The rear of the house showing the blank wall of the shippon (right) the stair window marking the position of the cross passage (centre) and the rear wing and outshut (left).

The shippon is separated from the cross passage in the domestic portion of the house by a wall of rubble masonry rising almost to first-floor level, overlain with cob (Fig 14). This is almost certainly an insertion and may replace an earlier timber screen or part screen (spere) for which some evidence remains in the adjoining cross passage (see below). The lower part of the wall is of solid masonry and appears to be added underneath and around a large beam supporting the floor structure of the 'chamber over the entry'. The wall has been partially stripped of plaster and shows no evidence of any openings between the shippon and the cross passage. The apparent vertical breaks, which might initially have been taken to suggest the presence of a doorway here, prove to relate to the rebuilding of the jambs of the garage door in c.1935 and the insertion of a soil pipe serving the bathroom in the chamber over the entry in the 1950s (Fig.14).

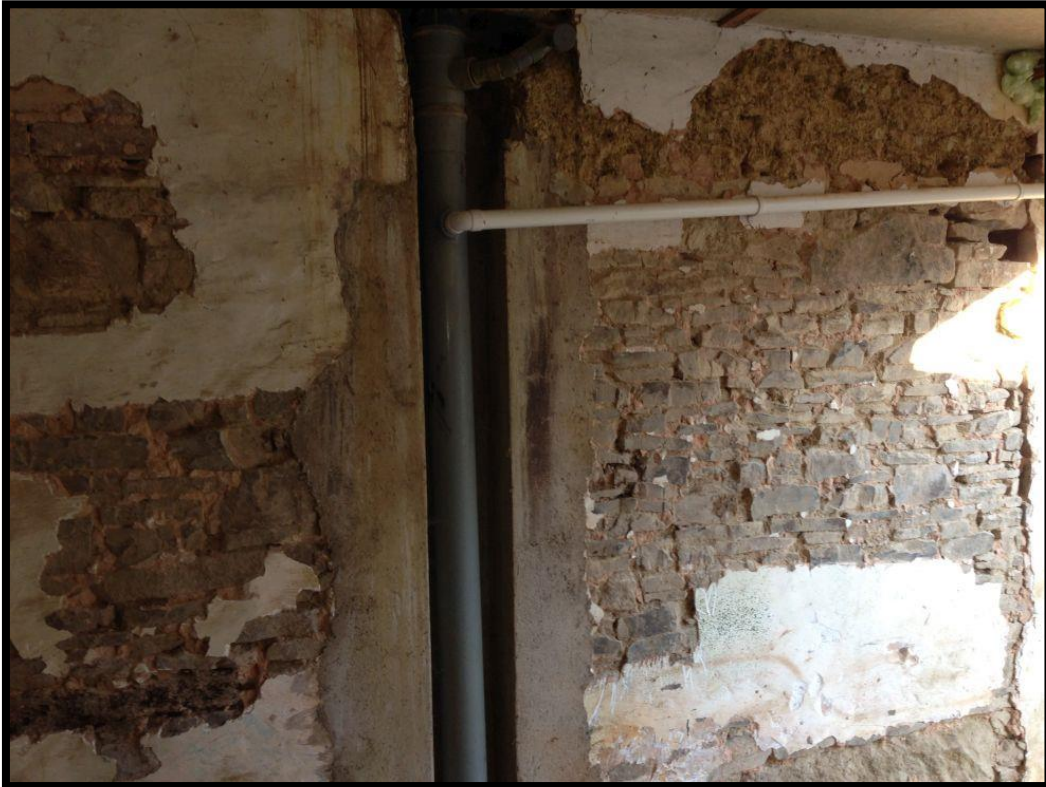
Fig. 15 The stone and cob wall separating the house from the shippon, probably a 17th-century insertion, showing modern intrusions into the fabric.

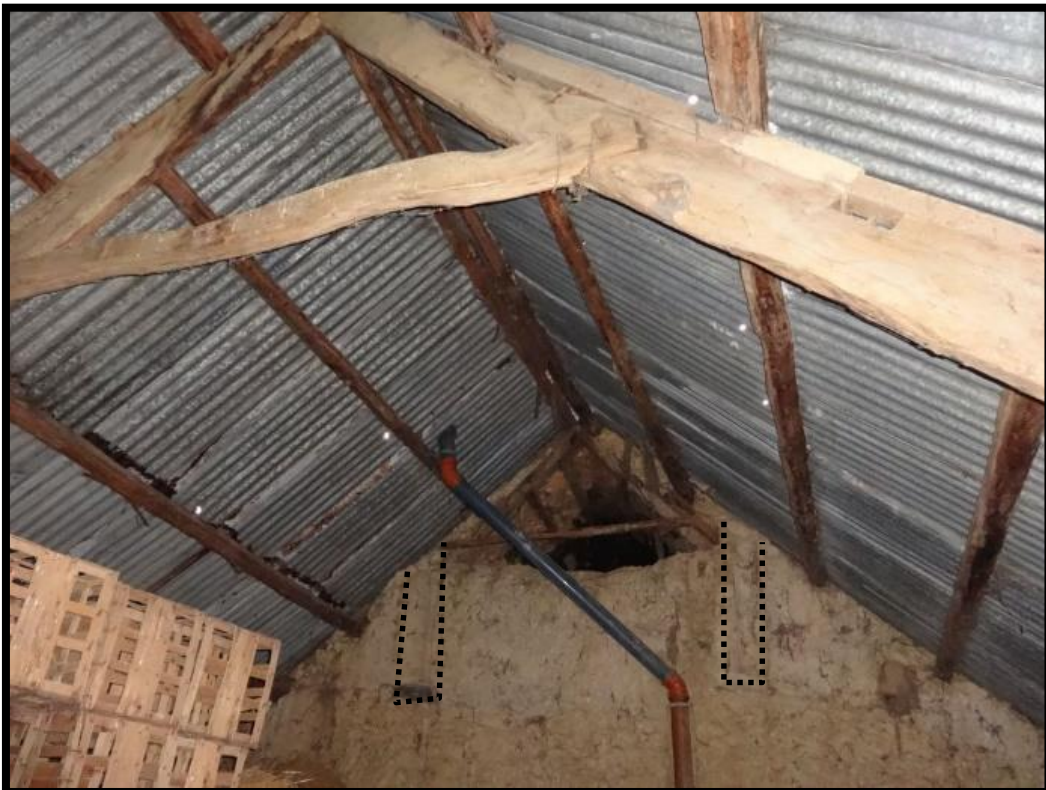
Fig. 16 The upper part of the wall separating the house from the shippon showing two vertical chases (dashed) for short wall posts, probably for braces to purlins or perhaps 'arcade plates' in the lost medieval roof.

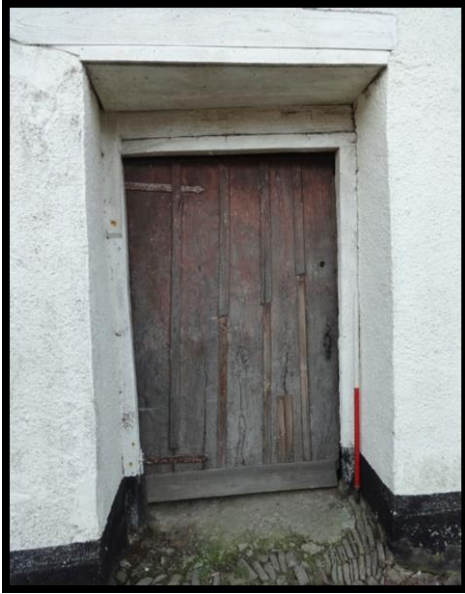
Fig. 17 The plank door to the shippon, possibly dating from the 18th century.

The doorway retains an historic plank door constructed of five narrow planks covered on the exterior by four applied fillets (Fig. 17). The interior has three horizontal ledges but is not diagonally braced (Fig. 19). The topmost hinge may be original; it is a long strap hinge with a dart-shaped terminal, and runs behind the fillets. The lower hinge is a plain rectangular strap and is evidently a replacement, the fillets being removed to allow its replacement. The door frame may also be a replacement. This door is of such simple and plain construction that it is very difficult to date. It could date from as early as the late 17th century, but the absence of any form of mouldings may indicate a date in the 18th century.

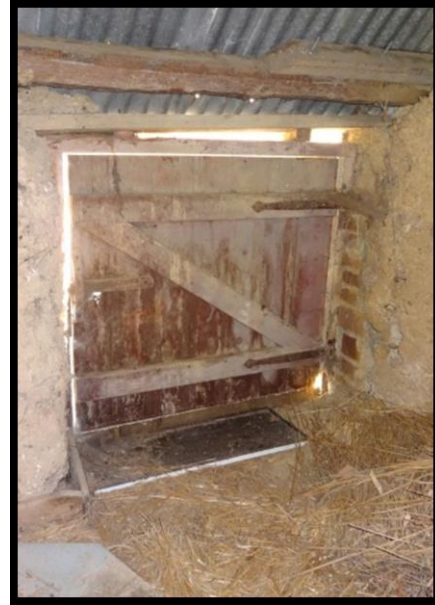
Fig. 18 The plank door to the loft of the shippon, showing reused hinges.

The jambs of the modern window and doorway to the garage are constructed of early-mid 20th century red brick. The wall above the doorway and window has also been rebuilt in brick of the same period, the cob wall presumably having collapsed or been demolished when these openings were made. A new loft hatch was created at the south-western end of the loft in the early 20th century. This has a 20th-century plank door with two ledges to the interior and a diagonal brace. The door is hung in a modern frame but retains a pair of reused earlier strap hinges with dart-shaped terminals (Fig. 18).

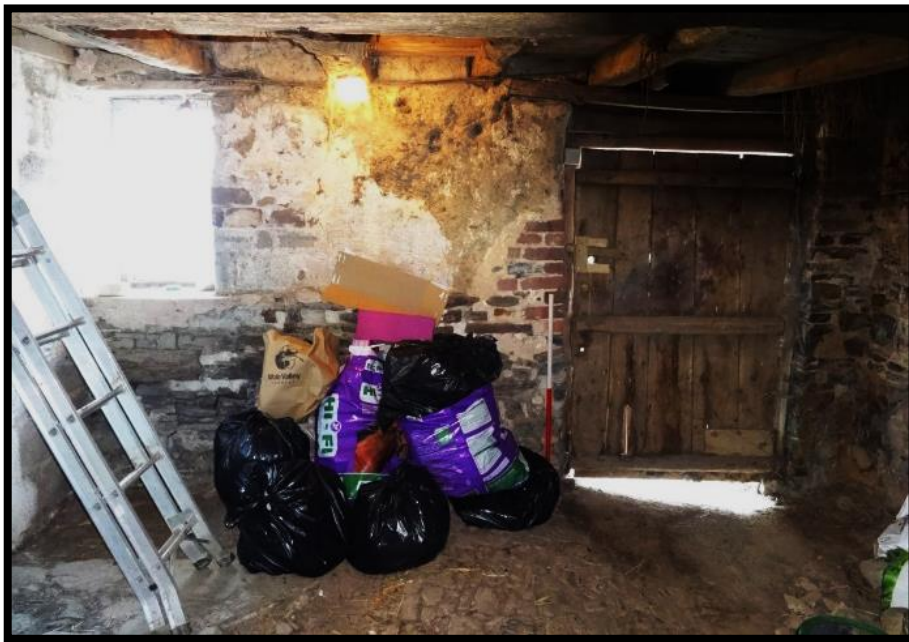
The shippon retains part of its early cobbled floor, though this is much obscured by the goods and materials currently stored there. The shippon floor is largely of small cobbles, but there are areas of larger cobbles which seem to represent drains or perhaps a head walk. Unfortunately the centre of the shippon floor was not visible and the central drain and its opening in the gable wall could not be observed. The garage area has a slightly higher floor of concrete, which may cover the earlier cobbled flooring of the shippon.

Fig. 19 The interior of the shippon, looking south-east, showing the surviving parts of the cobbled floor and the cob and later brick rebuilding of the front wall supporting the joists of the loft floor.

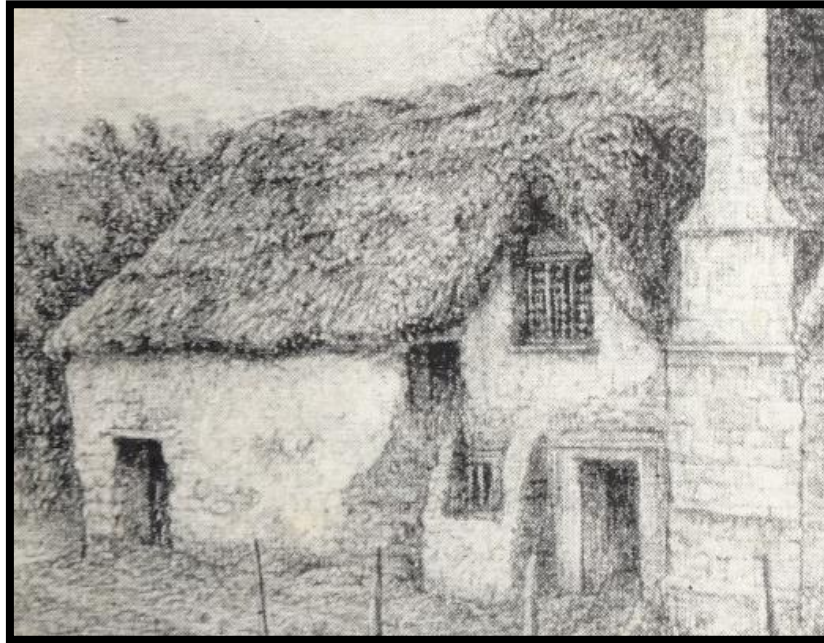
Prior to the early 20th-century alterations the original openings in the shippon (as recorded by Cletia Lega-Weekes in 1902, See Figs 2 and Fig. 20) included only a doorway at the south-western end of the façade, and a small loft hatch at the north-eastern end of the upper storey of the shippon. Lega-Weekes shows none of the usual narrow slits for lighting, and none survive today. She also shows a projecting feature in the wall below the hatch, and a scar in the wall adjoining this which might be interpreted either as simply a missing patch of render or the scar of a demolished external stair.

Fig. 20 Detail of Lega-Weekes' drawing of the shippon in 1902, showing the early openings in the south-eastern wall and other features now removed.

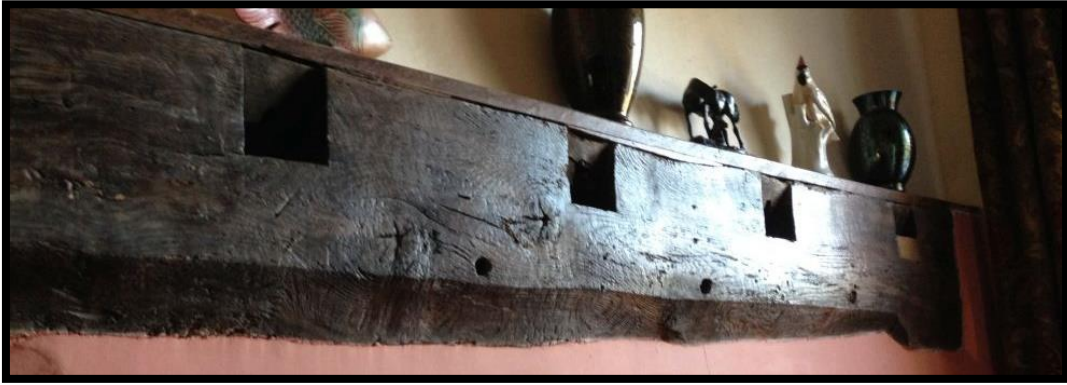
Fig. 21 The beam on the south-western side of the cross passage, supporting the floor of the chamber over the entry, showing the character of the sockets for the floor joists and the peg-holes, perhaps for a short spere, beneath them.

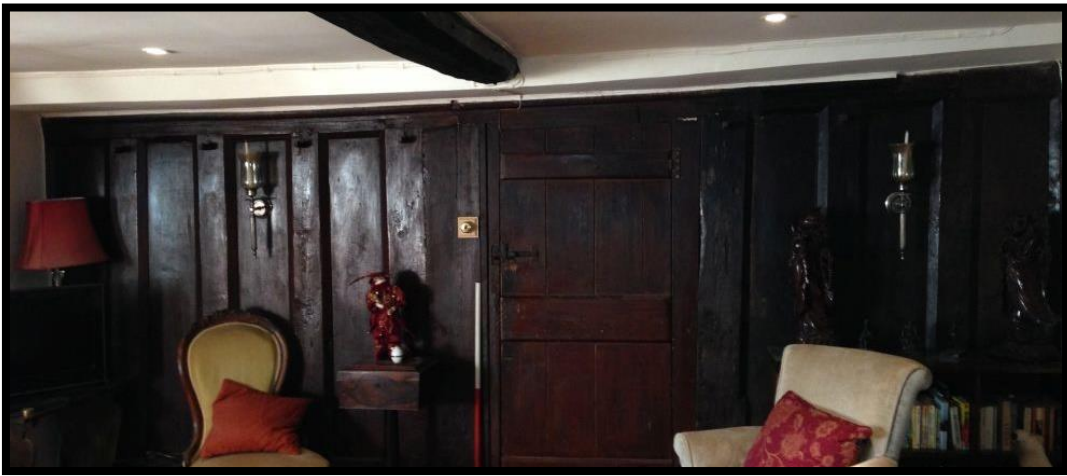
Fig 22 Elevation towards the hall of the hall screen, showing the position of the central doorway and the absence of provision for the staircase, right, suggesting that the screen predates the addition of the chamber over the entry.

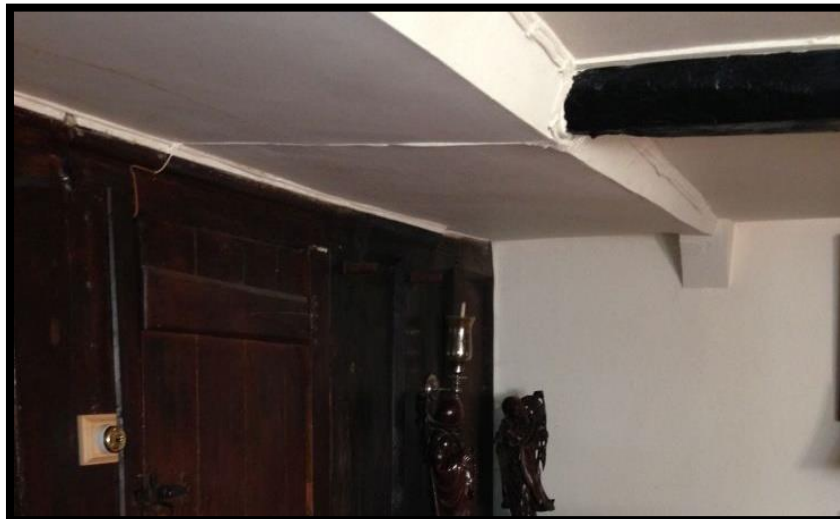
Fig 23 Detail of the hall screen, showing the pronounced internal jetty towards the hall formed by the joists of the chamber floor projecting over the earlier screen and the junction with the later beam supporting the hall chamber floor.

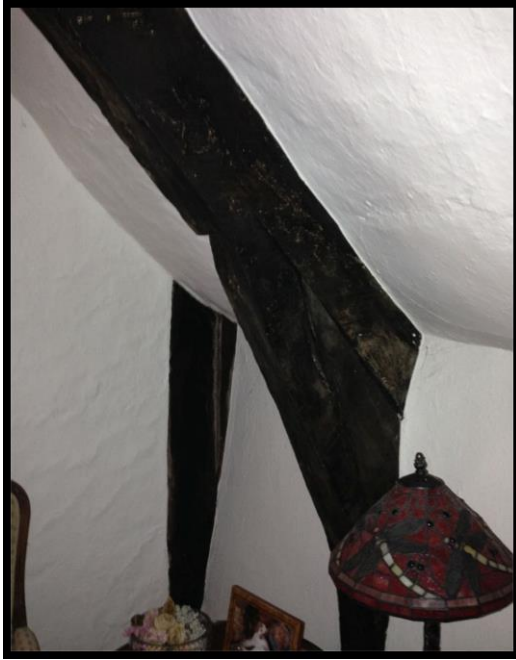
Fig. 24 Detail of one of the hall roof trusses showing its relationship with the partition behind.

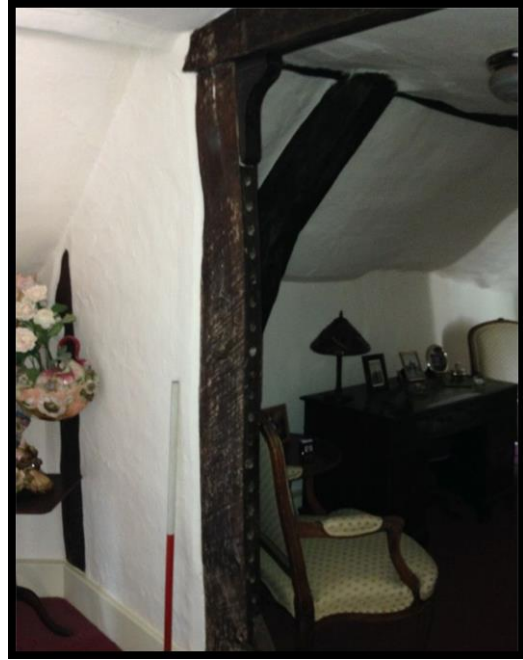
Fig. 25 Detail of the partition between the chamber over the entry and the hall, showing the hall roof truss beyond.

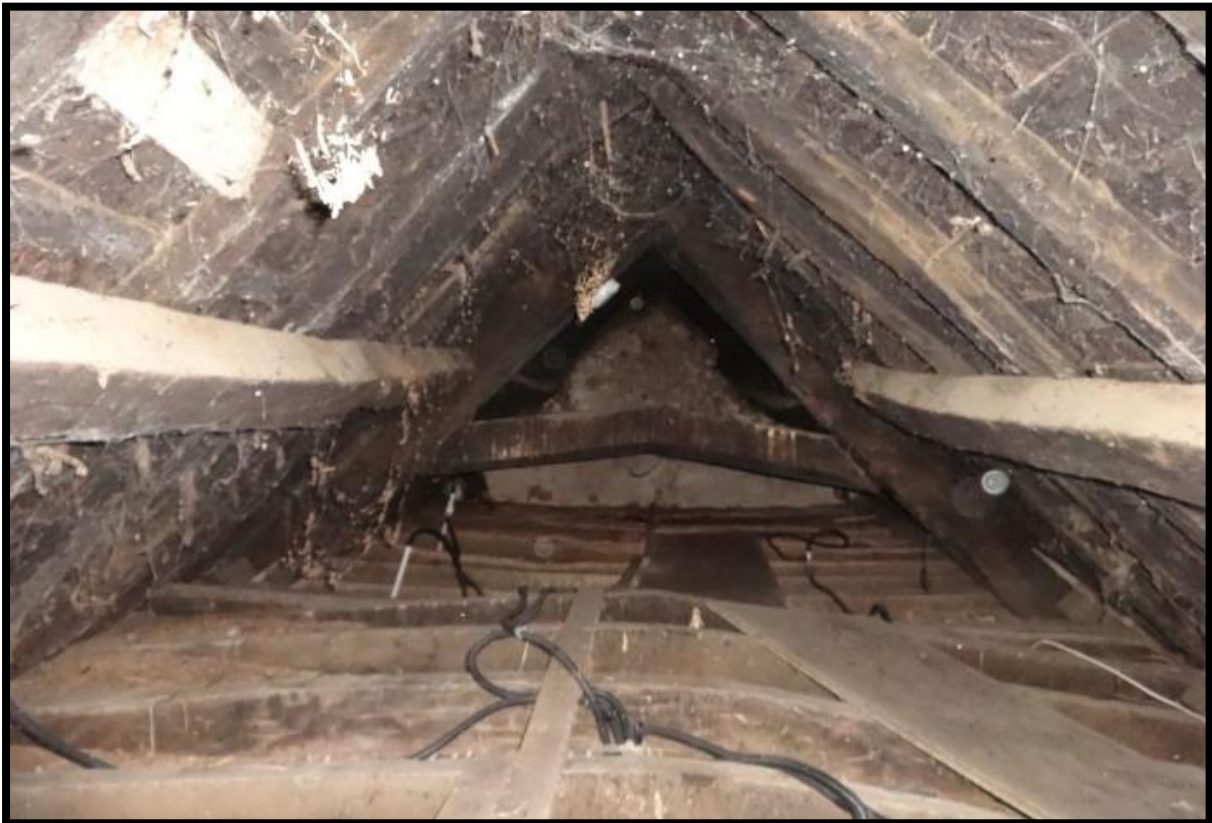
Fig. 26 The roof of the hall seen from the void at the end of the shippon, showing smoke-blackened medieval roof timbers, including a main truss with a high cranked collar, diagonally set purlins and exposed, blackened thatch. Beyond, plaster extends to the apex of the roof and, in the foreground, the cranked timbers of the ceiling over the chamber over the entry show light smoke-staining from the open hearth.

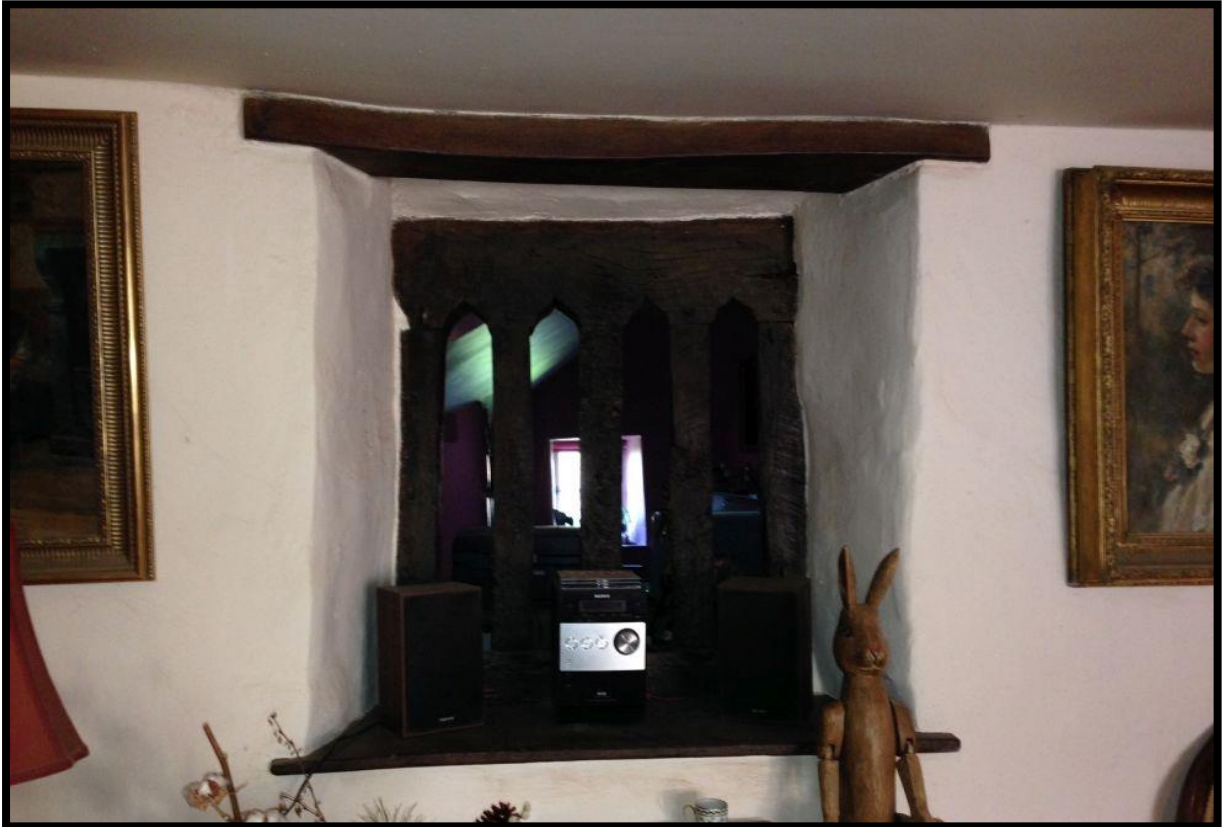
Fig. 27 The rear window of the hall, possibly of 14th- or early 15th-century date, now opening onto the later outshut at the south-western side of the rear wing

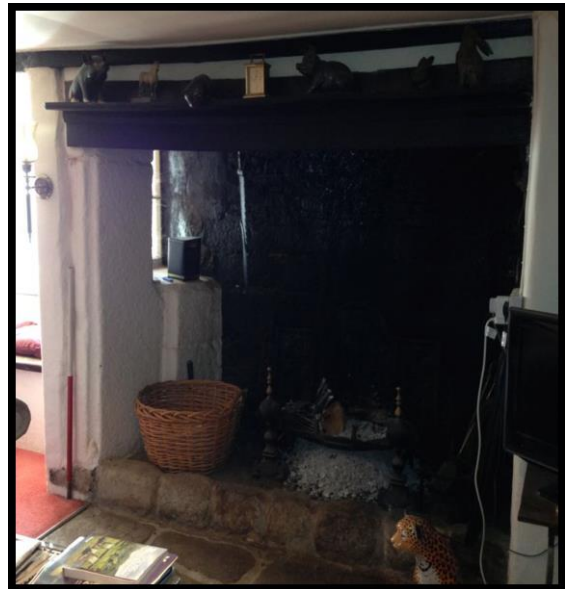
Fig. 29 Detail of the fireplace in the hall, showing the granite jambs pierced by a later window. The lintel, also of granite, rises well above the ceiling, which is supported by a trimmer against the lintel.

The north-eastern jamb of the fireplace incorporates a small window, which opens through the jamb into the embrasure of the hall window. This appears to have been cut through the granite jamb of the fireplace and may be a secondary feature. It is possible that this was an external opening before the hall bay was brought forward into its present plane, or that it was simply inserted to improve the light within the fireplace by borrowing light from the hall window embrasure.

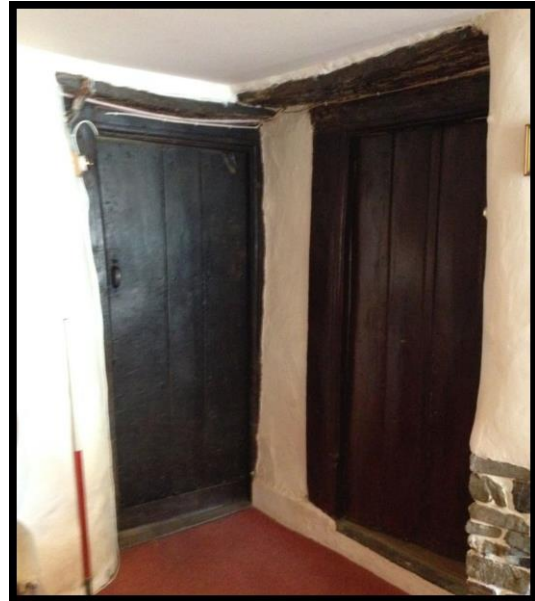
Fig. 31 Doors from the hall to the rear wing and inner room, decorated with ovolo mouldings and scroll and bar stops.

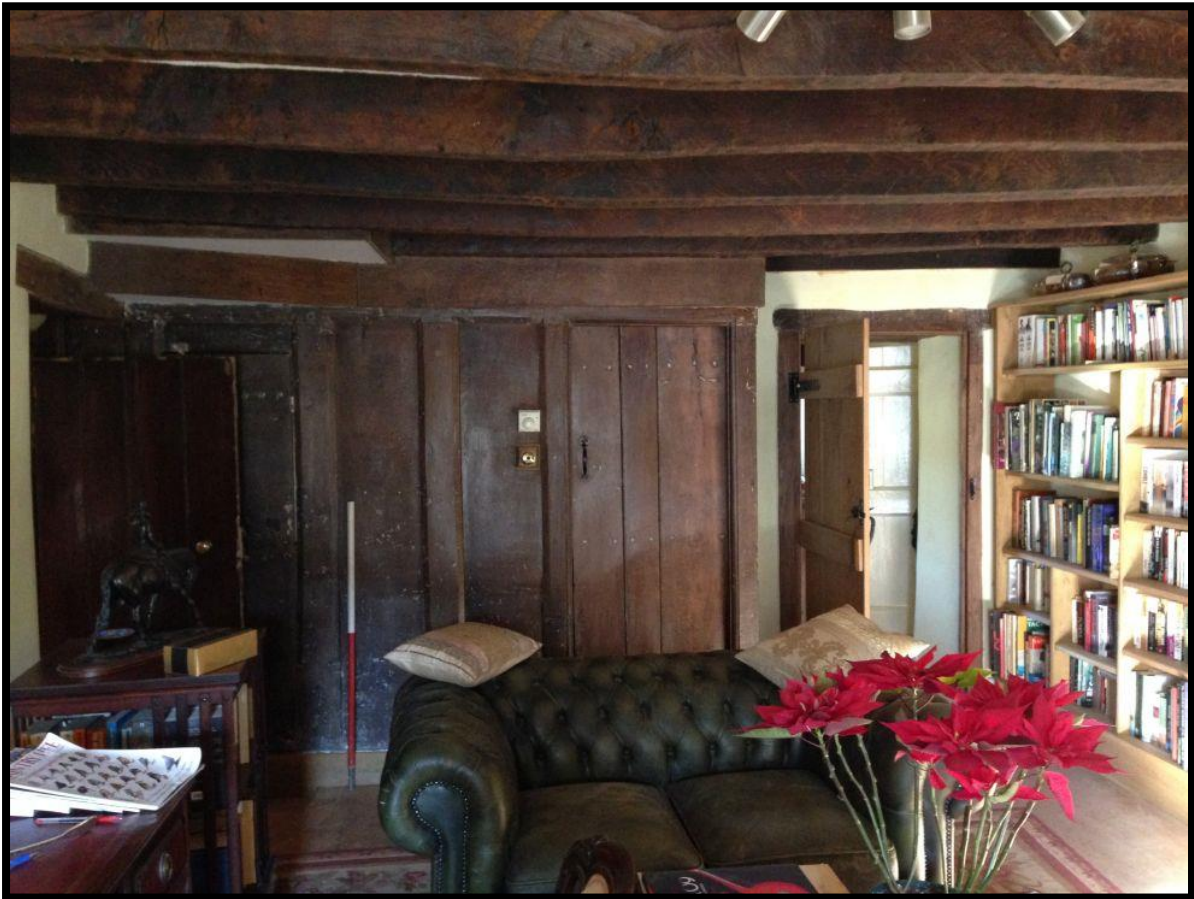
Fig. 32 The inner room from the south-east, showing the 17th-century plank and muntin screens hiding the staircase cut within its north-western wall and the joists of the ceiling reset in 1983.

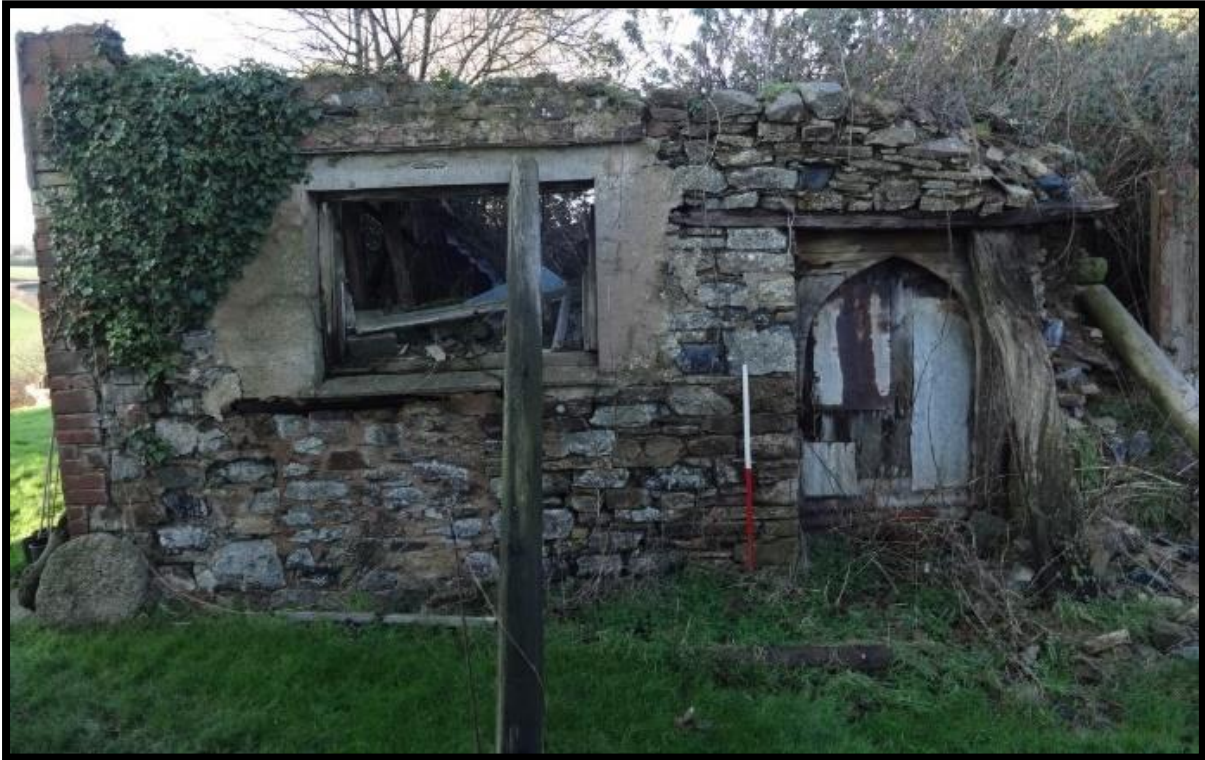
To the north of the house and slightly to its rear is a small outbuilding, now in ruins, which is of exceptional interest. This was in use as cottages when it was visited by Ethel and Cletia Lega-Weekes. Their drawing (Fig. 2) shows the building as having very high eaves and few windows, except where these have been added for its conversion to dwellings. The building is in two sections, the south-westerly part being of stone construction and the north-easterly part, which is considerably larger, of cob, probably an addition. The main surviving feature, in the stone portion of the building, is a timber doorframe (Fig. 33) with a two-centred arch, of very high quality and possibly dating from the 14th or 15th century. Access to the interior is no longer possible and the function of the building cannot be determined, but its orientation, nearly east west, the character of the doorway and the general proportions and appearance of the building are comparable with the surviving medieval chapel at Bury Barton, Lapford (Figs 34, 35). It is thus possible that this ruin represents the remains of a hitherto unrecorded private chapel at Powlesland, converted to profane use after the Reformation and now, rapidly, passing away.

Fig. 33 The remains of the ruined building to the north of the house, showing a 14th- or 15th-century arched timber doorway. Compare with Figs. 2, 34 and 35.

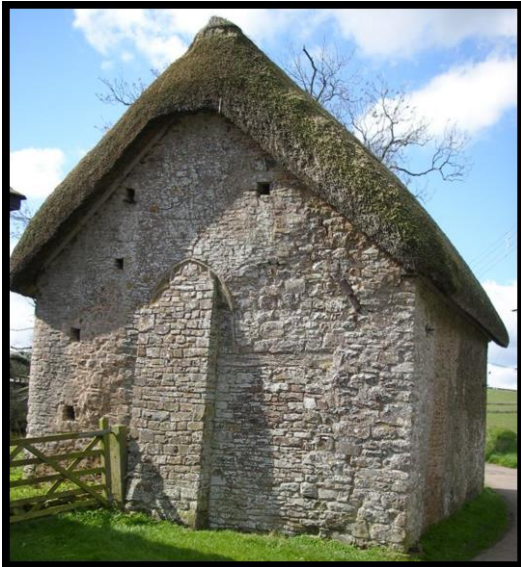
Fig. 34 View of the medieval detached chapel at Bury Barton, Lapford, showing the high eaves and small window openings, including an elaborate traceried east window behind the buttress.

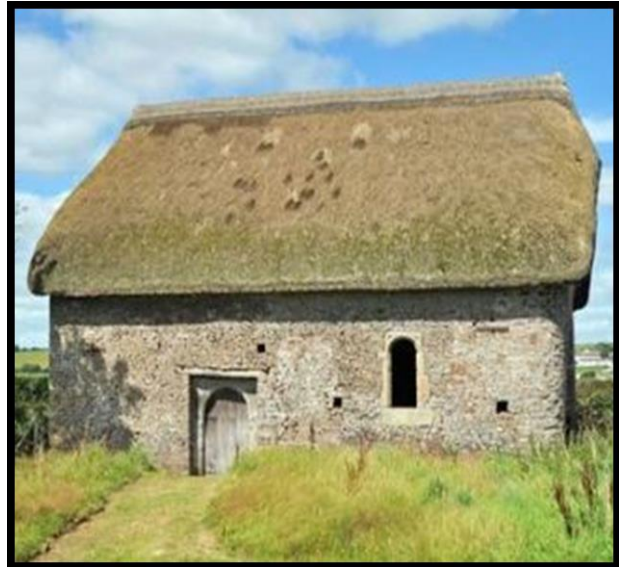
Fig. 35 View of the south wall of the chapel at Bury Barton showing the arched timber doorway and proportion of wall to windows (Compare with Fig. 2, showing the building at Powlesland before its ruination).
