Historic Building Survey

FAIRFIELD COTTAGE, COLEBROOKE LANE,
CULLOMPTON, DEVON

By R. W. Parker

REPORT No. 2016.02

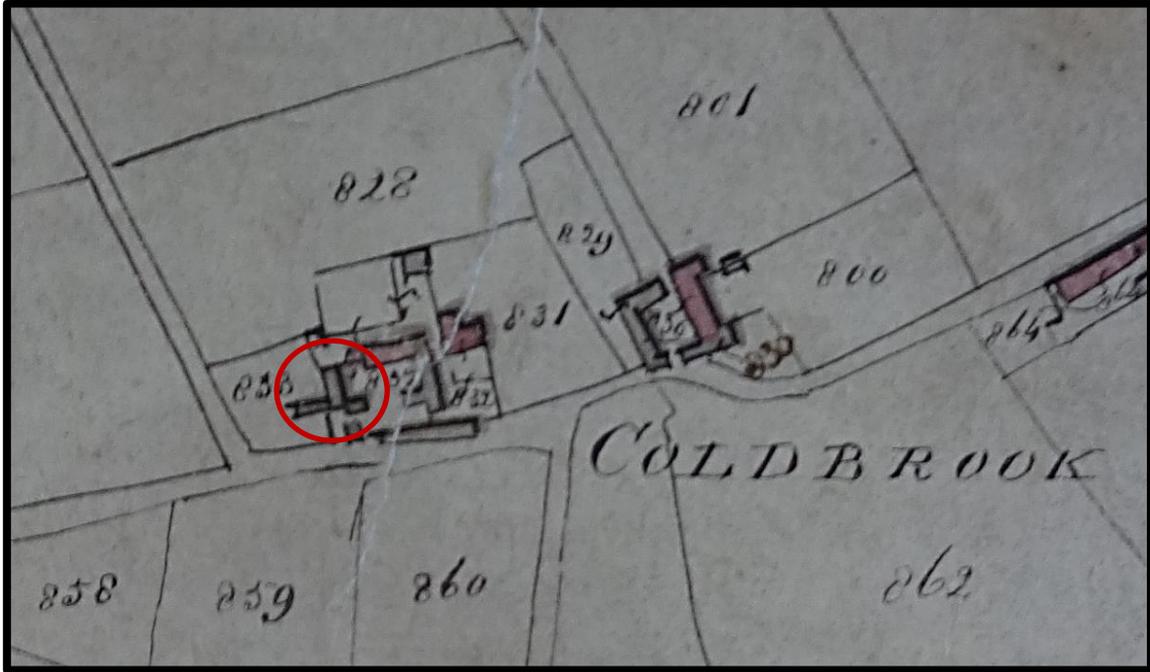
Fig. 2 Detail of the Cullompton Tithe map, surveyed in 1841 by Gideon Boyce of Tiverton, Surveyor, showing the buildings on the site of the current property circled. Residential buildings are coloured pink and other buildings grey.

The earliest map of the Colebrooke area readily available at the time of the recording is the Cullompton Tithe Map, surveyed in 1841 by Gideon Boyce of Tiverton Surveyor (Fig. 2) and the Tithe Apportionment associated with it, dated 1842. The map shows a considerable complex of buildings at ‘Coldbrook’ some of which, coloured pink, are dwellings. The property now consisting of Fairfield House and Cottage may be identified with Nos 832 and 833 on the Tithe Map. This is identified in the apportionment as part of a property owned by John Hayman Shaw and occupied by Thomas Marks, consisting of ‘Houses, Homestead and Garden’. Most of the properties surrounding this belonged to a landowner called Henry Palmer. There is very little correspondence between the buildings depicted on the tithe map and those presently on the site, though the footprint of some of the buildings is similar. Fairfield House cannot be identified as a dwelling, and both it and the adjoining buildings on the site of the cottage are shown in grey, as though, whatever their original function, they were then in use as agricultural buildings. It is highly likely that the property was subsequently rebuilt as a new dwelling with the earlier building alongside converted for use as a service wing.

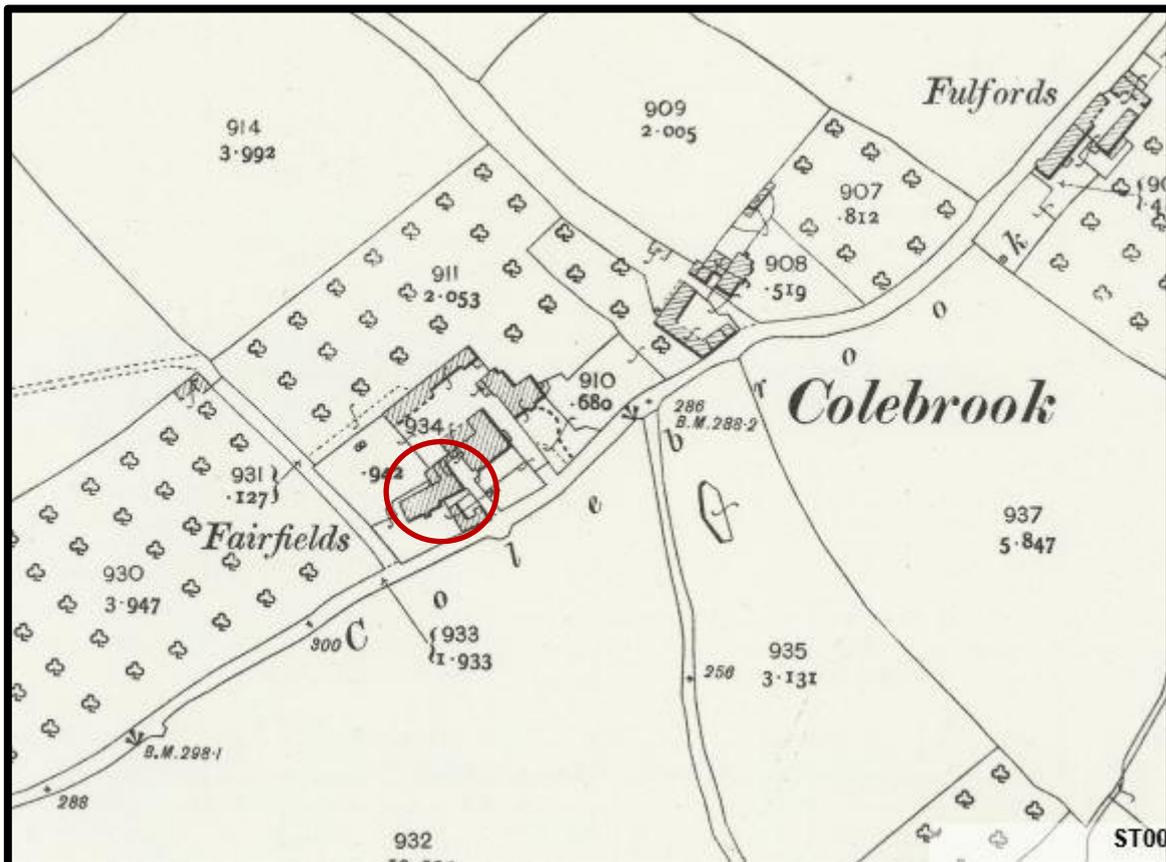
Fig. 3 Detail of the OS 25 inch map of 1892-1905 showing the current property after rebuilding, circled and identified as 'Fairfields'.

Later maps, including late 19th- and early 20th-century OS maps (Fig. 3), show the buildings in more or less their present form, again suggesting that significant rebuilding of the property was undertaken after the tithe survey of the 1840s, but that the property has not been substantially altered since.

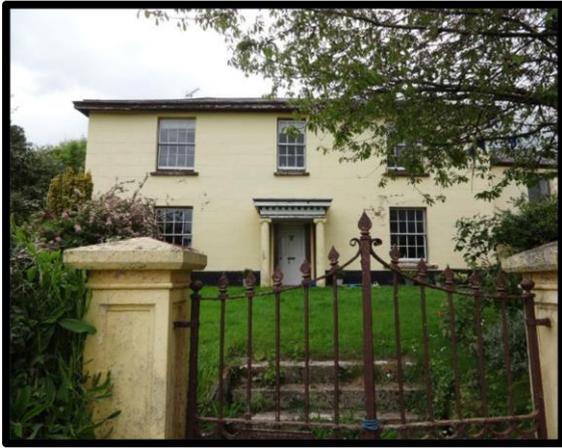
Fig. 4 Main elevation of Fairfield House showing features characteristic of the 1840s. This may represent a 19th-century rebuilding of an earlier structure.

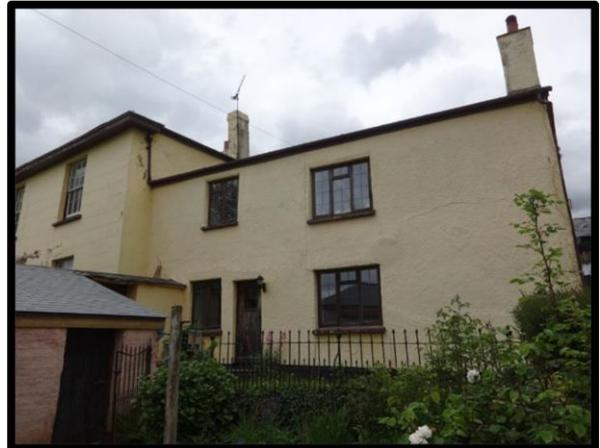
Fig. 5 Main elevation of Fairfield Cottage, showing the lower roofline, offset frontage and vernacular appearance in relation to the adjoining house.

The four windows in the main elevation (Fig. 5) are currently modern timber double-glazed casements replacing metal framed (Crittall?) windows noted in the listing description. These probably occupy the earlier window openings and the irregular fenestration of the façade may be assumed to preserve information about the layout of the original building. The closely-set doorway and window in the ground floor might, for example, occupy the site of a wider opening to a cross passage, and the obvious difference in first-floor levels at the two ends of the cottage, betrayed by the height of the windows, may also reflect a complex development including the insertion of first-floor structures at different periods, perhaps within an originally open structure. These conjectures could only be tested by closer examination of the fabric.

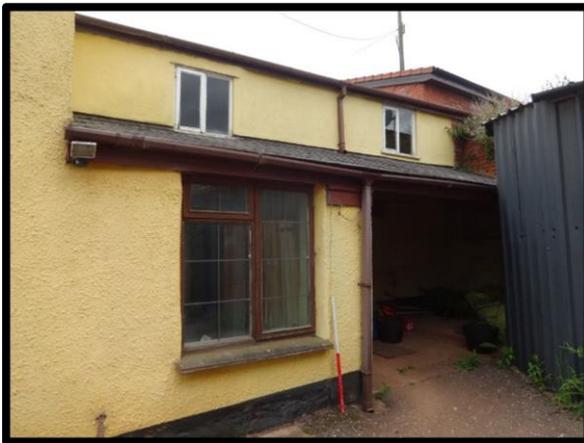
Fig. 6 Elevation of the rear range showing the open lean-to (now partially enclosed) and the thin wall of the rear range behind it.

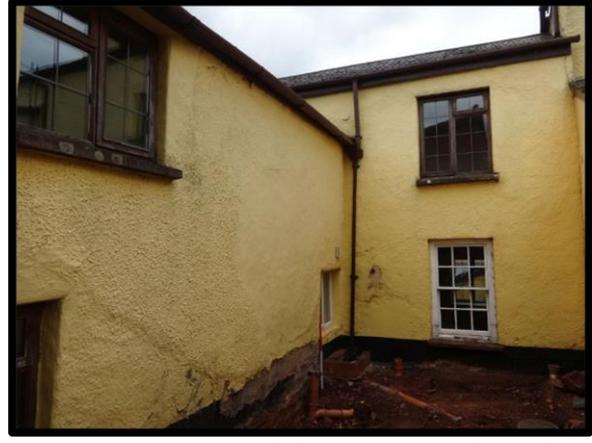
Fig. 7 Elevation of the rear range from the rear courtyard showing the substantial masonry wall (left) and the surviving sash window in the south-western part of the main range, (right).

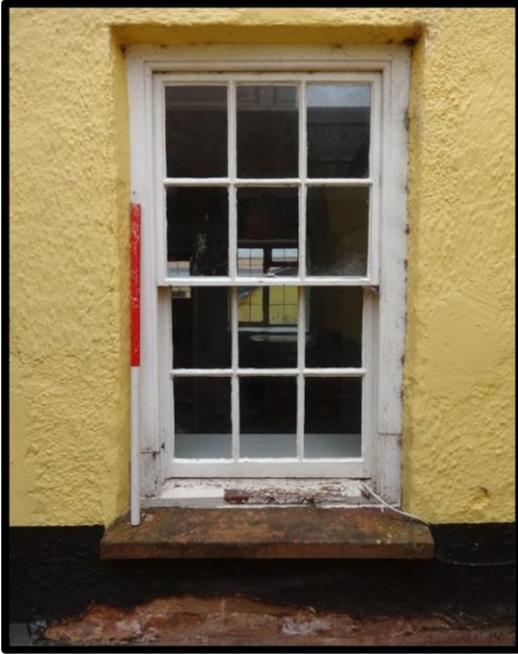
Fig. 8 Detail of the early 19th-century sash window in the rear elevation of the main range, showing its relationship with the door and window in the front wall, beyond. It is possible that this might have been the site of an earlier cross passage.

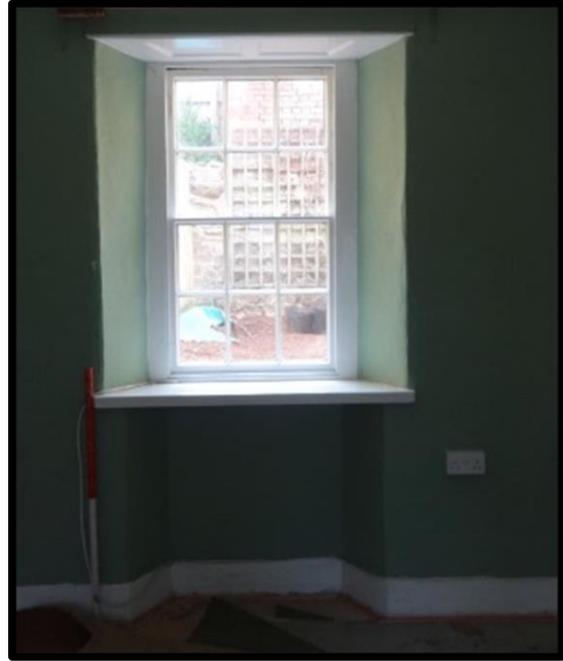
Fig. 9 The early 19th-century window in the rear of the main range from within showing the recess below the window, which might represent either a blocked opening or the remains of a cupboard below the window seat).

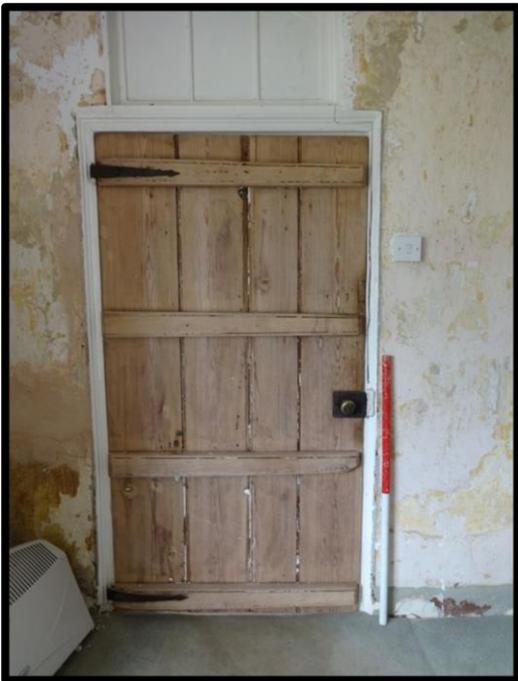
Fig. 10 The plank door to the south-west of the 'kitchen', possibly dating from the 18th century.

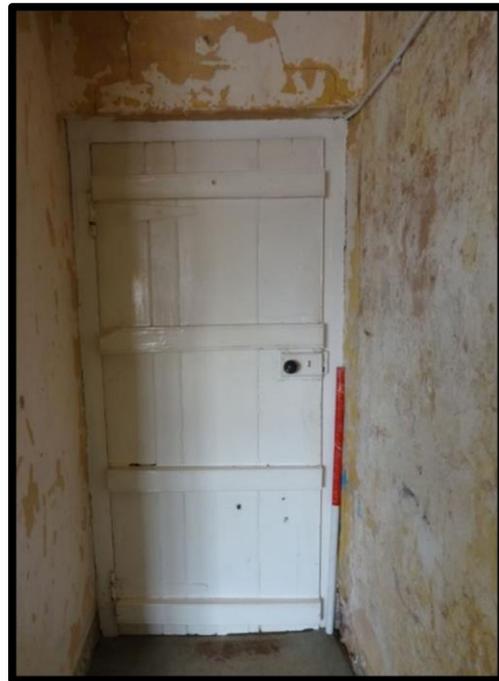
Fig. 11 The plank door to the north west of the 'kitchen' now hung on modern hinges.

The north-eastern room in the main range is probably now the principal room in the house. This room is entered by plank doors of 18th-century character from the north west and the south west, each consisting of three planks joined by four battens to the rear face. The south-western door (Fig. 10) is of pine planks and is hung on spear-headed strap hinges beneath a three-paned glazed overlight; this door has 19th-century door handles and a lock box but preserves traces of an earlier arrangement with a larger timber box; the door may date from the 18th century. The other door is painted and hung on modern hinges (Fig. 11) but is probably reused from another position.

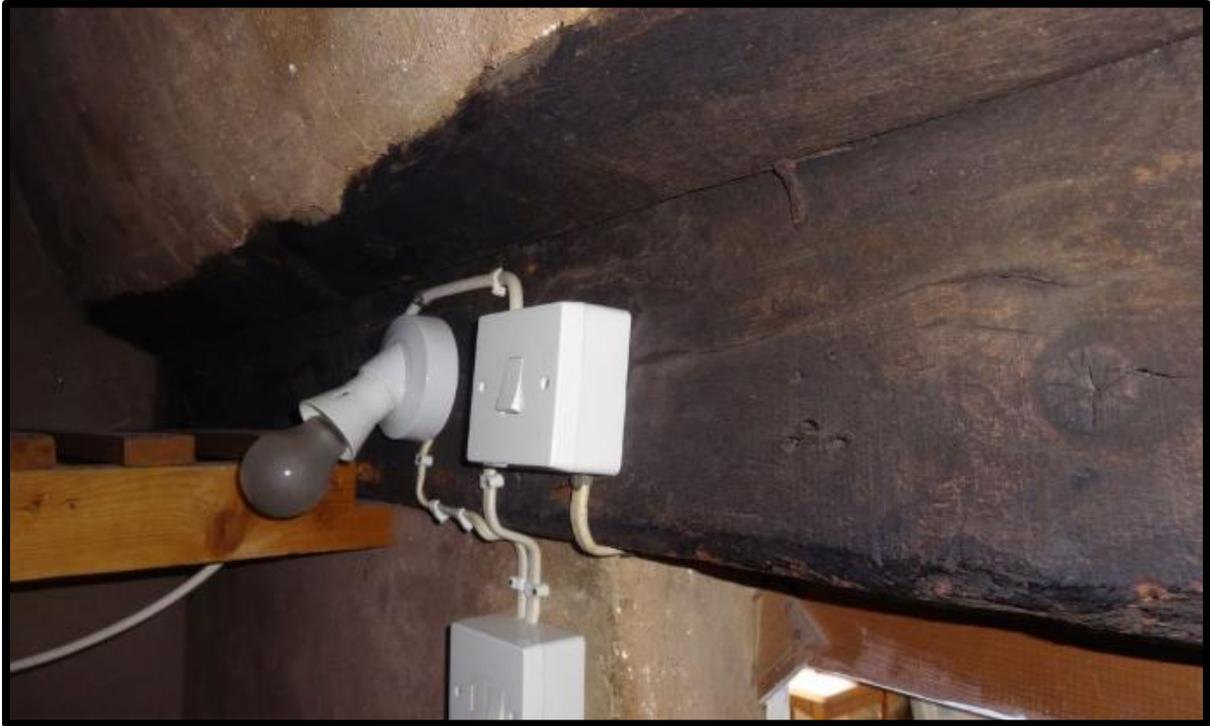
Fig 12 Detail of the rear elevation of the lintel over the very large fireplace in the north-east gable wall of the main range, showing the two substantial chamfered timber lintels or bresummers spanning the opening.

The room is dominated by an immensely wide and deep fireplace in the north-east gable wall, now disguised as a cupboard. Part of the original timber lintel is visible within the cupboard (Fig. 12). This has no external chamfer, but is chamfered internally and bears a second chamfered lintel or bresummer supporting the wall above the fireplace. The chimney breast can be seen passing through the upper storeys of the house as a huge 'fire hood', contracting as it rises through the structure (See Fig. 18). Unfortunately it was not possible to determine the relationship between this chimney and the first-floor joists. It is possible that the chimney rose originally through an open volume the full height of the house. The absence of decorative mouldings or stops to the

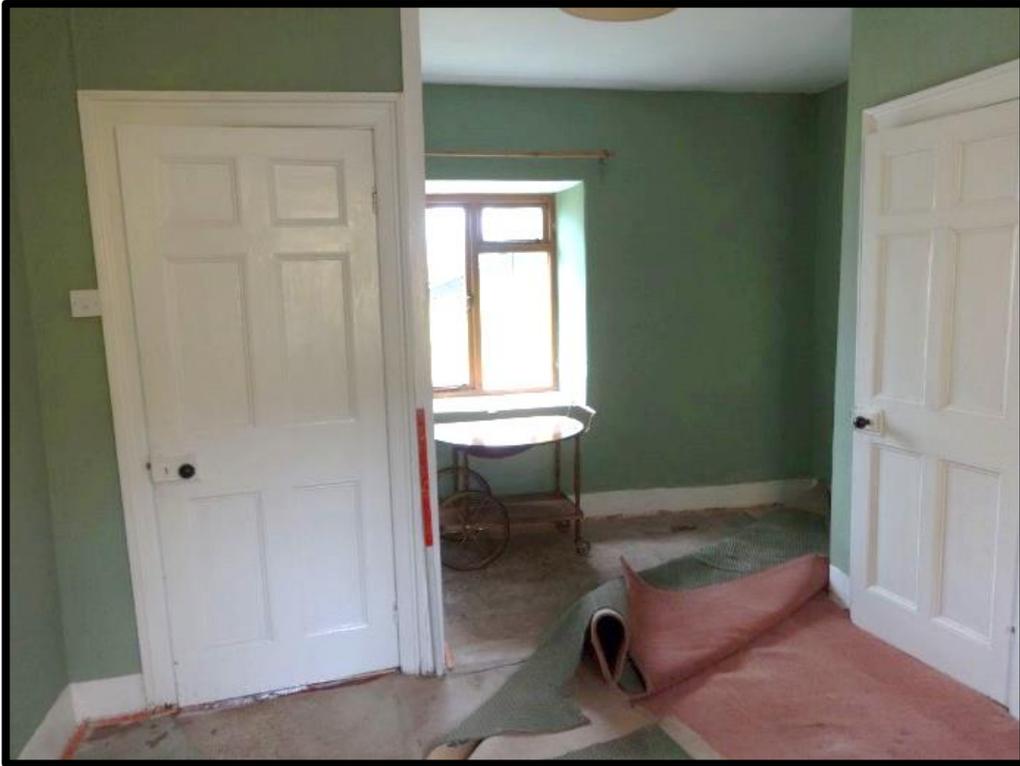
Fig. 13 The room to the south west, showing the 19th-century six-panelled doors and evidence of a dividing wall defining a walk in closet or store.

The south western room is very different in character, with handsome six-panelled doors to the main entrance and to the stair and other cupboards (Fig. 13). The room now has a modern brick fireplace, but all the other details of the doors and the rear window (described above) point to its refurbishment in the 1840s, with tight, Greek-Revival mouldings and a far more 'polite' presentation than the presumed kitchen to the north-east. The window has a panelled soffit and was formerly fitted with folding shutters above the presumed cupboard. The room may have been fitted out for a senior servant such as a housekeeper or, alternatively, the room may have been used as a private sitting room, farm or estate office for the farmer.

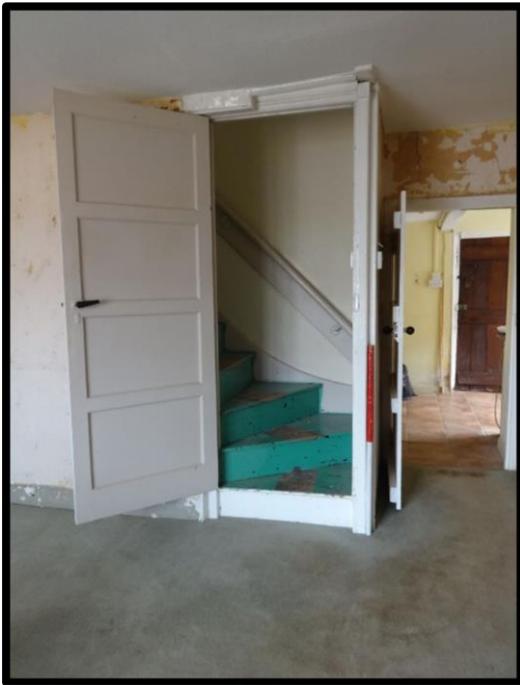
Fig. 14 The modern stairs to the first floor, closed by a mid 20th-century door and probably replacing a steeper flight in the same position.

The modern stairs rise against the rear wall of the range within the former kitchen and are closed by a 1950s door with many short horizontal panels (Fig. 14). The stairs must have been reconfigured in the mid 20th-century to ease their going, and this has resulted in their impinging on one of the upstairs rooms. Evidence of a blocked doorway to an earlier staircase, perhaps for a much steeper flight, can be seen within the stair cupboard off the south-western room and this suggests a steeper staircase with winders at the base, perhaps more awkwardly sited in relation to the first-floor rooms. This may again point to the conversion of an earlier building for domestic use in the 19th century.

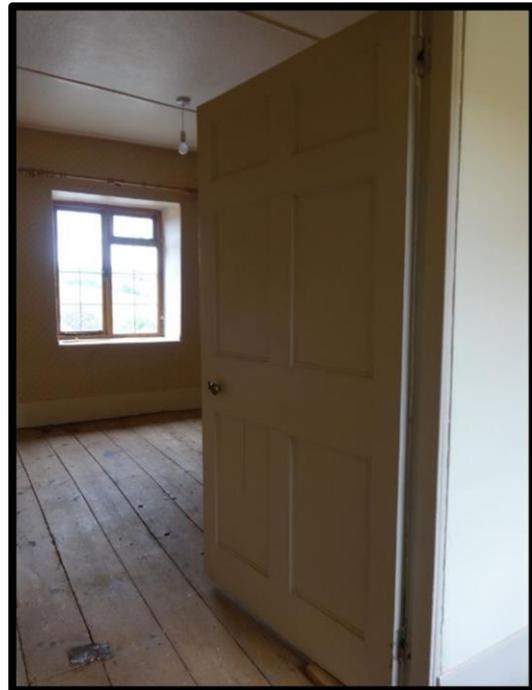
Fig. 15 A fine late 18th- or early 19th-century door leading into the south-western room at first-floor level.

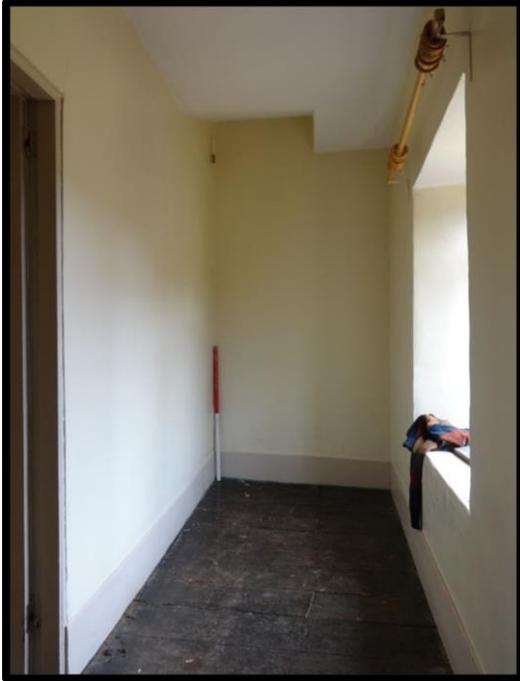
Fig. 16 The site of the corridor to the main house, showing the recess for the stairs in the ceiling: the site of the proposed new bathroom.

Adjoining this room is a short length of corridor which seems formerly to have been linked via a short staircase with the adjoining house (Fig. 16). The window of this room is a modern replacement and there is no enclosure of the staircase, suggesting that this formed part of the circulation space of the 19th-century dwelling. The ceiling is cut away into a sloping soffit to allow head room for the staircase, but otherwise the area has no surviving historic features. It is proposed to turn this area into a bathroom serving the first-floor rooms of the house

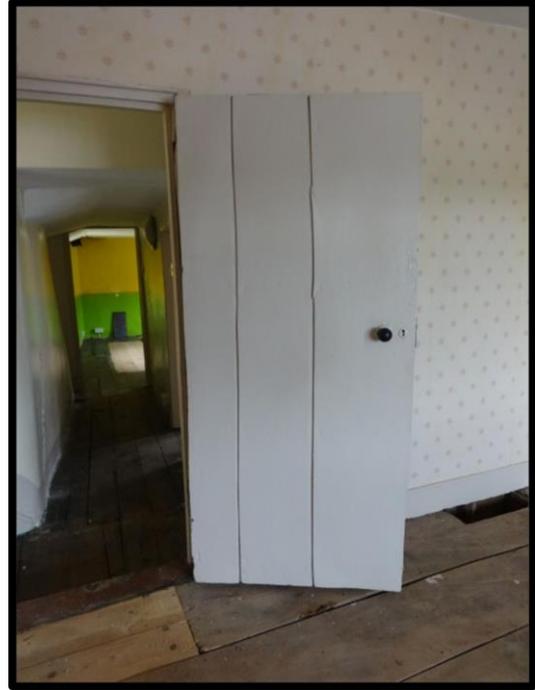
Fig. 17 A fine late 17th- or early 18th-century plank door leading into the north-eastern room at first-floor level, showing wide floorboards of elm.

The largest of the first-floor rooms is approached from the main landing by a handsome plank door with three unequally-sized planks and four battens to the interior (Fig. 17). This is hung on modern strap hinges and has 20th-century Bakelite door furniture, replacing the original lock box. The door is painted, and it is not possible to tell whether it is of oak or pine, but it might date from as early as the late 17th century.

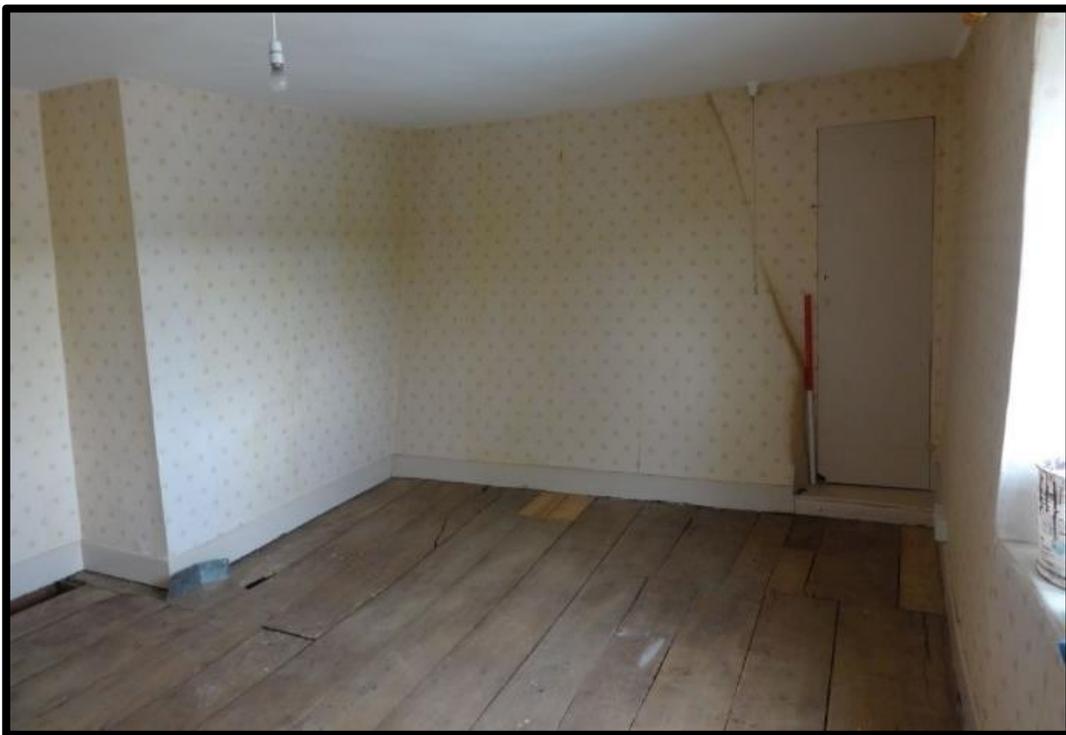
Fig. 18 The large first-floor bedroom, showing the tapering hood of the kitchen fireplace, the floor of wide, elm boards and the cupboard alongside the chimney. A new door to the *en-suite* bathroom is proposed in the wall to the left.

One whole wall of this room is filled with the huge chimney breast from the kitchen fireplace below. There is no evidence that this room was ever served by a fireplace opening into this chimney and the absence of such a facility, as well as the shape of the chimney breast, suggest that this room may not originally have been floored; the chimney breast may originally have been exposed within a full-height volume. The chimney breast has been slightly truncated to create a small cupboard with an interesting door in the form of a single plank and a range of assertive 19th-century coat and hat pegs. The room has a floor of wide elm boards, perhaps of late 17th- or 18th-century date.

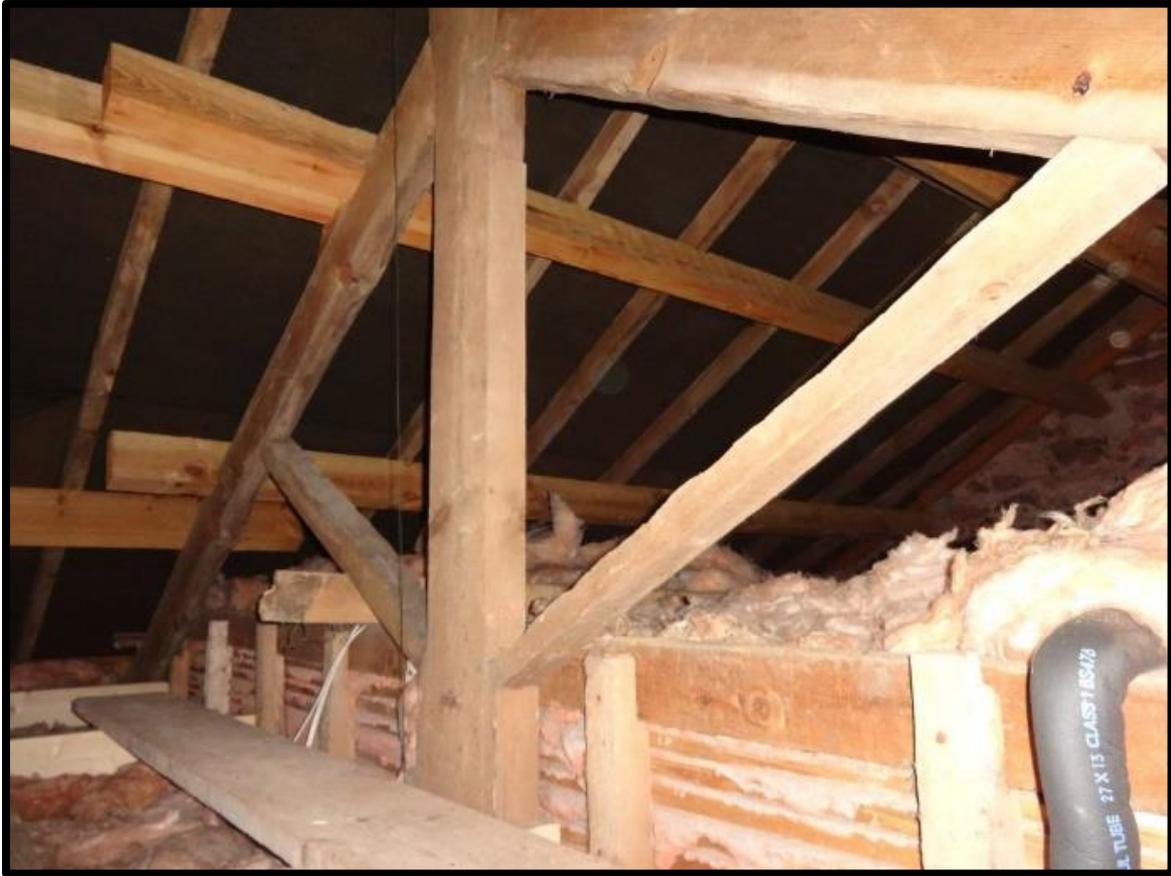
Fig. 19 The roof space over the main range showing King-post trusses, replacement purlins and the raised ceiling over the south-western rooms.

The roof of this range is supported by large strutted King-post trusses typical of the 19th-century and was presumably replaced when the adjoining house was rebuilt in the 1840s. The roof has been extensively refurbished and the present purlins are modern, but many of the original common rafters appear to have been reset.

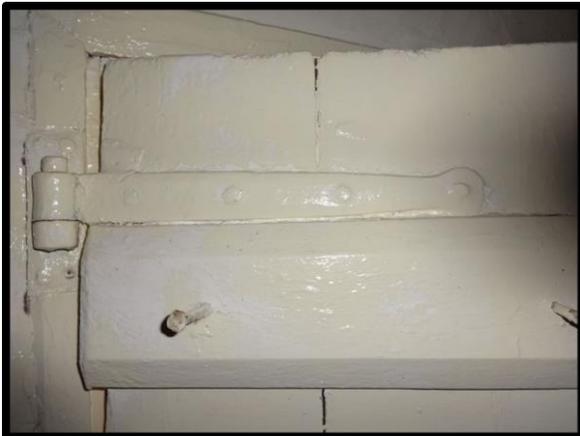
Fig.20 Detail of the late 17th-century hinge on the pantry door.

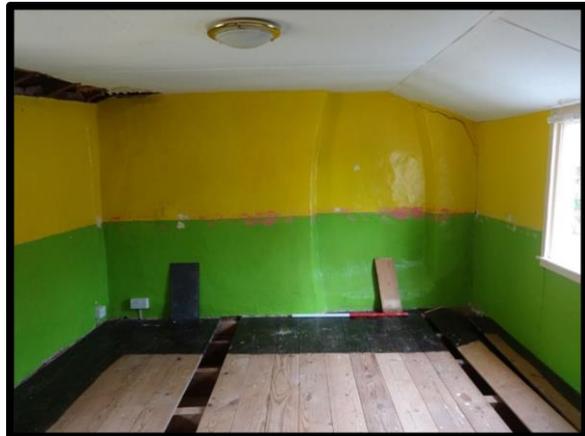
Fig. 21 View of the first-floor room in the rear range showing the recess for a demolished chimney.

The large end room has a modern roof and ceiling and is entered by a 1950s door from a corridor extending along the side wall of the range from the head of the stairs. The only early feature to survive in this area is the recess for a chimney, perhaps of 19th or early 20th-century date, which appears in the gable wall. The chimney may have been of brick, cut into an earlier cob or stone wall. Its removal has left an unusually-shaped recess in the wall. In this room it is proposed to construct a new partition within the very insubstantial north-eastern wall, doubling it in thickness and improving its insulating qualities, and also to raise the level of the collar beams of the modern roof to create extra headroom so that the room may serve as a bedroom.
