**Former Antiques Centre  
Pepper Lane  
Ludlow  
Shropshire**

**Report on an archaeological evaluation**

January 2004

*Marches Archaeology Series 317*

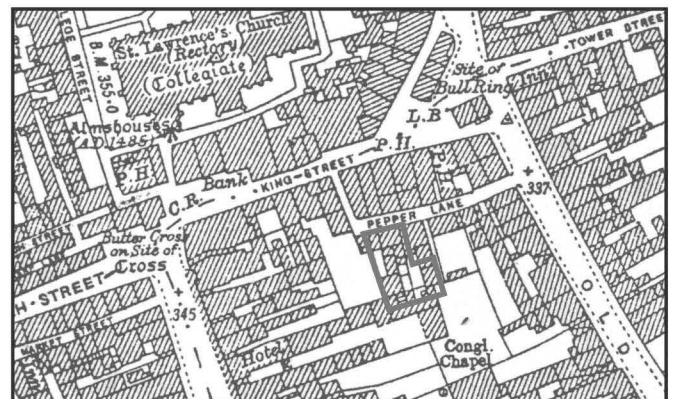
Fig. 3: Selection of maps showing the development of the Pepper Lane area (site shown in red)

The Pepper Lane site seems to have changed quite dramatically in the 19<sup>th</sup> century (Fig. 3). Evans' 1832 map shows Pepper Lane but gives no detail of buildings. In 1835 there were two large buildings overlapping onto the site, the southern one part of the eastern end of a Broad Street burghage. By 1862 the property boundaries were running roughly north-south. There were two buildings on the street frontage, presumably shops or residential with various sheds and ancillary buildings behind. The latter were altered in minor ways but the basic layout was maintained until the present warehouse was built in the 20<sup>th</sup> century.

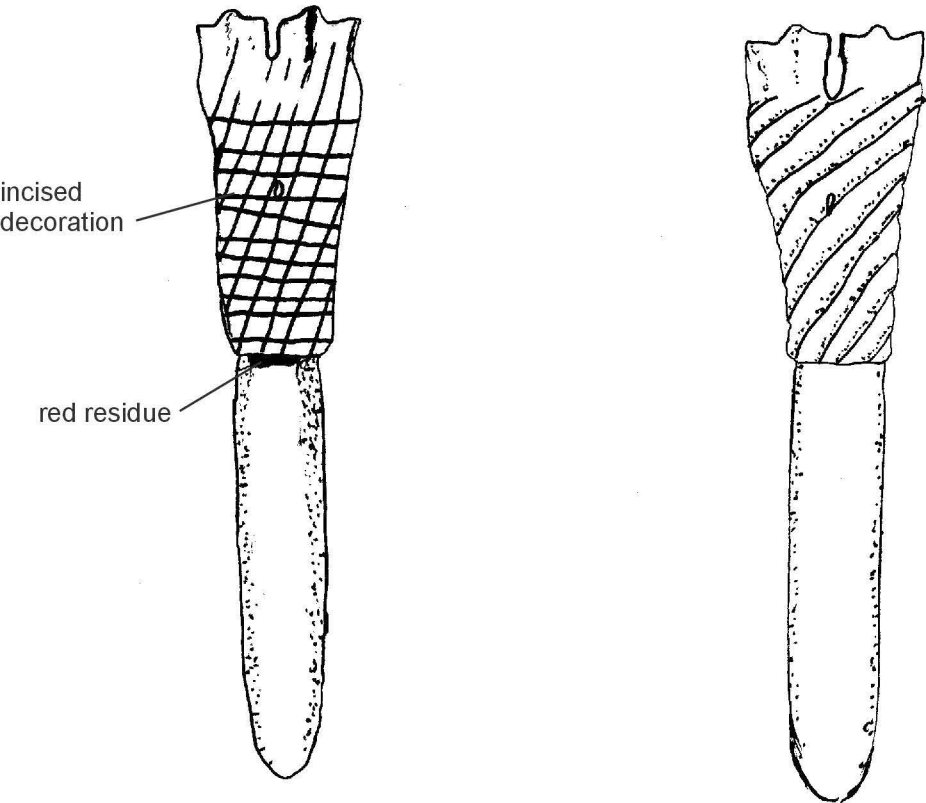
Fig. 12: Sketch of small find 01 at approx. scale 1:1

Most of the finds came from trench 1. Both the dark layer [115] below the brick floor [104] and the general layer below it [106] produced late 17<sup>th</sup>-early 18<sup>th</sup> century pottery. The fill [117] of the foundation trench for wall [116] produced pottery dating to *c.* 1700-1725. A sherd dating to the late 17<sup>th</sup>-early 18<sup>th</sup> century was recovered from [122], the rough stones forming the base for wall [116]. Fill [117] also produced an interesting worked bone artefact (small find 1, Fig. 12). This is a narrow scoop carved from a sheep metatarsal with decorative incised lines on the handle. Several of these objects were found in the Cathedral Close, Hereford (Stone and Appleton-Fox 1996, 56, fig 44) and they were described as apple corers. However, they could have been used for various functions. The scoop found on the present site has some red mineral material wedged into the hollow of the handle, which might relate to its last use.

Small find 1  
context 117  
Carved bone 'apple corer'

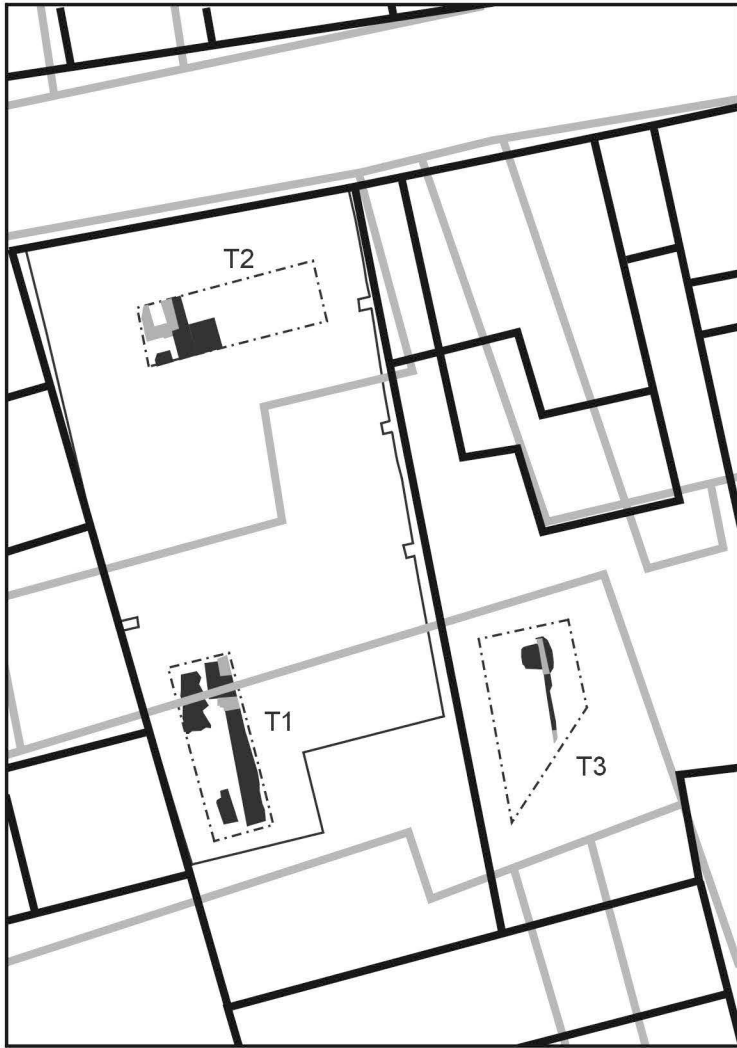
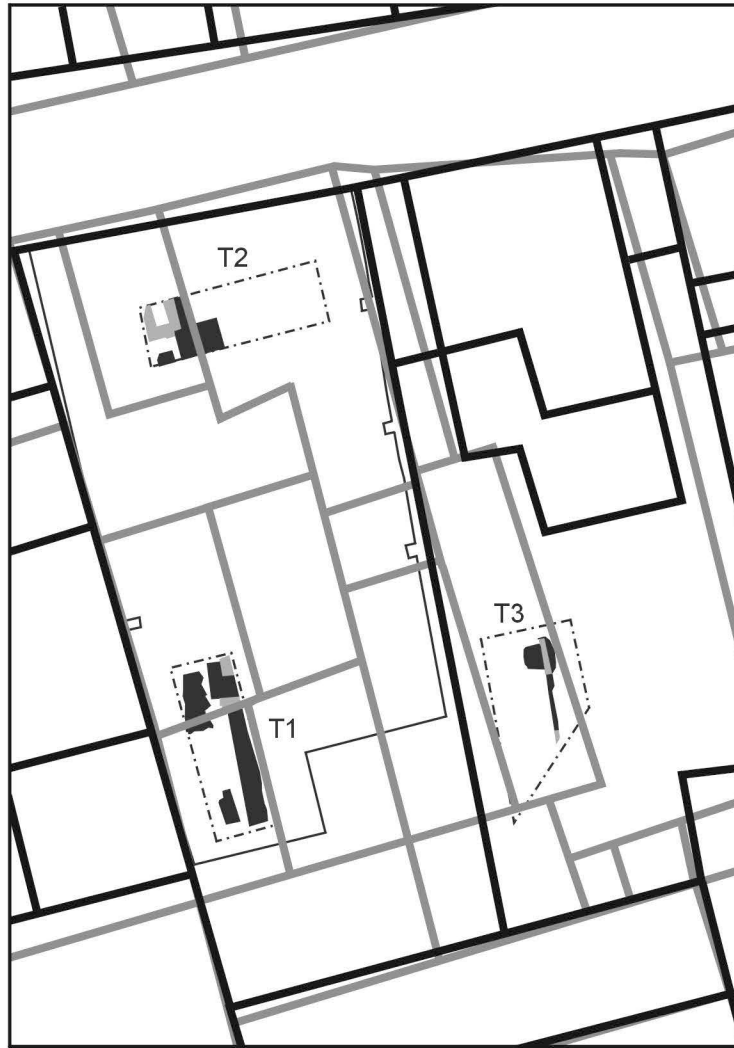
Fig. 13: Comparison of features in evaluation trenches with 19th century maps

The significance and date of some of the features seen in the evaluation trenches can be established by comparing the excavated plans with the early maps (Fig. 13). The most difficult map to overlay is that for 1835 as it is the least accurate and has fewest features in common with the modern map. However, it is possible to say that the alleyway between the development site and its neighbour to the east existed in 1835, but it did not continue as far south as trench 3. However, by 1862 there was a narrow courtyard in this location and, although not perfectly overlaid, it is possible to identify the wall [306] on this map. The

building above the cellar in trench 2 was also built between 1835 and 1862, the wall of this building coinciding quite accurately with wall [204]. There is a partition wall shown running approximately along the line of wall [108] in trench 1. This would seem to be too slight to account for the substantial stone wall seen in the trench, so [108] could be much earlier. This is very likely as the south-western corner of a building represented on the 1862 map and more clearly defined on the 1886 map may account for the walls [114] seen in the trench. Stratigraphically [108] is much earlier than this.

The 1886 map shows the building over trench 2 to still be there. The building to the east of trench 3 seems to be a little further away from the trench, but it is unclear whether this is due to map error or rebuilding. There was little change in the buildings of this area between 1886 and 1936, the latest alteration being the building of the present warehouse, which occurred before the survey for the modern 1:2500 OS map, published in 1988.

Modern map detail and evaluation trenches overlaid on 1835 map (scale 1:250)

Modern map detail and evaluation trenches overlaid on 1862 map (scale 1:250)

Modern map detail and evaluation trenches overlaid on 1886 map (scale 1:250)

From the maps it can be suggested that the alleyway and brick wall in trench 3 were constructed between 1835 and 1862. The cellar in trench 2 and possibly the structure related to wall [114] in trench 1 were also built in this period; the brick floor [104] being even later. All the other features in trench 1 are earlier, and can be dated by artefactual evidence.
