## **Furrows Garage, Coton Hill, Shrewsbury, Shropshire**

**Report on an archaeological desk-based assessment and  
building assessment**

February 2004

*Marches Archaeology Series 322*

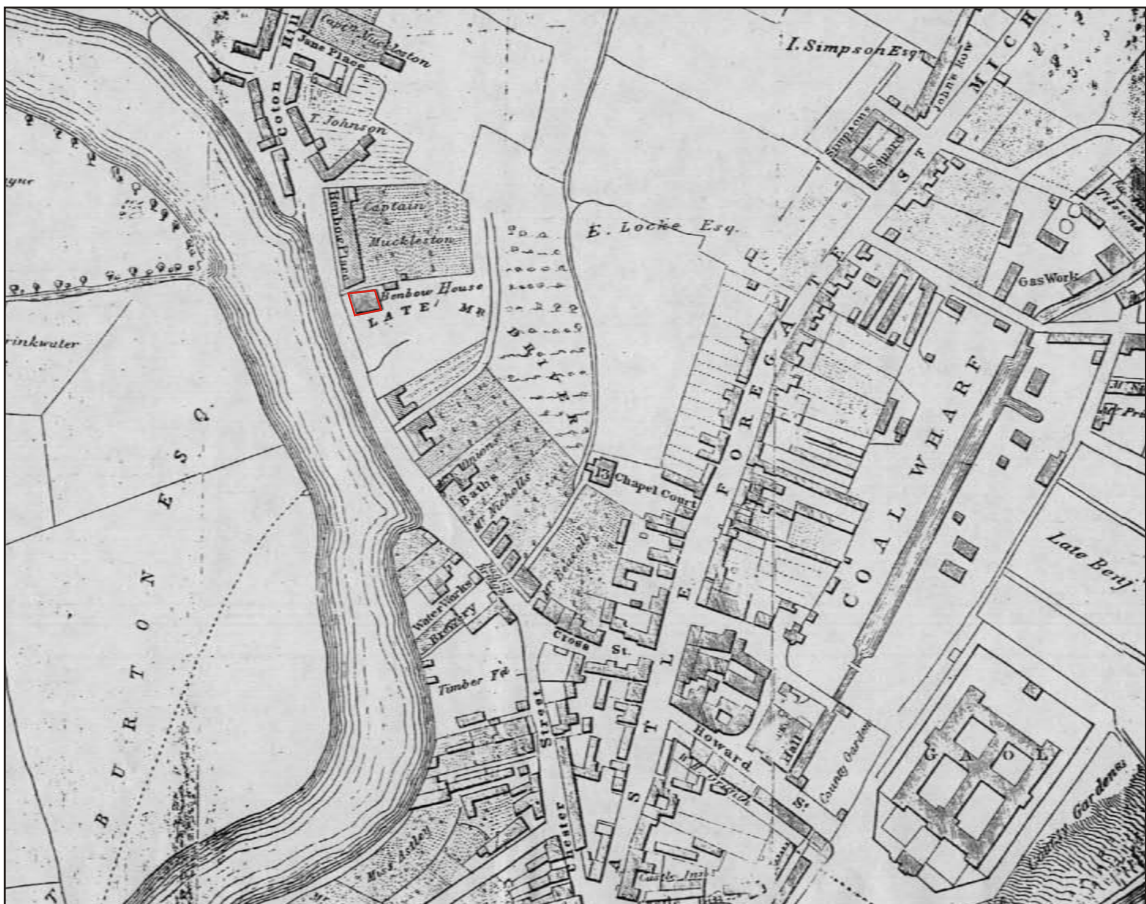
Figure 3b: Woods Map of Shrewsbury 1838

By 1547 Coton appears to have ceased to be an island, and by 1575 is referred to as Coton Hill (SALOPSMR 12004/2091). There are a number of known 17<sup>th</sup> century buildings along Coton Hill, including Benbow House (SALOPSMR 2036/12053). The house is referenced as the birthplace, in 1635, of Admiral John Benbow, the son of a tanner called William Benbow of Coton Hill, and the nephew of John Benbow, a renowned royalist, who was executed for his part in the Battle of Worcester. There is no direct evidence as to the origin of Benbow House however, and his father's occupation as a tanner may suggest rather that the Admiral built or purchased the house during his financially successful career in the navy. Speed's map of Shrewsbury dating to 1610 (Figure 2b), shows a large house in approximately the right location in relation to the course of the river and Pintle Brake, but is not accurate enough to specify this as Benbow House. Roque's plan of 1746 shows the first building (Figure 3a), which can in plan be recognised as the group of buildings named as Benbow House and Benbow Place on later maps, but it is not until Wood's map of 1838 (Figure 3b) that Benbow House is named as such.

At this time the house is shown as square in plan, with small outlying building to the east, and this probably represents the original 17<sup>th</sup> century structure. A sales particular of 1865 records it as having lately belonged to, and occupied by a Captain Ryder (SRO P257/V/1/1). A plan (Figure 4) attached to a second sales particular of 1869 (SRO P257/V/1/2) shows that a bay

The earliest accurate map depicting a building known to be Benbow House dates to 1838 (Wood's map of Shrewsbury). However Roque's map of Shrewsbury dated to 1746 shows a range of buildings of similar plan to Benbow House, and the adjoining Benbow Place, depicted on the later maps. Earlier, pictorial maps of Shrewsbury (Speed 1610, Burghley 1547) show a representation of buildings in the area of the site, but neither is accurate enough for a specific building to be identified.

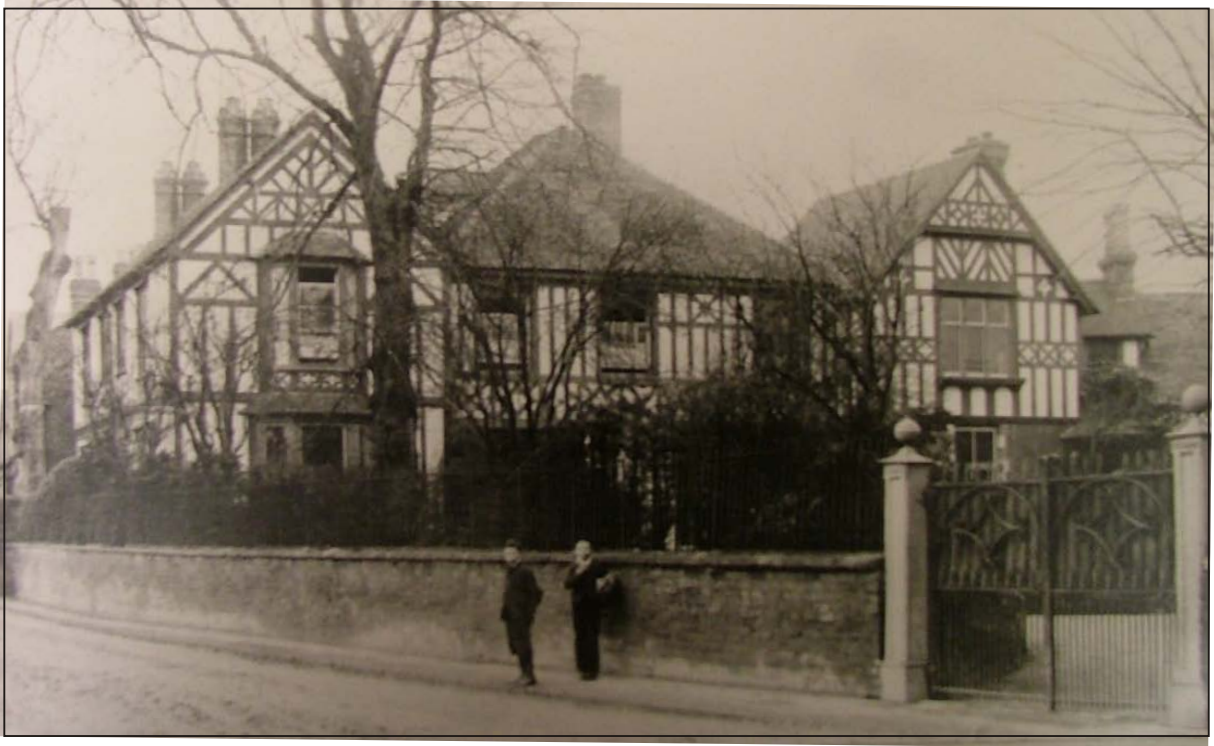
Plate 1: Photograph of Benbow House, 1890

A doorway in the north-west corner of the northern office leads to the external, roof height passageway which accesses the attic of the west cross wing (Plate 19). This was of a queen post roof structure, within which was contained the remains of two diamond plan chimneys, which had been demolished to just below roof level (Plate 20). These appear on early photos of the wing, each with two small diamond-shaped chimneys (Plates 1 & 2). The attic of the east wing was not accessible for inspection.

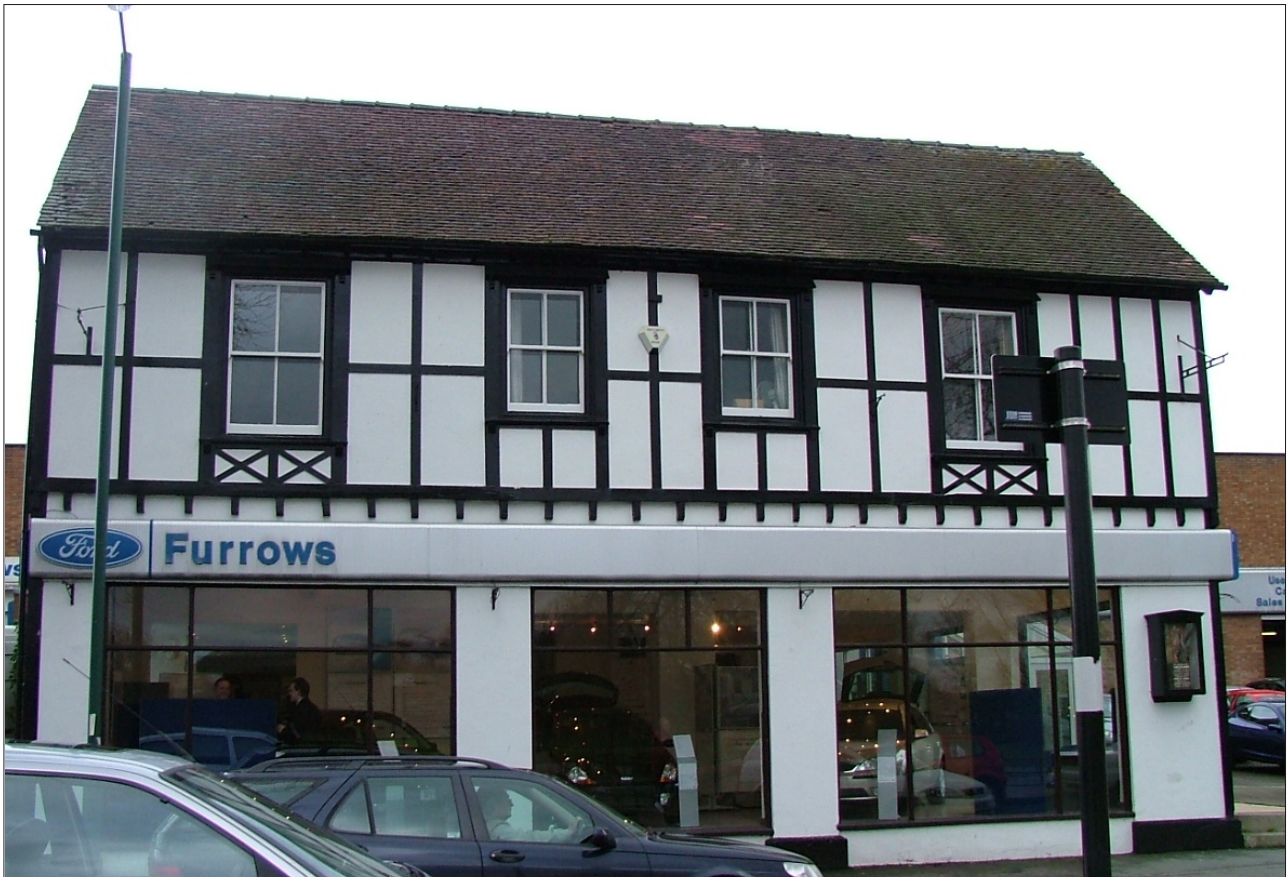
Plate 5: West elevation of Furrows Garage

The photographic evidence shows that the building was in use as Furrows Garage by 1965 (SRO SN 597B), and the ground floor of Benbow House used as a showroom with large plate glass windows along the west side (Plate 3 & 4). Dormer windows have been inserted in the attic storey, facilitating the conversion of the upper storeys to offices. To the south of the house, the large gardens had been converted into an open forecourt, with a large brick built workshop to the east. This has an façade sporting with ‘The Shrewsbury Motor Works’ inscribed across the front (SRO D71:4, Plate 4). By the 1980s the ground floor had been converted with larger plate glass windows in a steel frame along the west and south side, and the chimney stacks in the western cross-wing had been reduced to their present level below the roof line. The showroom has subsequently been modernised to the current appearance of the showroom (Plate 5).

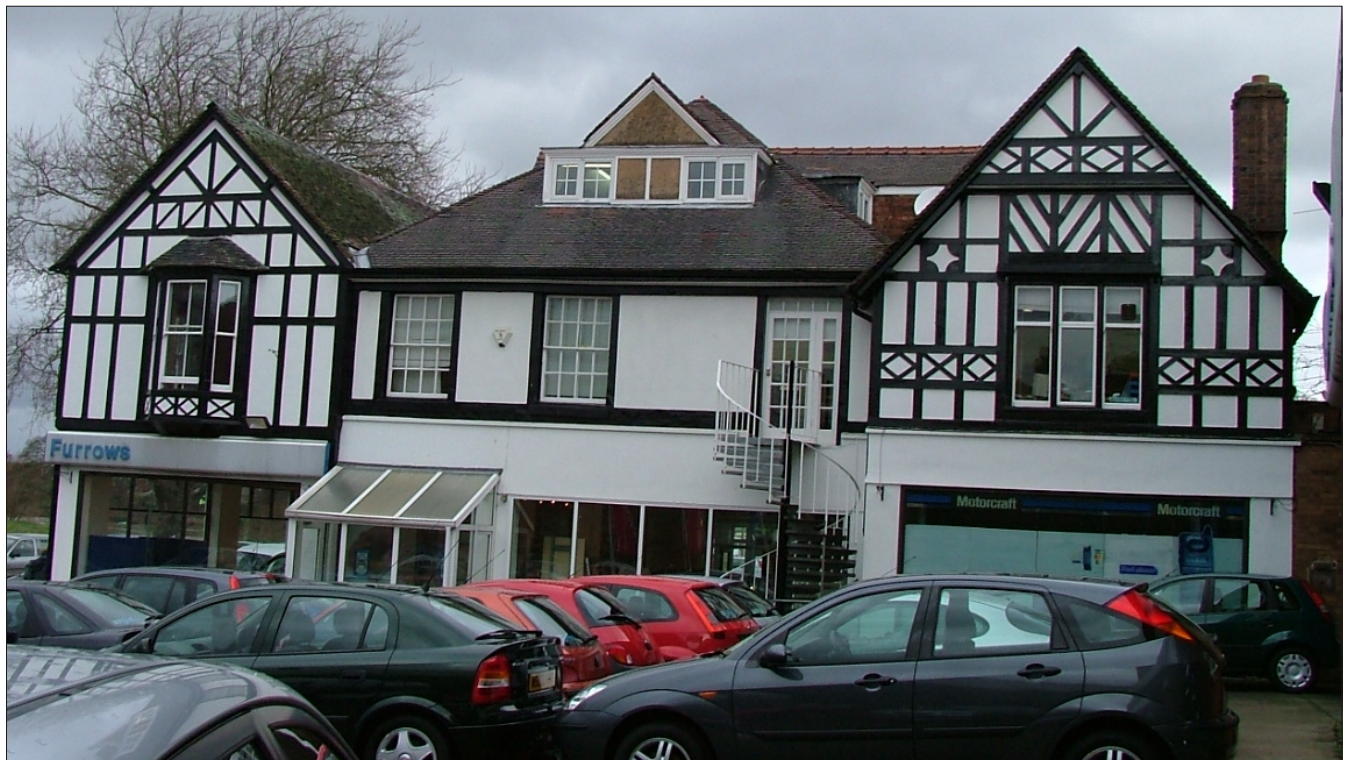
Plate 6: South elevation of Furrows Garage

The two and a half storey central bay has a rendered south elevation, and only a small portion of the external north elevation is visible on the first floor, due to the later extensions. This is of painted brickwork laid in a random bond, and which, from the size and shape of the bricks, dates to the 17<sup>th</sup> or early 18<sup>th</sup> century. The roof is hipped, and covered with plain tiles, and has late 19<sup>th</sup> or 20<sup>th</sup> century dormer windows inserted into the north, south and east sides. Some of the windows in this bay are 19<sup>th</sup> century 4-pane sashes, with some casements of a 19<sup>th</sup> century and later date (Plates 6 & 7).

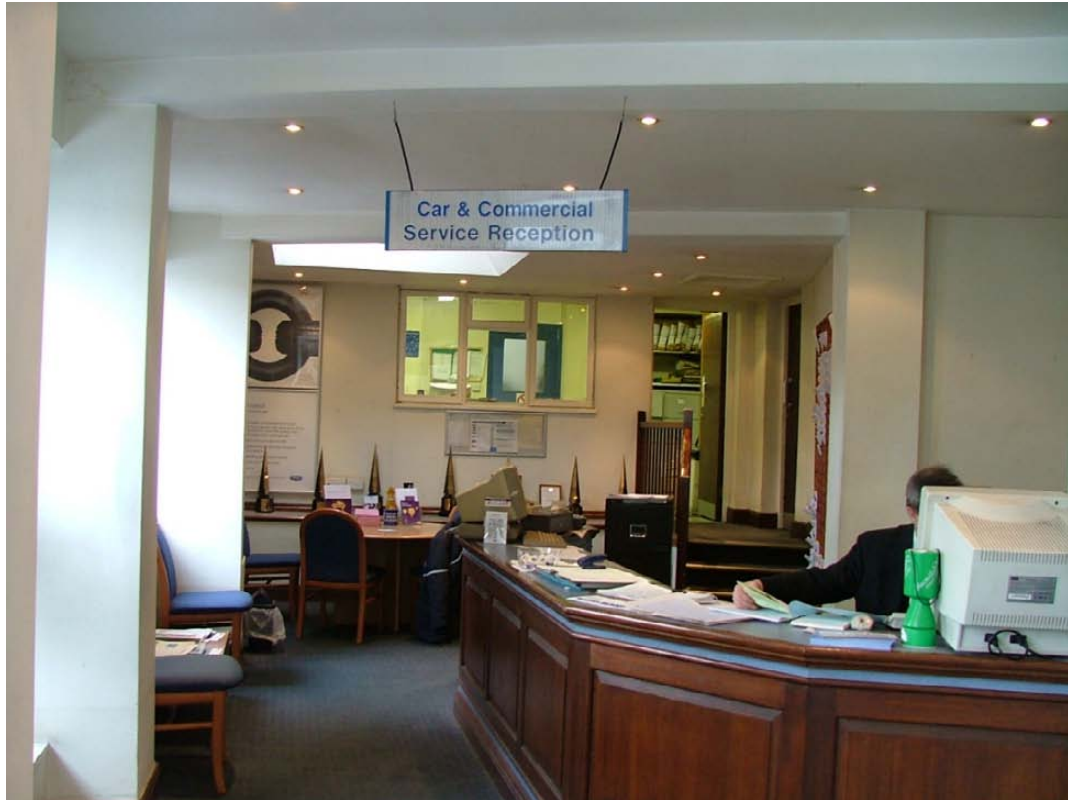
Plate 9: Ground floor of Furrows Garage, car showroom and reception

The majority of the ground floor of Benbow House is in use as a car showroom, with one small office and a separate cloakroom at the eastern end (Plates 9 & 10). The showroom itself has no internal divisions, and both the south and west walls are formed of floor to

ceiling plate glass windows. The north wall is of modern brick construction, and it appears that the conversion of this floor has removed any original, or even 19<sup>th</sup> century, fabric.

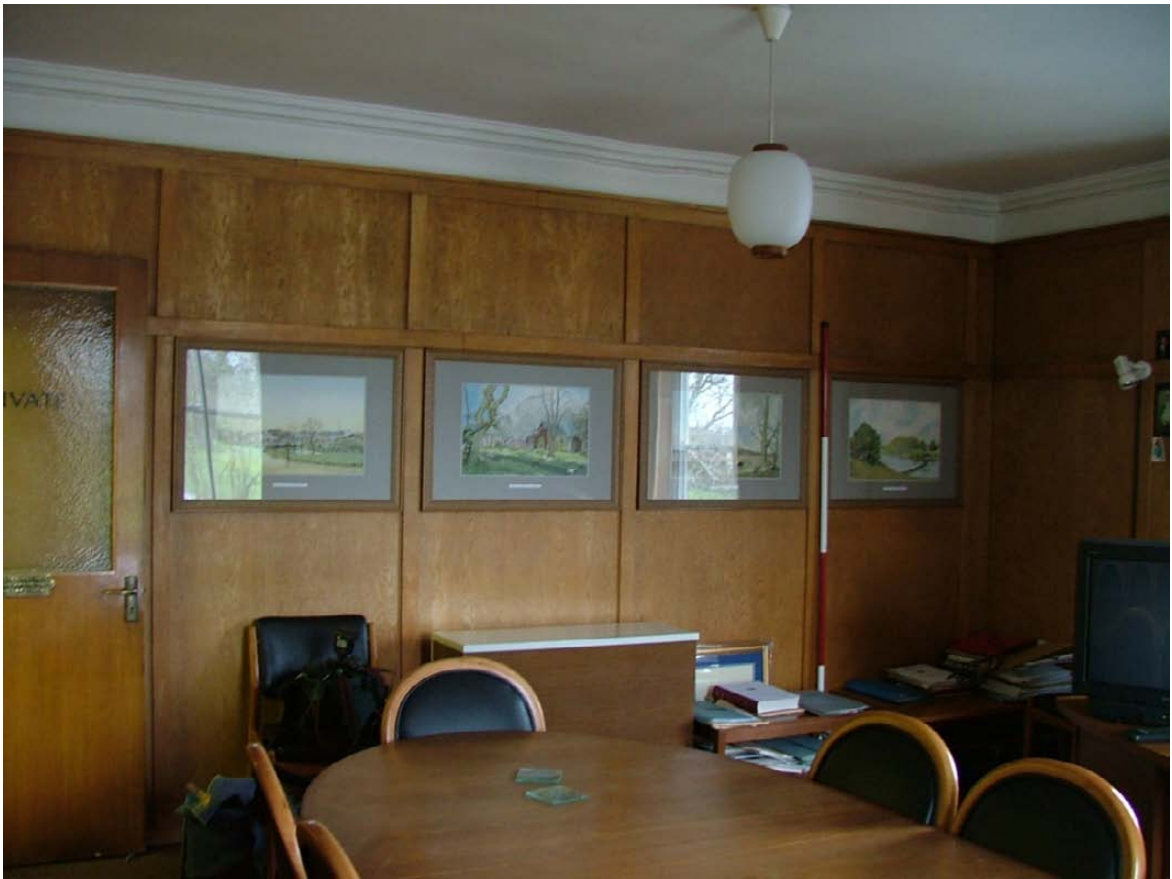
Plate 11: Meetings Room on first floor

The majority of the first floor is used as offices, with a kitchen and cloakroom at the eastern end (Figure 7a). The vast majority of these rooms are plasterboarded or plastered internally, with chipboard wallpaper then applied on many of the walls and the ceilings artexed (Plates 11-14). The meetings room is panelled with plain, raised panels of a light wood, which stylistically dates to the mid 20<sup>th</sup> century (Plate 11). These features have effectively covered the building fabric, making it impossible to determine if any of the house on this floor predates the Victorian restoration. Very little of the Victorian fabric is in evidence, being limited to the sash windows, and to covings and skirtings which include a range of different ovolo and ogee mouldings. One exception is in the east end of the securities office, where the base of the 19<sup>th</sup> century roof trusses, including the collars and purlins, of the eastern cross-wing are exposed (Plate 15). There are only two visible fireplaces, one in the small office in the west wing which is boarded over, and a second in the securities office. This has a brown brick fireplace, probably of mid 20<sup>th</sup> century date.

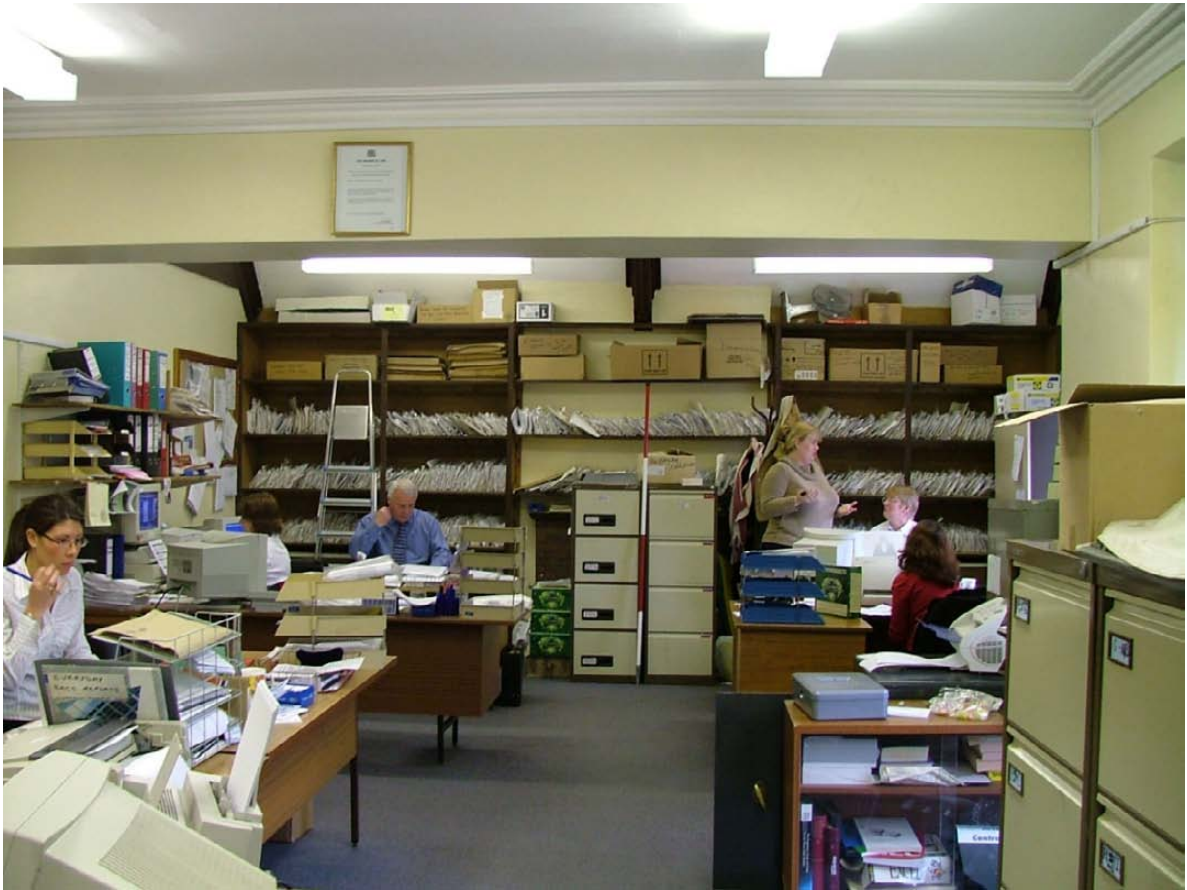
Plate 13: Securities office looking east

The securities office has been formed from two smaller rooms, the original division marked by a large square headed arch located where the east wall of the central bay would have been. The eastern portion of this room would have formed a bedroom occupying the whole of the eastern wing on this floor, while the rest of the securities office appears to have formed a large room extending to its current limits. The conversion to offices otherwise appears to have caused little disruption to the 19<sup>th</sup> century plan of the house.

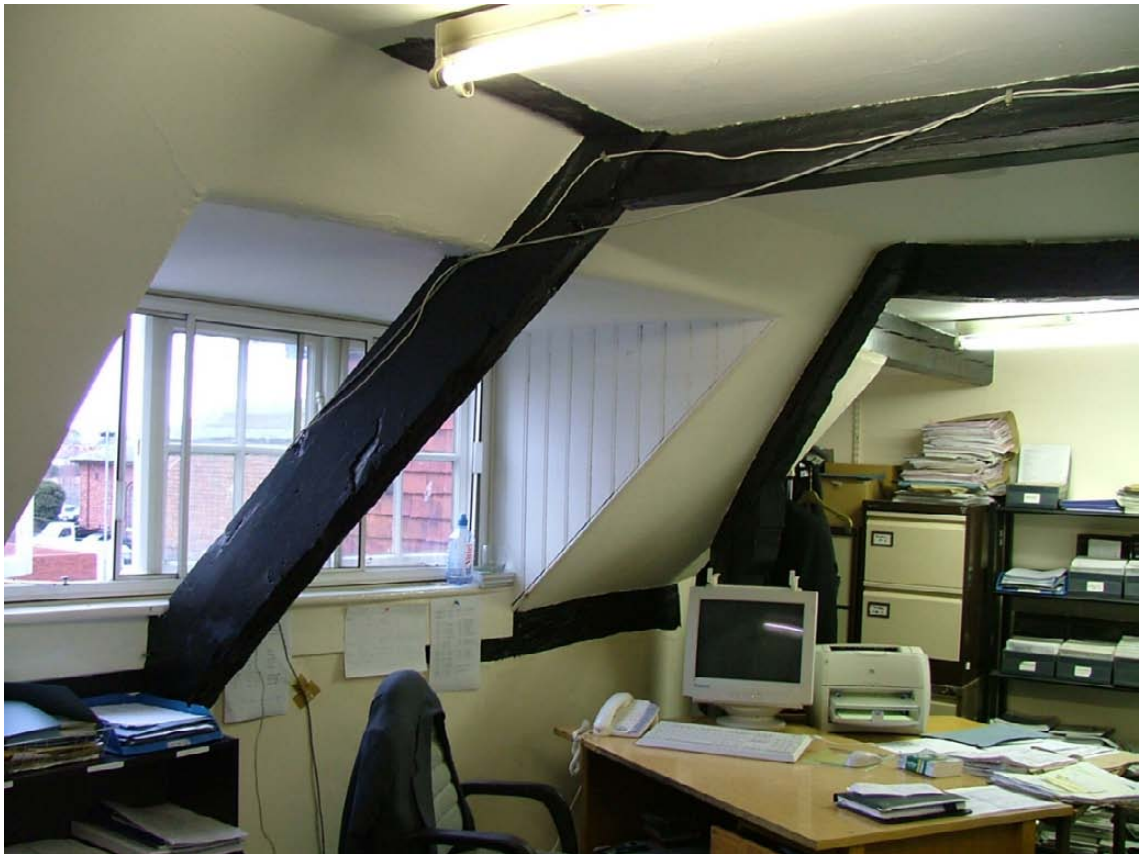
Plate 16: Exposed roof timbers in north attic office

The attic of the central range is currently divided into two equally sized rooms, both of which have some exposed roof timbers which are of 17<sup>th</sup> century date, together with some 19<sup>th</sup> century replacements and supports. The 17<sup>th</sup> century timbers consist of three valley rafters (in the south-west, south-east and north-east corners) and a two principal rafters which formed a central north-south truss (Figure 7b), all exposed only for the central part of their length (Plates 16 & 17). The valley rafter for the north-west corner of the roof appears to have been removed below ceiling level, and a prop inserted. This has taken place in order to accommodate a doorway leading to a passage accessing the west cross-wing attic.

West, south and east trenched purlins are visible at ceiling height, although no northern purlin is exposed. Either side of the dividing wall is a single upright, in each of which is a empty mortice hole (mirrored in the principal rafters) indicating that they carried the ends of an interrupted collar from the principal rafters (Plate 18). There was a second mortice hole in each upright indicating that the collar continued between the two uprights at a higher level. This was removed when the dividing wall was inserted at a later date, certainly by 1869 (SRO No.P257/V/1/2).

A small length of the wall plate along the western wall was visible in the northern office. There were also a number of reused and 19<sup>th</sup> century timbers that had been placed to support the original roof timbers. The dividing wall contains the chimneystack, with no evidence that this provided fireplaces at attic level at any time.

The building assessment of the main car showroom and offices has shown that the core of the current building relates to the building shown on the 1838 map. The roof structure, which appears to be a variation on the queen strut roof, together with the area of brickwork visible on the north elevation of the building indicates a 17<sup>th</sup> century date for this structure. How much else of this phase of house remains on the first floor behind all the modern fittings, and behind the 19<sup>th</sup> century façade known to underlie the cement render covering the south elevation is impossible to ascertain however. It is certain that on the ground floor no trace of this building survives, but the position of the cellar on the sales plan of 1869 suggests that it
