Motte at East Dudston Farm Chirbury Shropshire (SAM 281)

**A report on emergency
Archaeological recording**

April 2004

Marches Archaeology Series 339

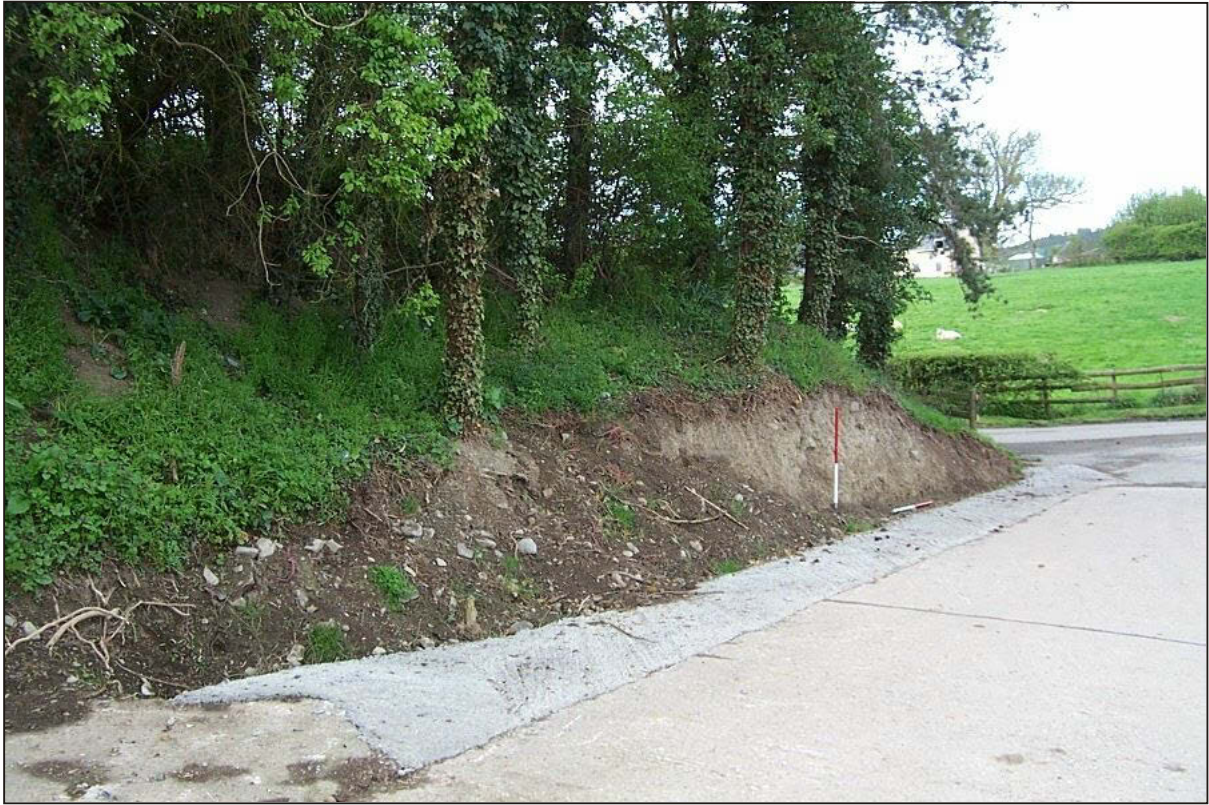
Plate 1 View of the motte looking north west prior to cleaning

A small area of the motte at East Dudston Farm, Chirbury, (Scheduled monument 281) was damaged (NGR SO 2445 9741) during road widening works (Fig.1). Emergency recording was undertaken prior to reconstruction of the motte (Plate 1).

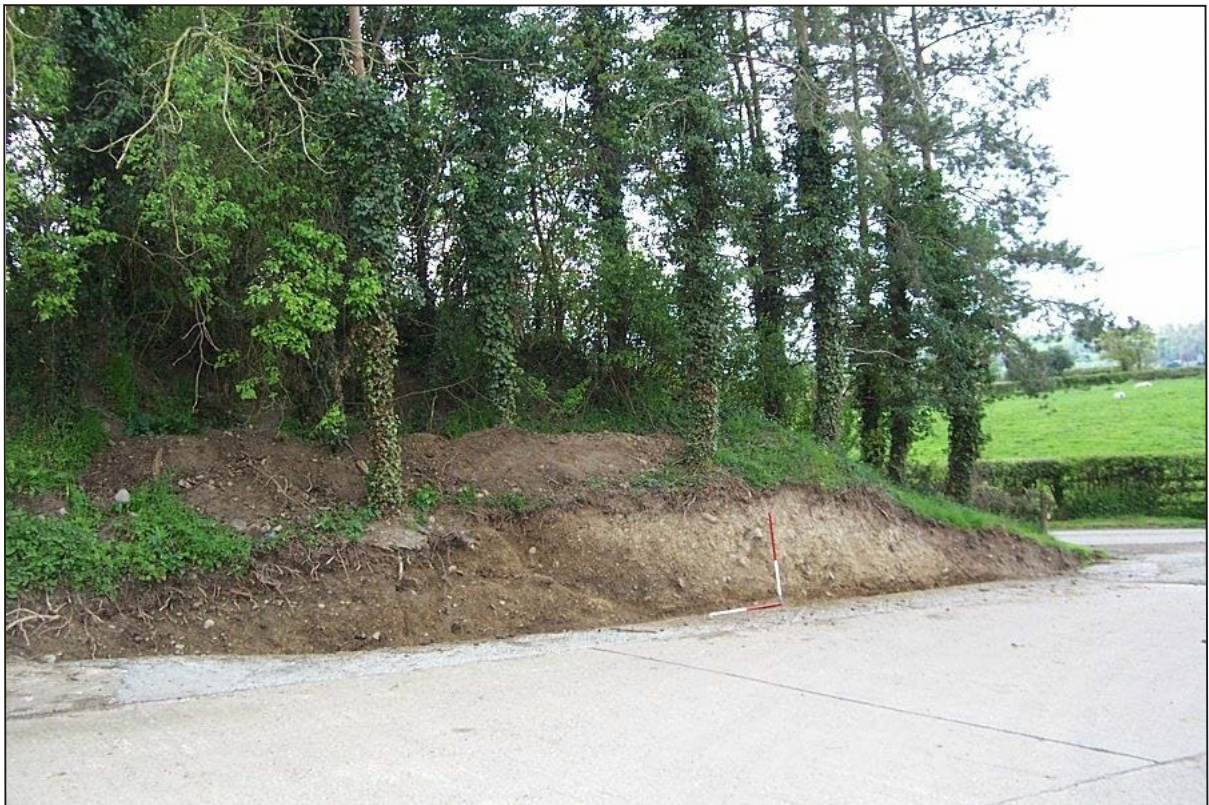
Plate 2 View of the motte looking west (east facing section)

The area of the damaged motte was cleared of the soil, which had been displaced during the road widening works. The exposed face of the motte was cleaned to reveal the stratigraphy of the construction of Scheduled Monument 281 (Plate 2). The recording in the field consisted of a site plan (Fig. 2) and a drawing of the exposed north facing section (Fig. 3). A photographic record was also undertaken. An OS map was obtained that indicated the site of a bench mark on the northern corner of Barn 1 (Fig. 1).

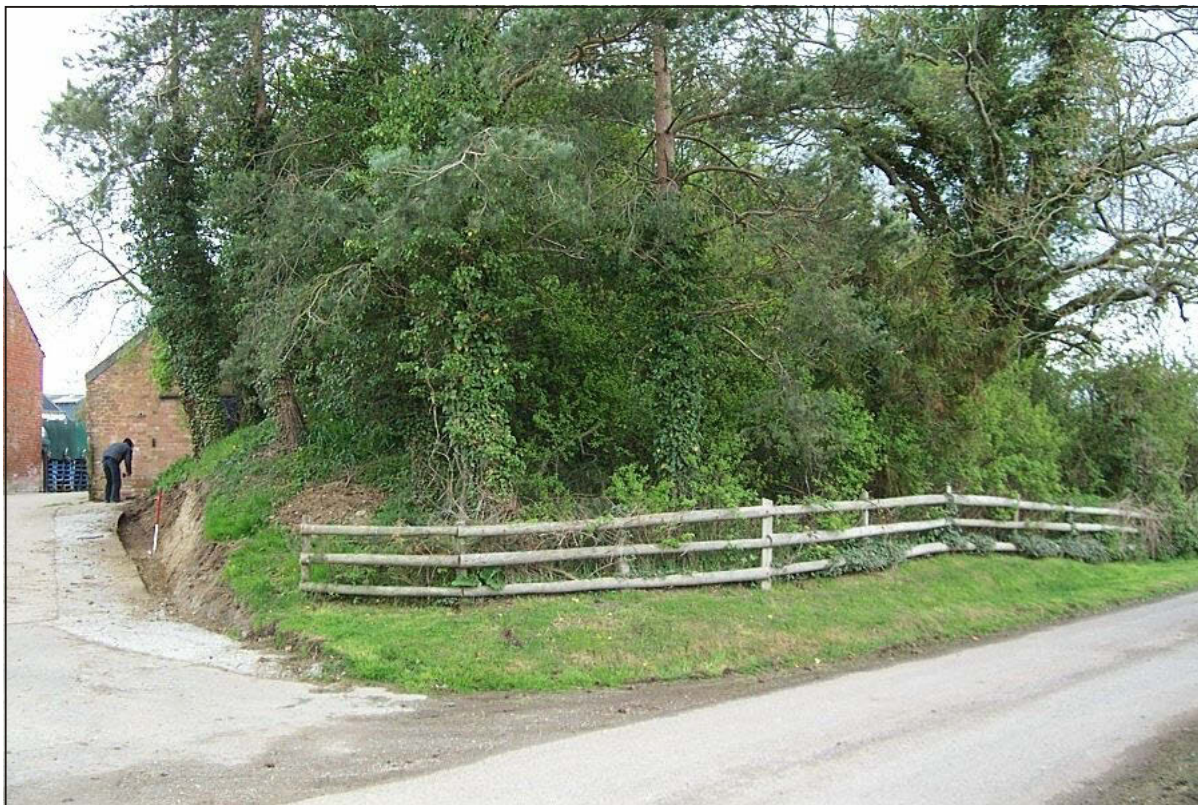
Plate 3 View of the motte facing south -
(noting the distance between the concrete and motte)

Scheduled Monument 281 is located at the entrance of East Dudston Farm, Shropshire (NGR SO 2445 9741) and is situated to the south-east of the B4386 between Chirbury and Montgomery. The motte is situated to the right of the farm entrance (see Plate 3). The entrance to the farmyard has been concreted over. The motte had previously extended to the edge of the concrete, however, following the damage caused by road widening works, a gap of approximately a foot separated the concrete from the motte (Plate 4). Barn 2 (Fig. 1) was situated at the southern extremity of the motte that can also be seen in Plates 3 and 4.

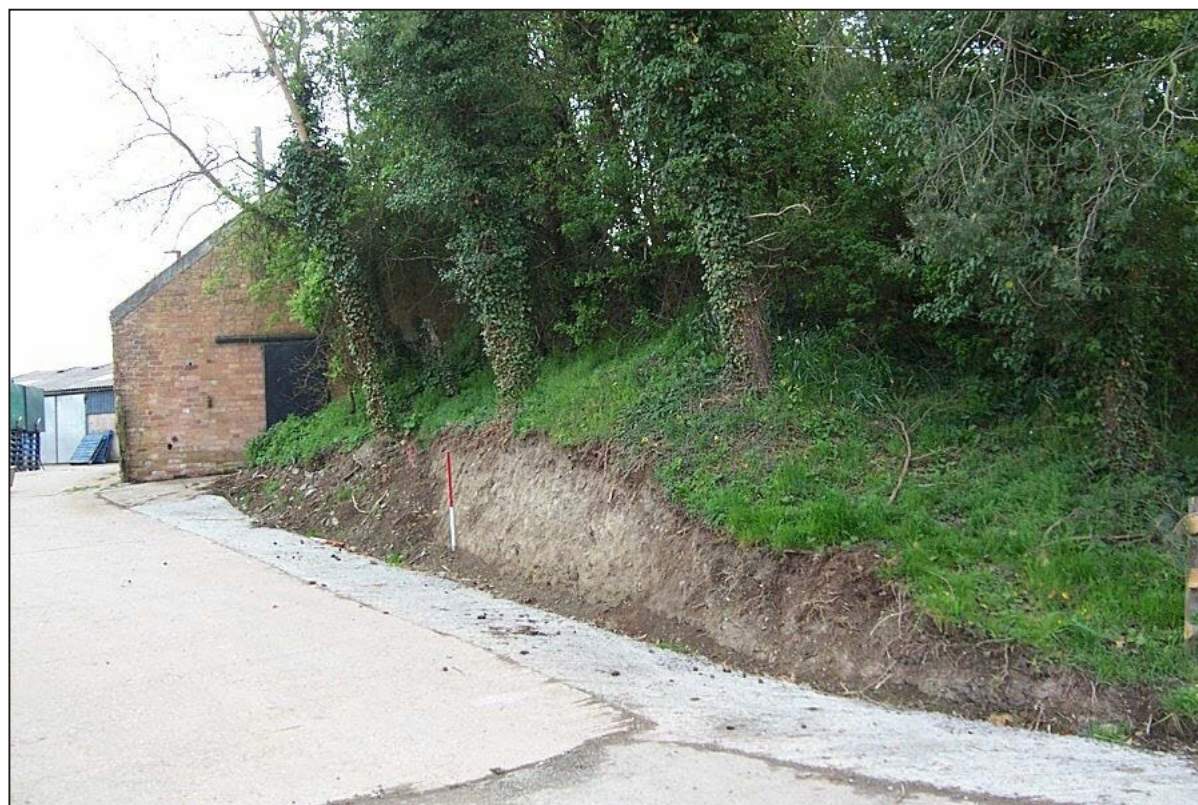
Plate 4 View of the motte facing south
(Barn two is visible in the background)

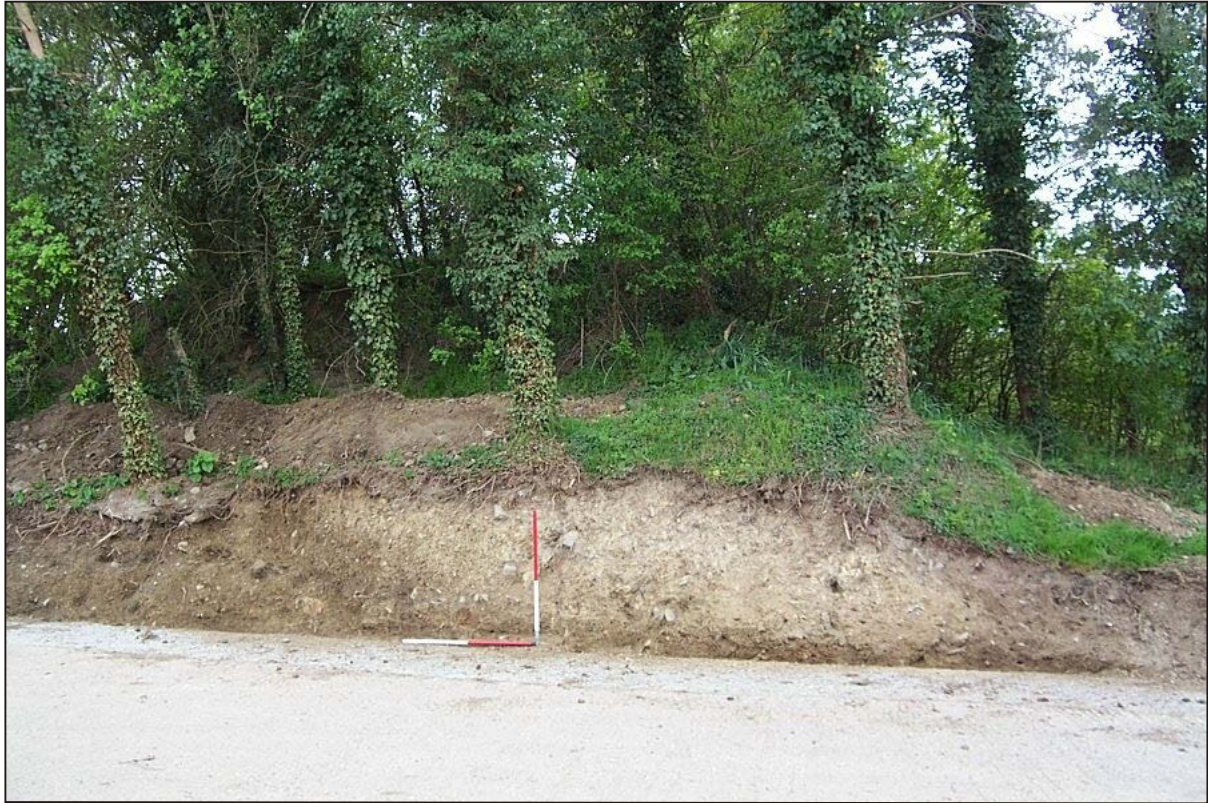
The general stratigraphy of the motte (Fig. 3 and Plate 5), was capped by the topsoil (1), a mixed mid brown silty clay with occasional pebbles and a thickness of approximately 300mm, which covered the entire exposed face of the motte. In the eastern area of the motte a sub-circular cut [3] with a dish shaped base was observed. The fill (2) was a mid to light beige with frequent stones and a substantial amount of root action. The feature was interpreted as a tree bole. Layer (4), a mid brown clay silt with frequent stone, pebble and charcoal inclusions was also situated at the southern extremity of the motte. This may be an earlier soil horizon. In the central to western area of the motte, a layer or dump of material of very compact, hard yellowish brown clay silt with frequent stones and pebbles was observed (5). A mid grey brown silty-clay (6) with occasional flecks of charcoal and mortar was recorded in the central area. This layer was interpreted as an earlier soil horizon or a turf line and was very similar to layer (4) in its consistency. Cut [8] was noted in the western end of the scheduled monument. It had a sharp break of slope and near vertical sides. The interpretation of this feature was that of a possible post-medieval cut into the side of the motte or it may have been a natural slippage of topsoil. The fill (7), was very similar to the topsoil, however, it contained a larger amount of stones. Layers (9) and (10) were interpreted as re-deposited natural from the construction of the motte. Both consisted of hard yellow clay with frequent stones. Layer (10), however, was less clean and contained a higher soil content.

Plate 5 The stratigraphy of the motte

In conclusion, the motte appears to be of single phase construction. There was evidence of a possible later soil horizon (post-medieval?), which may suggest that the motte had been

altered at a later date by means of activity around the base of the motte, or natural slippage from the top. However, no dating evidence was recovered to confirm this. Cut [8] also poses similar questions regarding to a later alteration to the motte. This may however, simply be due to a natural slippage of the topsoil.
