**Westhill Centre,
107 Hagley Road,
Stourbridge**

**Report on archaeological building recording and an
ornamental audit**

May 2004

Marches Archaeology Series 342

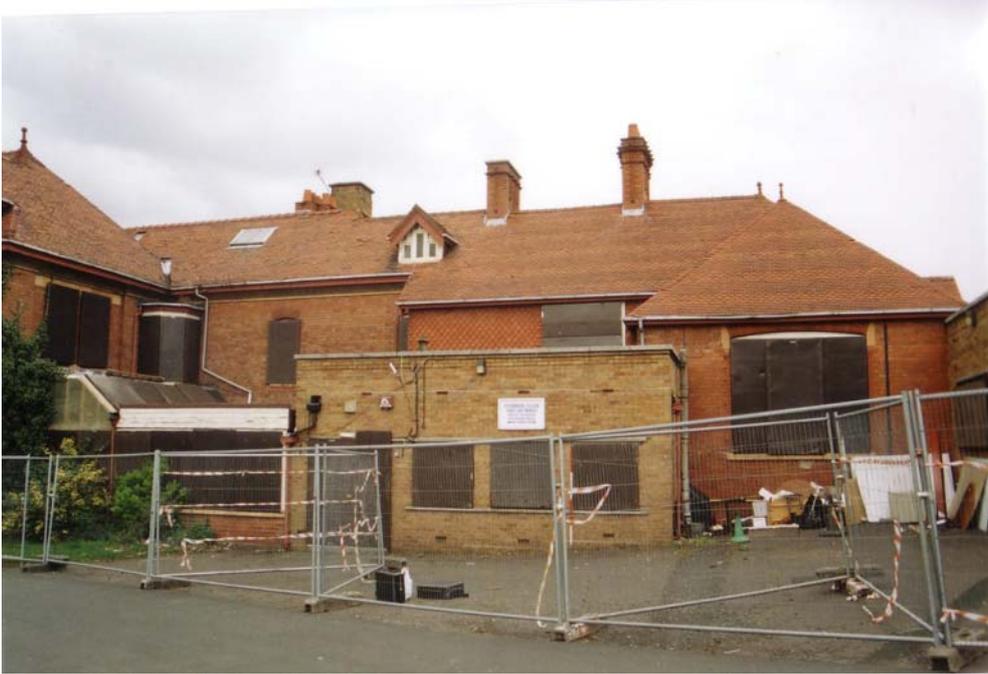
Plate 1: Rear bays of house from the south

South elevation	
Walls	Red brick in English Garden bond. Red tile cladding on eastern section of elevation.
Roof	Red tile roof with regular bands of straight and curved edged tiles. Plain ridge tiles, and decorative ball finials. Decorative timber barge boards over gables, with bands of moulding including billet decoration.
Window	All windows of ground and first floor covered by shuttering. On both storeys the lintels are picked out with yellow stone, with the cills formed of yellow tiles.
Door	Only one original doorway, which is concealed by dense growth of ivy.
Chimney	Four chimneys, rectangular in plan but with three bands of brick moulding with a series of regular triangular projections along each side. Clay chimney pots with bands of bead moulding and strigilated decoration.
String-course	Moulded string course at ground floor level in terracotta. Second narrow moulded string-course in yellow brick, immediately under eaves.

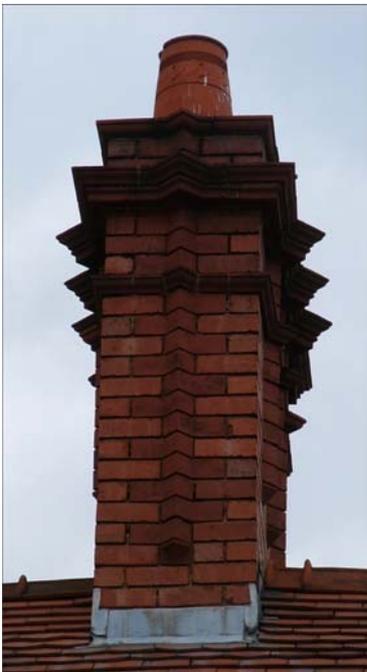
Plate 2: Example of chimney

Door	Door to cellar
Chimney	Chimneys, rectangular in plan but with three bands of brick moulding with a series of regular triangular projections along each side. Clay chimney pots with bands of bead moulding and strigilated decoration.
String-course	Moulded string-course in terracotta is on chimney stack at west end of elevation only. Narrow moulded string-course in yellow brick, immediately under eaves.
Plinth	Narrow plinth at base of wall with simple moulding forming upper edge.
Other	<p>On gable end wall approximately half way along the elevation, there are vertical wooden struts either side of the attic storey window, with more struts above it, creating an effect of timber framing.</p> <p>Small projection at first floor level to the east of this gable. This is tile clad, and supported by two moulded, wooden brackets.</p> <p>Low wall surrounding steps to cellar entrance. Red brick also in English Garden bond, stepped, with a yellow terracotta, moulded coping.</p>

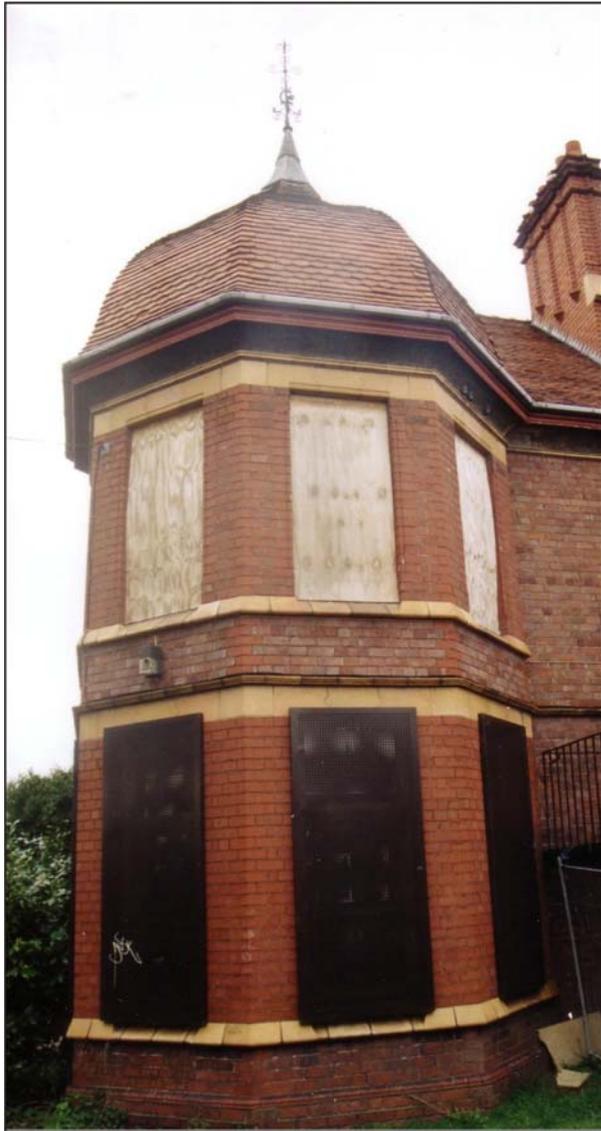
Plate 6: South-west tower from south

South west tower	
Walls	Red brick in English Garden bond.
Roof	Faceted cupola roof, octagonal in plan. Red tile roof with regular bands of straight and curved edged tiles. Toped by decorative wrought iron finial with scrolling and spiral decoration on a lead flashing base.
Window	All windows of ground and first floor covered by shuttering. Bands of yellow stone forming the lintels are continuous around the tower, as are the bands of yellow tiles forming the cills. Yellow stones are laid with joggled vertical joints.
Door	None
Chimney	None.
String-course	Moulded string-course in terracotta is immediately over lower lintel band. Narrow moulded string-course in yellow brick, immediately under eaves forming top of upper lintel band.
Plinth	Narrow plinth at base of wall with simple moulding forming upper edge.
Other

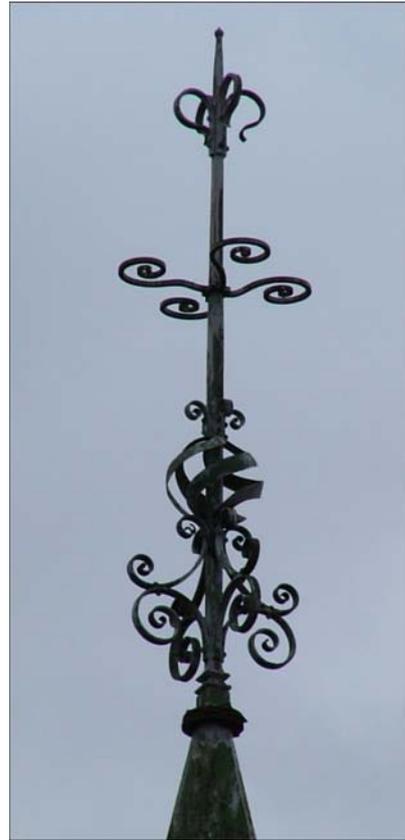
Plate 7: Detail of wrought iron finial

The south-west 'tower' is topped with an octagonal faceted cupola roof, also of decorative bands of tiles (Plate 6). This is topped with a decorative wrought iron finial of scrolls and spirals (Plate 7).

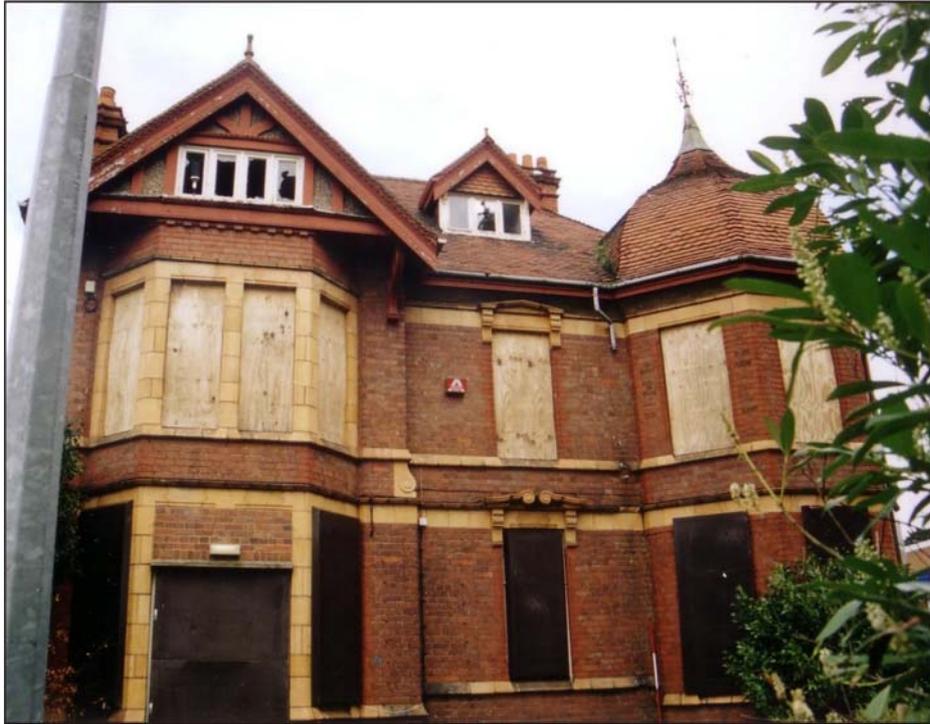
Plate 8: Main house from west

West elevation	
Walls	Red brick in stretcher bond, with bands of yellow stone and tile at level of window lintels and cills.
Roof	Red tile roof with regular bands of straight and fish scale tiles. Decorative timber barge boards over gables and dormer windows, with bands of moulding including decoration. Ball finials.
Window	<p>All windows of ground and first floor covered by shuttering. All window lintels are of yellow stone with joggled joints, and have yellow tile cills.</p> <p>Ground floor window is topped by an open scroll pediment with a background of leaf decoration, supported on two scrolled corbels with fluted and ribbed decoration.</p> <p>First floor window, has triangular pediment with central panel of acanthus leaf decoration, supported on two scrolled corbels with fluted and ribbed decoration.</p> <p>Ground floor bay window to north has plain stone mullions of yellow stone with straight joints.</p> <p>First floor bay window to north has plain stone mullions of yellow stone with straight joints.</p>

Door	Door is covered by shuttering. Door surround of yellow stone.
Chimney	None
String-course	Moulded string-course in terracotta is immediately over lower lintel band. Narrow moulded string-course in yellow brick, immediately under eaves forming top of upper lintel band.
Plinth	Narrow plinth at base of wall with simple moulding forming upper edge.
Other	<p>On gable end wall forming northern part of elevation, the brick courses between the lower string-course and upper band of yellow tiles are terminated in yellow stone quoins with scrolled decoration.</p> <p>Two large scrolled, wooden brackets support the overhang of the attic storey from the line of the main wall. There are vertical wooden struts either side of the attic storey window, with raking struts above it, creating an effect of timber framing</p>

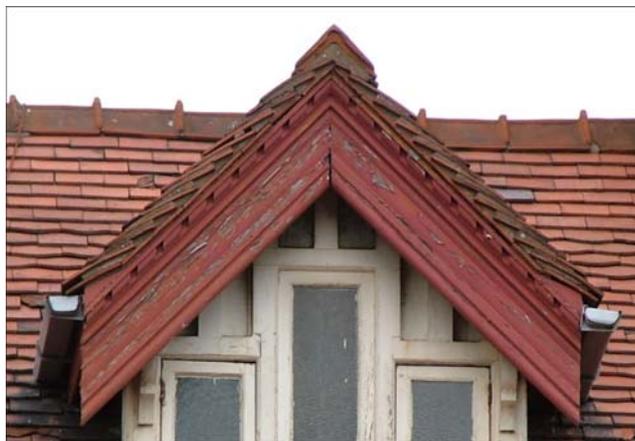
Plate 11: Detail of decorative bargeboards as seen on south, west and north elevations

North elevation	
Walls	Red brick in stretcher bond, with single band of yellow tile at first floor level.
Roof	Red tile roof with regular bands of straight and fish scale tiles. Decorative timber barge boards over gables and dormer windows, with bands of decorative moulding. Ball finials.
Window	<p>All windows of ground floor covered by shuttering.</p> <p>Oriel window at ground floor level with moulded terracotta forming the ornate supporting corbel decorated with ovolo moulding.</p> <p>All other windows have segmental arch head formed of gauged brickwork, with ovolo moulding along the lower edge. Chamfered edges to openings. Cills of yellow tiles.</p> <p>First floor window over oriel is formed of three lights, with a larger central section having a lower cyma-headed pane of glass, with two mouchettes above, while the smaller, side sections have rounded arched upper segments over rectangular lower panes. All the upper panes of glass are leaded with patterns of circles and arches with stylised flowers, and contain coloured glass.</p> <p>Triangular dormer window over.</p>

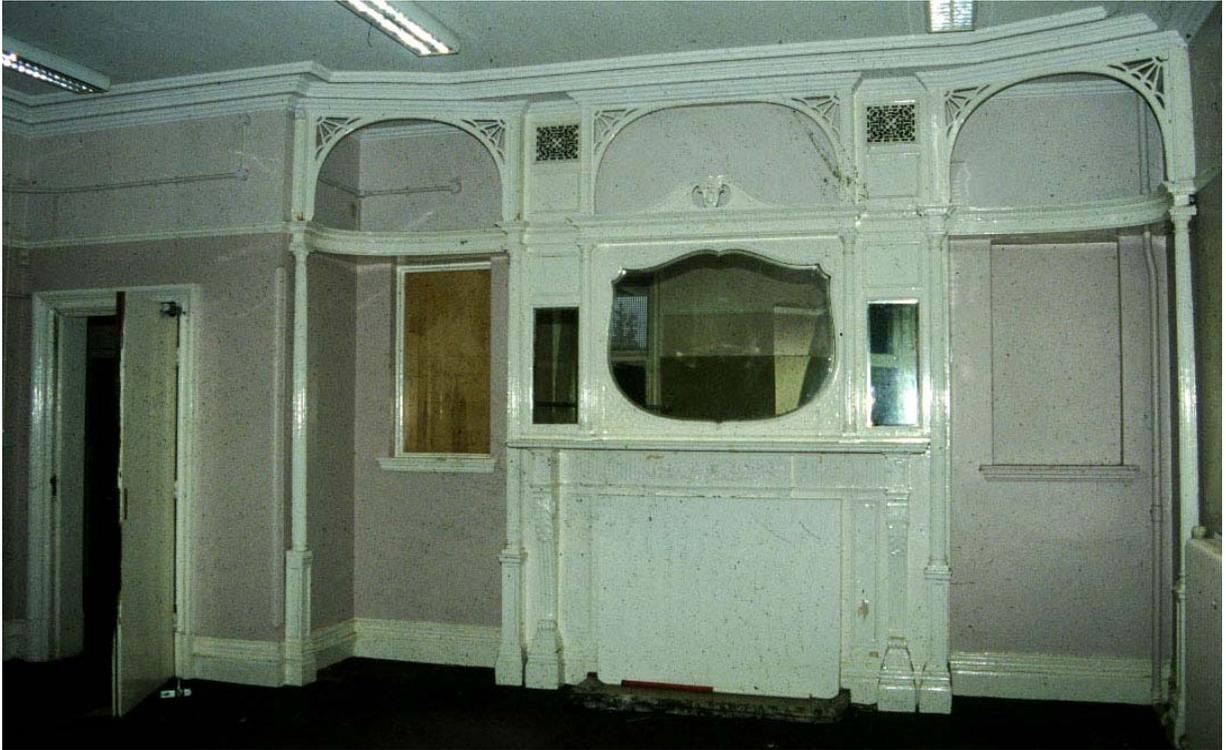
Plate 15: Fireplace and chimney-piece on east wall of Room 1

Cornicing	Deep cornice of two bands of ovolo moulding with fillets.
Skirting	Skirting with bands of ovolo and half round moulding with fillets along its upper edge.
Picture rail	Picture rail with cavetto and half round mouldings.
Window	Six sash windows. Wooden frames with two large panes of glass, and metal clasps with concentric circle decoration. Moulded surround and cill, both with wave mouldings.
Ceiling	A third band of ovolo mouldings runs parallel to the cornice, slightly in from the edge of the ceiling to create a further band of decoration.
Door	Two modern firedoors with moulded door frames of wave and ovolo mouldings
Other	Either side of the elaborate chimney piece, are alcoves dressed with timber surrounds to match the chimney piece. In each case this consists of a fluted column and square pedestal to match the outer column of the chimney-piece supporting a curved cornice with dentil decoration. This supports an open arch with pierced fan decoration spandrels. Blind window in each alcove with deep moulded cill.

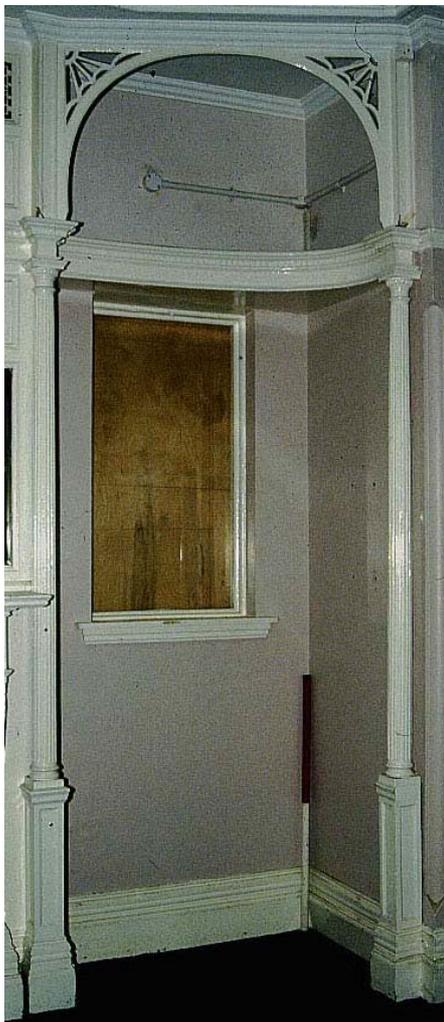
Plate 16: Alcove decoration in Room 1

Room 1: Reception	
Fireplace	Fireplace with large ornate chimney-piece. Grate not visible. Purple veined grey marble slab hearth and hearth surround. Timber surround consisting of fielded panels with ovolo moulding to either side of grate, flanked to either side by Corinthian style pilasters sporting acanthus leaf decoration over a scrolled foot. Frieze with a central lion's head and scrolling foliage decoration, flanked on either side by fluted decoration. Deep plinth of multiple ovolo and cyma moulding. Mantel-piece with roll and cyma moulded edge, over which is a shield shaped mirror, flanked by thin fluted columns with roll-moulded bases and capitals including egg and dart decoration. These columns are flanked by smaller rectangular mirrors with square panels with bolection mouldings above them. The whole is topped with a cornice decorated with dentil decoration and ovolo and cyma moulding, with a central scrolled pediment. The whole is flanked by a pair of fluted columns supported by a panelled pedestal and moulded plinth. Over this combined fire surround and mantel mirror is a further stage of chimney-piece consisting of a wide arch of small square columns with a cornice over, and spandrels with pierced fan decoration. Either side are further square panels with bolection moulding, and highly decorative iron air-vent covers sporting intricate designs of geometric tracery.

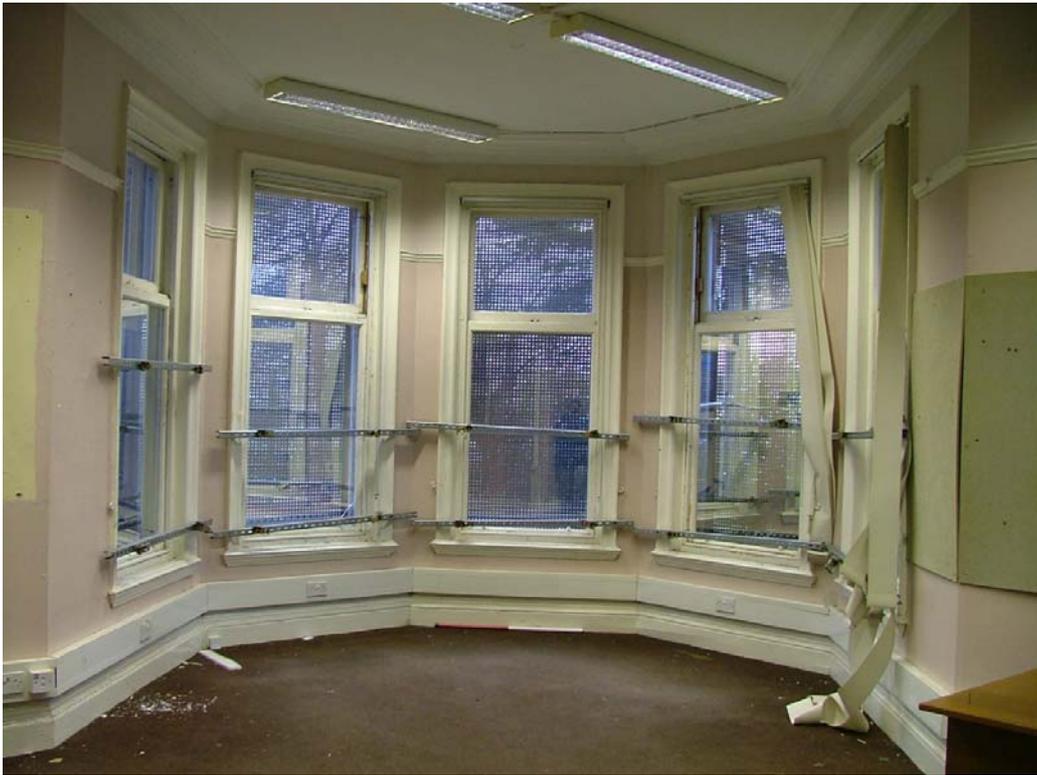
Plate 20: Bay window in south-west corner of Room 1

In the south-west corner of the room is the polygonal projection of the south-west tower, containing a bay window of five sashes with moulded surrounds and cills (Plate 20). There is a further sash window in the west wall.

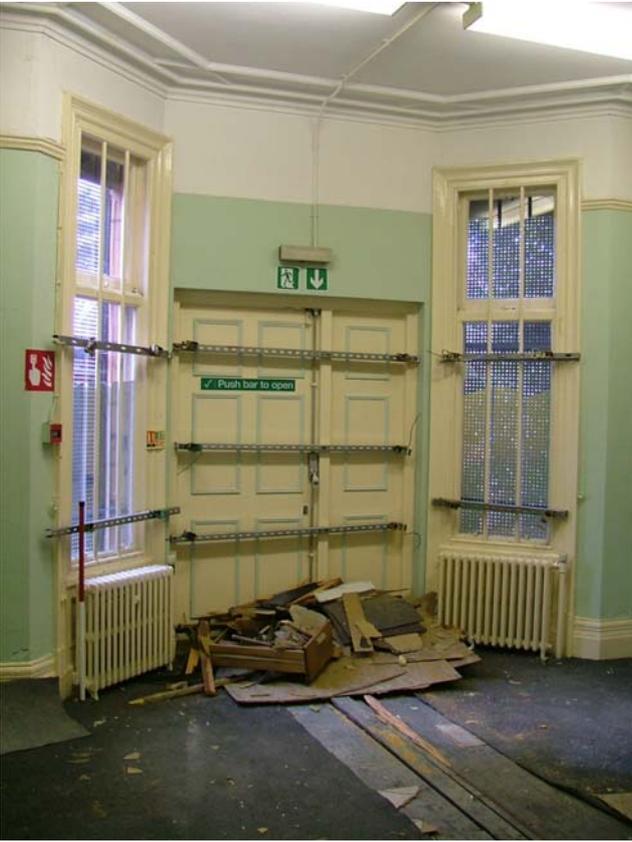
Plate 23: West entrance into Room 2

Cornicing	Cornicing of two deep, parallel bands of ovolo mouldings with fillets. (see Plate 24). On north, west and south walls only.
Skirting	Skirting with bands of ovolo and half round moulding along the top..
Picture rail	Picture rail with half roll, and ovolo mouldings.
Window	Two sash windows. Wooden frames with two large panes of glass, and metal clasps with concentric circle decoration. Moulded surround of wave moulding which extends down to the floor. No cills. Fielded panels below each.
Ceiling	A further two bands of moulding run parallel to the cornicing, connected at corners by further bands of moulding to create a pattern. Moulding is again of ovolo and half rounds with fillets.
Door	Internal doors are modern fire doors in moulded door frames. External door in west wall has six fielded panels with ovolo mouldings. Fixed panel to right of the door has a further three fielded panels.

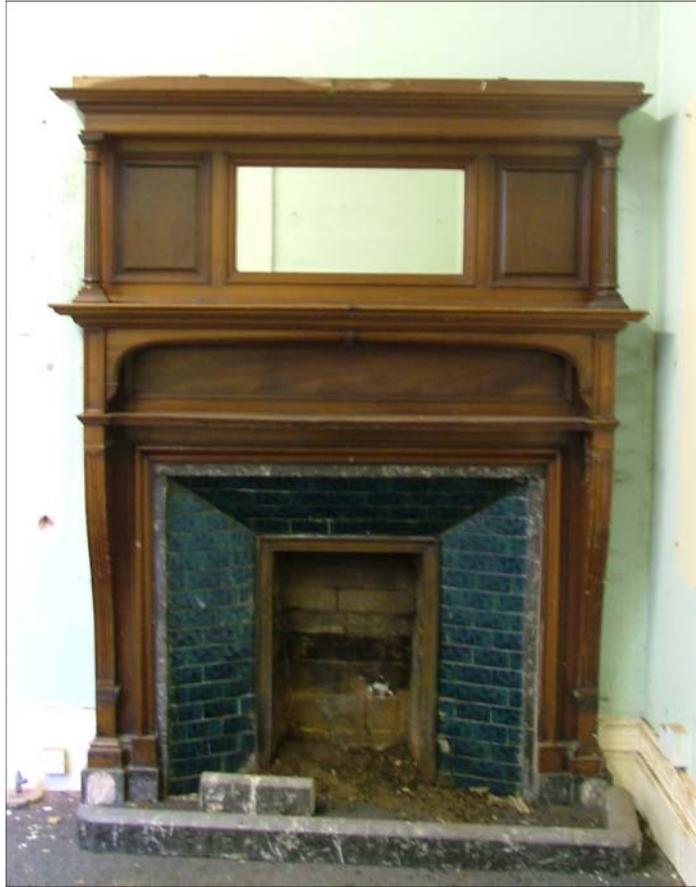
Plate 25: Fireplace in Room 2

Room 2: Reception	
Fireplace	Fireplace with grate removed. Brick fireback and cheeks framed by a surround consisting of a thin inner frame of timber with simple roll moulding along the inner and outer edge, a splayed surround of dark green, rectangular glazed tiles, with a thin outer frame of grey marble. Surrounded by second timber frame with cyma and bead moulding along the inner edge, flanked on either side by a fluted pilaster on a stepped square plinth. Over this is a simple frieze of a horizontal panel with cyma and bead moulding, set forward of which is a shallow arch edged with the same moulding, supported at each end by a small console. This arch is flanked by small vertical panels with moulded edges. This supports a mantel with a highly moulded under edge of multiple cyma moulding. Above the mantelpiece is a rectangular mirror framed with reverse cyma and bead moulding. This is flanked to either side by a raised and fielded panel with the same mouldings, which are in turn flanked by fluted columns, with roll moulding above and below the fluting. These are on square stepped plinths and have capitals with egg and dart decoration. These support a cornice with reverse cyma mouldings. White veined grey marble slab hearth and hearth surround. Two pierced iron air vents, identical to those in Room 1, in wall over fireplace.

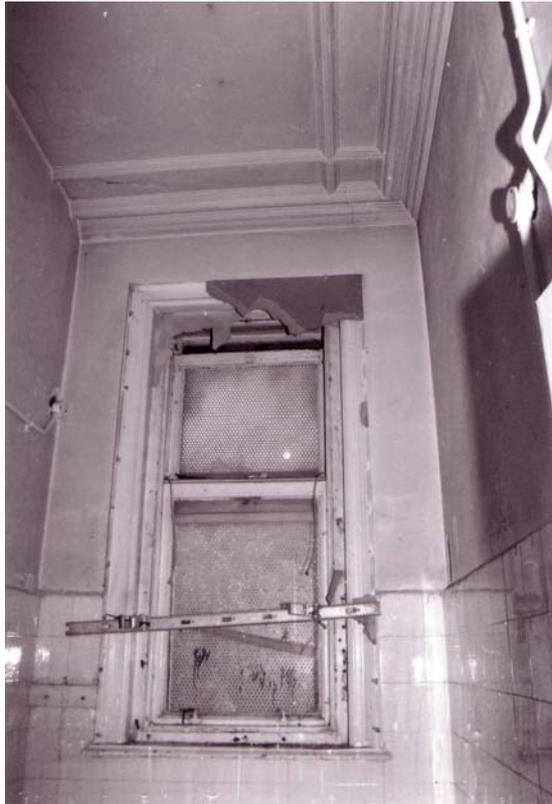
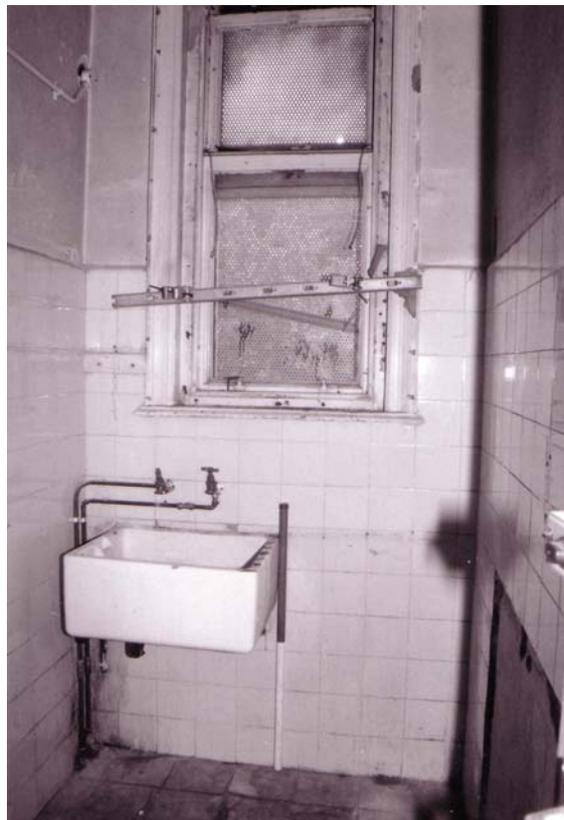
Plate 26: Room 3 looking north

On the ground floor, a small room was inserted into the north–east corner of Room 2. Room 3 was tiled and a belfast sink was plumbed into the north-west corner (Plates 26 & 27). Room 5 was subdivided, creating Room 8, and a doorway inserted into the west wall giving access from Room 4a. The westernmost window of Room 5 was replaced with a metal framed casement window, and the room as a whole modernised, with cornicing and picture rails removed (Plates 35 & 36).

Room 3: Reception	
Fireplace	None.
Cornicing	Cornicing of two deep, parallel bands of ovolo mouldings with fillets. On east and north wall only.
Skirting	None.
Picture rail	None.
Window	Sash window with moulded surround as in Room 2, and a simple cill. Two panes of plain glass with metal clasp with concentric circle decoration.
Ceiling	A further two bands of moulding run parallel to the cornicing, connected at corners by further bands of moulding to create a pattern. Moulding is again of ovolo and half rounds with fillets.
Door	Modern fire door with frame of multiple ovolo moulding.
Other	Walls of room tiled to half height. Belfast sink in north west corner. Tiled floor.

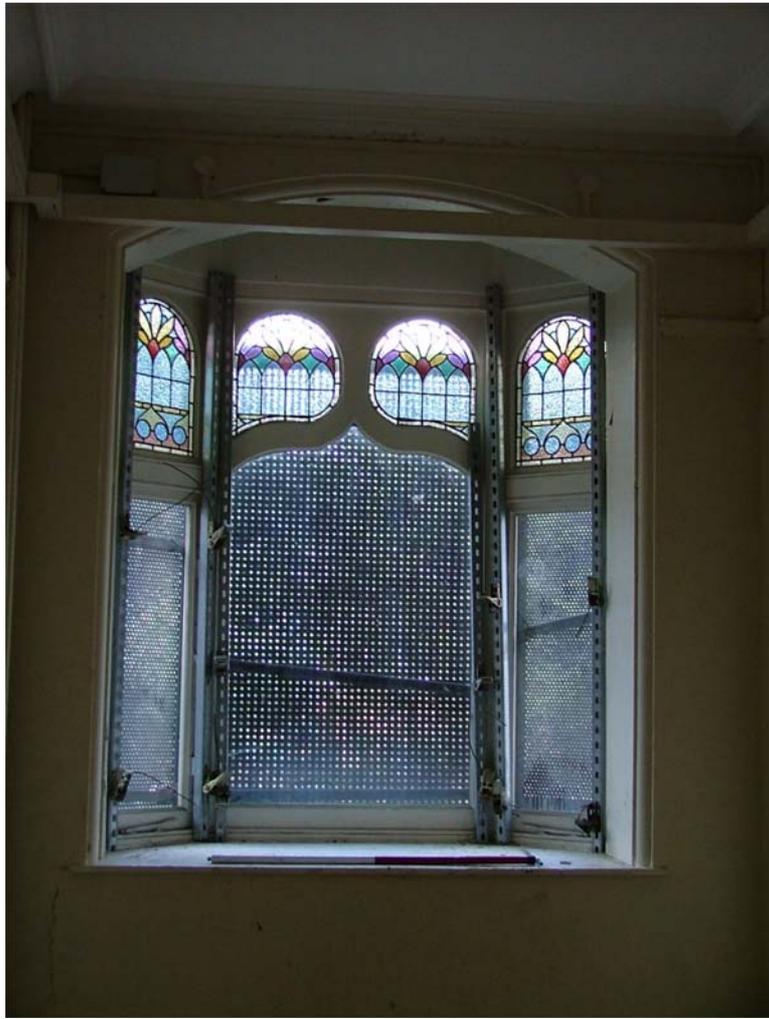
Plate 28: Oriel window in north wall of corridor 4a

The corridor (4a & 4b) is L-shaped, and continues the highly decorative theme of reception Rooms 1 and 2. The western end of the corridor (4a) contains the large oriel window with stained glass decoration (Plate 28), together with ornate cornicing, picture rail and skirting. At the junction of corridors 4a and 4b there would have been an open staircase leading to the first floor. The banisters have been removed and the staircase blocked in at a later date, but the edge of the bottom step, and the moulded corner of the newel post can be seen protruding from the wall that now forms the south side of corridor 4b (Plate 30). The entrance to corridor 4b, and the base of the stairs were spanned by a plaster arch with decorative corbels (Plates 31 & 32), which has since been bisected by the inserted wall. Under the staircase can be seen a small round-headed entrance, now blocked, and an ornate newel post which may have accessed steps down to the cellar (Plate 33).

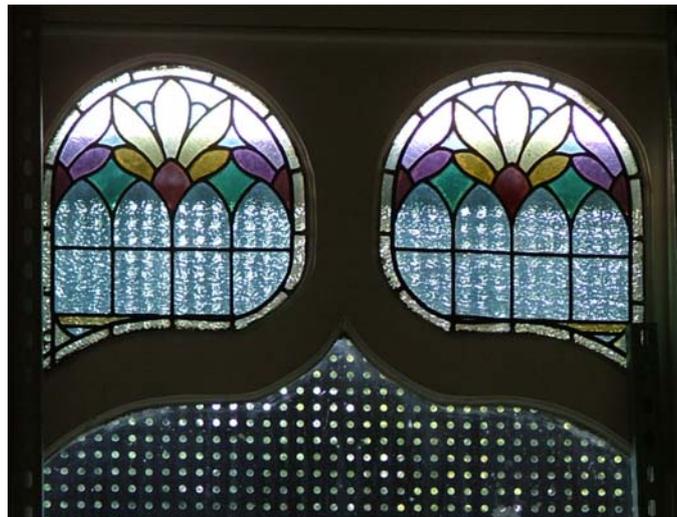
Plate 29: Detail of oriel window

Room 4a: Lobby	
Fireplace	None.
Cornicing	Deep cornice of two bands of ovolo moulding with fillets as seen in Room 1.
Skirting	Two types. Skirting with bands of ovolo, cavatto and half round moulding along top edge present on north wall, in south-west corner, and part of east wall. Rest of area has more modern plain skirting with no moulding.
Picture rail	Picture rail with band of half round moulding along top edge and two further bands of bead moulding.
Window	Large oriel style window in north wall. Segmental headed arched opening edged with ovolo moulding and a plain wooden cill. Window is formed of three bays, with a larger central bay having a lower cyma-headed pane of glass, with two mouchettes above, while the smaller, side bays have rounded arched upper segments. All the upper panes of glass are leaded with patterns of arches and circles with stylised flowers, and contain coloured glass.

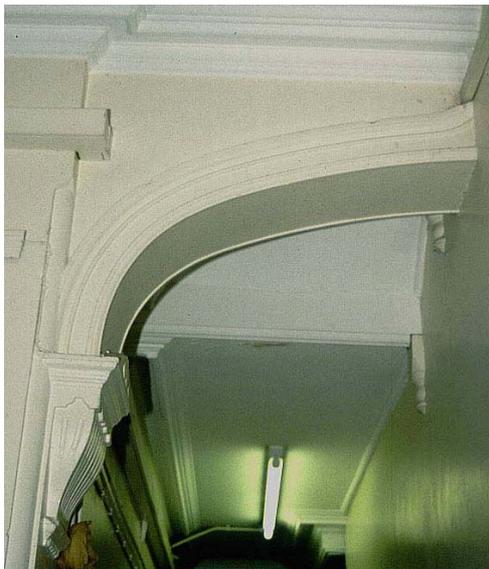
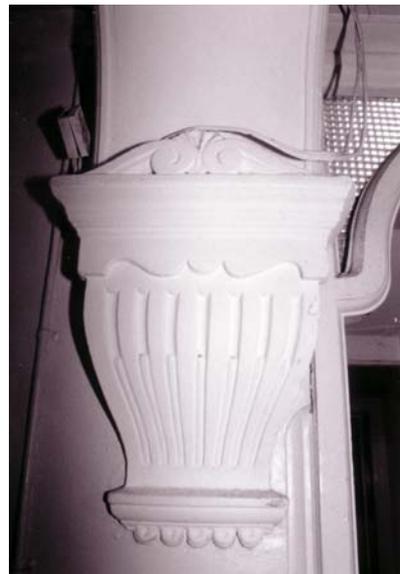
Plates 31 and 32: Northern half of plaster arch spanning corridor 4b and staircase 38

Other	<p>Arched entrance between 4a and 4b is decorated with a plaster arch. The underside of the arch is plain, with both faces decorated with bead and ovolo mouldings. Terminates in an urn shaped corbel, heavily carved, including fluting and ribbing, a double cyma decoration and with a scrolled pediment. Only northern half seen within this room, with the southern half of the arch within the stairwell.</p> <p>Staircase is now blocked off, but various elements of it are visible within the south wall of the corridor. Three turned pendants are visible, together with the rounded end of the bottom step and the moulded edges of the newel post. Under the staircase, at the east end is a very decorative moulded post, supporting one side of a wooden, round headed arch with pierced decoration above and a central carved keyblock.</p> <p>Semi-circular, round-headed niche, with simple chamfered edge, adjacent to the door to room 7 (to the west).</p>

Ceiling	Plain.
Door	Two doorways with plain doorframes, and modern firedoors.
Other	Other half of arch observed in 4a. The underside of the arch is plain, with both faces decorated with bead and ovolo mouldings. Terminates in an urn shaped corbel, heavily carved, including fluting and ribbing, a double cyma decoration and with a scrolled pediment.

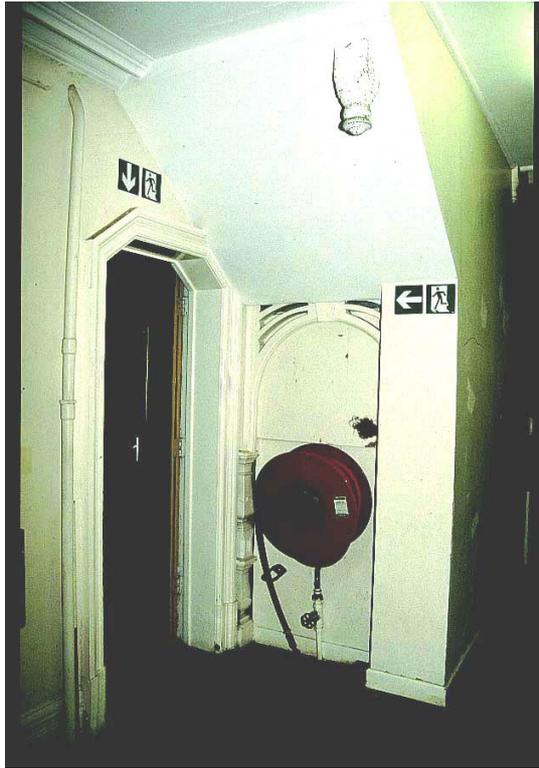
Plate 33 Blocked entrance to stairs and doorway to Room 6

A door to the east of the staircase accessed Room 6, a second large reception room. This doorway has a polygonal head (Plate 33), a design necessitated by the presence of the sloping staircase to the right. This room currently has no fireplace, but the presence of a chimney on the south elevation, and its obvious function as a main reception room indicates that one must originally have been present. In the south wall is a large recess with an ornate wooden surround extending to ceiling height, which now houses a modern fire exit (Plate 40). It is certain that this recess must have originally accommodated a fireplace and chimney-piece on the scale of that seen in Room 1, which has been removed at a later date.

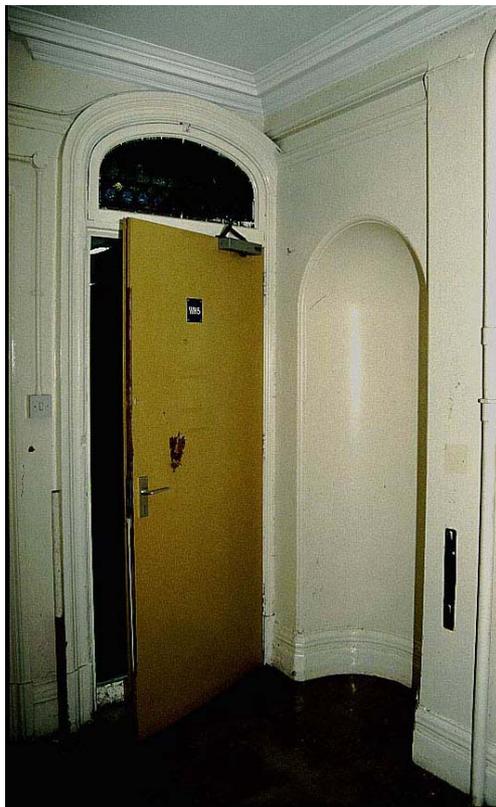
Plate 34: Second entrance and niche in corridor to east of Room 6

Approximately half way along corridor 4b, to the east of Room 6 was a second entrance into the house. This is a smaller doorway than that seen at the west front, with a four-centred arch surround incorporating a coloured glass fanlight (Plate 34). Immediately inside the door, on

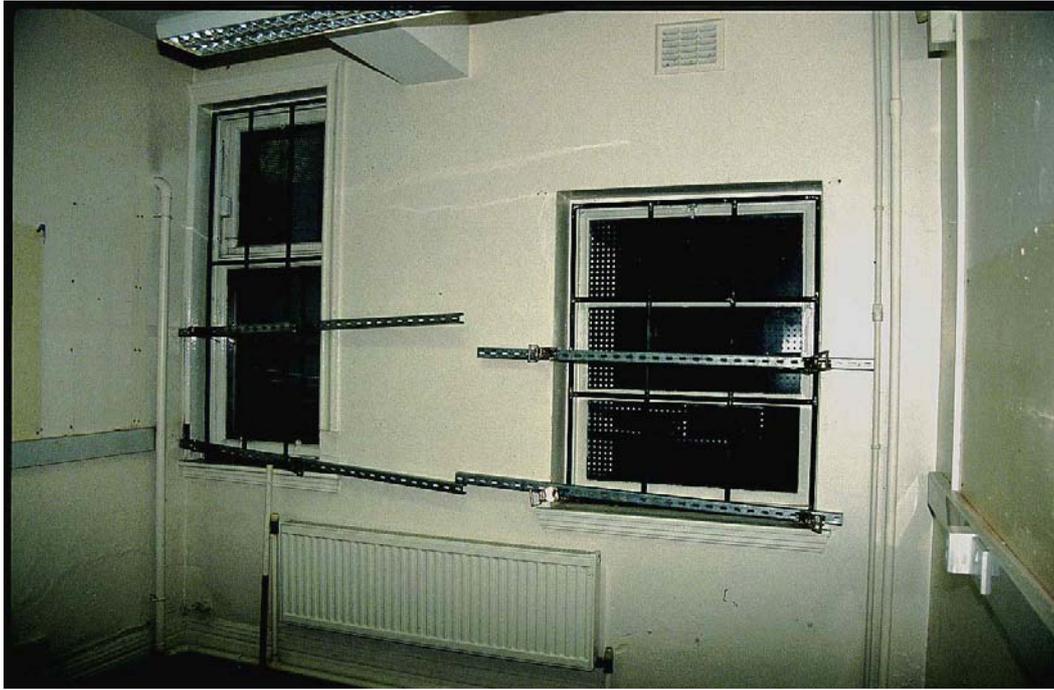
Plate 35: North wall of Room 5

Room 5: Reception	
Fireplace	None.
Cornicing	None.
Skirting	Moulded skirting with bands of ovolo moulding and fillets along the upper edge.
Picture rail	None.
Window	Two windows. Eastern window is a two-paned, wooden sash window with a moulded surround as seen in Rooms 1 and 2, with cyma moulding. The western window has a metal frame, and is divided horizontally into three lights. Both windows have a cills with deeply moulded undersides.
Ceiling	Plain.
Door	Modern door with plain wooden doorframe.
Other

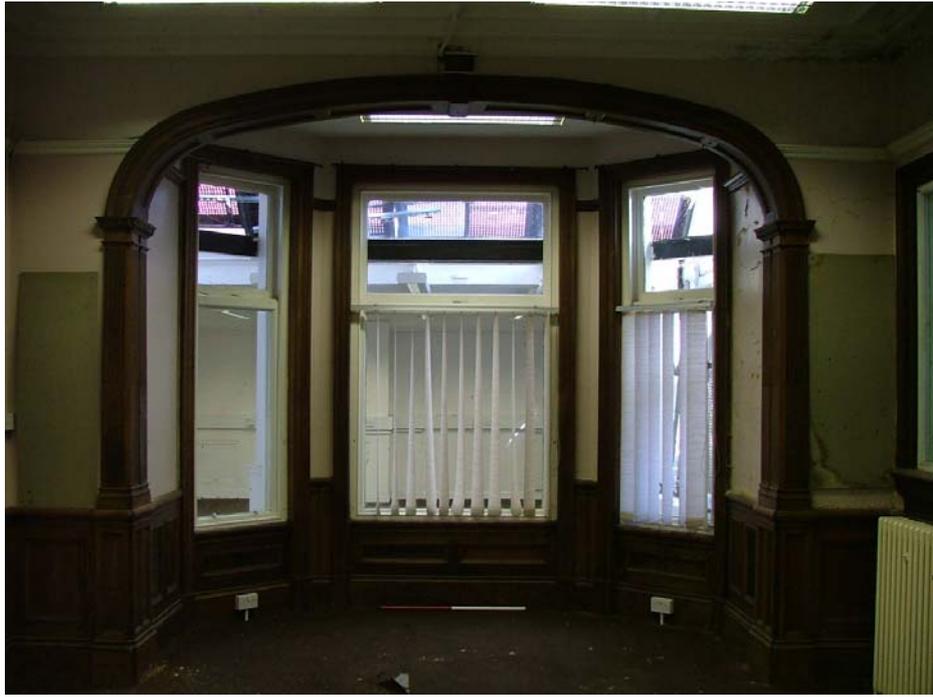
Plate 37: Arched recess and bay window at east end of Room 5

In the east wall is a large bay window, the recess for which is headed by a timber arch with panelled and moulded decoration (Plate 37). There is wooden panelling on all walls to a height of approximately 0.75m (Plate 38), and the ceiling has applied moulded decoration to create a coffered ceiling (Plate 39).

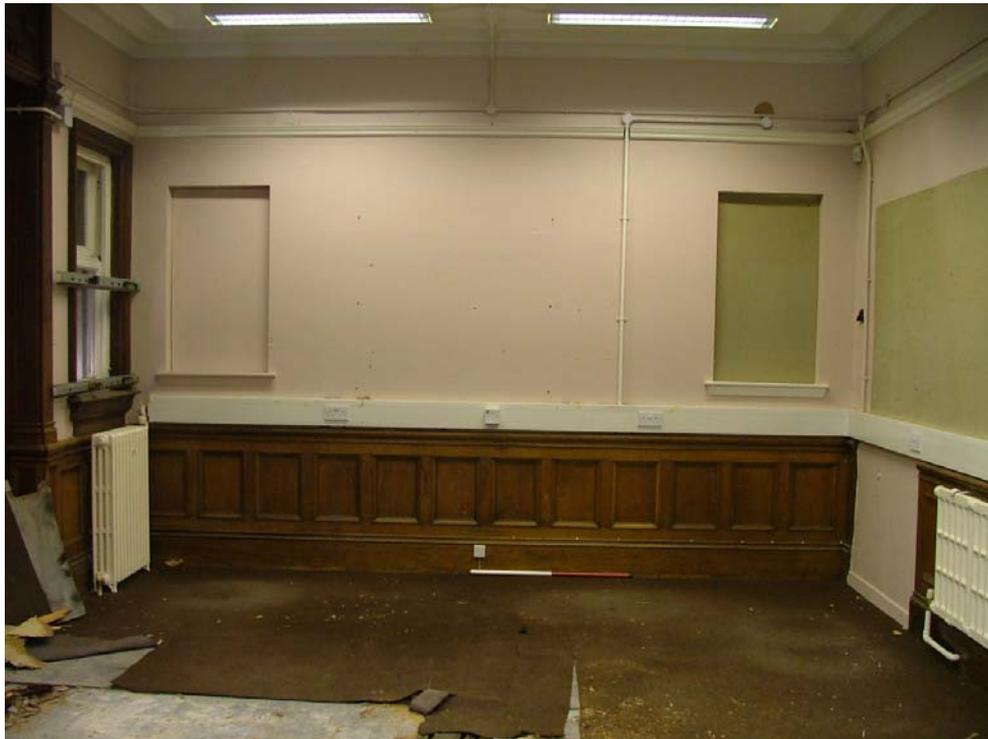
Plate 38: West end of Room 6

Ceiling	Plastered coffered ceiling, the square panels formed by lines of half round and ovolo mouldings.
Door	<p>Polygonal headed doorway from corridor 4b has a square headed, moulded surround with a modern fire door.</p> <p>Double doors in south wall are also modern firedoors. Set in much larger recess with ornate wooden surround. Fluted columns with moulded plinths and capitals with egg and dart decoration (corner eggs carved with foliate decoration) support a thin architrave of cyma and ovolo moulding, a wide frieze decorated with a geometric design in relief, and a narrow cornice again of cyma and ovolo mouldings. The reveal linings are panelled.</p>
Other	The room has panelling to a height of approximately 75cm on all walls. The rectangular panels are sunk, and framed with bead and ovolo moulding. The top of the panelling has a band of bead and ovolo moulding with a fillet.

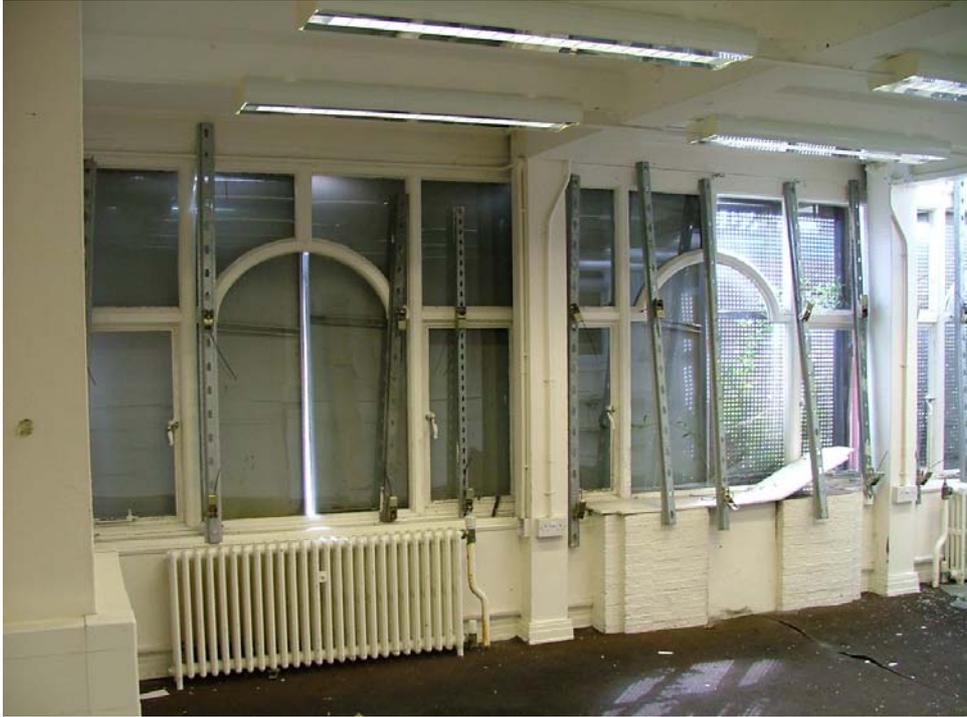
Plate 41: Windows in south wall of Room 7

window of Room 6, flattening off to a flat, roof constructed of RSJ's, with wooden boards between and externally lined with felt. The south elevation consists of a low brick wall with a series of three large windows running the entire of its length (Plate 41). The partition wall between Rooms 4b and 7 is thin in comparison to the other external walls of the house, suggesting that it was always an internal wall and that the current conservatory replaced an existing structure in this position. It is unlikely that the canted bay window of Room 6 was enclosed in the first phase of construction, but the original lay-out of this area is difficult to reconstruct.

Room 7: Conservatory	
Fireplace	None.
Cornicing	None.
Skirting	Simple skirting with two bands of bead moulding.
Picture rail	None.
Window	<p>Three large windows along south wall. Wooden frames of seven panes, consisting of a large central pane with an arched head, two smaller, rectangular panes to each side, and four panes over. All plain glass.</p> <p>Blocked window in north wall. No surround to moulded cill, and a plain wooden frame.</p>
Ceiling	Sloping glass roof at west end of room. Main part has boxed in iron beams with sunken ceiling panels between.
Door	Door leading from 4b. Simple moulded surround with a round headed arch, and arched fanlight with leaded pattern of circles, arches and flowers in coloured glass.
Other	Moulded panelling to a height of some 0.75m on the north wall.

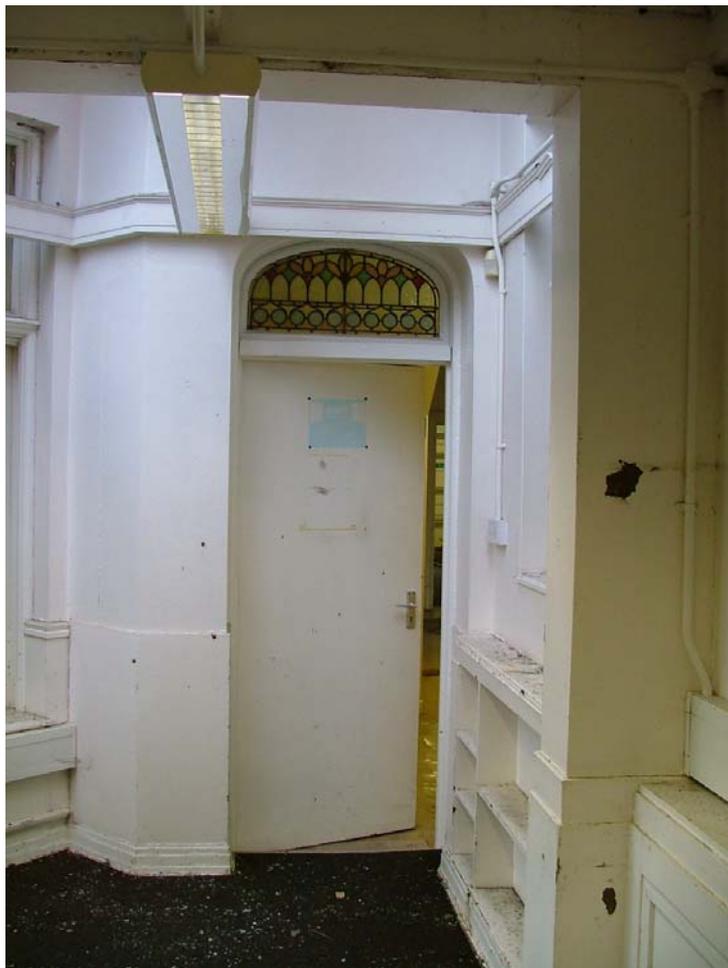
Plate 42: Second entrance to house, with decorative fanlight

Room 4b: Corridor	
Fireplace	None.
Cornicing	Deep cornice of two bands of ovolo moulding with fillets as in Room 1. None in eastern half.
Skirting	Majority of skirting is moulded, with half round and ovolo moulding along the upper edge. Plain skirting along south wall of corridor where staircase has been walled off, and in eastern half of corridor.
Picture rail	Picture rail as in Room 4a, with upper bands of half roll and bead moulding. None in eastern half.
Window	Blocked window in south wall, eastern half of corridor. Sash window with moulded surround and cill with multiple ovolo mouldings on underside.
Ceiling	Changes in ceiling level are framed by cornicing.
Doors	All doors are modern fire doors. Majority of frames are square headed with moulded surrounds as seen in previous rooms. Doorway to Room 6 has a polygonal head, with a moulded surround of half round and ovolo moulding. This allows the moulding to tie in with the base of the staircase doorway through to Room 7 is square headed with an arched fanlight above. The fanlight contains coloured glass set in a leaded panes creating a pattern of circles, arches and flowers (Plate 42). The moulded door surround is arched to accommodate the fanlight.

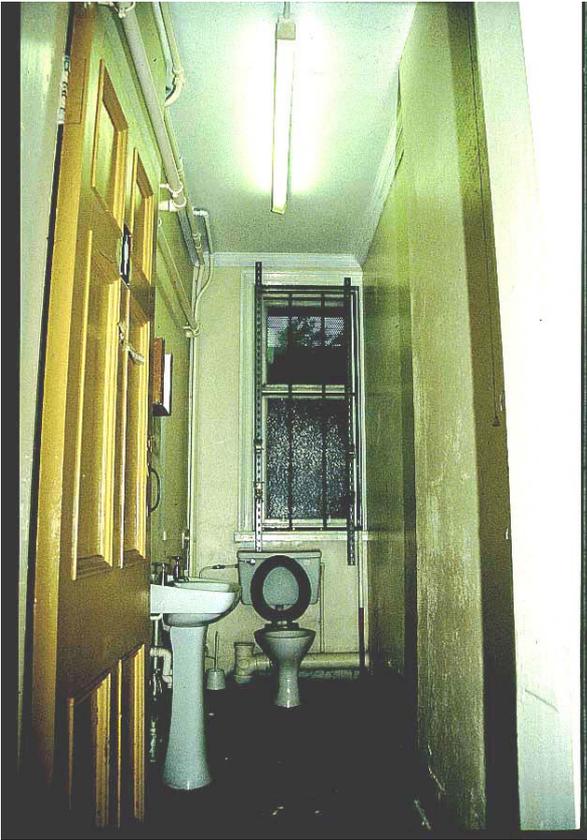
Plate 43: Cloakroom 8 from south

Room 8: Cloakroom	
Fireplace	None.
Cornicing	Cornicing with ovolo and cyma moulding with fillet.
Skirting	Plain.
Picture rail	None.
Window	Sash window, wooden frame with two panes. Moulded surround of ovolo and wave moulding, with simple cill with half round and hollow moulding bands along its upper edge.
Ceiling	Plain.
Door	Door with six panels, framed with ovolo and bead mouldings. Moulded door surround externally in corridor, but plain surround internally.
Other	Ceramic toilet and wash basin dating to second half of 20 th century/

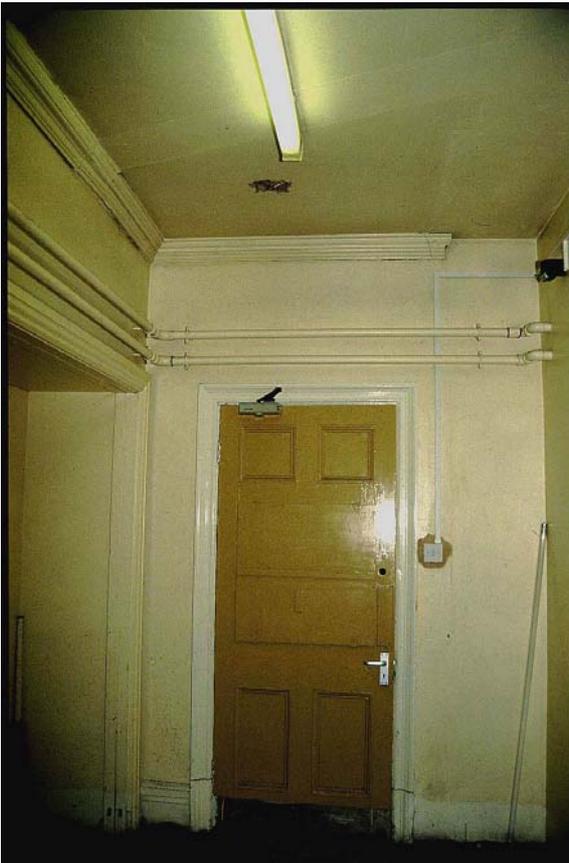
Plates 44 & 45: Room 9 from north and south respectively, showing discontinued corning and large recess

East of this point Rooms 9-15 appear to have been more utilitarian rooms. Room 9 was slightly smaller during this phase than it is currently, as evidenced by the scar of a removed wall across the ceiling and the mitred ends of the cornicing (Plates 44 & 45). In the east wall is a large recess, with a wooden surround which has a central groove on its inner face. This suggests the recess was originally a large cupboard.

Room 9: Cloakroom	
Fireplace	None.
Cornicing	Deep cornice with cyma and ovolo moulding with fillet. Not present on west wall, or western ends of north and south walls.
Skirting	Majority removed. One very short section east of door with simple band of cyma moulding along the top.
Picture rail	None.
Window	Sash window with wooden frame. Two panes of plain glass with metal clasps of concentric circle decoration. Surround of ovolo and wave moulding, with a plain cill.
Ceiling	Plain.
Door	Moulded door frame of multiple ovolo mouldings, with panelled door. Has two central plain panels, with two panels above and two below that are framed with ovolo and bead mouldings.
Other	Large recess in eastern wall, with a moulded timber surround of ovolo and bead moulding. Vertical groove in inner face of surround suggests that it was originally fitted with folding doors. Recess contains two sinks of later 20 th century date. Two toilets of same date against the west wall.

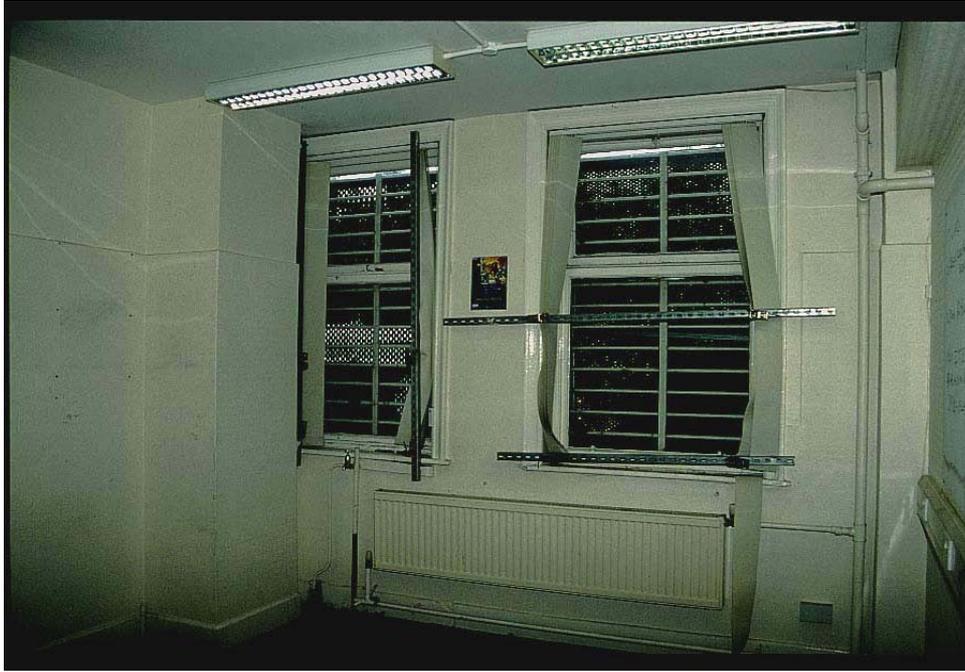
Plate 46: Room 10 from the south-east

The tiling in Rooms 10, 11 and 13 appears to be original to this phase, and suggests that these, together with Room 12 formed a small collection of household rooms (plates 46-49). These probably included a kitchen, scullery and pantry, although there are no utilitarian fittings remaining in any of the rooms to clarify this further, with the exception of a 'dumb waiter' in the south-east corner of Room 13 (Plate 48). These rooms have no decorative features such as cornices or picture rails.

Room 10: Room	
Fireplace	Probable blocked chimney breast, with small iron plate - possible air vent cover.
Cornicing	None.
Skirting	Plain skirting with no moulding.
Picture rail	None.
Window	Two sash window with wooden frames. Two panes of plain glass, one with metal clasp of concentric circle decoration. Surrounds of ovolo and wave moulding, with plain cills.
Ceiling	Plain.
Door	Plain door frame with no moulding, modern fire door.
Other	Walls are currently papered, but the outline of tiles can be clearly seen beneath it. All walls of room tiled up to a height of approximately 2m.

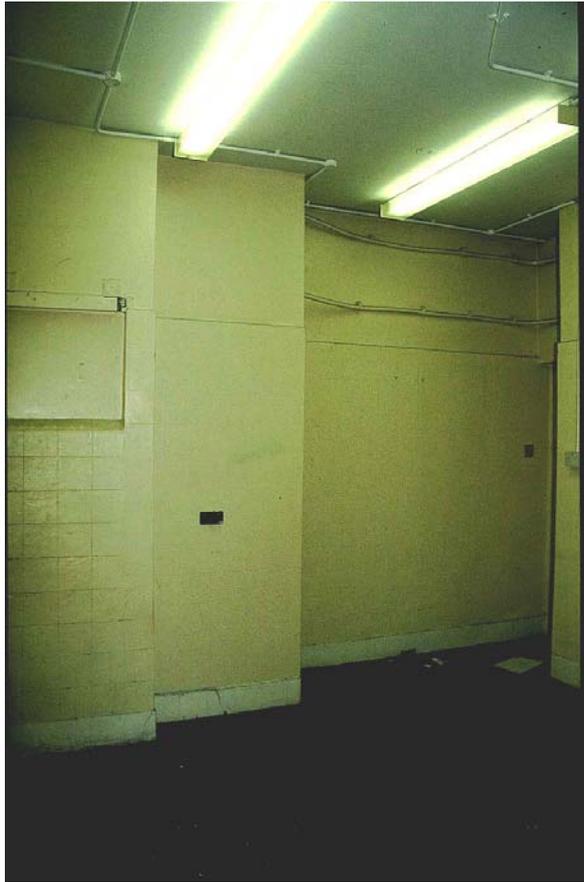
Plate 48: Room 13 showing tiling and dumb-waiter

Room 13: Kitchen?	
Fireplace	None.
Cornicing	None.
Skirting	Tiles.
Picture rail	None.
Window	Large windows in north wall largely boarded over – fixed. No surround, and frame is divided horizontally into two panes.
Ceiling	Plain.
Door	Doorway with moulded door frame, and modern fire door
Other	All walls tiled to a height of approximately 2m. 'Dumb waiter' in south-east corner.
