**Westhill Centre,
107 Hagley Road,
Stourbridge**

**Report on archaeological building recording and an
ornamental audit**

May 2004

Marches Archaeology Series 342

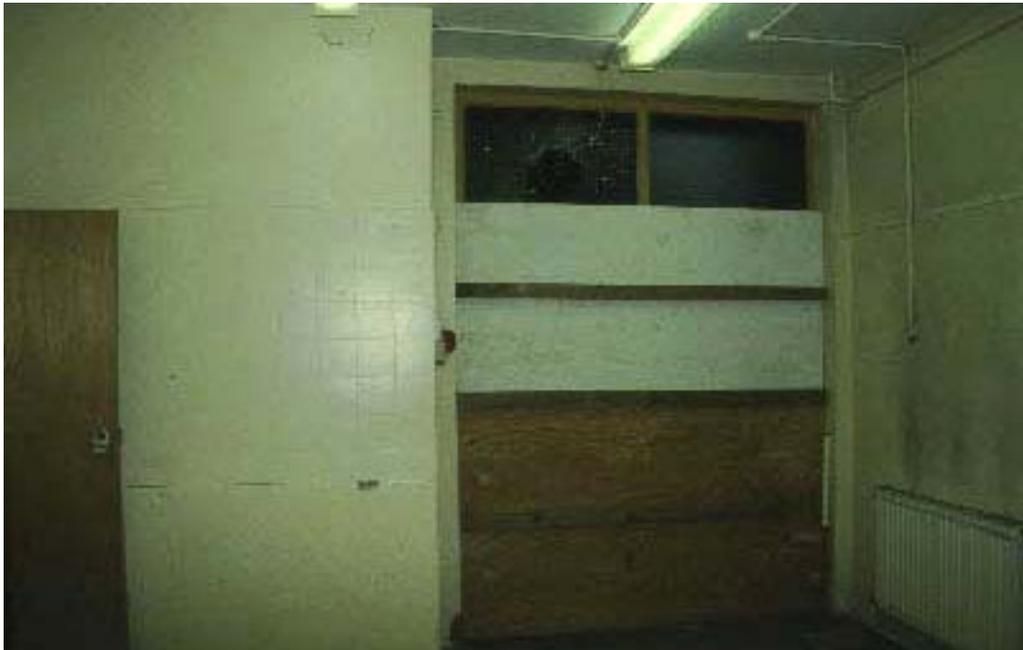
Plate 49: Room 13 looking east

Room 13: Kitchen?	
Fireplace	None.
Cornicing	None.
Skirting	Tiles.
Picture rail	None.
Window	Large windows in north wall largely boarded over – fixed. No surround, and frame is divided horizontally into two panes.
Ceiling	Plain.
Door	Doorway with moulded door frame, and modern fire door
Other	All walls tiled to a height of approximately 2m. 'Dumb waiter' in south-east corner.

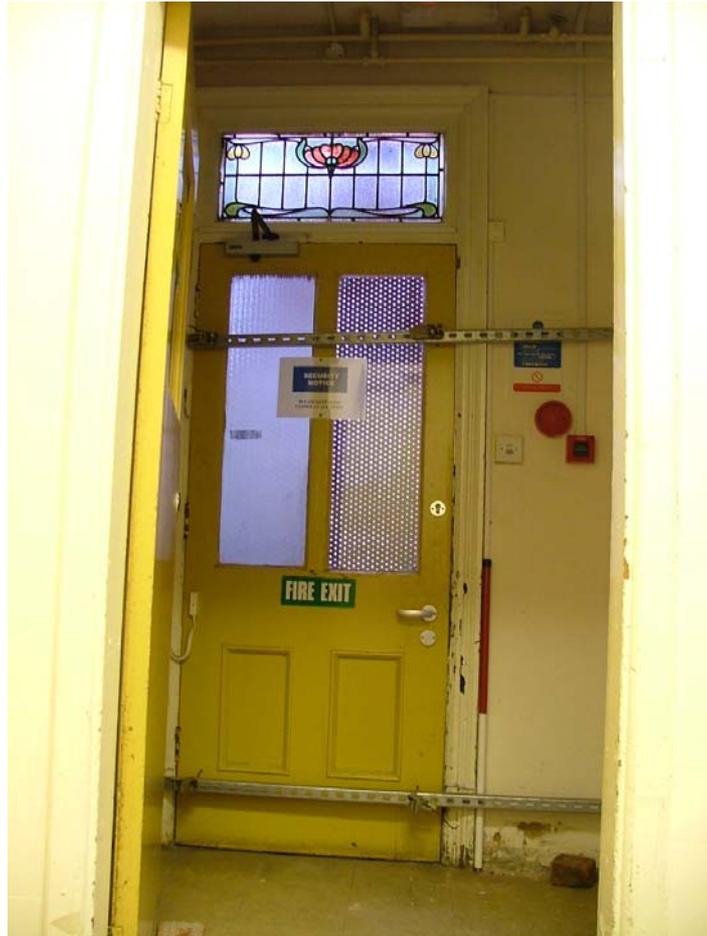
Plate 50: Room 14, tradesman's entrance with panelled door and decorative light

In the north-east corner of this block of rooms, Room 14 is a small entrance hall for a third external doorway (Plate 50). This would have been the back door, and tradesman's entrance, but still has a decorative fanlight of coloured glass over it. Immediately to the left of the door is a small room (15), which may originally have been a cloakroom (Plate 52).

Room 14: Entrance lobby	
Fireplace	None.
Cornicing	None.
Skirting	Plain skirting, missing on east wall.
Picture rail	None.
Window	None.
Ceiling	Plain.
Door	Doorway with moulded door frame, and wooden door with two vertical, plain glass panes in the top half, and two panels with ovolo and bead moulding in the lower half. Rectangular fanlight over containing a leaded pattern including flowers of coloured glass.
Other

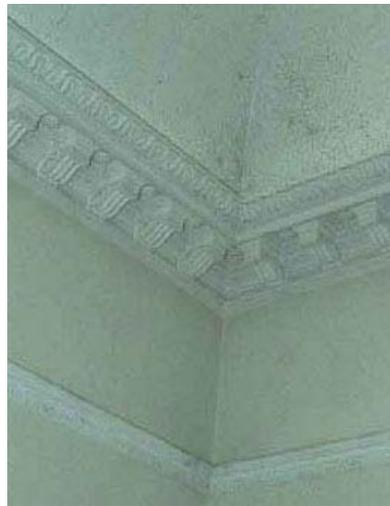
Plate 58: Detail of plaster ceiling

The arches and spandrels of the recesses are decorated with further classical motifs (Plate 60), and the plaster ceiling is decorated with further mouldings and foliate motifs (Plate 58). The walls are bowstring in profile from the ceiling to a lower cornice, which is again formed of multiple bands of moulding, some decorated, as is the picture rail below (Plate 59).

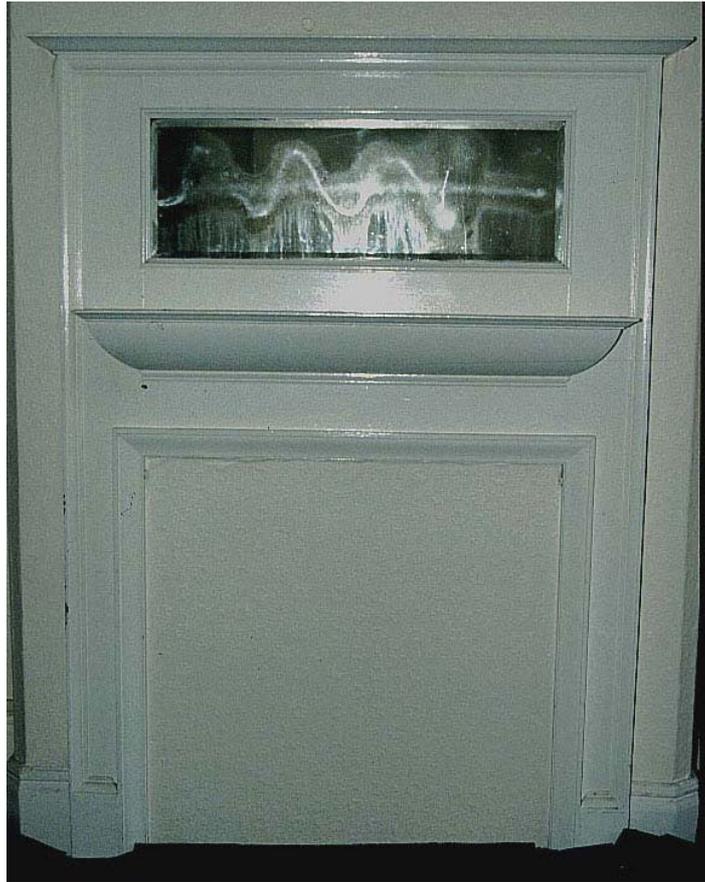
Plate 64: Fireplace in Room 22

Room 22: Bedroom	
Fireplace	Fireplace with grate removed. Timber surround with reverse cyma moulding around inner edge and ovolo moulding around outer edges. Mantel with wide convex underside and cyma moulding. Thin cornice of cyma moulding. No hearth visible.
Cornicing	Cornicing of two parallel bands of cyma and ovolo mouldings with fillet. One band around main ceiling of room, with another around the window recesses.
Skirting	Skirting with band of bead, hollow and fillet mouldings along the top.
Picture rail	Picture rail with bead and cyma mouldings.
Window	<p>One window of the form seen in Room 7 in south wall. Consists of a large central pane with an arched head, with two smaller, panes over. Flanked on either side by a further window divided horizontally into three panes. All of clear glass. Simple surround with bead moulding, no cill.</p> <p>Sash window in north wall. Wooden frame with two panes of plain glass and metal clasp of concentric circle design. Moulded surround as seen in ground floor windows and plain cill.</p>

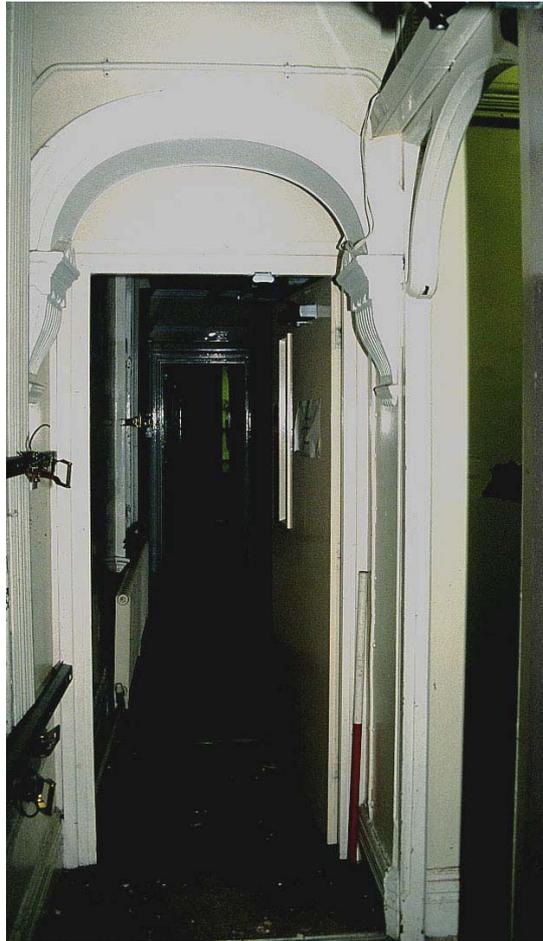
Plate 65: Corridor 23 from east, showing plaster arch

Room 23: Corridor	
Fireplace	None.
Cornicing	Cornicing of two parallel bands of cyma and ovolo mouldings with fillet. One band around main ceiling of room, with another around the window recesses.
Skirting	Skirting with band of bead, hollow and fillet mouldings along the top.
Picture rail	Picture rail with bead and cyma mouldings.
Window	Sash window in south wall. Wooden frame with two panes of plain glass and metal clasp of concentric circle design. Moulded surround as seen in ground floor windows and cill with underside of ovolo mouldings.
Ceiling	Plain.
Door	Doors from stairs and Room 22 have moulded frames of ovolo and wave moulding, with modern fire doors. Doorway between 23 and 24 has a plain frame to ceiling height, with a rounded arch forming the doorway, above which are panels of patterned glass. No door.
Other	Entrance from 23 into 28 is decorated with an ornate plaster arch similar to that in corridor 4b. The underside of the arch is plain, with both faces decorated with bead and ovolo mouldings. Terminates in urn shaped corbels, heavily carved, including fluting and ribbing, a double cyma decoration and with a scrolled pediment.

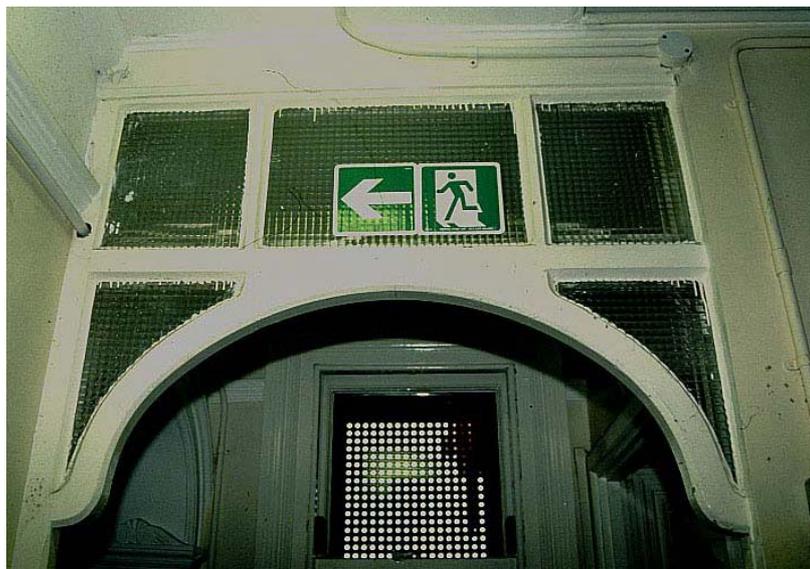
Plate 66: Timber archway in corridor 23

There is an open archway with a decorative plaster arch, similar in style to that seen spanning the corridor and staircase in corridor 4b, towards the eastern end of this corridor, with a second, simpler wooden fanlight archway at the junction of the L-shape (Plate 66).

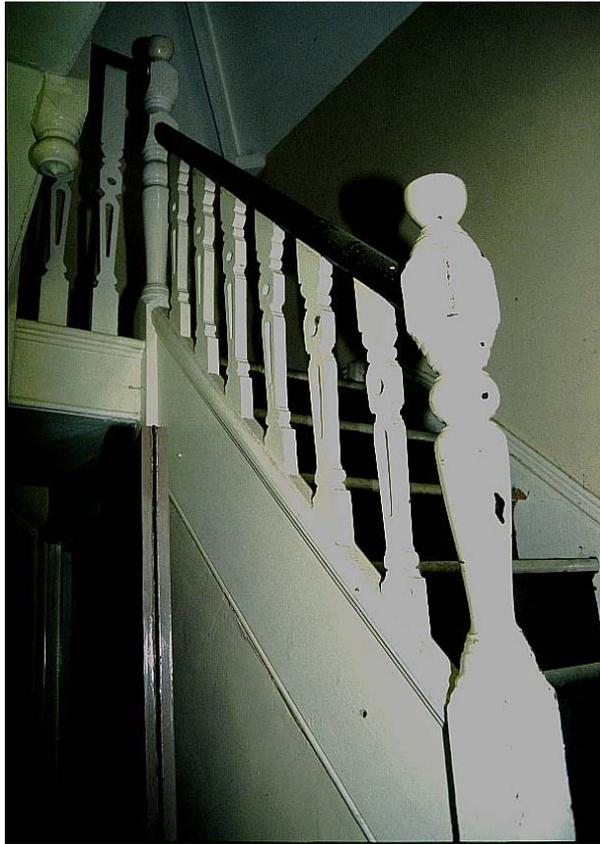
Plate 67: Staircase to second floor from corridor 24

The staircase to the attic storey rises from the east end of corridor 28, and has a balustrade of splat balusters with pierced decoration, turned newel posts and a plain hand rail (Plates 67 &

Room 24: Corridor	
Fireplace	None.
Cornicing	Cornicing of two parallel bands of ovolo and half round mouldings with fillet..
Skirting	Skirting with band of bead, hollow and fillet mouldings along the top.
Picture rail	Picture rail with ovolo and cyma mouldings.
Window	None.
Ceiling	Plain.
Door	<p>Doors Room 25 has moulded frames of ovolo and wave moulding, with modern fire door. Door to Room 26 has a plain frame with a modern fire door.</p> <p>Doorway between 23 and 24 has a plain frame to ceiling height, with a rounded arch forming the doorway, above which are panels of patterned glass. No door.</p>
Other	Staircase to second floor in north-east corner of room. Turned newel post with tapered shaft, square base, mouldings and ball finial. Splat banisters with pierced decoration. Plain handrail. Stairs covered with modern materials. Pendants from half landing and second floor landing are also ball variants.

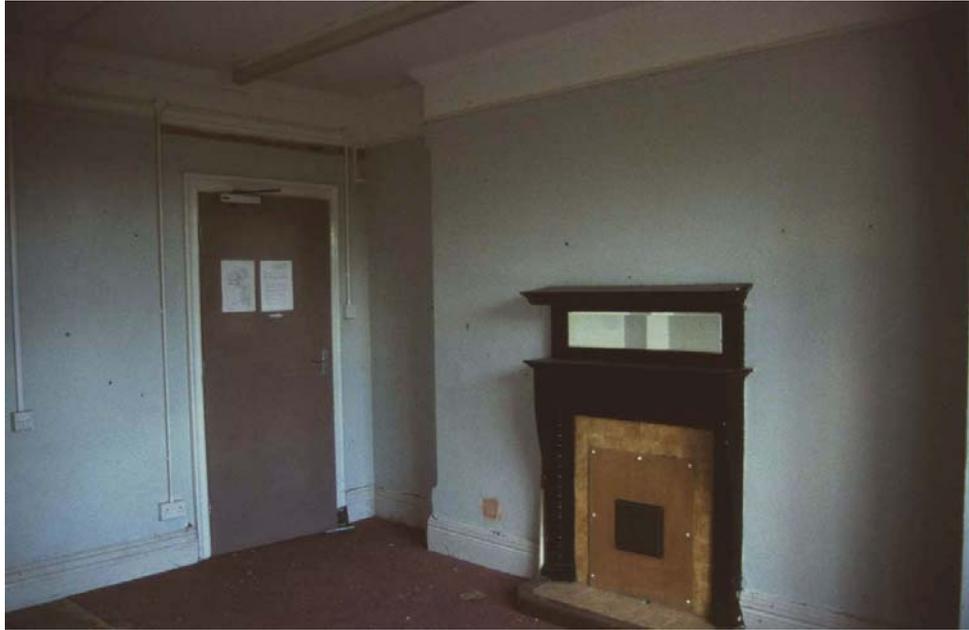
Plate 71: Room 27 from north-east

Room 27: Bedroom	
Fireplace	Fireplace with opening boarded up—grate not visible or removed. Beige tile surround framed by timber moulding including egg and dart decoration. Flanked by thin, fluted pilasters on a stepped plinth with ovolo moulding. Supports a mantel with a moulded soffit of reverse cyma and ovolo moulding. Immediately beneath the mantel is a plain panel, set forward of which are two shallow arches separated by a fluted mutule. Rectangular over mantel mirror within a frame of cyma moulding. Fluted decoration to either side, with a cornice incorporating reverse cyma moulding and dentil decoration. Tiled hearth and hearth surround
Cornicing	Single band cornicing of ovolo mouldings.
Skirting	Skirting with bands of ovolo, hollow and half-round mouldings along the top.
Picture rail	Picture rail with ovolo and cyma mouldings
Window	Window of 3 lights, central light is a sash window, the outside windows are fixed. Wooden frames, each with two panes of plain glass and metal clasp of concentric circle design on centre one. Moulded surround of ovolo and wave mouldings. Cill with underside of ovolo mouldings.

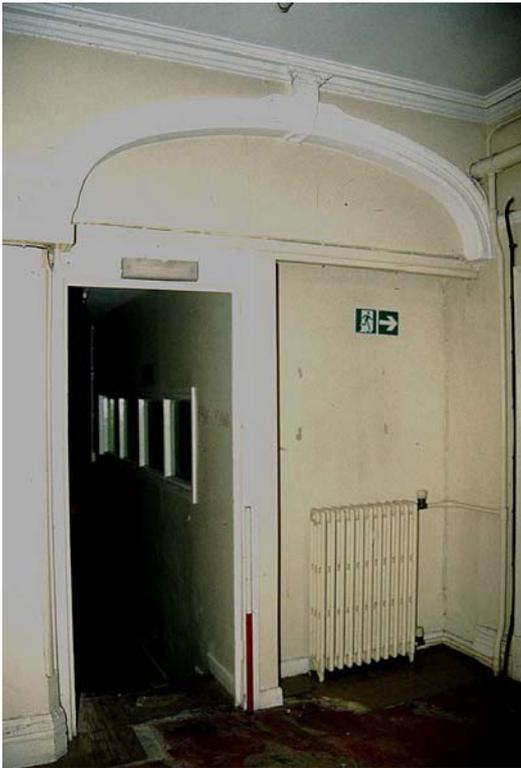
Plate 74: Archway spanning landing 29 and staircase 38

seen spanning the corridor and staircase on the ground floor, can be seen within corridor 29, spanning what would have been an open landing (Plate 74).

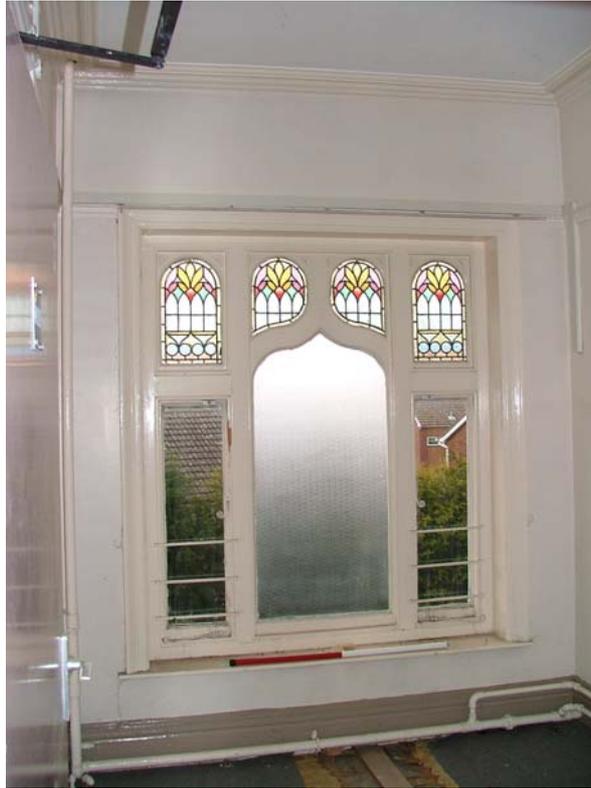
Plate 79: Window in Room 34

At the west end of corridor 28 a doorway led into corridor 29 originally an open landing, which was also L-shaped and originally incorporated Room 34. This was lit by a large window, now in Room 34, which again reflects the style of the oriel window in 4a (Plate 79), with upper panes of leaded decoration with coloured glass, as well as that at the top of stairs 38. As mentioned above, the landing was spanned by a decorative plaster arch, with two open archways with plaster arches with identical decoration gave access into Rooms 30 and 36a.

Room 34: Bedroom	
Fireplace	None.
Cornicing	Deep cornice of two bands of ovolo moulding with fillets as seen in west corridor 28.
Skirting	Skirting with bands of ovolo, hollow and half-round mouldings along the top.
Picture rail	Picture rail with ovolo and cyma mouldings.
Window	Large window mirroring that in 4a. Window is formed of three lights, with a larger central section having a lower cyma-headed pane of glass, with two mouchettes above, while the smaller, side sections have rounded arched upper segments over rectangular lower panes. All the upper panes of glass are leaded with patterns of circles and arches with stylised flowers, and contain coloured glass. Moulded surround with plain cill.
Ceiling	Plain.
Door	Modern door leading into room 29 corridor through modern partition wall. Blocked doorway in south-east corner has plain surround.
Other

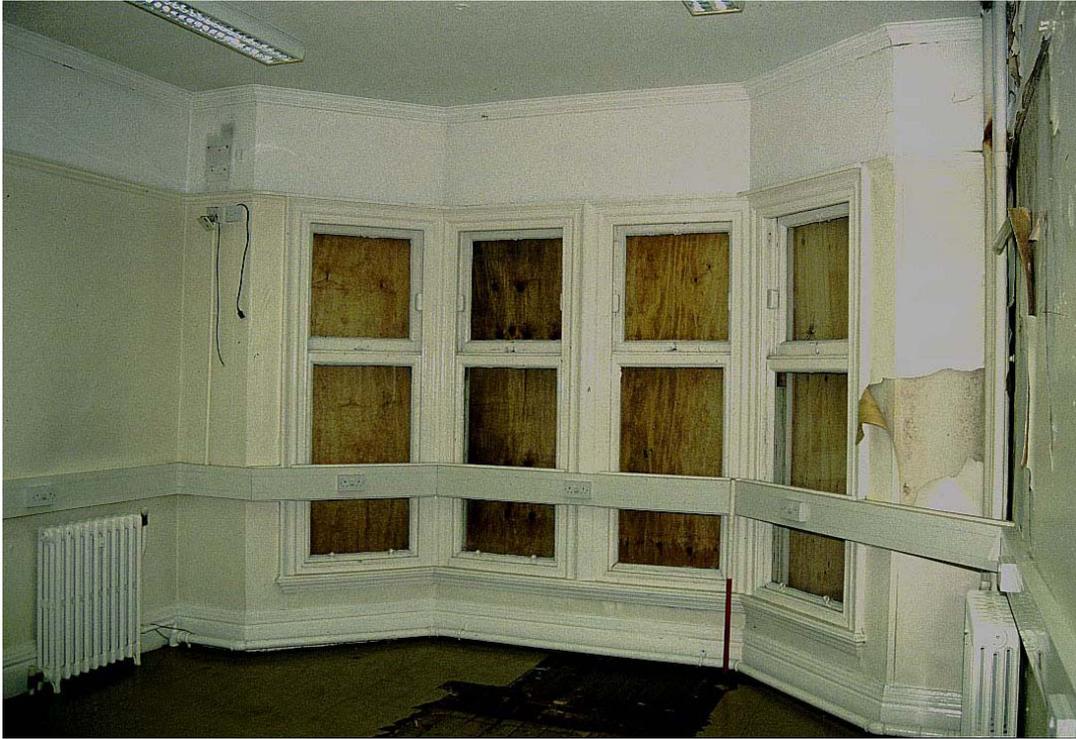
Plate 81: Bay window in west wall of Room 35

Room 35 has a large bay window of four sashes (Plate 81), while Room 36 contains the projection of the south-west ‘tower’ and the corner bay window of five sashes identical to that in Room 1 (Plate 83). Room 36 may originally have had a sash window either side of the fireplace recess, with that to the right of the fireplace replaced by a later fire exit (Plate 86).

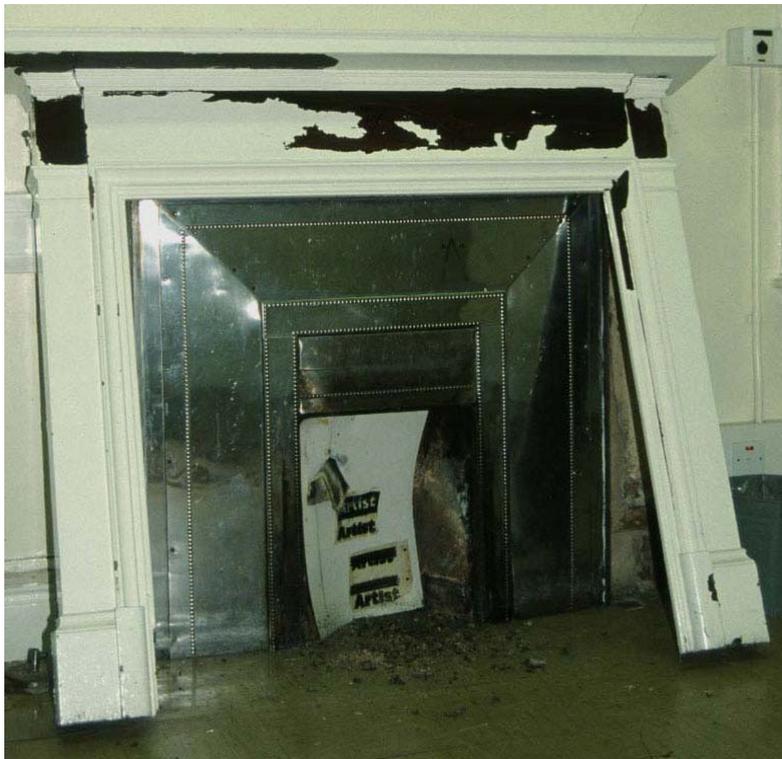
Plate 82: Fireplace in Room 35

At the west end of corridor 29 are three large bedrooms 35-37. All three contain small fireplaces with ornate surrounds, although the polished steel surround in Room 35 (Plate 82) is probably a later replacement. All also have moulded cornices, picture rails and skirting, although the cornicing is of a simpler design than that seen in the reception rooms downstairs.

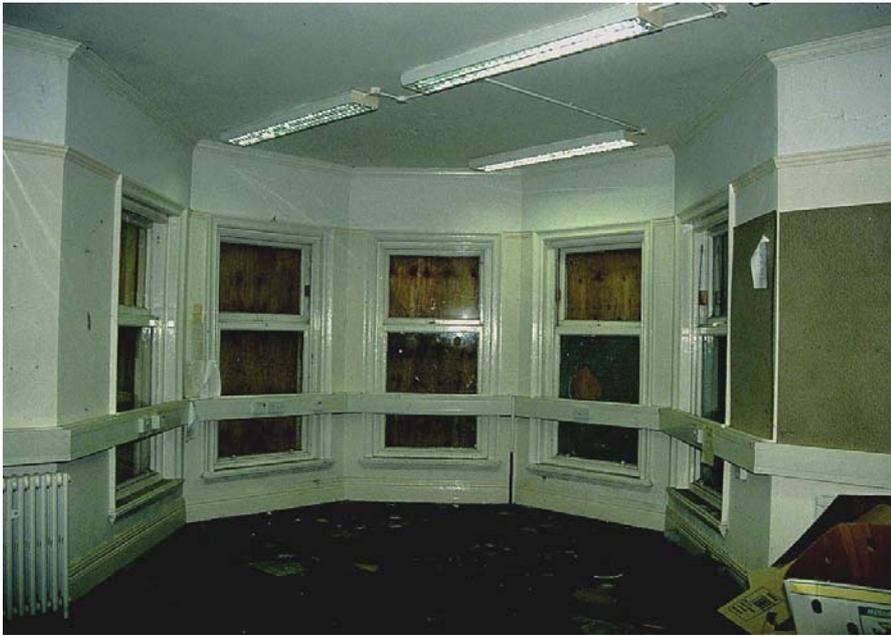
Plate 83: Bay window in south-west corner of Room 36

Room 36: Bedroom	
Fireplace	<p>Fireplace which has been blocked up, the lower half of which is obscured by demolition material. Timber chimney-piece with lower fireplace surround decorated with a band of reverse cyma and roll moulding, the horizontal line of which is stepped to accommodate a small panel. Mantel with reverse cyma and ovolo moulding supports two Ionic columns on square plinths, which in turn support a cornice with bands of reverse cyma moulding and dentil decoration. Rectangular mantel mirror in a frame of cyma moulding, flanked by two small shelves supported by block brackets with panels over.</p> <p>Edge of chimney breast has draw-stop chamfering with ovolo moulding.</p>
Cornicing	Relatively simple cyma and ovolo cornicing.
Skirting	Skirting with bands of ovolo, hollow and half-round mouldings along the top.
Picture rail	Picture rail with ovolo and cyma mouldings.
Window	<p>Large canted corner bay window consisting of five sash windows. Wooden frames with two panes each, and metal clasps with concentric circle decoration. Moulded surrounds and cills with bands of ovolo moulding on underside.</p> <p>Further sash of identical form in west.</p>

Ceiling	Plain.
Door	Doors with moulded doorframe, and modern firedoor.
Other	<p>Two air vents with metal Chinese fretwork covers in chimney breast over fireplace.</p> <p>Blind window in recess to north of fireplace has cill with ovolo mouldings on underside.</p>

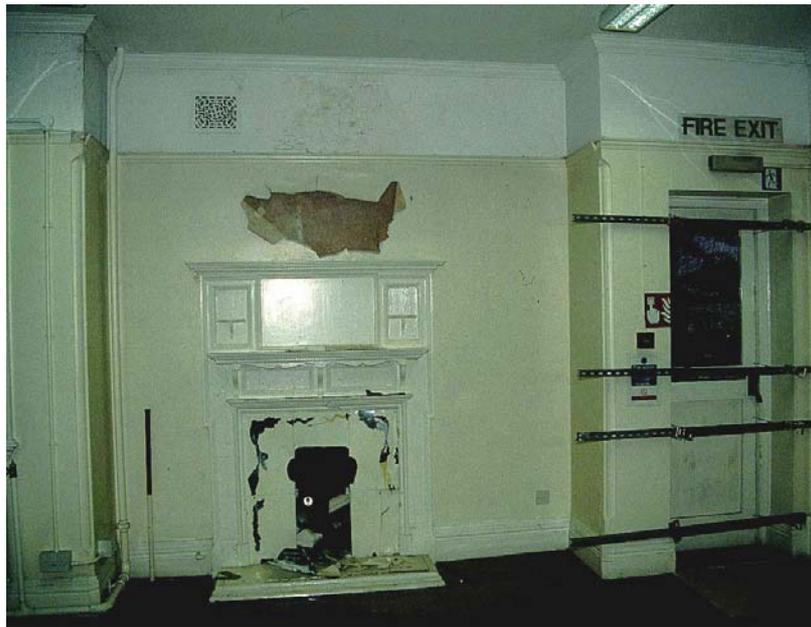
Plate 86: Room 37 from north

Room 37: Bedroom	
Fireplace	Fireplace with grate and canopy removed. Plain steel sheeting forming inner surround, framed by outer timber chimney piece the vertical sides of which are stepped. Inner surround framed by a band of double cyma moulding, with similar moulding around the whole of the outer edge of the chimney piece. Over the inner surround are two panels separated and flanked by three block brackets with fluted decoration. These support two pronounced cyma headed arches. The mantel has ovolo and cyma moulding above a band of dentil decoration. Above it is a large central panel which may originally have held a mirror, flanked by two smaller panels framed with ovolo and cyma moulding and each containing a small bracketed shelf. The cornice has double cyma moulding and a band of dentil decoration. Painted stone (?) hearth with timber hearth surround.
Cornicing	Cyma and ovolo moulded cornicing.

Skirting	Skirting with bands of ovolo, hollow and half-round mouldings along the top.
Picture rail	Picture rail with ovolo and cyma mouldings.
Window	Three sash windows. Wooden frames with two panes each, and metal clasps with concentric circle decoration. Moulded surrounds and cills with bands of ovolo moulding on soffit. Further sash of identical form in west.
Ceiling	Plain.
Door	Two doorways with moulded doorframes, and modern fire door. Doorway in south wall to fire escape. No surround, modern fire door.
Other	Air vents with metal Chinese fretwork cover in chimneybreast over fireplace. Blind window in west wall, has cill with ovolo mouldings on soffit. Edges of fireplace recess have draw-stop chamfering with ovolo moulding.

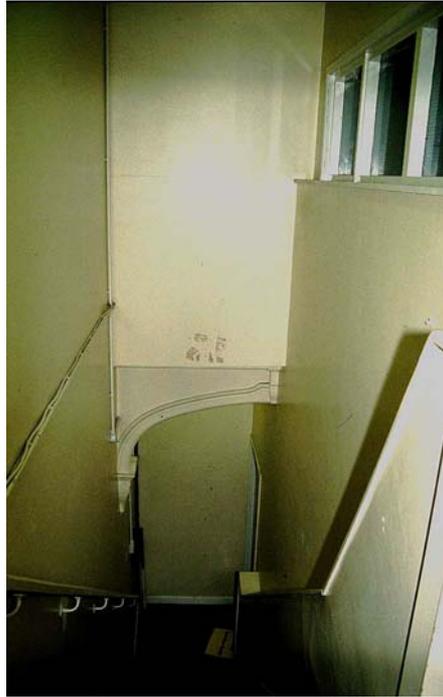
Plate 88: Staircase 38 looking west

Room 38: Staircase	
Fireplace	None.
Cornicing	Deep cornice of two bands of ovolo moulding with fillets as seen in Room 4b on south and east walls only.
Skirting	Skirting on south wall is moulded, with half round and ovolo moulding along the upper edge. Plain skirting on north wall, where staircase has been walled off.
Picture rail	Picture rail as in Room 4a, with upper bands of half roll and bead moulding. Only on southern wall.
Window	Corner bay window in south-east corner mirroring the decoration of the bay window in 4a. Window is formed of three bays, with a larger central bay having a lower cyma-headed pane of glass, with two 'tear-drop' shaped sections above, while the smaller, side bays have two rounded arched upper segments. All the upper panes of glass are leaded with patterns of arches and circles with stylised flowers, and contain coloured glass. Moulded surround, with cill of deep ovolo moulding.

Ceiling	Plain.
Door	Two doorways with plain doorframes, and modern firedoors.
Other	Other half of arch observed in 4a. The underside of the arch is plain, with both faces decorated with bead and ovolo mouldings. Terminates in an urn shaped corbel, heavily carved, including fluting and ribbing, a double cyma decoration and with a scrolled pediment.

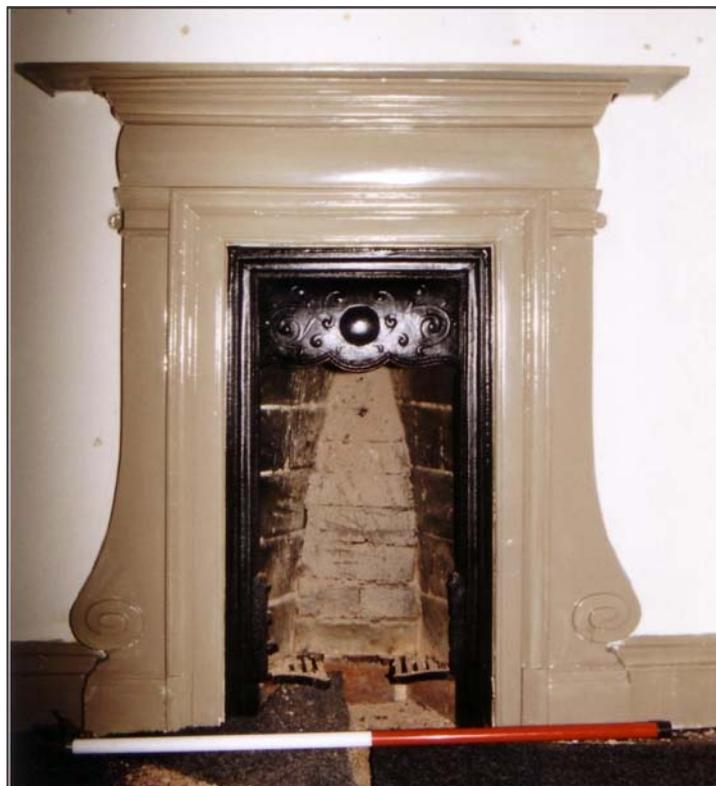
Plate 91: Fireplace in Room 39

At the east end of the corridor are two reasonably sized bedrooms (Rooms 39 and 40) both with small fireplace with art nouveau style surrounds (Plate 91). Both rooms have moulded skirting, but no cornices or picture rails, and are well lit with large casement windows.

Room 39: Bedroom	
Fireplace	Small fireplace with majority of grate removed, brick fire back and cheeks. Cast iron canopy with a scalloped edge, and decorated with a central boss surrounded by sinuous tendril design. Framed by bands of ovolo and cyma mouldings flanked by two pilasters which taper outwards towards their base to incorporate a scroll decoration, in a debased console form. Square plinths and capitals with ovolo and cyma moulding. Plain frieze, convex in profile, topped by a cornice with bands of ovolo and cyma mouldings. Simple mantel of cast iron. No hearth visible.
Cornicing	None.
Skirting	Skirting on south wall is moulded, with half round and ovolo moulding along the upper edge.
Picture rail	None.
Window	Large window with three fixed and three casement windows. Wooden frames with spiral clasps on bottom casements, and spiral clasp on upper casement. Moulded surround with plain cill.

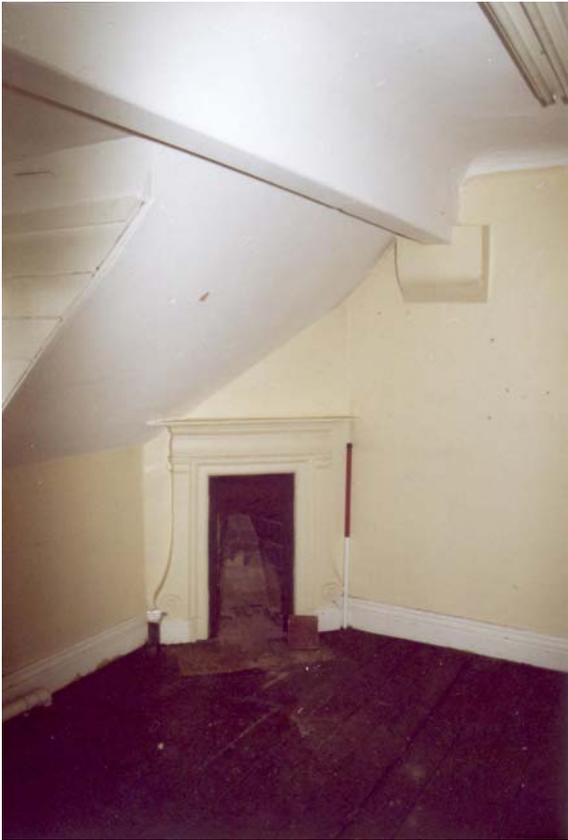
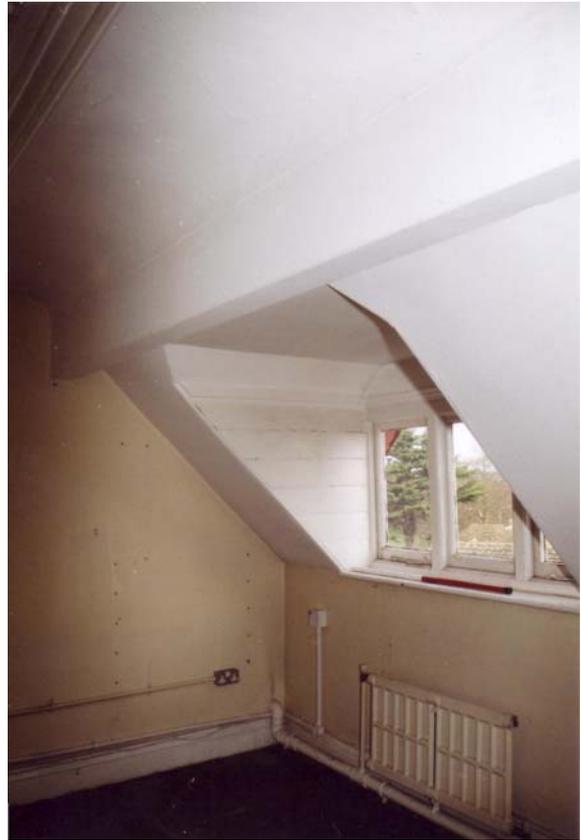
Plates 92 & 93: Room 40; fireplace and window

Room 40: Bedroom	
Fireplace	Small fireplace with majority of grate removed, brick fire back and cheeks. Cast iron canopy with a scalloped edge, and decorated with a central boss surrounded by sinuous tendril design. Framed by bands of ovolo and cyma mouldings flanked by two pilasters which taper outwards towards their base to incorporate a scroll decoration, in a debased console form. Square plinths and capitals with ovolo and cyma moulding. Plain frieze, convex in profile, topped by a cornice with bands of ovolo and cyma mouldings. Simple mantel of cast iron. Quarry tile hearth.
Cornicing	None.
Skirting	Skirting is moulded, with half round and ovolo moulding along the upper edge.
Picture rail	None.
Window	Dormer window of three lights, central one fixed, other two casements. Wooden frames with spiral metal clasps and bow-footed catches. Moulded band across top of window frames, plain cill.
Ceiling	Plain.

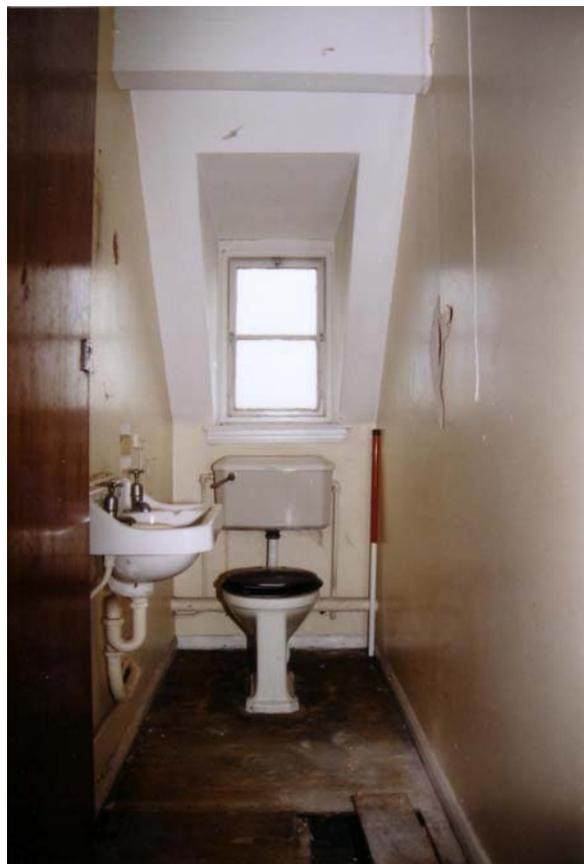
Plate 94: Room 41 from south

Room 41: Cloakroom	
Fireplace	None.
Cornicing	None.
Skirting	Plain skirting with no moulding.
Picture rail	None.
Window	Metal framed dormer window divided into two panes, centrally hinged for upper pane to open. Plain surround, cill with ovolo moulding on underside.
Ceiling	Plain.
Door	Doorway with moulded frame and modern fire door.
Other	Ceramic toilet and basin of early 20 th century date.

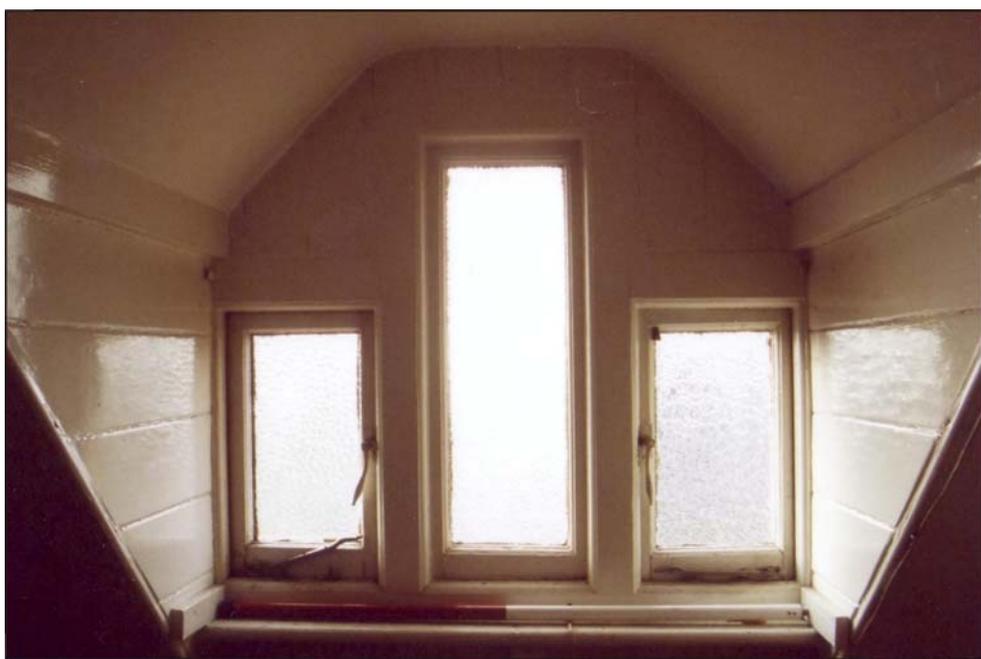
Plate 97: Window on second floor land 43a

Room 43a: Landing	
Fireplace	None.
Cornicing	None.
Skirting	Skirting is moulded, with half round and ovolo moulding along the upper edge.
Picture rail	None.
Window	Three windows in south wall. Two casements either side of a taller fixed window. Wooden frames with plain glass, coiled clasps and bow-footed catches. Surround of a single band of ovolo moulding, plain cill.
Ceiling	Plain.
Door	Two doorways with plain doorframes, and modern firedoors. One leading to fire escape.
Other	Splat banisters around landing, similarly pierced to those on staircase. Turned newel posts as seen at base of stairs.

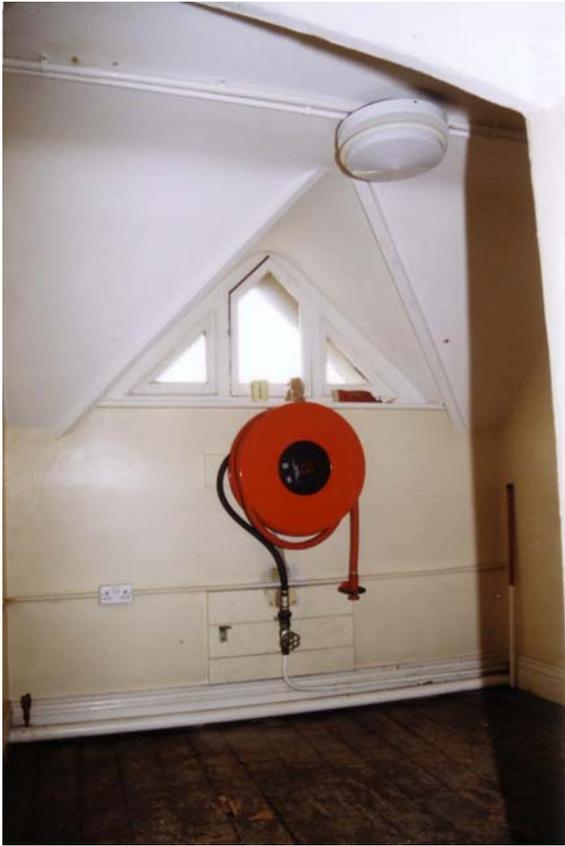
Plate 100: Triangular dormer in corridor 43b

Room 43b: Corridor	
Fireplace	None.
Cornicing	None.
Skirting	Skirting is moulded, with half round and ovolo moulding along the upper edge.
Picture rail	None.
Window	<p>Triangular dormer window of three lights in north wall. Central casement has pointed head, and plain metal clasp. Triangular fixed lights to either side. Simple surround of single band of ovolo moulding, plain cill.</p> <p>Window in east wall of south-western section of corridor. Two lights, one fixed, one casement. Plain wooden frames with modern metal clasp. Simple surround of single band of ovolo moulding, plain cill.</p>
Ceiling	Plain.
Door	Doorways with moulded frames, all with modern fire doors.
Other	Set of fixed wooden 'ladder' steps leading to window in east wall.

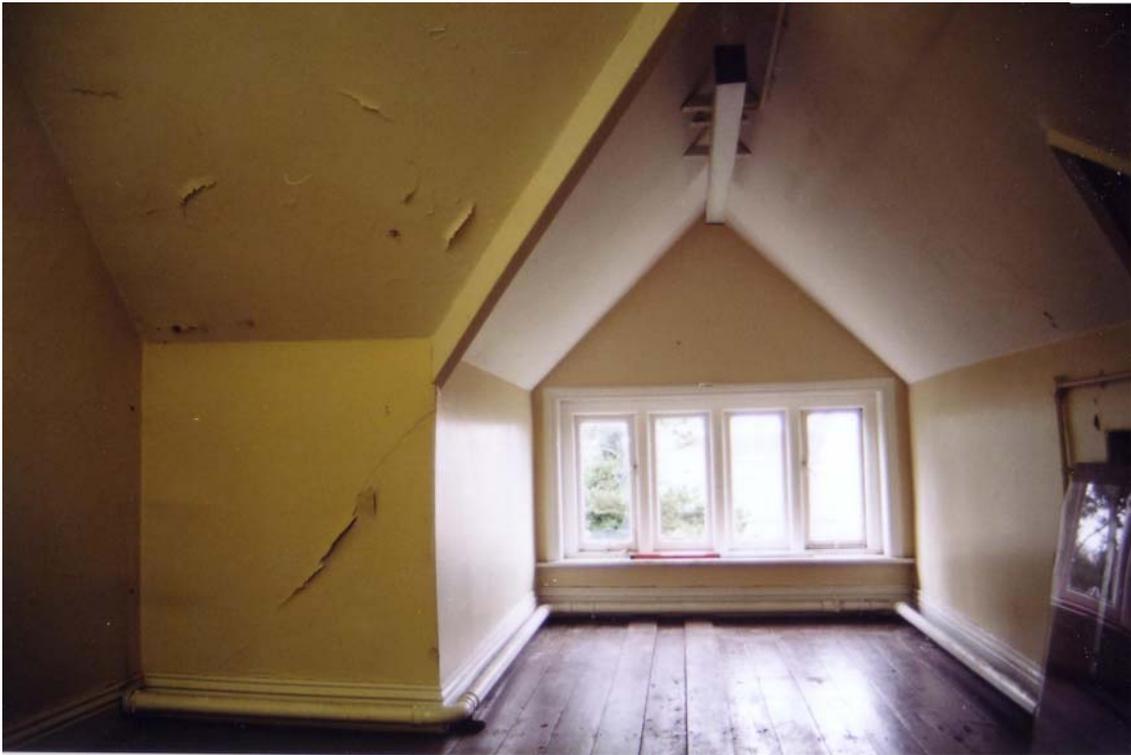
Plate 103: Room 44 looking west

Room 44	
Fireplace	Small fireplace with opening bricked up and canopy removed. Opening framed by bands of ovolo and cyma mouldings flanked by two pilasters that taper outwards towards their base to incorporate a scroll decoration, in a debased console form. Square plinths and capitals with ovolo and cyma moulding. Plain frieze, convex in profile, topped by a cornice with bands of ovolo and cyma mouldings. No mantel. No hearth visible.
Cornicing	None.
Skirting	Skirting is moulded, with half round and ovolo moulding along the upper edge.
Picture rail	None.
Window	Set of four windows in west wall consisting of two fixed and two casements. Wooden frames with plain glass, spiral metal clasps and plain catches with butterfly-headed screw locks. Moulded surround with plain cill.
Ceiling	Plain.
Door	Doorway with moulded frame and modern fire door.
Other	Recess for fireplace has a triangular arch head, edged at the front with a plain fillet.

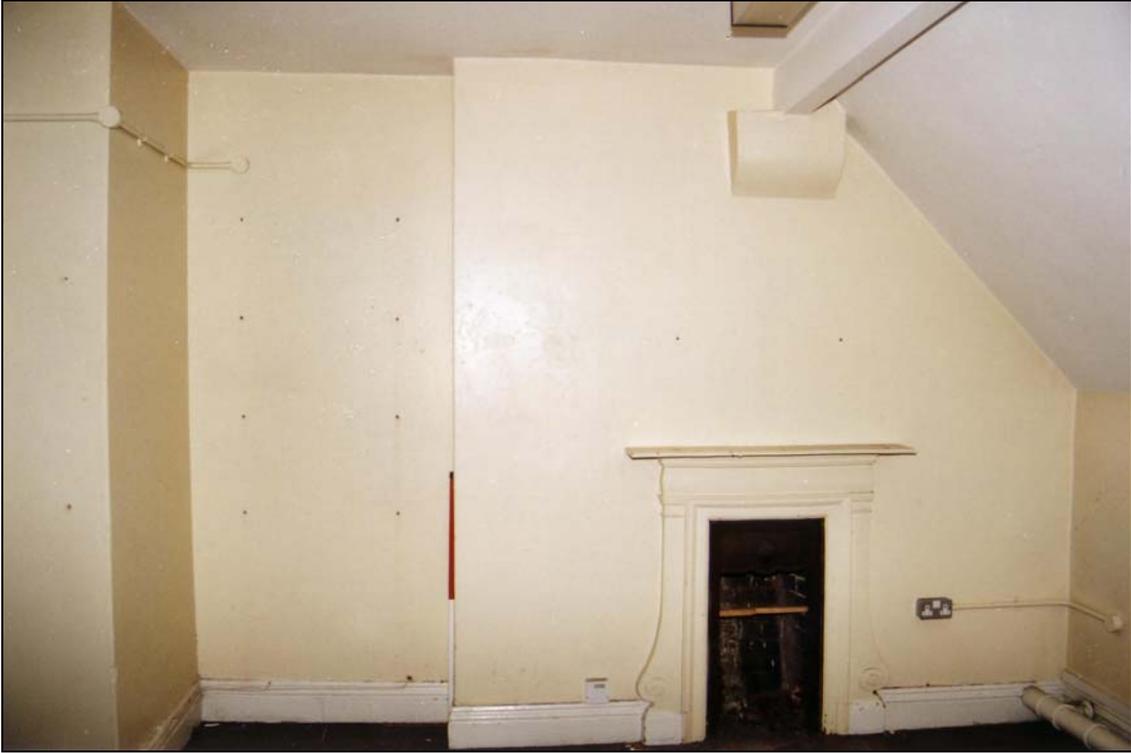
Plate 105: Room 45 looking east

Room 45	
Fireplace	Small fireplace with majority of grate removed, brick fire back and cheeks. Cast iron canopy with a scalloped edge, and decorated with a central boss surrounded by sinuous tendril design. Framed by bands of ovolo and cyma mouldings flanked by two pilasters which taper outwards towards their base to incorporate a scroll decoration, in a debased console form. Square plinths and capitals with ovolo and cyma moulding. Plain frieze, convex in profile, topped by a cornice with bands of ovolo and cyma mouldings. Simple mantel of cast iron. Quarry tile hearth.
Cornicing	None.
Skirting	Skirting is moulded, with half round and ovolo moulding along the upper edge.
Picture rail	None.
Window	Dormer set of three windows in west wall, consisting of one fixed and two casements. Wooden frames with plain glass, coiled metal clasp on left casement and spiral clasp on right. Metal catches with flat spiral decoration. Moulded surround with plain cill.

Ceiling	Plain.
Door	Doorway with moulded frame and modern fire door.
Other

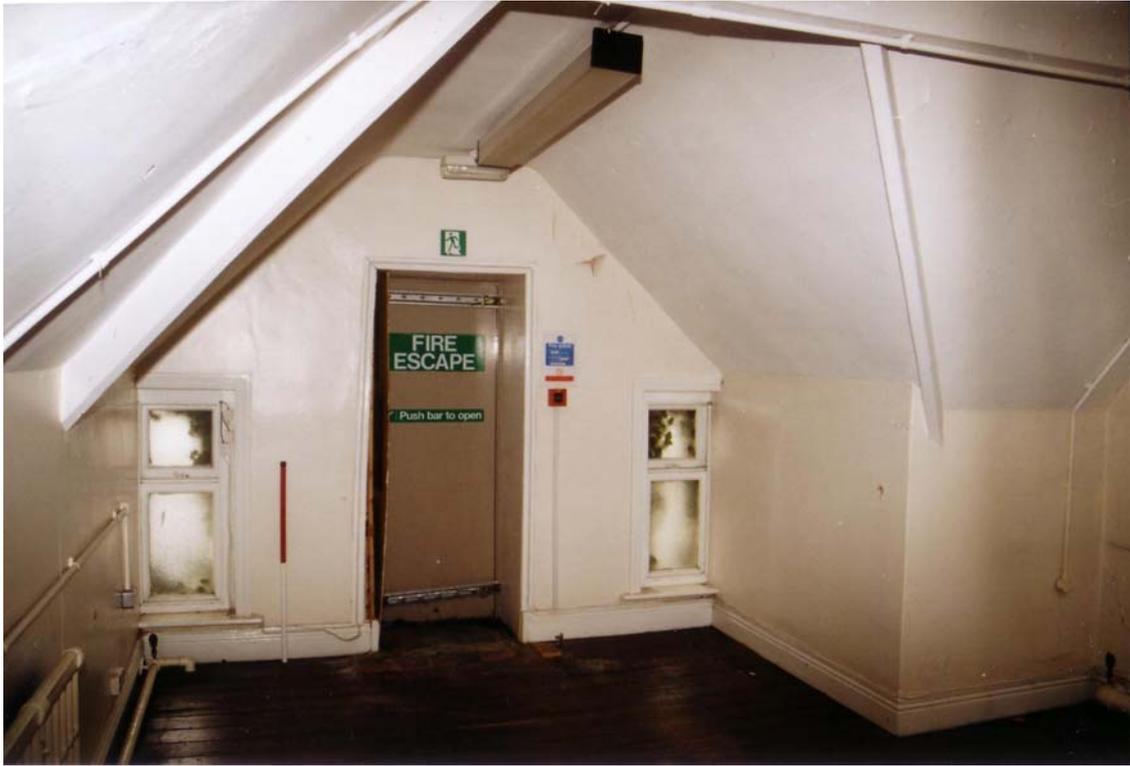
Plate 107: Room 46 looking south

Room 46	
Fireplace	None.
Cornicing	None.
Skirting	Skirting is moulded, with half round and ovolo moulding along the upper edge.
Picture rail	None.
Window	Two sash windows at low level in south wall. Wooden frames with plain glass in upper panes and frosted glass in lower panes. Metal clasps with concentric circle decoration. Moulded surrounds with plain cills.
Ceiling	Plain.
Door	Two doorways with plain doorframes, and modern firedoors. One leading to fire escape.
Other

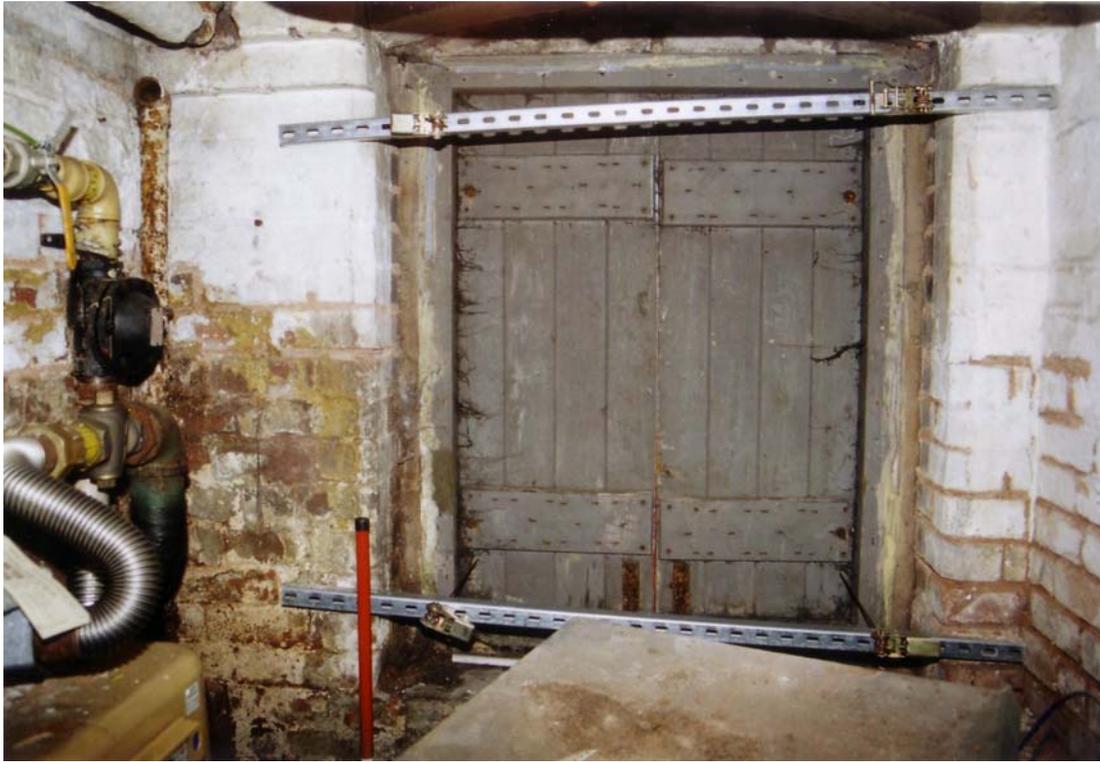
Immediately to the right (west) of the entrance, Room 50 contains a small opening in the north wall, which has wooden doors. This appears to have been a small hatch (Plate 109).

Plate 109: Room 50 looking north showing hatch

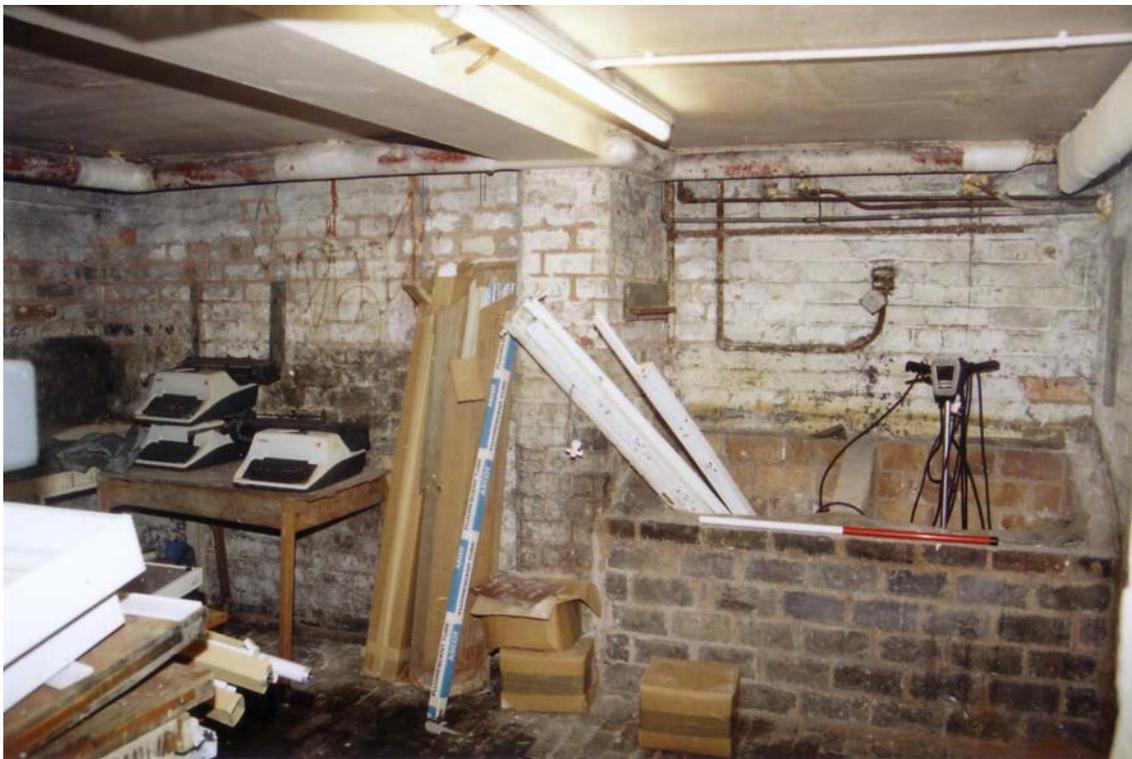
To the left (east) of the entrance are a series of three rooms, 46, 47 and 48. Room 48 has cellar light in the north wall which has been blocked by the later extension. It also contains two brick built ‘tubs’ (Plate 110) in the south–east corner of the room. Rooms 47 and 48 are both plain rooms with no external light or remaining features.

Plate 110: Room 47 looking east, showing brick 'tubs'

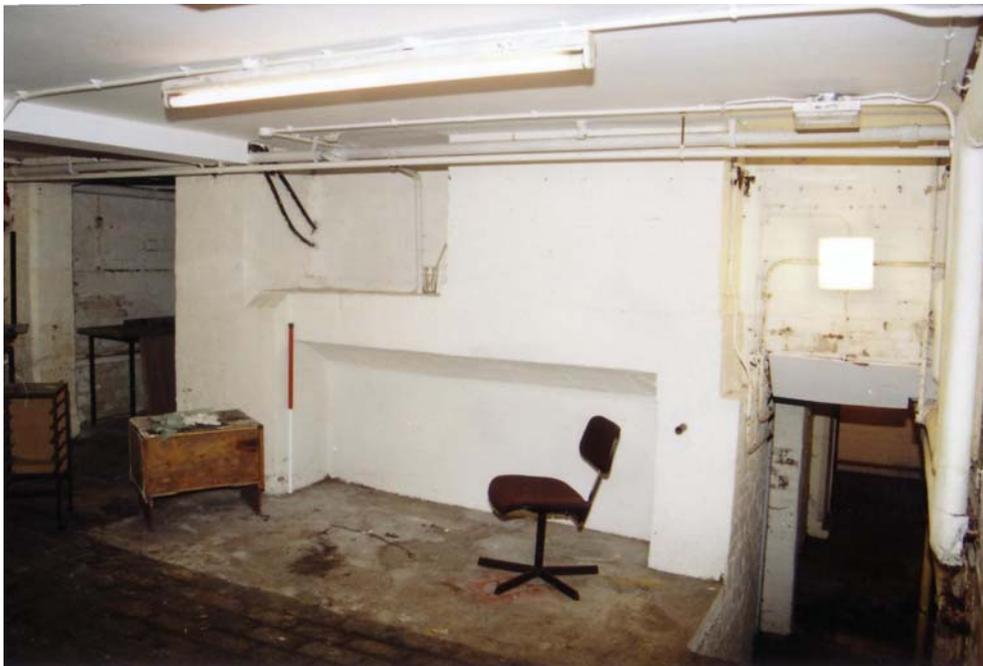
Plate 112: Room 51 looking west

These three rooms are all accessed from Room 51, an open room into which the entrance leads (Plate 112). This has a large recess in the west wall, with a second recess above it. At the south–west corner of the room is a narrow room with an arched recess at the end, and a sloping ceiling indicating where a second staircase accessed the cellars from inside the house (Plate 113).
