**Westhill Centre,
107 Hagley Road,
Stourbridge**

**Report on archaeological building recording and an
ornamental audit**

May 2004

Marches Archaeology Series 342

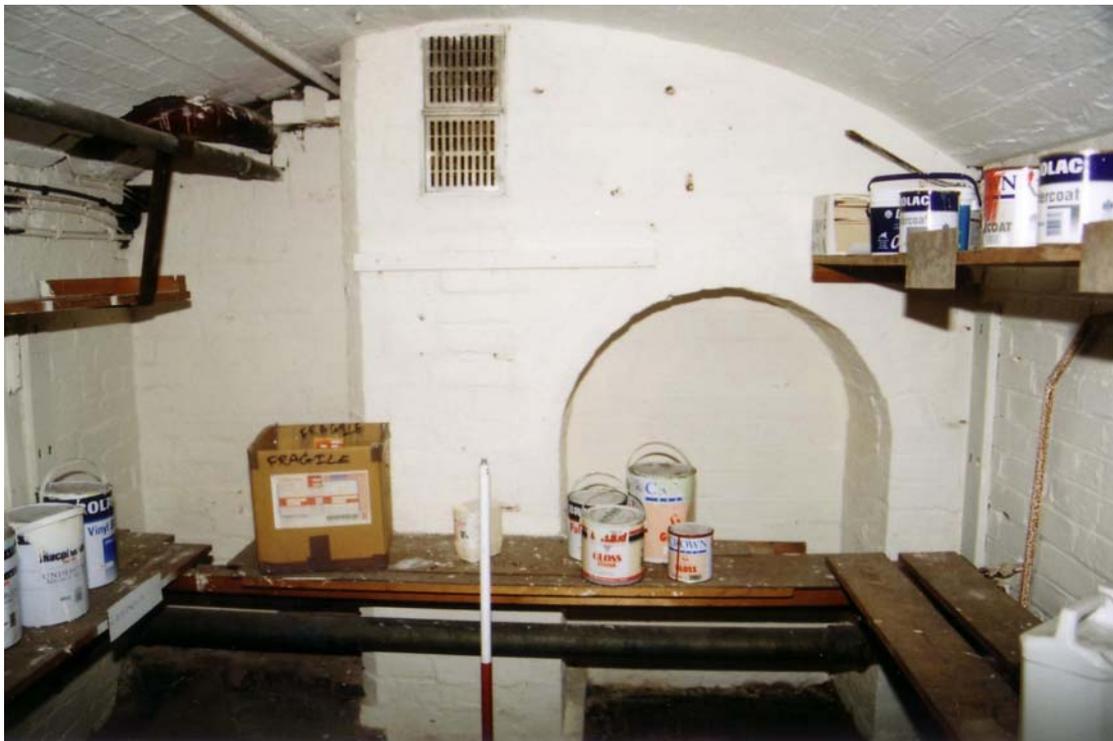
Plate 114: Room 53 looking west.

Steps lead from the north–west corner of Room 51 into corridor 54, a doglegged, barrel-vaulted corridor running generally east–west. Room 53 of the south side of this corridor at its east end is a small barrel vaulted room, with no natural light. There is a small arched recess in the west wall (Plate 114). When constructed this room would have been open to the corridor, with two pillars supporting the north side of the ceiling. The spaces between these pillars were blocked up at a later date.

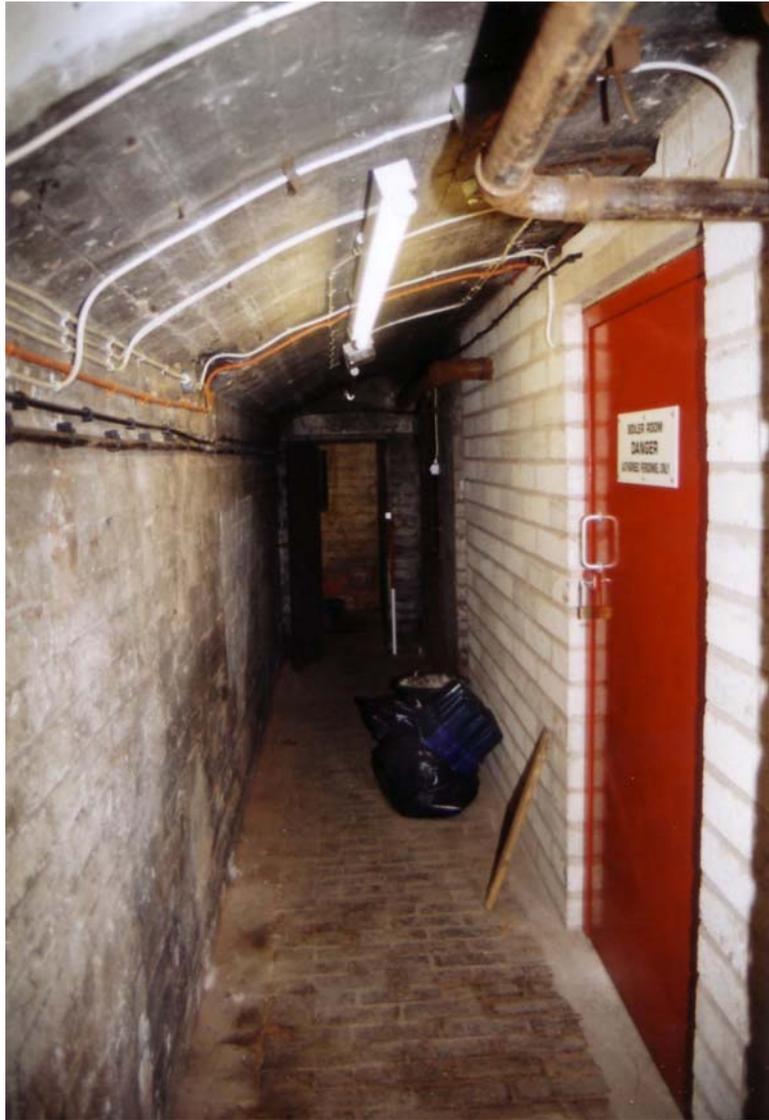
Plate 115: West end of corridor 53 looking west.

Opposite this room, on the north side of the corridor is a light well, covered with an iron grating. West of the dog-leg, the corridor probably opened out into a larger room, but a breeze-block wall has recently created a boiler room on the north side of the corridor which was not accessible (Plate 115).

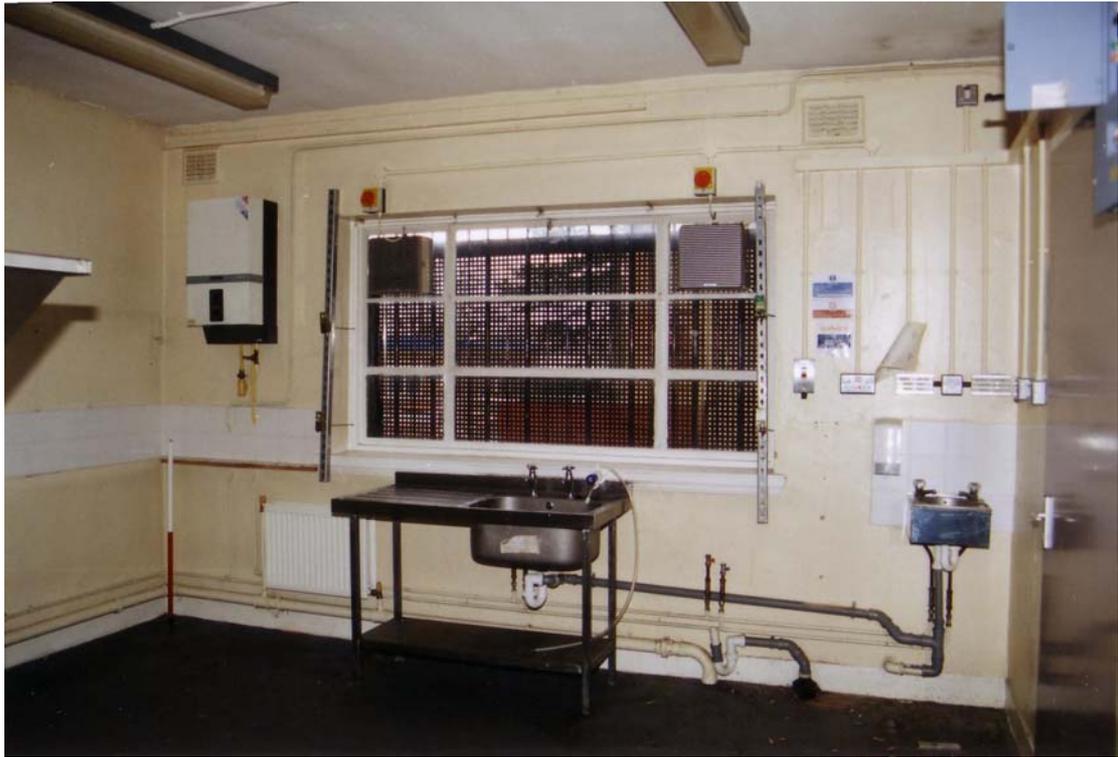
Plate 116: Room 57

Room 56 can be seen from the remaining fittings to have functioned as a kitchen, with tiling on the walls, and some stainless steel fittings remaining (Plate 116). There is a large metal framed window of nine panes in the west wall, and to the east an open archway accesses a servery area with a shuttered serving hatch in the east wall (Plate 117).

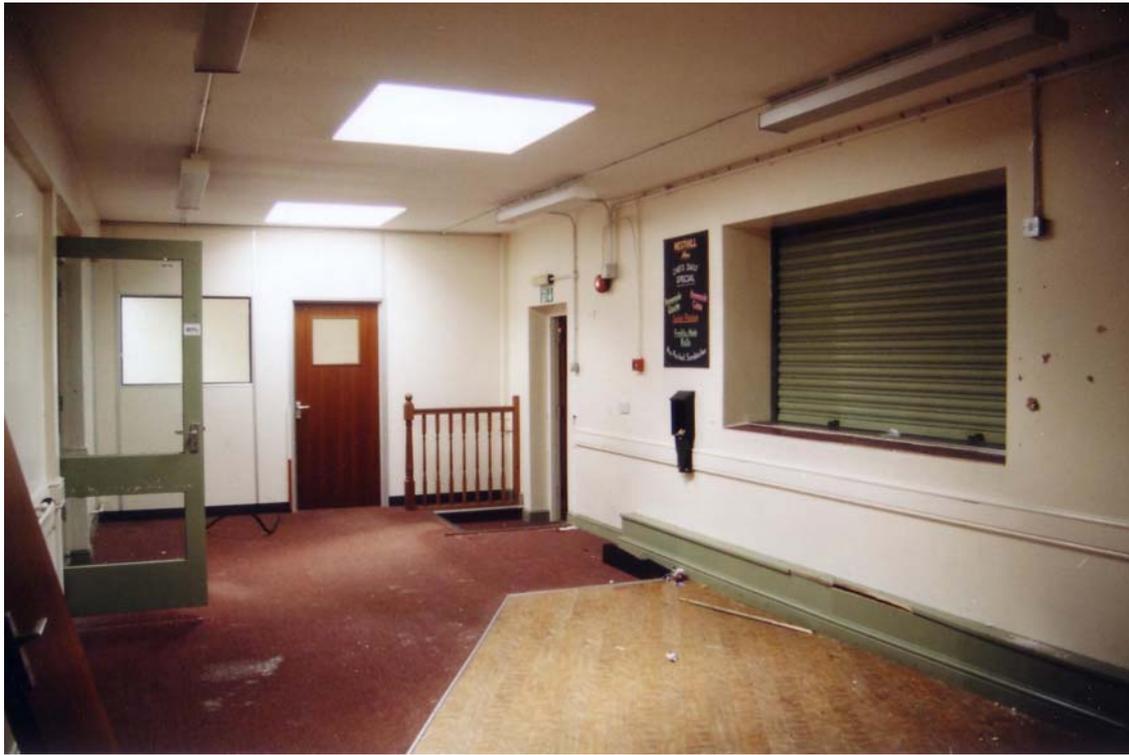
Plate 118: Room 58

The eastern extension consists of 10 new rooms (see Figure 2) .A corridor (57) led into a large central area (58) around which the rooms were arranged (Plate 118). This has moulded skirting and a dado rail.

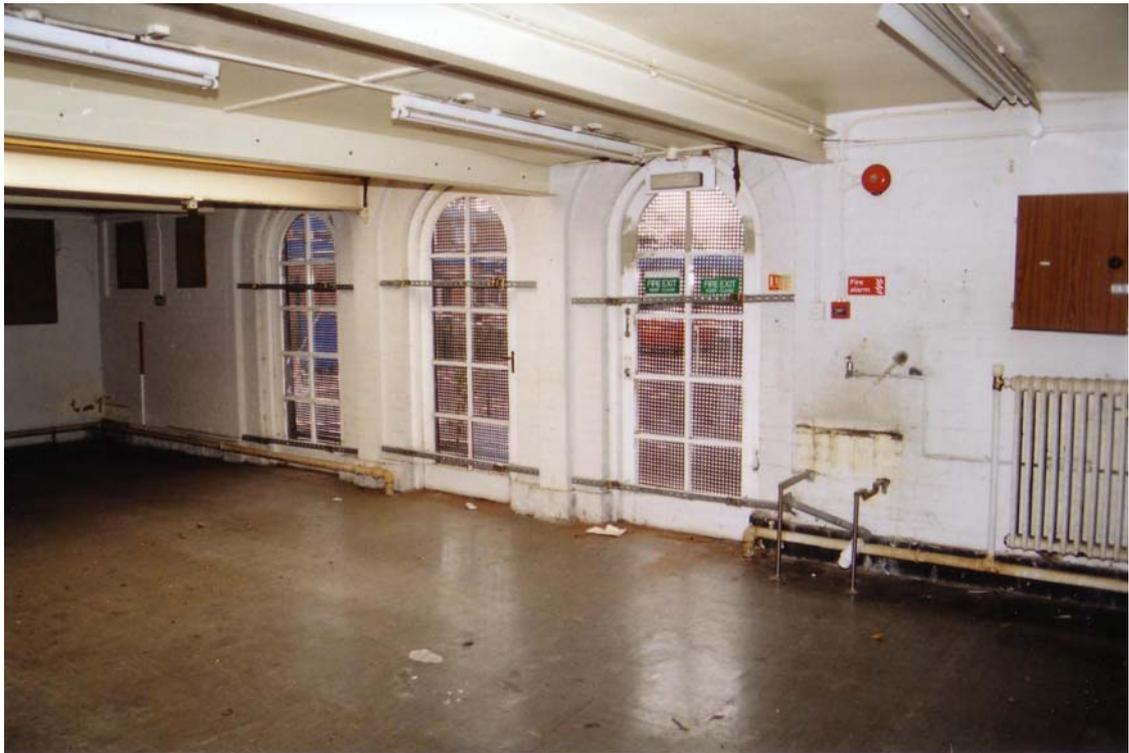
Plate 119: Room 59

To the south of the kitchen, Room 59 has unplastered, painted brick walls with plain skirting. In the west wall are three round-headed, metal framed windows which extend to ceiling height (Plate 119). There is a 4th window, now blocked, in the east wall.

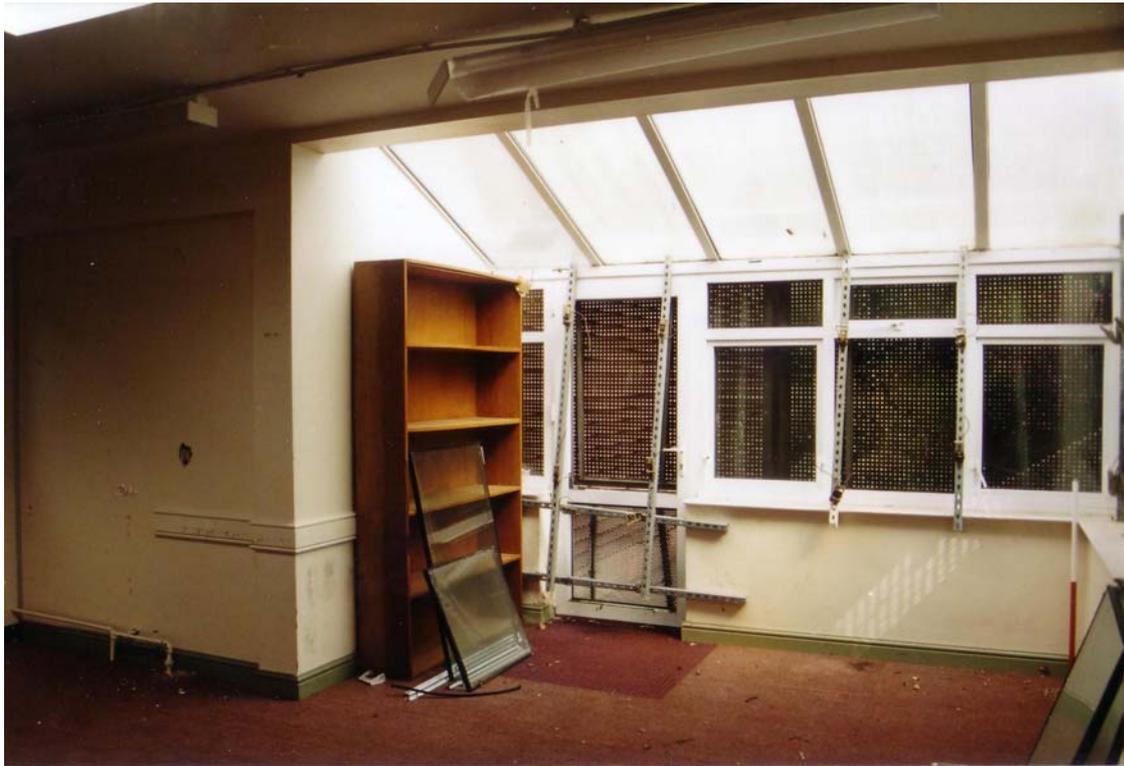
Plate 120: Room 60

Room 60 appears to have been constructed as one large room with Room 58, the dividing wall being a very thin partition wall, and the applied mouldings seen in Room 58 extend into this room. In the south-east corner is a very modern uPVC lean-to (Plate 120).

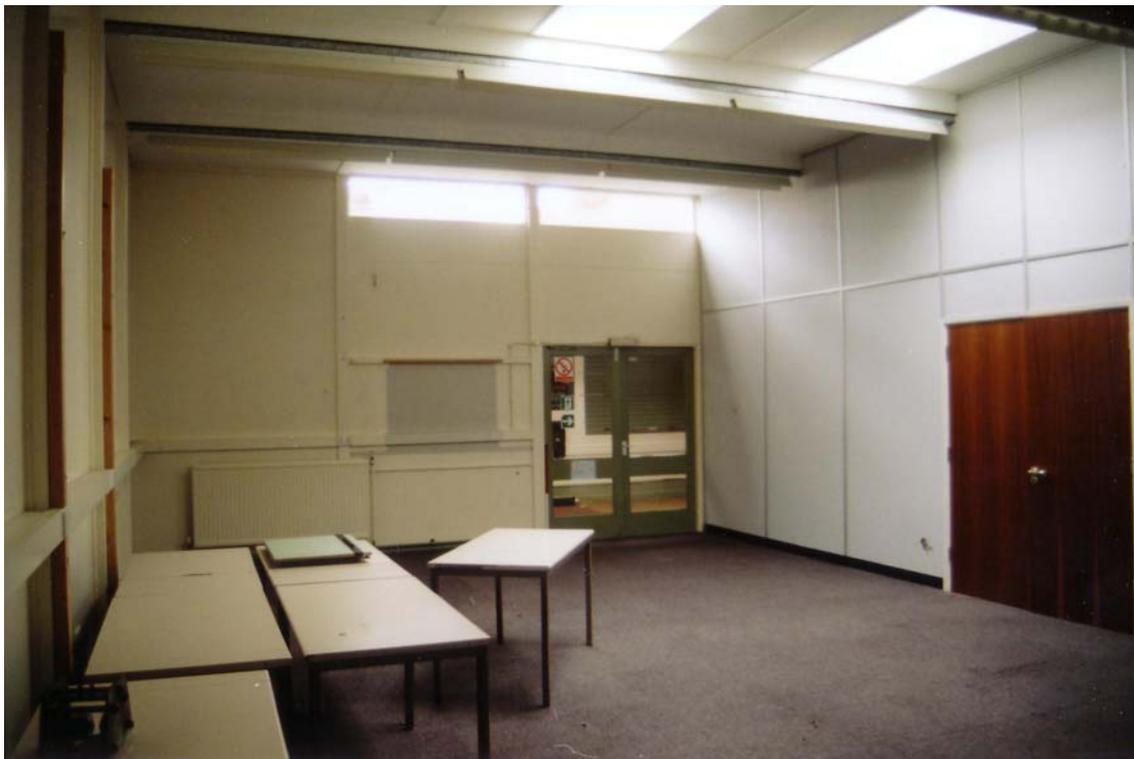
Plate 121: Room 61

Rooms 61 and 62 were also constructed as one room, with a very thin partition wall now dividing them (Plates 121 & 122). They both have large windows in the north walls that are wooden framed with 8 lights each. Room 61 is also lit by skylights. The walls are plastered with plain skirting, and have no further architectural details.

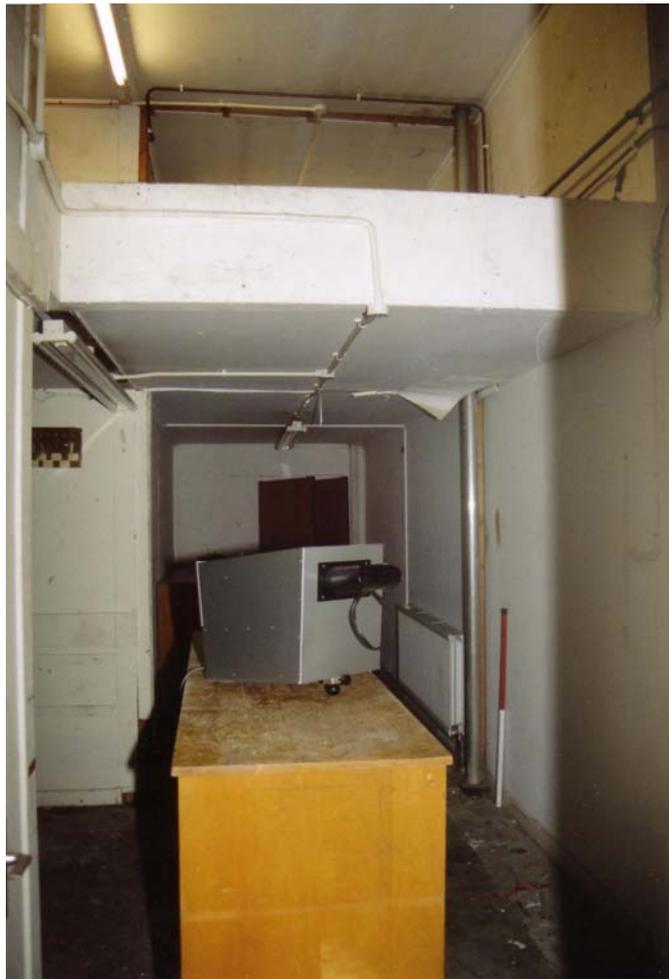
Plate 123: Room 63

Room 64 is a small passage containing a large cupboard, and giving access to Rooms 63 and 65. Room 63 to the east is a small room, with a mezzanine floor, to which there is no apparent access (Plate 123). Room 65, however, is a large hall lit by eight large skylights (Plate 124).

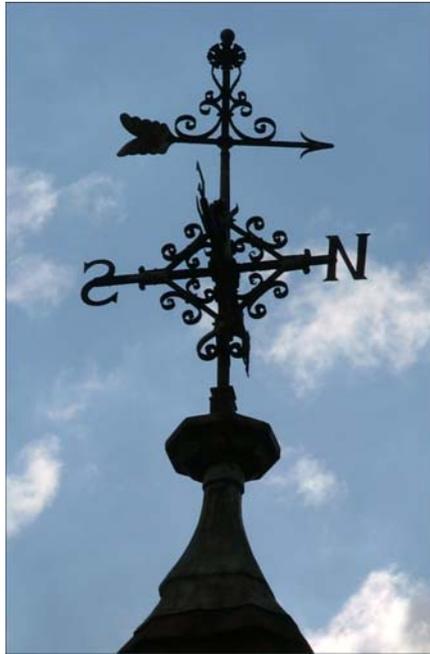
Plate 129: Weather vane on folly

Folly	
Walls	Red brick in English Garden bond.
Roof	Facetted broach spire roof, octagonal in plan. Red tile. Topped with ornamental wrought iron weather-vane.
Window	Blocked window at ground floor level. Segmental headed arch and yellow tile cill. Bricked up at a later date with stretcher bond. Two narrow, bricked up windows on first floor.
Door	Doorway with plain wooden plank frame, wooden door with vents.
Chimney	Plain brick stack.
String-course	Moulded string course at first floor level in terracotta..
Plinth	Narrow plinth at base of wall with simple moulding forming upper edge.
Other	Cast iron steps with plain handrail leading up to door.

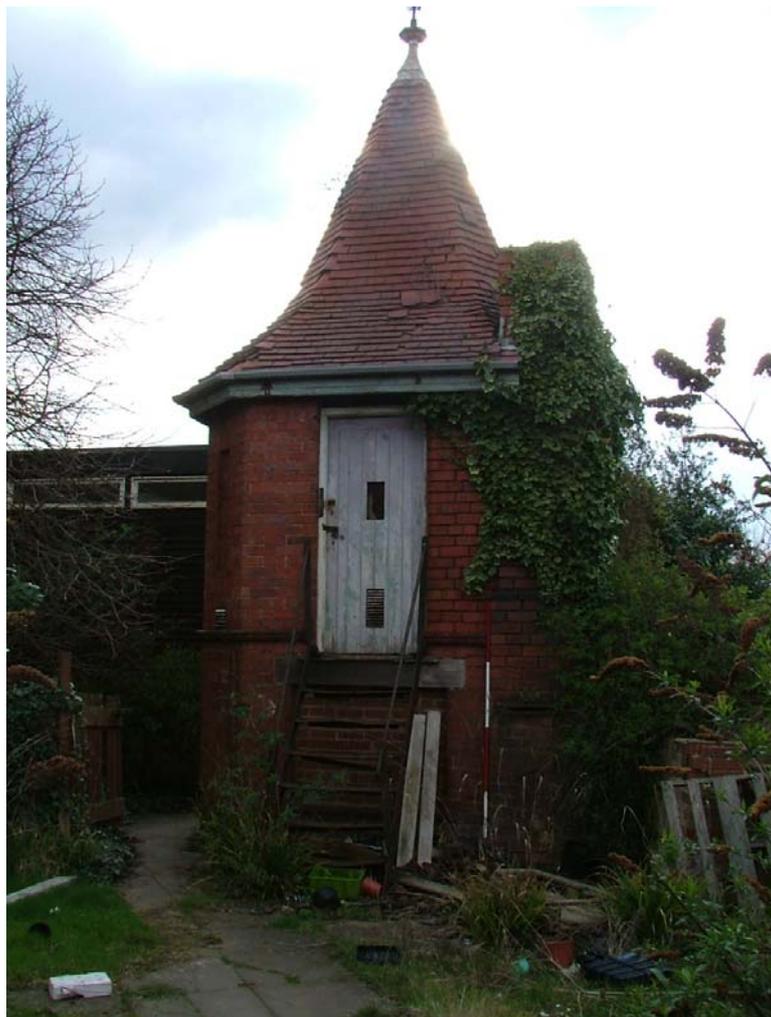
Plate 130: Folly from east

The folly, constructed to the north – east of the house is also of Phase I date. Access to this structure was not possible, and the inside was not inspected, and there was thick vegetative growth around much of the west and north sides. This is an octagonal, two-storey structure with a angled, steeple roof, topped by an ornate wrought iron weather-vane (Plates 129 & 130). Access is through a first floor door, reached by a set of iron steps, and on this floor there appear to be a number of narrow slit, windows blocked at a later date. On the ground floor, there is at least one larger opening, headed by a segmental arch, which has also been blocked. A chimneystack is visible on the north elevation, indicating the presence of fireplaces inside.

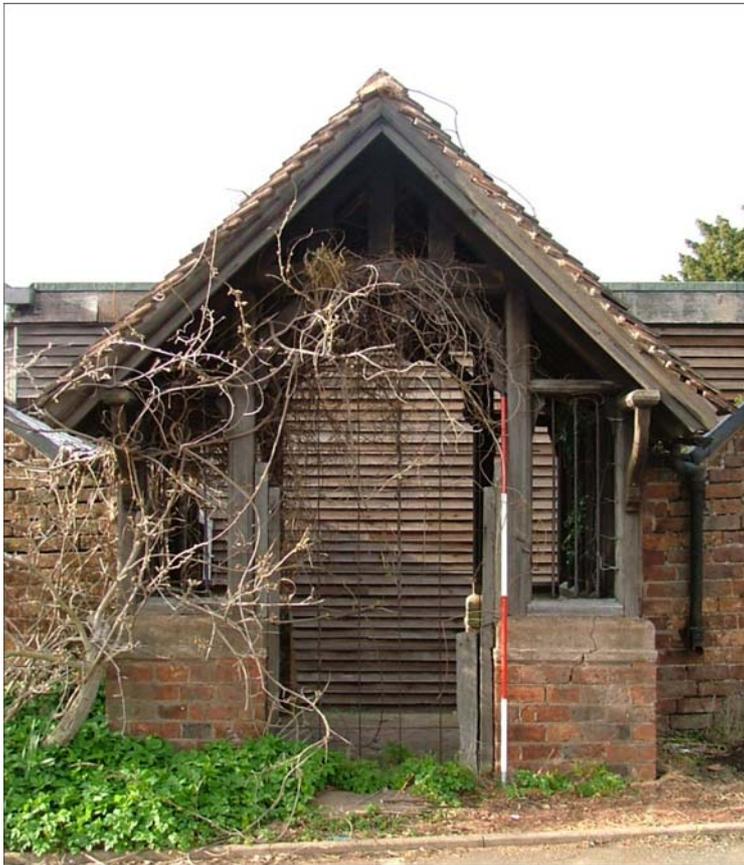
Plate 131: Lych gate from south

The lych gate is probably also of this date, with the brickwork of the low wall matching that of the house. The gate is a timber-framed structure, with a tiled roof (Plates 131 & 132). It accesses the garden from the south, and running east and then north from this is a wrought iron fence, which is probably also Phase I.

Lych gate	
Walls	Open timber framing on a low brick wall..
Roof	Red tile roof with straight edged tiles. Plain ridge tiles. Decorative timber barge boards over gables, with bands of moulding including billet decoration.
Door	Two opposite entrances formed by timber uprights and tie-beam, with decorative arch-braces
Plinth	Stepped plinth at base of wall.
Other	Open brackets extending from each corner post to 'wall-plate' which extends beyond the length of the rest of the structure.
