Detached kitchen at The Parsonage Kyre Worcestershire

**A report on an archaeological
watching brief**

May 2005

Marches Archaeology Series 380

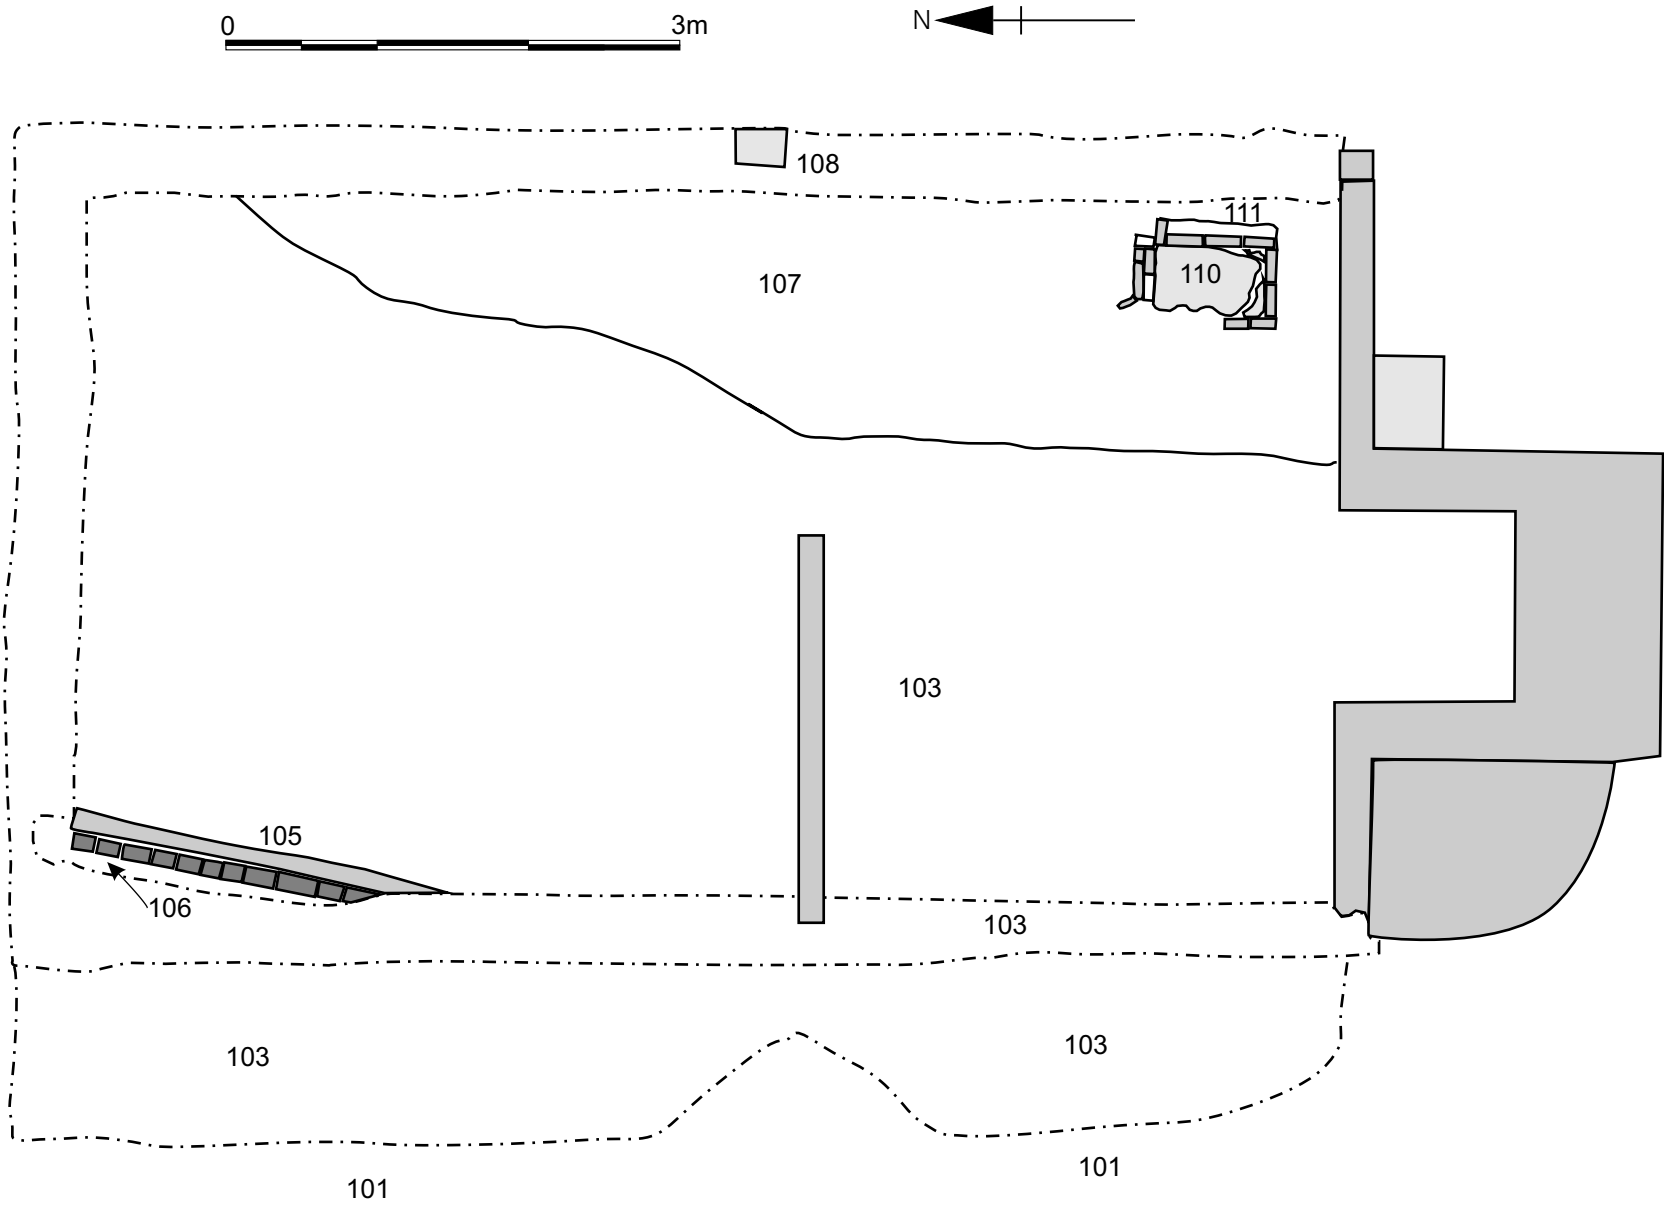
Fig. 1 Plan of the area of the watching brief

A series of mixed dumps of dark brown silty clay [107] with frequent mortar, plaster, brick, tile and charcoal covered the eastern part of the building (Fig. 1). These were excavated by machine and were treated as a single deposit though it was recognised that there were many dumps within the material.

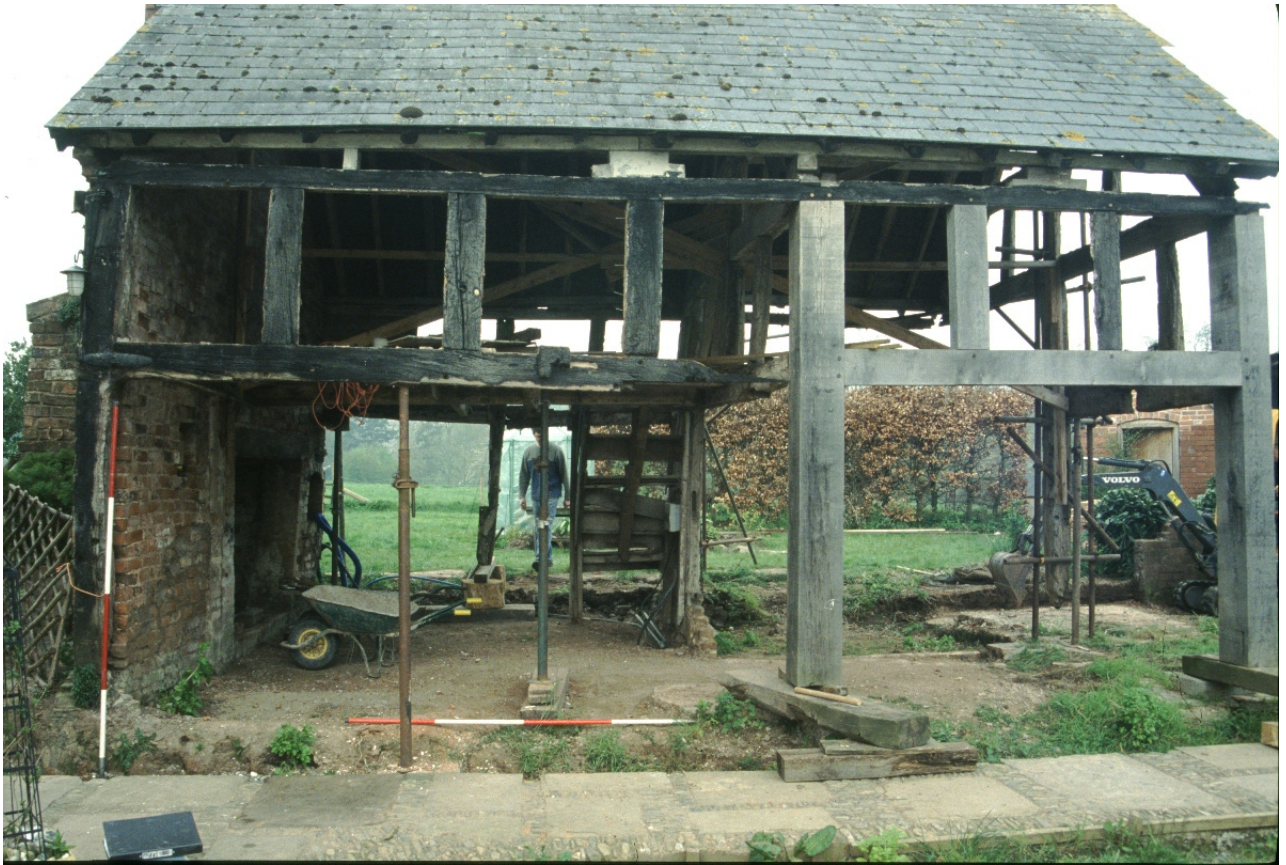
Plate 1 Kitchen looking west

A brick lean-to at the north of the kitchen had been removed prior to the watching brief, along with much of the west, north and east walls of the kitchen (Plates 1 and 2). New footings were excavated to a depth of 600mm along the east and west sides of the existing building and extended northwards to form footings of similar depth for a new extension on the footprint of the lean-to. The internal ground surface of the kitchen was also reduced by up to 250mm using a mini digger.

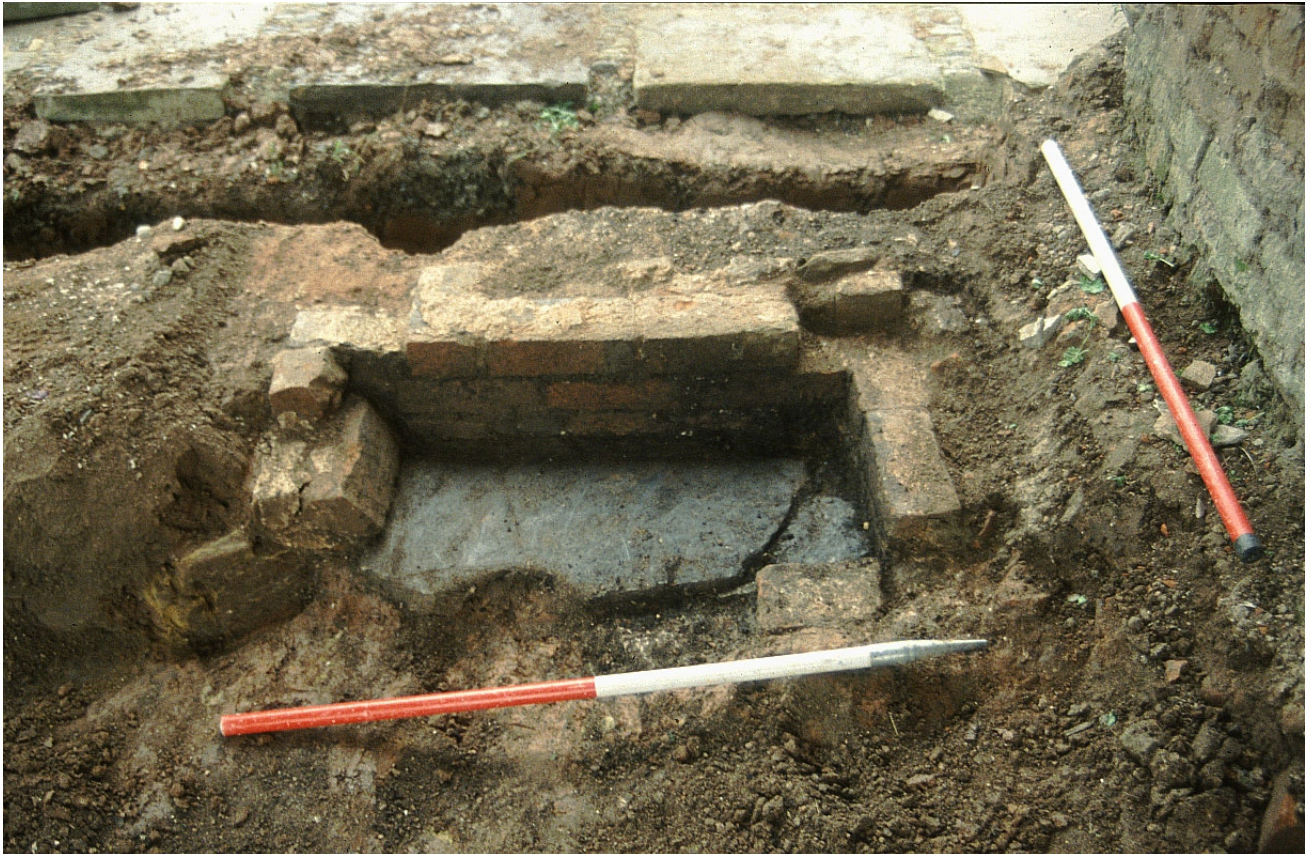
Plate 3 **Hearth 110**

Close to the south-east corner of the kitchen was an internal hearth [110] consisting of a stone base, with brick sides, dug into the natural subsoil and probably cutting through [107] (Plate 3). Only the bottom three courses survive, sufficient to indicate a construction date in the early 19th century. Within the hearth was fire debris [109].

The hearth [110] is an unexpected discovery. It lies within two metres of the fireplace which represents the principal purpose of the kitchen. The standing building provides no clear evidence to identify where the flue for this hearth was. The possibility that it had some industrial function (e.g. forge) cannot be ruled out but nor was any evidence present to support such an interpretation. The bricks are of typical early 19th century size and form which indicates the date of this hearth.

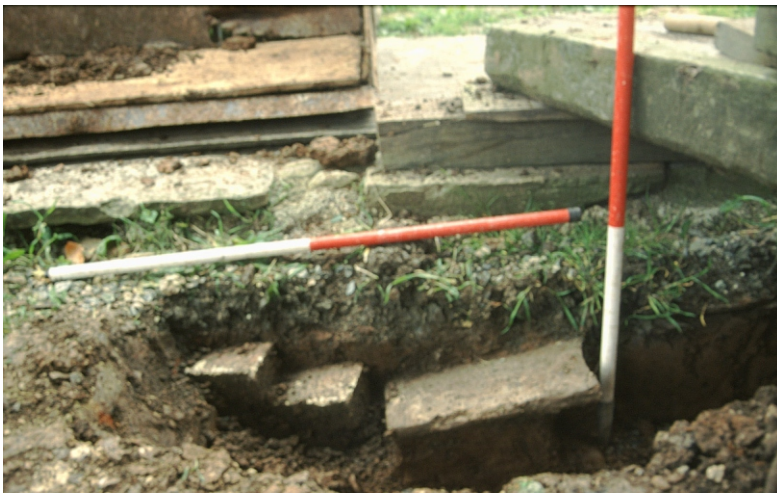
Plate 4 **Sandstone slab108**

At the east was a sandstone slab [108] which may be structural but its purpose is unclear (Plate 4). Adjacent to it were two concrete slabs. Slightly further east a path was dug by Mr Beavan and further slabs were apparently found so this may be part of a path running east-west.

No deposits demonstrably earlier than the late 18th century were encountered. This suggests that during the 19th century works were carried out which removed any earlier remains, such as former floor levels. The sandstone slab [108] could be earlier, but there is certainly no reason to suspect that it pre-dated the kitchen.

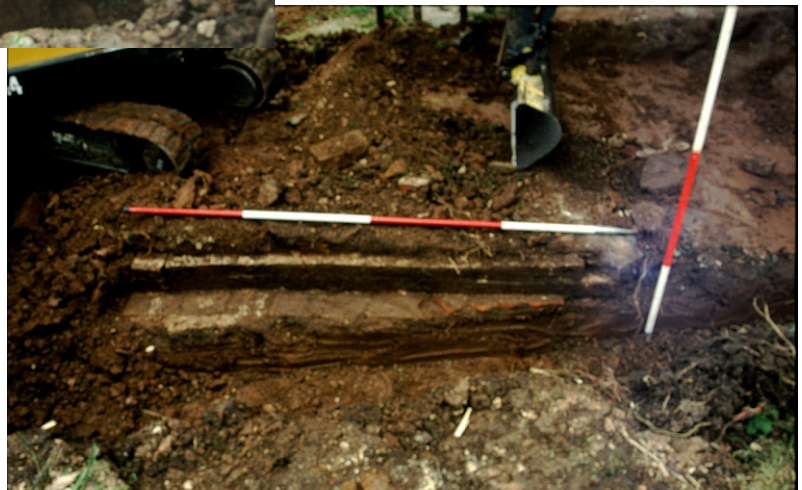
Plate 5 **Drain 105**

At the north-west of the area observed was a brick-lined drain [105], oriented north-north-east, cutting through the natural clays (Plate 5). The soil below this was a silty clay [106] which was presumably trample derived from the construction of the drain and formed bedding for it. The drain was cut through by the brick footings [104] of the north wall of the lean-to.
