The Church of St James Stirchley Shropshire

Report on an archaeological building assessment

June 2005

Marches Archaeology Series 387

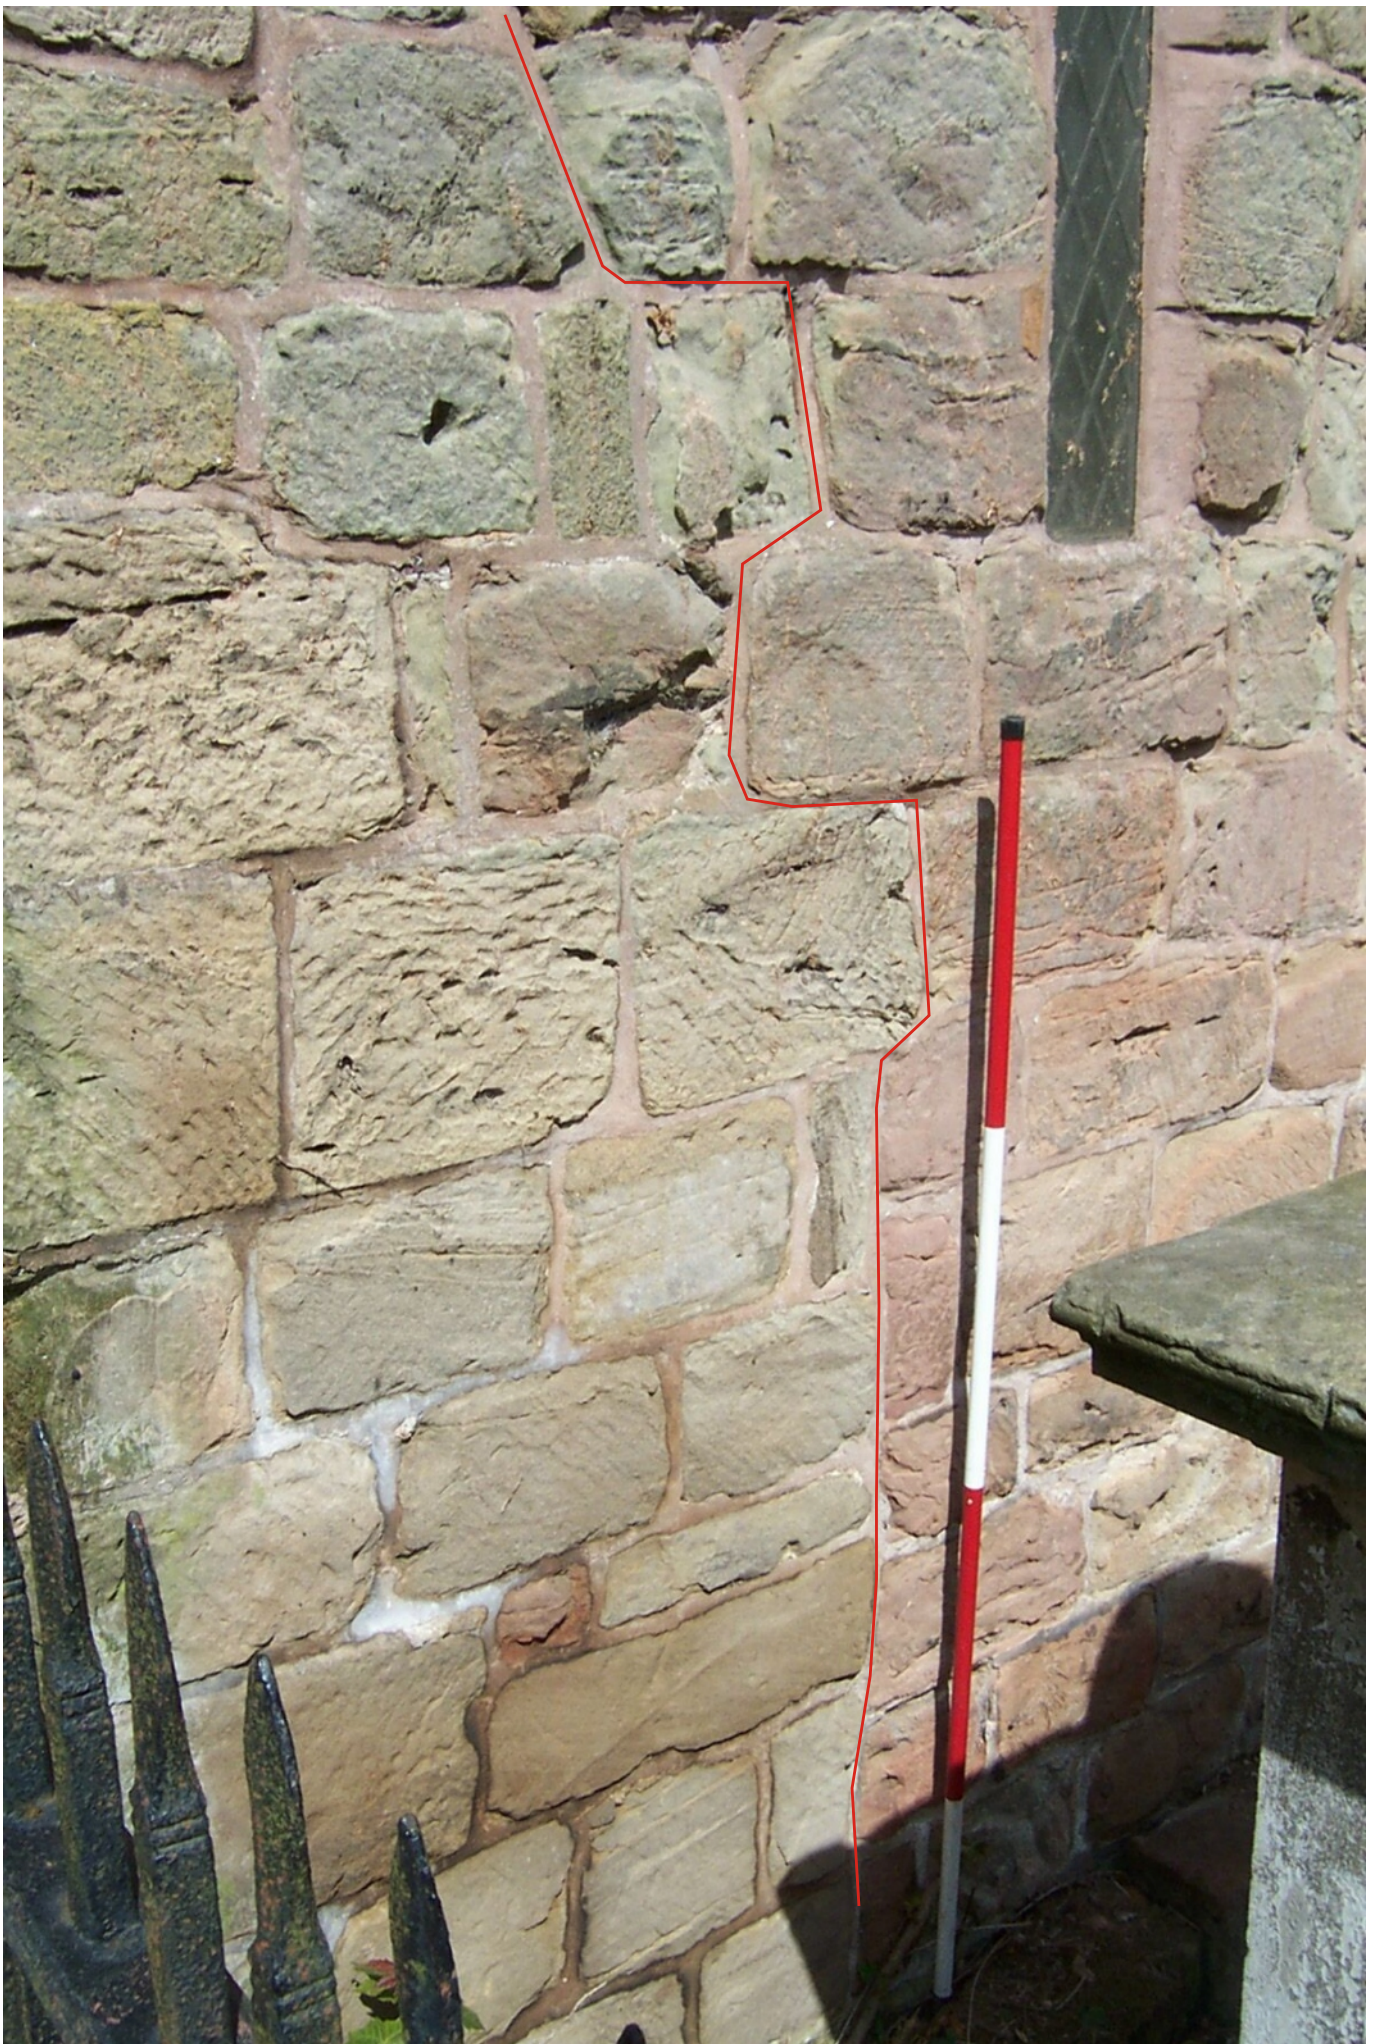
Plate 1 The blocked doorway in the south wall

Phase 1 The chapel of ease (Figs 2 & 3, Plate 1)

The first phase of building appears to have taken the form of a simple chapel probably no larger than the surviving chancel. There was a door in the west end of the south wall, the thickness of the wall, compared to the symmetry of the doorway suggests that they are not contemporary. Scarring is visible immediately to the west of the construction break where the 18th century church butts up against the original. This may be the clue to the fact that the west wall is actually later than the initial construction. There is a slanting piece of stone at a height of 3 metres above the ground that represents the height of the relieving arch for the door. The rebate in the east wall suggests that there was a floor or ceiling above the chapel at this time.

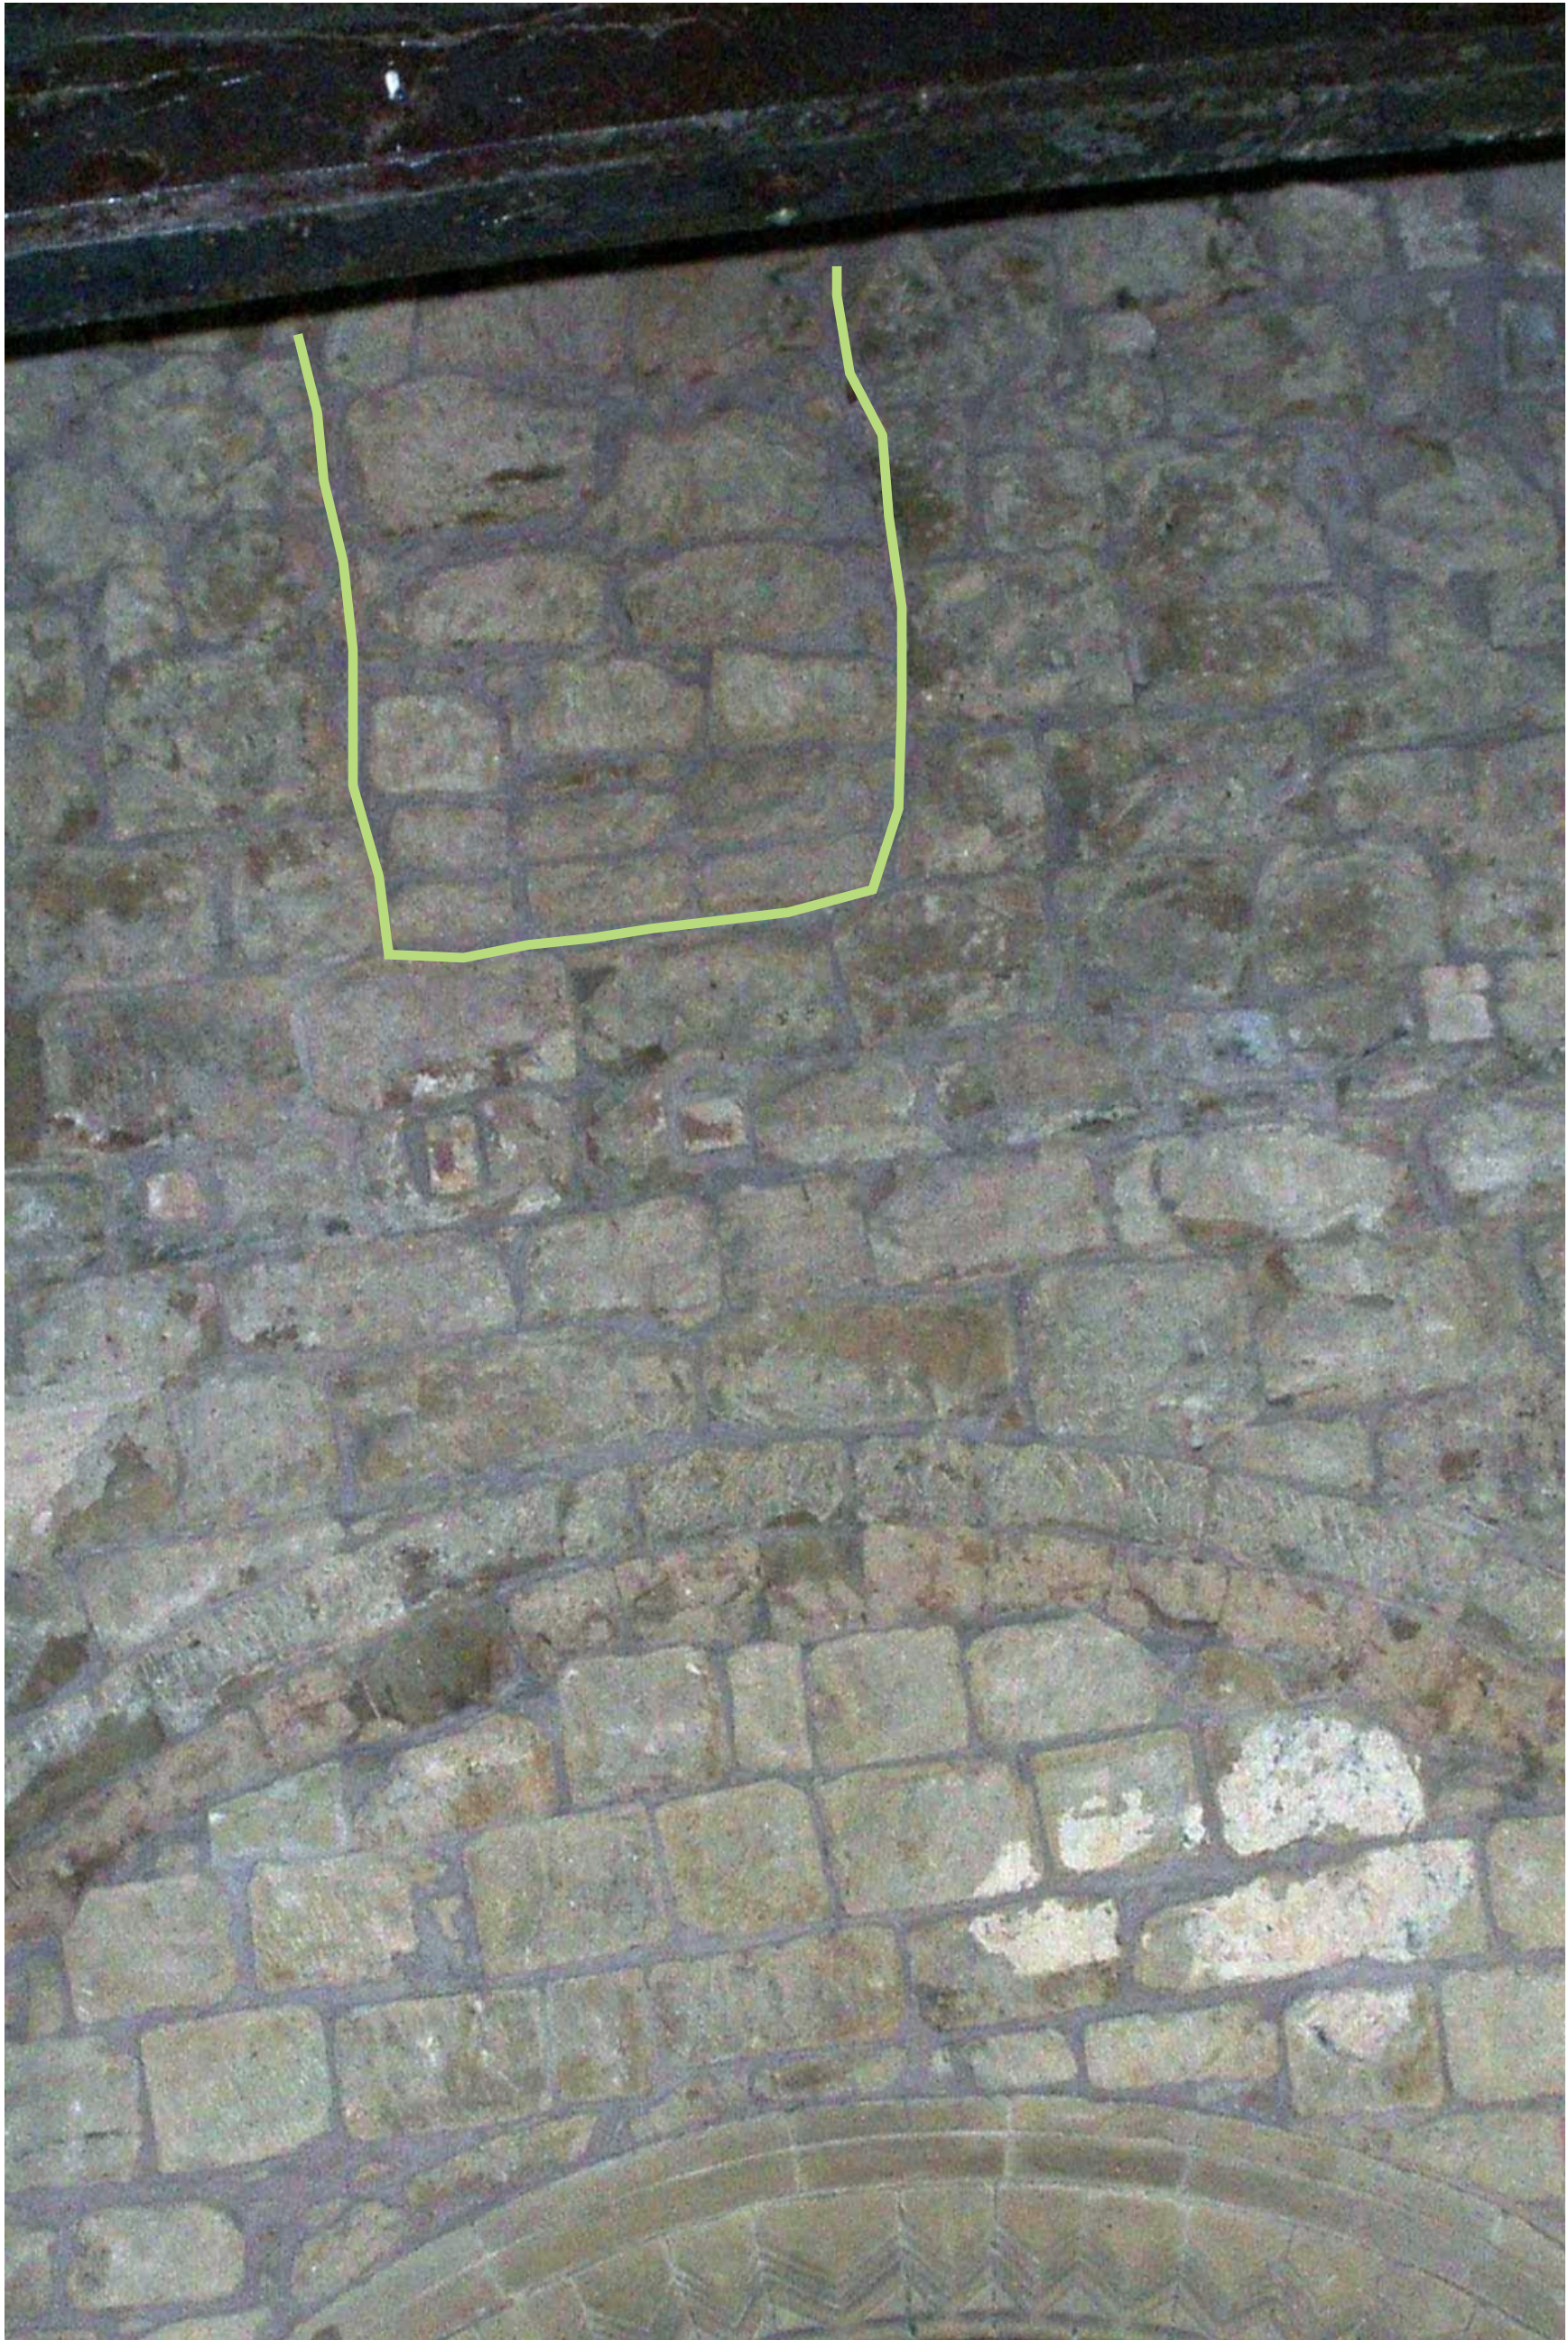
Plate 2 The blocked opening in the west wall

evidence for this is the change in build seen to the immediate west of the blocked door in the south wall. The simple form of the arch places it in the middle part of the 12th century. It presumes that the nave was constructed of wood, evidence for which is now masked beneath the present Georgian one. How far it extended is not known. The blocked central opening in the west wall indicates that there was still a first floor room in this phase.

The first phase of this building poses the biggest problem in determining the development of the building. The presence of the door in the south wall, the internal plinth and blocked opening in the west wall all suggest that it was built as a single celled chapel. However, there is no obvious construction break for the later insertion of the plain arch. It is possible that the design was changed very early in the building programme, this would explain the plinth, but not the blocked opening towards the top of the wall. The evidence suggests that the west wall was completely rebuilt early in the history of the chapel, probably when a nave was added. Either way a lot of activity and changes went on in its early life. This may reflect that Stirchley was a fertile and productive settlement. Certainly the number of times it changed hands in the 13th century suggests it was a valuable asset as abbeys frequently coveted rivals holdings. As the floor of the nave is raised it is quite possible that evidence for the Norman end later medieval alterations to the church may survive relatively intact beneath the current floor.

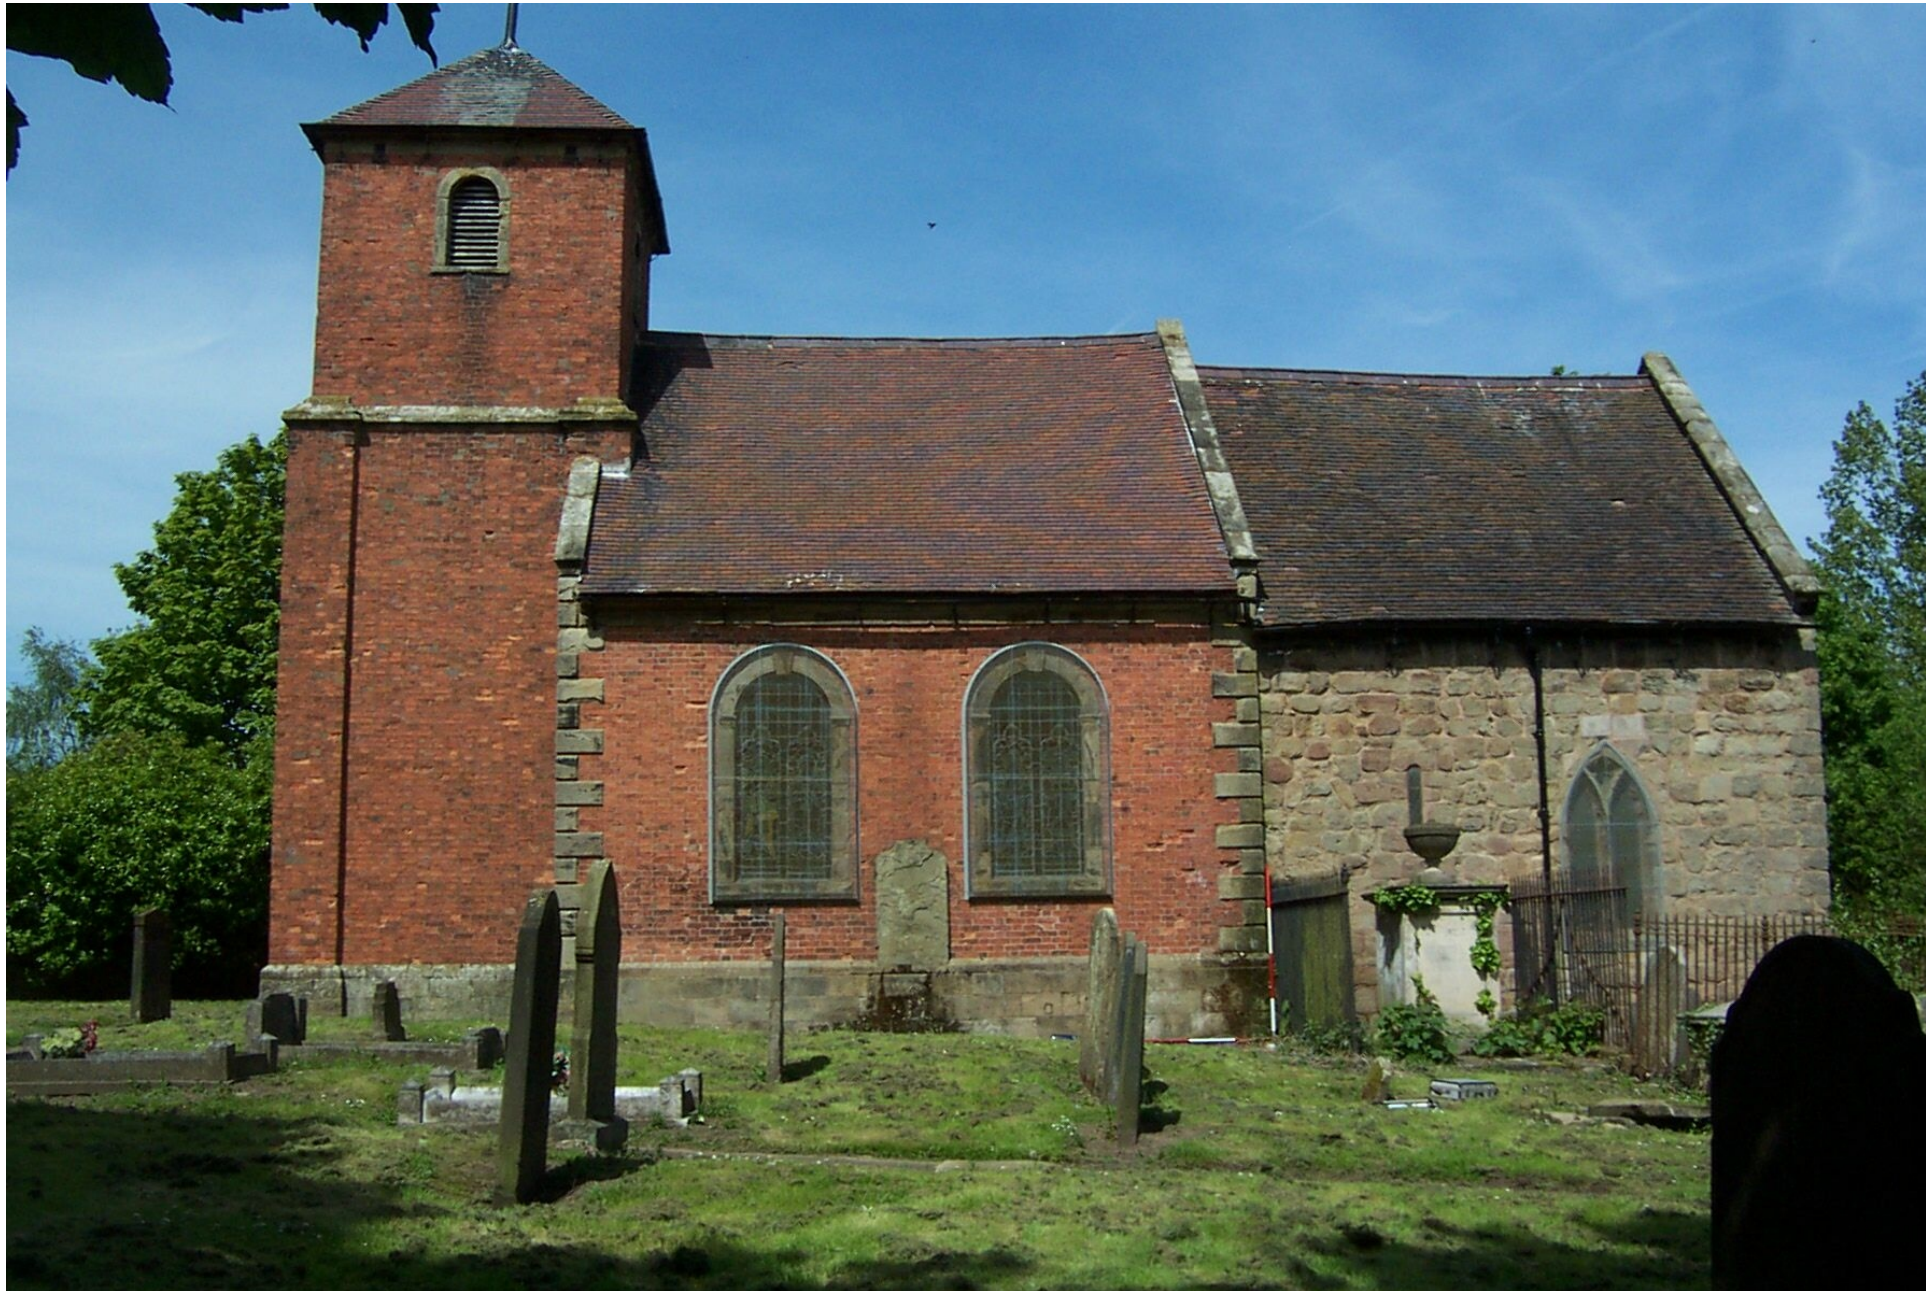
Plate 3 The Georgian rebuild

Phase 5 The Georgian rebuilding (Plates 3 to 5)

During the 1740s the nave was rebuilt in brick, obscuring any intermediate phases that may have occurred after the later Norman work. This brickwork is thought to clad earlier stonework. The choice of brick was unusual for an area so rich in building stone and may represent an attempt to show the wealth of the benefactors. The nave is quite plain as was the style at the time, with a tower at the west end. The tower incorporates a small minstrel's gallery. The nave has two stained glass windows in the south wall with rounded heads

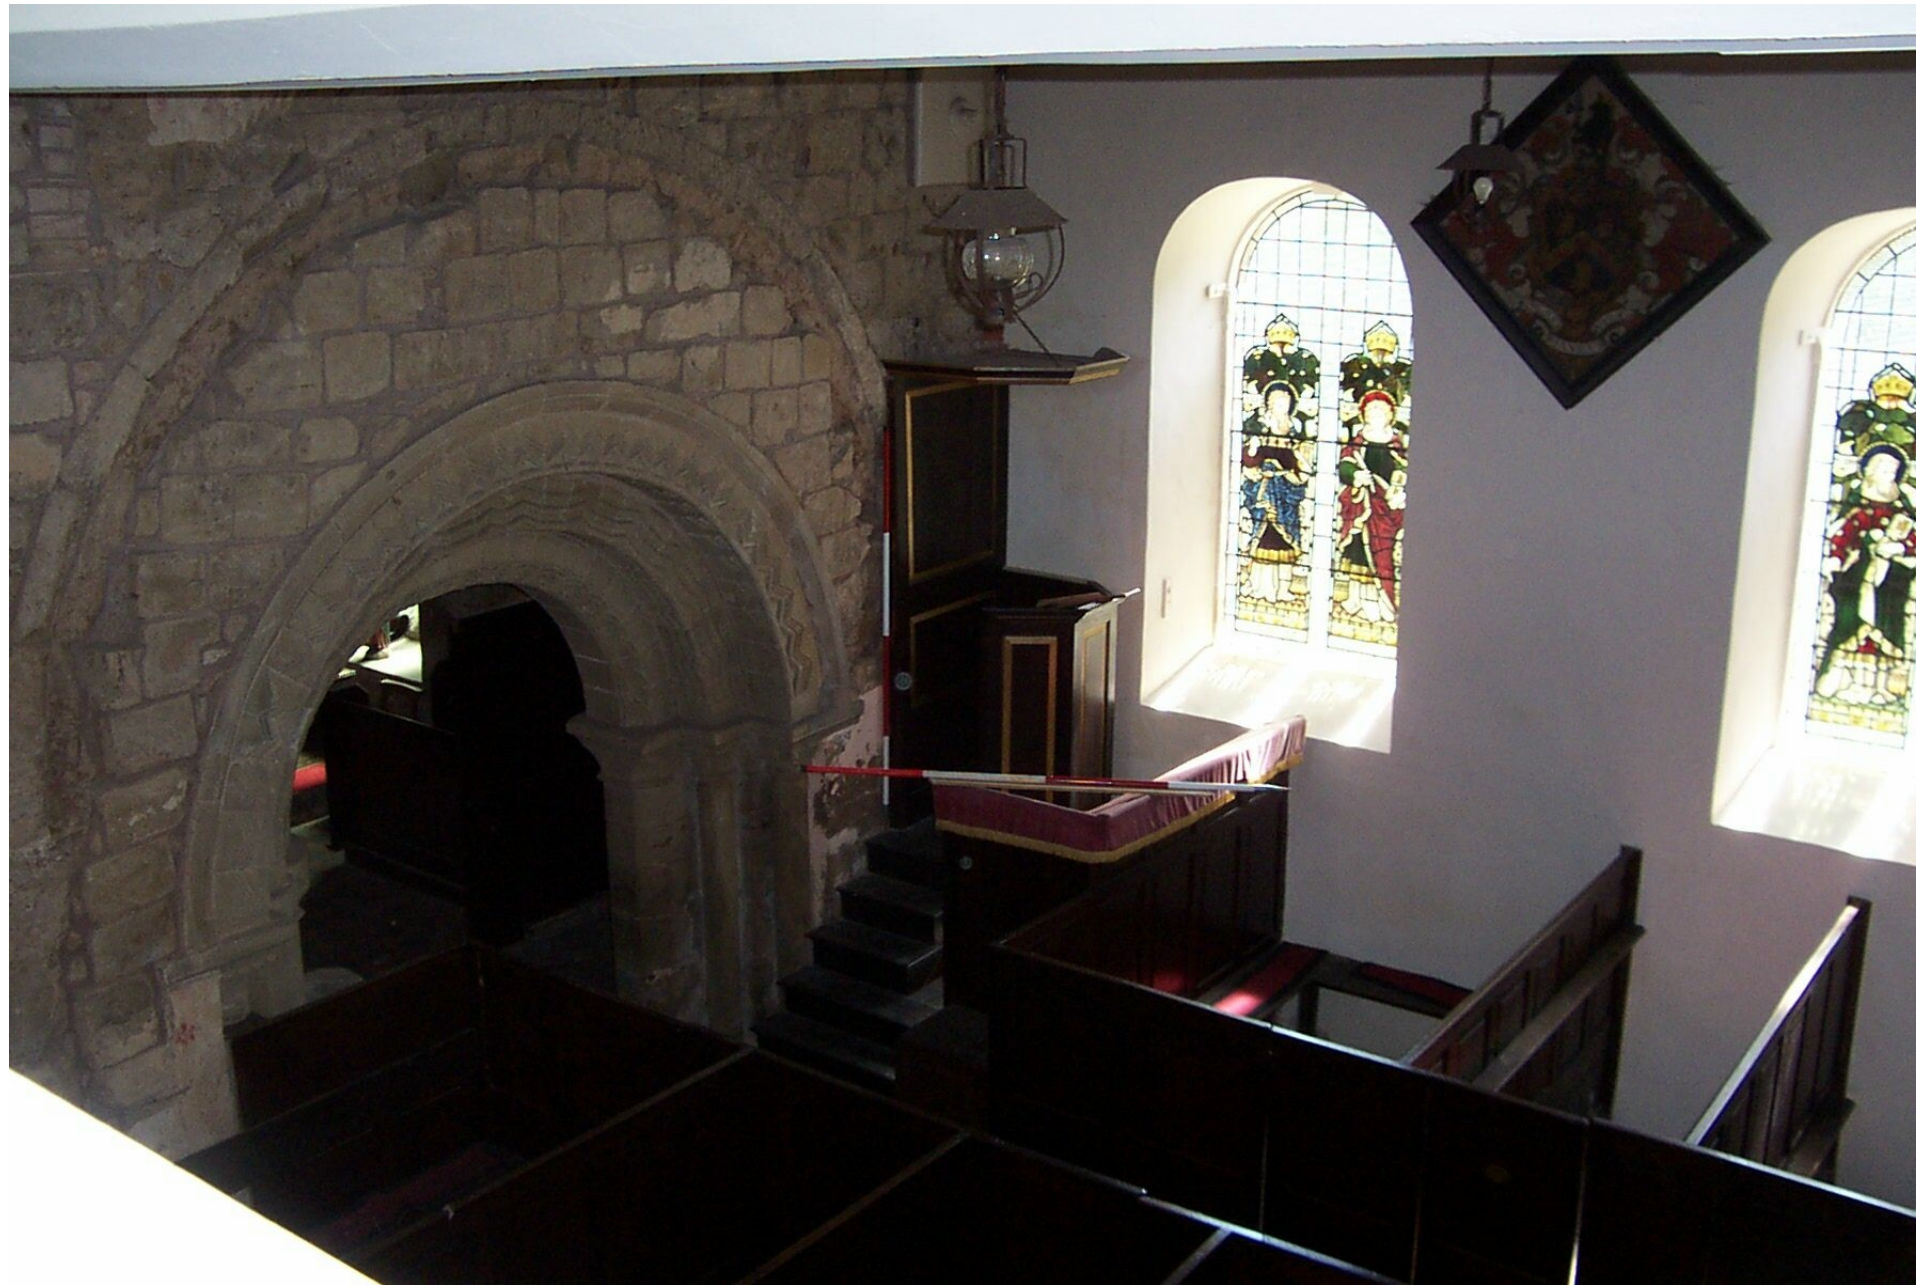
Plate 4 The Georgian pews and pulpit

The body of the church was fitted out with box pews, pulpit and reading desk which remain in place today.

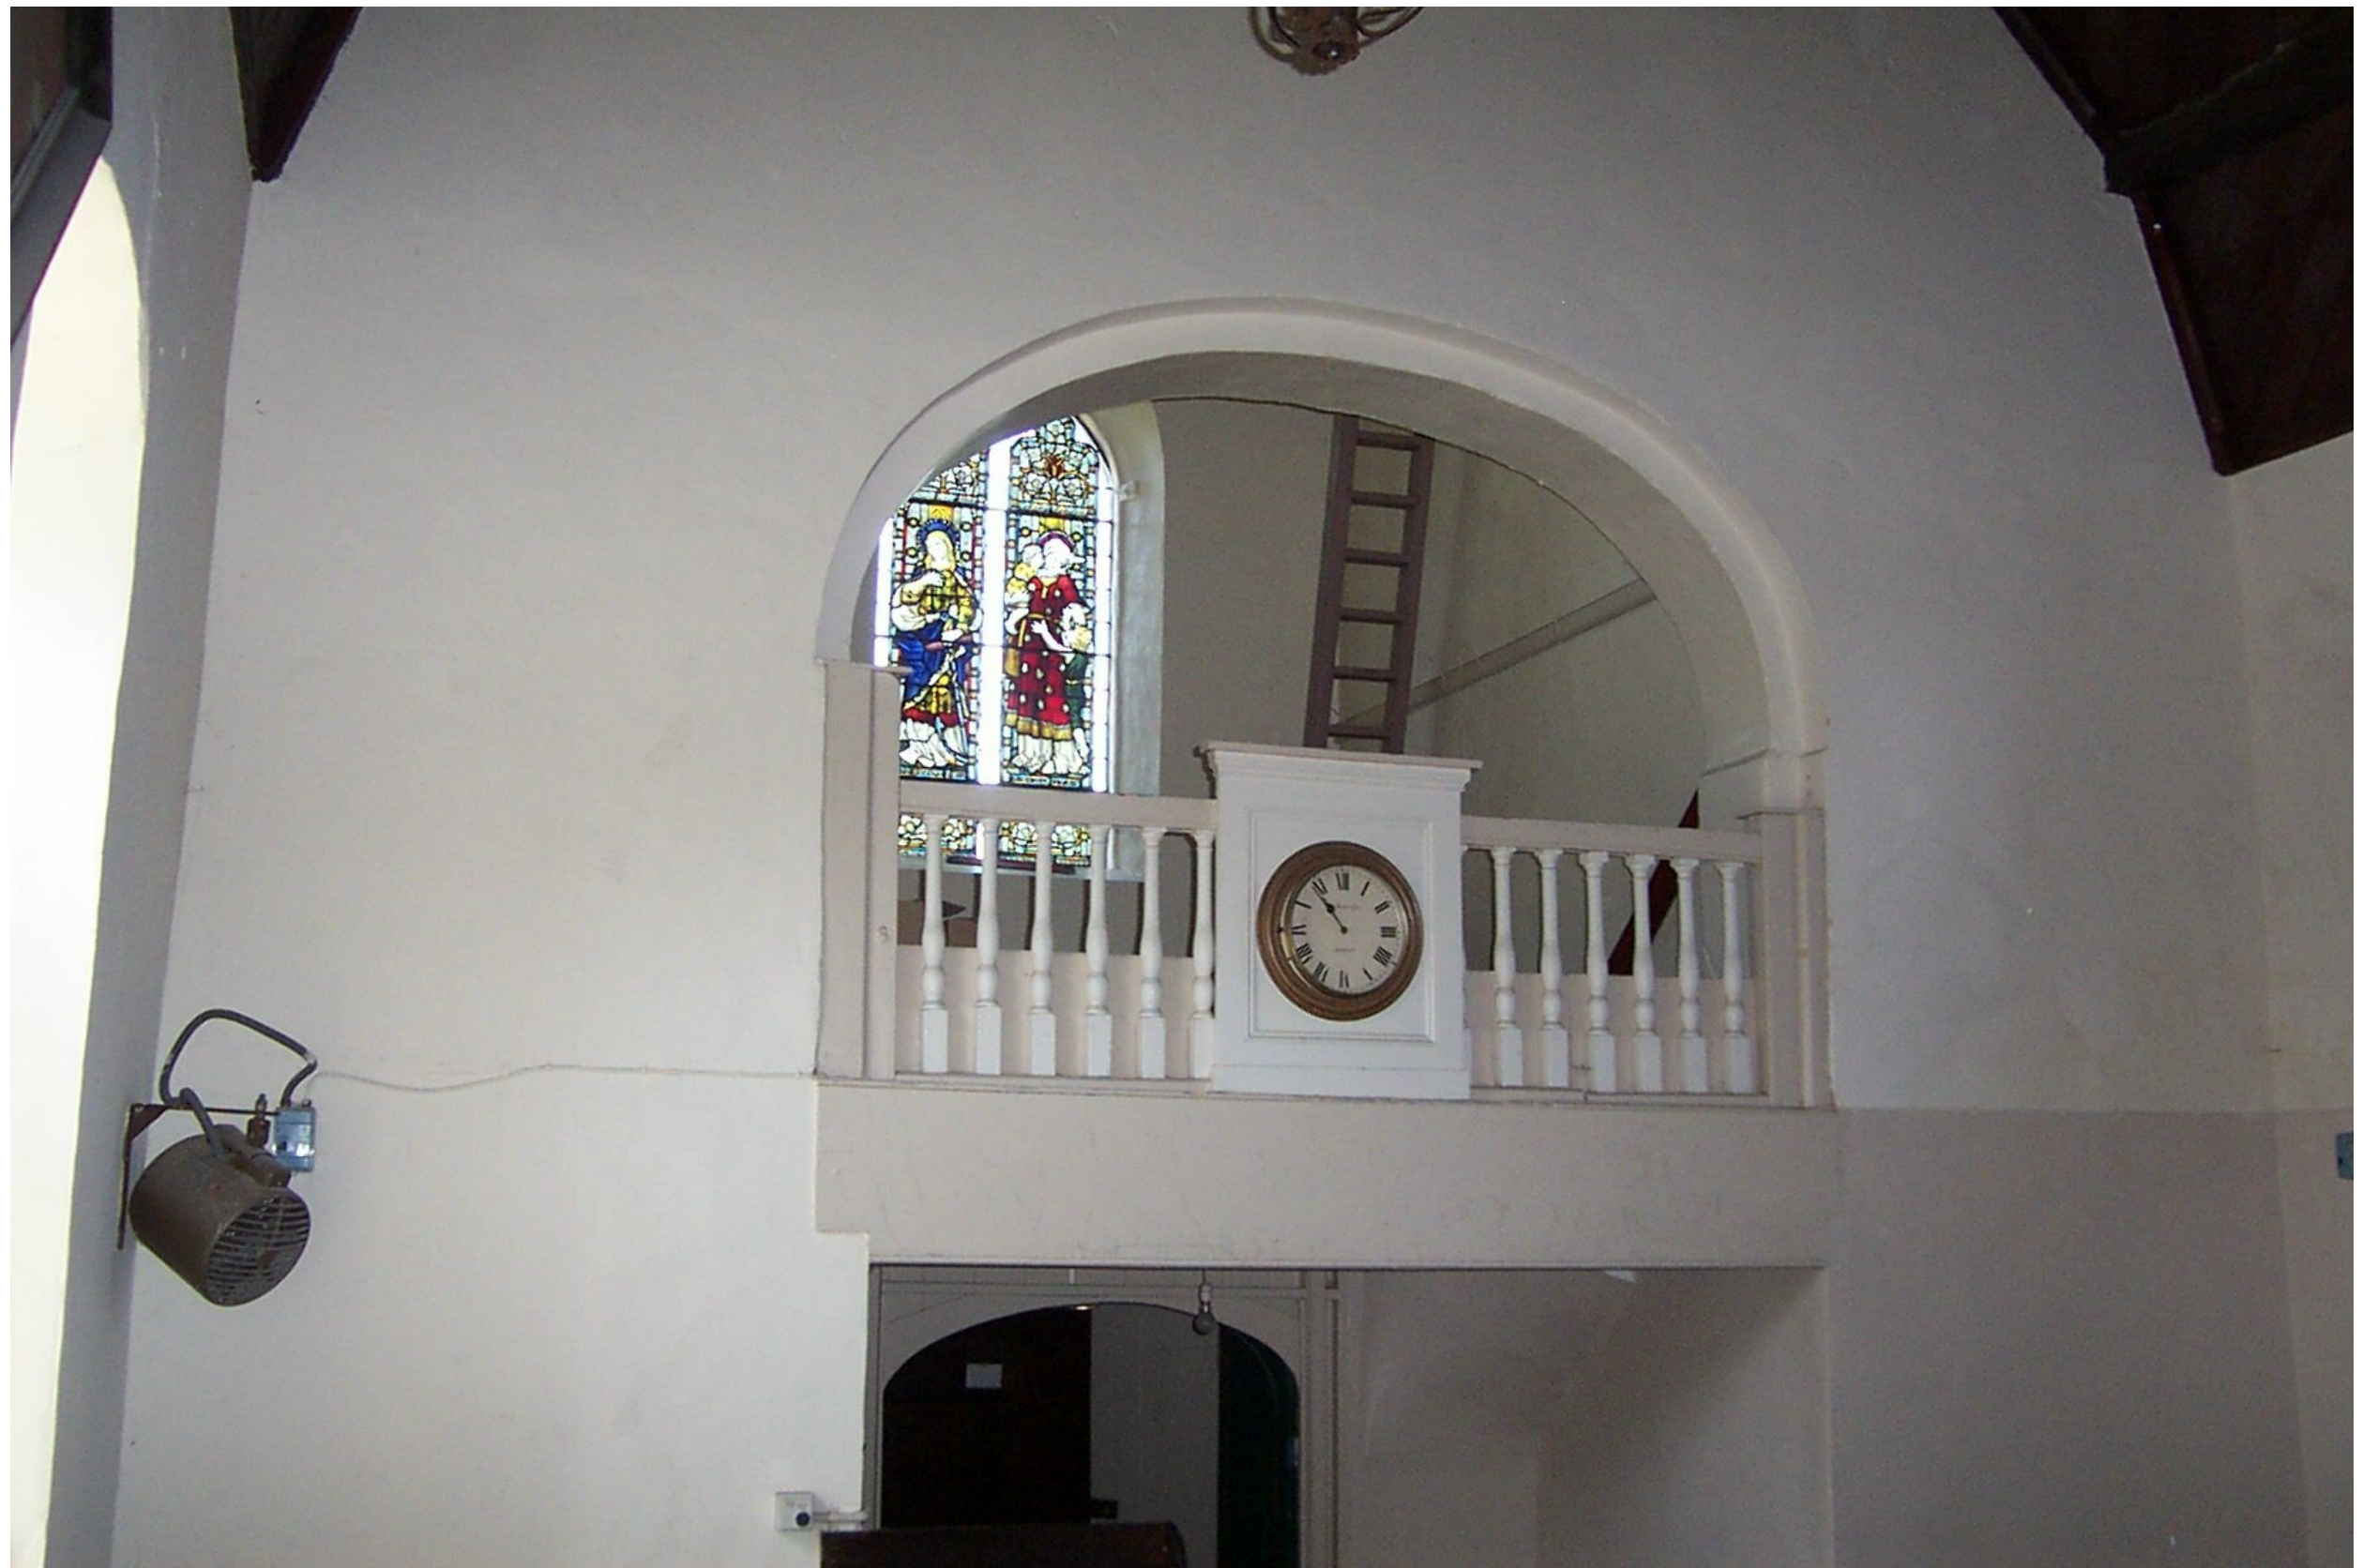
Plate 5 The minstrel gallery

In the tower is another large rounded head window behind the gallery.

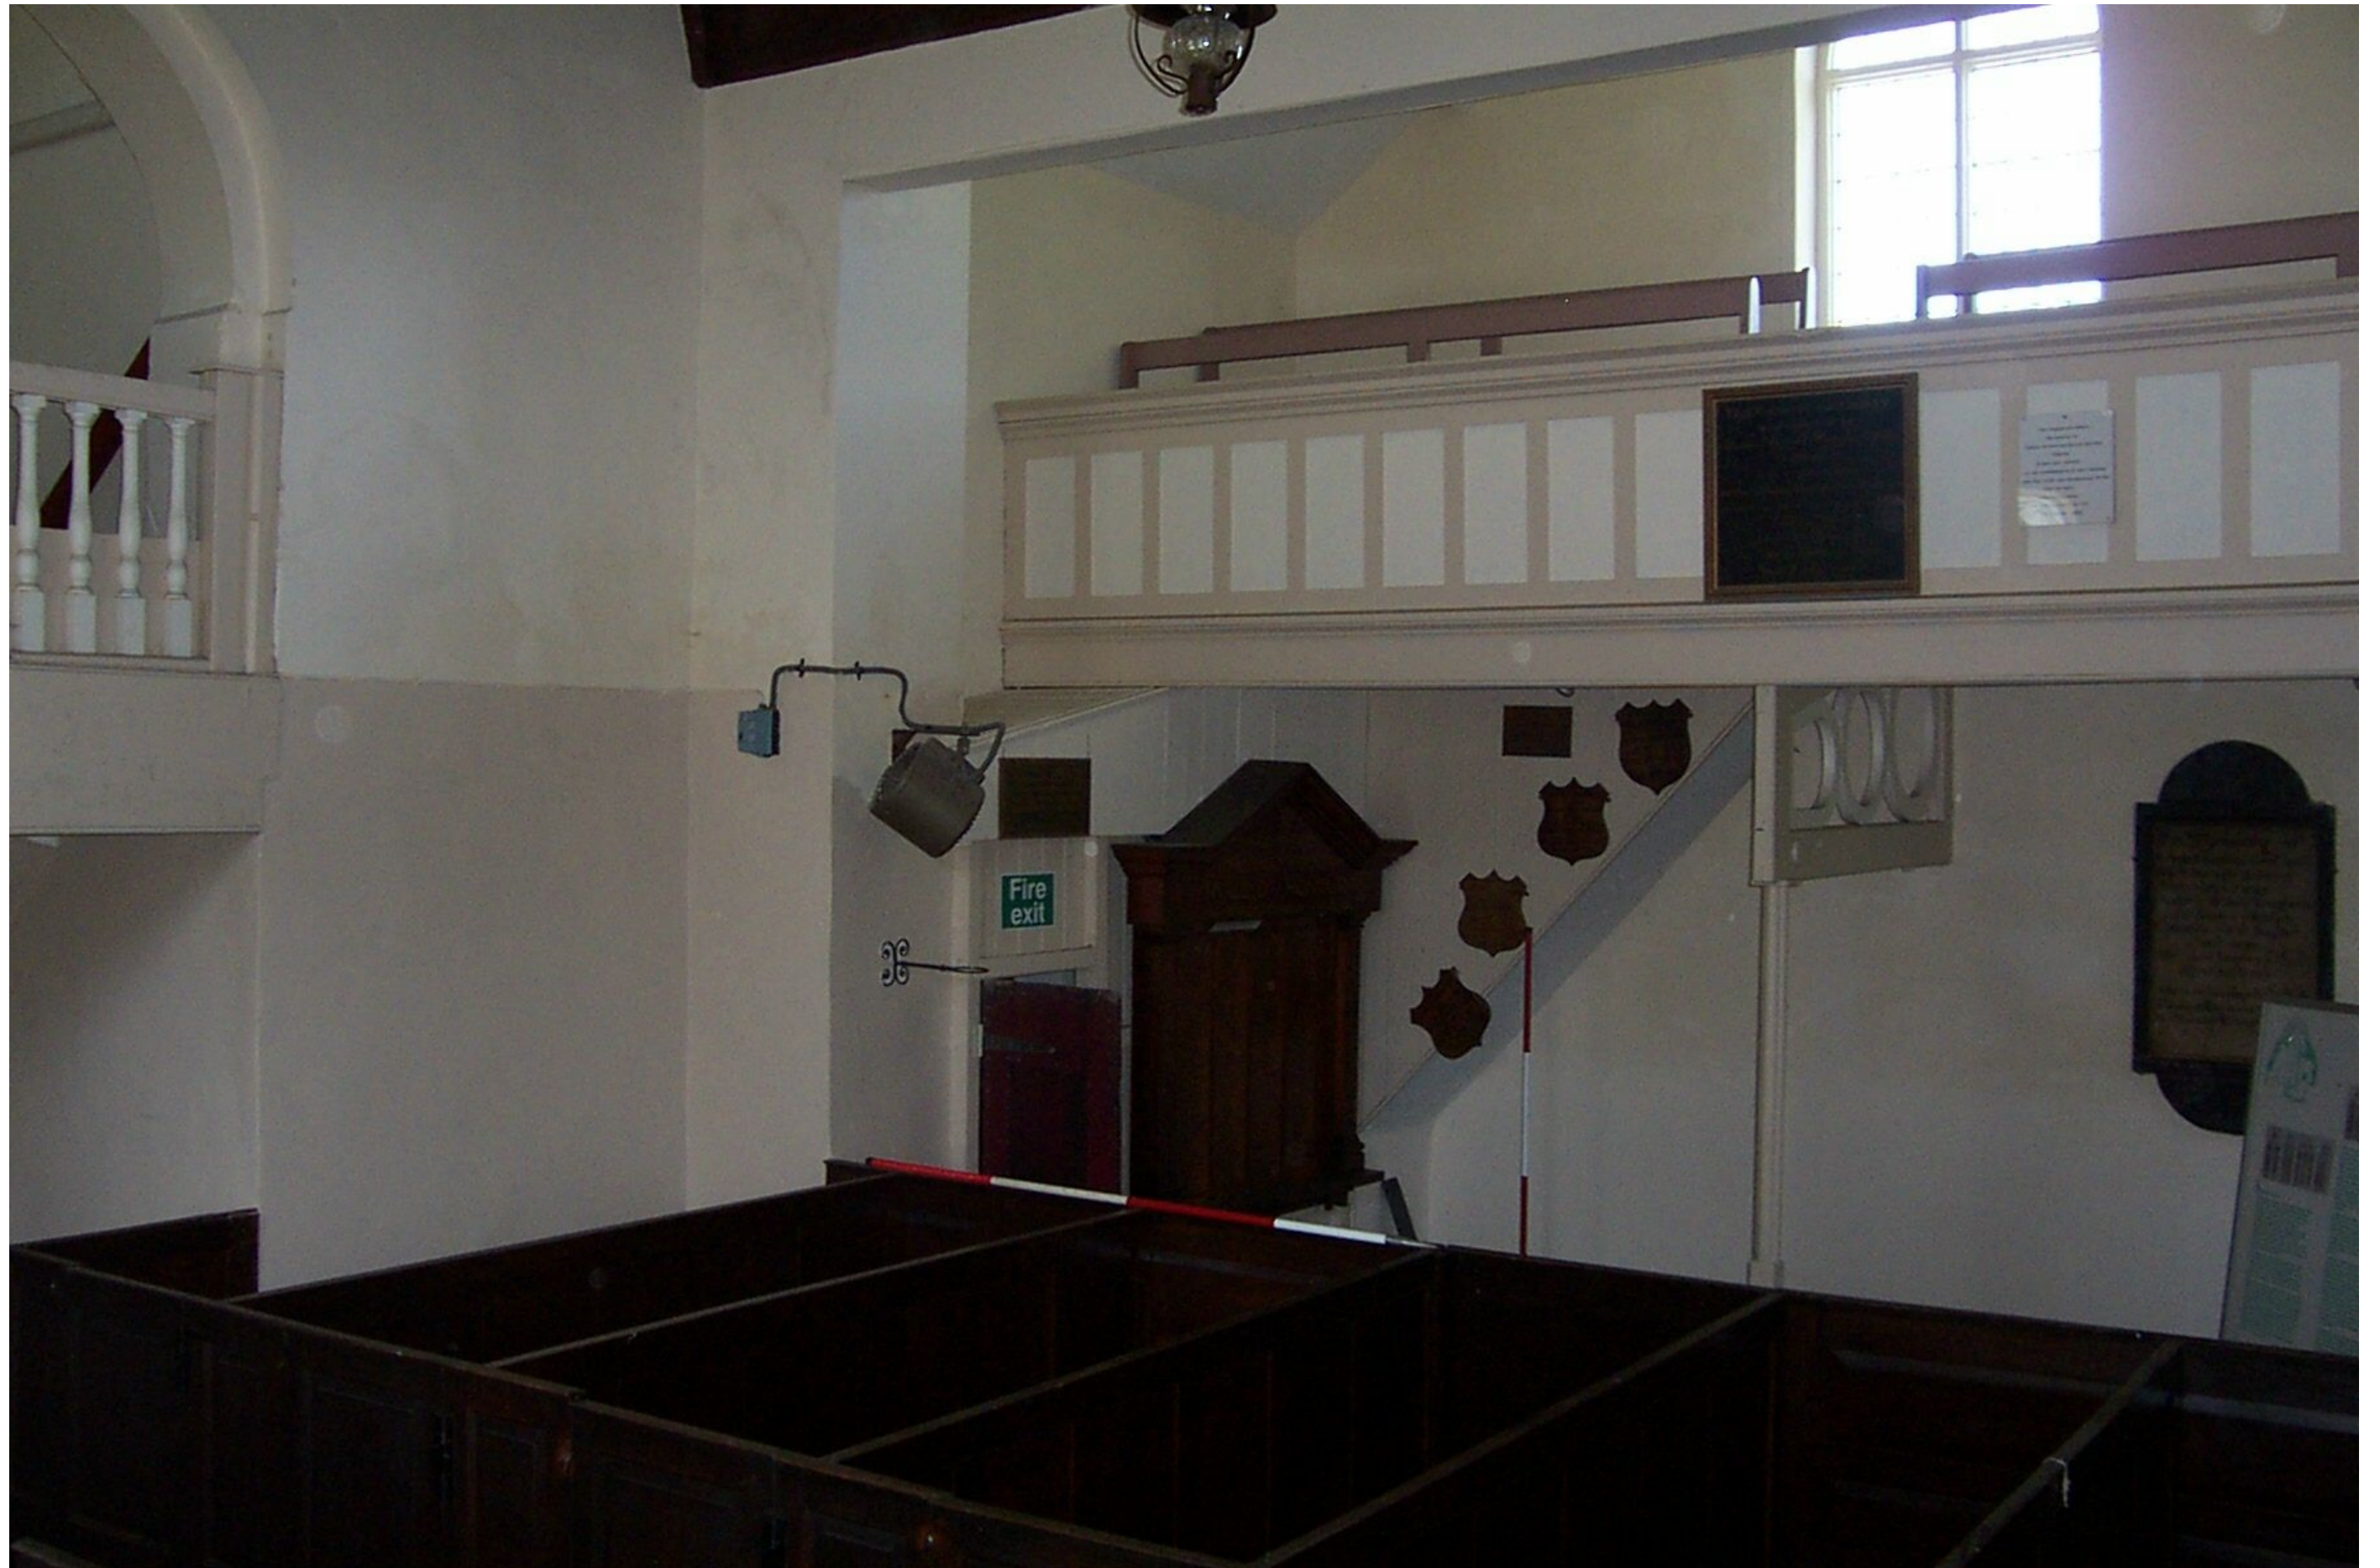
Plate 6 The balcony in the north aisle

In 1838 a north aisle was added again in brick. It housed a gallery that could seat 120 people and was erected by a local businessman to accommodate his workforce. This gallery was so large that it projected into the nave obscuring the view of the chancel.

In 1919 the roof had become dangerous and needed replacing. Whilst this work was being carried out the opportunity to reduce the size of the north aisle gallery was taken and it was reduced to its present size. At some unspecified date in the early part of the century, possibly at the same time, the lower of the two windows in the east wall was replaced with a larger one
