Steeple Church, Dundee

*Archaeological Rescue Excavation: September 2011 – March 2012
Data Structure Report*

Data Structure Report

(project AA. 0465)

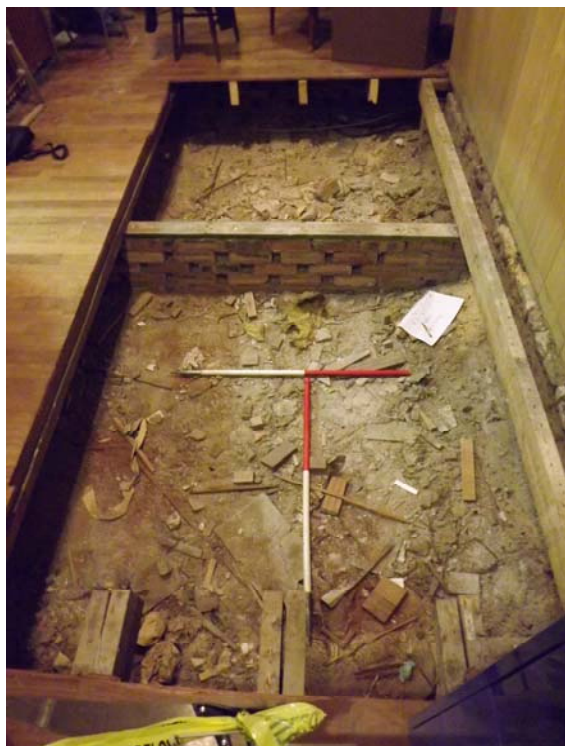
Plate 1 Pre-excitation view of Trench 1 showing build-up of 20th century detritus (1001) (Photograph 3)

The initial deposit to be removed comprised an accumulation of fine grain dust and modern detritus. Recorded as (1001), this deposit was very dry and light, consisting almost wholly of dust and broken angular stones and building rubble. The depth across the Trench varied but in no place was deeper than 0.15m. Letters, newspapers and cigarette packets indicate work was undertaken in 1964, coinciding with the construction of the Overgate Centre and re-working of St. Clements Church, known today as The Steeple Church. At this time the N porch of the Steeple Church at the entrance was removed and the congregation reordered to face E, as it does today. A small quantity of charnel recovered from (1001) also indicated that this 20th century work had disturbed human remains, whether *in situ* inhumations or charnel.

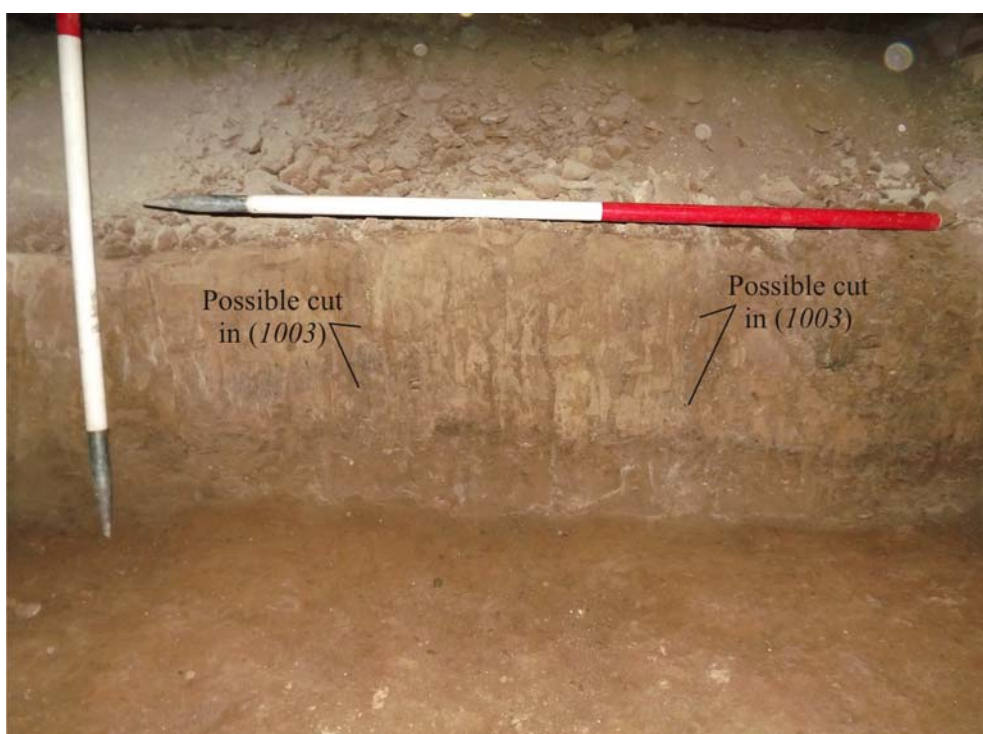
Plate 3 E facing section of Trench 1 S Area. Note the possible cuts in (1003) and small flecks of mortar in the foreground (Photograph 109)

The location of these small inclusions in (1003) aligned on the required W-E axis for an inhumation, with two clear vertical 'cracks' in the E facing section of (1003). These cracks were the only obvious anomaly in the makeup of (1003) and taken together with the other factors described above, seem to indicate the presence of an inhumation beneath the LOE. Indeed subsequent excavation in Trenches 2 and 3 showed that in some cases where an inhumation was present, 'cracks' in the very firm burial soil were visible (e.g. Skeleton #08).

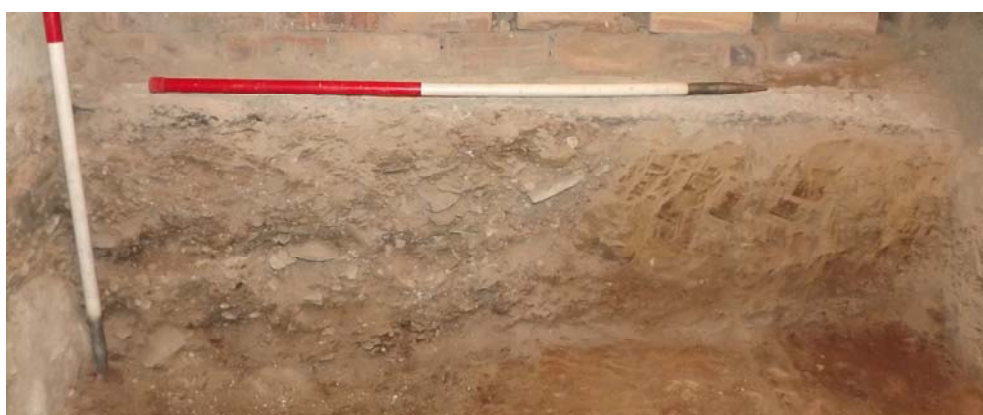
Plate 4 N facing section of Trench 1 S Area showing [1004/1002] (left) cutting through (1003) (right) (Photograph 95)

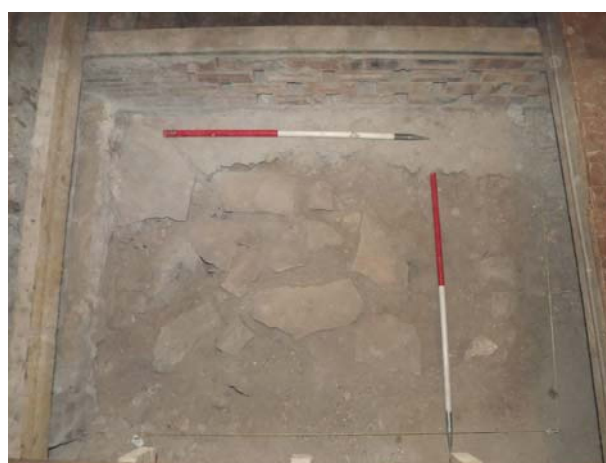
Plate 5 Mid-excavation view of Trench 1 N Area, looking S post-removal of (1001) showing (1006) (Photograph 63)

Beneath (1001) it immediately became apparent that the firm deposits of possible natural (1003) visible in the N Area did not continue southwards. More surprisingly however, the construction cut [1004] did not appear to continue N of the cross wall. Instead removal of (1001) revealed a spread of rubble and stones consisting almost exclusively of small to large mid-blue gray angular stones with dressed facings – (1006). These stones were very firmly compacted together, but voids were clearly visible between them, extending beyond the LOE. A large quantity of modern detritus was recovered from in and around (1006), all likely dateable to 1964. However, as was noted during excavation, items could easily fall through the voids between the stones and the presence of this 20th century material does not necessarily mean (1006) was deposited in the 20th century. The presence of human bone in and around (1006) is also likely dateable to the works of the 1960s.

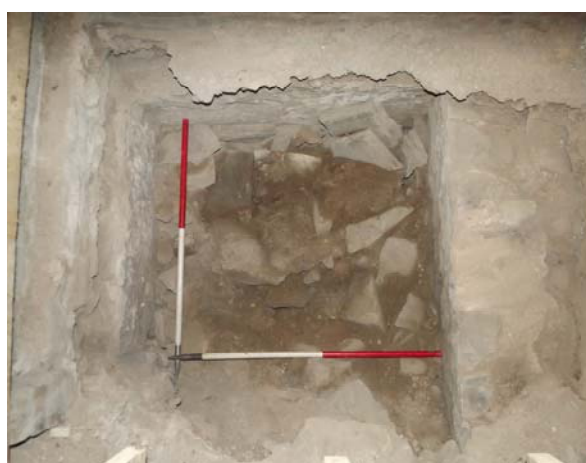
Plate 6 Post-excavation view of Trench 1 N Area, looking S. Note wall {1005} containing (1006) (Photograph 103)

(1006) was bordered on all but the N side by {1005}, a wall of varied angular boulders and whin stone slabs seemingly bonded with gritty lime mortar. The faces of {1005} seemed to have cement smeared across them, perhaps dating to the work of the 1960s. This cement masked a clear assessment of {1005} and its constituent parts. Within the constraints of the N Area, {1005} ran along the E facing section, measuring 1.34m southwards, before turning E directly beneath the sleeper wall for a further 1.27m, and once again returning northwards directly beneath the upstanding church wall {1007} immediately E of Trench 1.

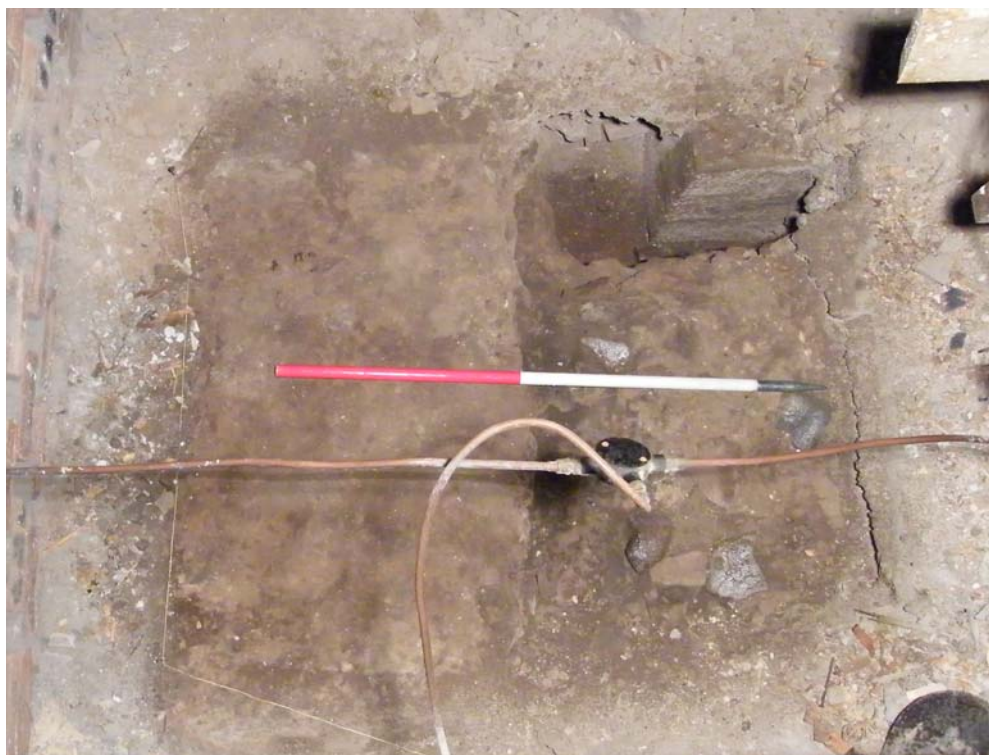
Plate 7 Mid-excavation view of Trench 2 Bay 6 looking N, post-removal of (2001). Note [2004] to the right

The main proposed foundation trench straddled both Bays 5 and 6 in Trench 2, measuring 1.5m N-S by 0.6m W-E with an overall depth of c.0.6m. Removal of (2001) revealed a W-E aligned loosely compact spread of mid brown silt and construction debris (2002). Excavation of (2002) revealed the vestigial remnants of a wall {2007} set within its construction cut [2004]. The wall had been almost wholly robbed, surviving as imprints of masonry blocks in the base of [2004]. Packed around the edges of the cut, a number of small, flat stones (2006) survived, which were obviously packing around the now robbed wall. The overburden (2002) is in all likelihood comprises a build up of material within [2004] post-robbing of {2007}.

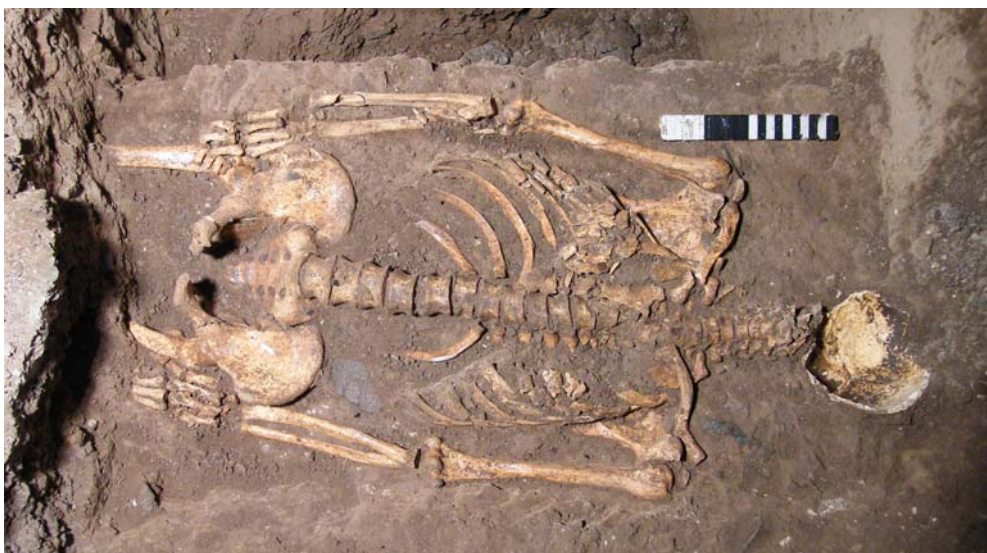
Plate 8 Post-excavation view looking S of Skeleton #5 (Photograph 307)

Skeleton #5 was the most intact of the inhumations recovered in Trench 2, with all the other inhumations revealed consisting almost wholly of legs. In total four sets of legs were excavated protruding from the E facing section Bays 5 and 6.

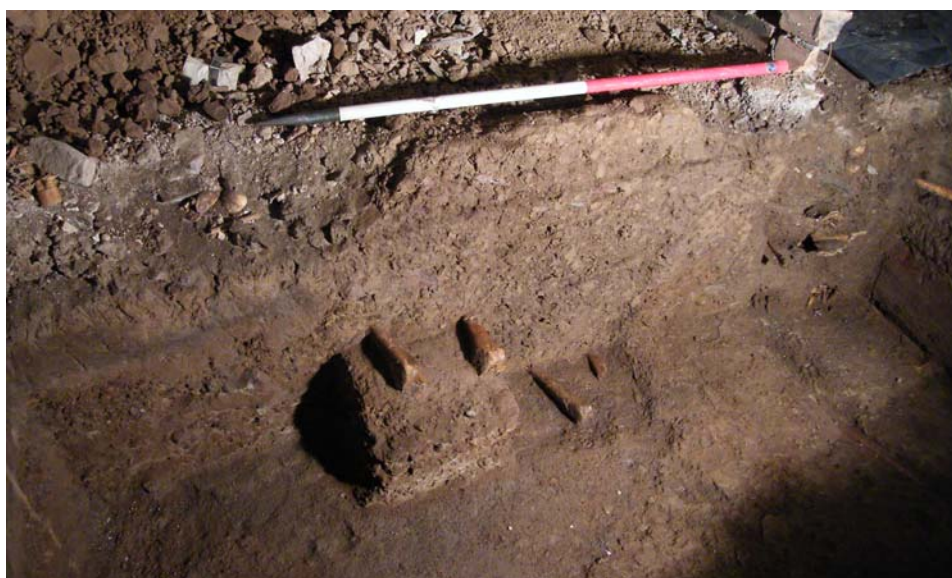
Plate 9 E facing section of Trench 2 Bays 5 and 6. Note Skeleton #3 (left) and 7 (centre)

Skeleton #7 cut Skeleton #3 at a much higher level, but Skeleton #3 too only consisted of legs – this time both fibulae and tibiae were recovered with the section crossing the legs at the knees. Skeleton #3 was also cut by the robbed wall {2007}, which is interesting to consider further. If {2007} represents fragmentary remains of the medieval church, this makes it possible that Skeleton #3 provides excellent dating evidence for the construction of this wall as it predates the foundation trench [2004].

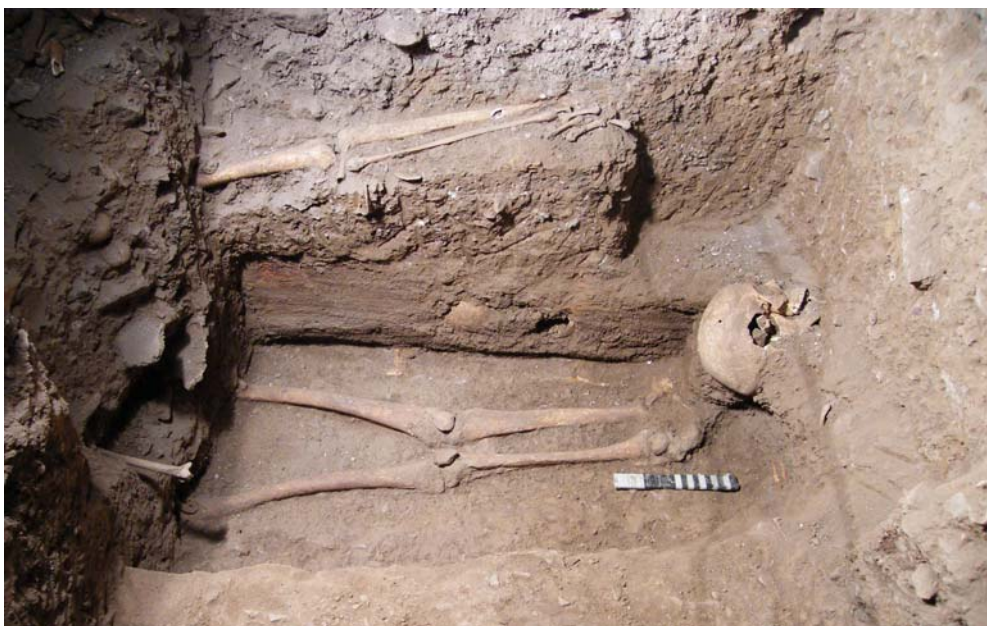
Plate 10 View looking N over Skeleton #11. Note the skull of Skeleton #10 overlying the feet and Skeleton #12 at the rear of the Trench. Also note the well preserved coffin imprint (2029) adjacent to Skeleton #11

At the very base of Skeleton #11, the right foot was overlain by a skull. This did not directly impact upon the survival of Skeleton #11, but the skull protruded into Trench 2 and was required to be removed before the development of the foundations could continue. Investigation revealed the skull to be articulated, meaning this represented a further inhumation running eastwards into the W facing baulk. This was recorded as Skeleton #10.

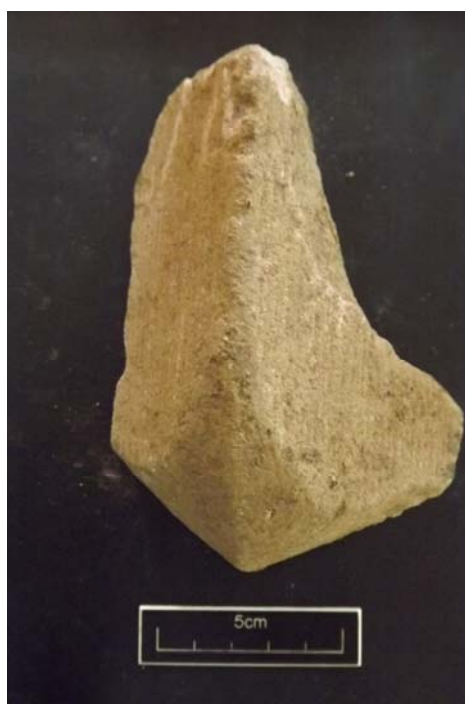
Plate 11 Detail of SF064

Removal of (2028), the fill of [2030] around Skeleton #11 also revealed an interesting architectural feature (SF064), typologically dateable to a 12th or 13th century church building (plate 10). The fragment is carved from hard fine grain sandstone, with fine droved tooling detail. The detail is preserved remarkably fresh on the flat faces, with polishing on the carved surfaces. This fragment likely comprised a corner of a cushion cap, possibly from a Romanesque style structure.

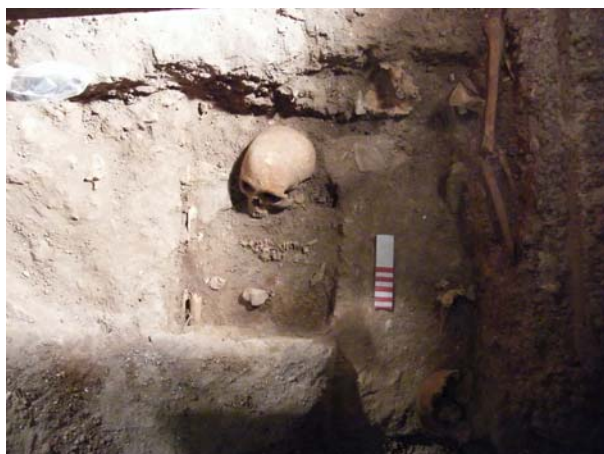
*Plate 12 View looking W across Skeleton #14.
Note the W-E aligned [2034] (top) and
articulated charnel material within (2038) (right)
(Photograph 396)*

Within (2038), a coffin stain was visible. [2034] was too extensive to comprise the cut for the burial and as no cut could be discerned for the placement of the coffin, excavation continued within the areas limited by the coffin stain with the intention of locating the skeleton and subsequently the cut by excavating outwards from this. In contrast to surrounding (2038), the interior of the coffin was less firmly compacted with frequent flecks of sandstone and charnel from other inhumations. Skeleton #14 within the coffin was in an exceptionally degraded condition, presumably as a result of the damp interior of the coffin, with only isolated areas of survival. The upper part of the skull survived intact, although the lower and mandible had disappeared. Fragments of both left and right humerus were also retrieved as well as the sternum and isolated vertebrae. No clear cut for Skeleton #14 was located although this was tentatively assigned [2037] immediately adjacent to the coffin stain. Once again, any change here was felt more than seen and [2037] may not exist in this location. It is possible the cut was very narrow with the coffin nestled securely inside, although it is also possible [2034] represents part of the burial cut.

It seems likely that [2034] may be the burial cut for Skeleton #14, but also may represent further successive burial cuts, providing an isolated island of natural subsoil to the W. In addition, the depth at which Skeleton #14 was interred may indicate a phase of landscaping and down-cutting across this area of the site, as the burial was discovered very close to the surface.

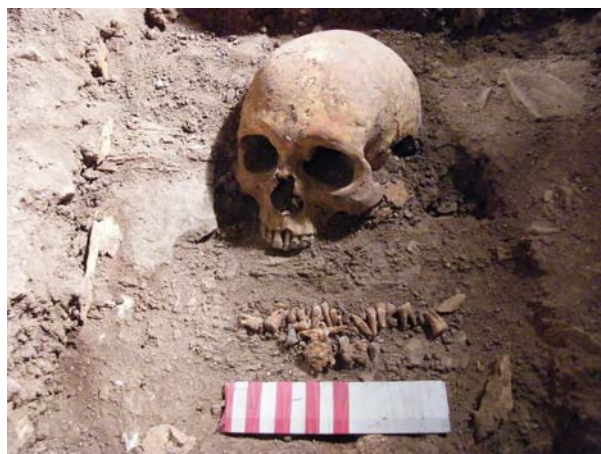
*Plate 13 Detailed view of Skeleton #14 looking
W. Note imprint of coffin wood on base of burial
(Photograph 400)*

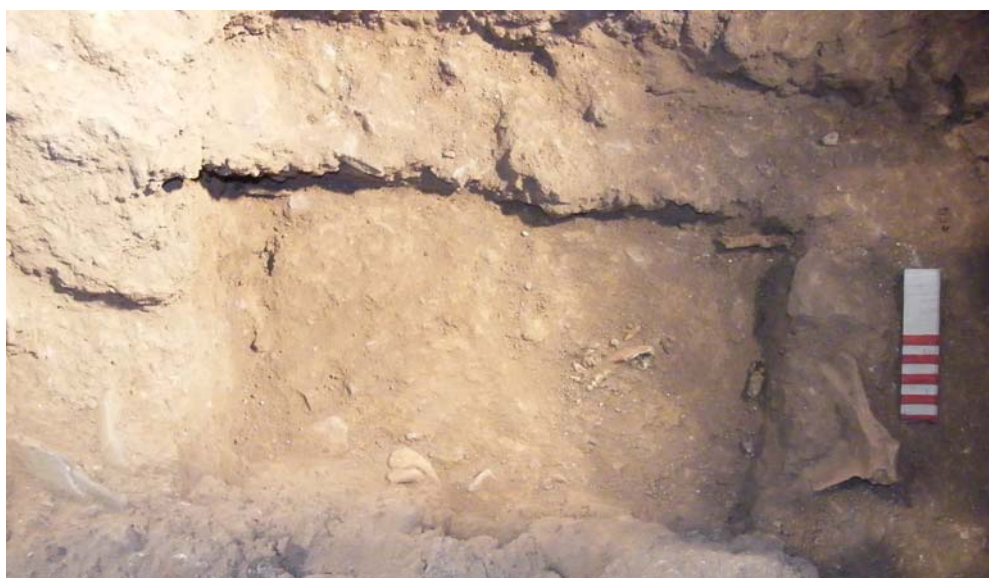
Plate 14 Skeleton #015 in situ at the limit of excavation (Photograph 405)

Post-removal of Skeleton #14, excavation continued with the removal of (2038) to the required depth. Subsequently, very close to the limit of excavation, evidence of a further inhumation becomes apparent. As the required depth of 0.25m is reached, the coffin-staining becomes clearly visible with a number of *in situ* teeth poking through the soil alongside a mandible, with the right scapula and clavicle recorded disappearing into the section with the left humerus also detected. This burial was recorded as Skeleton #15, but remained undisturbed by the development and could remain *in situ*. The burial cut [2048] was located to the W and N where it ran into [2034]. The eastern limit of the burial was not visible. This supports the theory that [2034] represents a series of inter-cutting burial cuts, with (2038) comprising a mixture of graveyard soil and fills of burials.

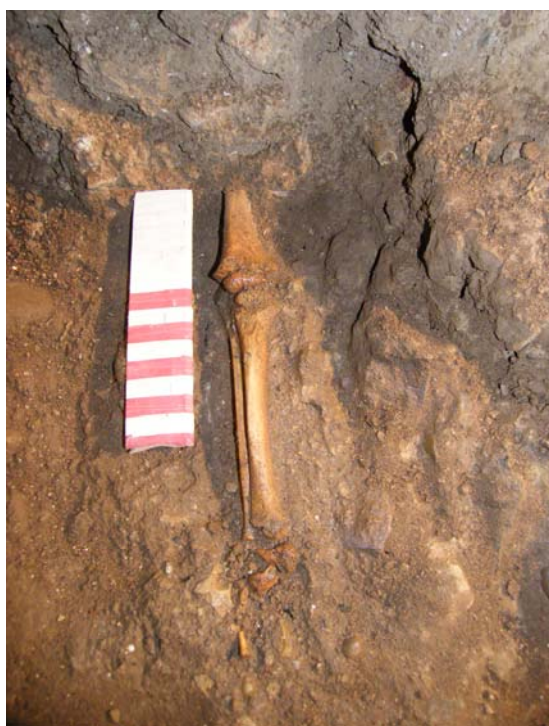
*Plate 15 Skeleton #16 in situ looking W. Note the bone has been sprayed to make it clearer
(Photograph 423)*

At the very limit of excavation however, one final development remained to be seen. Excavation revealed a very small and fragile set of bones, seemingly the right leg of a very young child protruding from the E facing section. Categorised as Skelton #16, a further long bone was noted in the section but no further remains were recovered and can remain undisturbed.

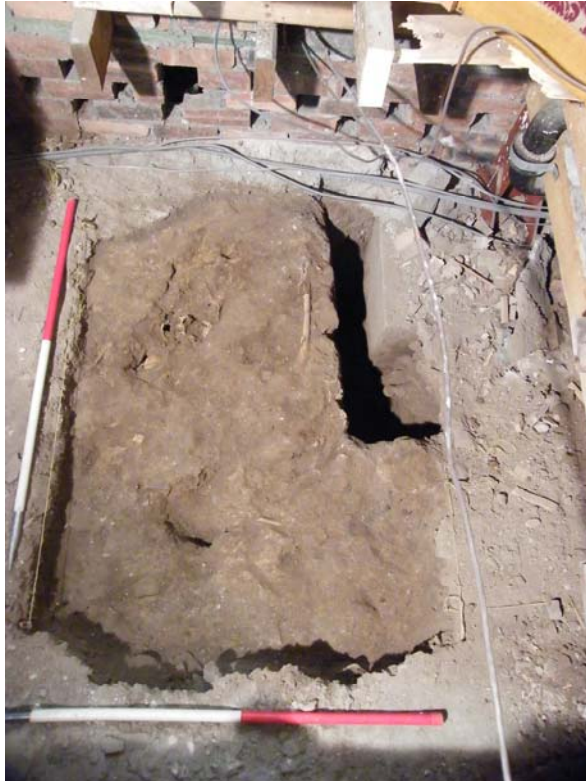
Plate 16 Mid-excavation view looking N across Trench 3 Bay 3 post-removal of (3001) and (3003) (Photograph 183)

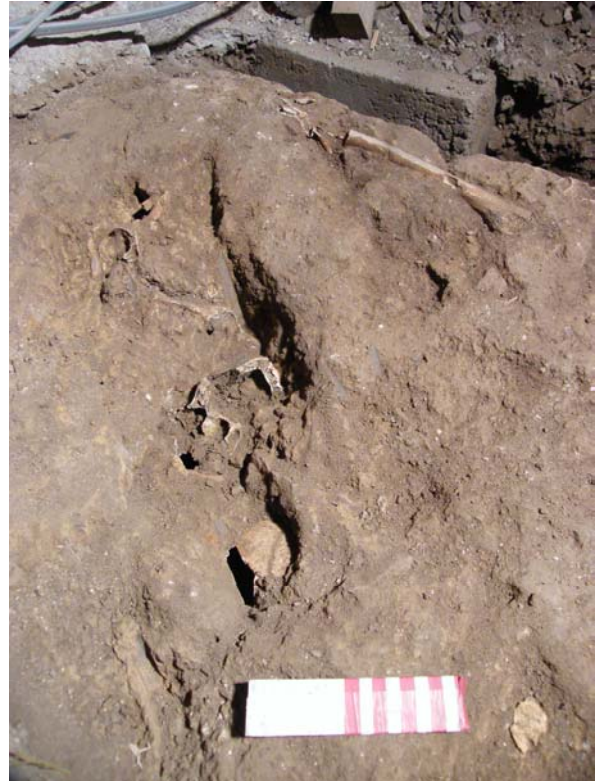
Plate 17 Detail view of pick marks in (3004) (Photograph 185)

The main deposit across Trench 3 below (3001) consisted of a very firm mottled grey, orange brown and mid brown clay silt and boulder clay (3004). Totally devoid of moisture, (3004) was very firm and difficult to excavate. Despite prior knowledge that inhumations may be present and even their potential location, cleaning of the trench revealed no obvious sign of a grave cut despite use of a water spray and careful consideration. What removal of (3001) did reveal was clear areas of bone protruding from (3004), obviously damaged and cut by the use of a pick, presumably at some point in the 1960s (*plate 17*).

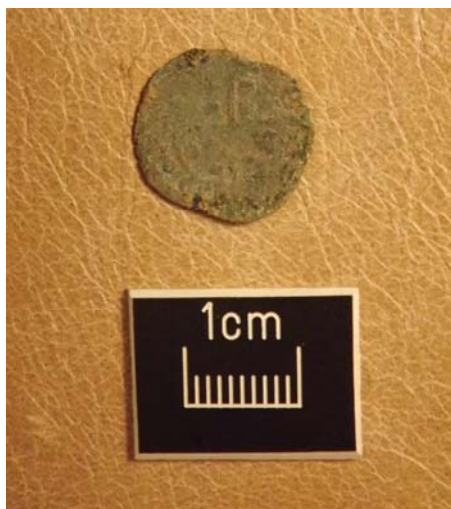
Plate 18 Reverse of long cross penny of unknown date (SF016)

Working in the knowledge that inhumations were almost certainly present, excavation continued in Trench 3 with caution, removing spits of soil with a mattock. As excavation continued, (3004) revealed a large quantity of *ex situ* human bone and no sign of a grave cut. At this stage it was assumed that (3004) in actual fact may comprise the fill of a large charnel pit as represented by [3007]. In addition to the large quantity of human bone recovered, a well preserved long cross penny (SF016) (*plates 18 and 19*) was retrieved, providing possible dating evidence.

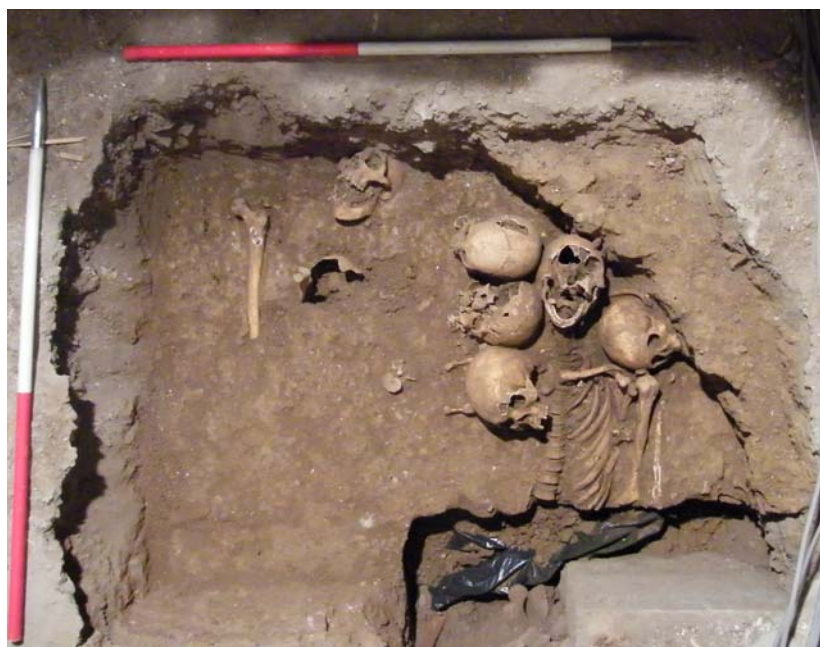
Plate 20 Mid-excavation view looking W of Trench 3 Bay 3 showing Skeleton #04. Note the skull adjacent to the E facing baulk (SF037), the cranium immediately E (SF034) and [3007] in the NW (immediately to the right of Skeleton #04) (Photograph 229)

One of the most interesting and unusual discoveries when excavating Skeleton #04 was the presence of 4 further skulls (SF024-026 and SF029) in direct proximity to the articulated skeleton. As can be seen from *plates 20-22*, these lay at the W end of the skeleton and indicate the alignment of the grave cut. Skeleton #04 was the most recent inhumation interred in the area that became Trench 3, located closest to the surface and not truncated by any subsequent burials. At this stage the graveyard soil (3004) would be rich in *ex situ* skeletal material and human charnel arising from earlier burials and truncations of graves, so when Skeleton#04 was interred, it either cut through earlier burials at a higher (now lost) level or revealed disarticulated human bone during excavation. Either way, the burial party clearly took the opportunity to re-inter these remains in the grave alongside Skeleton #04. The preponderance of skulls and long bones relates to the ease with which these are noticed and collected by the excavators. Smaller bones would undoubtedly have been lost during this process.

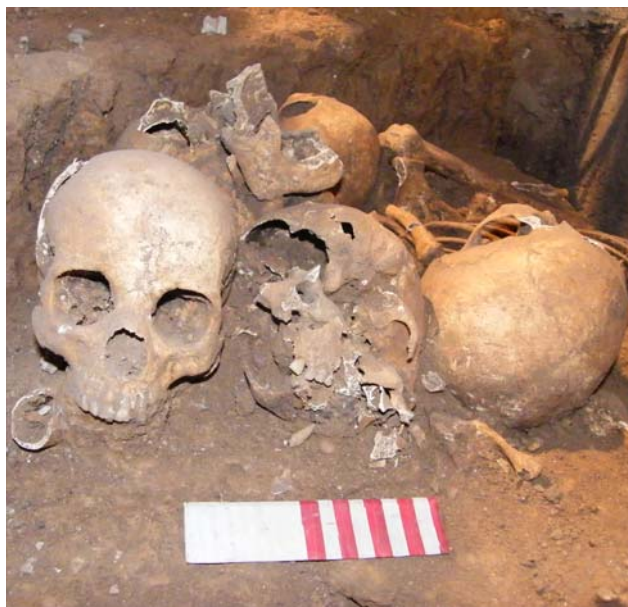
*Plate 21 Charnel within [3006] (SF024-026)
(Photograph 251)*

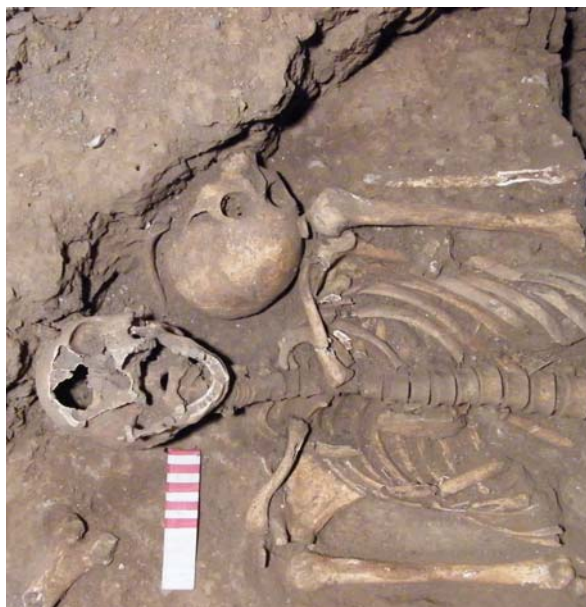
*Plate 22 Post-excavation view of Skeleton #04
(Photograph 265)*

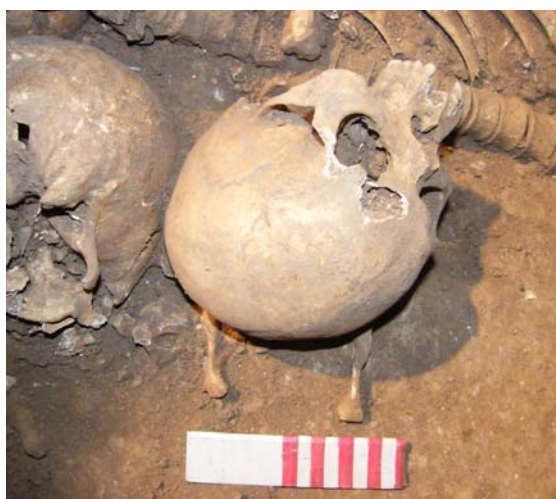
*Plate 23 Detailed view of SF024
(Photograph 248)*

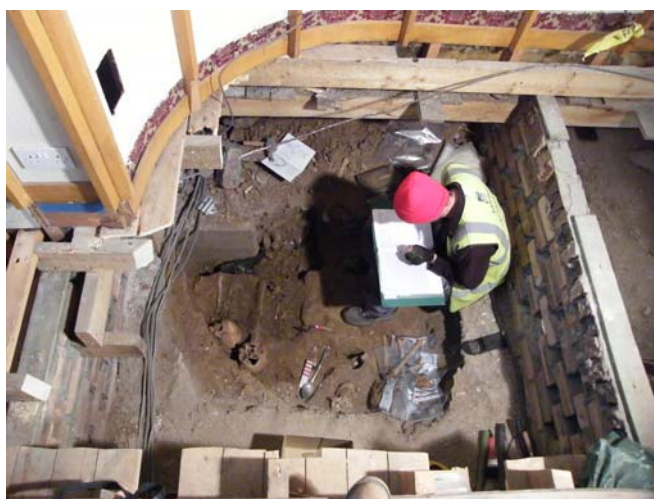
*Plate 24 Working shot looking E showing removal of
Skeleton #04 (Photograph 273)*

A number of Fe nails were recovered from around Skeleton #04, and whilst forming no distinct pattern, the presence of these and manner in which the skeleton lies indicates the existence of a coffin. The prominent cut [3007] within the natural remains of unknown function, although hit seems likely this must be an isolated survival of undisturbed natural which has perhaps survived successive excavations in this area.

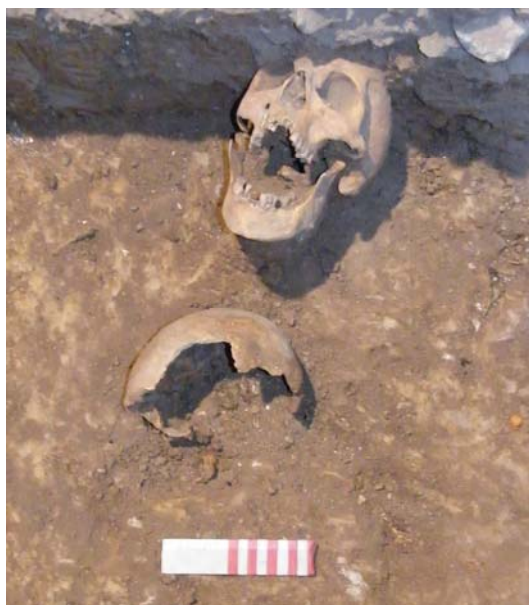
Plate 25 Mid-excavation view looking W of articulated ex situ skull SF037 (top) and cranium SF034 (bottom). SF034 is the head of Skeleton #06, the cut of which can faintly be made out to both N and S of the scale (Photograph 297 cropped)

As excavation continued, it remained impossible to discern cuts within the graveyard soil (3004). A great deal of care was taken around the skull (SF037) and cranium (SF034) visible to the SW of Skeleton #04, in particular that both seemed to rest on the correct W-E alignment and SF037 was clearly articulated to a spinal column and with lower jaw bone or mandible still in place. In addition, a line of degraded timber and shadowing in the soil to the S indicated the presence of a coffin, which it was assumed represented the S edge of a grave incorporating either SF034 or SF037. However, as excavation continued, it became clear that no further articulated remains were apparent in addition to the skull and cervical vertebrae. The skull to the E however (SF034) began to appear articulated as poorly preserved skeletal remains became apparent on the correct alignment to the E. This was subsequently recorded as Skeleton #06.

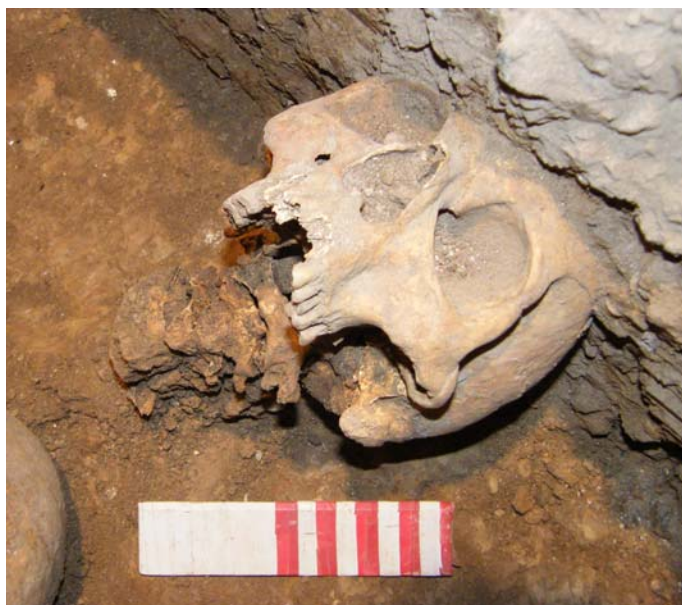
Plate 26 Skull SF037 post-removal of mandible. Note the articulated cervical vertebrae (Photograph 311)

The articulated nature of SF037 presents a number of possibilities. It is possible that the skull and vertebrae represent the vestigial remains of an inhumation truncated by the placement of Skeleton #06 to the E. However, the lack of charnel material recovered from the vicinity of Skeleton #06 makes this unlikely. What seems more likely is that during the digging of graves within the area, an inhumation was disturbed within ten or so years after it was interred. Still articulated by surviving tissue, SF037 was re-deposited, where it subsequently remained within the graveyard soil (3004).

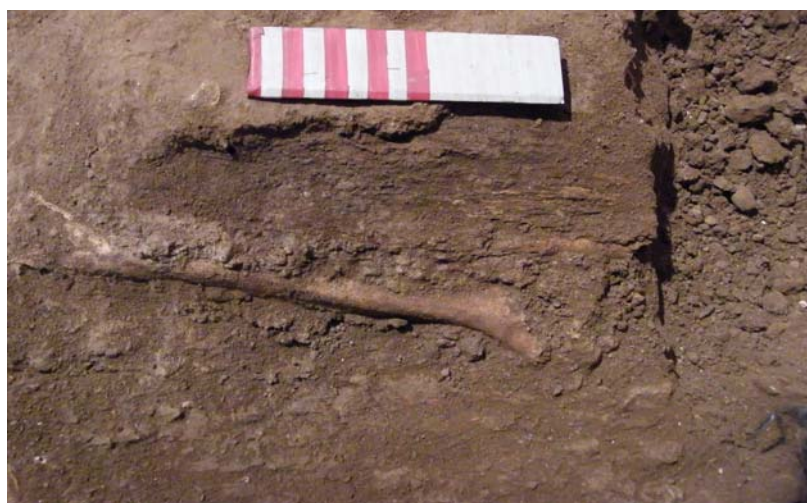
Plate 27 Coffin staining around Skeleton #06 (Photograph 321)

A coffin stain had been noted to the S during the initial investigations of SF034 and SF037 and was assumed to make up the southern limit of what became Skeleton #06. However, as excavation continued in this area it became clear that the limits of Skeleton #06 were not so wide and the southern limit of the grave in actual fact lay much closer to the bones. Continuing excavation around the stain to the S of Skeleton #06 demonstrated this to form the northern limit of a further inhumation – Skeleton #08.

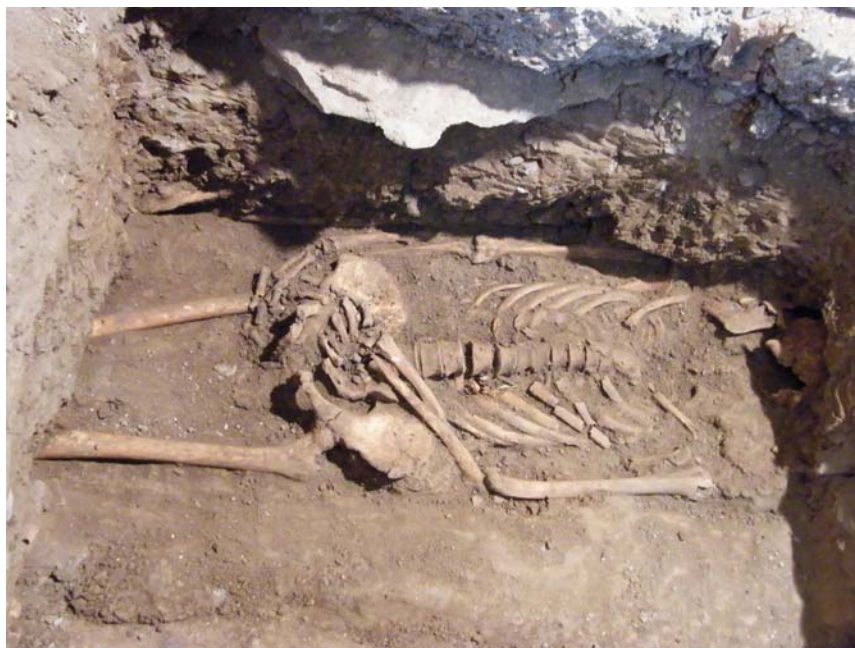
Plate 28 Skeleton #08 in situ (Photograph 339)

Skeleton #08 lay W-E within [3016], almost wholly underneath the sleeper wall dividing Bay 3 from Bay 4 necessitating the removal of this redundant wall and extension of Trench 3 slightly to the S. The skull of the burial survived in the E facing baulk whilst the W facing baulk directly overlay the body midway along both femurs. Buried in an extended supine position with the skull rolled slightly to the S and the face pointing over the right shoulder, Skeleton# 08 was clearly buried in a coffin and was male. The left hand rested over the pelvis, while the right lay on the right hip. A number of Cu fragments were noted within the fill (3015), although these appeared to be waste material rather than artefacts.

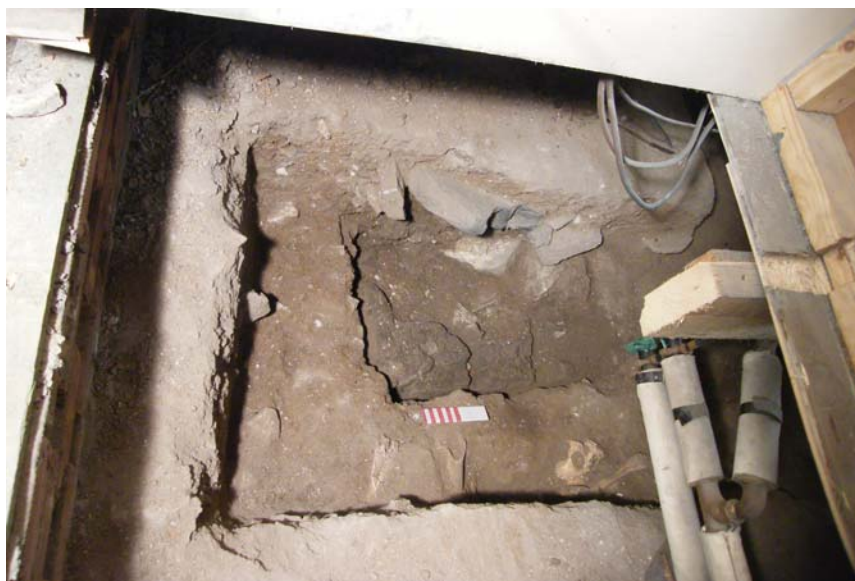
Plate 29 General view looking ESE across Trench 3 Bay 2. Note Skeleton #018 - a clear square-sided grave cut [3023]; Skeleton #017 immediately below the scale; and charnel pit [3030/3031] to the bottom right

It is likely that Skeleton #017 was cut by Skeleton #018. To the immediate E of Skeleton #017, a clear coffin [3026] was noted with very well preserved wooden sides. This lay within [3023]. Excavation to the required depth did not reveal any skeletal material and Skeleton #018 was allowed to continue resting in peace. The fill (3024) remained very firmly compact, but was much darker than seen elsewhere, in this case a grey black colour. Coffin nails were clearly apparent in the corners, driven through perpendicular to the sides.

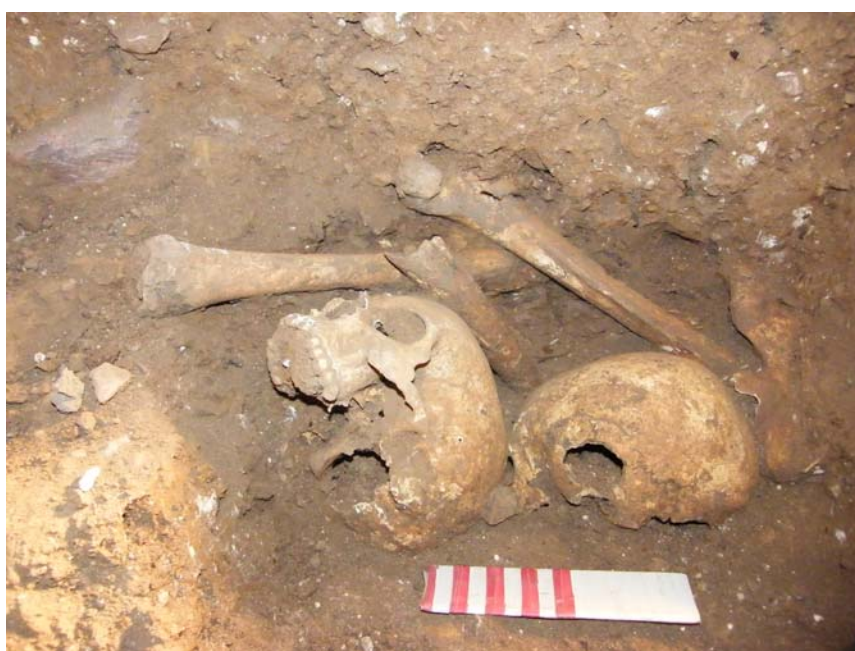
Plate 30 Charnel pit [3030] looking E including SF0124 and SF0125 (Photograph 451)

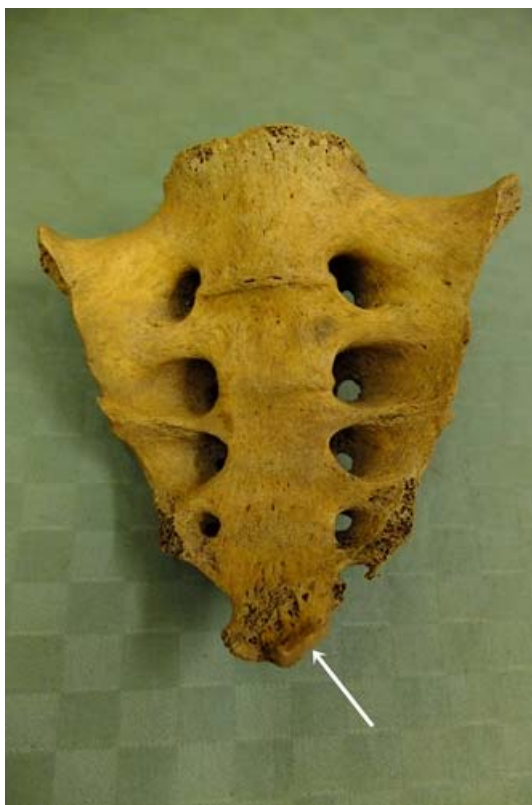
Plate 31 SK 05 fractured sacrum. The articular surface for the coccyx arrowed.

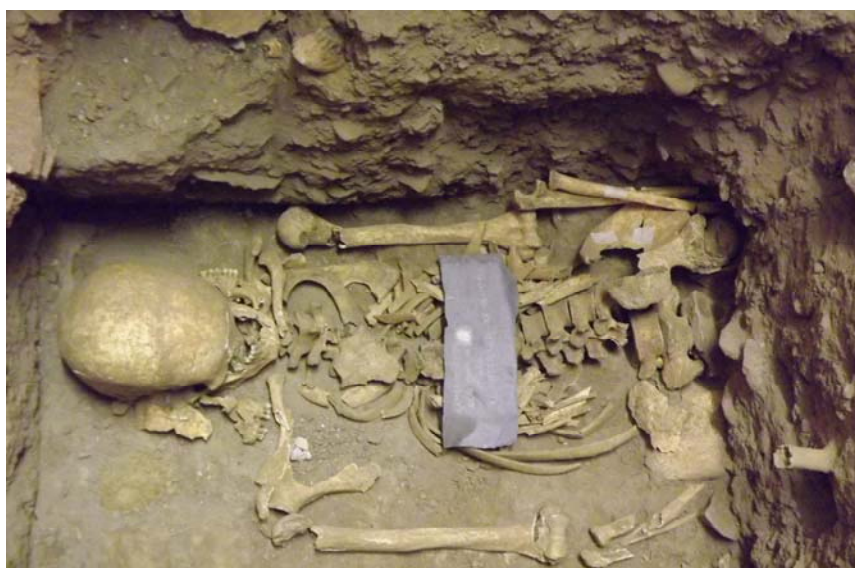
Plate 32 *Re-interment within Trial Pit 2 of Skeleton #01 from the evaluation stage*

The first task Addyman Archaeology had to complete was the re-interment of the disturbed skeletal remains from the evaluation stage.⁷ All skeletal material recovered from Trial Pit 2 were re-interred, with Skeletons #01 and #02 replaced adjacent to the remains still *in situ*. The skeletal material recovered by the Church from the Boiler Room Trench was also re-interred within Trial Pit 2. All assemblages were geographically separated and clearly marked with the use of slate panels with incised details.

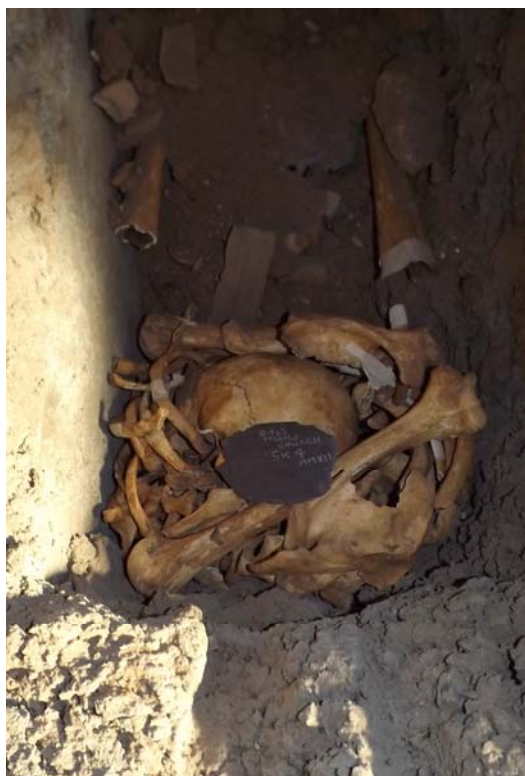
Plate 33 Looking E across Skeleton #04 being re-interred within [3003] (Photograph 465)

Clearly realising their error, the contractor had shovelled a small volume of semi-set cement from two areas of [3003] within Trench 3. The southern of these small areas (within Bay 3) was large enough to re-inter Skeletons #04, #06 and #08 – all the articulated skeletons from Trench 3. A number *ex situ* long bones recovered from [3003] and Bay 3 were also re-interred atop the skeletons. In addition a small volume of charnel material from Trench 3 could be re-interred within the second of the small holes in [3003] within Bay 2.

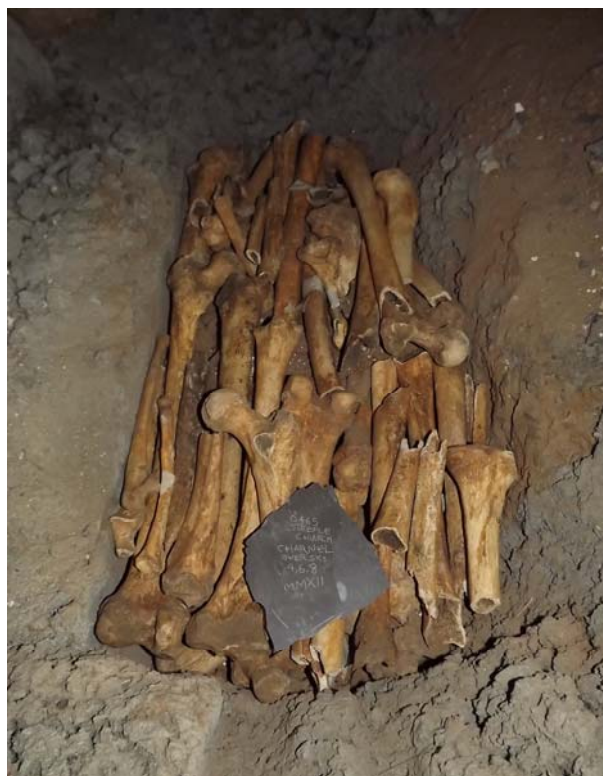
Plate 34 Charnel material re-interred within [3003] (Photograph 471)]

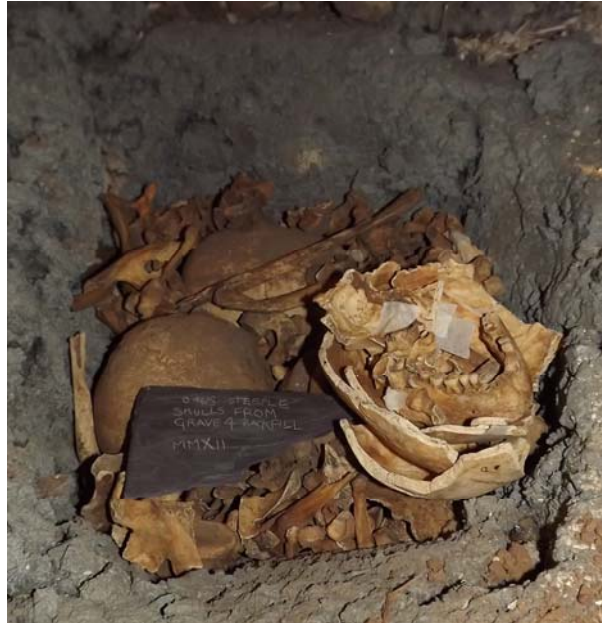
Plate 35 Charnel from Grave #04 re-interred within Bay 2 (Photograph 474)

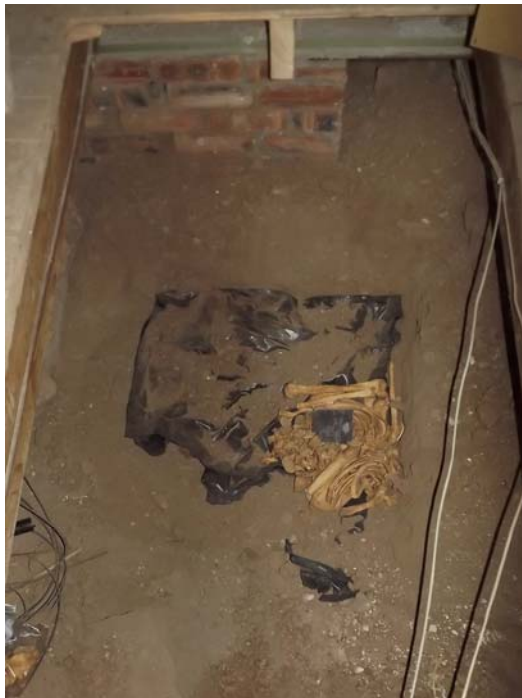
Plate 36 Looking N across Skeleton #05 re-interred within Trial Pit 2 (Photograph 465)

This left a significant volume of charnel material and all the inhumations from Trench 2 requiring re-burial. Trial Pit 2 from the evaluation stage provided the solution. Located immediately E of Trench 2, Addyman Archaeology had previously re-interred the skeletal remains from the evaluation stage and backfilled the Trench. This was re-excavated and all the bone material placed within. As with earlier re-internments, all assemblages were kept as geographically separate as possible and marked with incised slate recording their original location, the date of disturbance and record number. The Trench was re-instated and a cairn of stones and spoil placed atop to prevent any further intrusion.

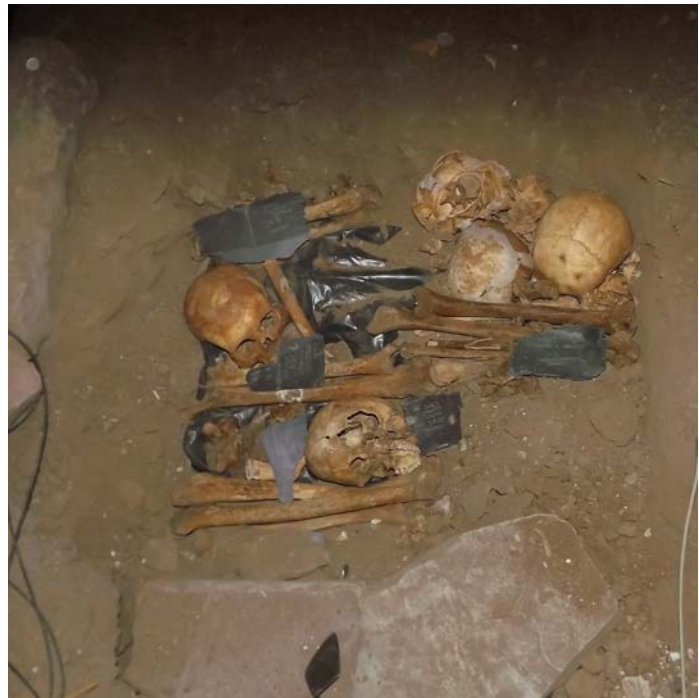
Plate 37 Skeletons re-deposited within Trial Pit 2 (Photograph 471)
