York Mint Yard, *City of York*

Archaeological Watching Brief on Engineering Trial Pits:

Data Structure Report

(project AA. 1953)

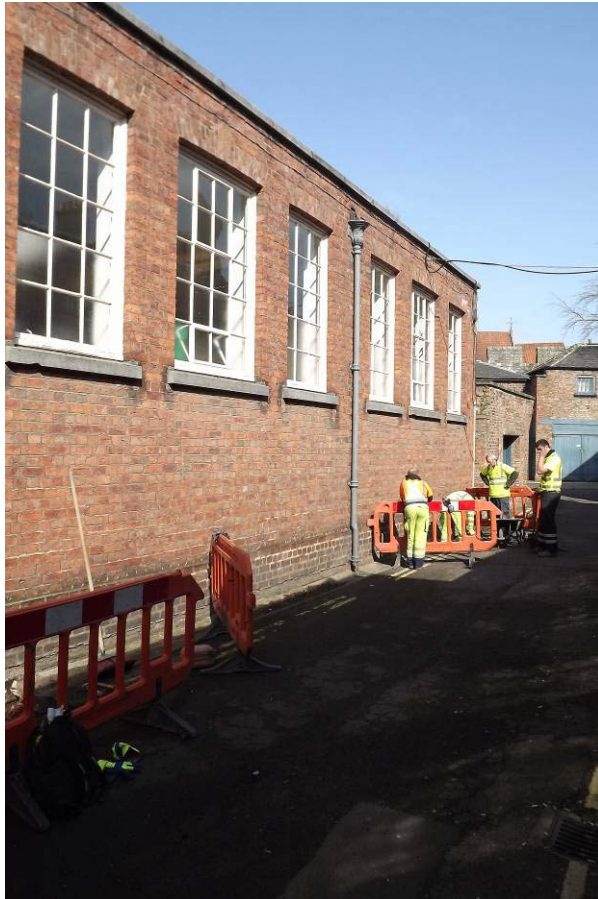
*Plate 1 Trench locations looking NW across site
(Photograph 004)*

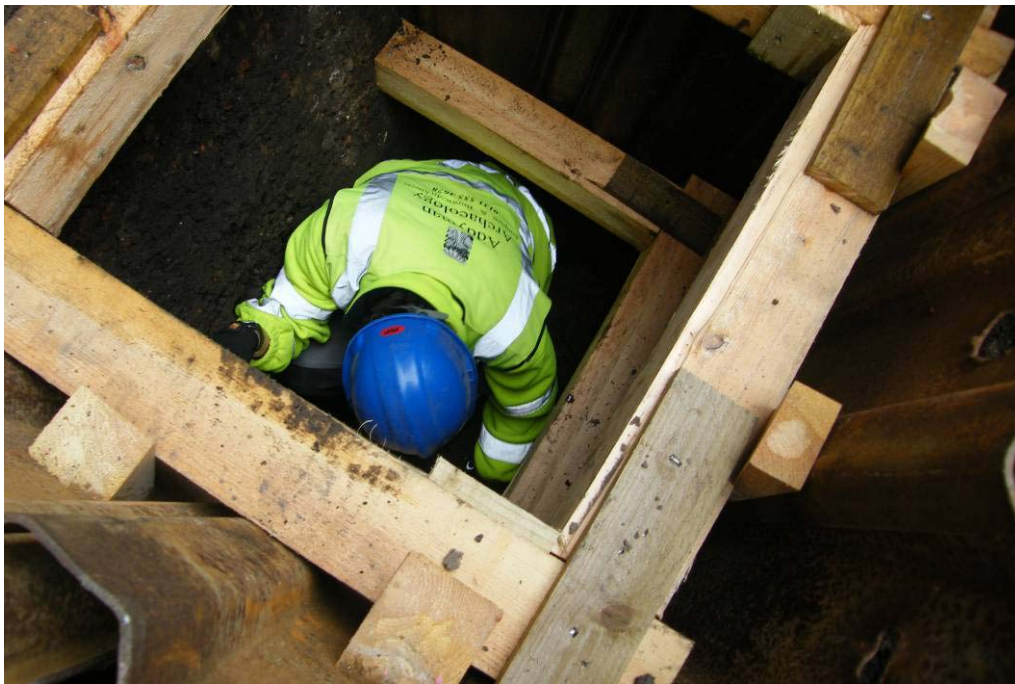
Plate 3 Working shot showing excavation of Trench 1

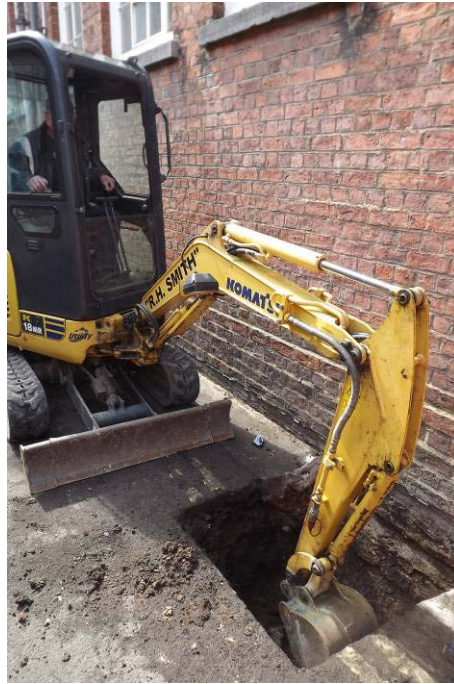
Plate 4 Machine excavation of Trench 1 looking S (Photograph 017)

Excavation in Trench 1 ceased when the base of the slightly stepped foundation was encountered at a depth of 2.15m

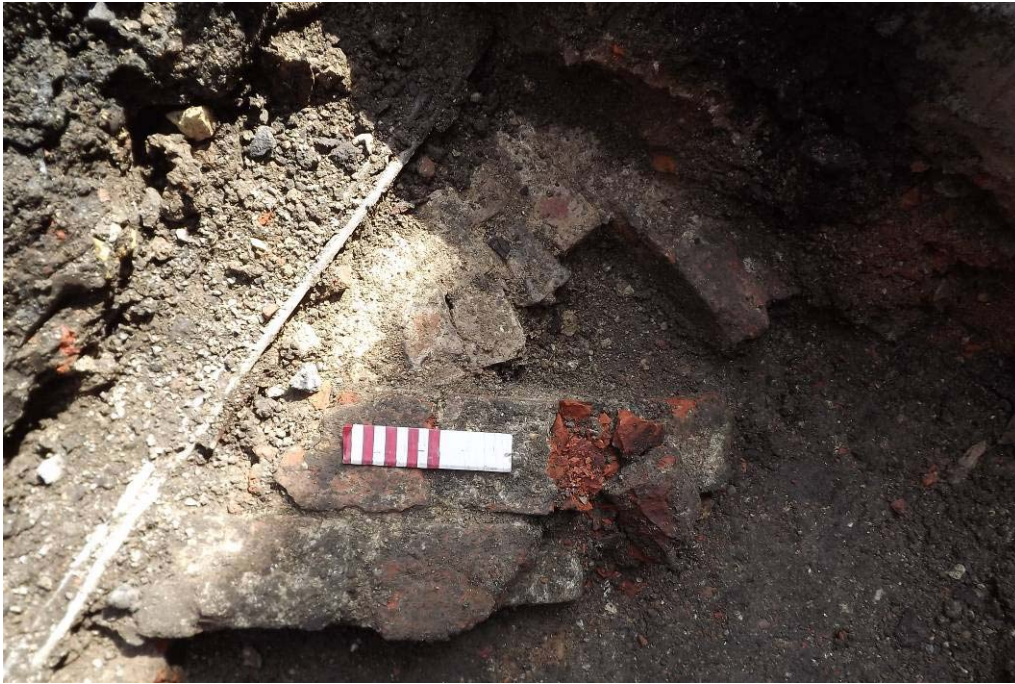
After removal of the modern 20th century road deposits (201), (202) was revealed to be a moderately compact white and light brown gritty mortar-rich sand, likely to be a landscaping and demolition deposit. This directly overlay the vestigial remnants of a brick structure {203} with associated brick flooring {209}. These were hand-made, orange red, unfrosted bricks of late 18th to early 19th century character.

Plate 5 {203} and {209} in situ looking SE (Photograph 23)

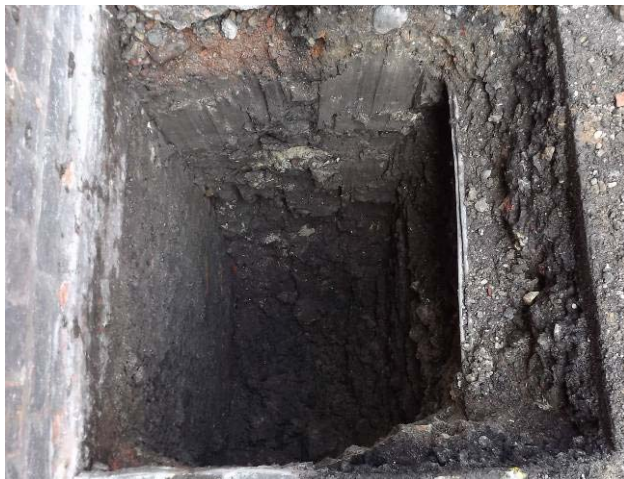
Plate 6 Post-excavation view of Trench 2 looking NNW and showing the SSE facing section (Photograph 044)

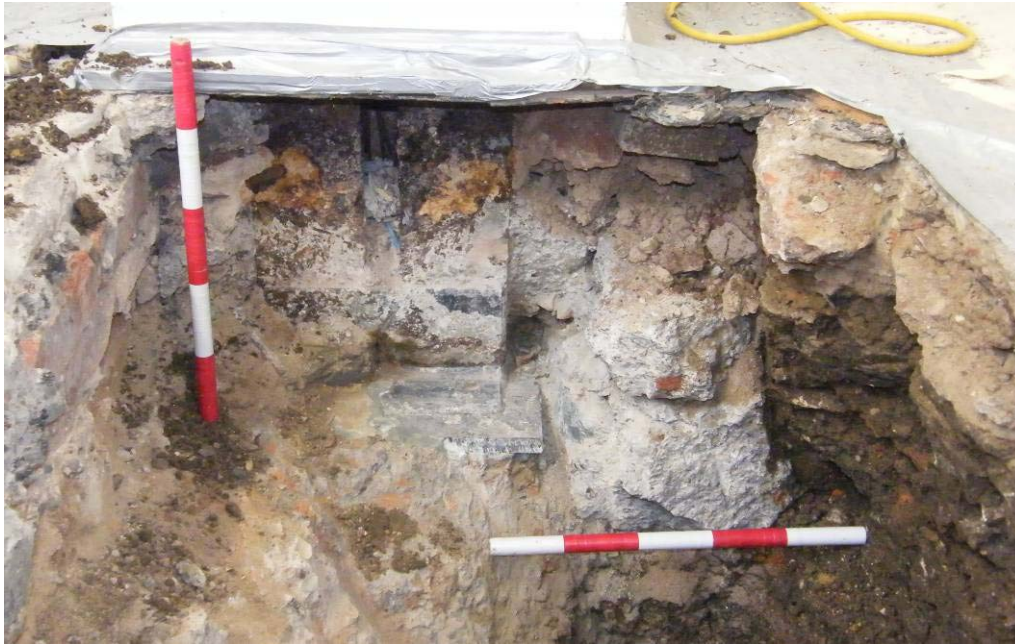
Plate 8 SE facing section of Trench 3 (Photograph 076)

Removal of the modern floor surface {301} was completed by the contractor prior to arrival on site and revealed a spread of reinforced concrete which was removed by use of a pneumatic breaker. This revealed the Fe structure of the upstanding pillar to begin at a depth of 0.5m below the floor surface. The Fe pillar and associated concrete were recorded as {302}. {302} rests directly atop (plate 8) a NNW-SSE aligned foundation wall {303}

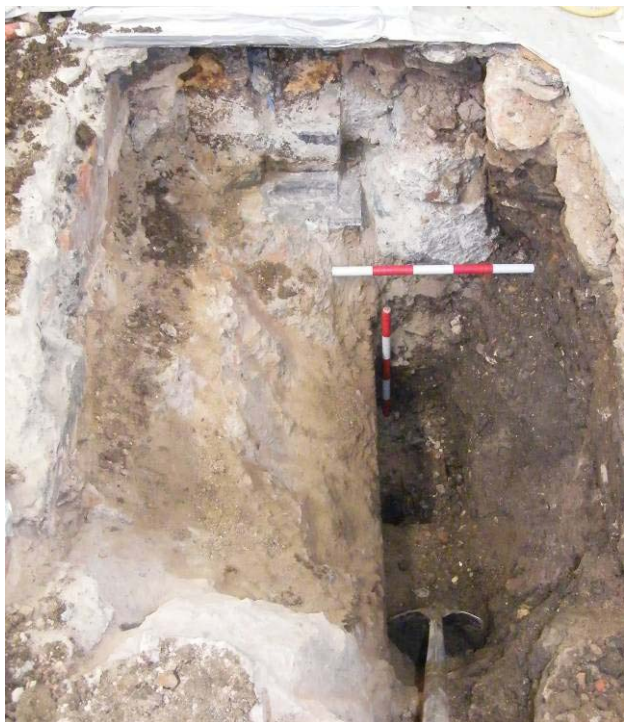
Plate 9 SE facing section of Trench 3 (Photograph 084)

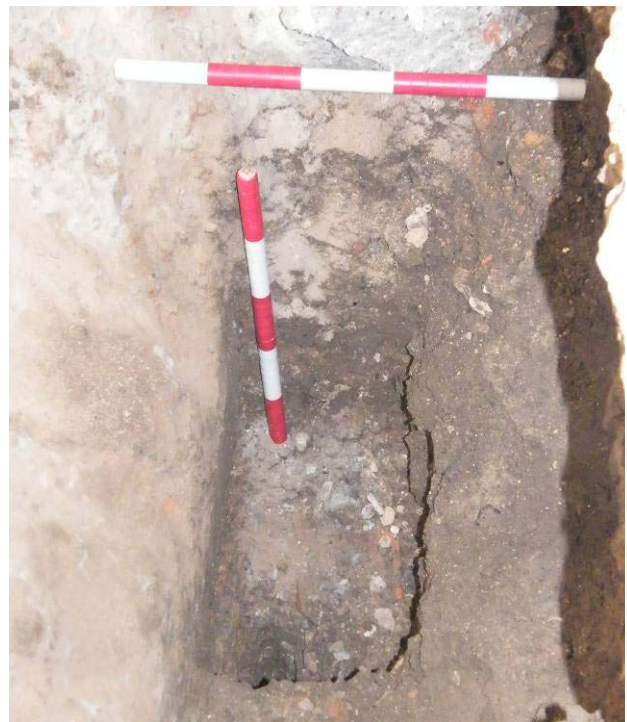
Plate 10 Post excavation view of slot through (304) (Photograph 085)

Excavation along the line of this wall revealed a deposit of mixed and mottled mid brown gritty silt abundant in stony inclusions and fragments of lime mortar – (304). Excavated in a slot to a depth of 1.3m below the floor level, (304) revealed no traces of archaeological material. It was unclear whether this deposit had been built up against the foundation {303}, or whether {303} had been poured into place against shoring, leaving the clean straight edge visible during excavation.

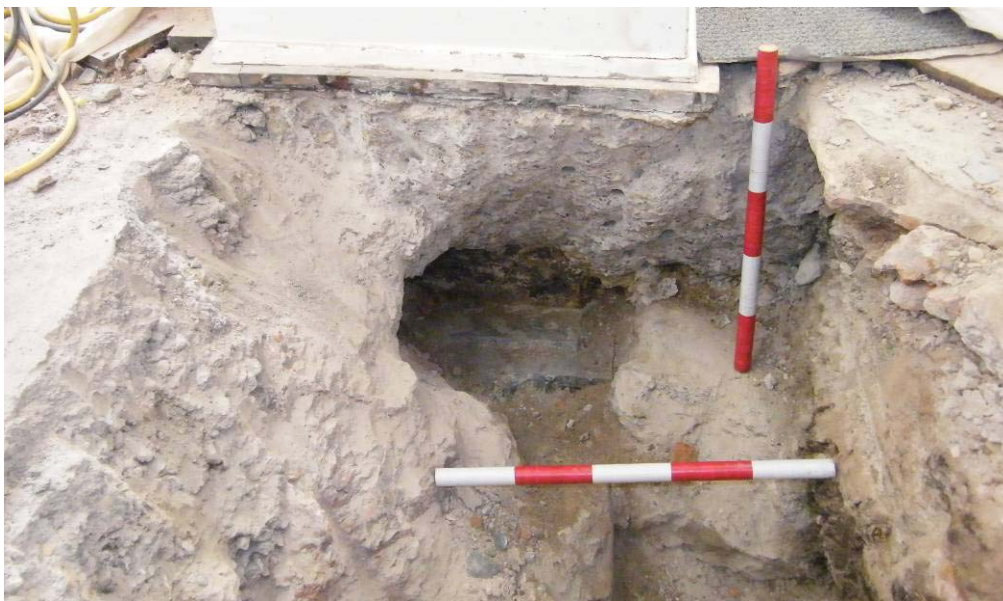
Removal of the floor surface {401} revealed the same thick deposit of concrete encountered in Trench 3. This was removed by a pneumatic drill and proved to follow the same pattern as Trench 3 with a concrete deposit {402} placed around an Fe load-bearing pillar and directly atop a concrete wall foundation {403} at a depth of c.0.5m below floor level (*plate 11*).

Plate 11 The base of pillar {402} atop concrete foundation {403} (Photograph 093)

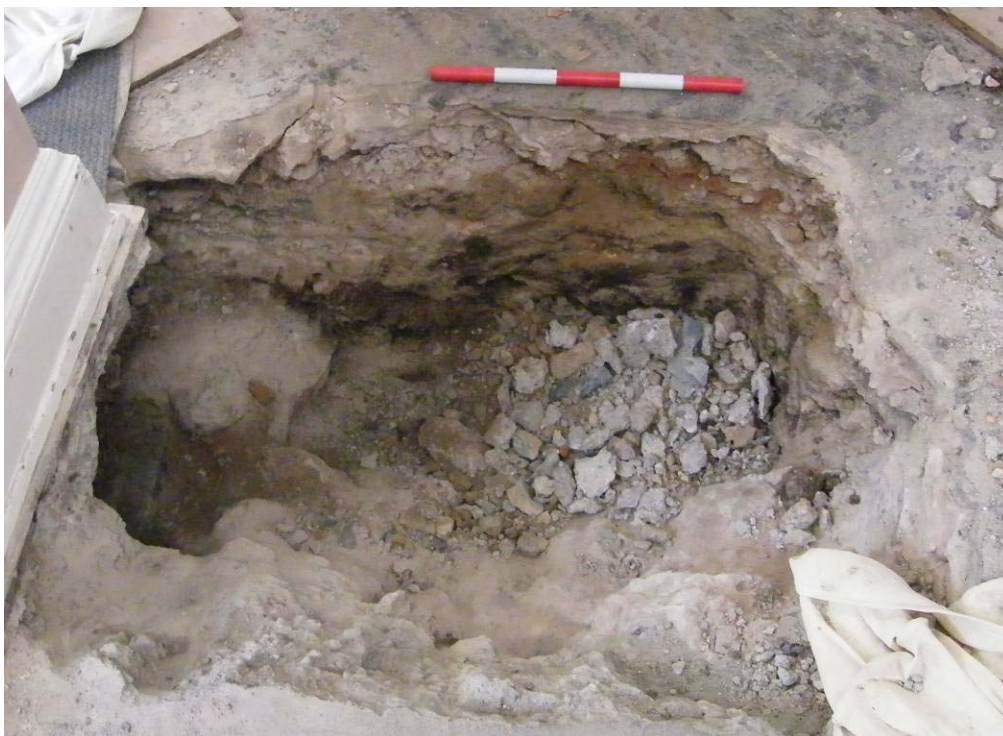
Trench 4 essentially mirrored Trench 3 in being essentially archaeologically sterile and composed almost entirely of concrete.

Plate 12 Post-excavation view of trench 4 (Photograph 100)

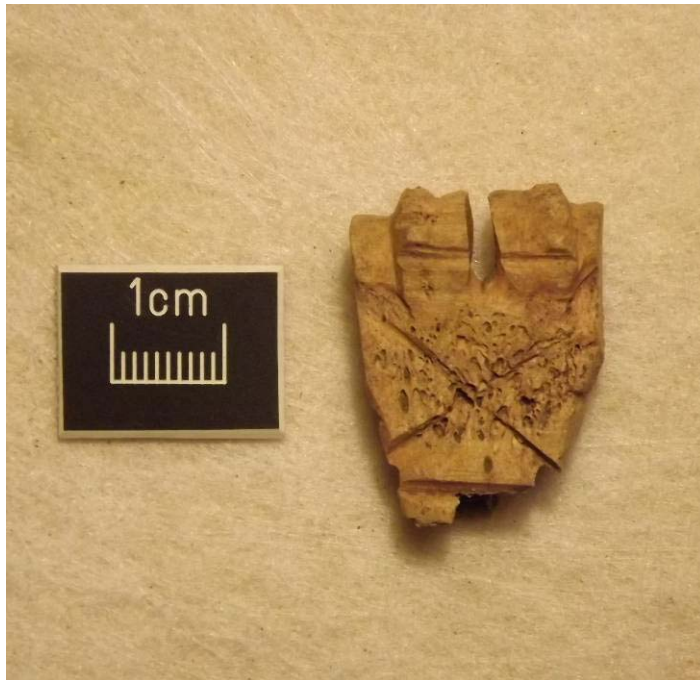
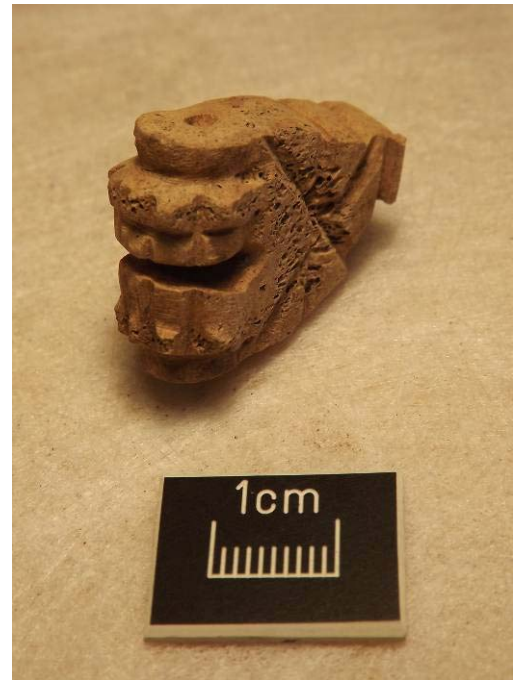
The item of worked bone from (104), SF003, was made from the distal end of the right metacarpal of a sheep. The preservation and lack of surface patina suggests that it was not much handled, and perhaps broke during manufacture.

Plate 13 Detailed view of SF003

Plate 14 Detailed view of SF003

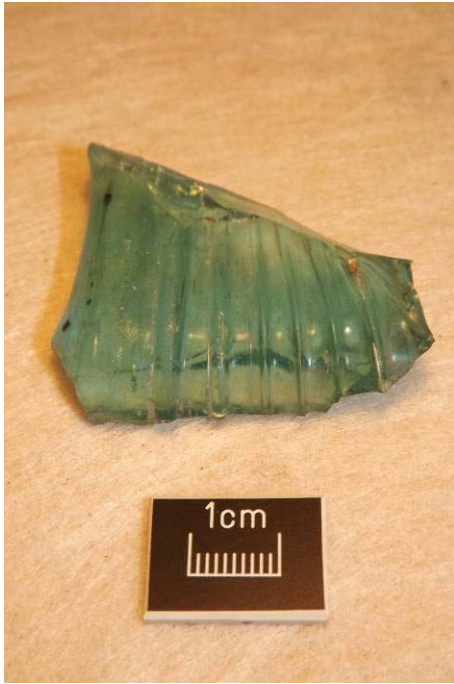
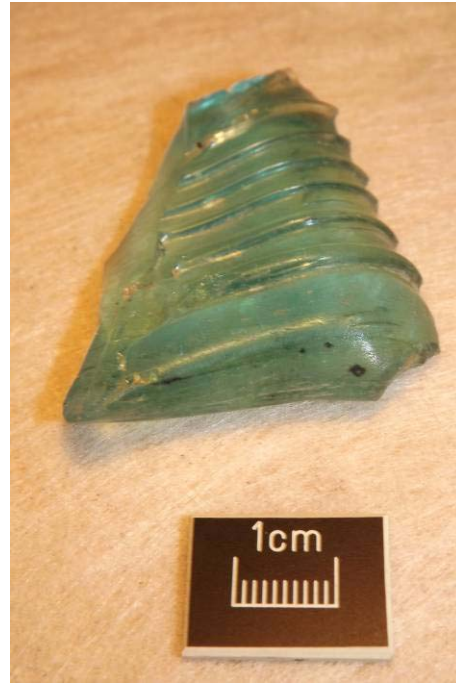
The assemblage of glass recovered from the trenches at York Explore was small and on the whole of limited archaeological interest. However, one fragment was of particular note. SF017 is a handle fragment of deep aqua glass from a free-blown Roman bottle and was recovered from the deep deposit of made-ground within Trench 2.

Plate 15 Detail of SF017

Plate 16 Detail of SF017

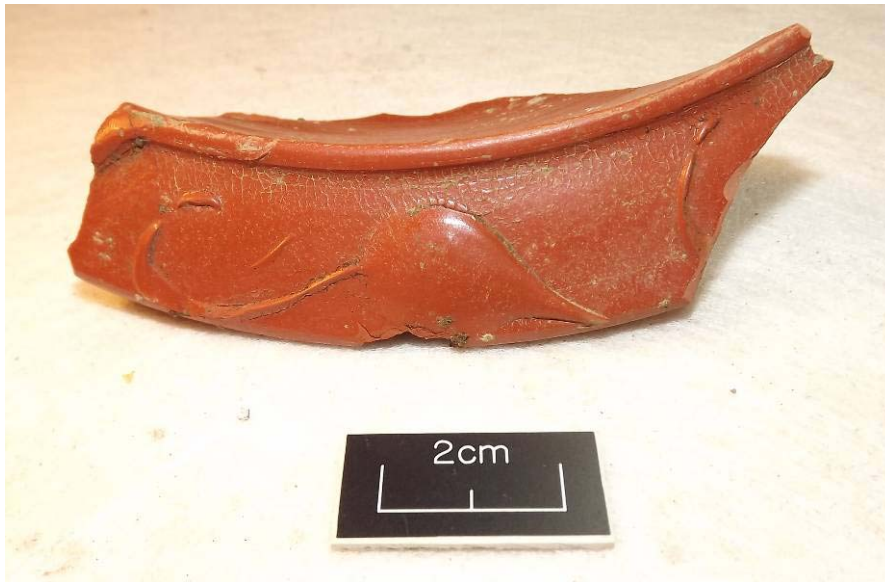
- 1 lead glazed red ware vessel. Medieval.
 - 1 miscellaneous red ware sherd. Part reduced. Medieval-17th century.
 - 1 rim sherd of *terra sigillata* (samian) ware with vine motif (*plate 17*).

Plate 17 Detail of ceramic – terra sigillata (samian) ware rim sherd from assemblage SF009

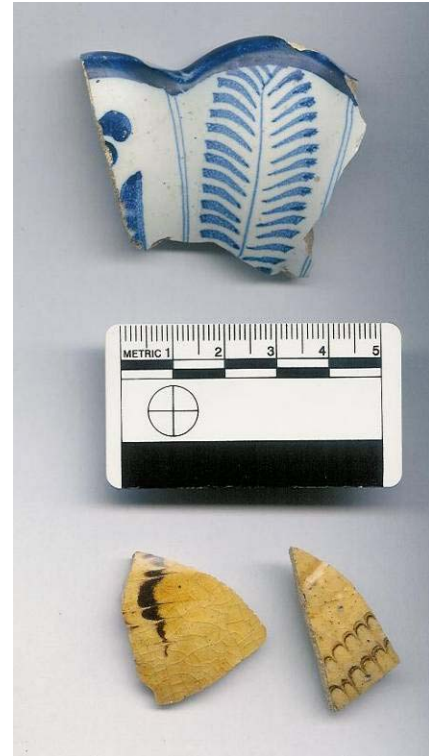
Plate 19 Ceramic sherds from assemblage SF005 (top) and SF001 (bottom)

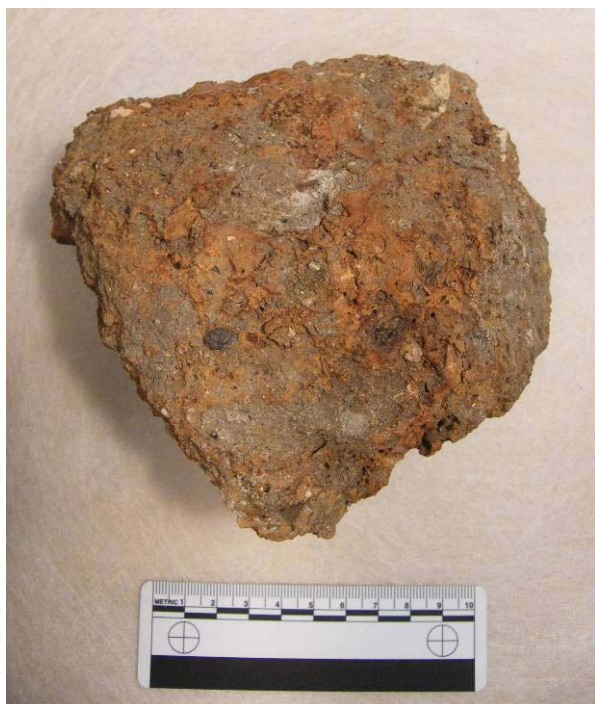
Five large concreted masses of iron were recovered, four from Trench 2 and 1 from Trench 1. Those in Trench 2 were recovered from the very base of the Trench, all in wet and damp conditions. Preliminary assessment indicates they are more likely to be 'hearth bottoms', or the material collected at the bottom of a fire, and not corroded objects as such, but further analysis will be required to determine this.

Plate 20 Large Fe object SF016.1

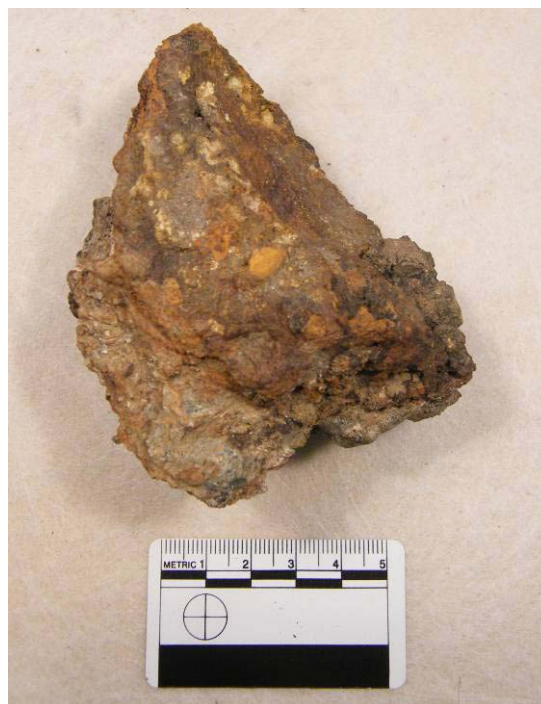
Plate 21 Large Fe object SF016.4
