Ford Colliery engine houses
Northumberland

Volume 2:
Historic Building Survey and Analytical Assessment

for Ford and Etal Estate

Final Report January 2013

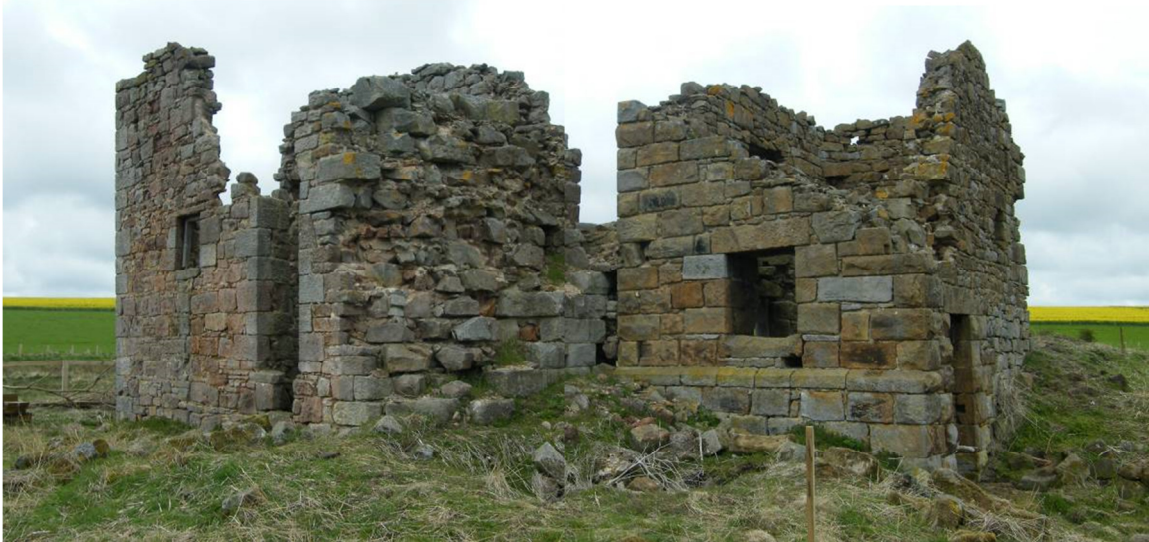
Figure 2 The two engine houses with the rubble-clogged pit head between, looking NW

The Moss Pit pit shaft lies at the reentrant at the junction of the two engine houses where a circular depression marks its site. The shaft head is presently obscured by debris, evidently deliberately pushed in to cap the shaft. Much of this material apparently comes from the adjacent walls of the engine houses themselves – perhaps their upper parts and, particularly, from the massively constructed eastern wall of engine house 2.

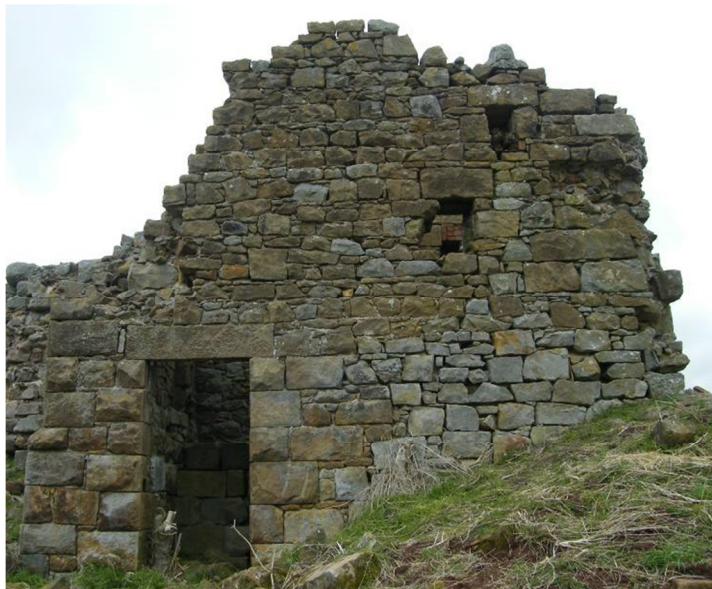
This rebuilding of the earlier structure perhaps reflects the installation of a later generation of machinery. There are a number of openings and apertures within the later fabric, particularly within the west and east walls, that were deliberately formed during its construction. To the east this includes the existing ground level entrance and two smaller rectangular openings built high up possibly for pipe work from the possible boiler house to the east. To the west at first floor level there is a broad rectangular opening incorporating a stoutly formed embedded timber frame (Figure 5 and Figure 6). The sill of this wide opening preserves the bolted seatings for two axle housings; the base of one of the axle housings remains *in situ*. The timber lintel is failing, causing the masonry of a window opening above to fail in turn, its displaced southern jamb now hanging precariously.

Figure 3 Engine House 1: east exterior; Figure 4 south elevation, with pit shaft in foreground

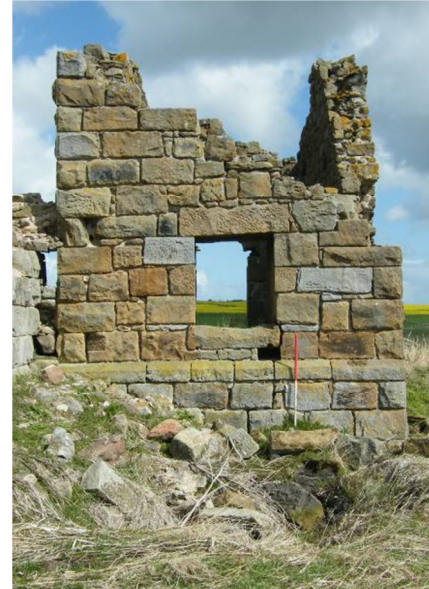
At about 0.95m thickness the southern wall is massively constructed in contrast to the other walls of the structure (at 0.50m). This, the bob-wall that formed a principal support for the machinery above the pit-head, rises from a projecting base (1.10m thick overall) that is detailed with a chamfered plinth course. On the exterior face of the surviving masonry of the south wall some cut sockets and trimming back of the wall face can be seen in the area of its principal feature, a centrally-positioned large aperture. The sockets presumably relate to mechanisms above the shaft head. To the west of and below the opening a neatly cut socket cuts in at a steep angle to the masonry; a possible second one sits at lintel height. Two small cut seating holes are cut into the base of the sill of the opening, with a larger socket below. The face of the upper parts of the opening have been trimmed back flush to the line of the general wall face.

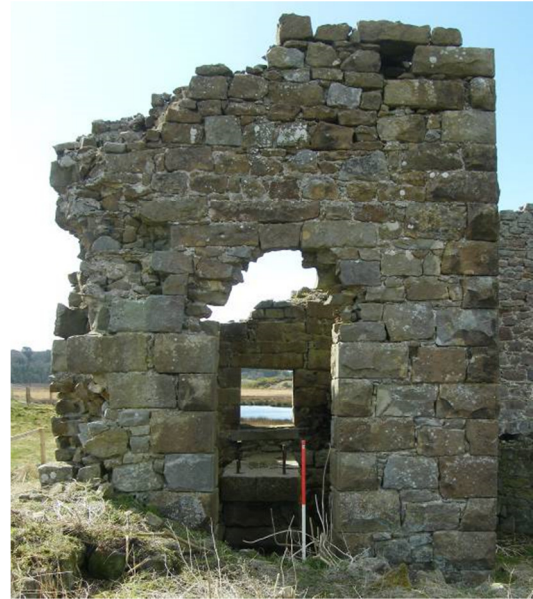
Figure 6 north elevation

On the north elevation an entrance leads into the building at first floor level; the top of the machine plinth lies at this level. It is clear that between the plinth and the entrance there had existed a partial timber floor. Joist sockets cut into the north wall, etc are patched around with brickwork of 19th century character.

The door was linteled over the interior with timber, the eroded stub of the timber lintel remains. The exterior may have been linteled with stone but the façade has now fallen. The quoining of the NE corner has largely gone, possibly the structures to the north were latterly tied into the corner and when they collapsed the rubble work of the original build was exposed

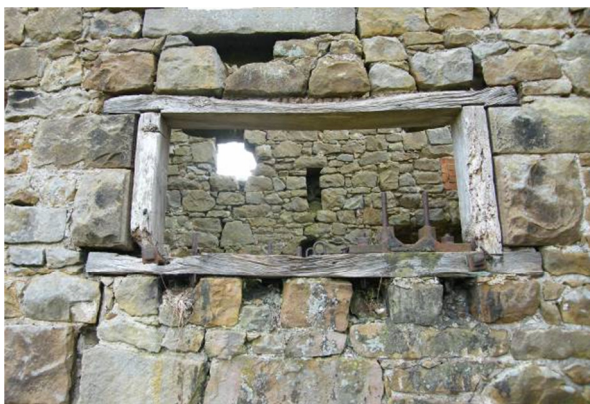
Within the lower opening in the west wall four vertical bolts remain *in situ*; the southern two hold down the lower half of a cast iron axle housing. It is likely that the northern two held something similar though they are not parallel. Some black substance, perhaps residues of grease, can be seen in the vicinity of this housing, dripping down the wall face from it.

Figure 7 *In situ* axle housing, exterior of west wall

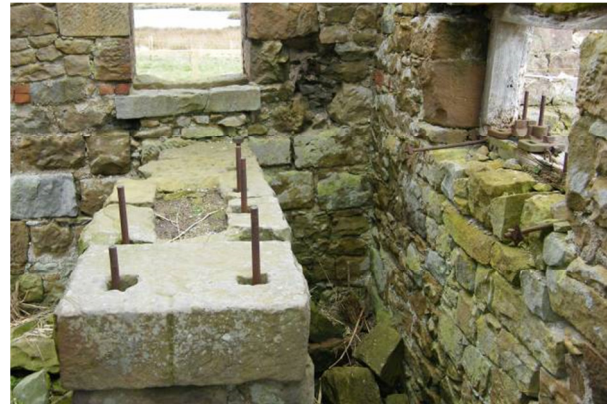
Figure 8 Interior with curved cut in plinth top

Centrally set within the southern part of the interior is a stout masonry plinth, aligned N/S and capped with substantial squared blocks (Figure 8). The latter are held in place by a series of iron uprights set within drilled holes. In the centre of the plinth top there is a shallow curved cut depression 0.39m wide and 1m long; this had evidently been cut to accommodate rotating mechanical apparatus. The position of this cut corresponded to the line of the surviving iron axle housing within the opening in the west wall. The cut depression (and associated wheel?) were set on the central axis of the structure, and also aligned with the aperture in the south wall.

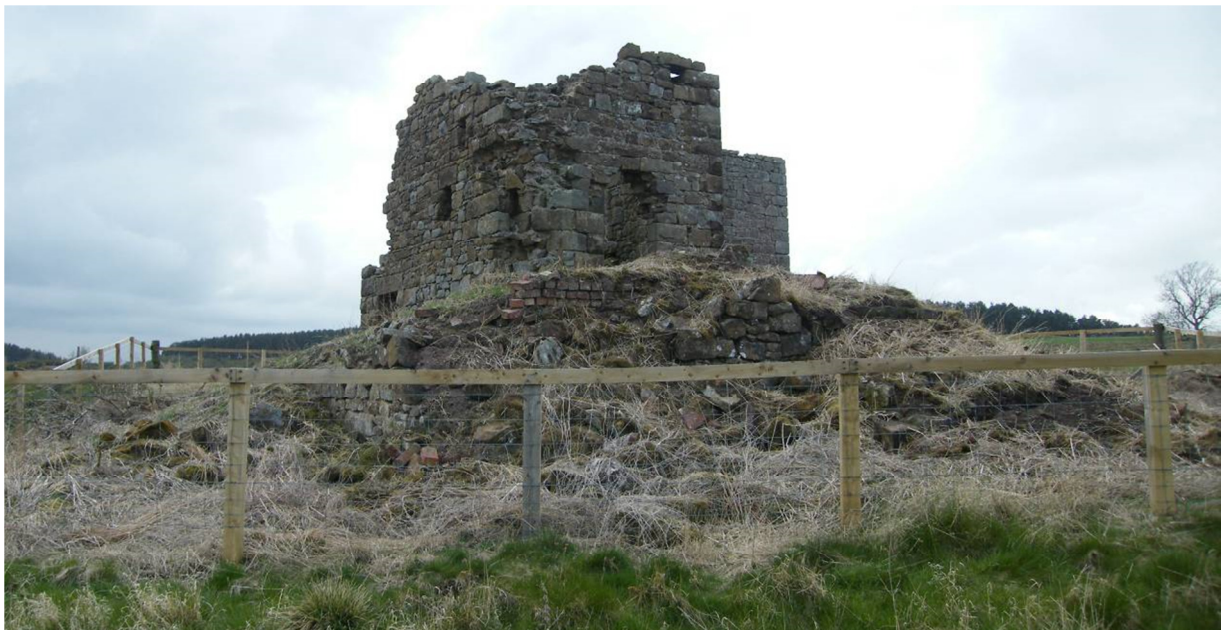
The footings of another structure lies against the east wall of engine house 1, extending further to the north for some distance (Figure 9). This associated structure may have been a boiler house, tank, coal store or workshop. It was possible to define the leading edge of its wall top to the north, east and south; this survived to a greater height to the east and north. The wall foot is obscured by debris in all areas and it is thus unclear how high the remains still stand – possibly up to 1.5m – 2.0m in some places. The building measured 9.86m N/S by 3.40m in width to its exterior faces. Within the northern interior of the structure alignments of brickwork were visible at the surface at two points (one, off-set to the west, N/S aligned (Figure 10); the other towards the N end, E/W aligned). It is possible that these formed parts of the basal support for a boiler.

Figure 9 Remains of structure (north side) in foreground, with brick lining part exposed

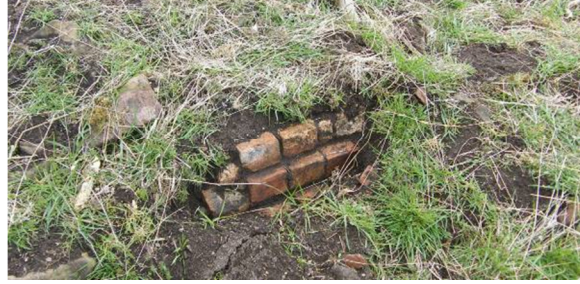
Figure 10 Remains of structure alignment of brickwork on west side, partly exposed

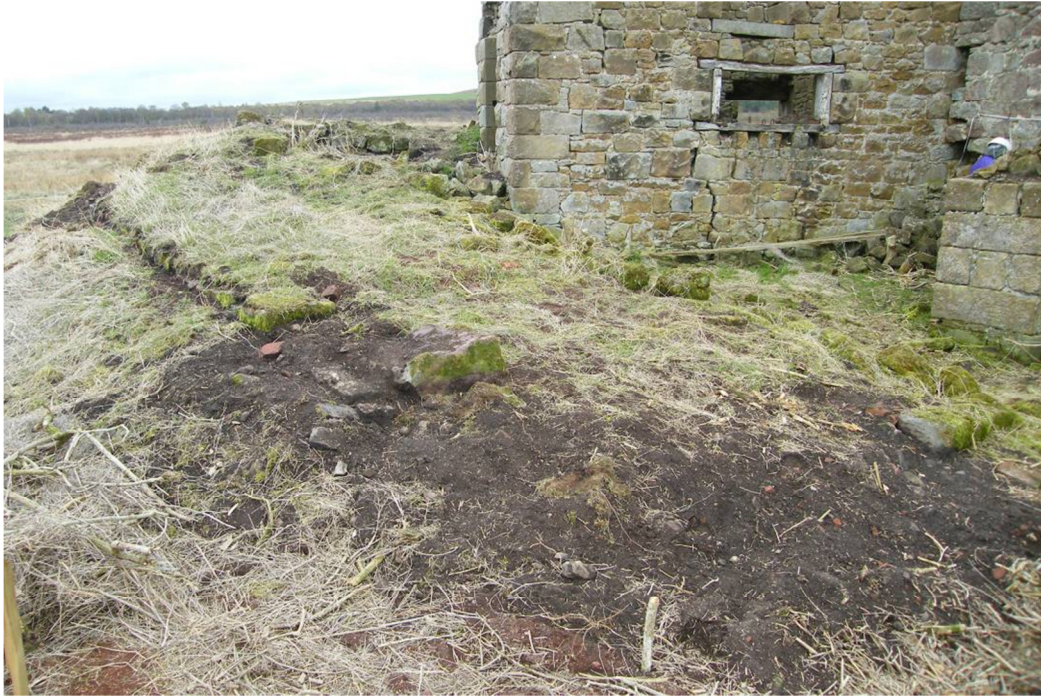
This feature was accessed by what appears to have been a broad ramp-like feature rising gently from the WSW for a distance of 8m – 10m (Figure 11). Sections of retaining walling on either side are visible at the surface at points, most exposed to the SE; these indicate the width of the feature to have been some 3.6m – 3.8m. A gap between the ramp and the engine house at its NW corner seems likely to have been occupied by a stair, now choked with debris (Figure 12).

Figure 11 Ramp to the north and NW of engine house 1

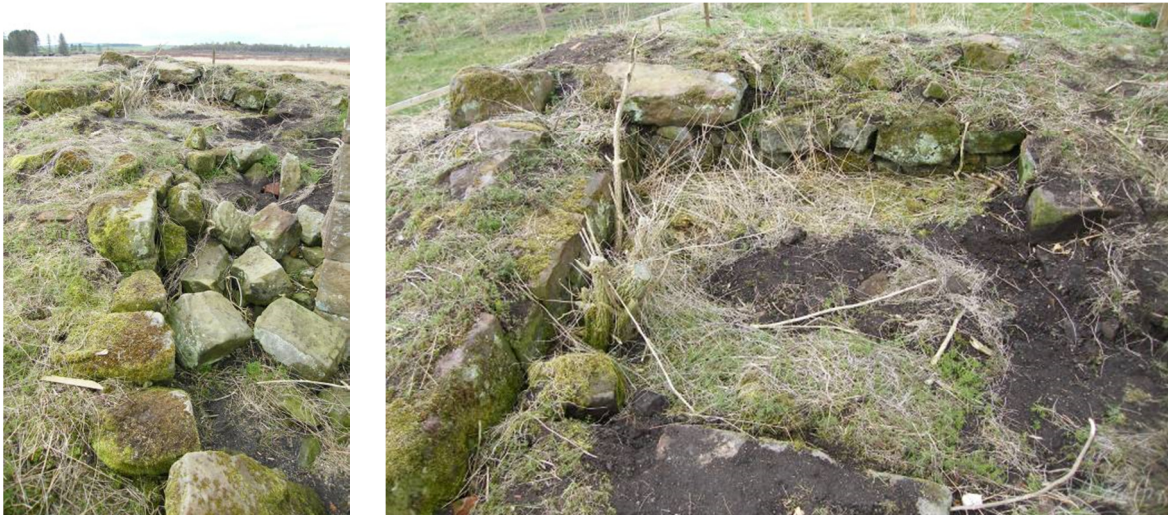
Figure 12 Possible site of stair at NW angle of engine house 1

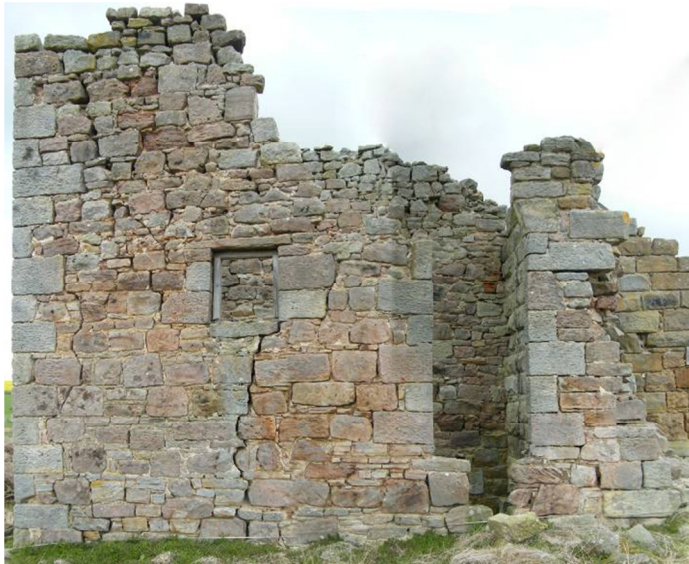
Figure 14 Engine House 2 south elevation

Engine house 2 is an E/W aligned structure that lies at right angles to engine house 1, its NE corner abutting the SW corner of engine house 1 on its west side (tied in at two points); in plan the structure measures 7.35m by 4.0m. The massively thick east wall – the bob wall – rises adjacent to the pit shaft. The wall is some 1.5m thick, with two further steps towards the wall base internally. The other walls of the structure are of some 0.5m thickness. The structure is formed of mortared sandstone rubble that is generally grey to reddish brown in colour, becoming a more purple hue on its north side. The quoining and facing blocks of the east gable is of generally of a grey sandstone. With the exception of earlier walling incorporated within its north wall this structure is of a single build. To the west its walls still rise to a height of over 6m; further east this decreases to 4m – 5m overall. The exterior face of the east wall has been extensively reduced; however enough remains to demonstrate that this had been faced with cut blocks laid to courses; the construction is of similar character to the internal face of the same wall.

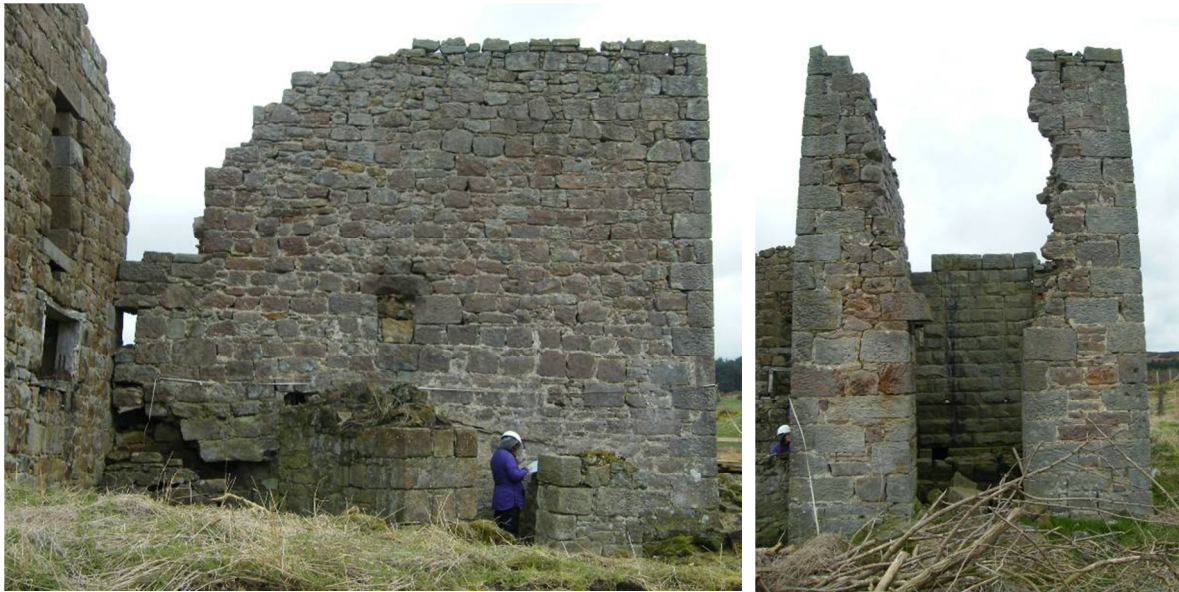
The north elevation had a small opening built within the masonry in the centre north above a small lean to structure and a possible window / opening at the NE corner only the west jamb survives.

Figure 16 Engine House 2 north elevation

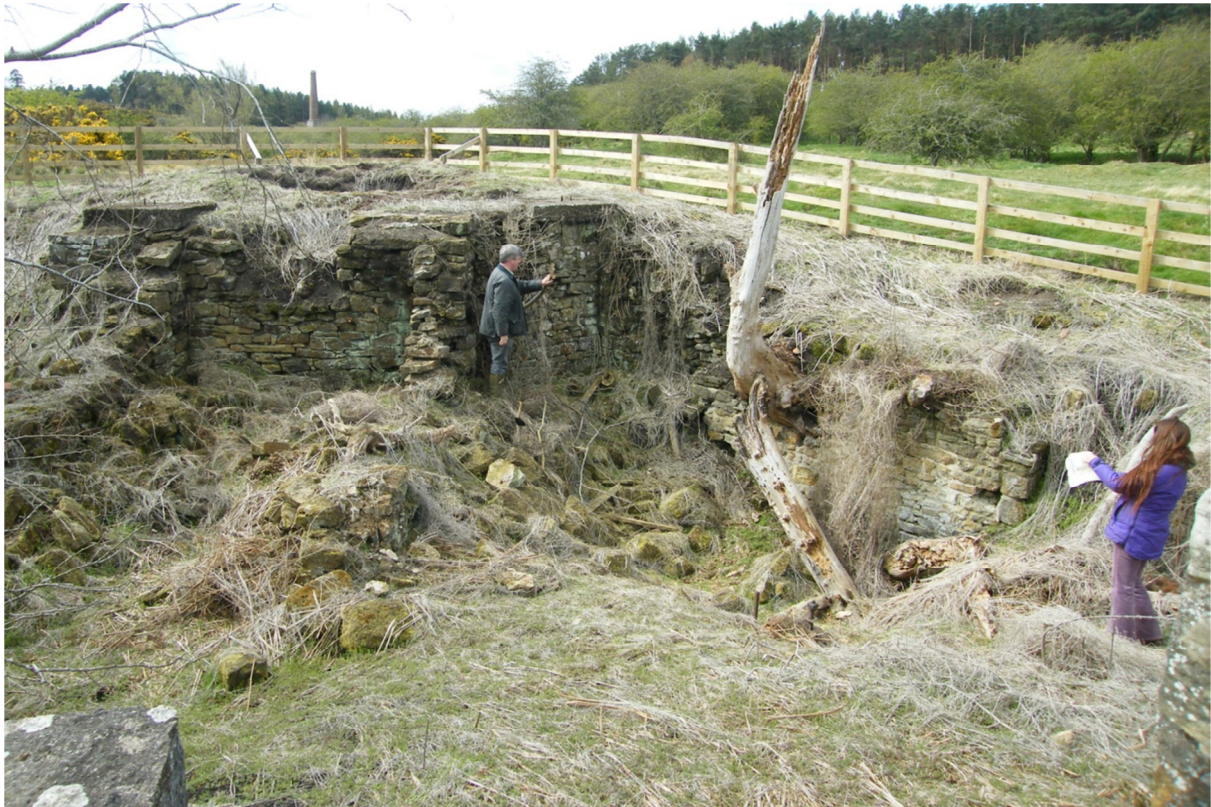
The structures recorded at the Temple Pit are far more fragmentary than those seen at the Moss Pit. The remains occupy the interior and sides of a broad hollow some 25m in diameter (E/W) by about 11m (N/S) located upon the rising ground a short distance above the NW perimeter of Ford Moss. The remains comprise the lower walling of various structures of mortar-bonded masonry composed predominantly of buff-coloured sandstone rubble. Other remains at the site, of considerably more recent date, are of concrete construction and correspond well with documented early 20th century re-use of the pit.

Figure 18 The Temple Pit engine house structures looking S.
