# Culross Palace

*Culross, Fife*

*Historic Building Recording and Analytical Assessment CUR/12/1*

The National Trust for Scotland

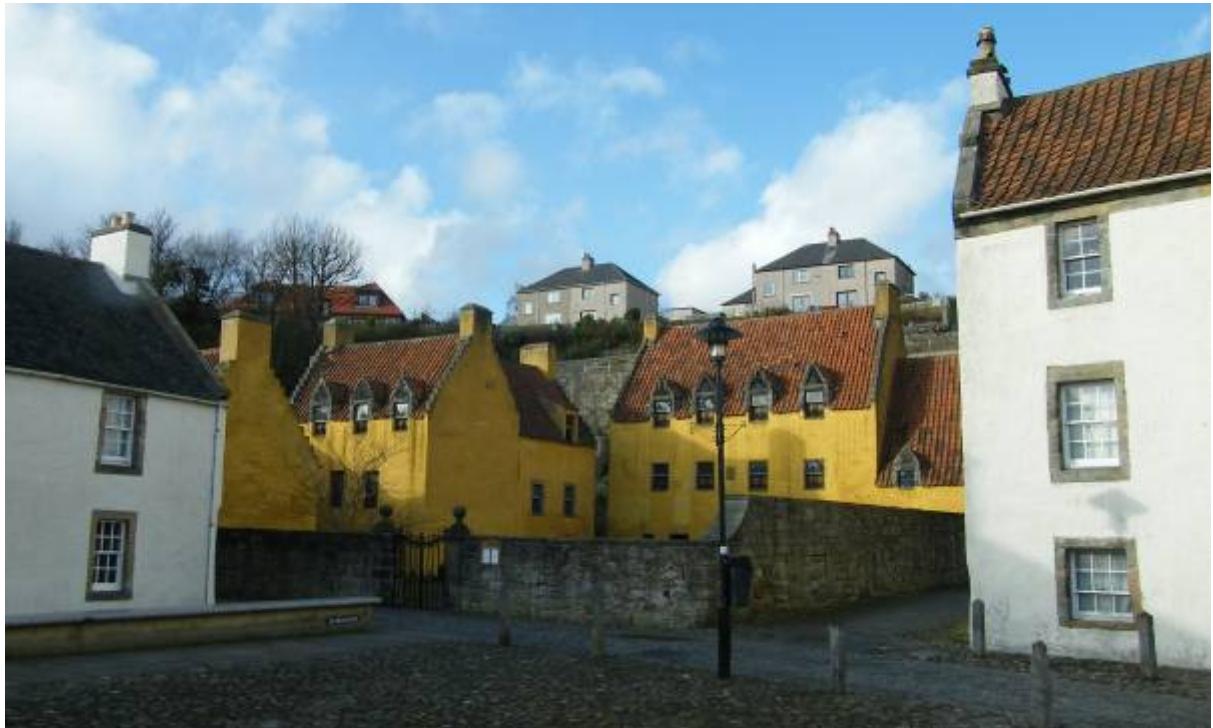
*Figure 1 – View of Culross Palace from SE. The 1597 West Range is the main building on the left, showing the three dormers. The North Range sits to the north / right with its south façade of four dormers.*

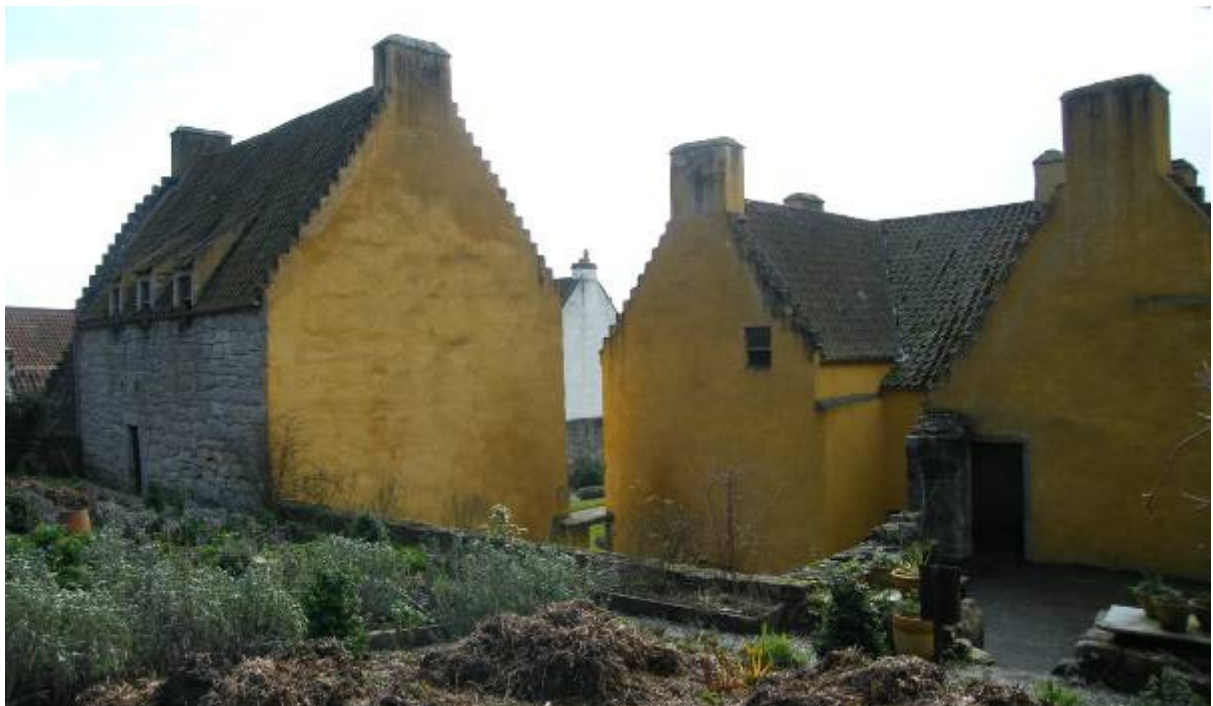
*Figure 2 – View of Culross Palace from NW, the rear garden, before the stripping of the W gable. The N elevation had already been stripped in 2007. The rear of the West Range complex and inner courtyard below are shown to the left.*

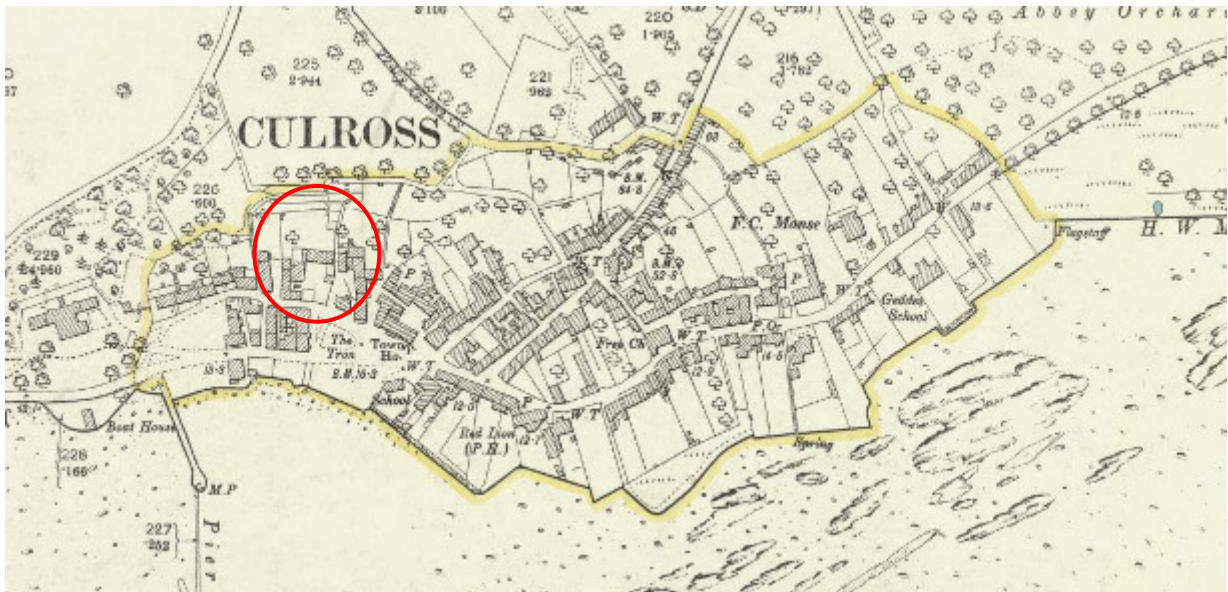
Figure 6: Second Edition OS Map, 25-inch scale, Fifeshire, Sheet 037.12, revised c1895, published 1896. NLS.

By the time the 1<sup>st</sup> Edition OS map was revised (1895), the outbuilding to the E (the so-called Garage Bothy) had been separated from the courtyard ensemble and a small square structure had been built to the S of the E extension. The plot boundaries at the rear had been dissolved (*Figure 6* and *Figure 7*).

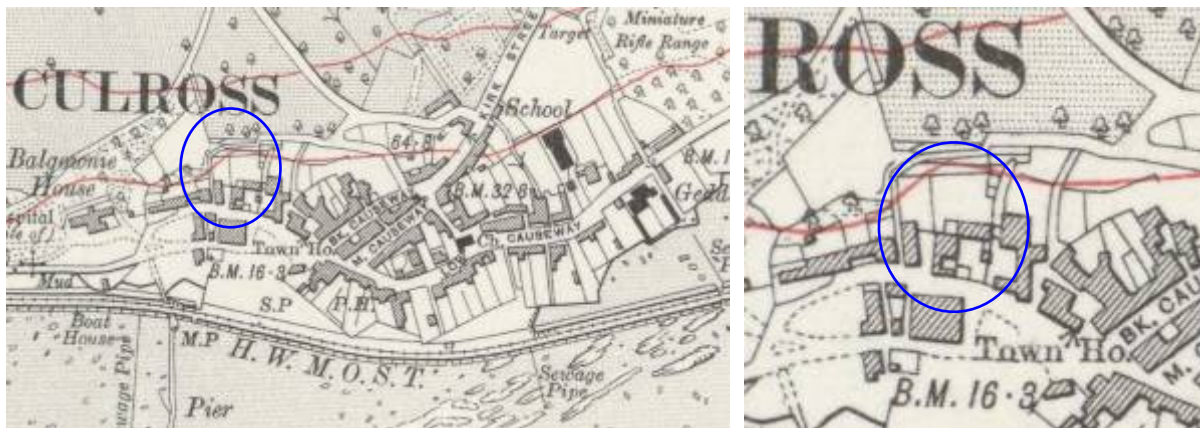
Figure 8 – Third Edition OS Map, six-inch scale, (general to right, detail to left). NLS.

Investigations related to the 19<sup>th</sup> century so-called “Garage Bothy” to the E of the site revealed the foundations of two unknown walls, associated with 16<sup>th</sup> to 17<sup>th</sup> century finds. The conclusion was that previously unknown structures of at least 17<sup>th</sup> century date seemingly existed underneath the present bothy structure. These may relate to a putative East Range, perhaps related to blocked openings and earlier fabric apparently surviving within the E boundary wall of the main courtyard. A summary of the reported investigations (as of October 2012) is given in Appendix A (compare later map regression for survival of structures on E side of main courtyard, e.g. *Figure 8* and *Figure 9*).

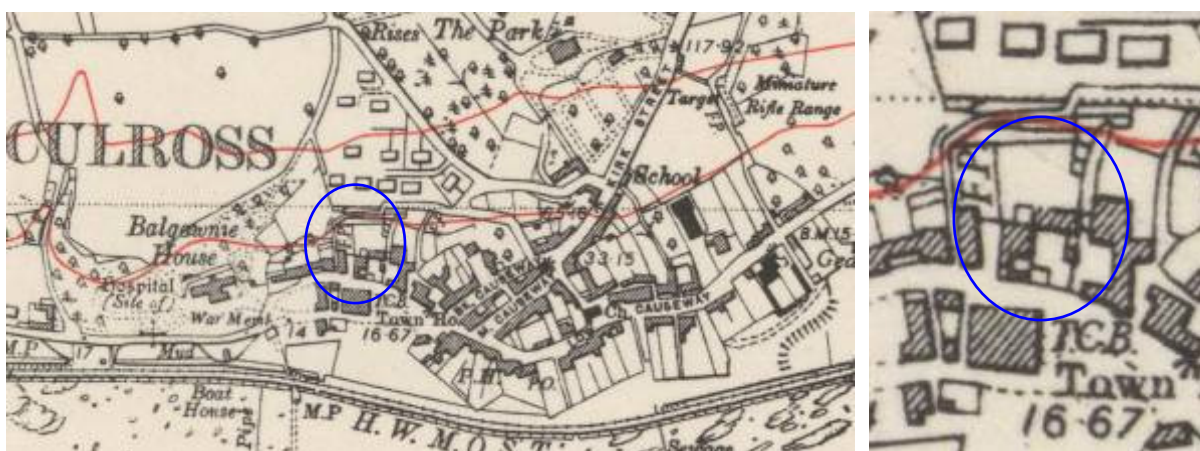
Figure 9 – OS Map revised in 1948, six-inch scale, (general to right, detail to left). NLS.

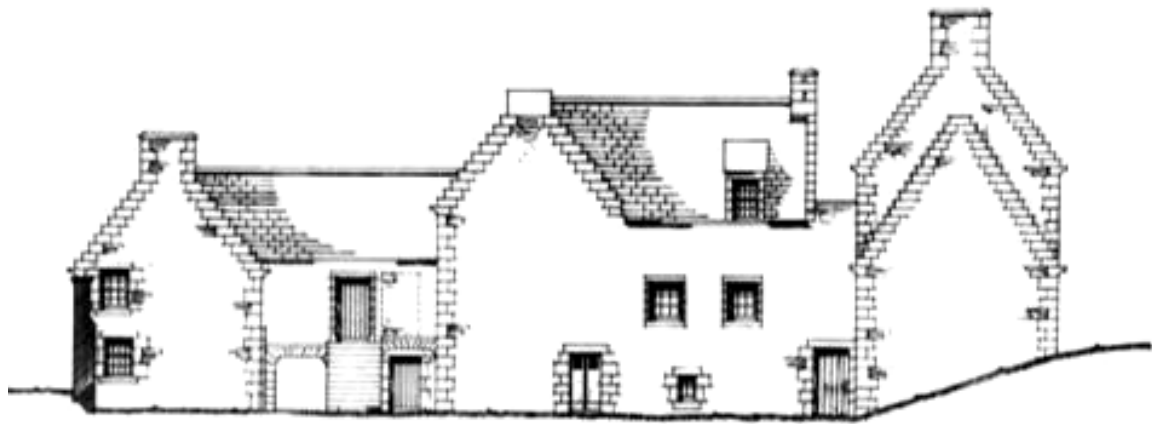
EAST ELEVATION.

Figure 17 – East elevation of Culross Palace by John S Hardie, dated 1904.  
©RCAHMS [03\_374368]. Licensor [www.rcahms.gov.uk](http://www.rcahms.gov.uk)

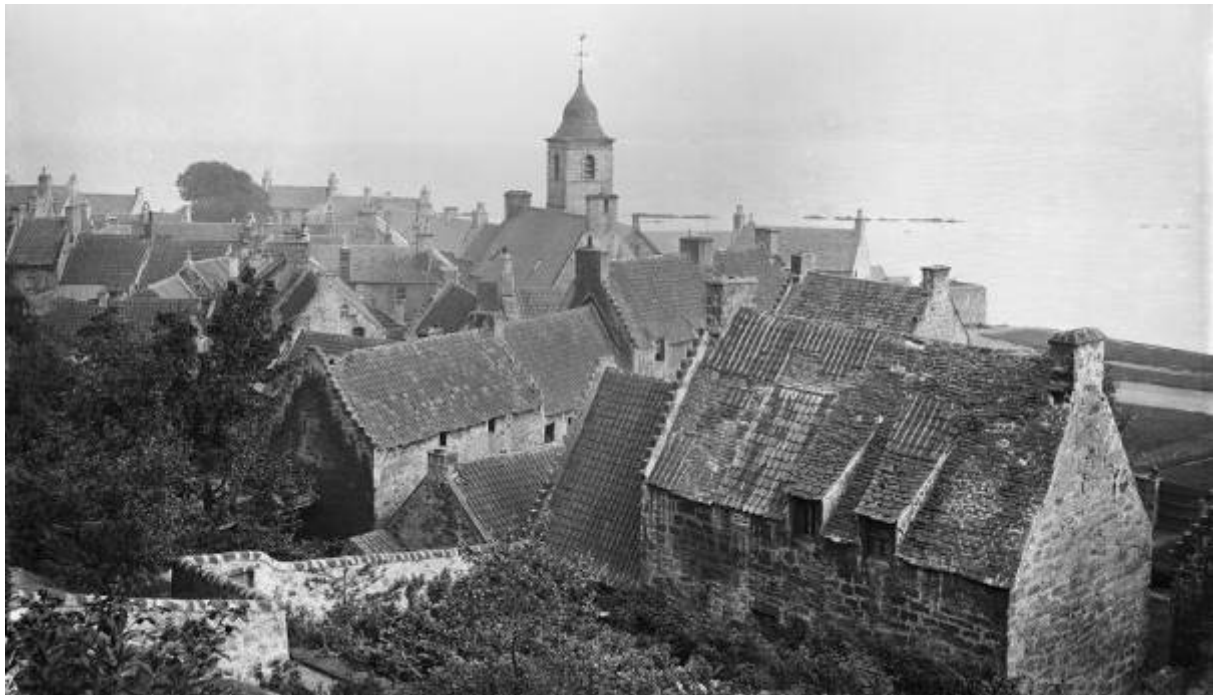
*Figure 19 – Early photograph of Culross Palace, north elevation, by Erskine Beveridge, dated c1883. ©RCAHMS [11\_1129143]. Licensor www.rcahms.gov.uk.*

The 1880s photographs also document the poor state of repair of the roof at that time. The south roof pitch is shown to have contained some ten to twelve courses of slate at the eaves; substantial mortar fillets secure the slates against the crow stepped gable. The remaining part of the roof is covered with pantiles, as is the complete roof of the eastern extension with no lower slate courses there. The fact that the slate courses are not carried regularly across the roof suggests that they represent various phases of repair; the quality and resolution of the photograph make it difficult to identify these in detail. The eaves and wall-head to the W are completely finished in pantiles with no lower slate courses evident; this seemingly indicates that pre-existing crow-steps had been taken down and this part of the roof was finished at this time completely with tiles. From the evidence of the S elevation one might therefore speculate that the lower slate courses represent an early, possibly original feature that saw later repair. However, the photographs by Erskine Beveridge of c.1883 date show the rear

roof pitch to N essentially as a patchwork of different tiles, slates and patches of poor repair, with no particular pattern identifiable (*Figure 19*). The area of the removed crow-steps at the NW gable head has in fact been finished with slates here. The extent of repair and patching on the rear roof pitch casts doubt over the original state of the S roof pitch, and questions in particular whether the lower slate courses to S definitely represent an early phase rather than a 19<sup>th</sup> century repair.

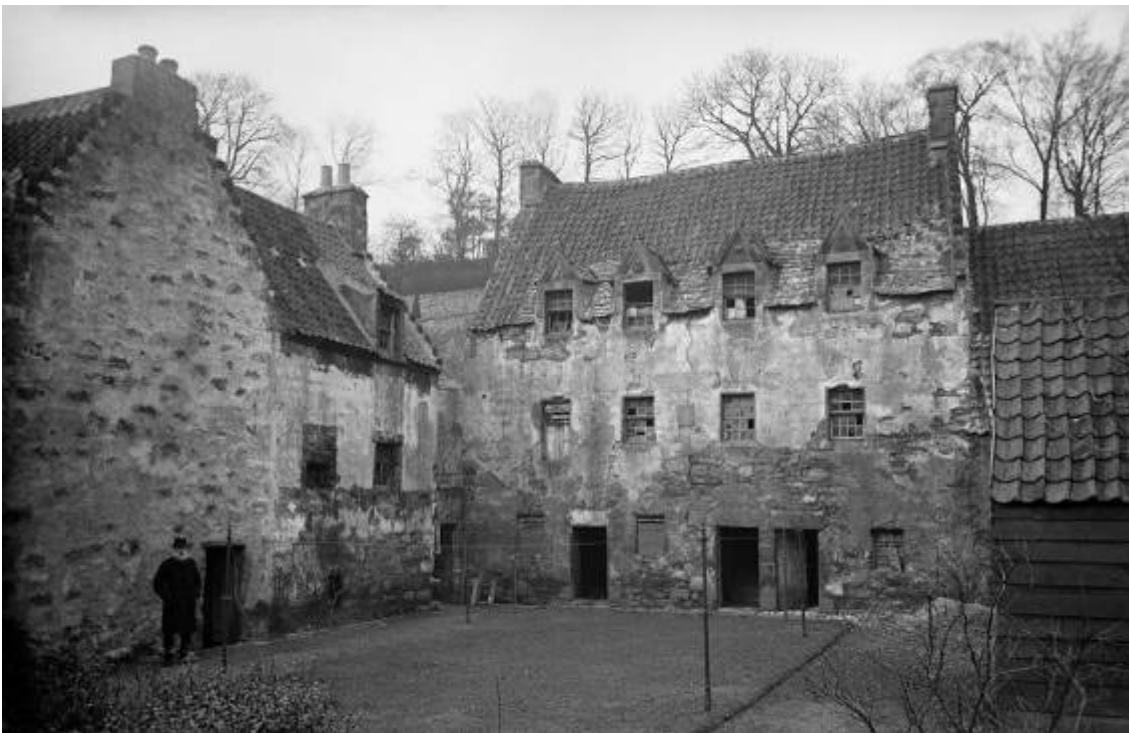
Figure 21 – Early photograph of Culross Palace, south elevation, by Erskine Beveridge, dated c1896.  
©RCAHMS [11\_1129178]. Licensor [www.rcahms.gov.uk](http://www.rcahms.gov.uk).

overlap to protect the wallhead.” Such detailing would help shed water (all quotes 2010, 145). In this detailing, the water drained off from the pantiles directly onto the main façade resulting in dirt markings and in the case of a lime harl finish with a detrimental effect on the durability of the lime harling. The impact of this can be seen at Culross Palace on historical photographs of late 19<sup>th</sup> to early 20<sup>th</sup> century date, with conditions certainly worsening as indicative by comparing *Figure 21* dated 1896 with the later images of *Figure 22*.

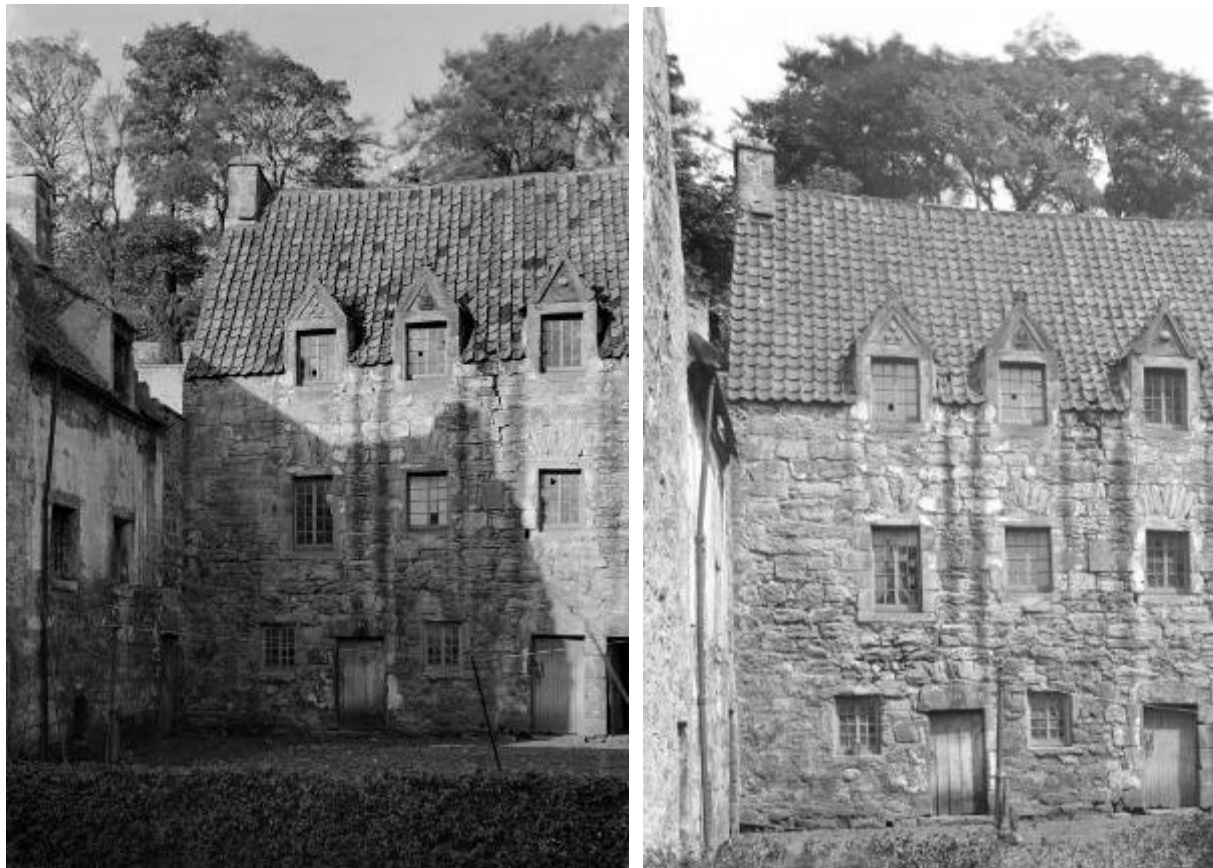
*Figure 22 – Two early photographs (right one collected before 1930s, left dated 1926), showing the missing crowsteps on the W gable, S façade.*  
©RCAHMS [11\_1106693 left and 12\_1205882 cropped]. Licensor [www.rcahms.gov.uk](http://www.rcahms.gov.uk)

The weathered crowsteps on the W gable were seemingly a late introduction, as photographs collected before the 1930s document missing crowsteps. It seems likely that this was undertaken as the first improvements by the NTS when they acquired the building in 1932. The roof was over-hauled and the ensemble completed with crowsteps – however, from where the weathered stones had been salvaged could not be established.

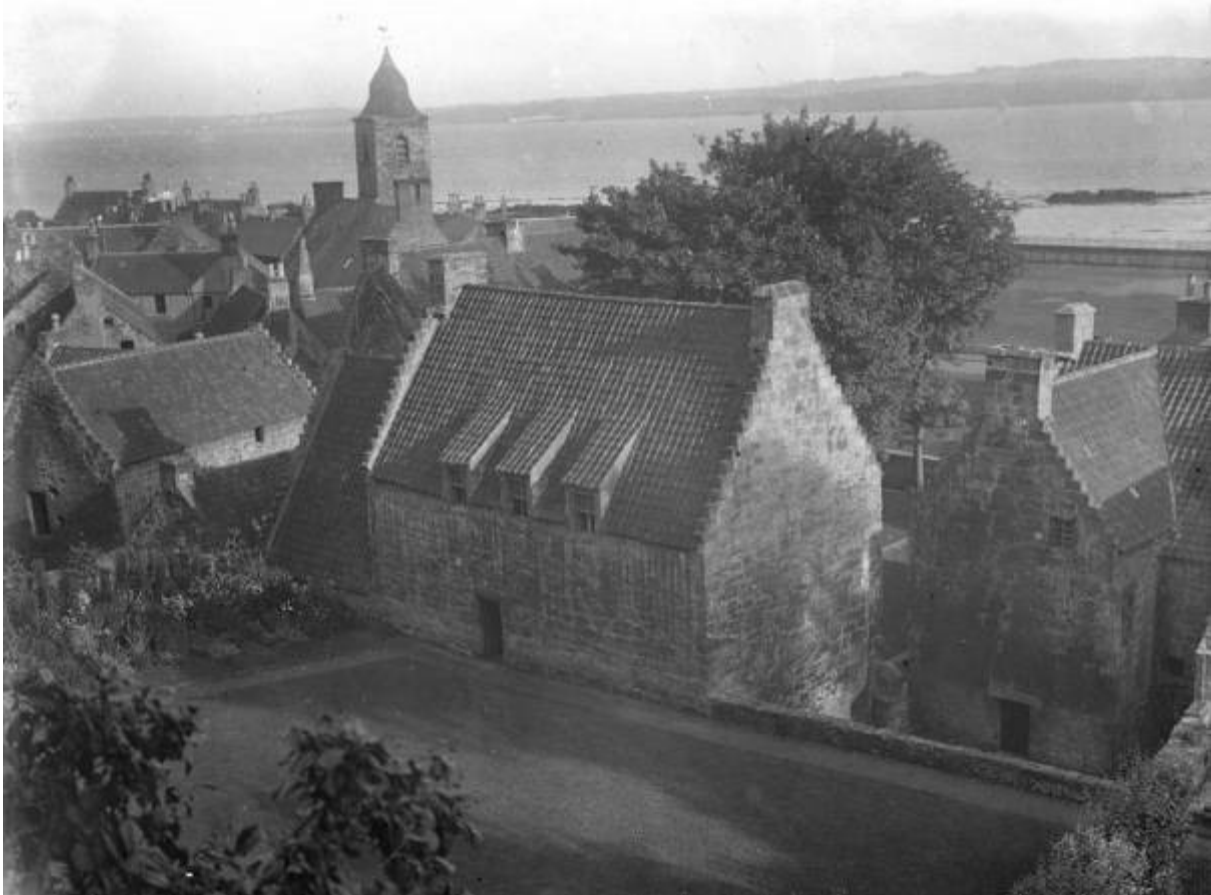
Figure 23 – Early photograph, probably mid to late 1930s<sup>4</sup>, showing north elevation with three dormers and the crowsteps on the W gable reinstated. The small lean-to structure to W has seemingly been demolished.  
©RCAHMS [11\_1104524]. Licensor [www.rcahms.gov.uk](http://www.rcahms.gov.uk).

Two black-and-white photographs of the rear elevation, held by RCAHMS (*Figure 23* and SC12\_1205856) with no date information attached, show the three dormers fully intact. The character of the photograph suggests a pre 1970 date for these images. The series of photographs implies that the third dormer must have been dismantled at some point prior to the 1880s and was reinstated in the first half of the 20<sup>th</sup> century.

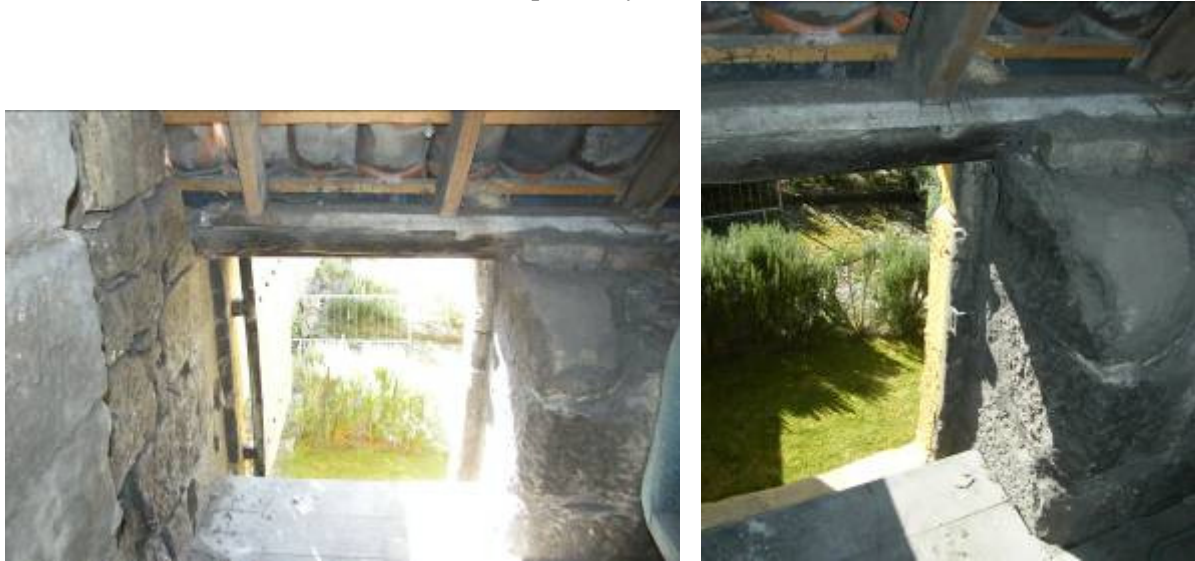
Figure 24 – Evidence for a much taller opening into loft of E extension.

drawing and the late 19<sup>th</sup> century photographs suggest that at some point before the 1880s this entrance, presumably for loading goods into the loft above the E extension, was reduced. Whether the wallhead was lowered at the same time or whether the loft entrance and window had always been built as dormers could not be established on presently accessible evidence.

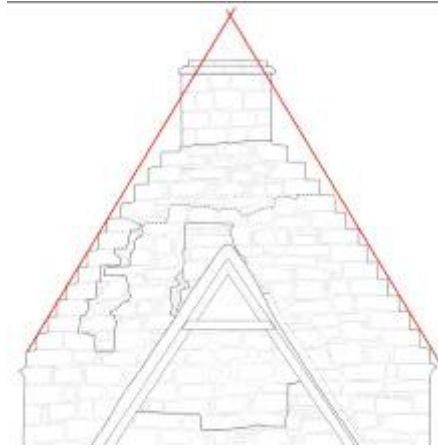
Figure 26 : Sketch outlining how far the top of the E gable diverges from projected straight-lines.

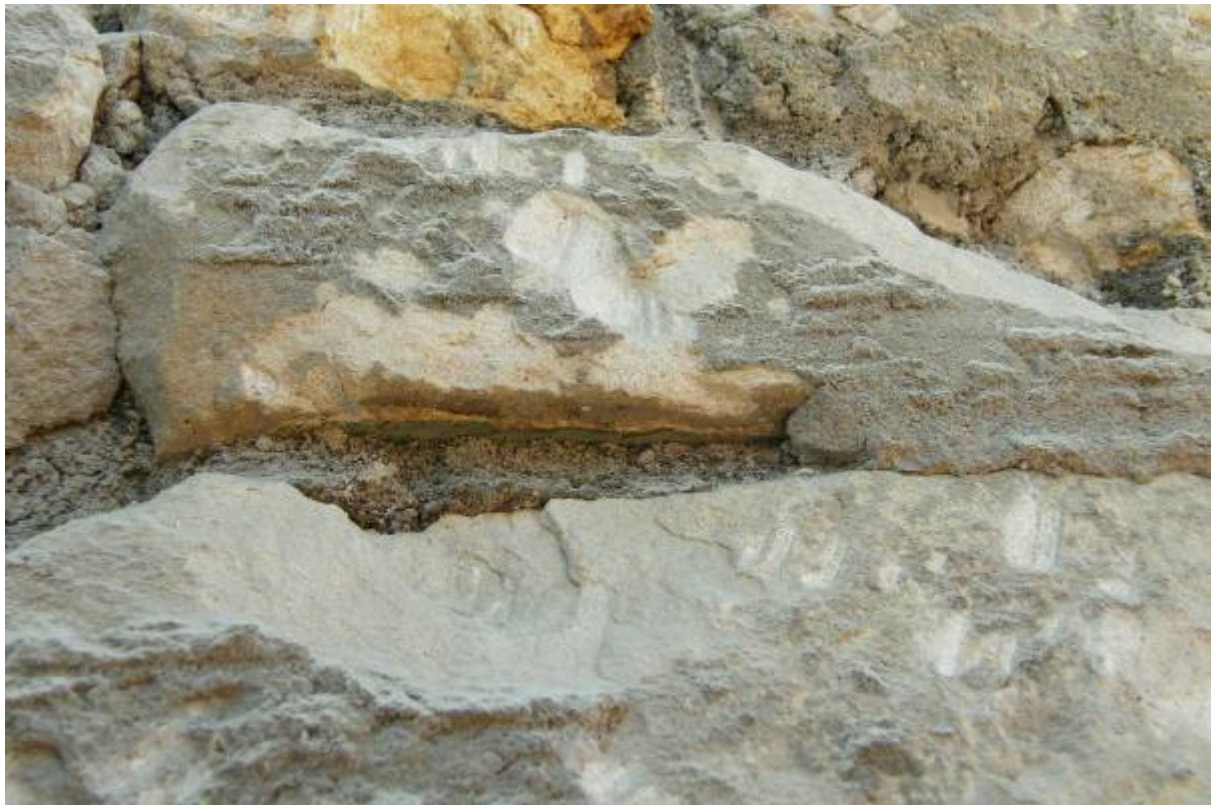
*Figure 27 – Remains of painted plaster on the underside of stones used for the flue repair and blocking of fireplaces (017, 018, 024 – here 017) of the W gable.*

On the W gable the S wall of the W extension was completely demolished bar the remaining stumps 013 and 027 which may have been incorporated in the later lean-to structure that is depicted on the 1904 plan, but not on the earlier plan of the 1880s. The original SW corner of the North Range was reinstated, but with poorer masonry (021), only a few quoins (011) or cross-ties (012) survived, albeit as cut-back remnants. The N wall was much reduced in height to form the present retaining wall (027) against the raised ground to rear. Possible fireplaces were removed and blocked (018 and 024) and some of the stones used for the repair and blocking within the W gable contained remains of plaster or limewash, some even with paint residues remaining – multiple coats of pale limewash (Figure 27). It seems likely that these stones had been part of the W extension and were reused for the repairs as part of the demolition. Purlins that had evidently existed were also removed and the beam holes filled in (019 and 020) and the entrance 009 at ground level was blocked off with rubble masonry 023.

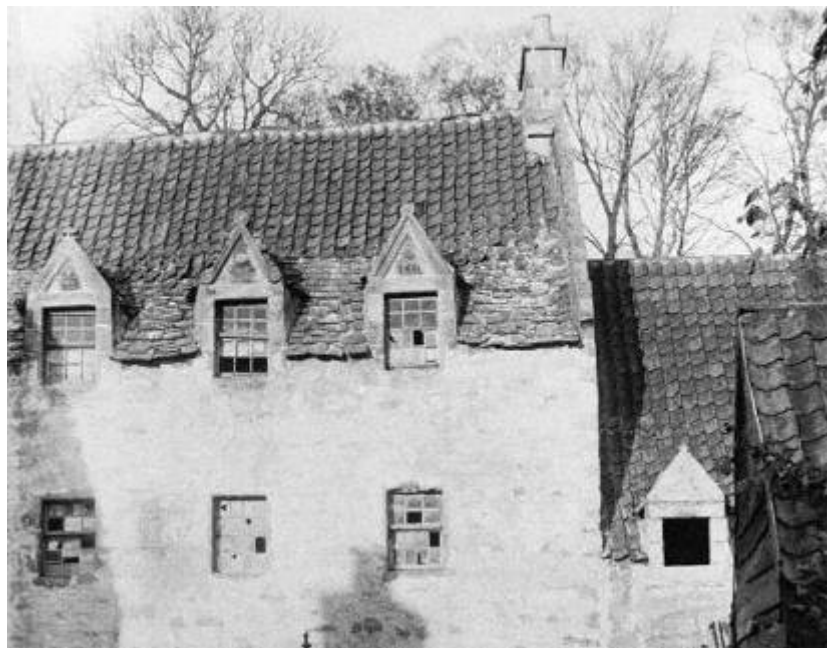
Figure 30 - Photograph of the North Range in ca. 1888, showing the lowest courses of the roof as slated. ©National Museums Scotland. Licensor www.scran.ac.uk.

MacGibbon & Ross also comment on the then condition of the North Range in the 1880s. Their commentary corresponds well with the photographic evidence available for this period (see *Figure 30*)<sup>1</sup>:

In early photographs, dating to c1888 (*Figure 30*), ca 10-12 courses of slate can be seen along the lowest part of the southern roof, forming the eaves of the North Range, a feature now missing. The photographs show evidence for substantial mortar patching in the slated area to apparently secure the slates against the crow-stepped gable. The remaining part of the roof is covered with pantiles, as is the complete roof of the eastern extension with no lower slate courses there. The slate courses and rows of pantiles are, however, not carried regularly across the roof. The area between the two central dormers has at least one further lower course of pantiles, compared to the eastern parts.

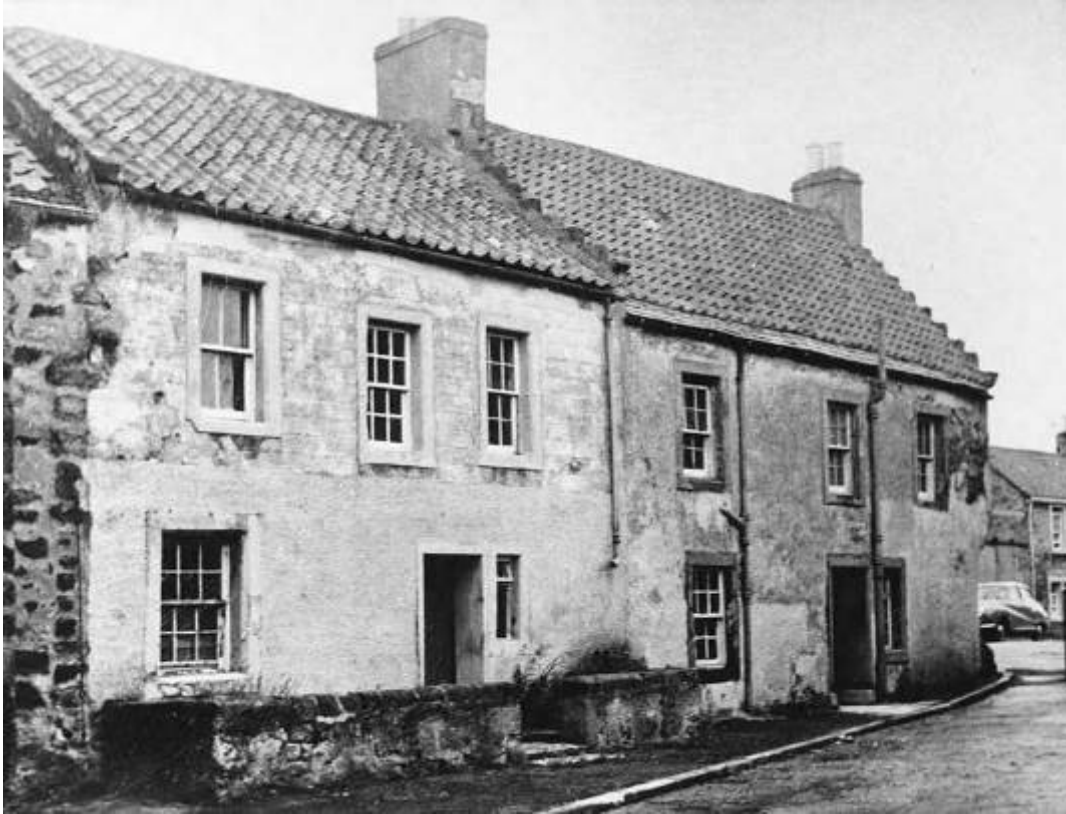
Figure 31 – Nos. 5-7 Rumford Cottage, Crail, before restoration in 1961 by The National Trust for Scotland.  
©National Trust for Scotland. Licensor [www.scran.ac.uk](http://www.scran.ac.uk).

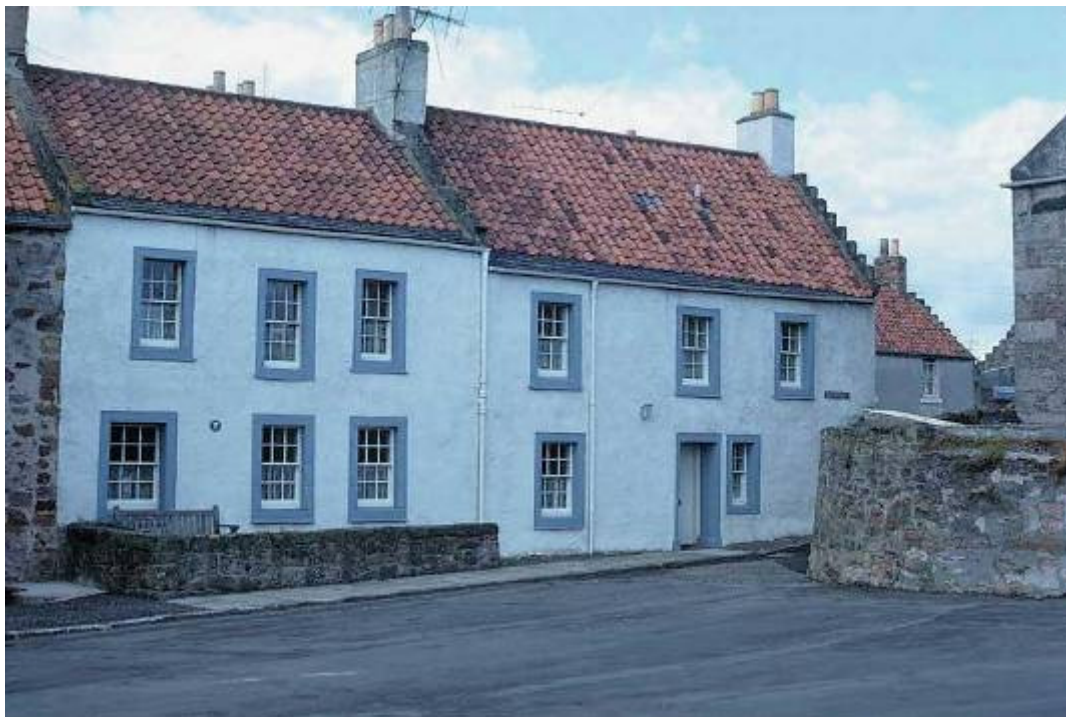
Figure 32 – Nos. 5-7 Rumford Cottage, Crail, after restoration by The National Trust for Scotland in 1961.  
©National Trust for Scotland. Licensor [www.scran.ac.uk](http://www.scran.ac.uk).

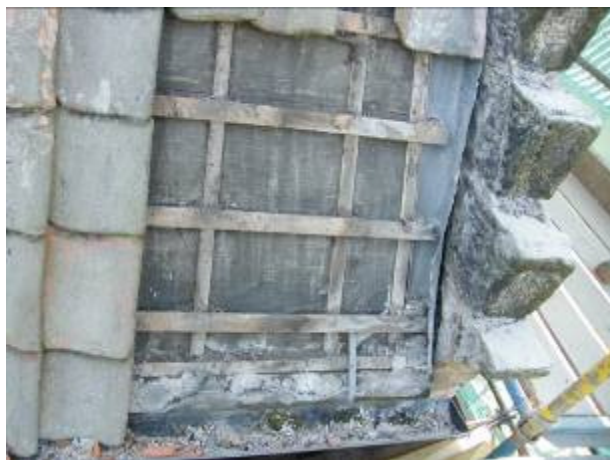
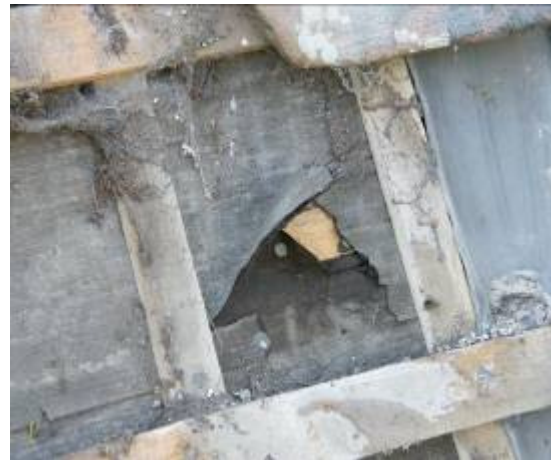
Figure 33 - Opening 1 at lowest level of investigation      Figure 34 - Opening 1, detail of sarking below tile.

The investigations for Opening 1 comprised a small area of four by four tiles, exposed at the NW corner of the main roof of the North Range. The tiles lifted off easily and exposed the underlying modern fabric. This fabric was fresh, modern looking sarking boards (exposed in a small area), covered with a layer of roofing felt. The tiles sat on modern batons nailed onto the sarking against the crowsteps with a lead flashing below the tiles. The modern fabric was not removed any further but an attempt to peer between the lead flashing and the crow steps revealed no evidence for former roofing on the sides of the gable wall.

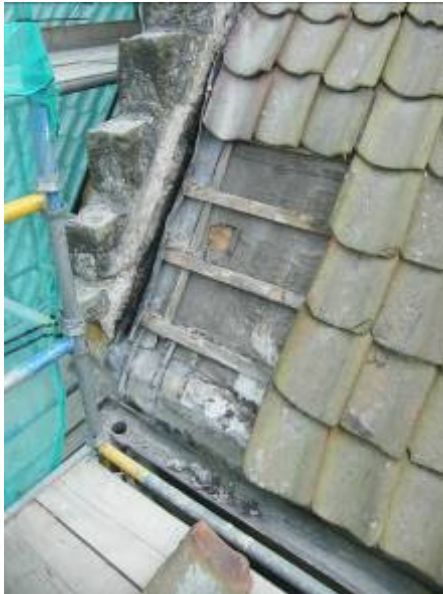
Figure 35 – Opening 2 at LOE.

A small area of three by four tiles was investigated at the northeast corner of the main building (North Range). Again, as seen in the first opening, modern sarking, felt and lead flashing was exposed. Attempts to see underneath or behind the lead flashing only exposed more modern sarking. No evidence for slates or mortar patching to secure the slates could be seen against the rear of the gable crow steps.

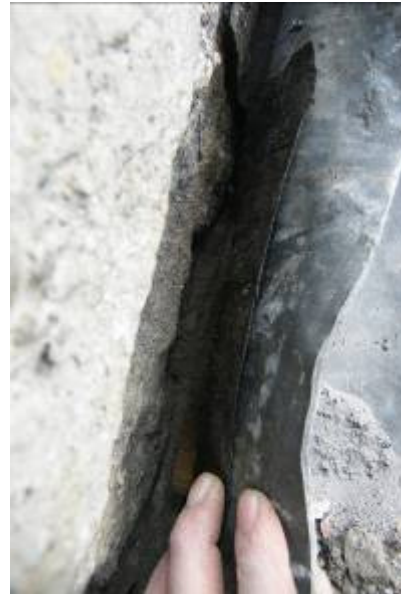
Figure 36 – detail of modern sarking below lead flashing at Opening 2

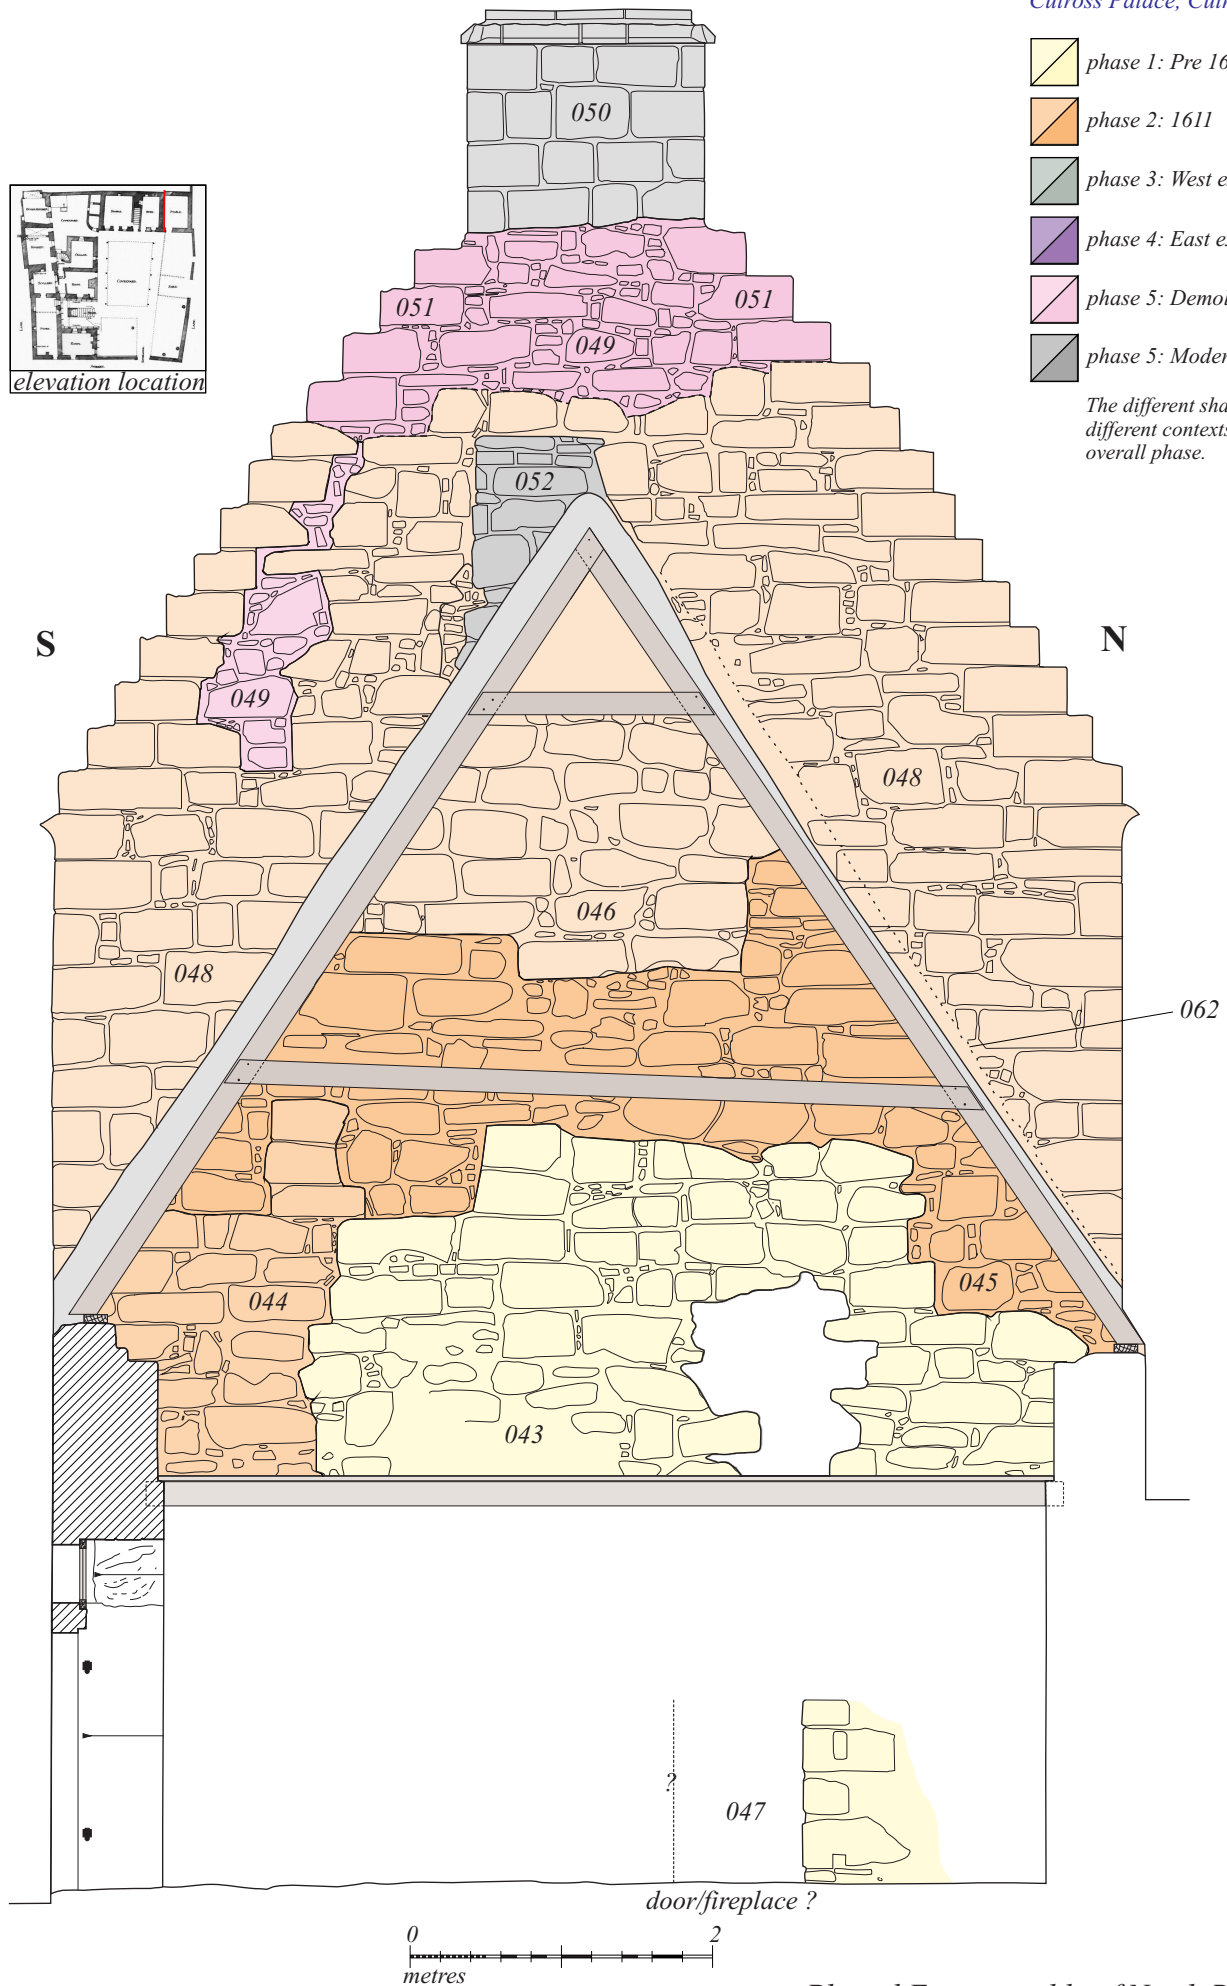
Phased Eastern gable of North Range

The different shades indicate different contexts within one overall phase.
