# Land at Wester Yardhouses

*Carnwath, South Lanarkshire*

*Archaeological Watching Brief – December 2012*

### **Data Structure Report**

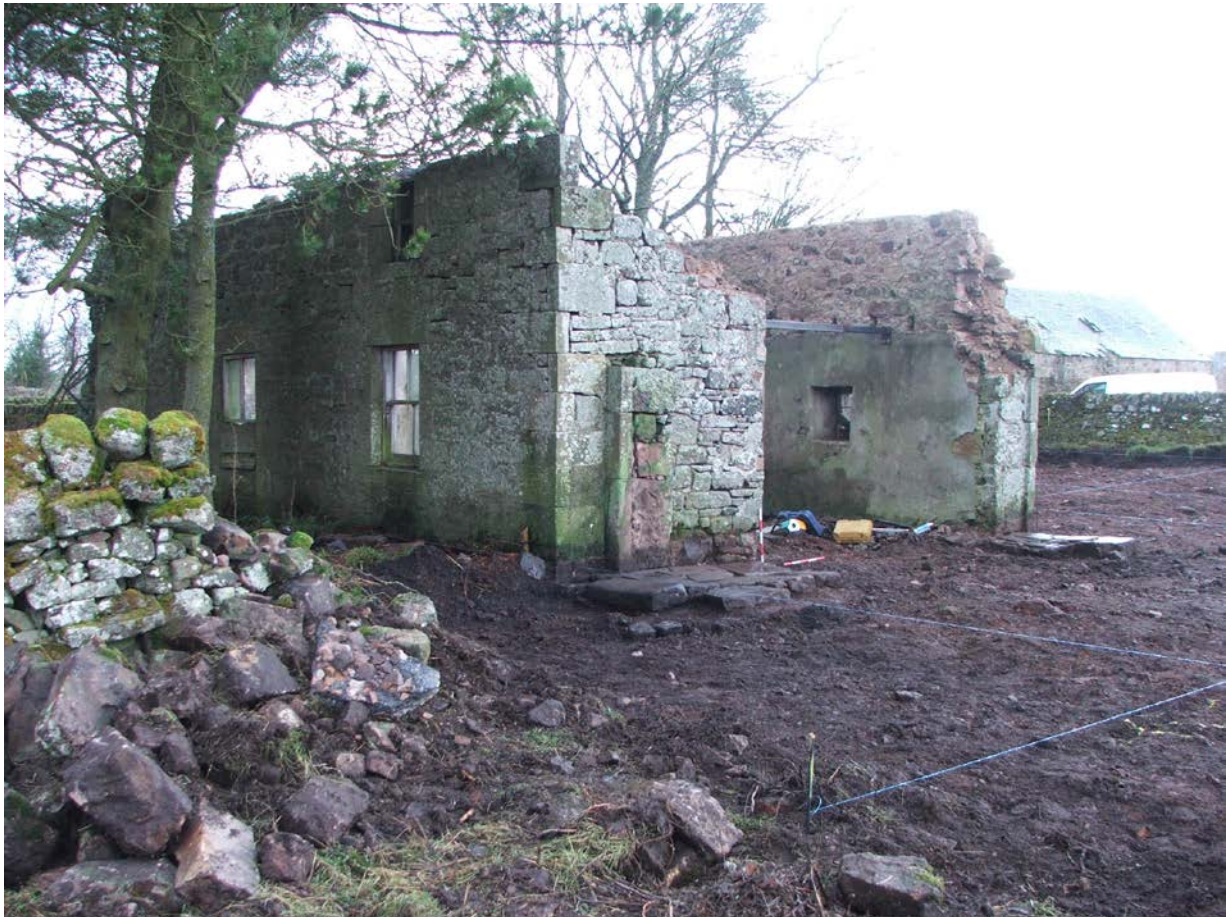
*Remains of agricultural building and area of earlier demolished structure from SE*

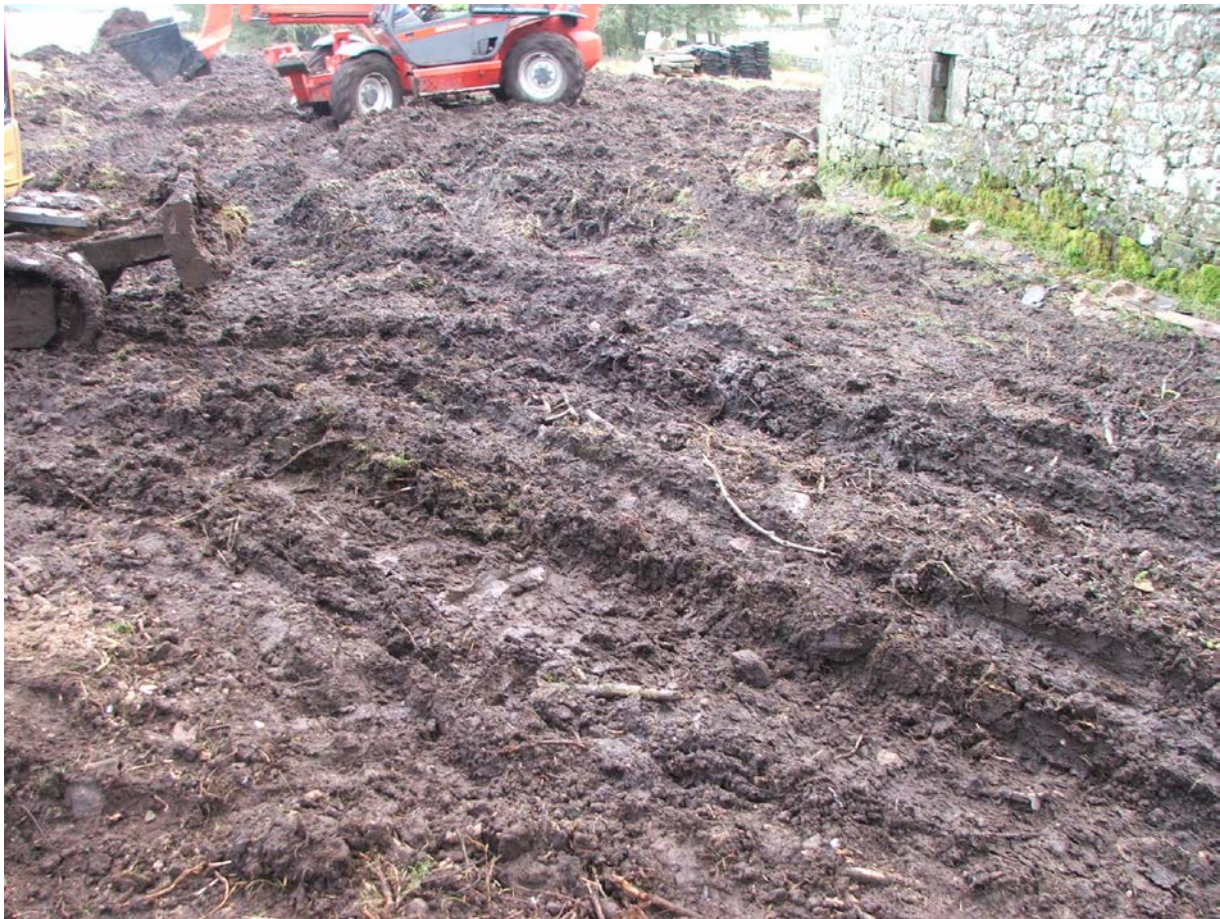
*Plate 1 Pre excavation (Photograph No. 004)*

With the exception of some remains of the mostly demolished existing structure no archaeological features were exposed across the stripped area. The topsoil when excavated showed to be 15-30cm deep across the site, overlying a packed stony natural across the whole excavated area. The topsoil was of a saturated mid to dark brown silty loam (001).

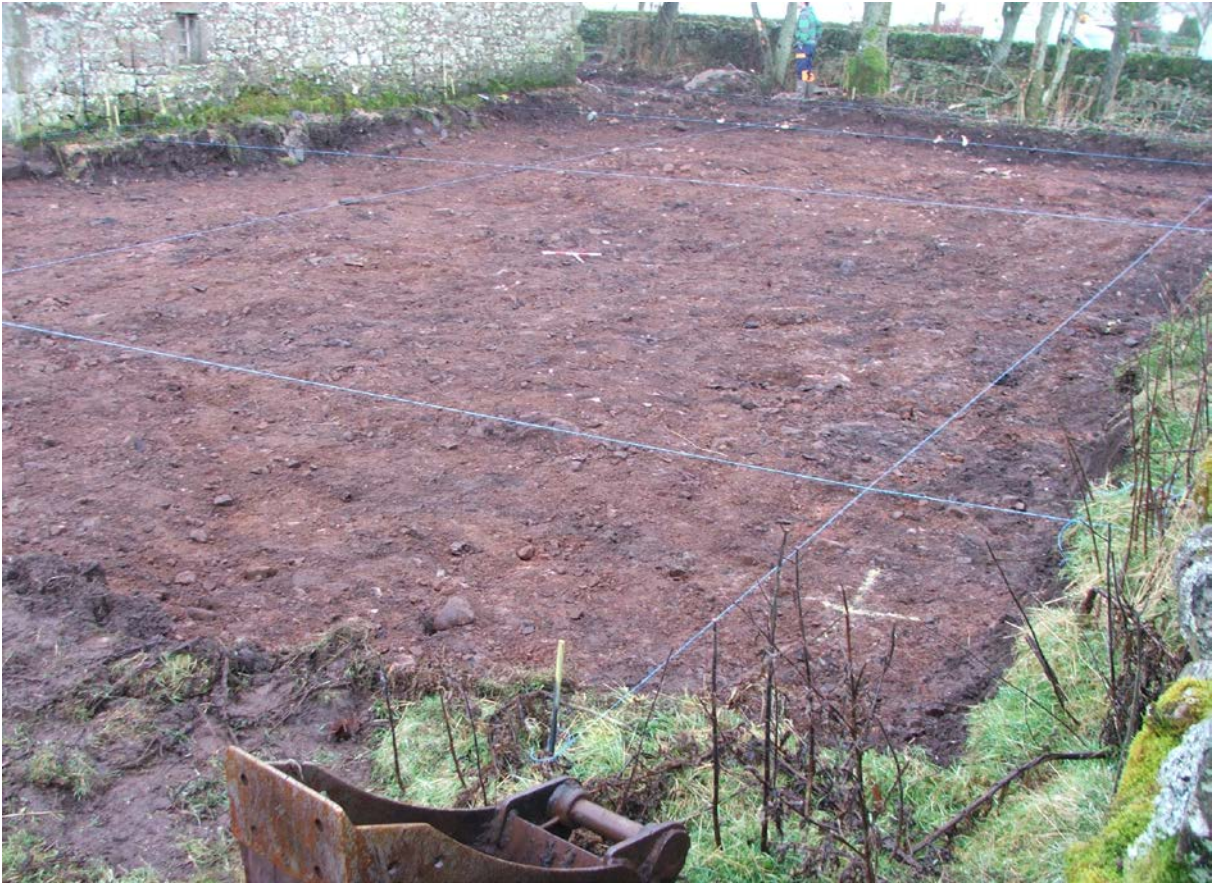
*Plate 2 Post excavation of northern area (Photograph 048) with foundations being laid out.*

Following the initial topsoil removal down to natural and with no apparent archaeological features visible on the surface a further spit 10-15 cm deep was removed from the natural to test if it was redeposited or if any indistinct cut features could be seen surviving below the upper surface. This exercise proved that the soil exposed is a solid, *in situ* and very stony natural. This was further confirmed in the much deeper foundation trenches. The natural was heavily compacted and the machine struggled at times to get through the packed material.

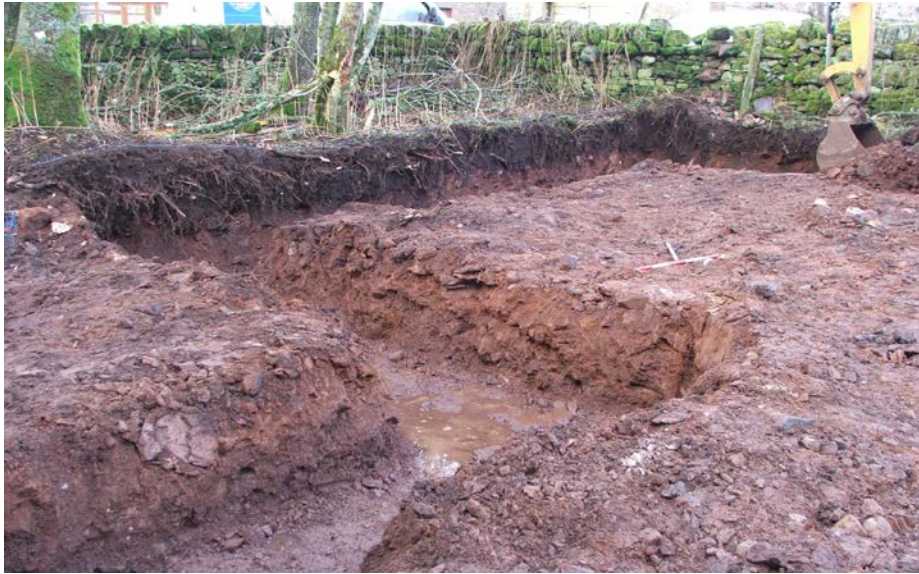
As part of the watching brief the excavation of the series of deeper trenches for foundations were also monitored. The foundation trenches were approximately 1m wide and up to 1m deep from the former ground surface.

Only the first few trench openings were closely monitored as the general make-up of the deposits within had already been identified as undisturbed natural during the previous topsoil stripping. This identification of undisturbed natural was confirmed within the deep foundation trenches. The remaining trenches were excavated by machine with occasional examination but as expected no features were noted within the natural.

*Plate 3 General view of foundation trenches under excavation (0.50m scale).*

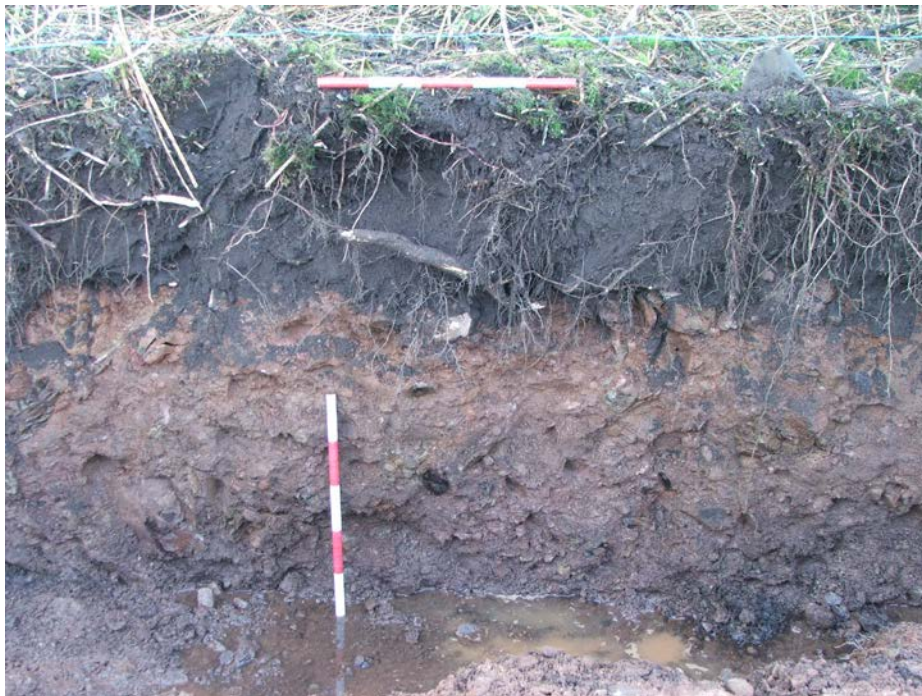
*Plate 4 West section of investigated area showing topsoil (001) and natural (0.50m scale).*

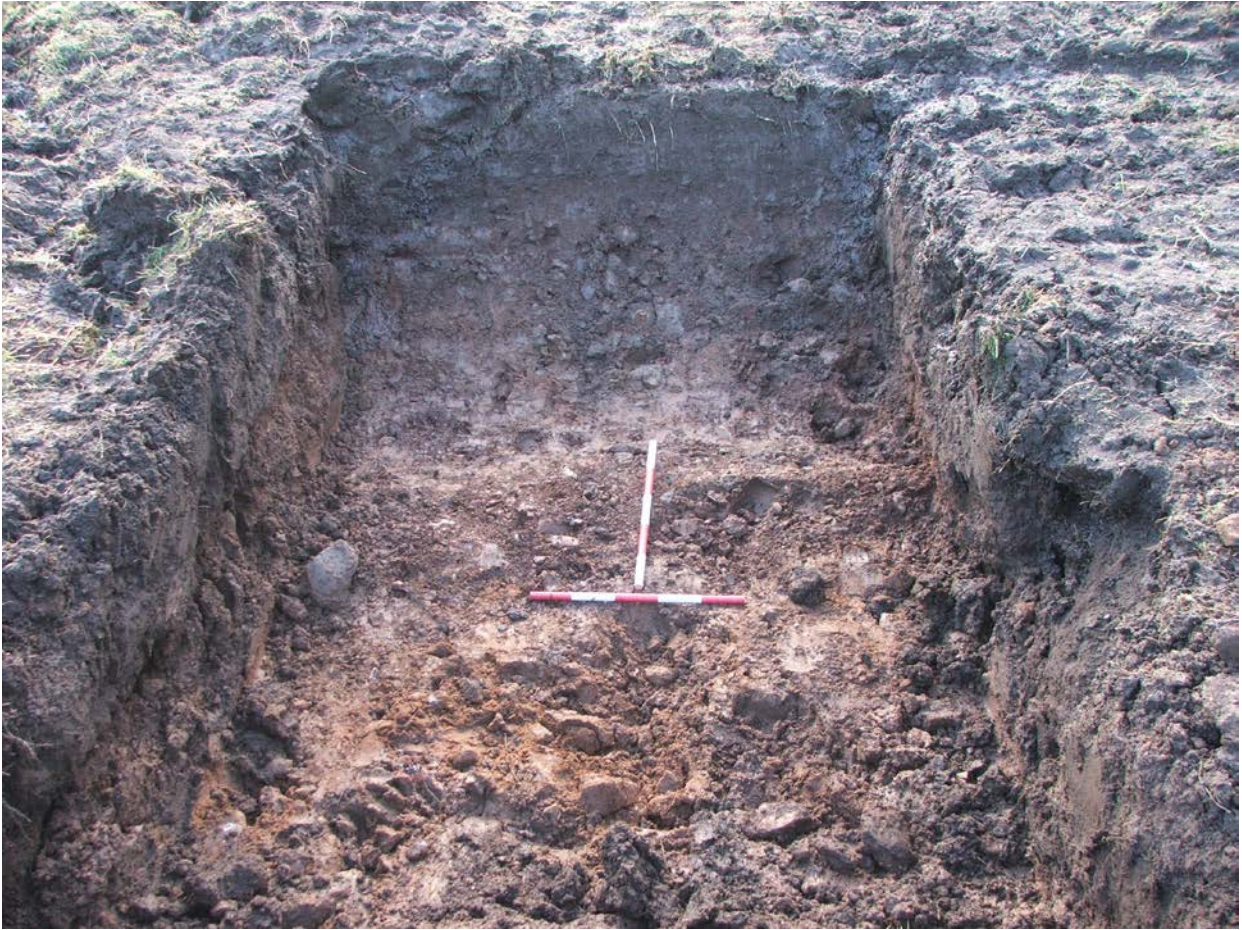
The installation of a septic tank to the SE of the existing structure necessitated a large and deep hole approximately 1.6m by 3m to be excavated. This was undertaken by machine with a 1.2 m bladed ditching bucket under archaeological supervision. The topsoil was removed in spits as before and natural exposed. Again, this proved the same as seen in the larger stripped area and the monitoring stopped once excavation had progressed 0.30-0.40m into the natural.

The topsoil was as before a saturated mid to dark brown silty loam (001), with no finds noted from this trench.

*Plate 5 Septic tank trench at monitored limited of excavation (LoE) showing natural deposits at base.*

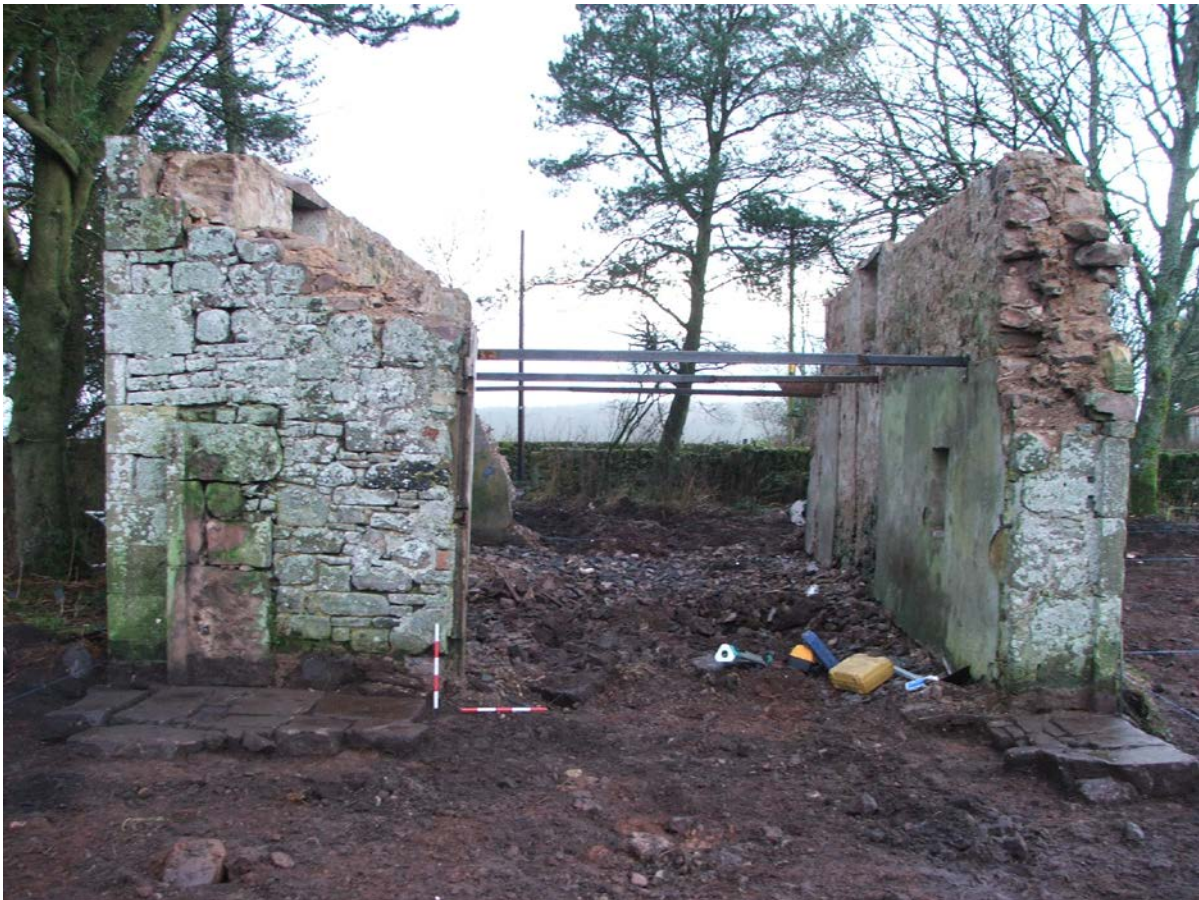
The agricultural building of which only two walls remained after the scheduled duntakings had historically extended to the east. This eastern part of the structure had already been reduced to its present extent at some point in the past. Evidence for its extent can be traced on historic maps (Romankiewicz 2012) and could be seen on the surviving east gable of the upstanding remains. Here the western jambs of doors on the north and south elevations (respectively) of the historically demolished range survive (*Plate 6*); the southern of these was formerly obscured behind a dry stone field wall. The photograph also shows that the masonry of the standing building had incorporated the lower part of the SE wall of the now demolished east part. This observation implies that the upstanding part is later than the now demolished east part.

*Plate 6 Post excavation of eastern area (Photograph 060) with surviving doors and threshold stones exposed; general view from E (0.50m scales).*

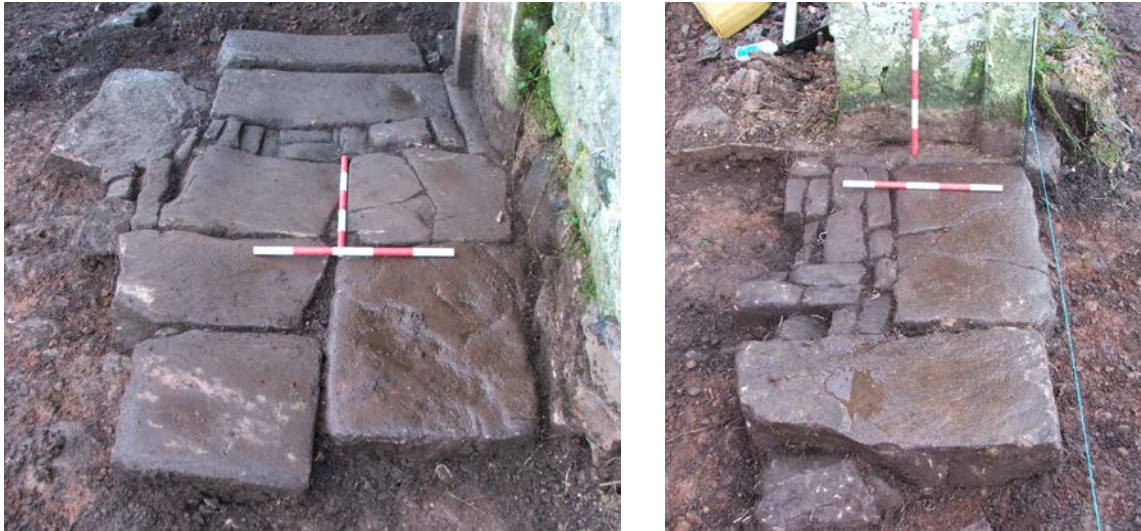
The threshold stones for both doors as well as a small area of surrounding flag and cobble flooring still survived and were cleaned for photographic record. The rest of the eastern extension had been completely robbed historically, leaving no structural trace; this is because the foundations for the remaining existing structure showed to sit directly on top of the compacted natural without any foundations or cut for such foundations. Thus the robbing of the building material did leave no apparent trace in the ground. The historic robbing appears to have been a total demolition and retrieval of material and disturbance at this time of the surrounding topsoil would also have been substantial. In addition, the condition of the disturbed topsoil both recent and likely historic had ensured that any cut associated with this structure was lost or truncated.

Plate 7 Exposed door thresholds and surviving cobbles and flagstones  
S door to left and N door to right (0.50m scales).

The two surviving small areas of flooring show the interior of this long demolished structure to have been floored in roughly rectangular sandstone flags with patches of smaller rectangular cobbles filling out any gaps. These flags and threshold stones show a degree of surface wear.

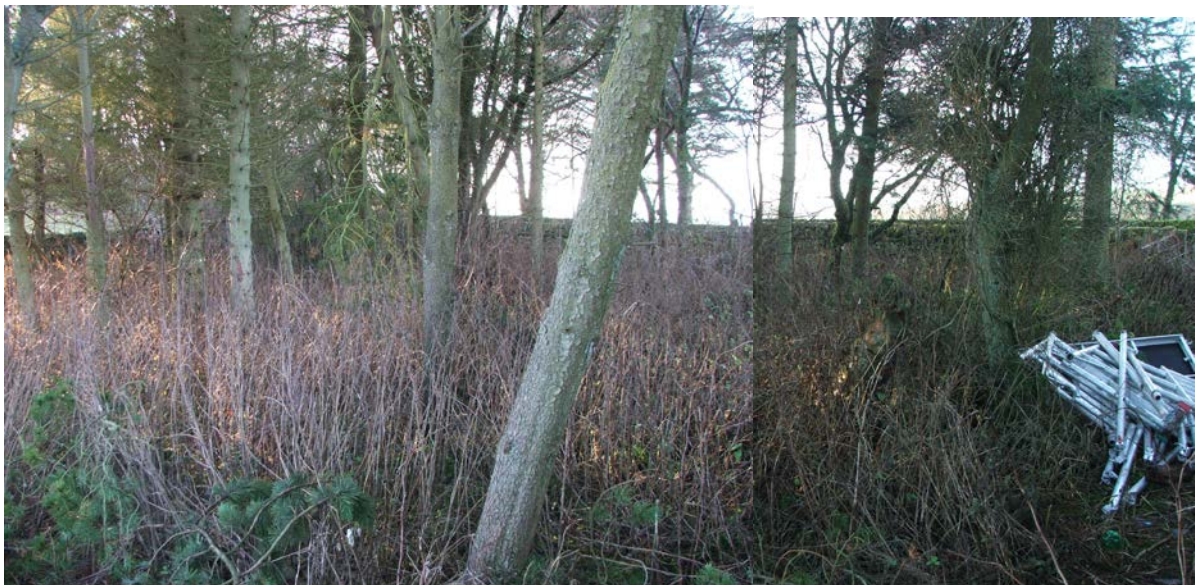
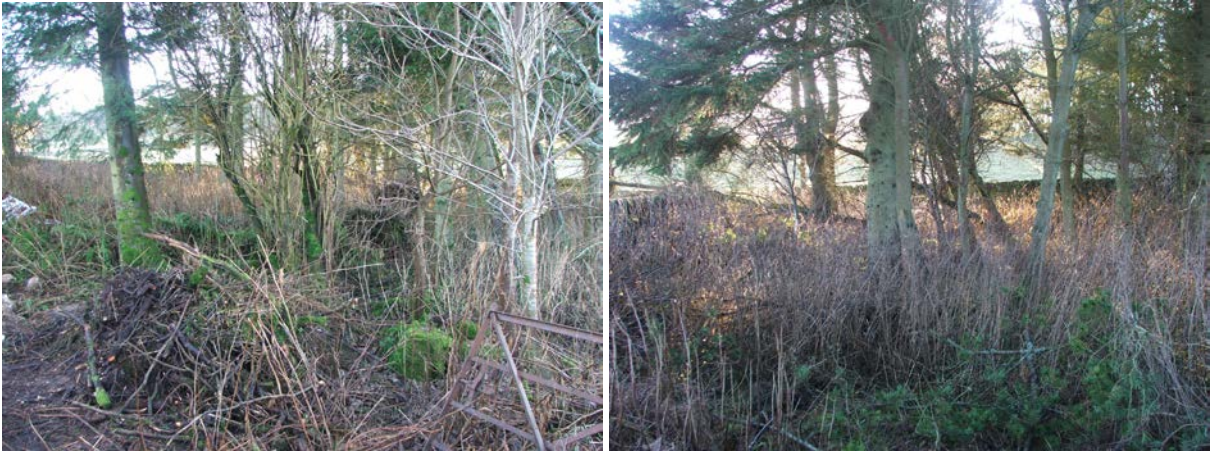
The remaining development works will include the scraping back of topsoil in the car park area. This is intended to impact into the topsoil to a depth of approximately 100mm, i.e. 0.1m, in an area that is generally covered by trees and therefore impacted by tree roots. The chances of survival and recovery of any *in situ* archaeological remains relating to this part of the works are assessed as minimal, and at most further chance discoveries of *ex situ* stray finds are to be expected.

Plate 8 Area of proposed car park (Photographs 107 left and 106 right cropped).

*Plate 9 and Plate 10 Area of proposed car park (Photographs 109 left and 108 right).*

Based on the result of the monitoring reported here, and in the light of only insignificant findings as part of the majority of the site works monitored so far, we would recommend that the topsoil strip of the car park area would not require archaeological monitoring, and that with the acceptance of the present report the archaeological planning condition for this development can be discharged. Given the minimal depth of the impact relating to the car park, and the existing disturbance by tree roots it highly unlikely that any *in situ* archaeological remains will be encountered.
