Panmure House
Canongate, City of Edinburgh

Archaeological Evaluation : Data Structure Report

Project No. AA.1910

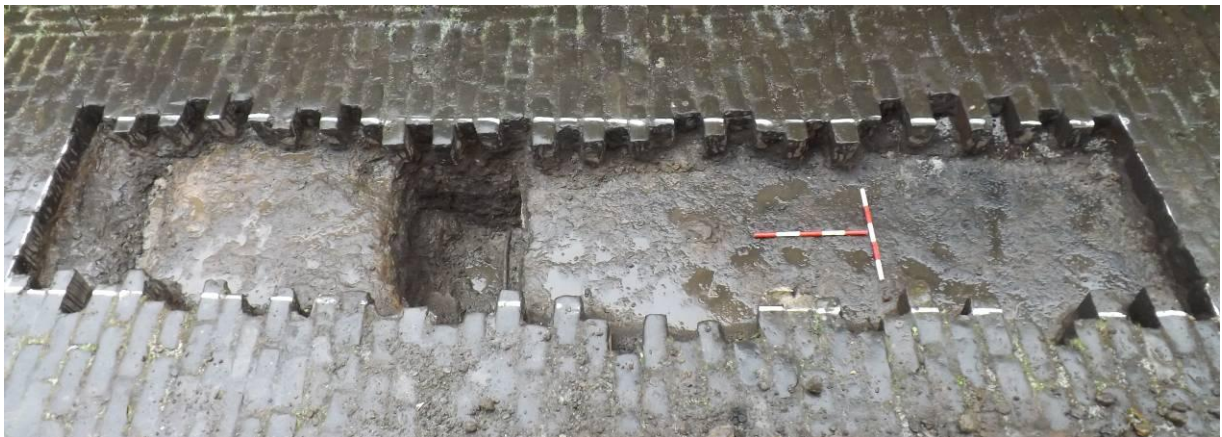
Noted cutting this packed layer were two linear cuts, one to the east end of the trench, 1009, and one across its mid part, 1005. These were considered to likely be modern services and were emptied. The 1005 cut was found to contain a lead water pipe, 1008, and backfilled with mixed fills, 1007, 1006.

Plate 1 and 1009 trench 1 cuts 1005 under excavation looking south (0.50m scale)

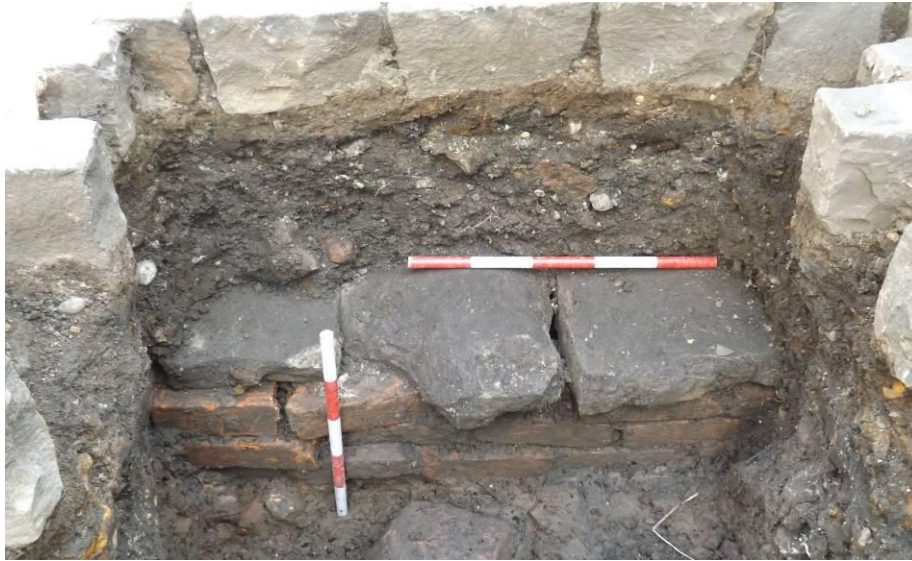
The eastern cut, 1009, which continued beyond the eastern end of the trench, was found to contain a north-south aligned masonry drain capped with sandstone flags, 1011. The sides of this were constructed of terracotta common bricks of early-mid C19th character, bedded in a soft white lime mortar; three courses of brick made up the sides. The cut for this, 1009, was quite tight to the side of the drain and close to vertical.

Plate 2 drain 1011/1012 detail following excavation

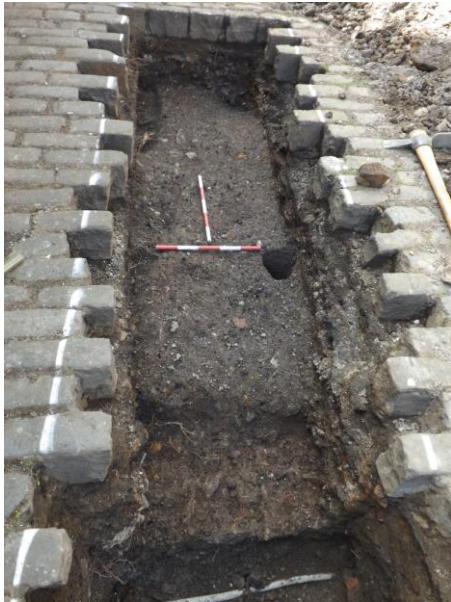
Underlying 1015 to the west was a packed mixed mid- to dark brown clayey deposit, 1019. This was more packed than the 1020/1021 to the east and was a somewhat stonier, although within a deep sondage some lumps of re-deposited natural clays started to be seen, again at approximately 1.20m below ground. Being similar to that seen in 1021 perhaps this indicated these were both parts of the same deep raising of the ground surface. Recovered from the western 1019 were a number of early white gritty pottery types (i.e. medieval).

Plate 3 surface of 1019 cleaned up

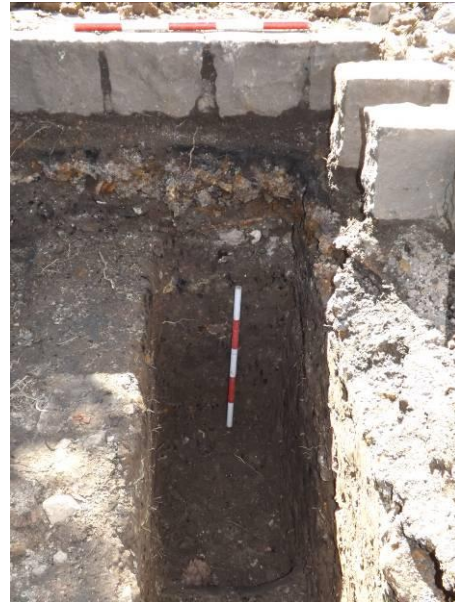
Plate 4 west section within sondage of 1019

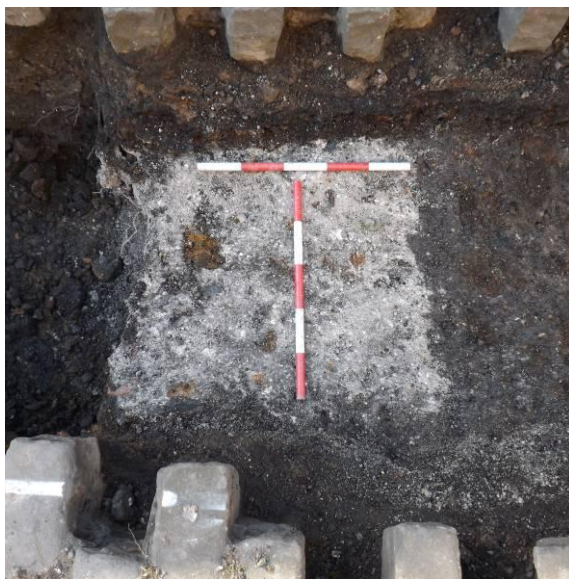
A further deposit overlay the cut 1017 and may have represented an upper fill though it continued to fade out for 0.20 m beyond the underlying cut. This was 1016 a clean deposit of crushed lime mortar 0.10-0.15 m deep in the south section and fading out to a trace in the north section. This seems to follow a similar line as the underlying cut and is also truncated to the east by 1005 but this may just be a chance dump within the 1015 working surface.

Plate 5 mortar layer 1016

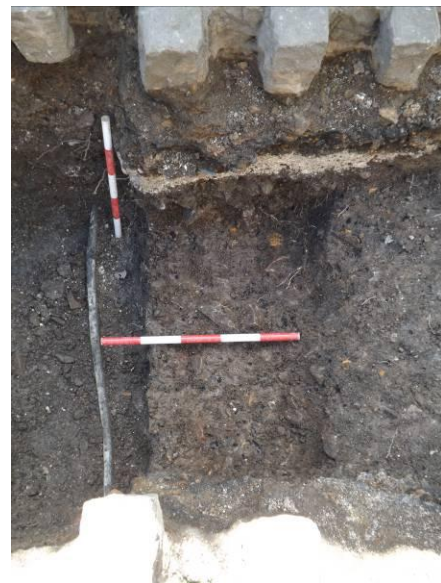
Cutting into the 1019 deposit was a shallow surviving cut, 1017; this was aligned north-south and was truncated to the east by the cut 1005. The feature survived to a depth of 0.20m and was in-filled with a very loose gravelly fill becoming more soily at its upper part, 1018. Recovered from within this

Plate 6 cut 1017 emptied, with 1016 in section

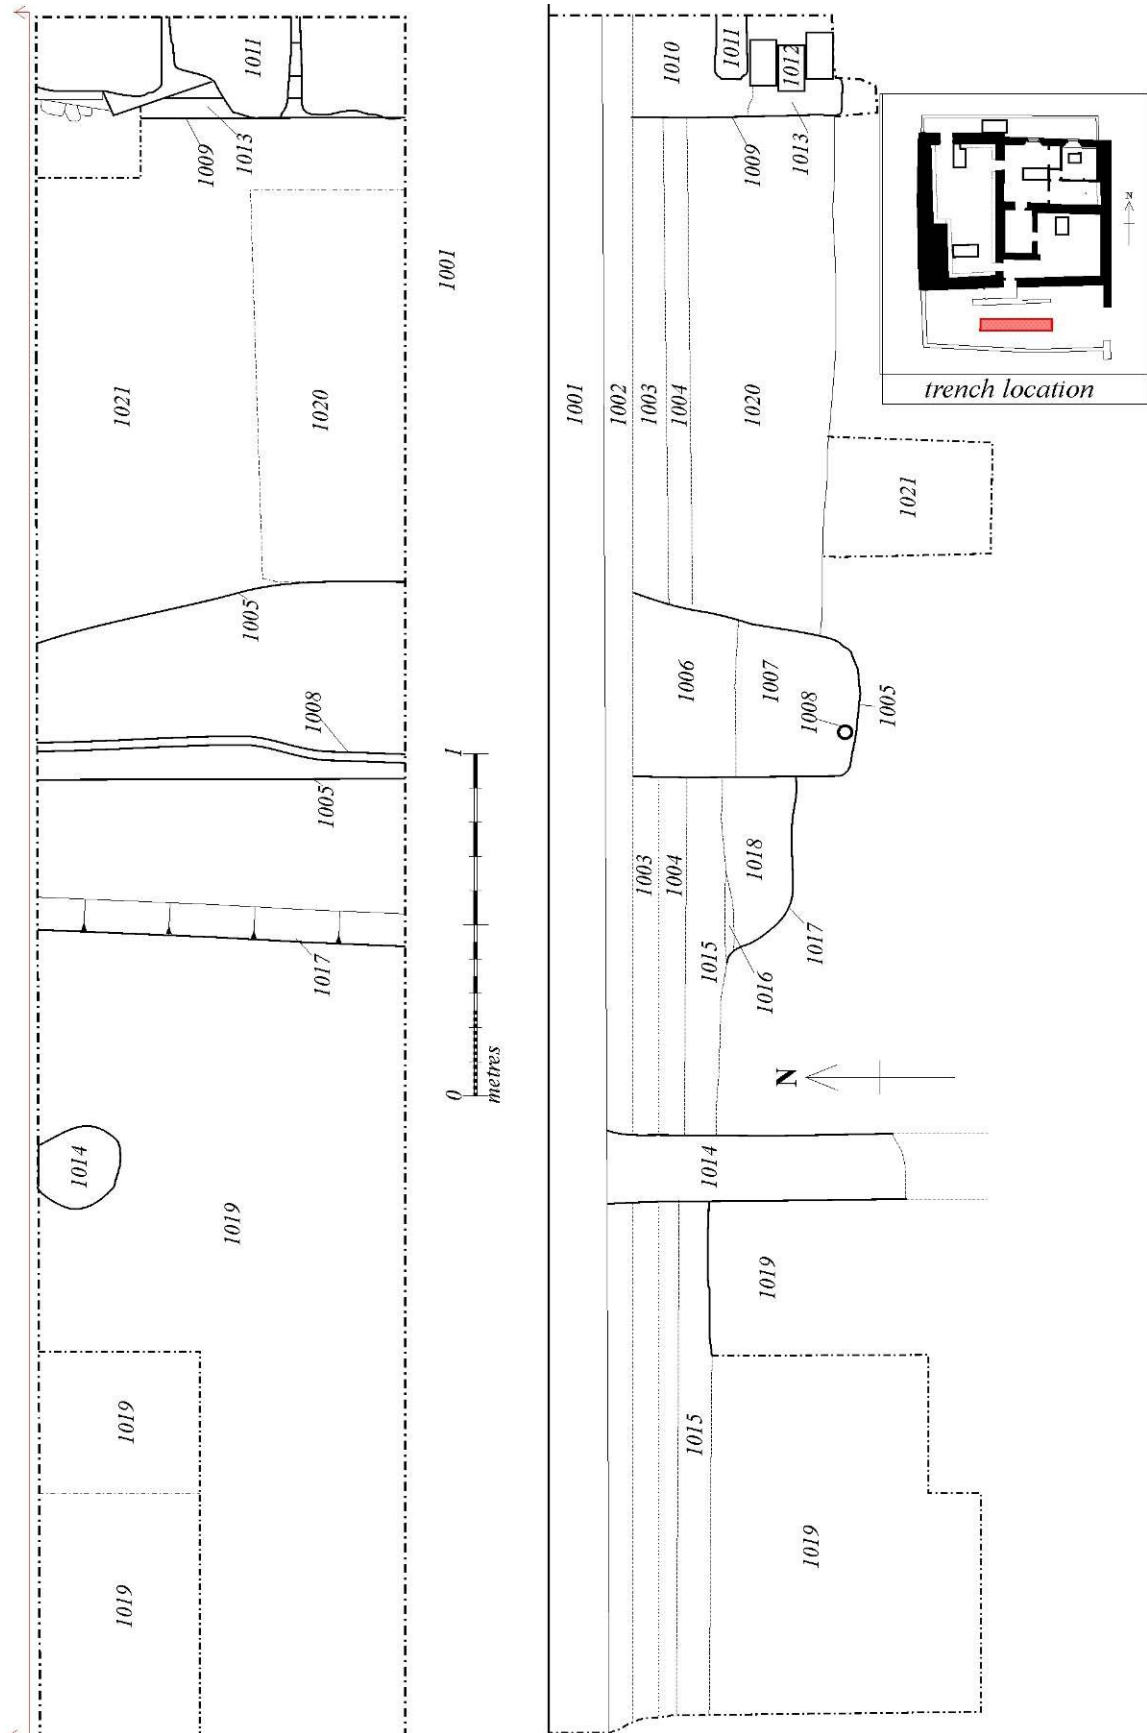
Figure 3 Trench 1 plan and section

Within the excavated trench no evidence for the structures hinted at on the evidence of historical mapping was encountered, but as natural was not seen anywhere within the trench there is a possibility that there may be surviving structures below the limit of excavation (LOE) at 1.2m below surface. The earliest deposits relate to a deep build-up of stony clay rich soils, 1019/1020/1021, the lowest levels of which at the LOE at 1.20m down have some re-deposited natural mixed through. The upper parts had none.

These deposits were fairly mixed but there appeared to be a slight difference either side of the cut 1005, this perhaps simply representing variations in a deep build-up or maybe an indication of differing land use either side of an historic boundary. The few finds from these were of early white gritty type, predominantly thin-bodied.

Cutting this is a much truncated linear cut, 1017; this contained a large number of early pottery sherds possibly from a few vessels, this is likely to have suffered truncation to form the road make-up as well as later services, so its former full extent is unknown. This was the only early discreet feature noted within the trench area; the loose gravelly fill of this may be related to drainage possibly related to the management of water run-off within early burgh plot back-land.

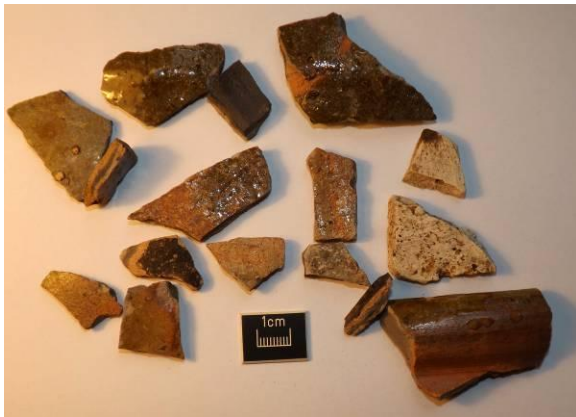
were a number of fragments of early pottery (white gritty wares), a large number of which may come from the same vessel; a couple of these were located deep within the deposit but the majority were clustered within the upper part of the fill. A few very similar sherds were recovered from surface cleaning the 1019 deposit prior to the cut 1017 being identified as a feature and likely came from this fill or could have been disturbed and historically moved around when the road / drive was being formed.

Plate 7 Pottery from 1018

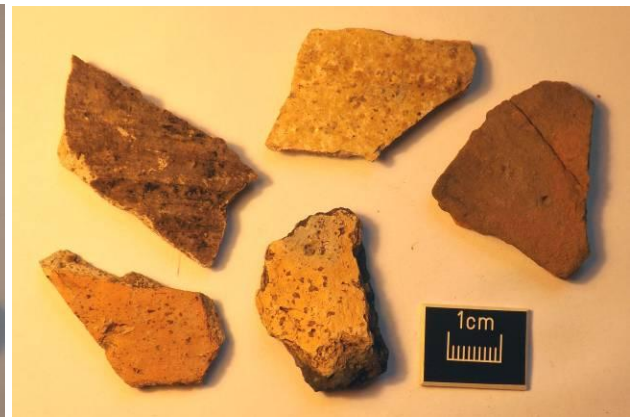
Plate 8 Pottery from 1019

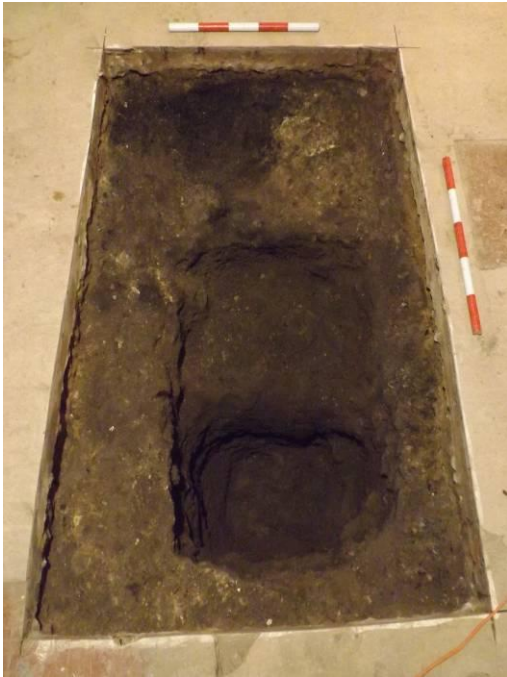
Plate 9 View looking S post-excavation of (2004/2005)
(Photo 1295)

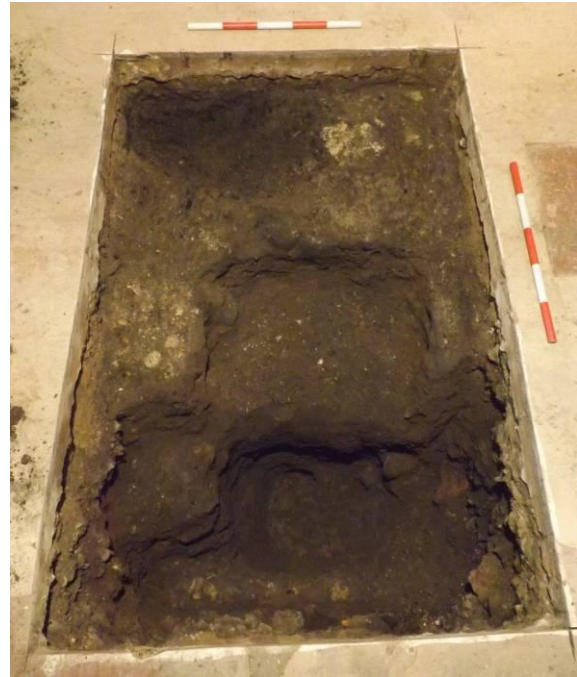
Plate 10 View looking S post-excavation of
(2006/2007)(Photo 1307)

To the N of Trench 2 it was clear that the modern test pit had been cut through gritty silt abundant in coal fragments, cinders, slag and fired stones – (2006). This deposit was clearly the fill of [2007], a W-E aligned cut which coincided with the cut of the shortened test pit [2005]. It is surmised that when the modern test pit was excavated, this proved slow going until the labourers located the existing edge [2007] and subsequently halved the size of the test pit, removing the loose fill (2006). White glazed ceramic from within (2006) indicated this to be a 19th century deposition.

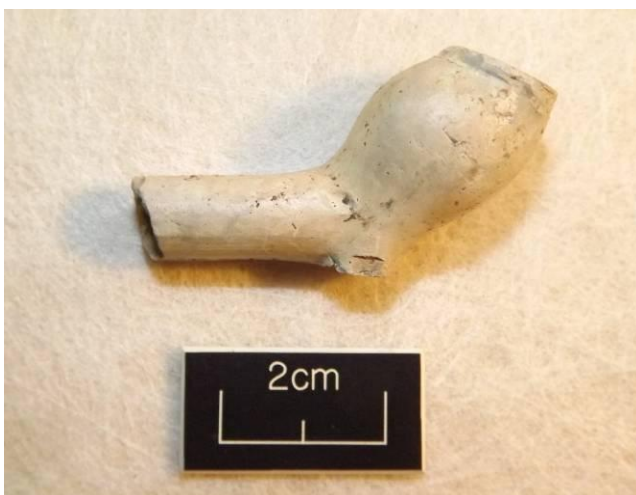
Plate 11 Detail of early 17th century pipe bowl SF005

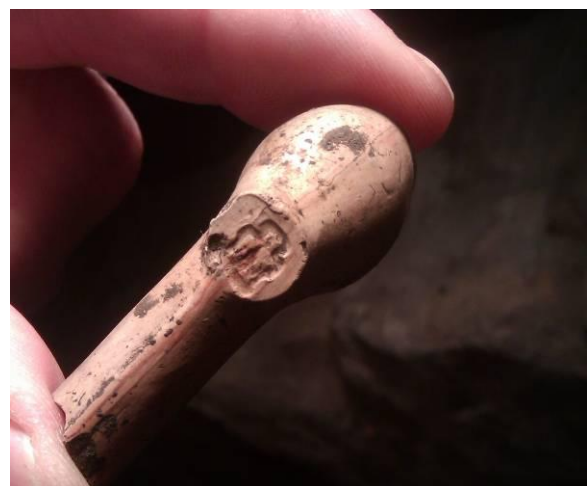
Plate 12 SF005 showing the 'castle' stamp on the
foot

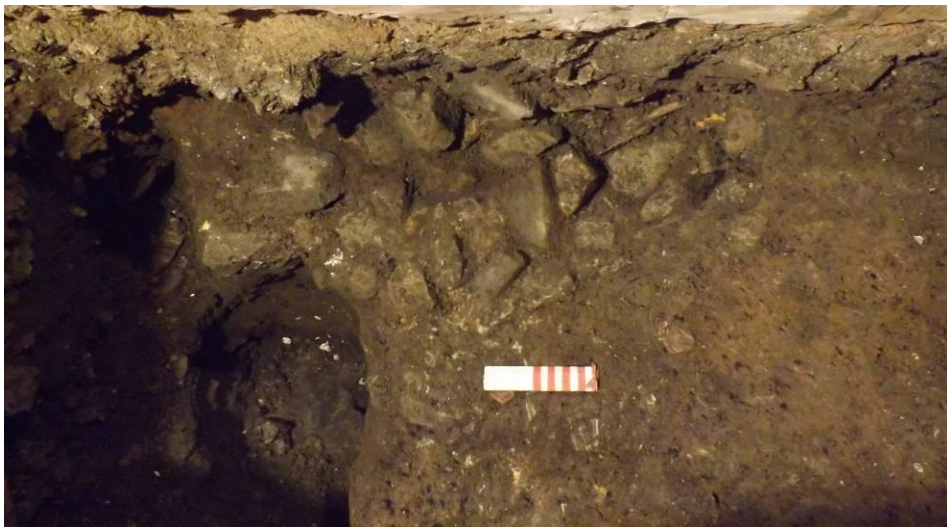
Plate 13 (2009/2012] becoming apparent (Photo 1328)

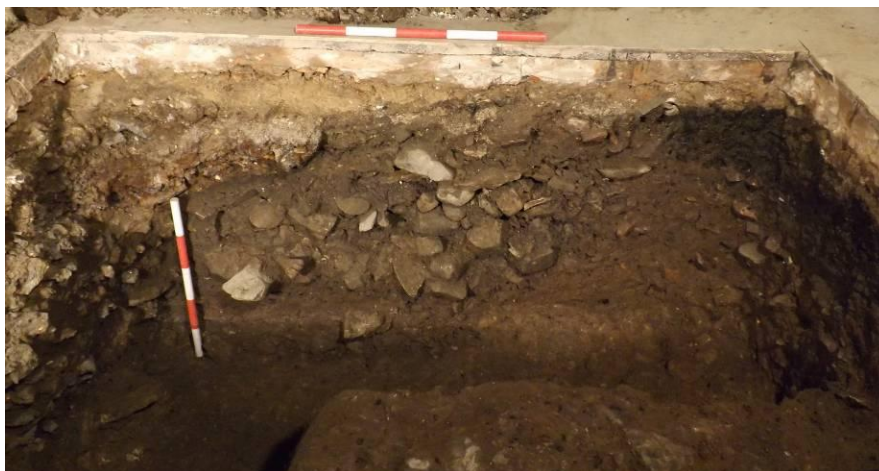
Along the E section of the Trench the outline of a pit was faintly discernible. Truncated by both [2005] and [2007] excavation of (2009) showed this to sit within an irregular pit [2012] which, with rounded S and SW edges, was in all likelihood circular in shape prior to truncation. A dark to mid brown silty clay abundant in small to medium angular stones, (2009/2012] was cut through (2010) and contained a significant number of medieval green glazed sherds of ceramic.

Plate 14 W facing section of Trench 2 showing (2009/2012] (Photo 1400)

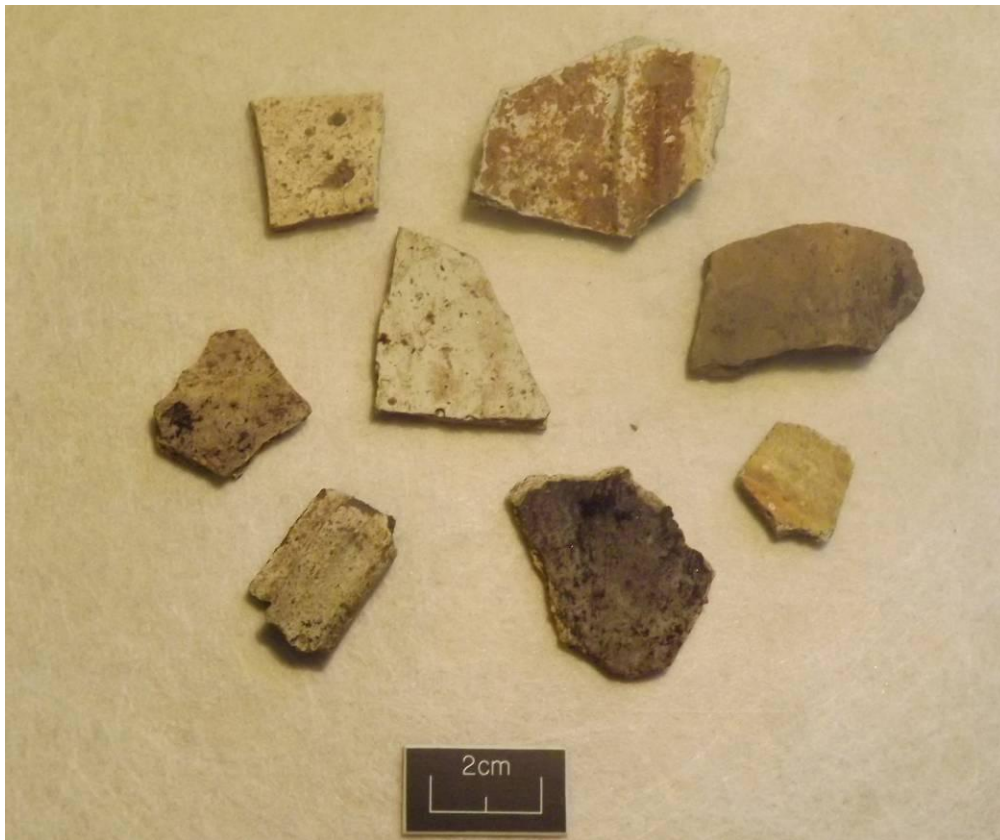
Despite initial appearances, no other features could be located cut into (2010), despite a clear difference between the 'cleaner' garden soil and darker deposits (2015) to the S and W. Continued excavation by spits, revealed (2010) to be a lens within the wider garden soil and contiguous with (2015). The garden soil proved to be c.0.50m deep and finds of early 'white gritty ware' ceramic were recovered from both contexts.

Plate 15 White gritty ware SF019 as recovered from (2010)

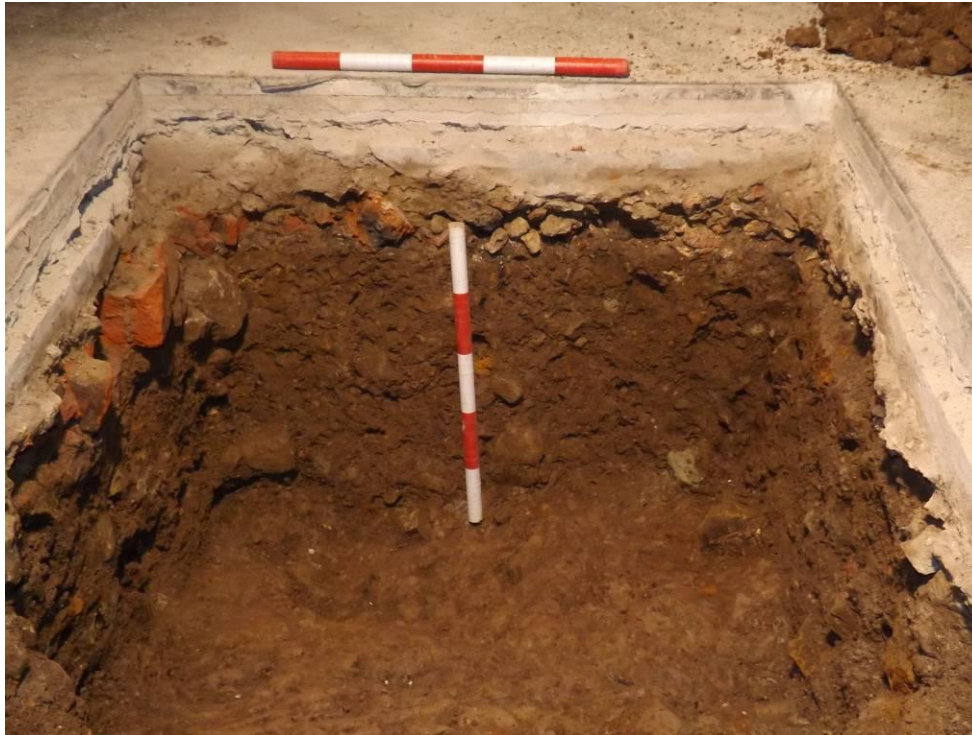
Underlying this bottoming deposit appeared to be a natural type deposit of compacted sands and gravels 3002 basically a general glacial till. This was reduced by a couple of 5 cm spits to check if it was indeed in situ natural and a further deeper sondage was excavated in the west half. Within this sondage soft bedrock 3003 was encountered, this bedrock sloped up to the east

Plate 16 trench 3 sondage down to bedrock 3003 with 3002 natural sands and gravels above and 3001 modern floor surfaces on top (0.50 m scales)

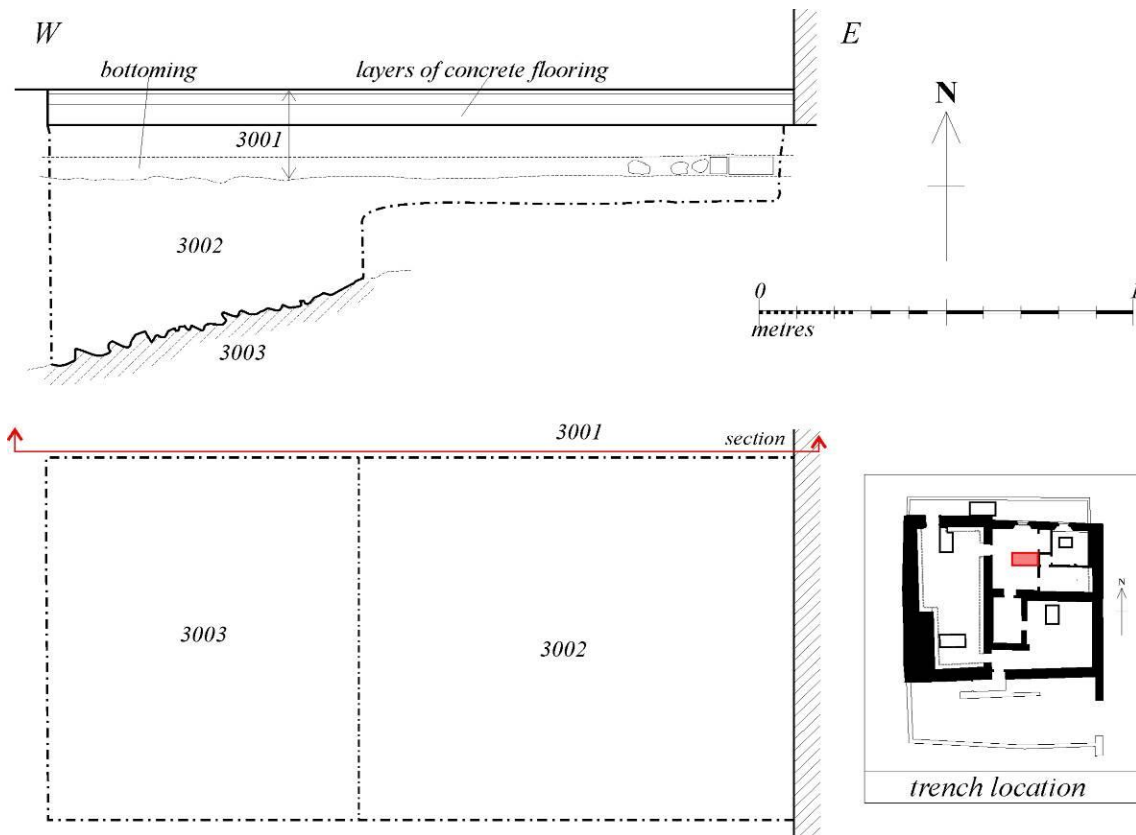
Within this trench no features or deposits of archaeological interest were seen, just mid-20th century concrete flooring over a truncated natural substrate.

Figure 5 trench 3 sondage down to bedrock 3003 with 3002 natural above and 3001 modern floor surfaces on top

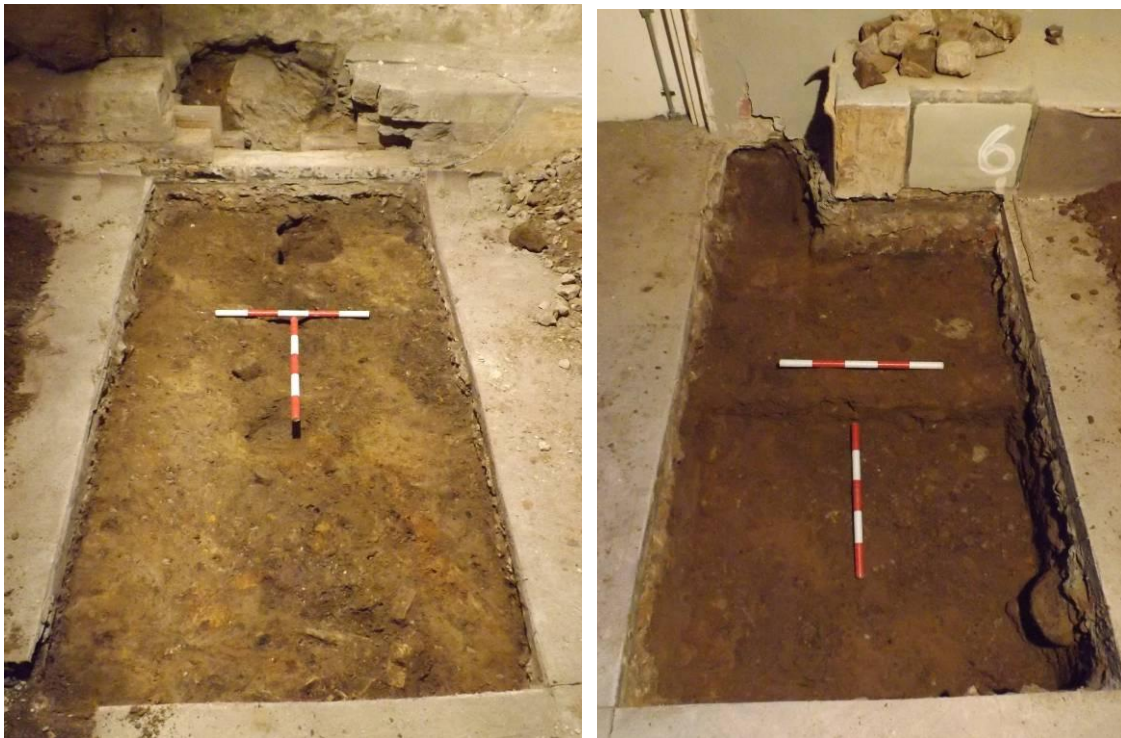
Plate 17 trench 5 cleaned up to show bands of natural Plate 18 trench 6 at LOE (0.50 m scales)

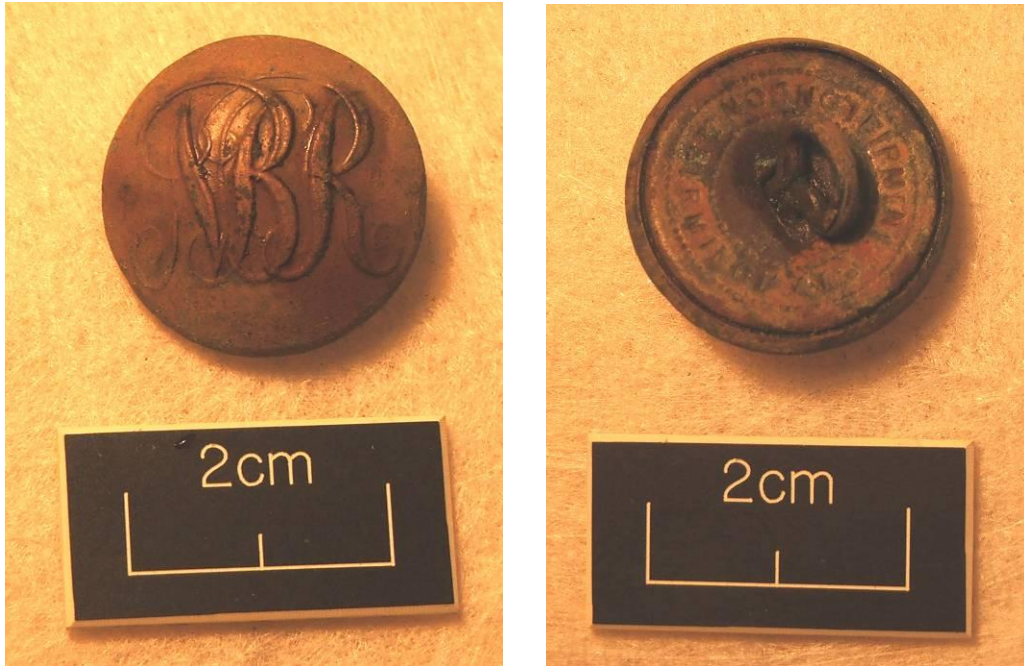
Plate 19 front and back of button recovered from 7004(SF023)
