Playing Fields, Callander Primary School

Archaeological Evaluation

Archaeological Evaluation: June 2013

Data Structure Report

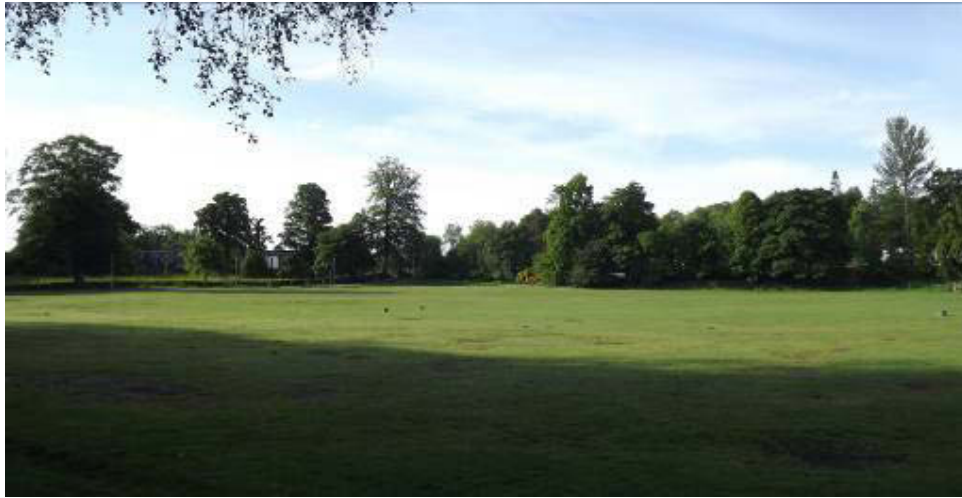
Plate 1 View looking SE across the development site (Photograph 002)

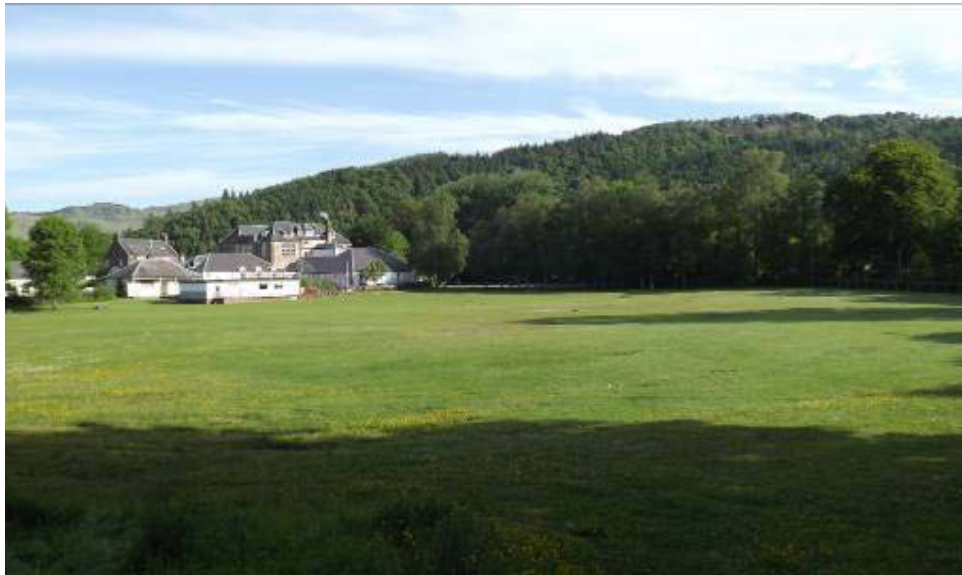
Plate 2 View NW across the development site (Photograph 015)

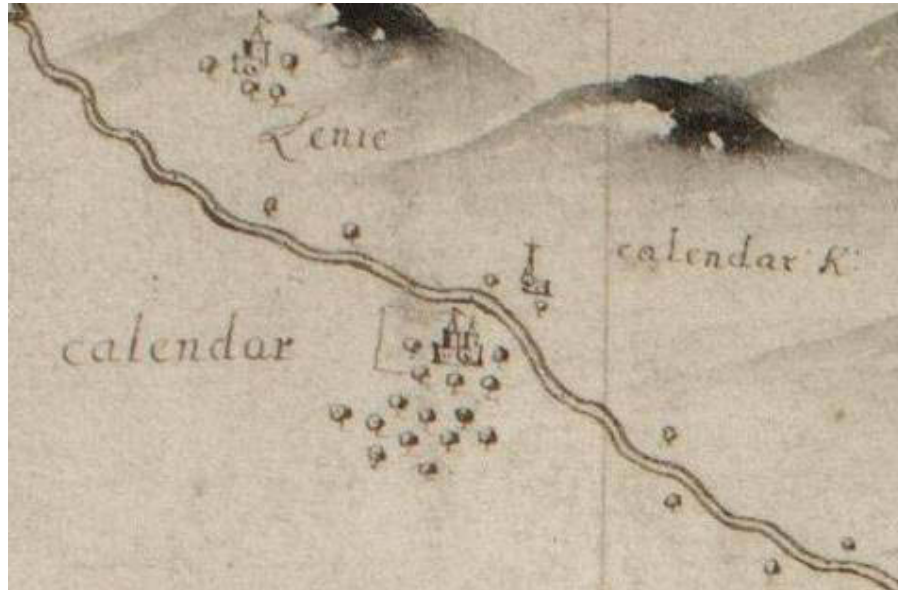
Figure 2 Earliest view of 'Calendar' as shown by John Adair in 1682 (NLS)

The structure to the S of the river is interesting in that it appears to be surrounded by what may be a planned park, with trees to the S of the structure and a possible boundary to the W. It is likely that this is a representation of Callander Castle as described above, while that to the N of the River may be what is now the Roman Camp Hotel, or a church. If a planned landscape existed around Callander Castle, it is possible this could have occupied some of the current development site.

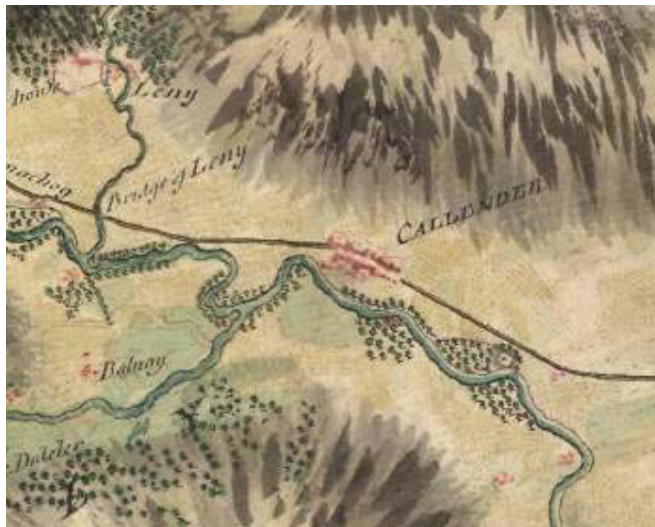
Figure 3 'Callender' as depicted on William Roy's 'Military Survey of Scotland'

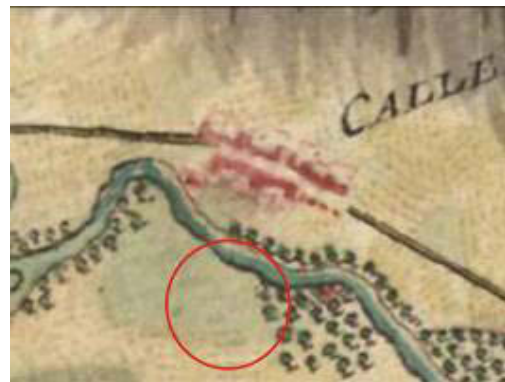
Figure 4 Detail of Roy's 'Military Survey of Scotland' showing the rough location of the proposed development

Roy's map shows no development S of the river with the exception of one structure, which is likely to be the site of Callander Castle, now occupied by the Old Manse.

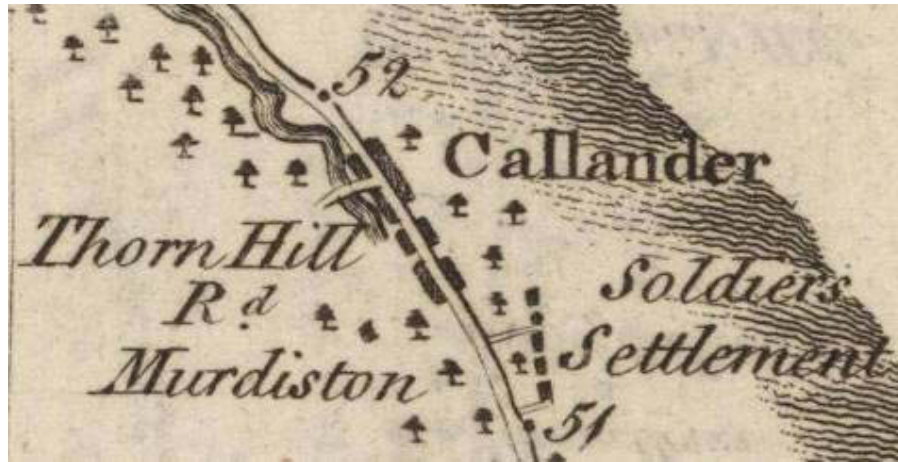
Figure 5 Callander on George Taylor and Andrew Skinner's 'The Road from Edinburgh to Stirling, Tyndrum and Fort William' from 1776. This is the first map to show a bridge across the Teith. (NLS)

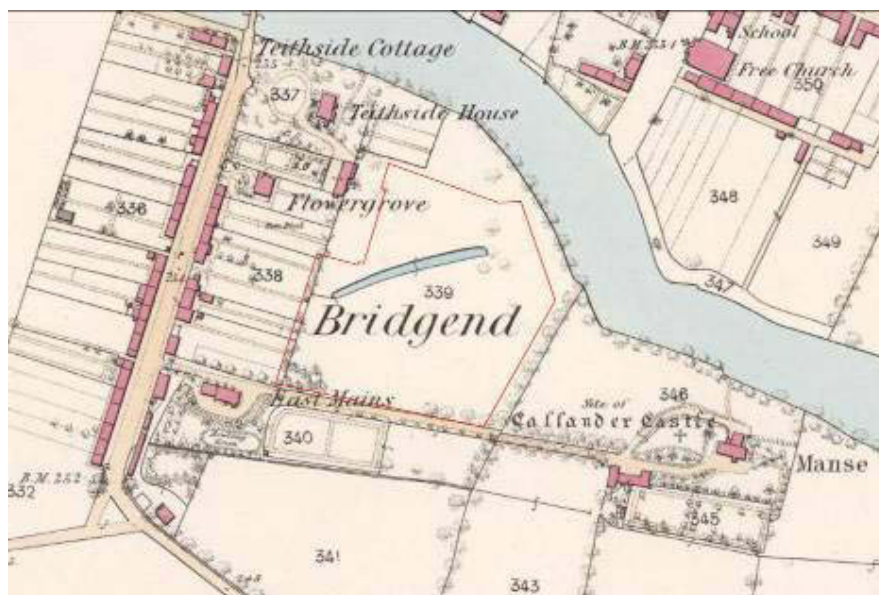
*Figure 6 OS 1st edition 25 inch, Perth and Clackmannan CXXIV.1 (Callander).
Surveyed 1862. Published 1866.*

Surveyed in 1862, the 1st edition (*figure 6*) already shows the site limits established by the back gardens of the houses in Bridgend and Manse Lane along the southern perimeter towards the Old Manse and the site of Callander Castle. The only feature of note within the limits of the development is a linear watercourse running WSW to ENE, with rounded terminals at each end. The function of this feature is unclear and it does not appear on any of OS maps post-1866. The shape of the feature makes it unlikely this is a natural occurrence and it may represent a culvert running from Bridgend to the Teith, perhaps uncovered for some of its length. The Category C Listed Primary School to the W has yet to be built although Teithside House to the NE is in place.

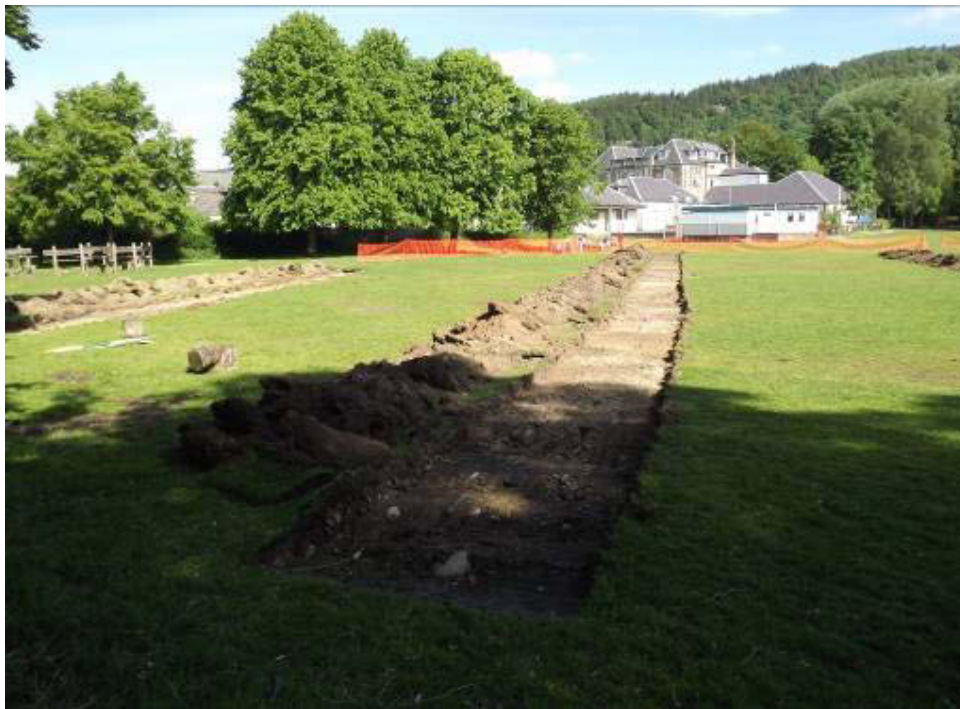
Two features of potential archaeological interest were noted during excavation of Trench 2, with a dark linear (205) feature running W-E across the N end of the site, and a more promising darkly coloured circular feature (206) of around 0.35m diameter 24m from the SE end of the trench.

Plate 3 Post-excavation view of Trench 2 (Photograph 039)

As anticipated, excavation of the linear [207/205) showed this to be a 19th century red ceramic field drain, with a dark grey cinder/charcoal flecked fill. (205) also contained sherds of 19th century ceramic.

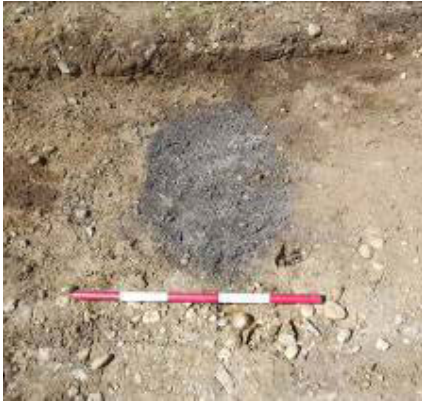
(206) proved to be the fill of a negatively cut feature [204] with gently sloping sides and a roughly domed base. However, this was found to contain a degraded Fe nail as well as coal and is likely to be 19th century in origin.

*Plate 4 Pre-excavation view of (206)
(Photograph 097)*

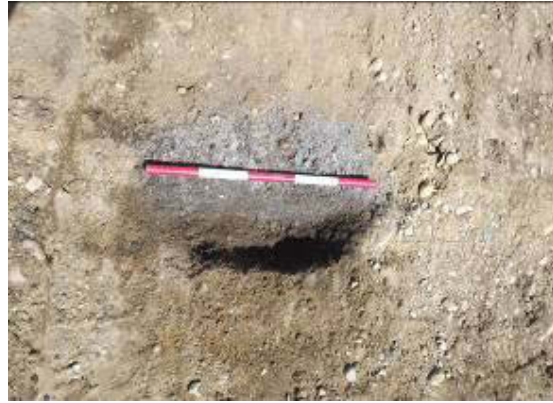
Plate 5 Post-excavation view of [204/206] (Photograph 100)

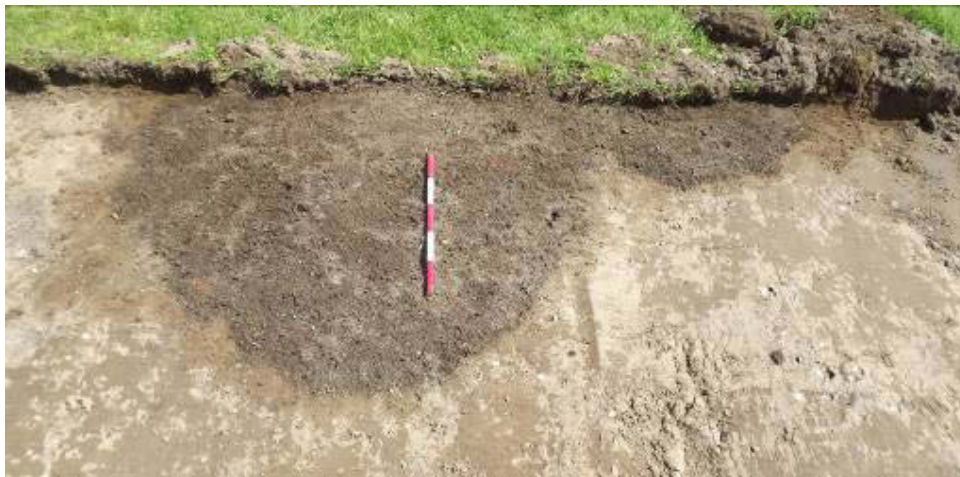
Trench 5 contained the most promising feature encountered during the evaluation. A large irregular feature, almost 'figure of 8' in shape was encountered against the SW baulk of the Trench, with the black brown silty fill contrasting sharply against the surrounding mid yellow and orange brown sandy subsoil. However, excavation of [503/504] revealed this to contain a fragment of plastic at the base of the deposit. This was not retained and the feature ignored as a modern intrusion.

Plate 6 Pre-excavation view of (504) (Photograph 116)

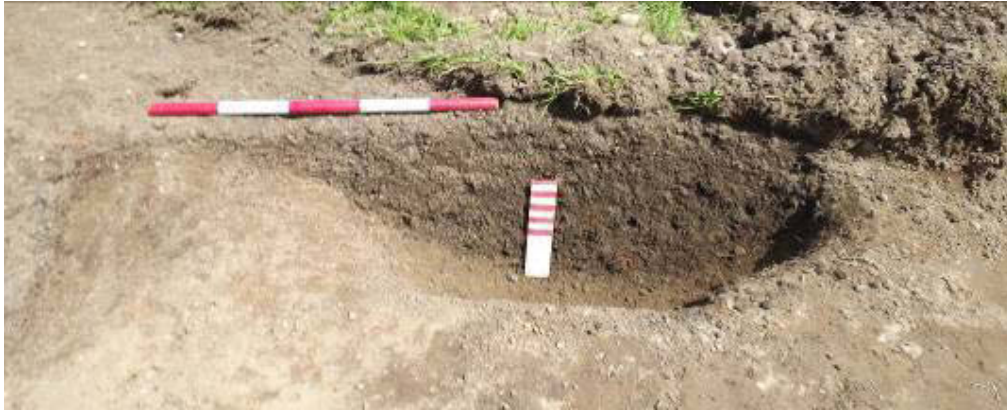
Plate 6 Post-excavation view of [503/504), SW facing section, S end (Photograph 117)

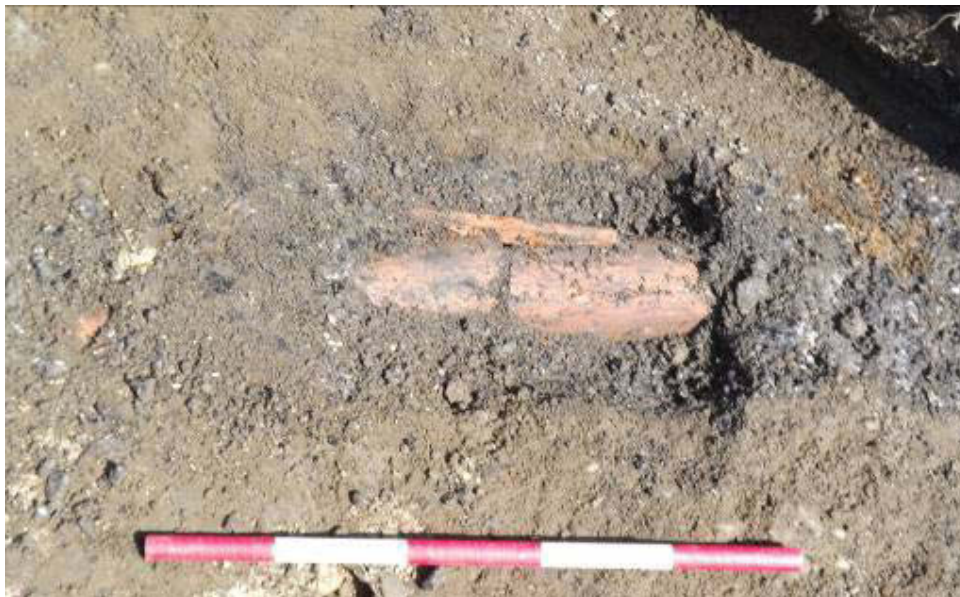
Trench 8 also contained two linear features which were discovered to be red ceramic field drains. Both of these features contained 19th century ceramic fragments.

Plate 7 Red ceramic field drain in Trench 8 (Photograph 126)

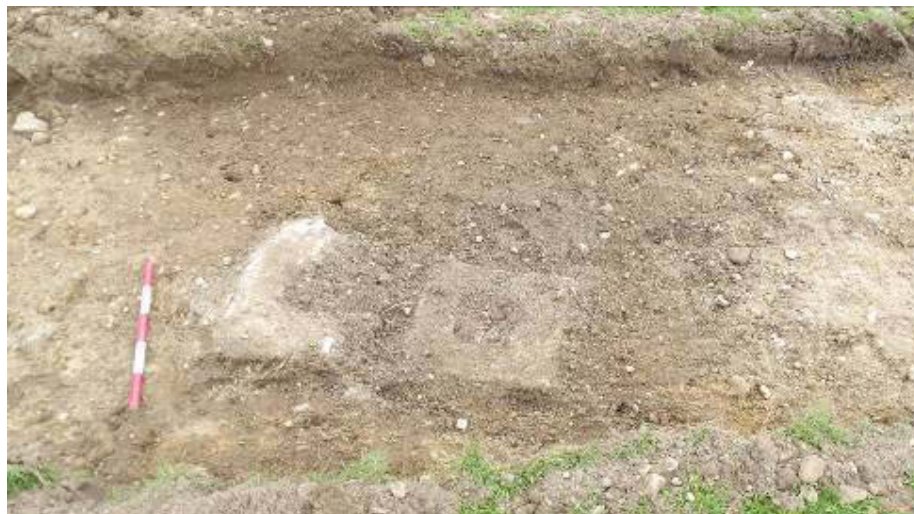
At the S end of the Trench (1604) a stone feature was revealed to be a setting for football post, subsequently grassed over and covered up by earth.

Plate 8 Feature (1604) (Photograph 227)

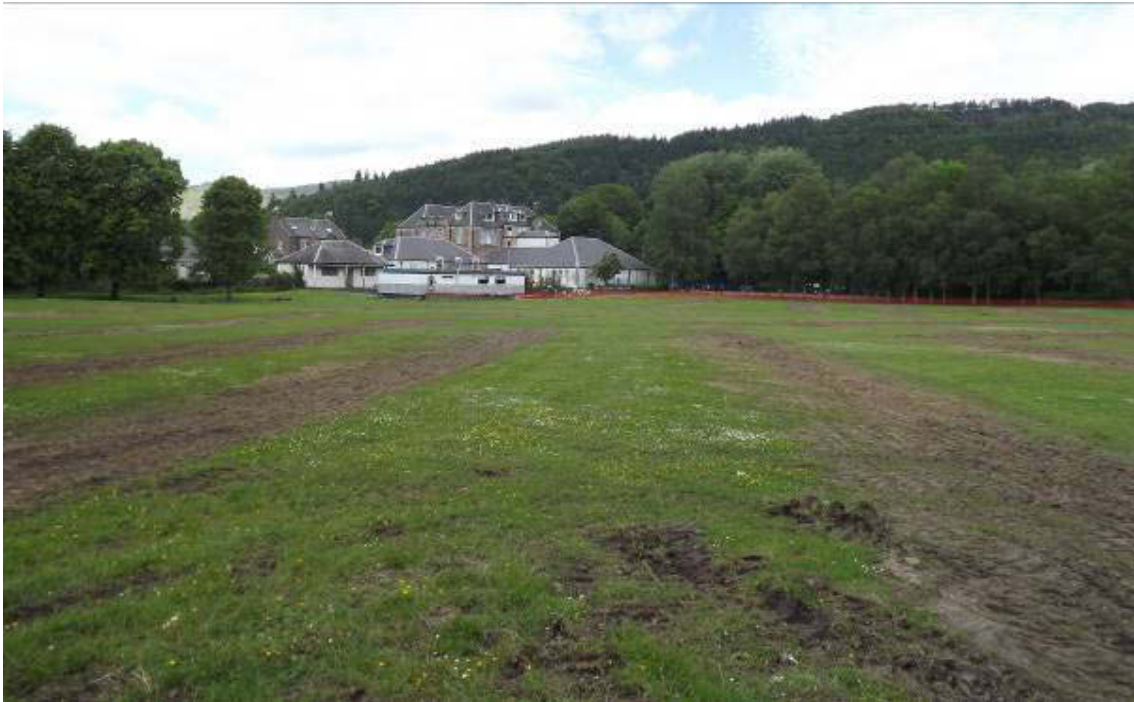
Plate 9 Trenches backfilled across site (Photograph 251)
