Calder Water Community Windfarm

Strathaven, South Lanarkshire

Archaeological Watching Brief: November 2012 – June 2013

Data Structure Report

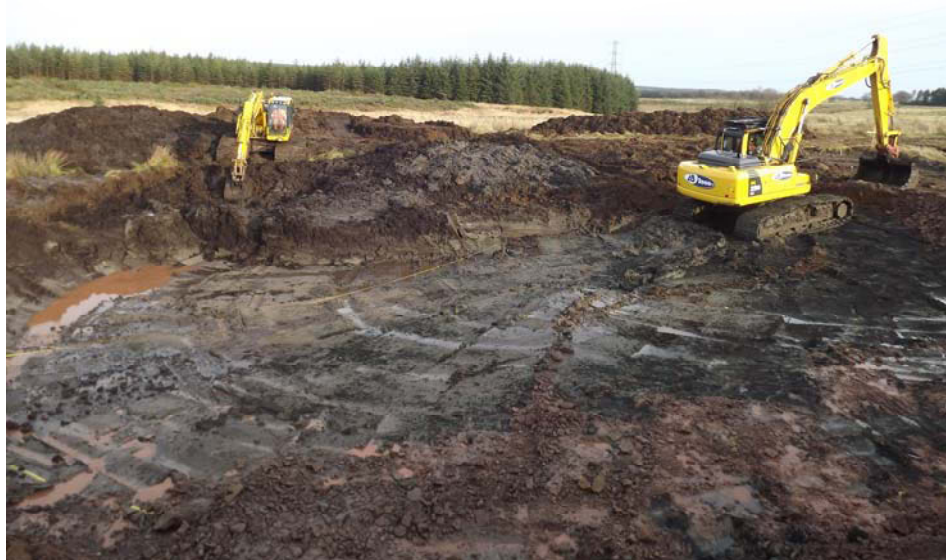
Plate 2 Excavating the original location of Turbine 4

On November the 22nd work halted at Turbine 4 and it was agreed at management level to re-align the access track to the north west and re-position Turbine 4 further north. On February 11th 2013, work began again on the now repositioned Turbine 4 and access track. From its junction with Spur 1, the access track would now float above the topsoil, due northeast towards Turbine 4, for approximately 150m. Subsequently, the method of excavation was to have a 360° excavator sit atop the completed road surface and excavate horizontally through the peat face. The peat along this realigned track (northwest of the original) was now at 2.0m deep and would quickly increase to up to 6.0m in depth. It was also found that an underground stream system was present in this area, flowing freely beneath the layer of peat. This meant that once the peat was removed and cleaned down onto the natural clay, the excavated area would quickly fill with water thus obscuring any potential archaeology that may have been present. The depth of peat at over 6 metres, the horizontal excavation method, and the limited visibility due to water logging made for difficult monitoring from an archaeological perspective. At this point, the peat was becoming more and more unstable, collapsing unpredictably and slipping into the road, creating large craters. Monitoring often had to be done at a safe distance. When the soft silty grey clay natural subsoil could be thoroughly investigated, it was found to be sterile and of limited archaeological potential.

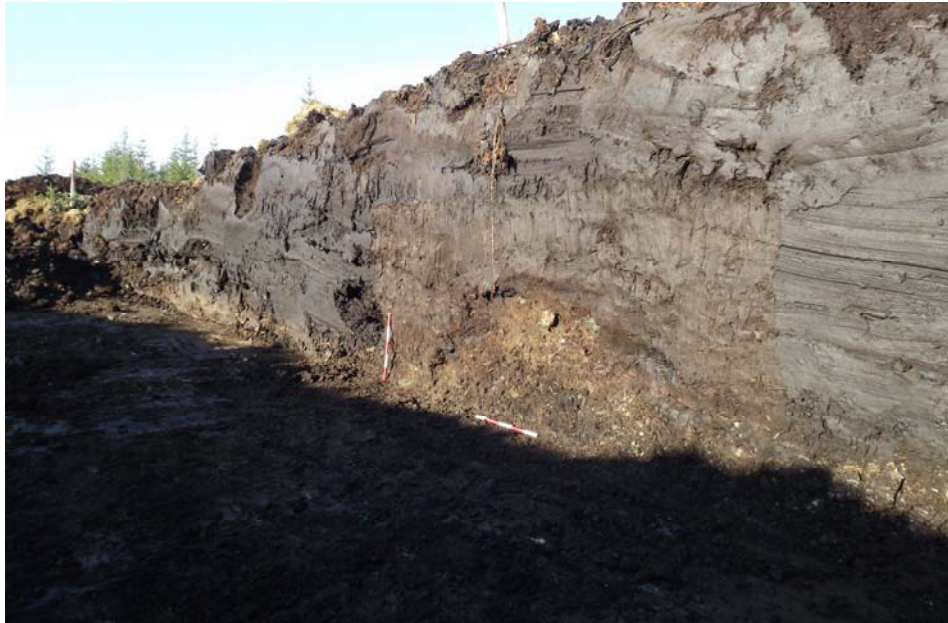
An isolated mound of re-deposited natural soil (014) was seen beneath the peat (002), measuring 1.90m NW-SE with a height of 0.85m. This mound extended c.1m into the excavation area, but excavation around this revealed little of note and it was felt appropriate to machine this portion away and record in section. In section the feature was seen to comprise a mound of re-deposited natural clearly overlain by a thin deposit of moderately compact dark brown black silty peat (015) with a depth of <0.12m. This darker deposit is overlain by the peat (002). It must be assumed the darker deposit (015) is an older ground surface, pre-dating the formation of the 2.3m of peat in this area.

Plate 3 Oblique view of feature (014) in the SW facing section of Spur 02

The function of (014) is unknown. Clearly this seems man made and no similar feature was noted anywhere else on site. The fact it underlies the peat build up indicates it could be prehistoric in date, but nothing was recovered either from the feature or in the vicinity to indicate the date or function.

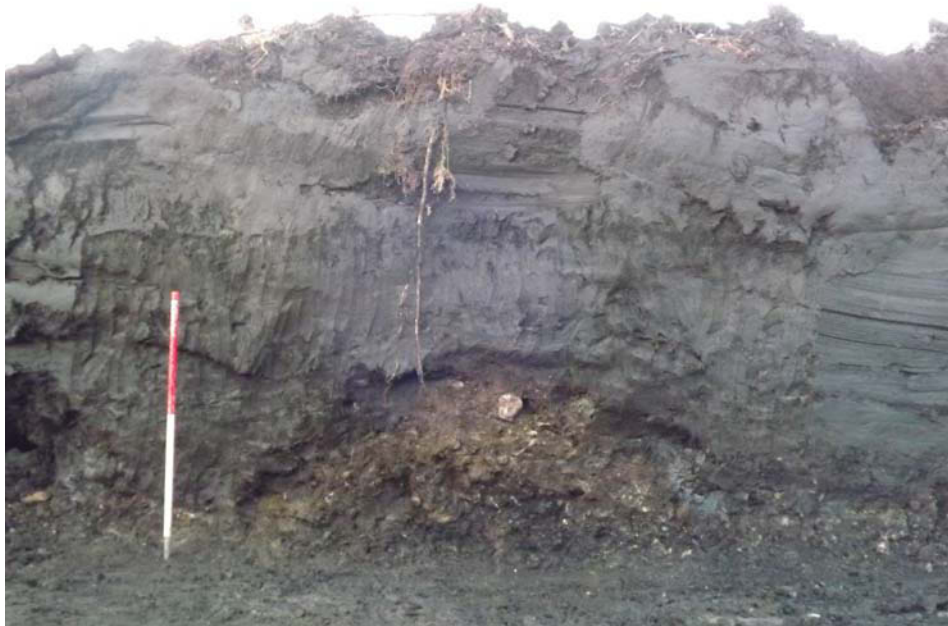
Plate 4 (014) in section looking NE

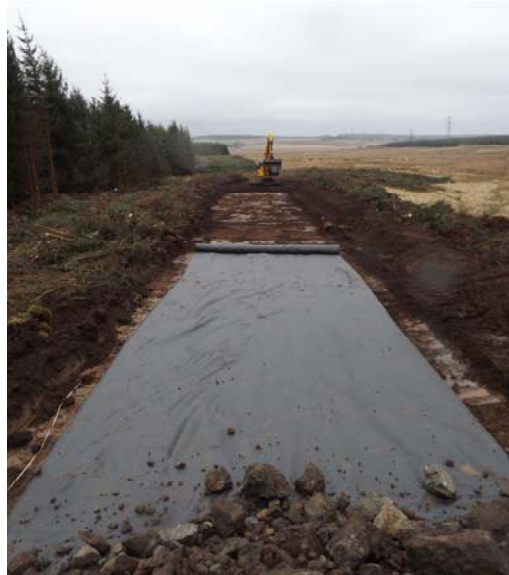
Plate 5 Stripping Spur 5

The agreed methodology for stripping the access to Turbine 11 involved stripping one side of the track to its full extent, putting the spoil on the baulk. Once the uncovered area had been thoroughly inspected, the remaining half of the Spur would be stripped and the spoil dumped on the excavated area. The spoil would then be shifted using a bulldozer. Topsoil in this area was thin at under 0.50m of peat overlying a mid-brown/ grey silty clay. The excavated area was until recently a coniferous plantation, and the subsoil revealed there to be extreme root disturbance and frequent tree hollows. Had there been anything archaeological in the area, it would have been severely disturbed. A single find of a 19th/ 20th century iron horseshoe was made in one of the tree hollows, likely churned up through root action, a remnant from before the tree plantation when the fields were being tilled. No additional finds or features were made in this area.

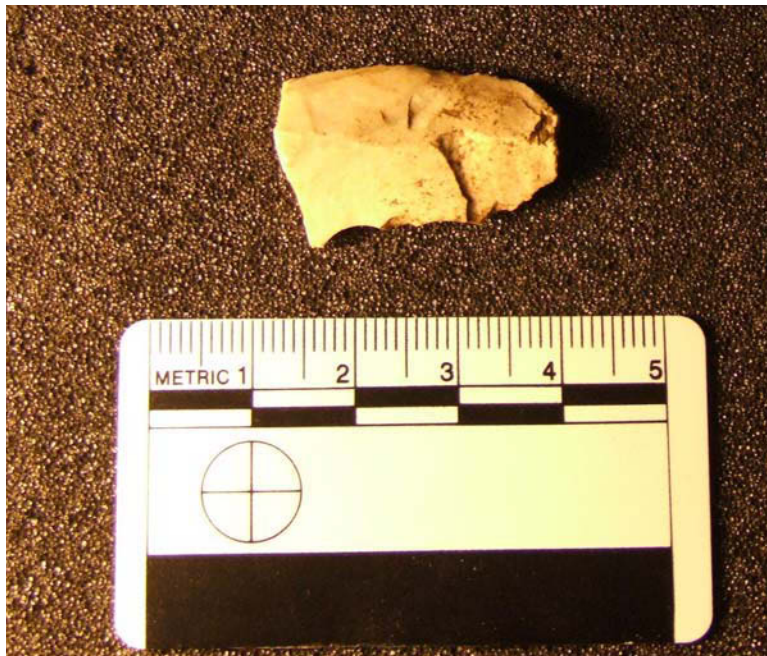
A single find of the proximal end of an edge-retouched flint blade (SF001-*Plate 6*) was found in the topsoil at the NW extent of the borrow pit. Found with no secure context, the entire area around the find was then investigated and was shown to be archaeologically sterile. The object is a typical early prehistoric artefact, pre-Neolithic in date, which in a Scottish context usually dates from the Mesolithic period. However, recent discoveries of earlier tools and working debris in the Biggar area indicate that the wider area was periodically inhabited from the Late Upper Paleolithic onwards (*pers. Comm.*, Alan Saville, National Museum of Scotland).

Plate 6 SF001

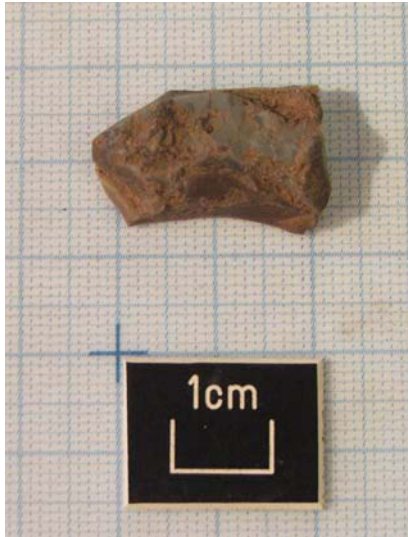
Plate 7 SF005

The flint fragment is highly battered and worn, likely owing to prolonged ploughing activity. It has possibly been retouched, though if it is a fragment of a flint tool, its type is difficult to establish due to its state of preservation. The find area was investigated thoroughly, and no features associated with these finds were present.

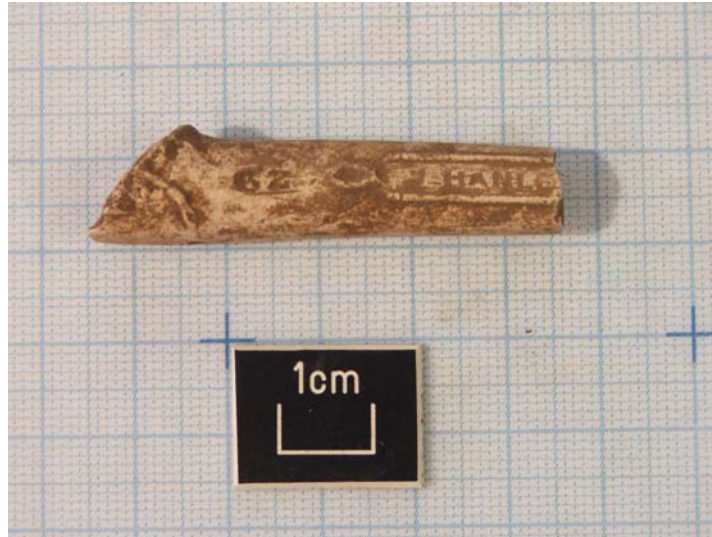
Plate 8 SF004

The clay pipe fragment is approximately 0.05m long, and is a section of the stem from where it connects to the bowl. Stamped 'J Hanley', it is most likely of mid to late 19th century date.

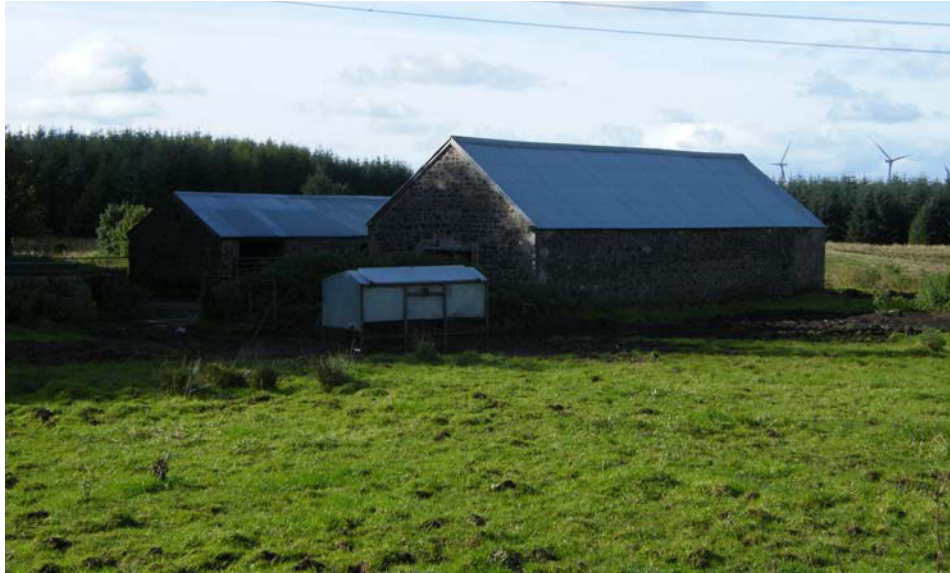
Plate 9 The farmstead of West Hareshaw as photographed during the walkover survey

The substation is located adjacent to the main roadway, at the windfarm's eastern extent, on the site of the pre-1750 West Hareshaw farmstead. Upon the initial arrival of the archaeologists on site, November 1st, it was discovered that the West Hareshaw farm had been demolished, and the foundations for the substation had been excavated. The farmhouses identified during the walkover survey were no longer upstanding.

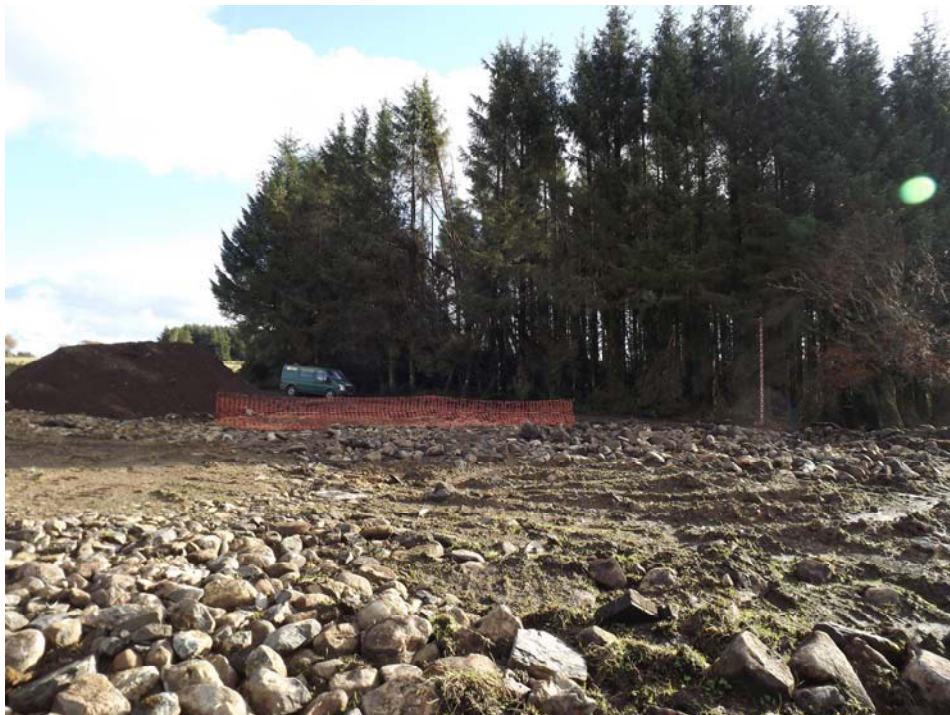
Plate 10 Looking S across the site of West Hareshaw

On closer inspection, a stub of lime bonded masonry was visible in the section, however it was determined in consultation with Martin O' Hare of WoSAS that no further archaeological work was required in this location.

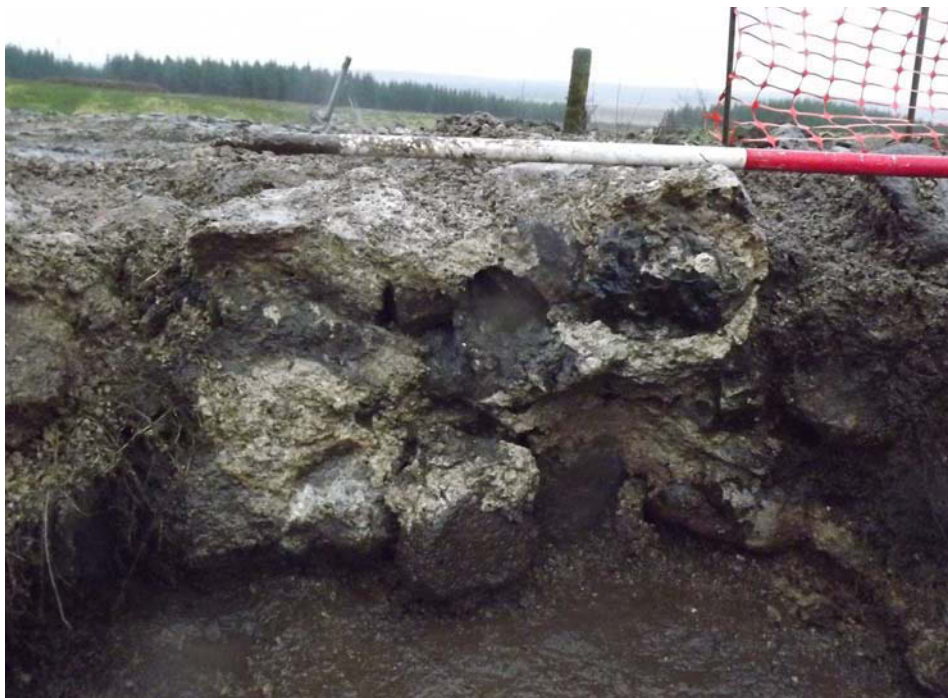
Plate 12 SE facing elevation of the stub of the West Hareshaw farmhouse NE wall

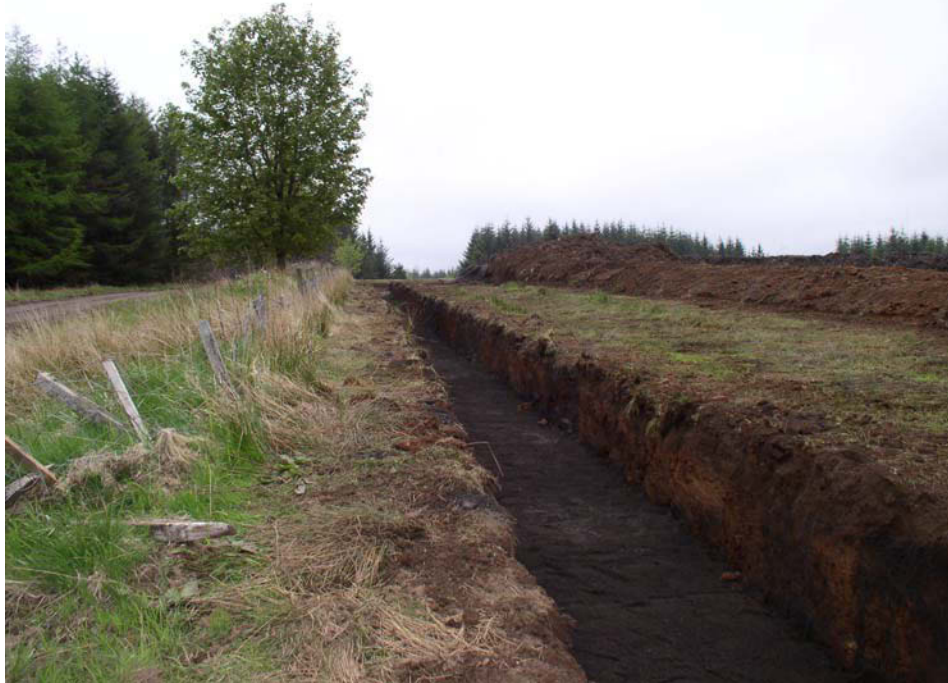
The Cable Trenches were excavated to accept the high voltage cables, connecting the turbines from across the site to the central location of the substation. Excavation of the cable trenches took place between the 3rd and 10th of June 2013. As cables are required to be placed 1m below the level of the road surface, the majority of the cable trenches were excavated through redeposited soil along the access track verges and did not need archaeological monitoring. A small number of the trenches, however, were excavated through virgin ground. Areas requiring archaeological monitoring were: along Spur 4- between Spur 3 and the forestry road, along the forestry road- between Spur 2 and Spur 4, and through the field and across the burn from Spur 4 towards the substation.

Plate 13 Cables trenches

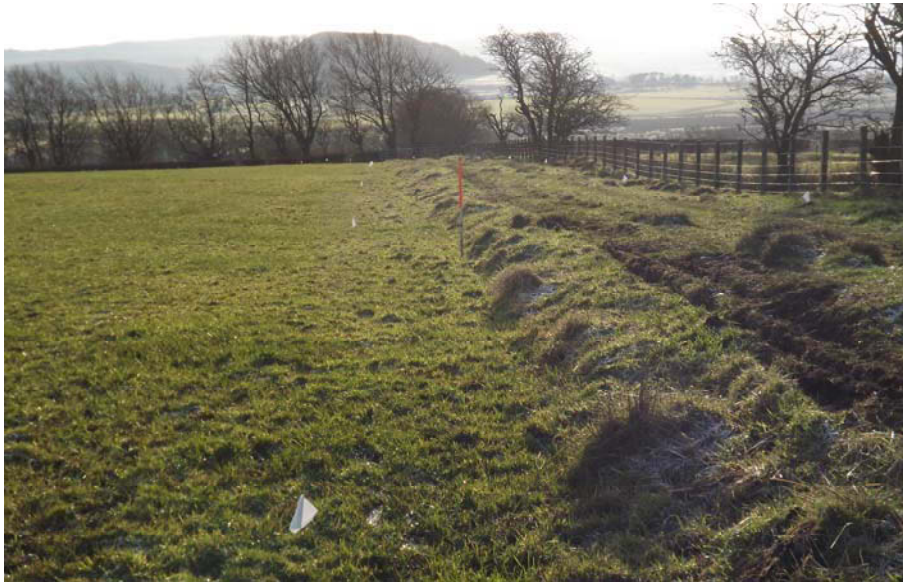
Further along the track's route, southwards following the fence line before turning southeast, a disused farm track was discovered orientated in the same direction adjacent to the fence, terminating at a gate on the road to Forehareshaw. The disused farm track (008) is approximately 4.0m wide by 0.40m in depth, and extends for roughly 175m in a north/south direction. The track is made up of medium sized angular stones, less than 0.20m in diameter, spread as a cobbled layer with a light brown sandy soil matrix. Immediately to the east was a modern red ceramic field drain running parallel to the disused farm track.

Plate 14 Looking SSW along the route of the site access track with the disused farm track visible along the fenceline

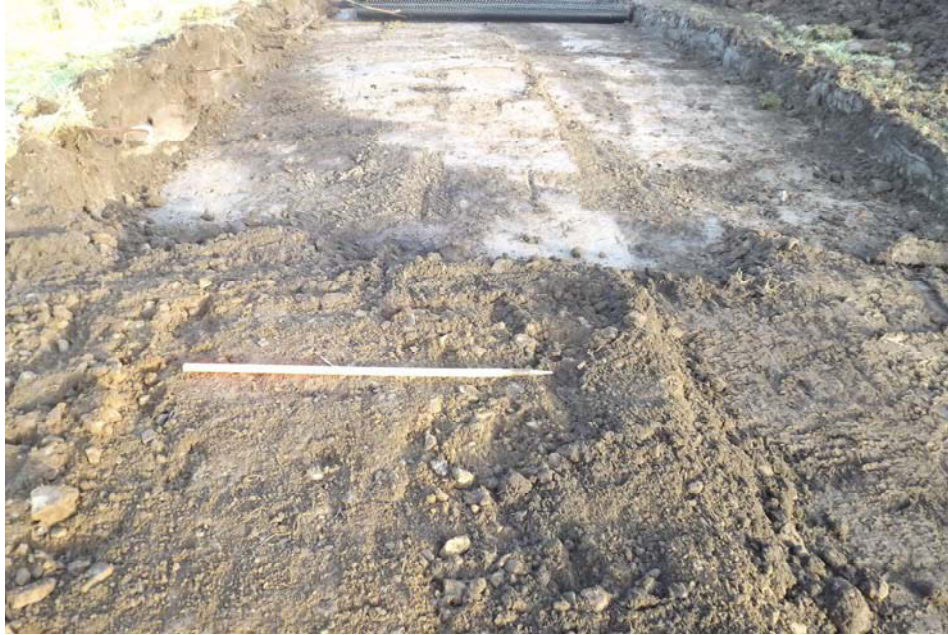
Underlying the north-south orientated disused farm track, Rig and Furrow (010) were uncovered running in a northwest- southeast direction, a different alignment to the modern field boundaries which are aligned north- south. The fill (010) of the furrow [009] was a dark brown- grey sandy humic clay of medium compaction and no inclusions. Removal of (010) showed [009] to be c.1m wide, with sloping sides onto a rounded base and a depth of 0.20m. No finds were made in association with the farm track (008), or Rig and Furrow (009).

Plate 15 Rig and furrow [009/010] in the background, with farm track (008) in the foreground

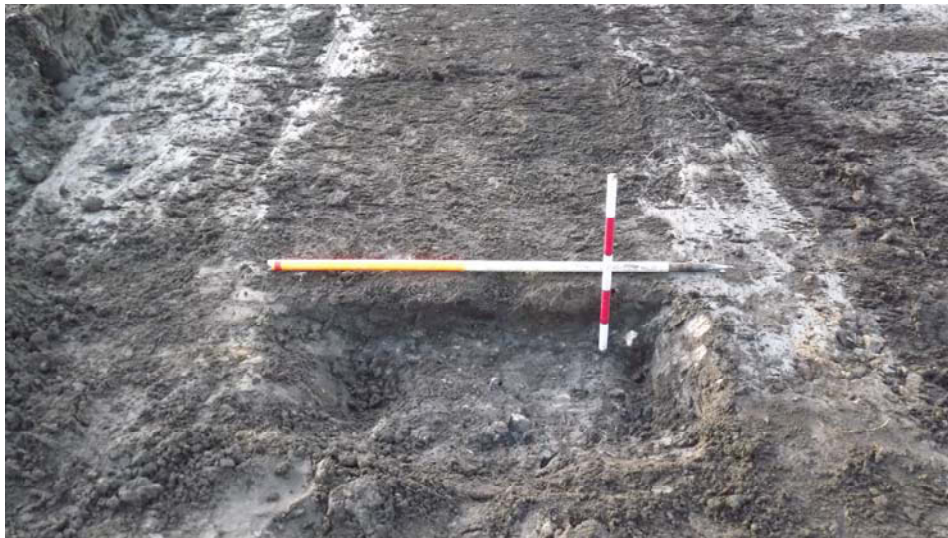
Plate 16 NW facing section of rig and furrow [009/010]
