Burnbrae, Ecclesmachan

Data Structure Report– Archaeological Watching Brief

Data Structure Report (DSR) for archaeological watching brief

by Andrew Morrison, edited by Tanja Romankiewicz

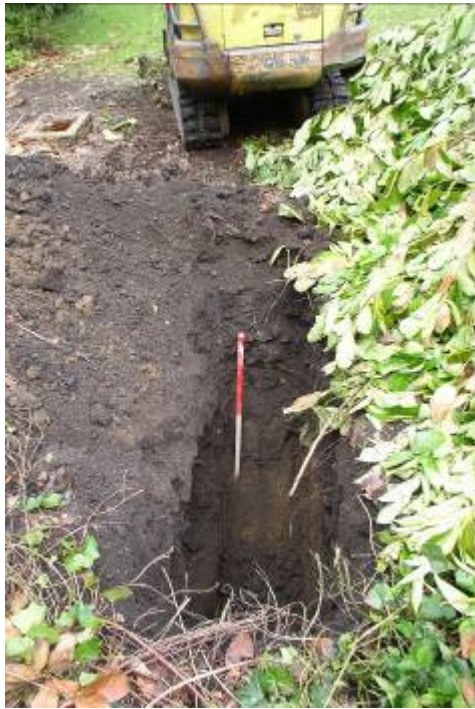
Figure 7 Trial Pit 1: post-excavation, E-facing section (Nr. 003)

Located at the southwest extent of the development area, at the edge of the terrace overlooking the burn.

Length: 1.60m, Depth: 1.70m. Topsoil, 1.0-1.5m deep. See *Figure 7* and *Figure 8*

Consisting of a single fill, dark brown-black humic clay-rich soil with rubble inclusions, including: ceramic drain fragments, red brick, sandstone blocks, modern glazed ceramic sherds, and plastic at the base of the deposit. Likely a levelling deposit to terrace the garden; this of post-1910 date according to a photograph of that date supplied by client Mr. C Miremont, and most likely to be of post 1950's date, because of plastic find at base of context. Overlies light brown sandy silt, naturally sloping from northwest to southeast.

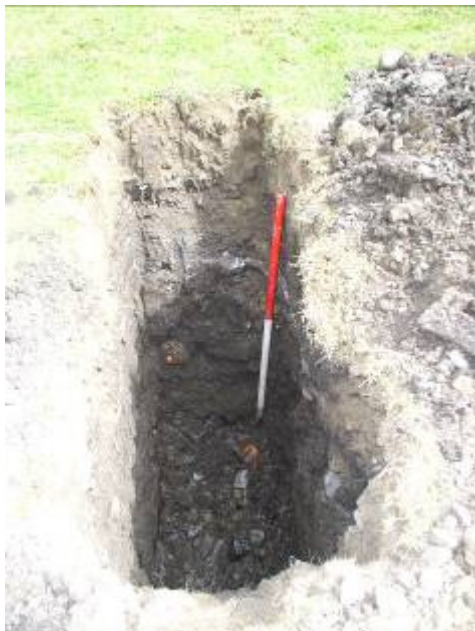
Figure 9 Trial Pit 2: post-excavation, S-facing section (Nr. 005)

Located at the northwest extent of the development area, central within the lawn area.

Length: 1.30m, Depth: 1.50m. Topsoil, 0.30m deep. See *Figure 9*

Consisting of a light brown compact garden soil. Overlies 0.20m of dark grey compact gravel with sandy soil matrix (this a possible path surface?). Overlies 0.50m of industrial waste deposit (likely Victorian or later) including: asphalt, firebrick, red ceramic drains, cast iron pipe (0.08m diameter). This deposit is potentially related to a nearby smithy. Overlies shale and light brown med.firm clay natural.

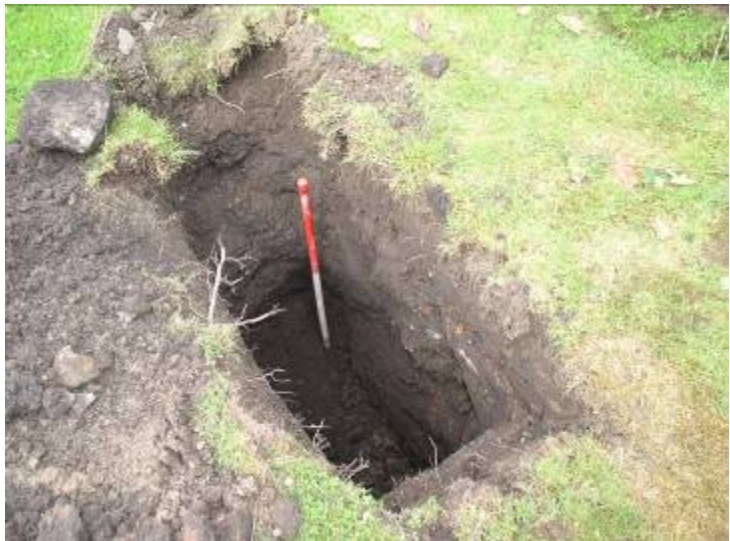
Figure 10 Trial Pit 3: post-excavation, S-facing section. (Nr. 009)

Located at the eastern extent of the development area along the hedge line adjacent to the garage.

Length: 1.40m, Depth: 1.70m. Topsoil, 0.30m deep. See *Figure 10*

Consisting of a dark brown humic garden soil. Overlies 0.06m lense to the eastern extent of the trench, of compact light brown sandy soil with brick fragment inclusions. Overlies 1.00m of industrial waste deposit similar to TP2. This includes: firebrick with the stamp 'ETNA', Fe strip with brass screw, ceramic drain, etc. Overlies shale and clay natural as in TP2.
