# Aikengall II Windfarm

Archaeological Evaluation: September 2013  
Data Structure Report

*Archaeological Evaluation (AA 2079.01)*

*September 2013*

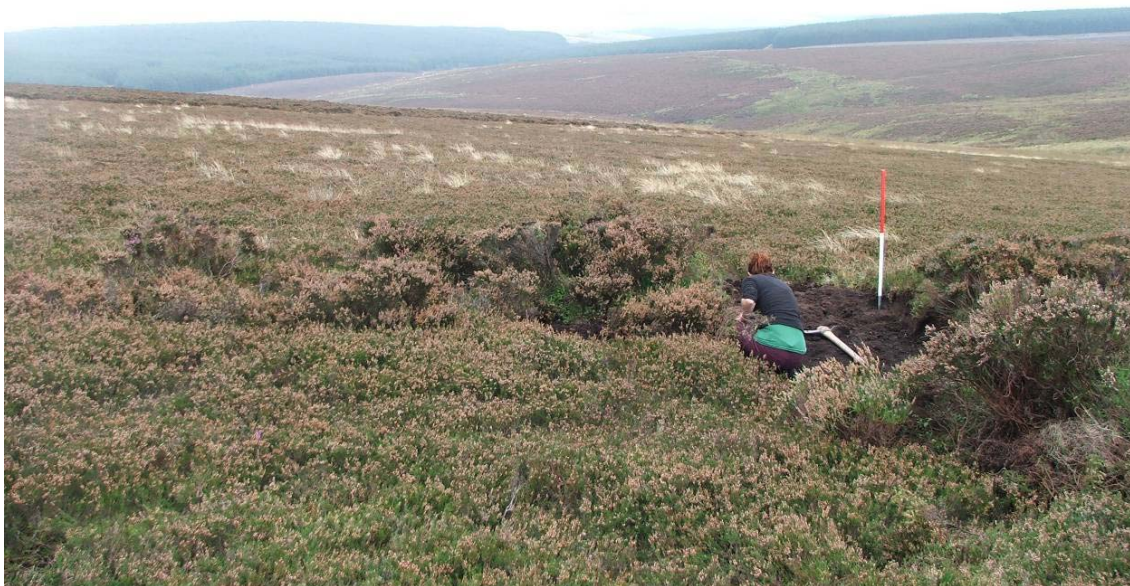
*View of Trench 3 under excavation*

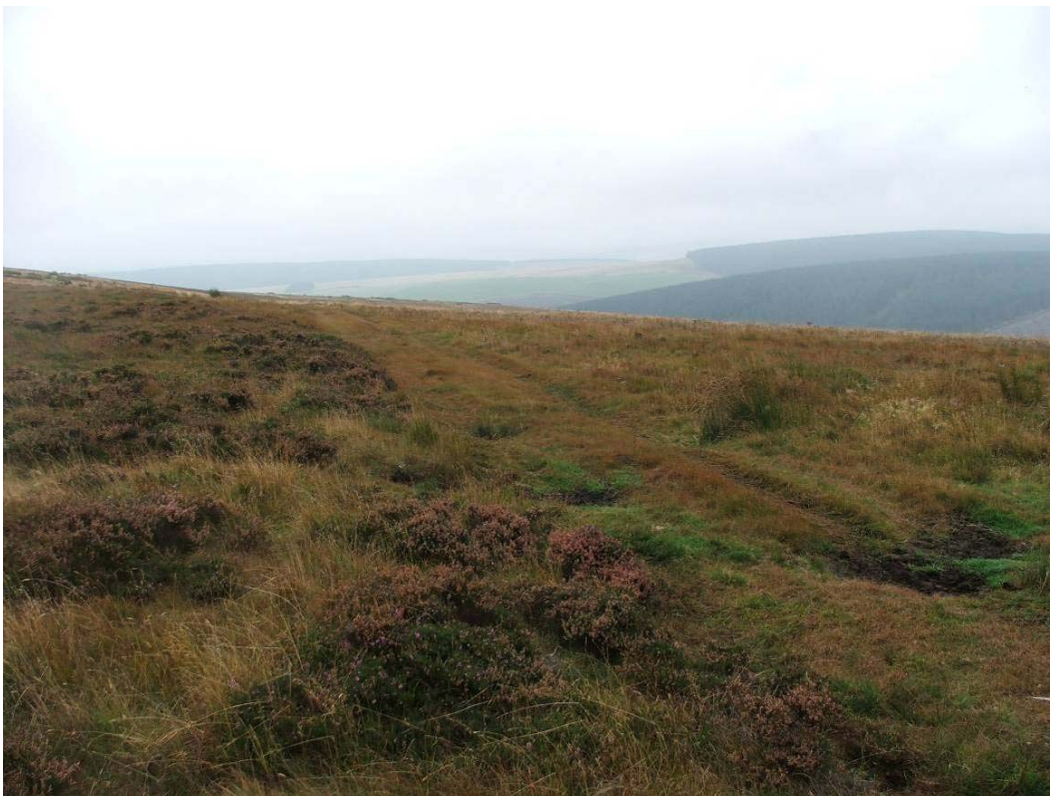
*Plate 1 General view of open heath along line of drove road*

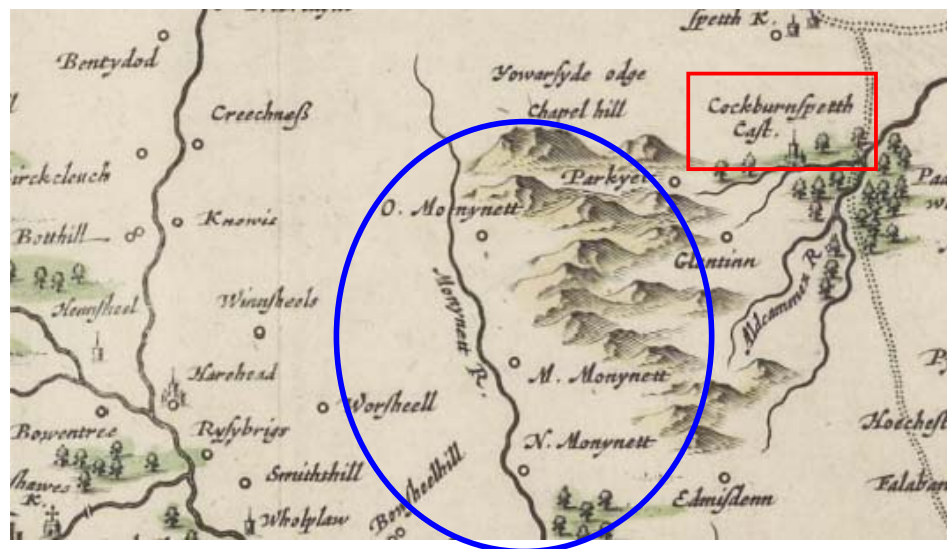
Figure 2 Joan Blaeu's re-issue (1654) of Timothy Pont's map of ca. 1583-1596 showing the locations of Cockburnspath, the Monymutt Water, and the Middle and Nether Monymutt farms (NLS)

By 1654 Joan Blaeu (*Figure 2*) produced his *Atlas of Scotland*, taken from the 16<sup>th</sup> century work of Timothy Pont. Blaeu's map of Mercia (1654) provided no new information, but it is notable that no woodlands were shown in the area.

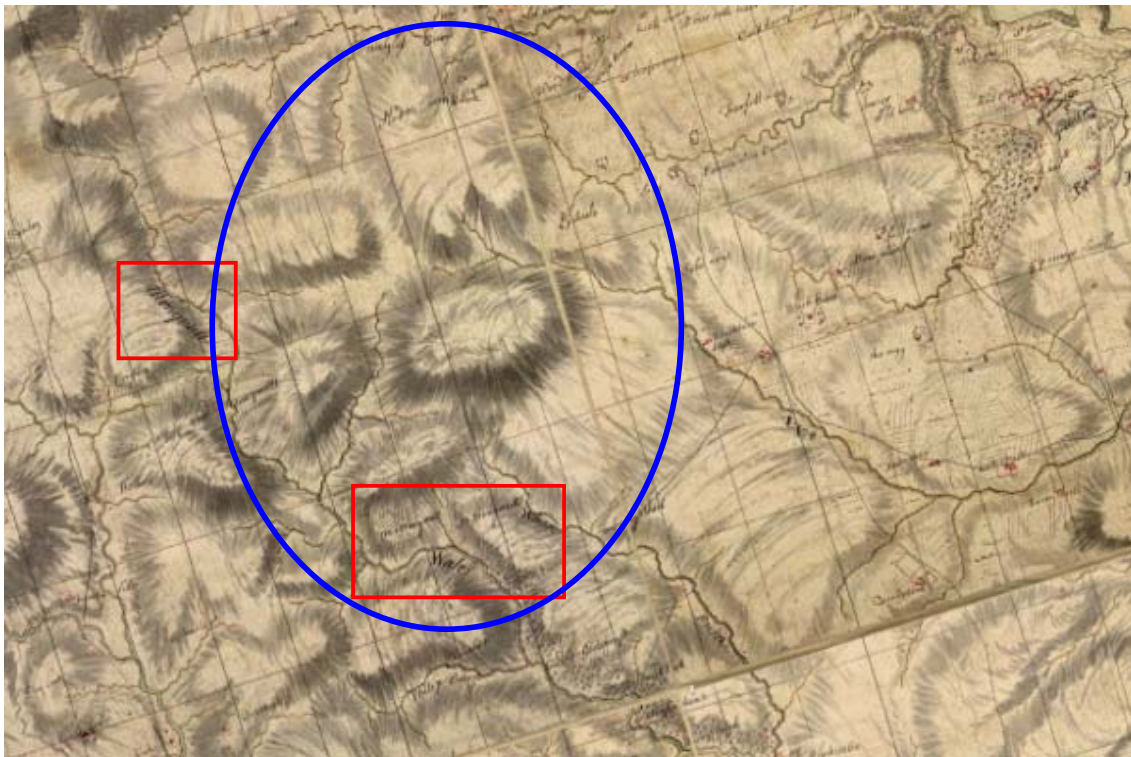
*Figure 5* Extract from William Roy's Military Survey of Scotland. Produced c.1750 this map has a remarkable level of detail. © The British Library Board. All Rights Reserved (Roy Military Survey of Scotland).

William Roy's military survey of Scotland conducted between 1747 and 1755 stands out as the first map with sufficient detail to analyse the development area (*Figure 5*). Roy's map clearly depicts the site area between the Monynut Water and Eye Water, and both farms of Middle and Nether Monynut are depicted, with areas of agricultural land around them. However, for the general development area no other features or landuse are depicted.

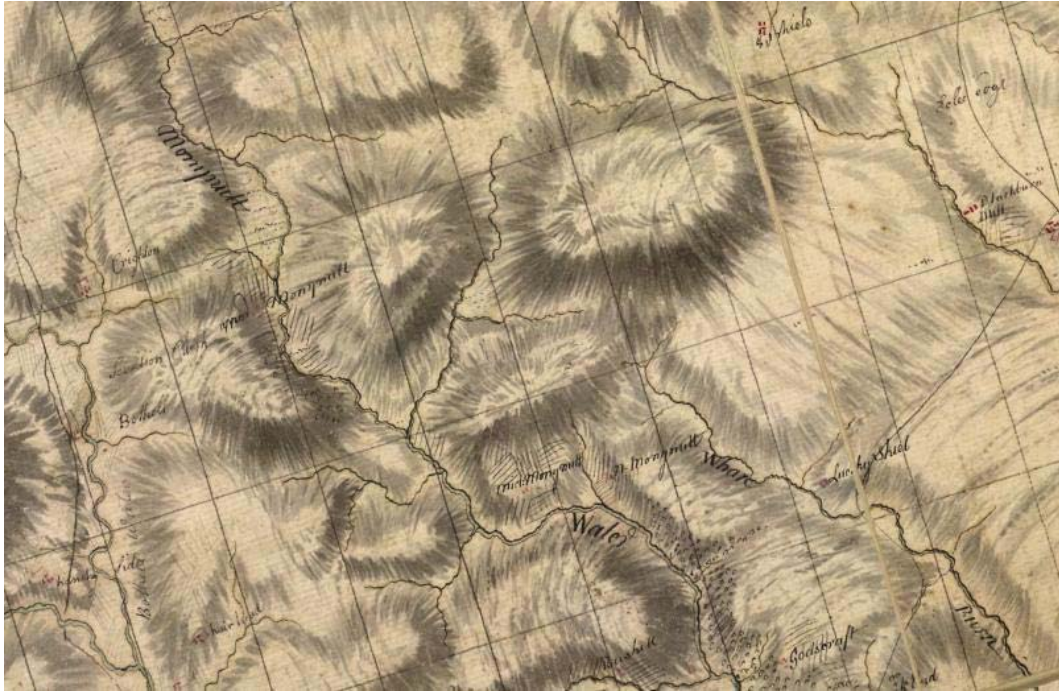
Figure 6 Detail of William Roy's Military Survey of Scotland, showing the area around the two Monymut farms.  
 © The British Library Board. All Rights Reserved (Roy Military Survey of Scotland)

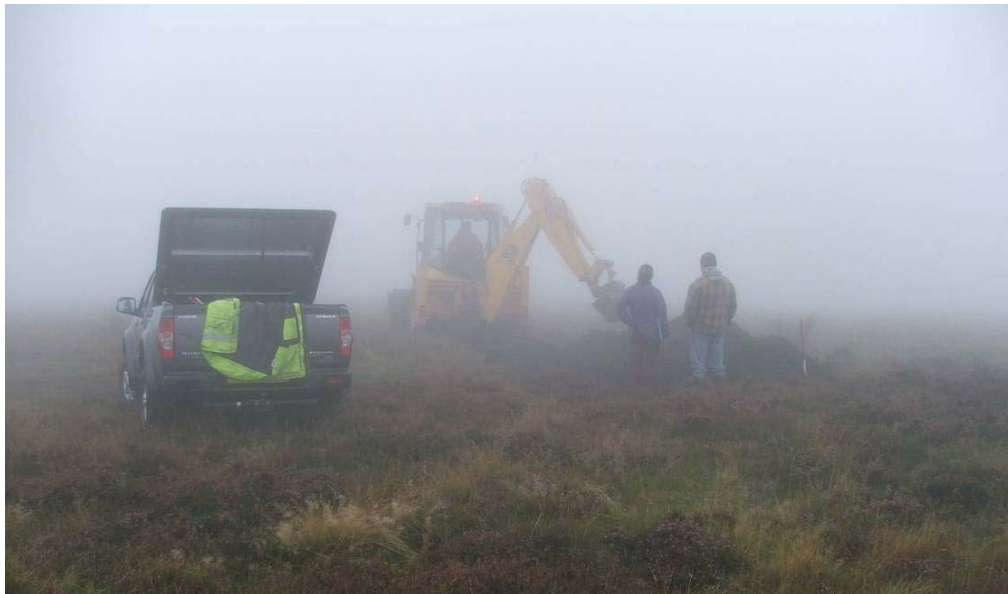
*Plate 2 Opening up Trench 1 in the fog*

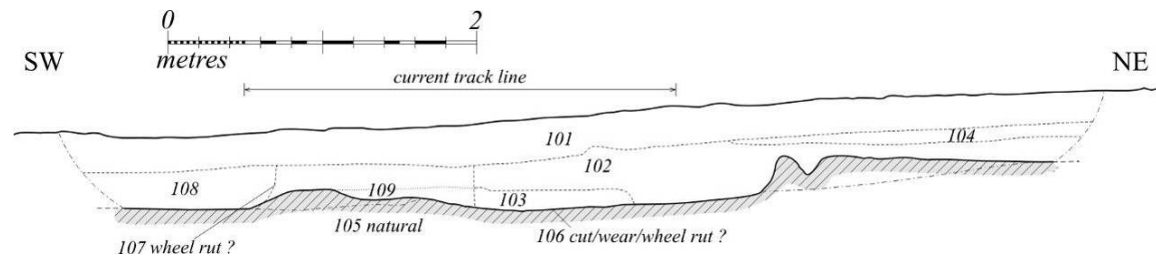
Figure 3 trench 1 Section across line of drove road

When exposed the surface of the natural subsoil was found to gently slope down to the west, reflecting the general slope and wider topography of the area. The subsoil surface was somewhat uneven, with notable depressions in two main areas ('cuts' [106] and [107]), interpreted as probably having been caused by down-cutting or wear. When first identified [106] was a possible candidate for the wear of a drove road but, when considered with [107], and with their relationship to the current machine track, these were felt more likely to relate to paired machine wheel ruts cutting down in to the soft ground. These cuts were filled with a dark silty soil (102, 108, 103) containing a high proportion of small angular stones; this likely represents the churning up and intermixing of the former top-soils and underlying stony natural (105).

Between the two probable wheel ruts a small island of a possible pre-existing surface survived - (109). This consisted of a layer of smaller angular stones within a dark soil matrix. It is possible (109) could be the remains of a road make-up deposit, although alternatively it could equally be a stony topsoil layer.

Overlying the whole trench was a fairly even continuous topsoil deposit (101) of dark black humic silt. This overlies all the deposits below to a depth of 0.20m - 0.30m. The absence of cuts disturbing the deposit demonstrated that the underlying rutting of the ground was not of very recent origin. In the northern part of the trench a shallow lens of stony soil (104) underlay the (101) topsoil; this possibly related to occasional strengthening or repair of the track.

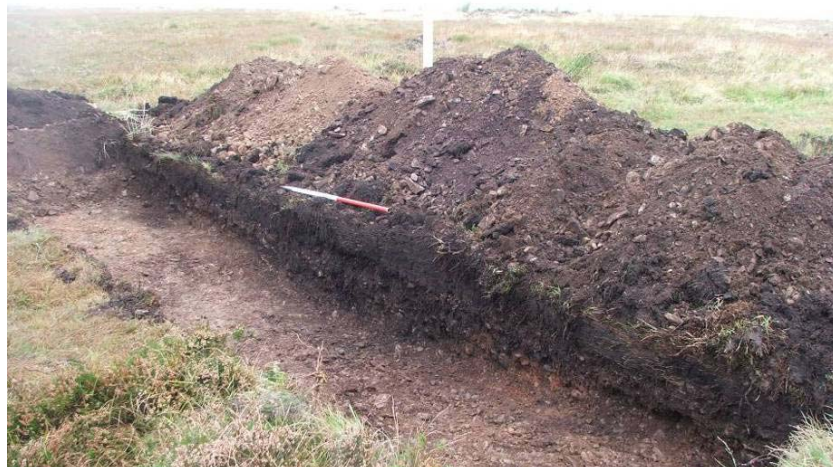
Plate 3 Trench 1 at LOE shows west section; turbine marker (white post) in background

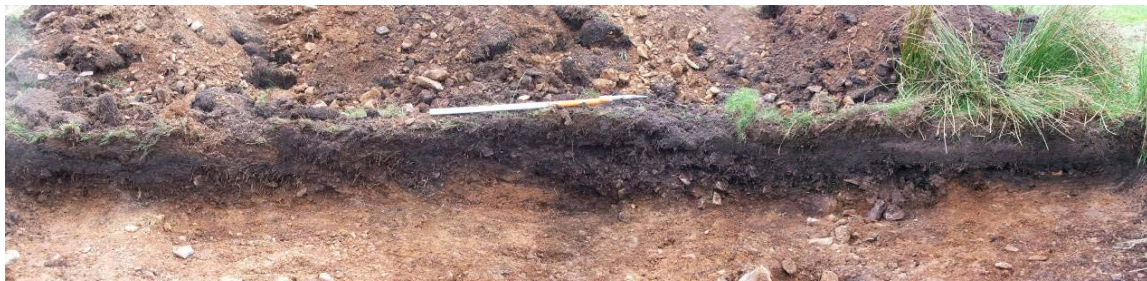
Again, as within Trench 1, there appeared to be paired, wide depressions worn down into the natural, running parallel to one another. The alignment of these depressions was found to tie in well with an opening in the field boundary to the W. Examination of the boundary revealed a much-buried sandstone mile marker surviving *in situ* to the immediate W of the trench. This marker confirmed the line of the former drove road ran on the same alignment as the existing track. A further feature of the field boundary was a degraded wrought iron gate with cast iron uprights, this possibly 19<sup>th</sup> or 18<sup>th</sup> century in date and presumably in place to service the road.

Plate 4 Trench 2 section

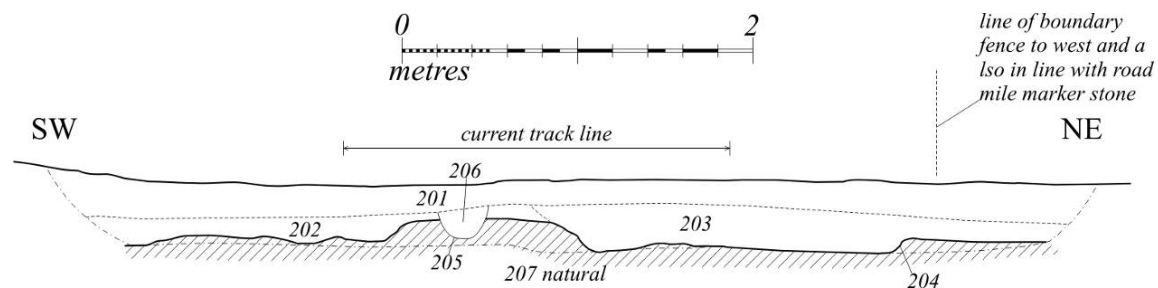
The rut-like depressions were in-filled with a mixed dark stony soil (202, 203); again much as in Trench 1 this is likely churned up/intermixed topsoil and natural subsoil. Between the two ruts subsoil survived to a higher level. In this area it had been further cut into by a clear rounded cut (205), this in-filled with a stony soil (206). The latter this soil was noticeably different to the surrounding deposits, being a more grey in hue with smaller stones mixed through, almost gravely. This was considered to perhaps be a motorbike wheel rut or similar (the JCB driver indicated that he and others drive their motorbikes up along these tracks).

Figure 4 Trench 2 section

As in Trench 1 the overlying topsoil (201) was a continuous humic silty soil with heavy root infestation; this overlay the whole trench. The interface with the underlying deposits is very clear but no obvious cuts for the underlying ruts could be made out, perhaps again indicating they are not of very recent origin.

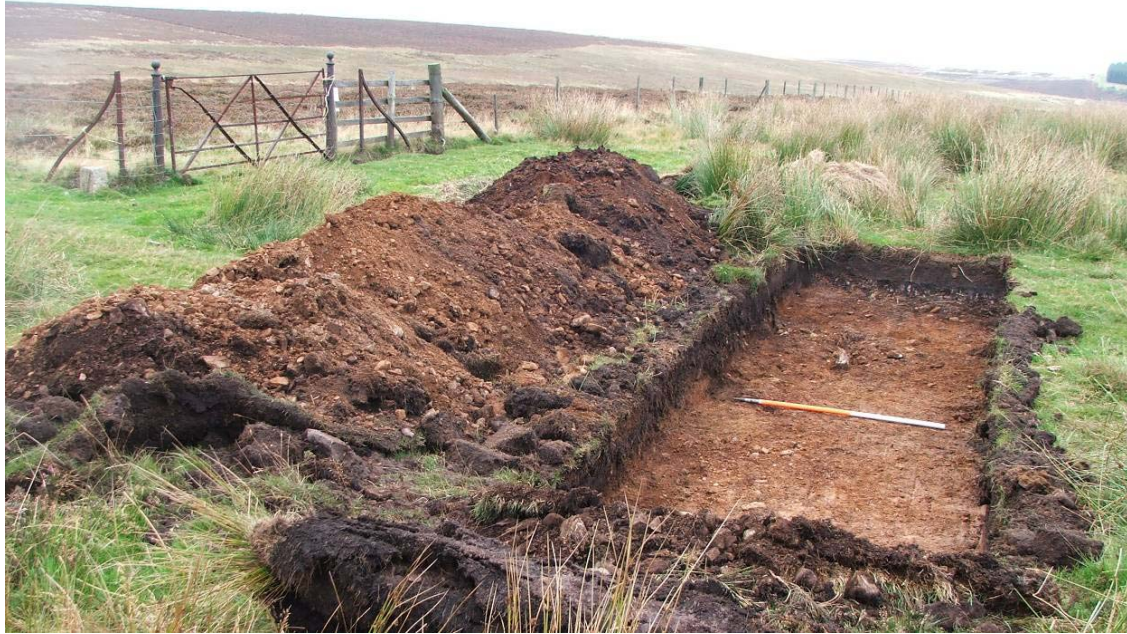
Plate 5 Trench 2 general location with wrought iron gate and mile stone to the W, looking N

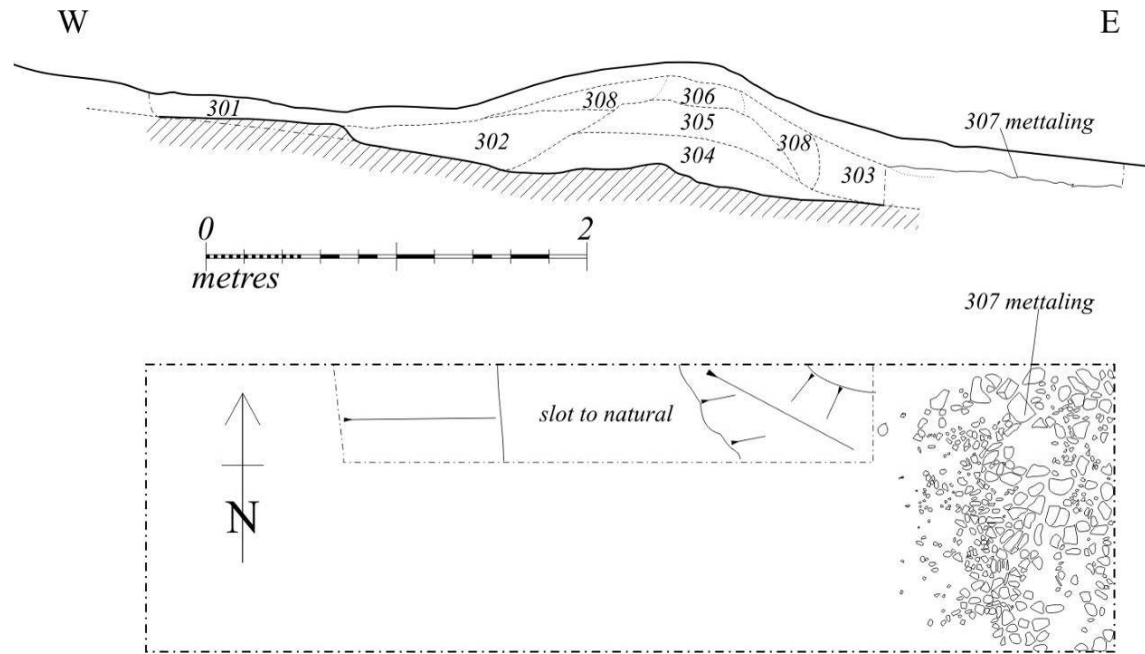
The upper surface of the underlying natural subsoil was exposed and this followed the general slope of the hill down to the N. The natural subsoil was shown to be an orange–grey stony, dry, clay/silt which appeared to have been cut into as part of the construction process to form the bank. This process of cutting into the natural subsoil may have been in order to borrow soil from nearby in order to form the base of the bank (304). (304) contained a high % of stone and was similar to the natural subsoil but with a higher degree of stones. This material was likely scooped from the natural subsoil either side of the bank and then mounded up to form the bank base; although it was a lot dirtier with soil than might be expected if the natural was simply shifted less than a metre.

Figures 5 and 6 Section and plan of Trench 3

Sitting on top of (304) was a well packed turf bank (305); many of the individual turves could be physically separated intact during excavation. These were approximately 0.15m square and 0.05m-0.08m thick. These were likely cut from along the line of the bank to construct it.

On top of (305) was a continuation of turf construction, possibly in the form of a vertical sided feature/turf wall about 0.50m wide (306). The extent of this was hard to define; it in part blended into the (308) deposits either side, which were interpreted as part collapse of the (306) turf wall.

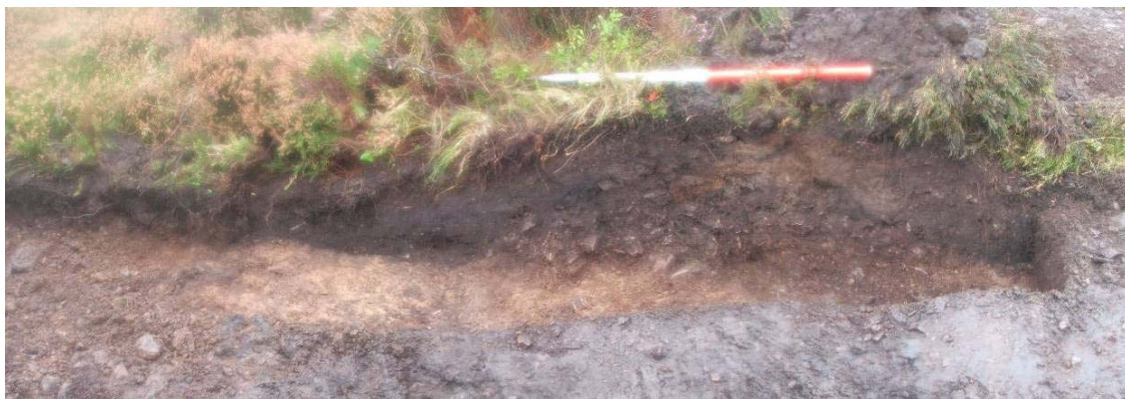
To the W and upslope the depression left by the robbing for the banks construction was in-filled with a dark humic silty soil (302). Elsewhere on the bank's circuit such depressions are still very visible either side of the bank.

Plate 6 Trench 3 section across turf bank (in heavy rain)

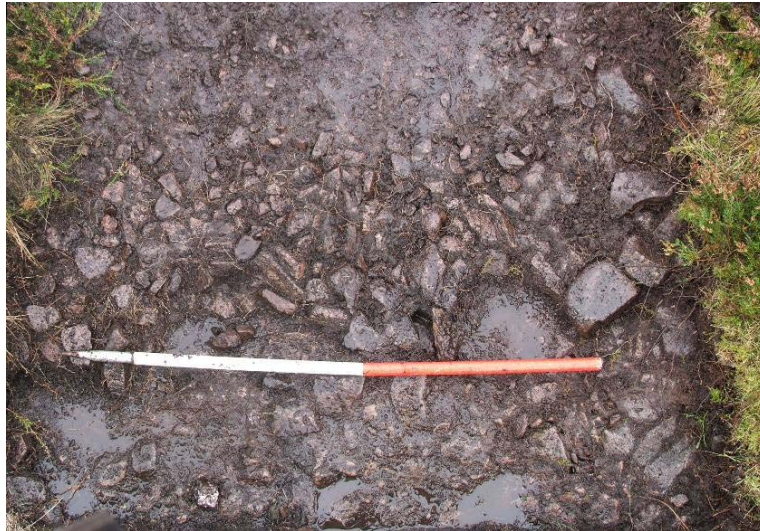
On the interior of the enclosure against the bank a deep deposit of dark humic silt (303) appears to be a similar build up to (302), infilling any construction cut for the bank. One feature of note was overlying this - a compacted metalling layer (307). This was very well defined at the E of the trench with the overlying (301) topsoil peeling off, but it became more patchy with smaller stones nearer the

bank. What this represents is unclear it is possible this could be a road surfacing around the circuit of the enclosure or it could relate to a structure; from localised exposure within the small evaluation area this was difficult to determine.

Plate 7 Trench 3 Metalling (307)

The banked enclosure was investigated with two trenches providing geographically separate sections across the enclosure bank. These proved the feature to be a low bank formed from the surrounding deposits. The trenches have adequately evaluated the structure and further sections are unlikely to provide any more understanding of its construction. However within Trench 3 a small area of metallurgy was noted within the enclosure. The purpose and date of this feature remains unclear, but it seems likely this represents some kind of prepared surface either for a road or perhaps occupation.

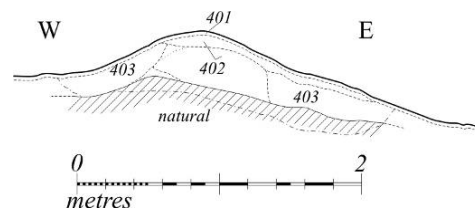
The linear bank was expected to be of similar construction to that exposed within Trench 3 but following excavation this proved to be of slightly different character – essentially it comprised a heaped-up bank of the surrounding natural subsoil with no real turf visible within its construction.

Figure 7 Section across Trench 4

The bank in this area was in places also flanked by visible shallow ditches, as seen in Trench 3. The origin of the bank's material, the natural subsoil in this area, comprised a greyish clay and the bulk of the bank was formed of this material (402). The bank make-up was found to be somewhat looser in its middle parts and it was thought that this may represent remnants of turfs within the bank. The turf (401) in this area is much shallower than elsewhere and there may have been little available to form the bank hence the use of a much greater proportion of re-deposited natural than was seen in Trench 3. (403) likely represents collapse of the bank over time

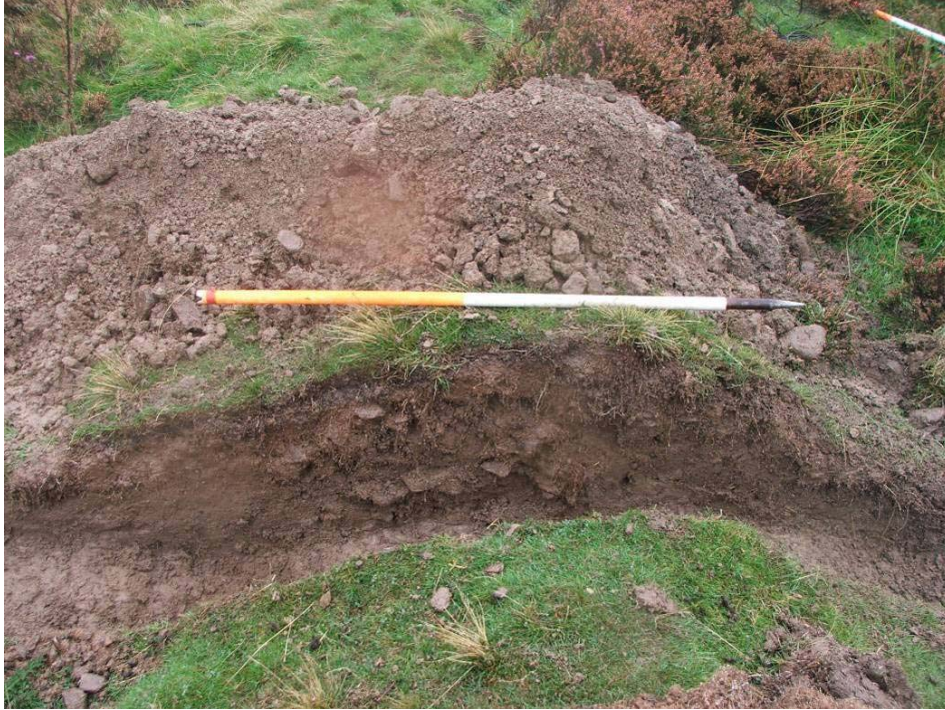
Plate 8 Trench 4 section across bank

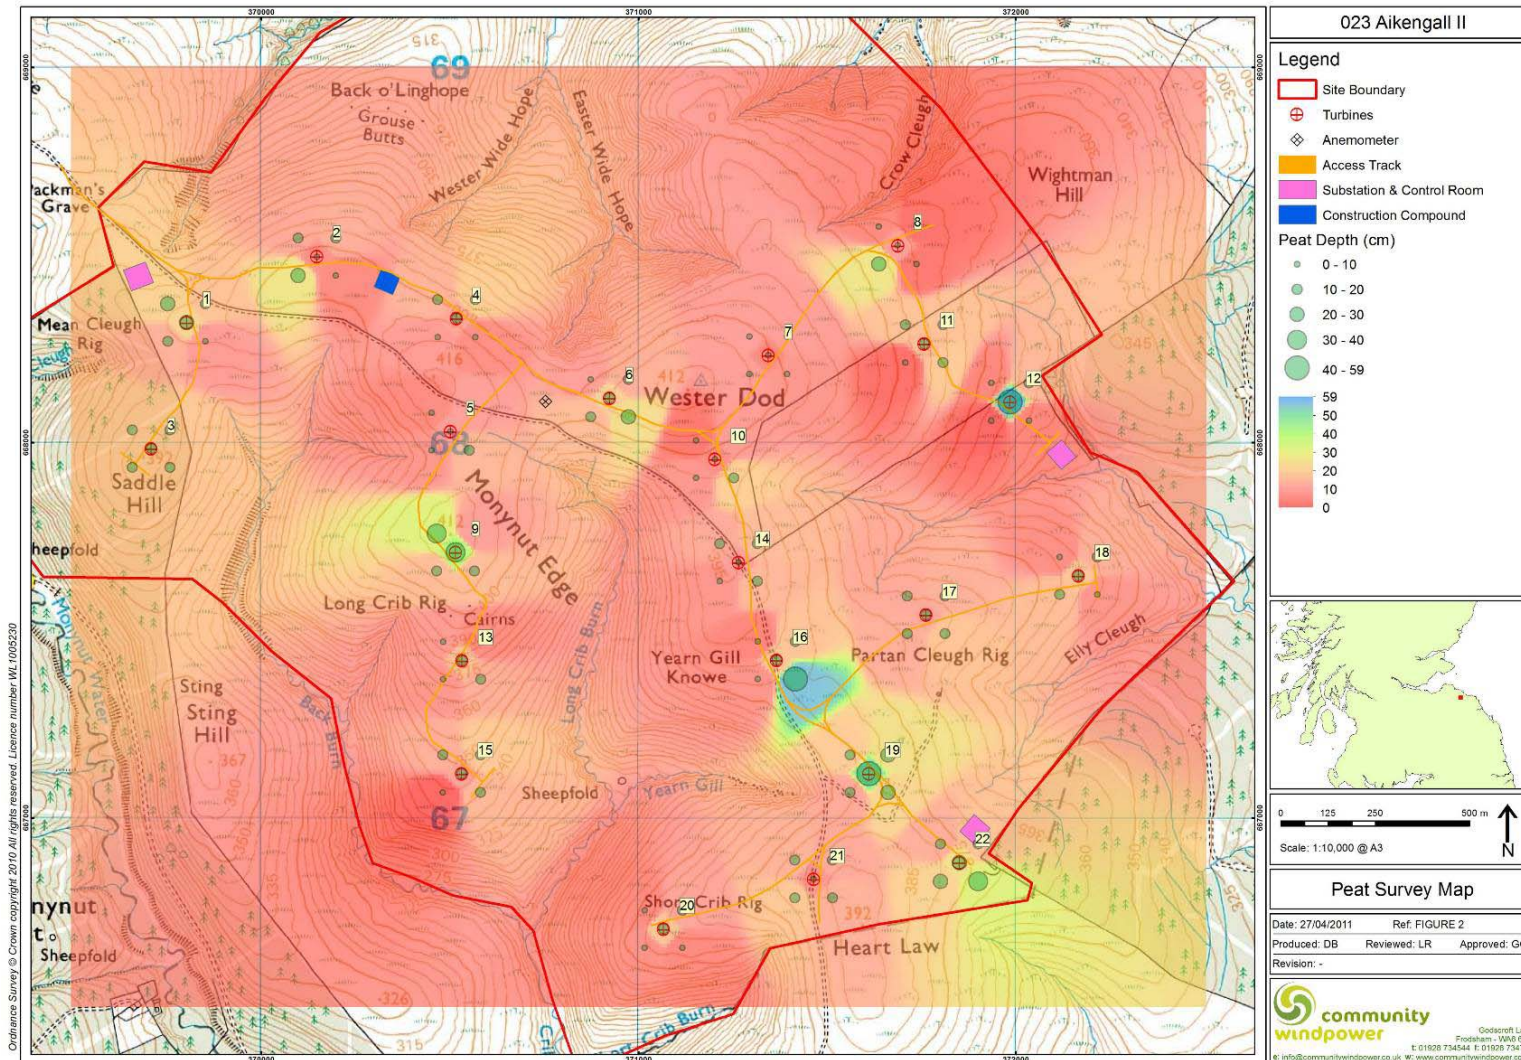
Figure 10 Peat depths across site as interpolated using an IDW method (courtesy of Community Windpower Ltd.)

The depth of 0.59m recorded in the vicinity of Turbine 12 was shown by adjacent cores (0-0.15m) to be anomalous, but indicative of the potential for localised deep peat deposits across the site and unrecorded by the assessment.

The survey showed the region around Turbines 16 and 19 to contain the deepest peat deposits. This was visually noted to be saturated at the time of the survey and the peat here was found to be up to 0.55m and 0.50m respectively.

The deepest deposits were noted in the vicinity of Turbines 16 and 19 and the erection of turbines and associated infrastructure could have a significant impact on any peatland identified in this area. However, the depths of peat remain relatively shallow and there is no direct evidence to suggest these deposits protect any archaeological material of interest.
