38 Gardner's Crescent

Historic Building Record and Archaeological Watching Brief

Madlin + Maddison

February 2014

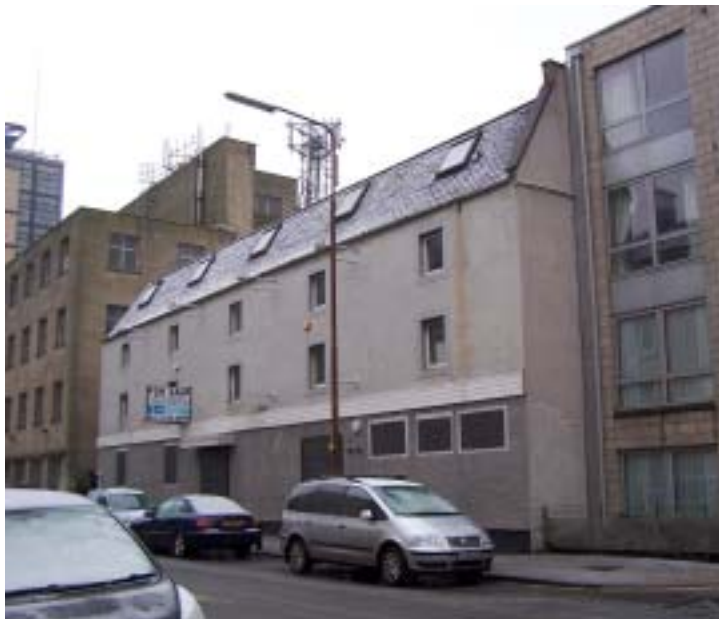
Figure 1 – East elevation of 38 Gardner's Crescent.

The building is a four storey plus attic, five-bay structure. While its east façade continues the line of the building to its south, the structure to the north is set back from the street line. The building has been used as office accommodation and is known as “Atlantic House”; it was prior to demolition unoccupied.

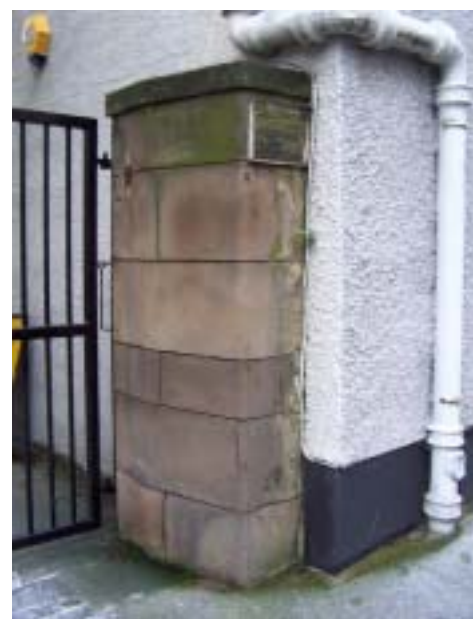
Figure 2 – Detail of northern gate pier

The driveway to the south of the building is enclosed by a modern iron gate, held by two sandstone piers. The northern pier was built into the east wall of 38 Gardner's Crescent.

The driveway to the south of the building is enclosed to the street by a modern iron gate, held by two sandstone piers (compare *figure 2* above). The northern pier is seemingly built into the east wall of 38 Gardner's Crescent. The assessment on site suggested that the north wall of 38 Gardner's Crescent is shared with the property to the north 43 Gardner's Crescent.

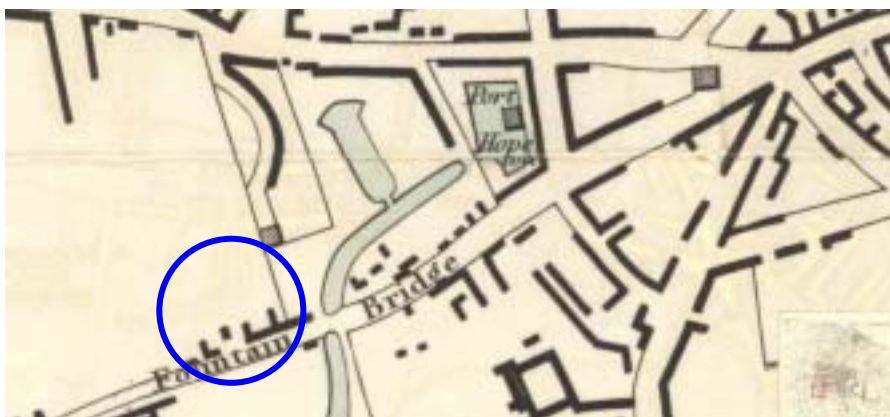
Figure 11 - "Edinburgh and Leith. Great Reform Act Plans and Reports" London: House of Commons, 1832, NMLS.

The more sketchy map for the "Great Reform Act Plans and Reports" published by the House of Commons in 1832 seemingly confirms that no built structure was extant on the site at that time.

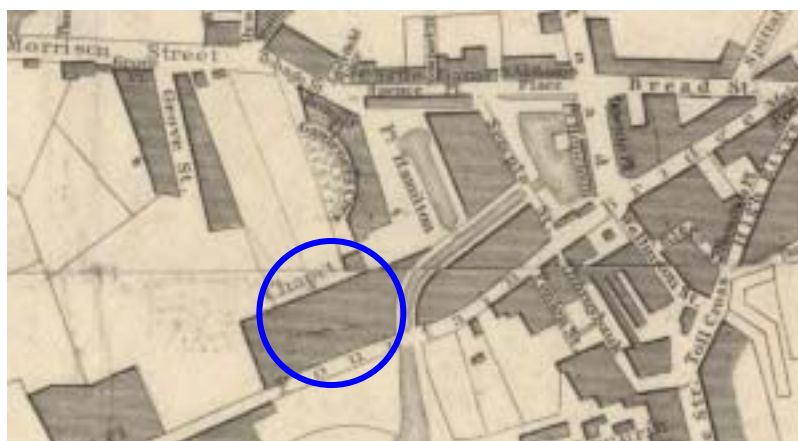
Figure 14 - "The City of Edinburgh" – Robert Stevenson & Son 1837, NMLS.

Stevenson's plan of 1837 is not detailed enough to ascertain that the site has now been built over, as he simply depicts built-up areas. However, if his plan is correct, this could be the earliest indication of a building appearing on the site.

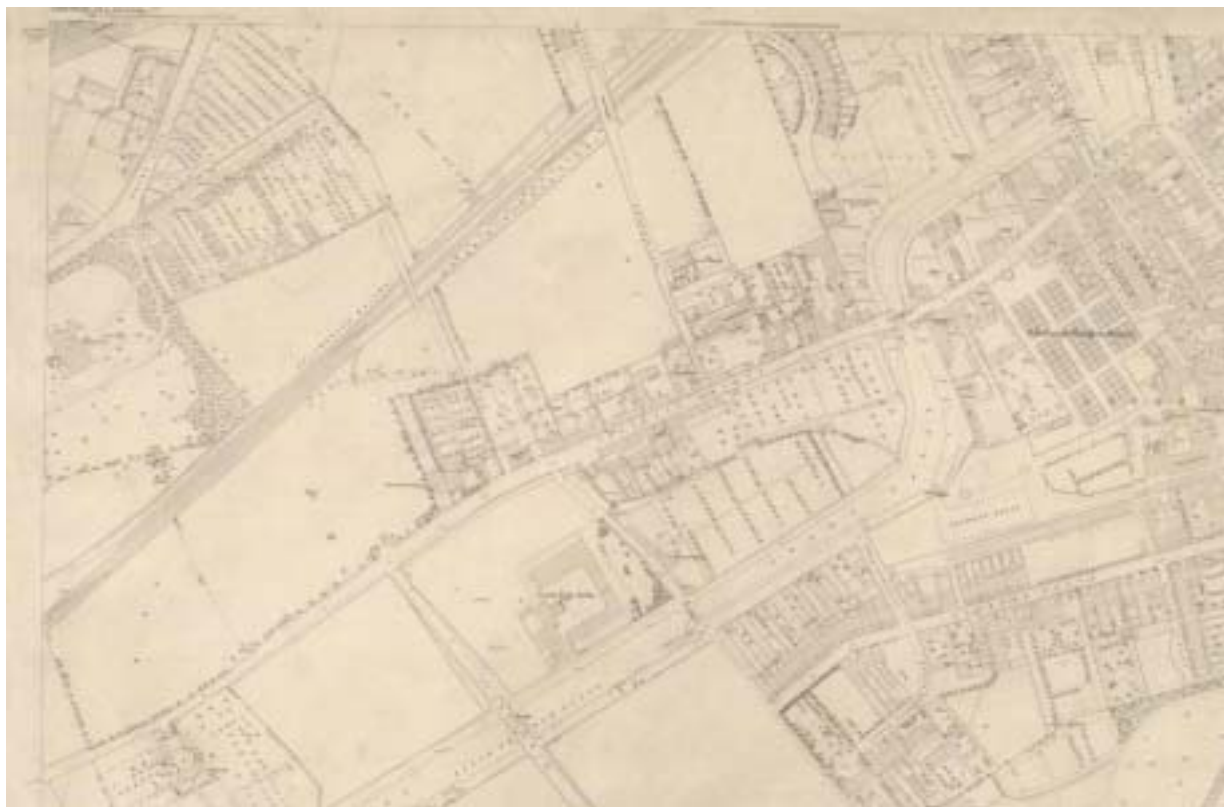
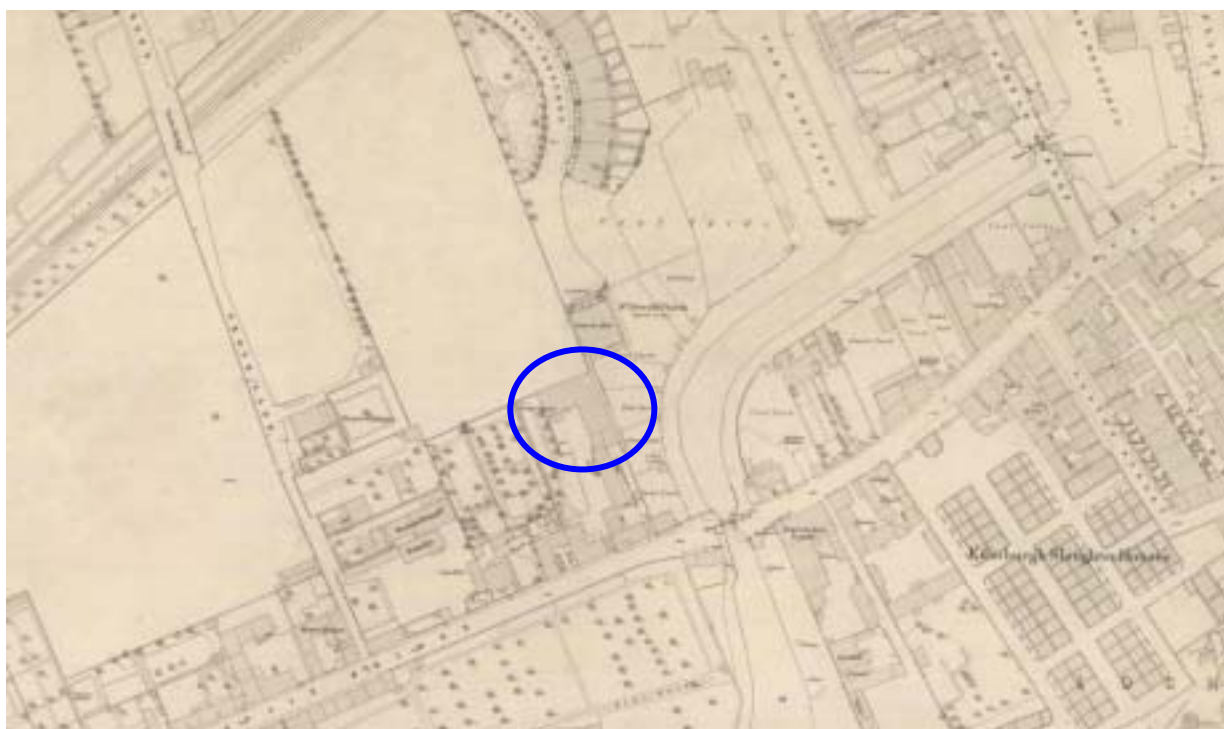
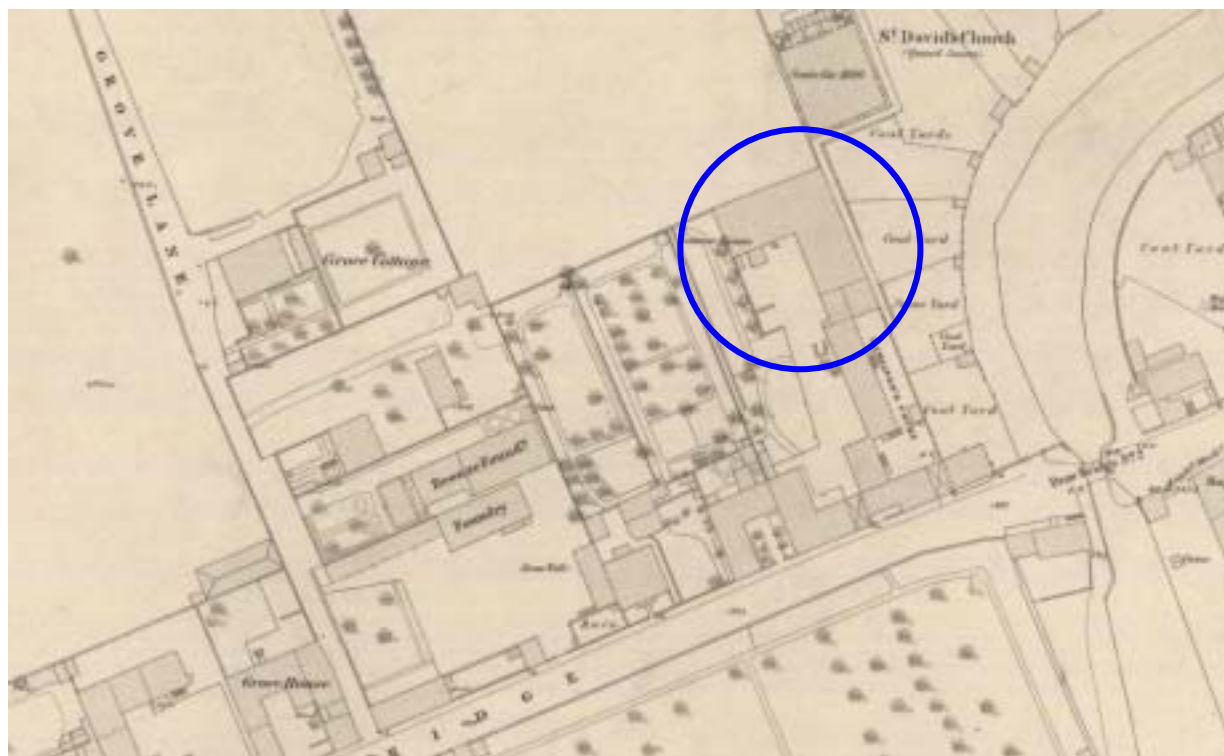
Figure 15 - "First Edition Ordnance Survey Map" 1851 - Sheet 38. NMLS.

It is not until the First Ordnance Survey of 1851 (published 1853) that we can confirm a building for the site. The structure is L-shaped with a rectangular courtyard formed in the re-entrant angle.

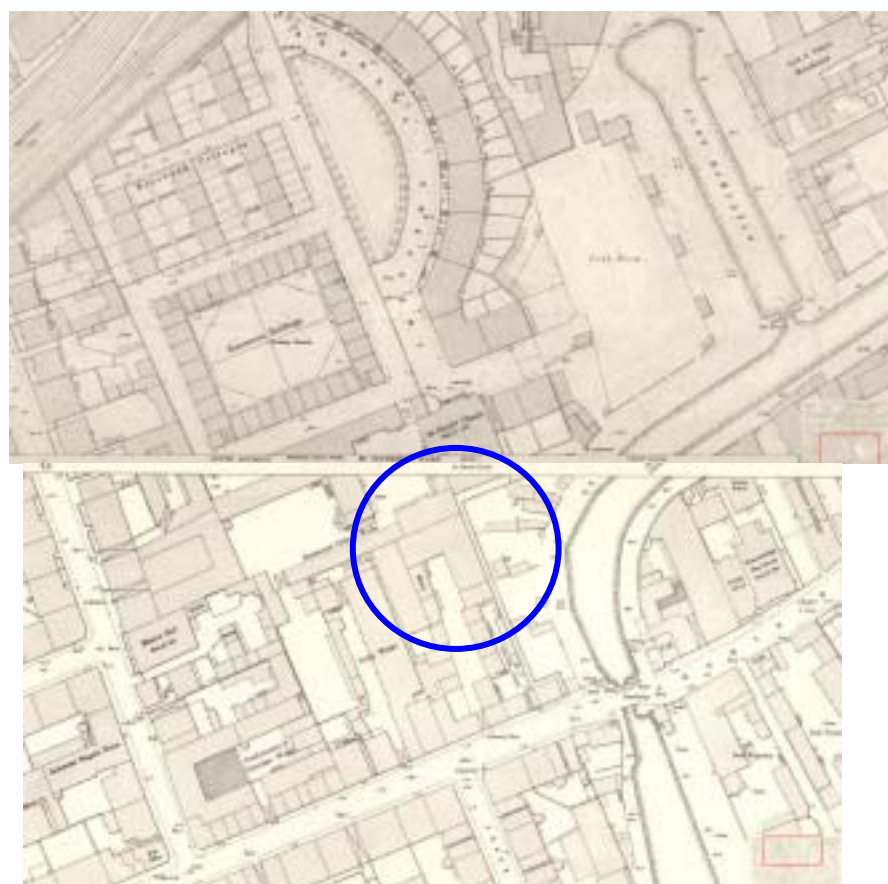
Figure 18 - "Second Edition Ordnance Survey Map" Edinburgh 1894 - III.7.23 and III.11.3, NMLS.

The building remains unchanged until the Second Ordnance Survey published in 1894. An overlay of the footprint of the 20th century structure upon the earlier maps shows its relation of the mid-19th century building.

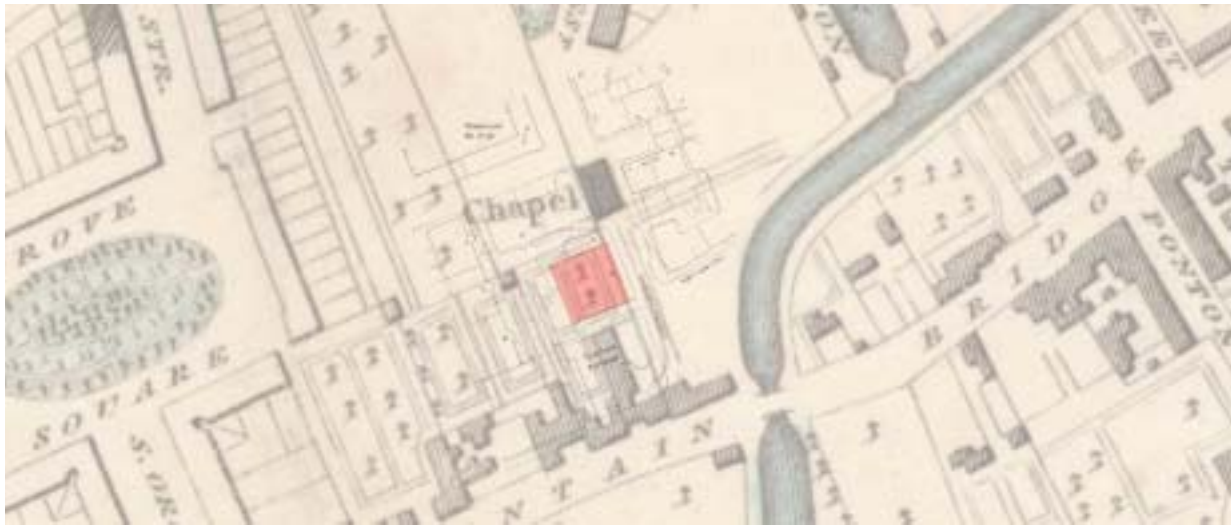
*Figure 19 - Map overlay of current location plan upon J Kay's Map of 1836.
NMLS and Madlin + Maddison.*

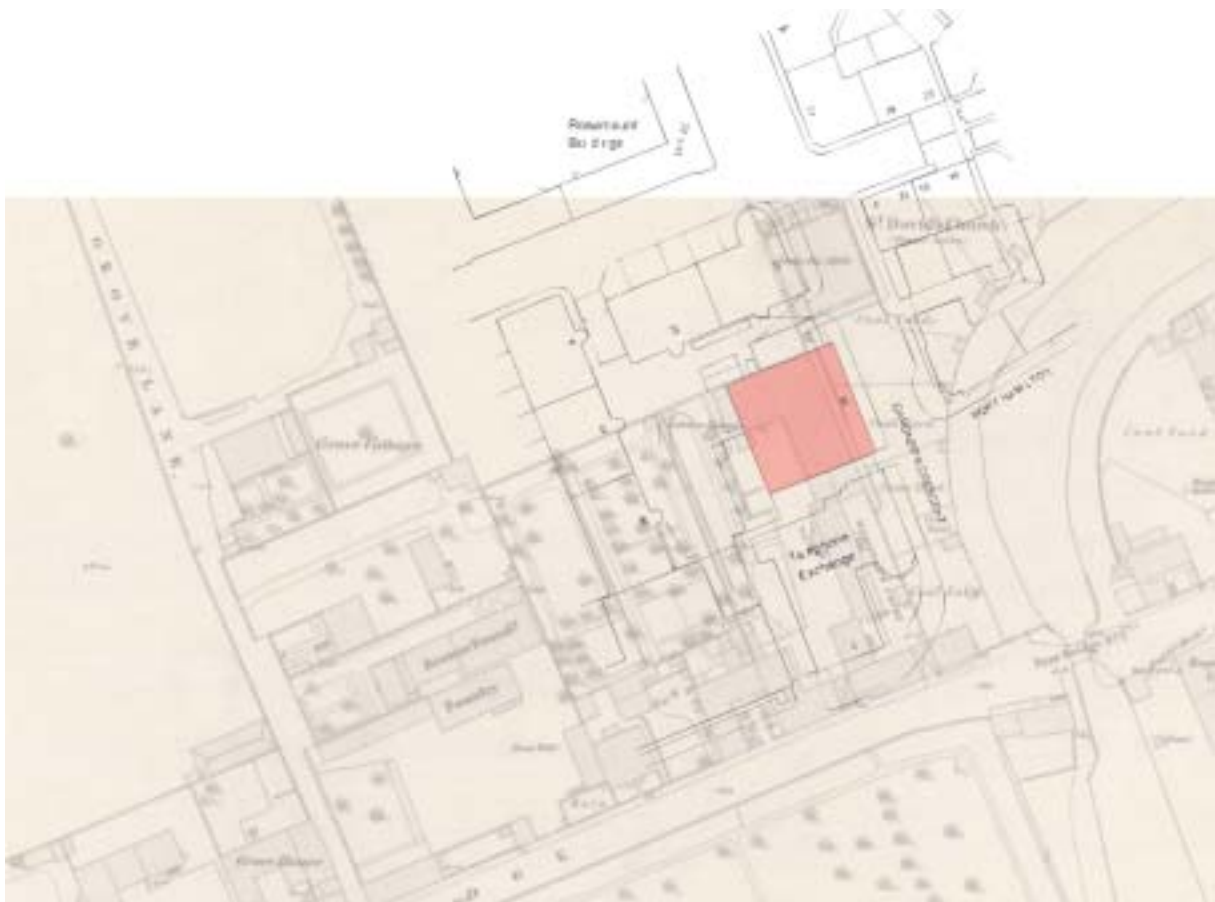
*Figure 20 - Map overlay of current location plan upon First Edition OS map, surveyed 1851.
NMLS and Madlin + Maddison.*

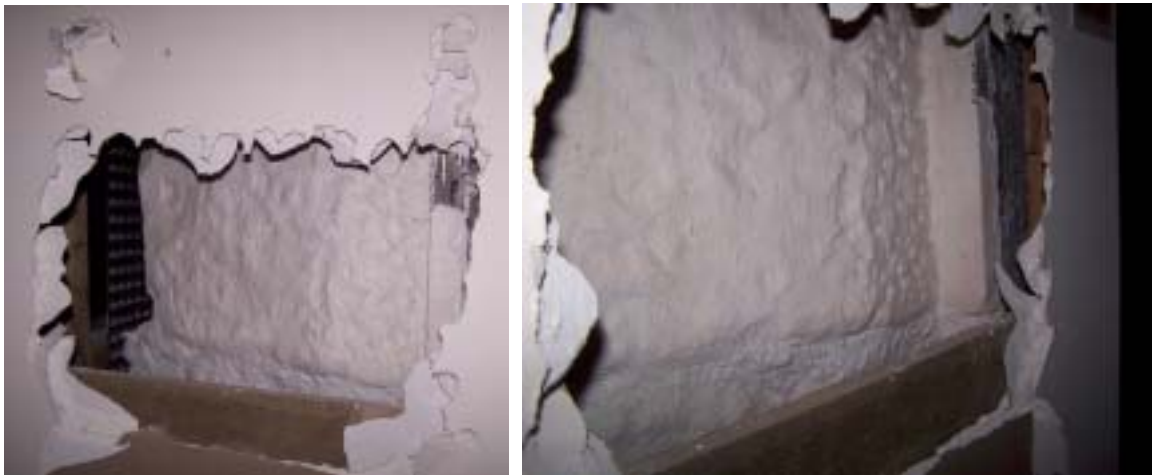
An internal wall, ca. 9m westwards from and parallel to the eastern external wall, was of notably greater thickness (above 0.6m) than the remaining walls, including all external walls to E, S, and W (cf. sketch plan for site visit, opening-up C). This wall thickness was recognised over all floors. Investigations showed this wall to incorporate earlier masonry consisting of rubble sandstone walls, with dressed ashlar masonry surrounding original openings. These original openings showed details of window or door margins surviving. Interestingly, the splay and position of the margin suggest that the wall was the western external wall of a building with the rooms lying within the eastern part of the present building.

Figure 21 - Ashlar masonry at margins for opening, view from NW (left) and NE (right)

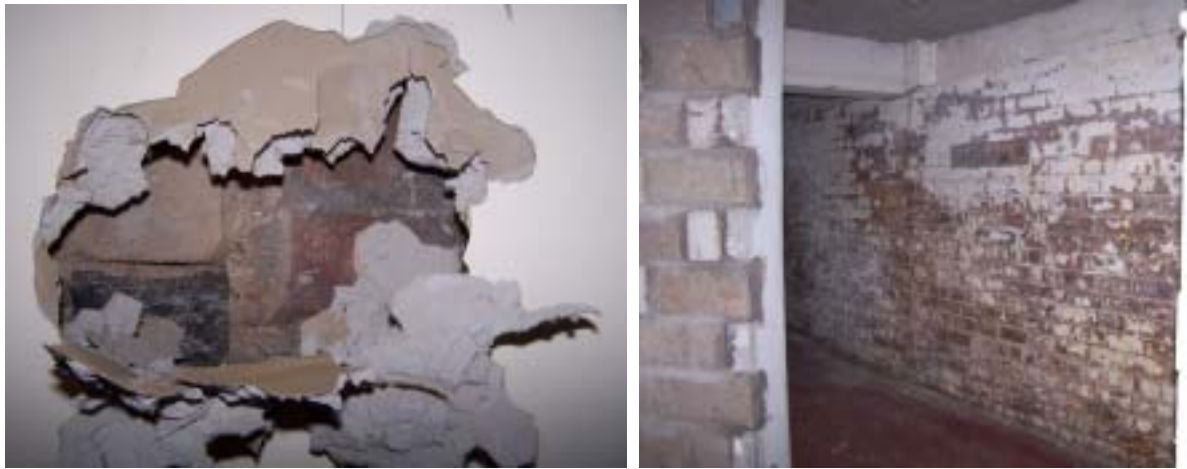
Earlier brick masonry seemingly survives within the rear wall of the present building, observed in the NW part of the rear wall and within the cellar. A similar possibly early brick masonry survives in an

E-W partition wall in the NW part of the building (opening-up A) – possibly on alignment with the S wall of the perpendicular jamb of the 19th century building.

Figure 22 - Surviving early brick masonry : within opening-up location A (left) and rear wall of basement (right).

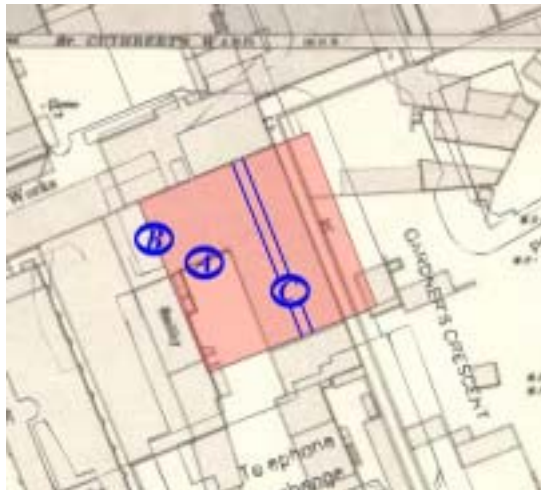
Figure 23 - Sketch plan of surviving earlier fabric as noted within asbestos test investigations.

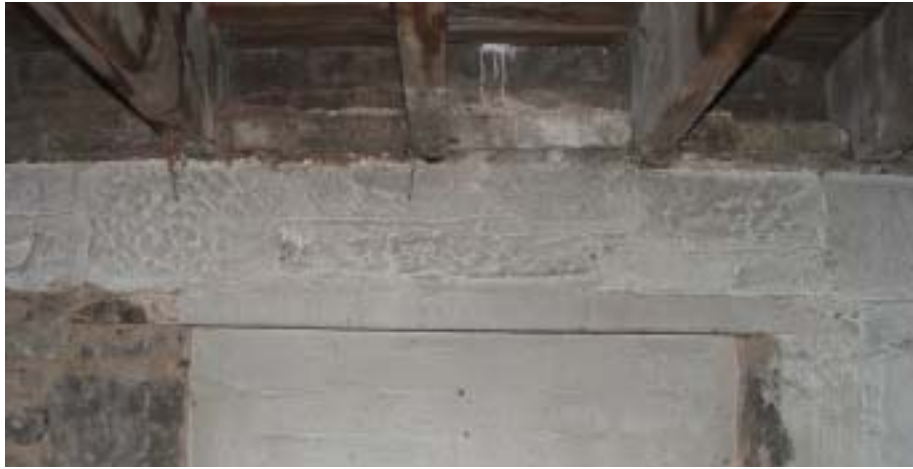
Upon the east elevation of the phase 2 extension, where the elevation wall supported no floor joists, the windows were arched over in stone rather than the iron lintels as elsewhere, presumably a cheaper alternative. A similar arched stone head was utilised in the phase 2 slapping of an access door into phase 1 at all levels.

Figure 24 cast iron lintel with tapered ends

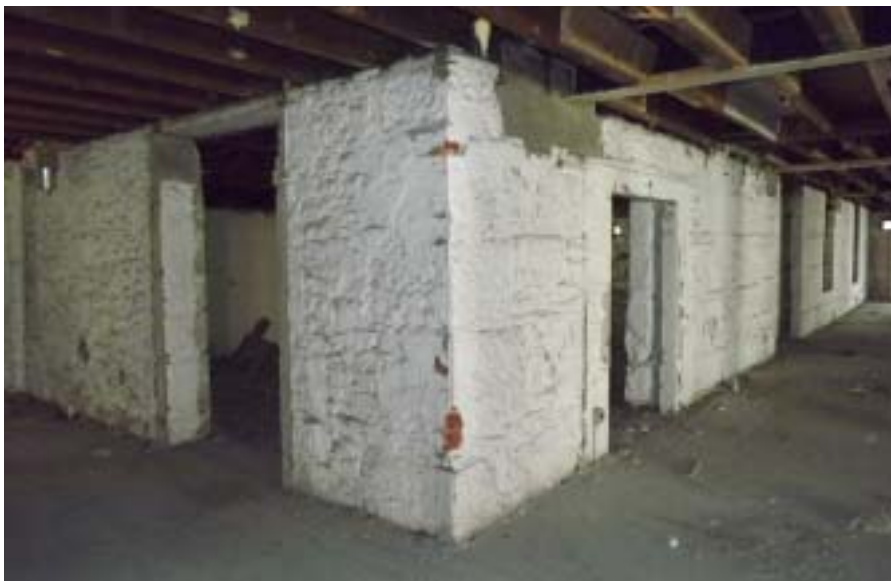
Although no evidence was seen of this in the grubbing up of the foundations, within the masonry of the north west corner of the phase 1 build there are patching's in phase 3 brick which may indicate the patching up of tie sockets of the masonry cross wall removed in the phase 3 reworking of the site. If there was no masonry (or timber) partition on this line then it is unclear how this roof junction was handled.

Figure 25 NW corner of phase 1 build, note brick patching on corner, possibly making good ties for a demolished cross wall

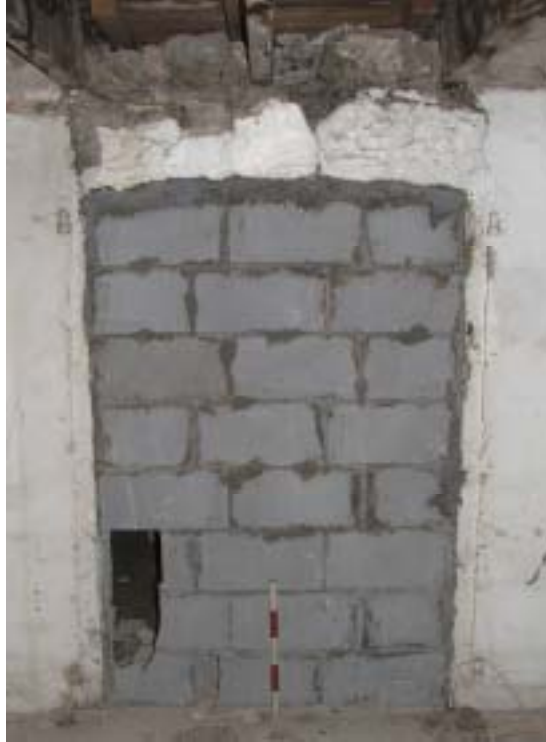
Upon the west end of the north gable of the phase 1 build a series of large loading openings survived on each floor level. On the exterior of the phase 1 build large iron pintles remained on either side of the openings indicating substantial double doors. The openings were arched over in stone originally; some of the arches had been removed during modern alterations but the springing for the arches survived, *figure 26*.

Figure 26 first floor phase 2 opening allowing goods access from phase 1 into phase 2

These openings had in the original assessment been considered to be original to phase 1 and related to loading, but further investigation suggested that they were secondary insertions and part of the phase 2 reworking that allowed access between phase 1 and phase 2 structures. The location of these, offset to the west on the gable, could be explained by the phase 1 loading doors to the immediate west of these that allowed easy access for loading goods into the phase 1 structure and the phase 2 build from the same loading bay.

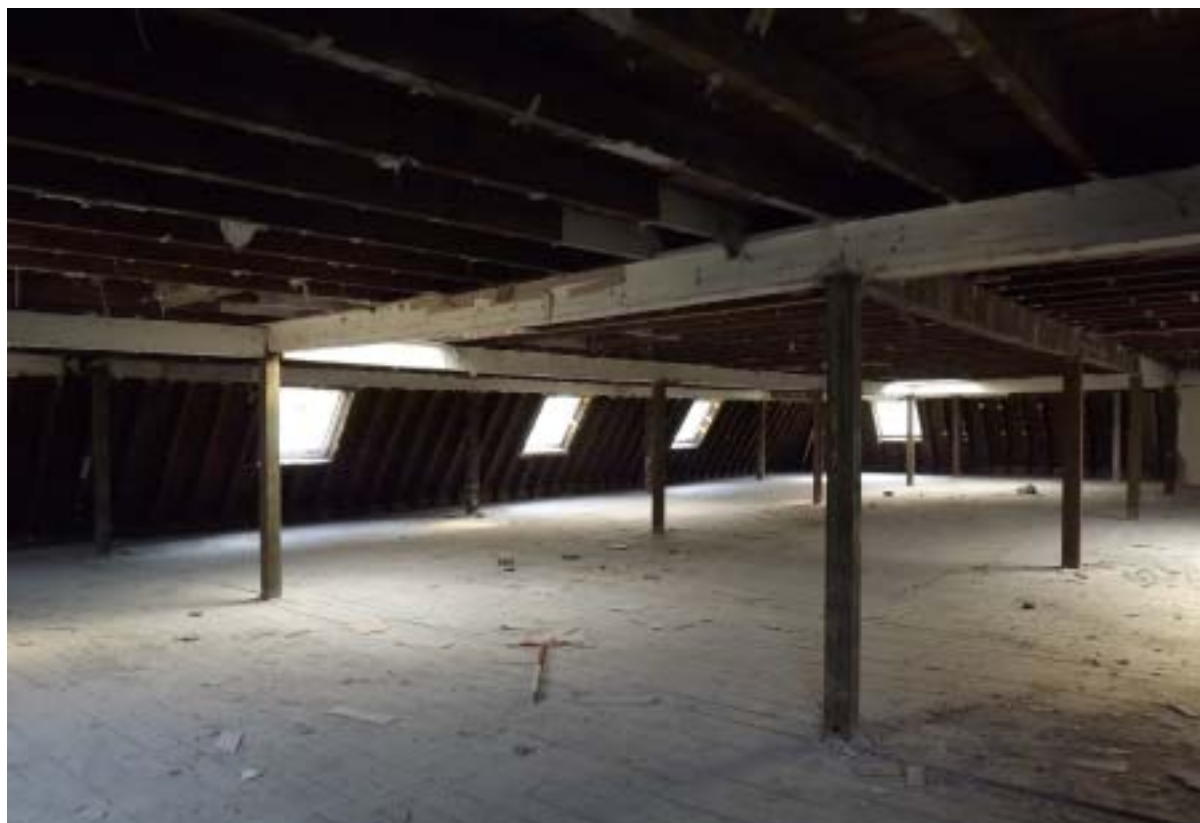
The roof was replaced with a new structure encompassing the whole building as newly extended, pre-existing roofs having been removed. This was part hipped with a large flat area in the centre, roof lights lighted the attic.

Figure 27 phase 3 Roof structure exposed in the attic

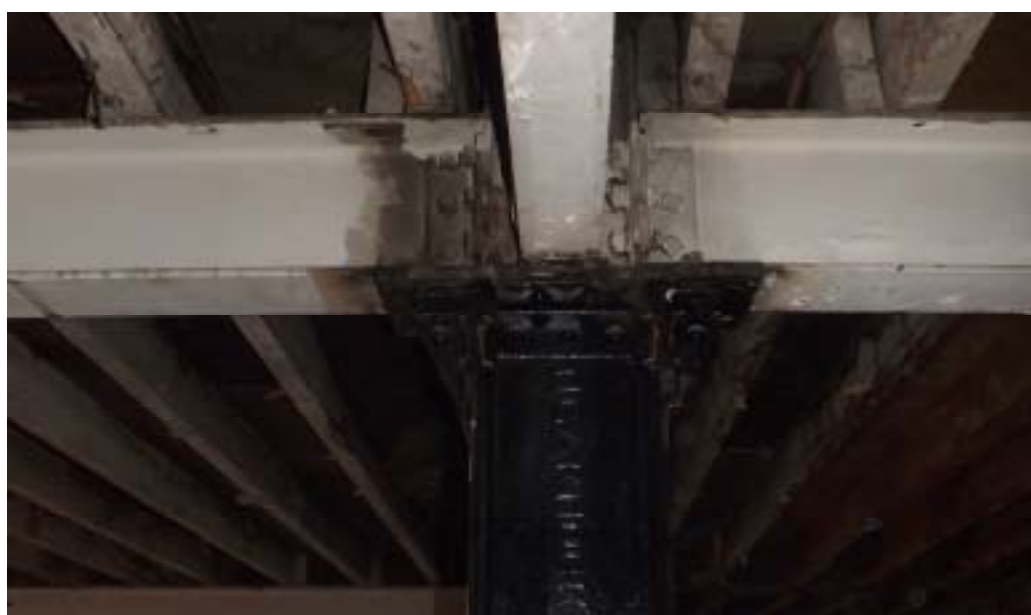
The interior of the new structure was floored with substantial joists sawn square supported by an iron frame. This frame was composed from 12 vertical I-beams evenly spaced through the structure, with horizontal I-beams bolted on, *figures 27 and 28*. The beams were marked with a manufacturer's mark; this was primarily "GLENGARNOCK STEEL" but there were at least two others of the same size marked "DORMAN LONG AND CO L, MIDDLESBURGH, ENGLAND", noted within the phase 3 extension to the SW, *figure 29*.

Figure 28 phase 3 Detail of beam jointing with joists sitting on top of beams

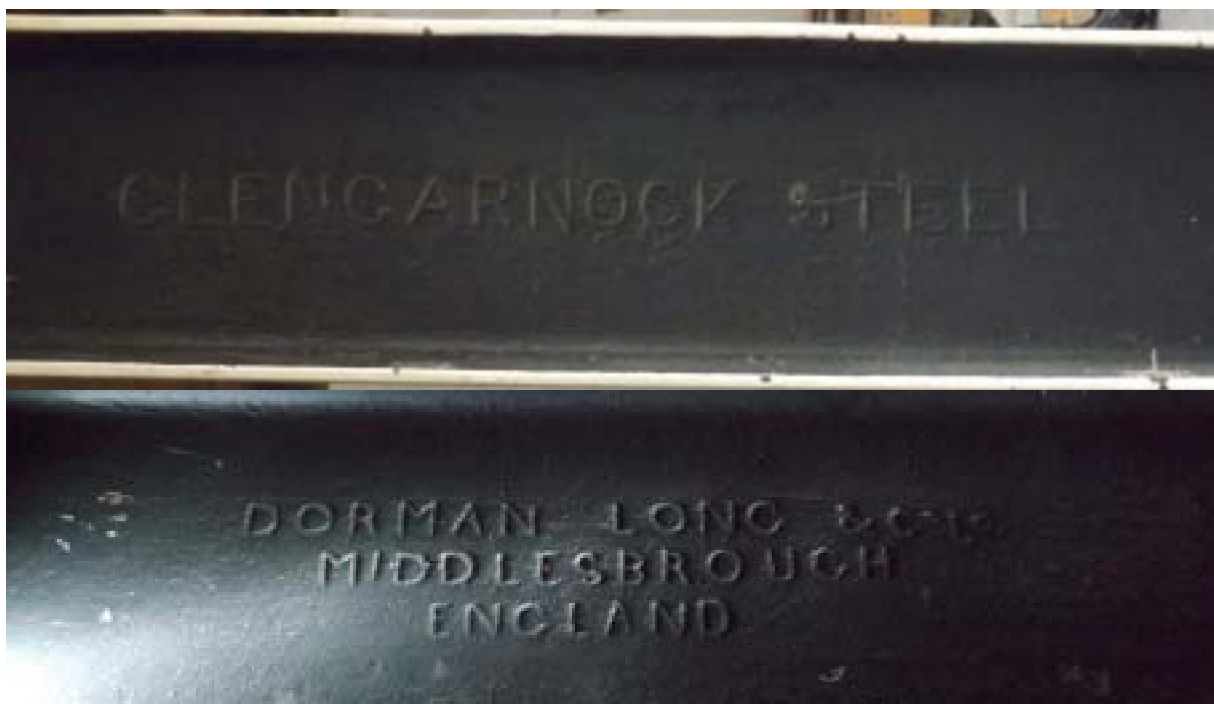
Figure 29 Details of the manufacturers' markings on the steel framework

The joists were of a slightly different in size in the new-build within the extension over the courtyard - of 22cm by 7cm compared to an average of 25cm by 6 cm within the phase 1 and 2 structures. This was perhaps thought to reflect the existing flooring within the early structures being reused in the newly refurbished building and new timbers in the extension. Alternatively the iron frame and flooring could represent two phases - an original build within the phase 1 and 2 structure and a secondary build within the phase 3 structure when it was erected. However in most respects these were of identical construction and if they were of two phases it is likely they were constructed within a relatively short period of time of each other.

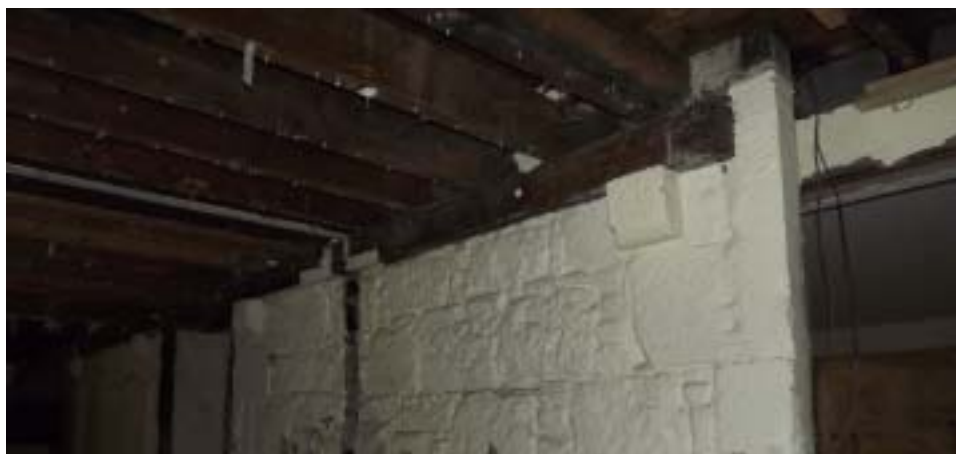
The steel frame was founded on large stone pads set into the underlying natural clays and continued up through the structure up to and supporting the roof. The flooring within the SW extension was to the north sitting upon a beam supported on inserted stone corbels upon the former exterior wall of the phase 2 west wing, *figure 30*. A number of the former windows on the elevations now encompassed within the phase 3 build were slapped down and widened to form entrances into the new phase 3 build for access.

Figure 30 Inserted stone corbels to the former exterior of phase 2 building to support the phase 3 floor

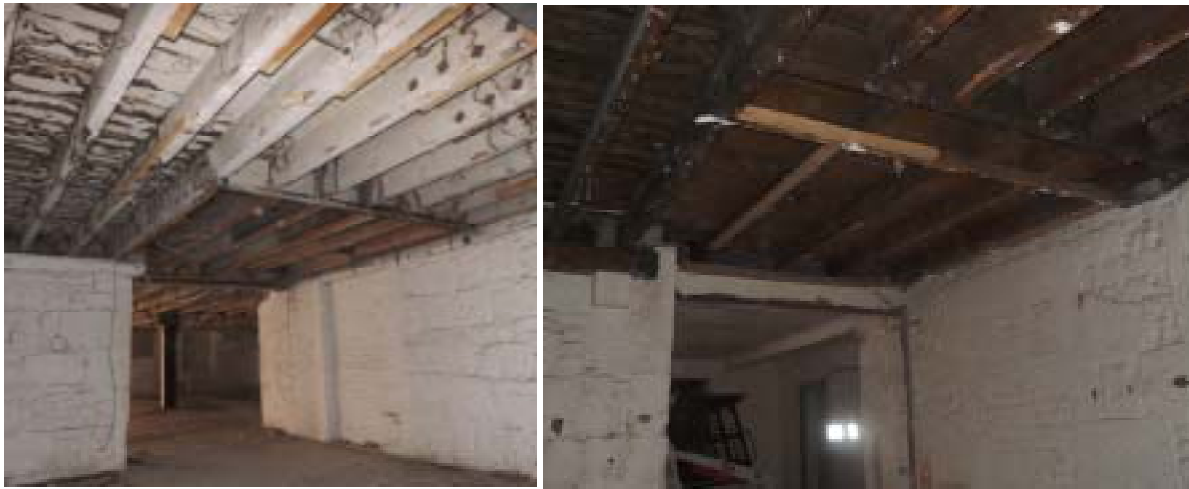
A further feature noted within the floor structure was an in-filled large square opening in the NE corner of the phase 3 extension in, the re-entrant angle between phase 1 and 2 builds. This measured 2.5m by 3m aligned north/south with the south extent defined by a substantial trimmer beam carrying the six joists to the south. This appears to have been a loading access, continuing the use of this corner of the building as the access to the floors above. The former phase 2 windows to the immediate north were widened to the full width of this loading hatch from the ground floor up to second floor obviously to allow full access to the openings.

The former phase 1 loading doors at ground, first and second floor and window at basement level, to the immediate east of these openings were bricked up. Apparently a reorientation of the loading access, originally in phase 1 this passed through the bricked up loading doors; in phase 2 this continued; however by phase 3 the loading was reoriented into the phase 2 structure, by slapping through the windows there to form the openings

Figure 31 In-filled loading access, looking up to second floor and first floors

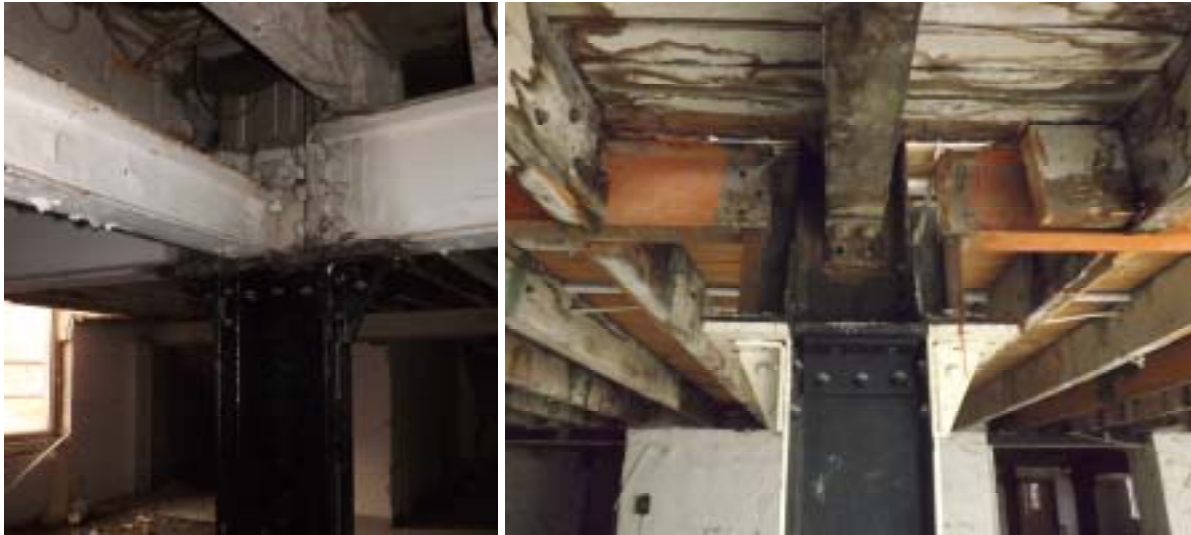
One effect of the 20th century refitting was the raising of the head height in some of the internal areas, the original iron beams sat below the floor joists and as such projected down into the room for 30cm (and no doubt banged a few heads). In order to lift and even out the ceiling for office use these horizontal beams were cut away and new beams fitted within the floor space. The floor joists then sat within the I-beam rather than on top. These new beams sat up from the original piers on thin crude lengths of box metal.

Figure 32 Original phase 3 horizontal beams and beams cut away, with new phase 4 beams set within the floor space

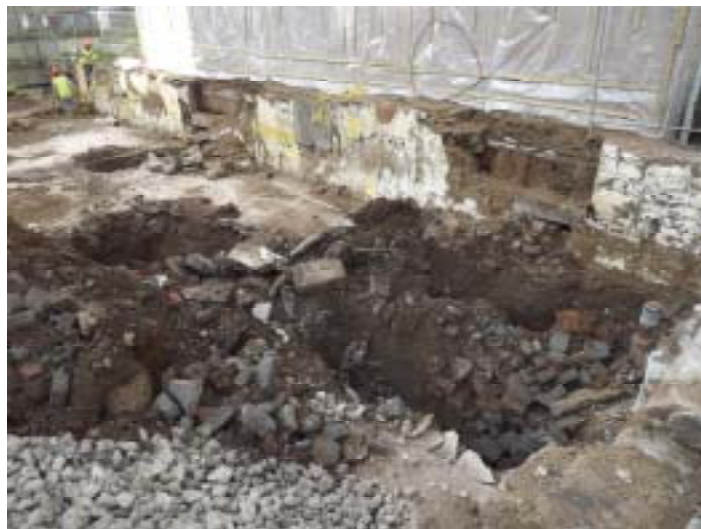
Trial-pit 4 was located to the SE of TP1 and the SW of TP's 2 and 3. This larger square test-pit measuring 2.0m x 2.3m revealed a reddish orange clay natural soil lying directly below the concrete pad.

Figure 33 NW facing view of TP's 1-4

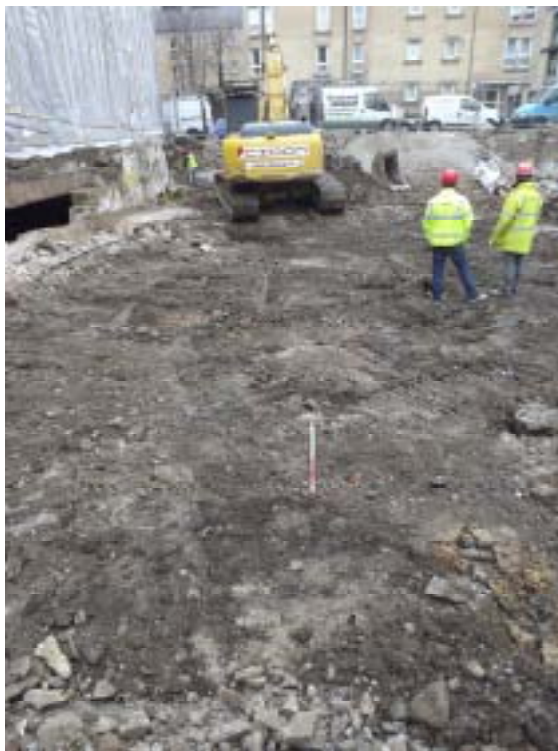
The concrete pad was relatively thin and broke apart easily, to its underside adhered a layer of either stone rubble or brick that directly overlay the natural clay soils. The wall foundations for the earlier L-shaped structure could be seen running from West to East, with large stone pads for the vertical iron beams situated at regular intervals just North of the wall foundations. The wall foundations and stone pads both directly overlay an orange/ brown natural clay soil.

Figure 34 East facing view of stone pads overlying clay

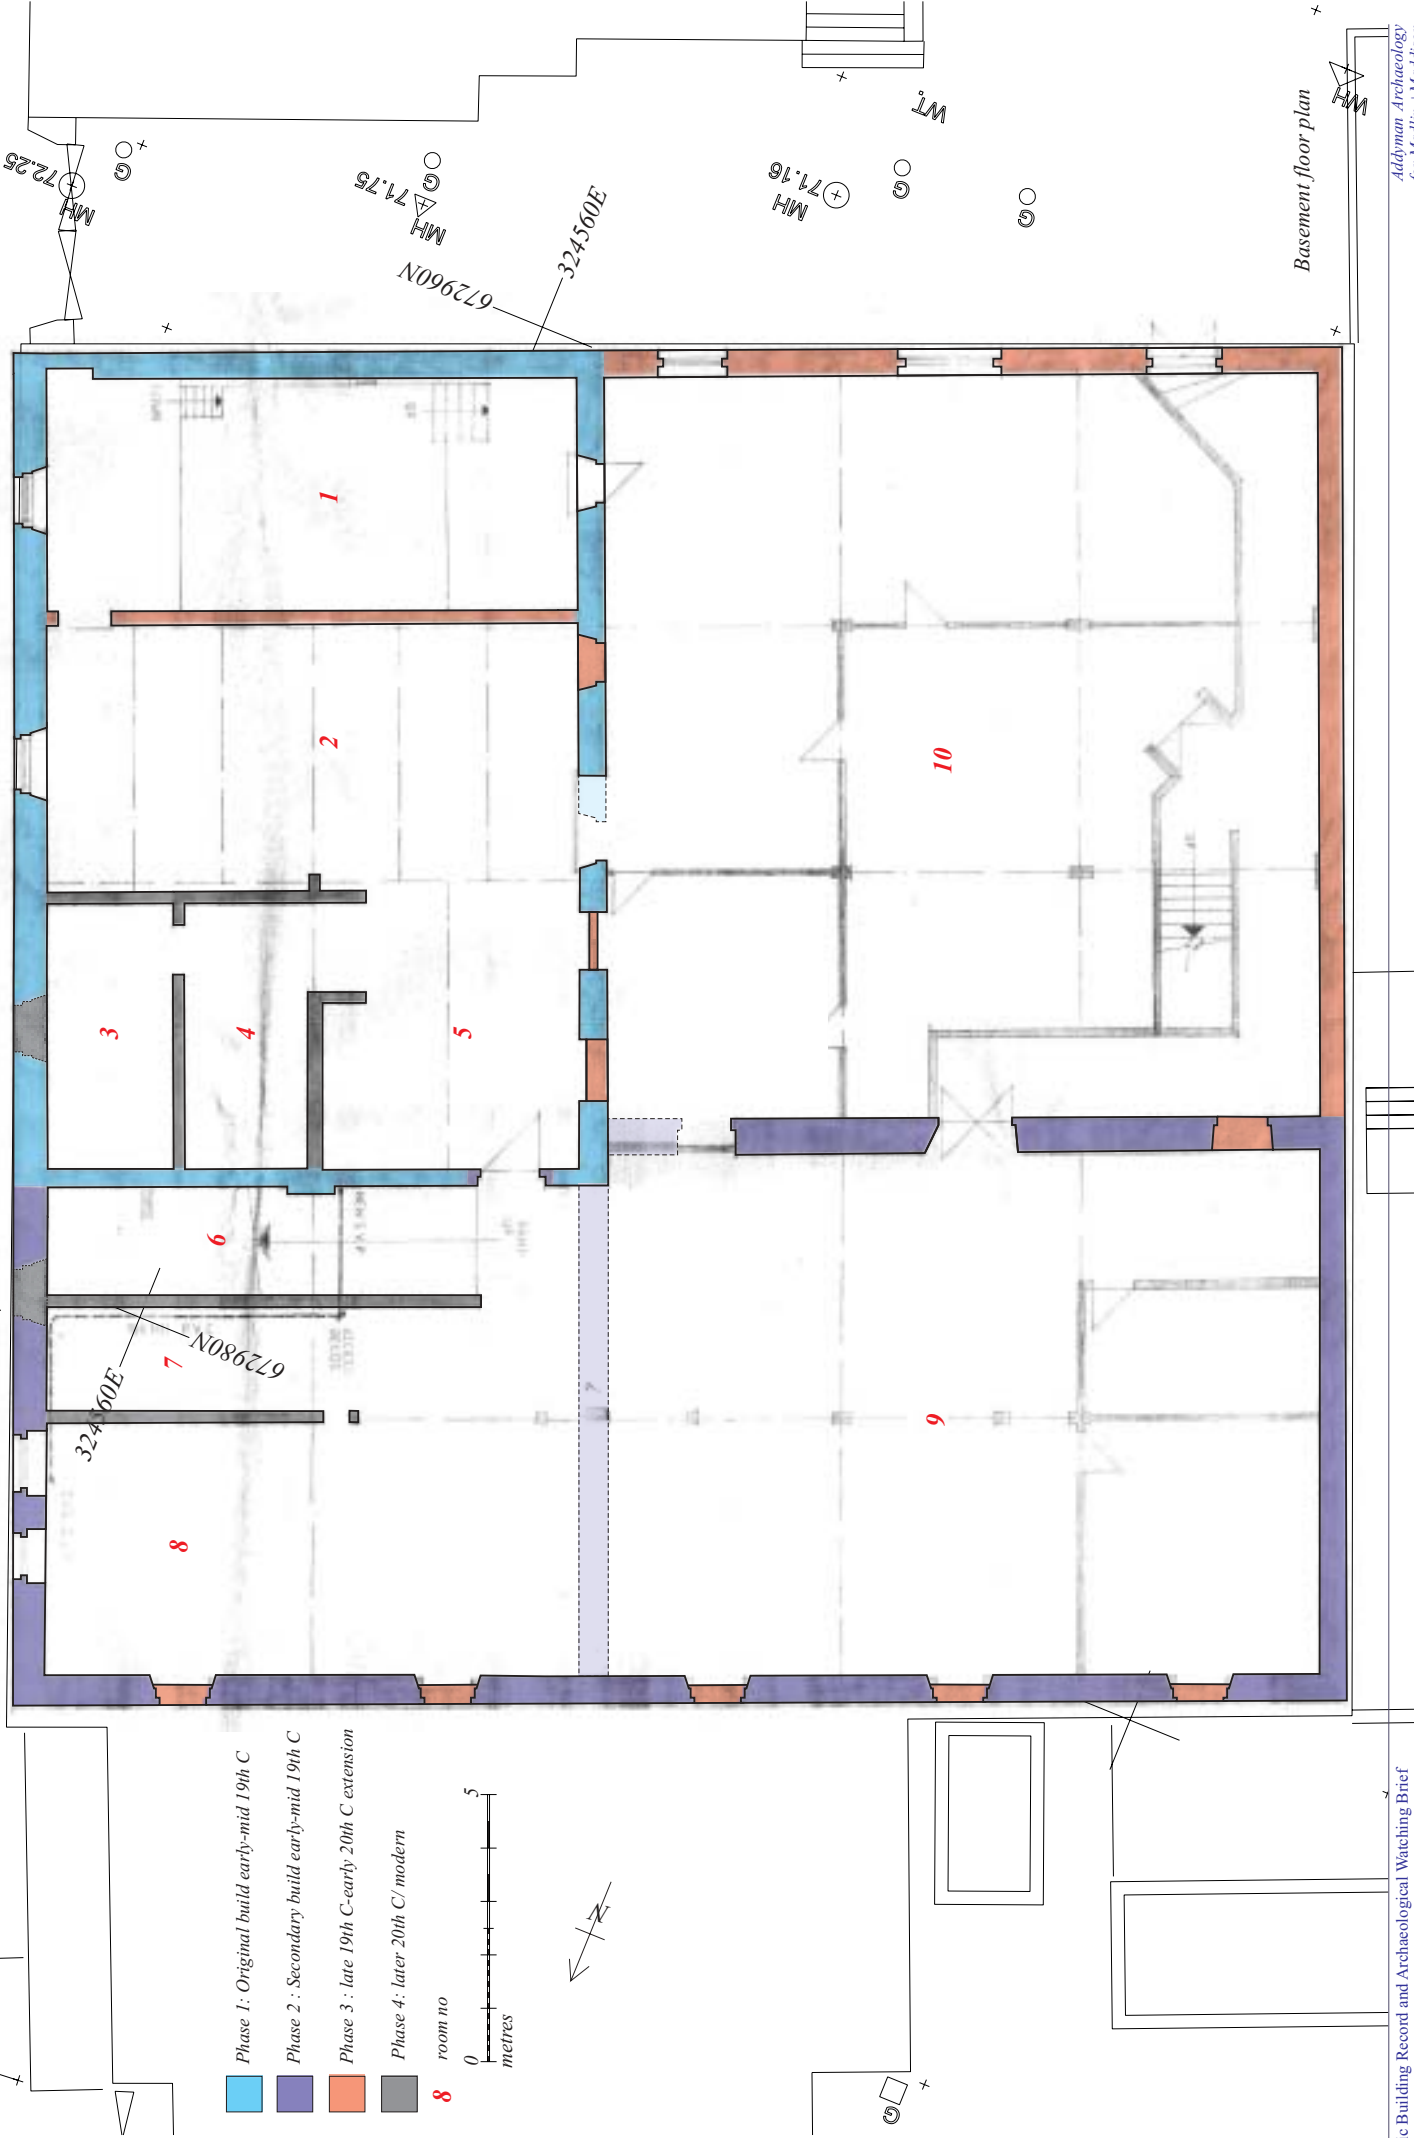
Basement floor plan

- Phase 1: Original build early-mid 19th C
- Phase 2: Secondary build early-mid 19th C
- Phase 3: late 19th C-early 20th C extension
- Phase 4: later 20th C/modern

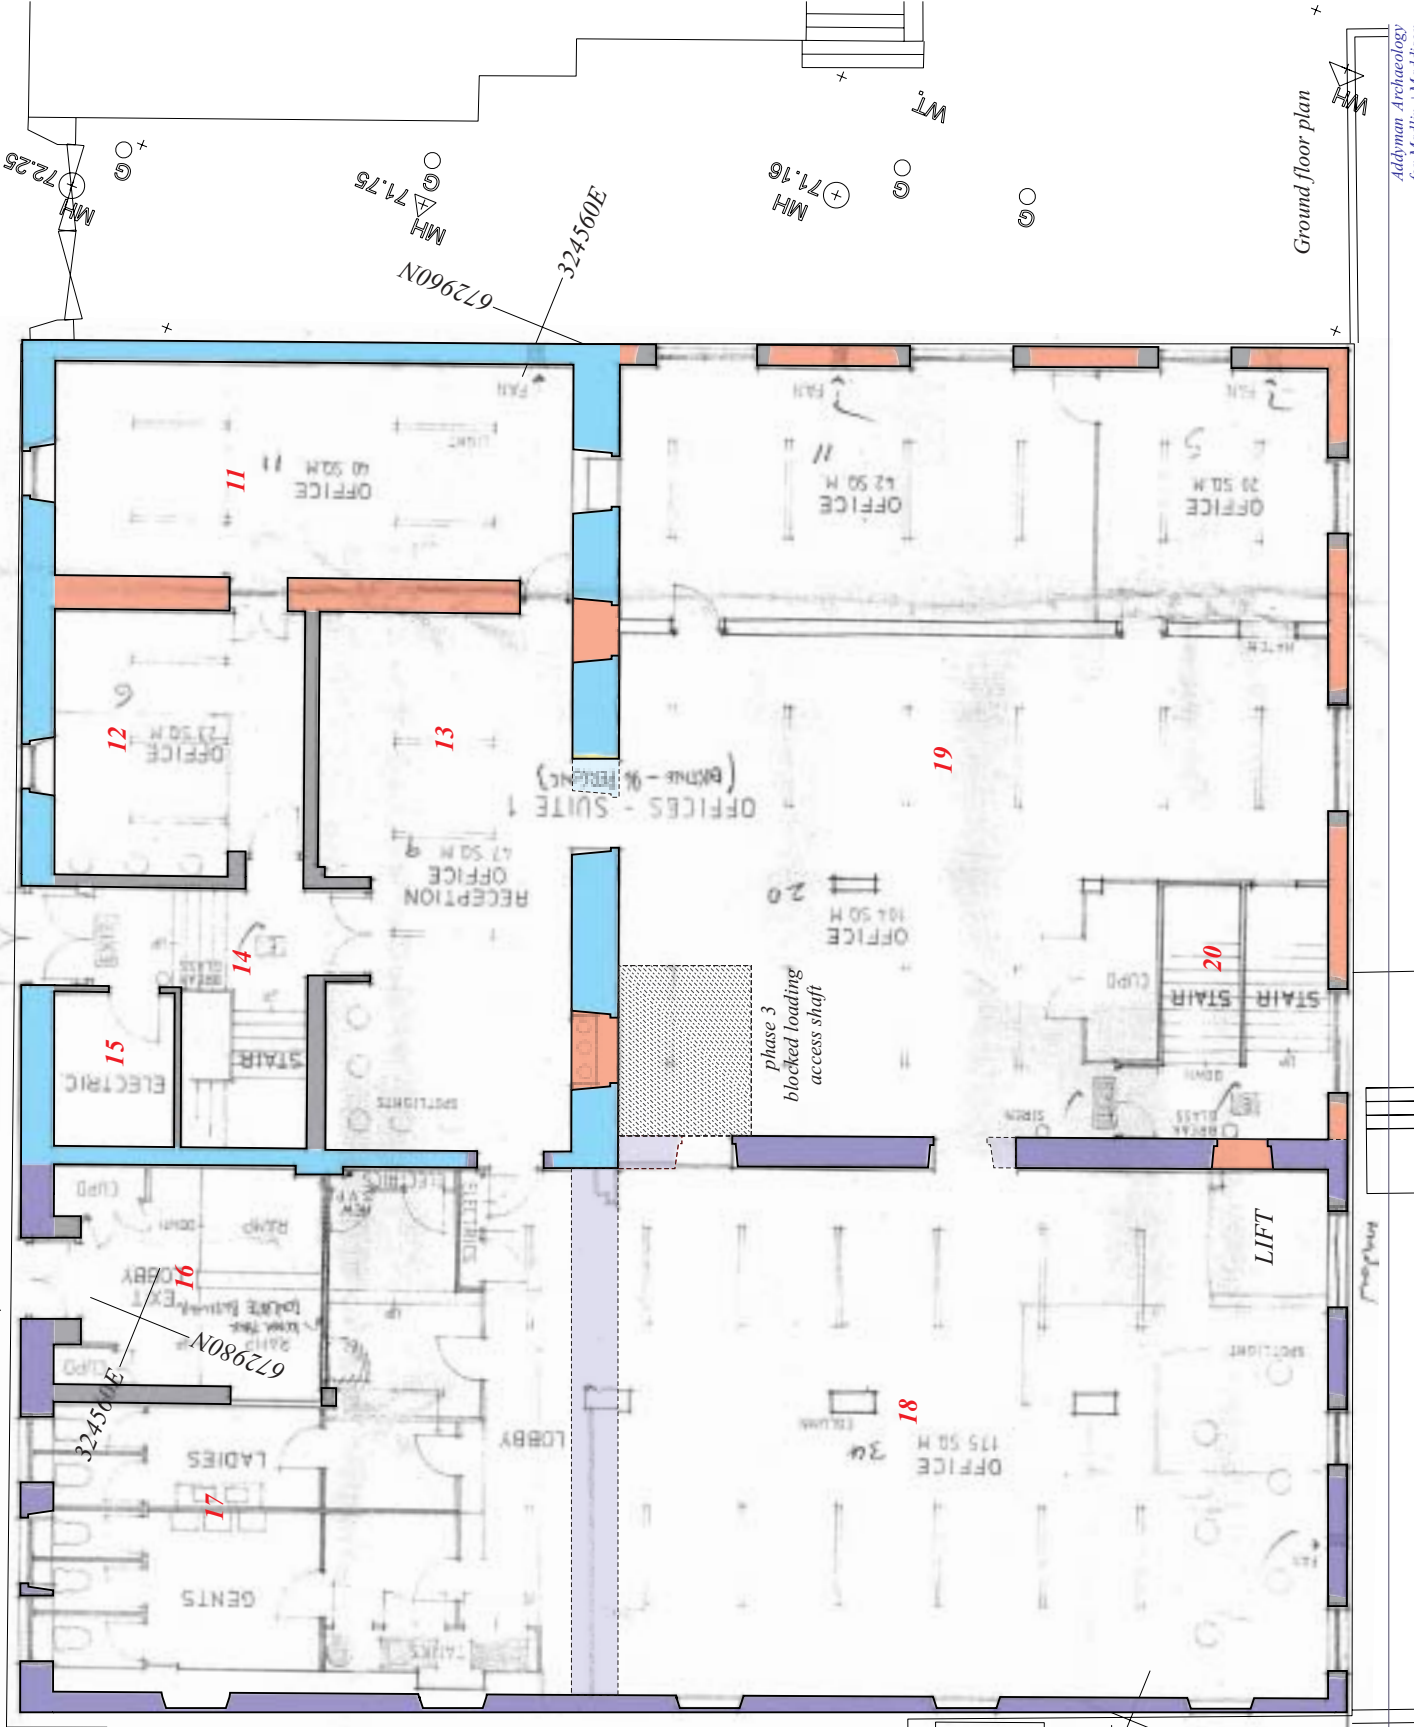
Ground floor plan

- Phase 1: Original build early-mid 19th C
- Phase 2: Secondary build early-mid 19th C
- Phase 3: late 19th C-early 20th C extension
- Phase 4: later 20th C/modern
