Mavisbank Estate

Loanhead, Midlothian

Visual Topographical Assessment

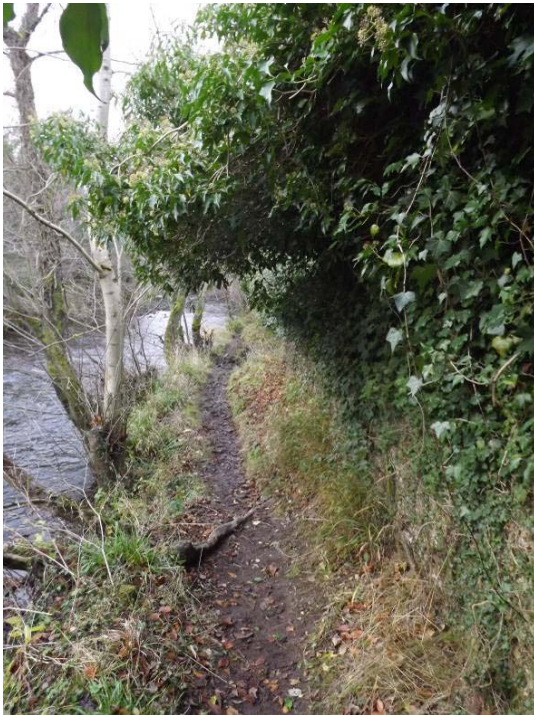
Access to the site is provided from Polton Road and follows an established path along the western bank of the River North Esk. The route of this pathway follows the line of the River and forms a narrow strip of land bordered to the west by a substantial masonry wall which stands over head height.

*Plate 1 Looking SW along the route of path one
(Addyman Archaeology)*

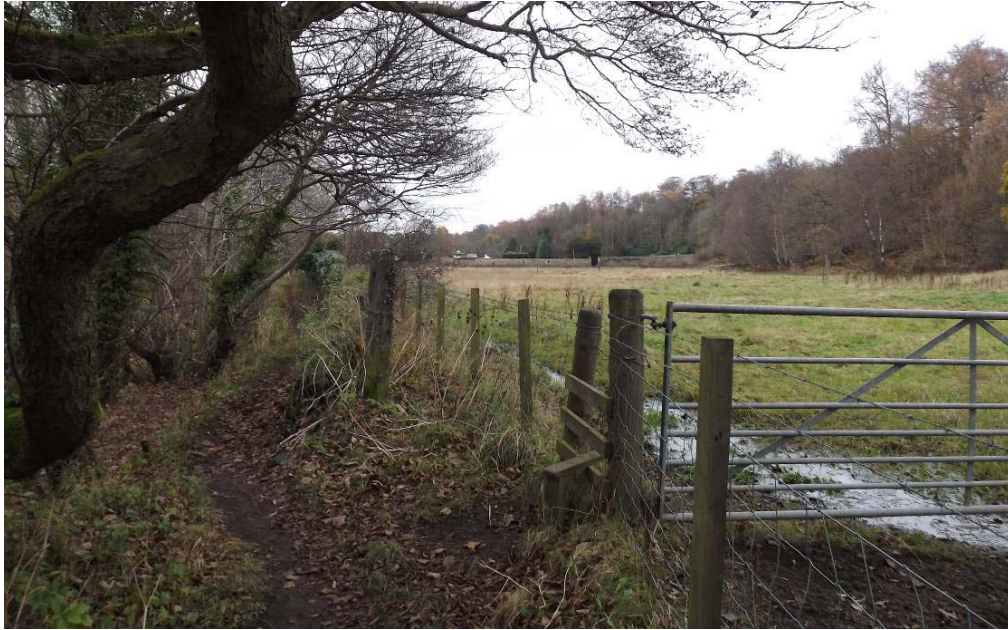
Plate 3 Looking SW along Path Two towards the walled garden

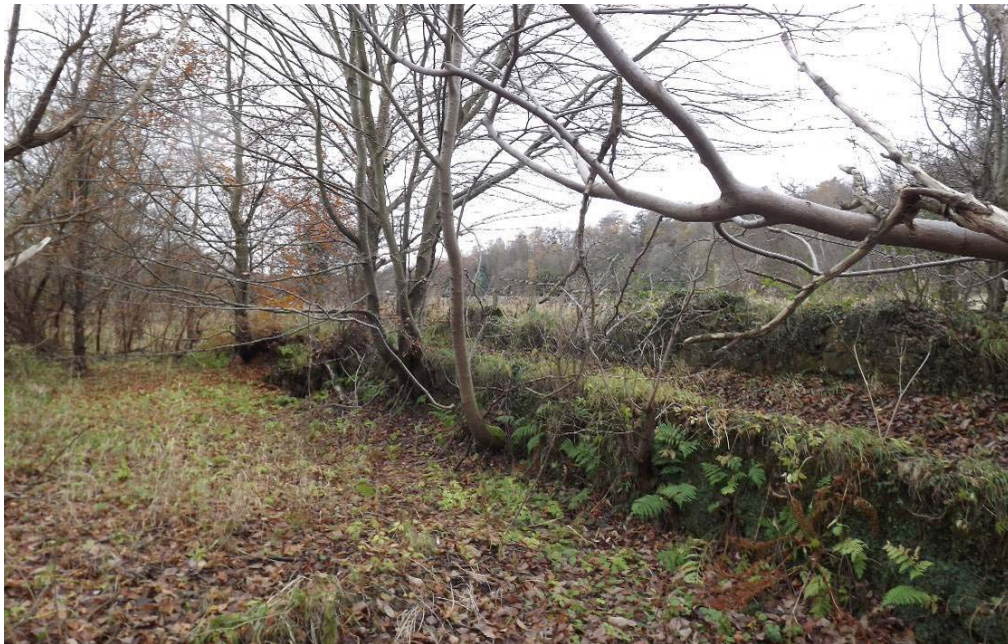
The proposed route of Path 2 continues north east and then northwards along the route of the River North Esk. Unlike Path One, Path Two is bordered to the west by modern fencing, or degraded masonry walls, with much more space available. The pathway remains well used and in areas the surface of the path is built up and revetted by the presence of masonry walling (*Plate 4*).

Plate 4 Revetting wall along the route of Path Two, building up this area to form a raised pathway

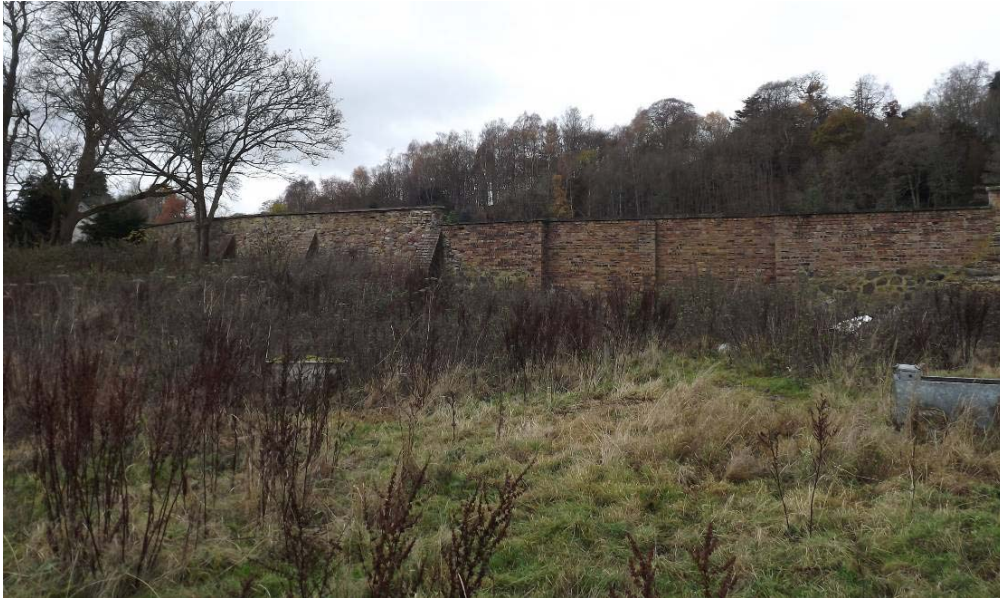
Unlike Path One and Path Two, Path Three cuts across an area where no clear path network currently exists. Desire lines cross the site in this area, following the natural route the topography allows towards Mavisbank House, and essentially skirting around the Walled Garden.

Plate 5 Looking SW towards the Walled Garden

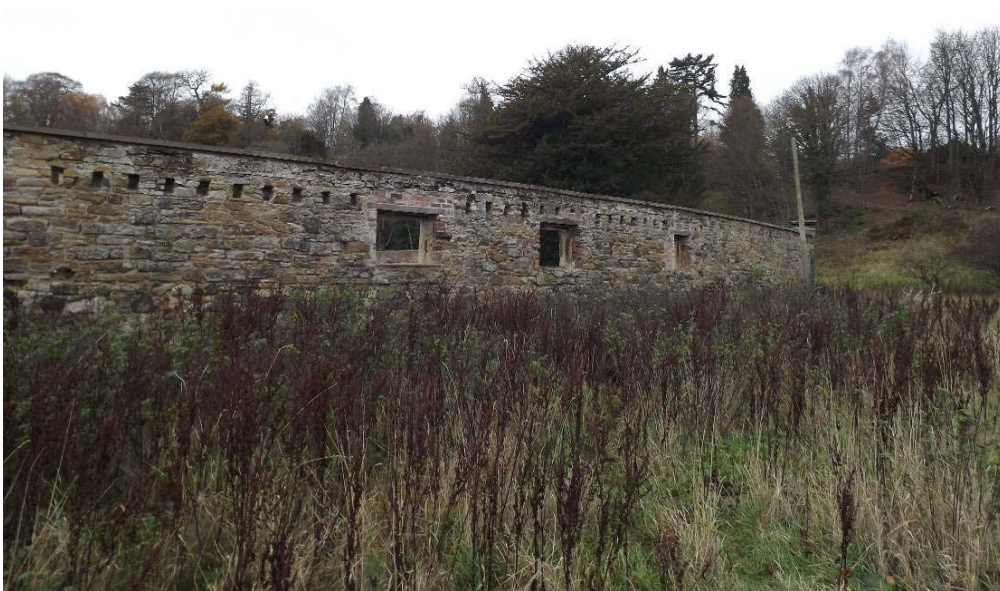
As discussed above, a number of structures are known to have existed along the outside perimeter of the Walled Garden. Of these, the cricket pavilion is the most significant, but some smaller structures preceded this and stables were built adjacent in the latter half of the 20th century. The location of the cricket pavilion can clearly be discerned by the window features in the perimeter wall of the Walled Garden (*Plate 6*).

Plate 6 Looking W across the site of the pavilion

Walking around the perimeter of the Walled Garden, there is clearly potential for surviving remains. The area directly adjacent to the wall is characterised by undulations and mounds crowned with high vegetation. Much of this appears to be detritus from gardening and landscaping activities, but concrete foundations are discernible immediately adjacent to the windows in the boundary to the Walled Garden. Whether these relate to the construction of the cricket pavilion, or later re-use of the building is unclear. A similar concrete foundation pad was noted to the south east on the location of the stable block.

Path Three crosses close to an area where structures are known to exist. In consultation with Charlie Cumming of ELGT, it was felt that the new path should follow the route of the existing desire lines. Two concrete foundations were noted along the length of the Walled Garden perimeter. Both of these extended 15m from the wall. It is felt that Path One should avoid these foundations for both archaeological and practical reasons, with a further buffer of c.1.5m. There is clear evidence that the Walled Garden was compressed after the realignment of the River North Esk and it is possible that remnants of the original east garden wall will survive in the area adjacent to the Walled Garden and crossed by Path Three. Although both possible alignments of Path Three from the River North Esk are acceptable, the more easterly of the two is preferable, avoiding the area immediately adjacent to the Walled Garden and any possible disturbance with earlier buried remains there. After Path Three passes the site of the cricket pavilion, this will be free to continue curving around the Walled Garden.

Addyman Archaeology recommend that a watching brief is maintained on all ground breaking works around the periphery the Walled Garden in the area of the cricket pitch.

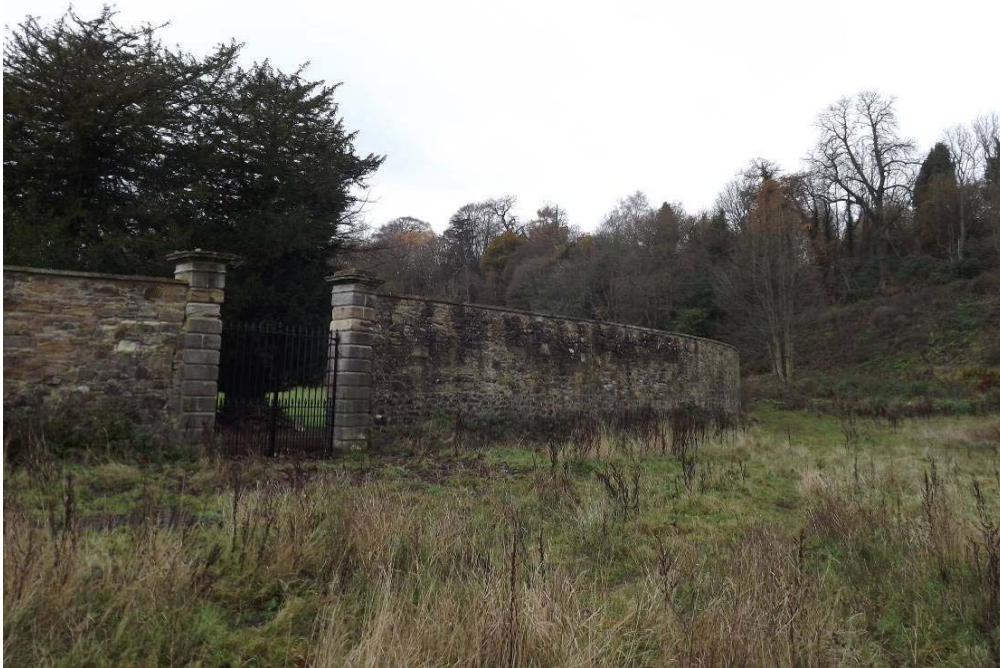
The desire lines naturally avoid these higher areas and sweep gently around the Walled Garden, only coming closer to the Walled Garden after they have passed the concrete plinth at the site of the cricket pavilion. As the route passes by the entrance through the Walled Garden, it comes much closer to the wall. It is possible that there may be earlier path networks in this location linking up with the entranceway.

Plate 7 Looking SW from the cricket pitch across the entrance into the Walled Garden

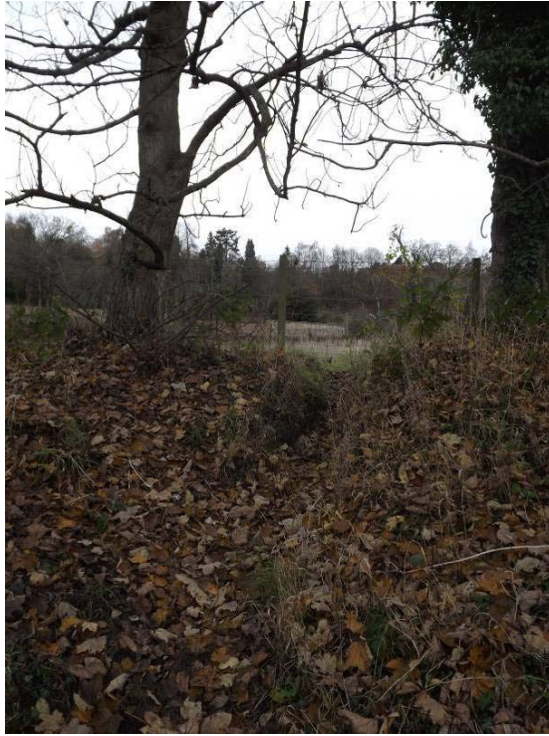
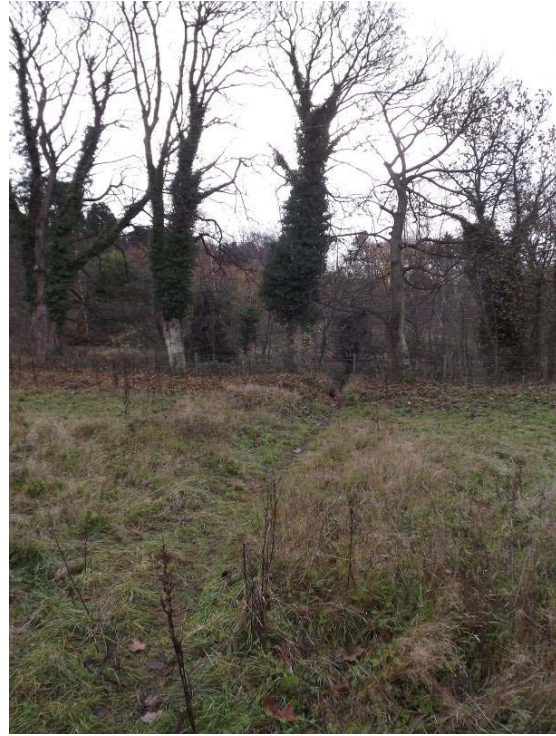
Two possible alignments of Path Three were discussed on site, a junction with Path One and Path Two (marked B on *Figure 1*) and an existing access through the fence line slightly further north (*Plate 8* and *Plate 9*). This second entrance seem to be formed from an attempt to drain the Cricket Ground area, but has subsequently been used for access. The desire lines here link up with those that sweep around the Walled Garden.

Plate 8 View looking W to the proposed new entrance to Path Three

Plate 9 Looking E along the drainage ditch and desire lines to the proposed new entrance to path Three
