# York Art Gallery, York City of York

Data Structure Report– Archaeological Watching Brief for the Investigation of Electrical Mains Cables

York Museums Trust

March 2014

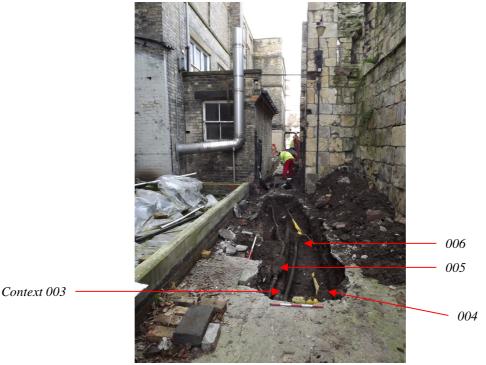
Figure 2 Post-ex view of trench facing NW (015)

A thin layer of concrete (0.10m - 0.15m deep), context 001, was removed. This directly overlay a deposit of mid-dark greyish brown clay-rich organic soil of moderate compaction, context 002. This level was interpreted as a redeposited fill of multi-period detritus located within the modern gas, electric, and water services trench. The water mains, context 003, gas supply, 004, and two electrical services, 005-006, were seen running NW-SE, with the electrical mains cable running into the timber and brick outbuilding attached to the gallery.

As the services were located relatively near to the surface and were grouped fairly close together, the width and depth required of the trench meant that the limits and full depth of the multi-period fill (002) was not located – i.e. no trench cut was identified with the excavation limits. Owing to the fact that the investigation trench was positioned to reopen a pre-existing service trench, and the excavated depth did not extend below that redeposited single fill (002), no secure archaeological finds or features were encountered during this operation.
